U.S. Department
of Transportation
**Federal Railroad
Administration**

STUB SILL TANK CAR RESEARCH PROJECT RESULTS OF A 15,000-MILE OVER-THE-ROAD TEST

DOT\FRA\ORD\95-11

September 1995

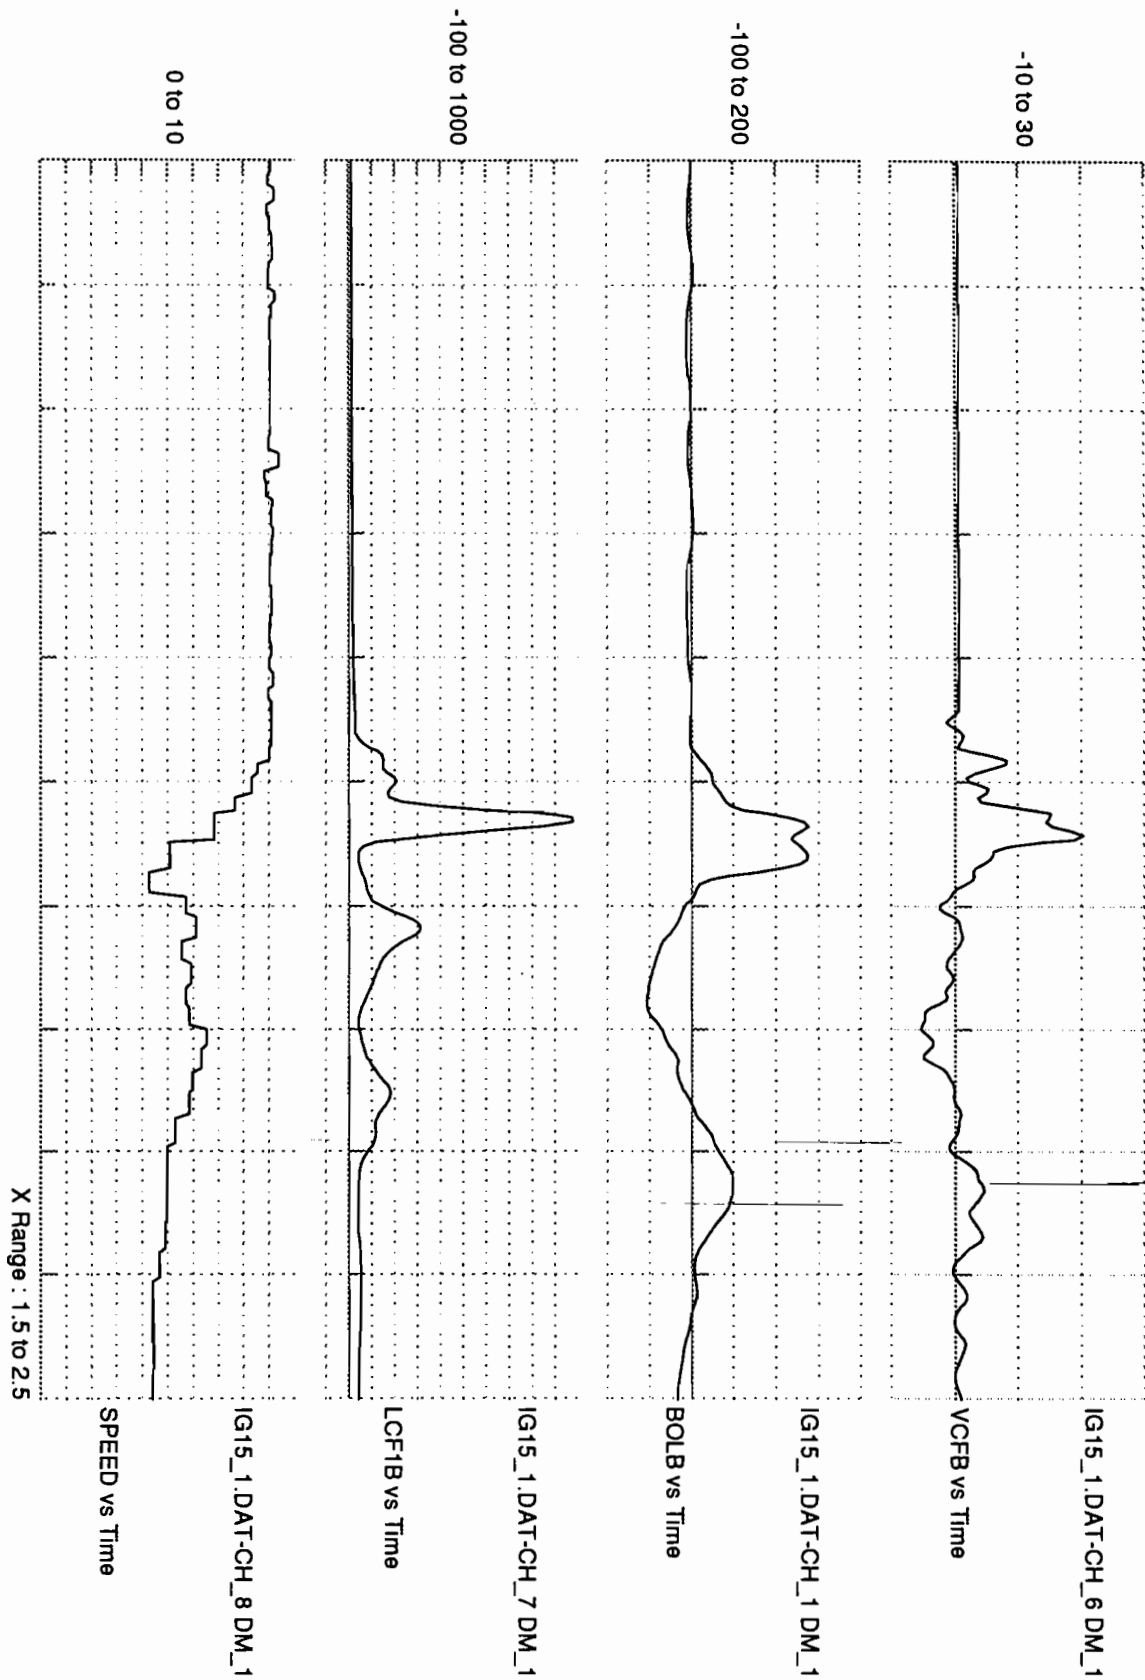
Figure 61. Surge Pressure Impact Test 9 mph Configuration A

9.0 MPH IMPACT CONFIGURATION A

Figure 61 shows the burst time history data for impact 32 which was a 9.0 mph impact in the A configuration. From this data, an estimate of the rigid body acceleration of the tank car can be derived from the SPEED vs TIME time history. From Figure 58, the change in speed (ΔV) is 4.8 mph during a time (Δt) of approximately .1 seconds. This corresponds to an average rigid body acceleration of 70.4 ft/sec² or approximately 2.2 g's which is a reasonable result. This illustrates that the 10 g's as recorded by the Shock Watch units have a higher frequency response (approximately 15 Hz) and as such are measuring the shock response of the tank car and the rigid body acceleration combined. When reviewing the data from the Shock watch units, the shock response as measured must not be confused with the rigid body acceleration values as illustrated above.
