Report No. FRA-OR&D 75-32

COMPARISON OF THERMALLY COATED AND UNINSULATED RAIL TANK CARS FILLED WITH LPG SUBJECTED TO A FIRE ENVIRONMENT

9. Performing Organization Name and Address U.S. Army Ballistic Research Laboratories Aberdeen Proving Ground, Maryland 21005				10. Work Unit No. (TRAIS)

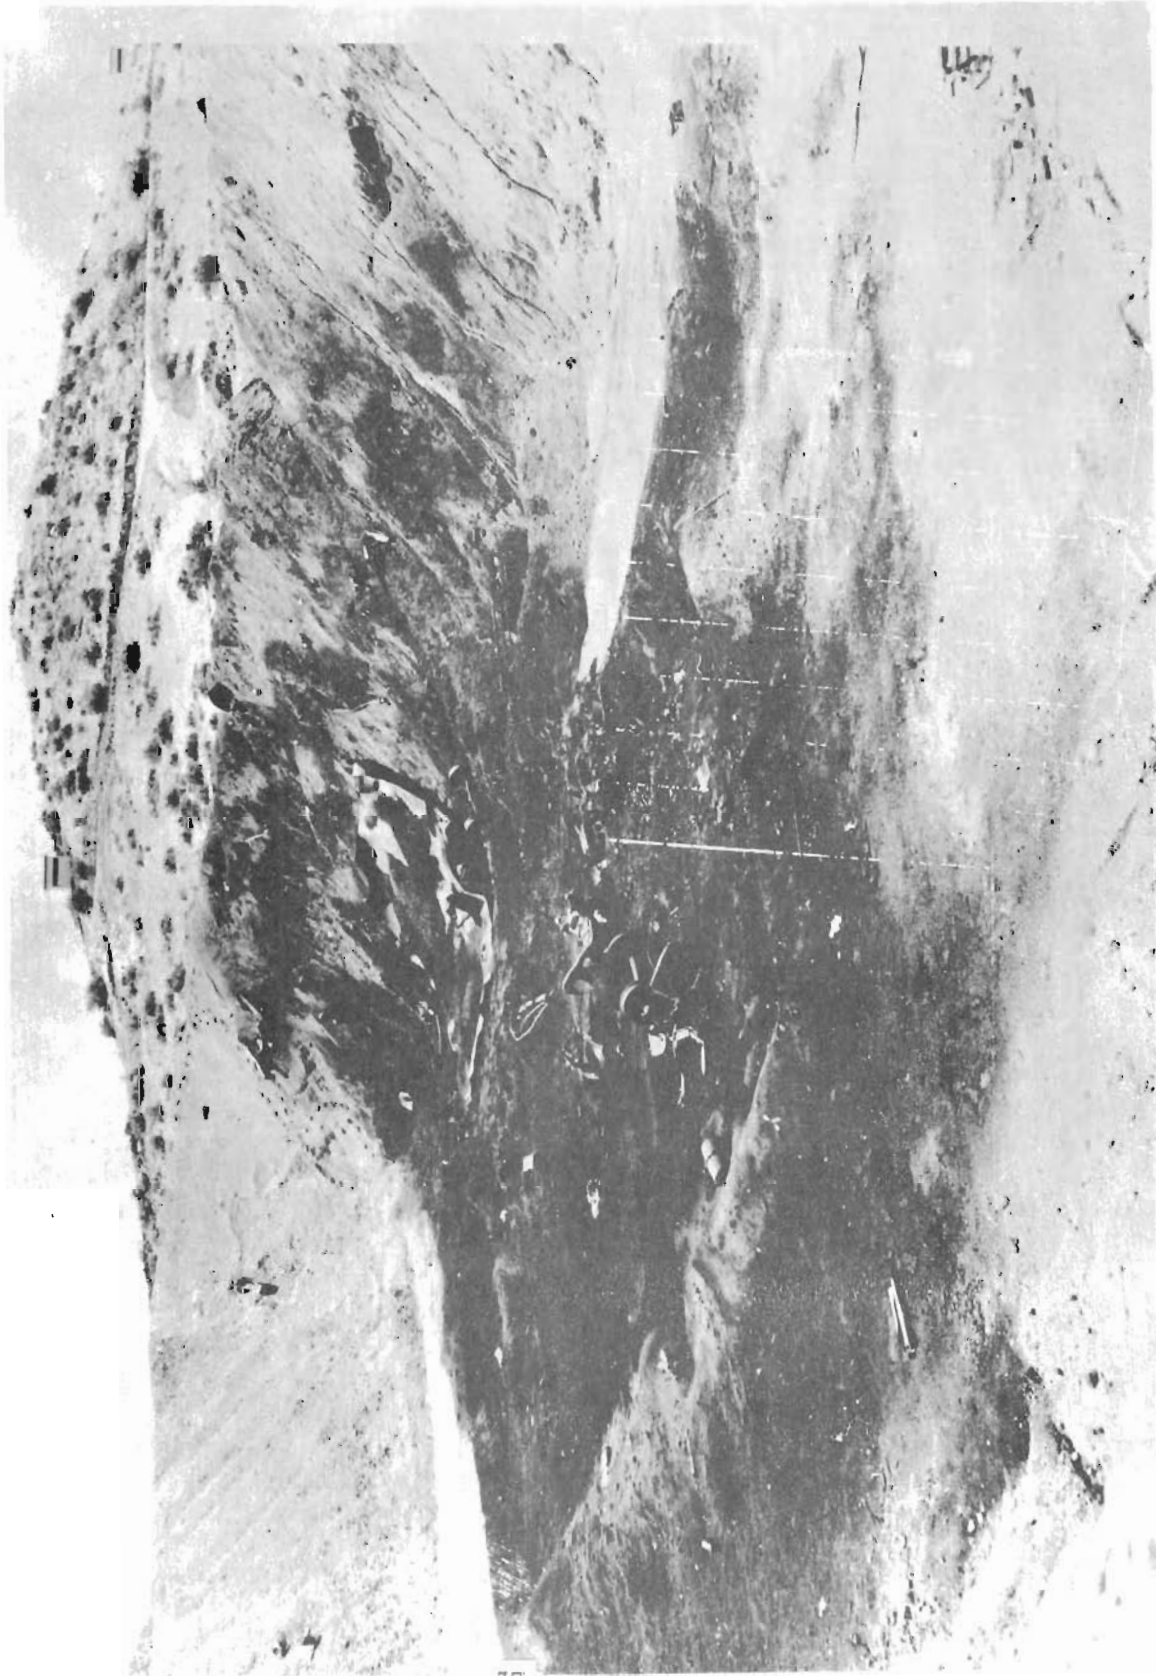
Figure 13. Fragment of RAX 201 in Test Pit

The cylindrical portion of the tank shell fragmented into two very large pieces, and several small sections. One of these major pieces, more or less flattened out from its cylindrical shape, is shown in the photograph of Figure 13. The other large piece of the cylindrical shell was hurled 133.4m (437.7 ft) from the center of the test pit. Figure 14 shows this, the largest fragment. Its relative size can be compared with the height of the two men investigating the fragments. Figure 15 is the main body of the tank car reassembled on paper from the fragments. The fracture paths and the initial fracture site are also depicted on this drawing. Several of the major fragments, Figure 16, can be seen and identified in the aerial photograph of the test area as it appeared one day after the fire test on RAX 201. Figures 17 and 18 are scaled maps of the general test area, and the area in the vicinity of the test pit. These two figures show the general distribution of the fragments. The fragment numbers of Figures 17 and 18 are identified in Table V. The ten major fragments and their respective distances from the center of the test pit are summarized in Table VI. Counting all the pieces of the tank car that were found and identified, including pieces of catwalk, trucks and wheels, etc., RAX 201 ruptured into approximately 65 fragments. Fragment number 47, a large piece of the catwalk was hurled the farthest, 407m (0.25 miles).
