TANK CAR HEAD PUNCTURE MECHANISMS

SCHOOL OF ENGINEERING AND APPLIED SCIENCE

FINAL REPORT

1. Report No. FRA-ORD-76/269	2. Government Accession No.	3. Recipient's Catalog No.	
4. Title and Subtitle TANK CAR HEAD PUNCTURE MECHANISMS		5. Report Date April 1980

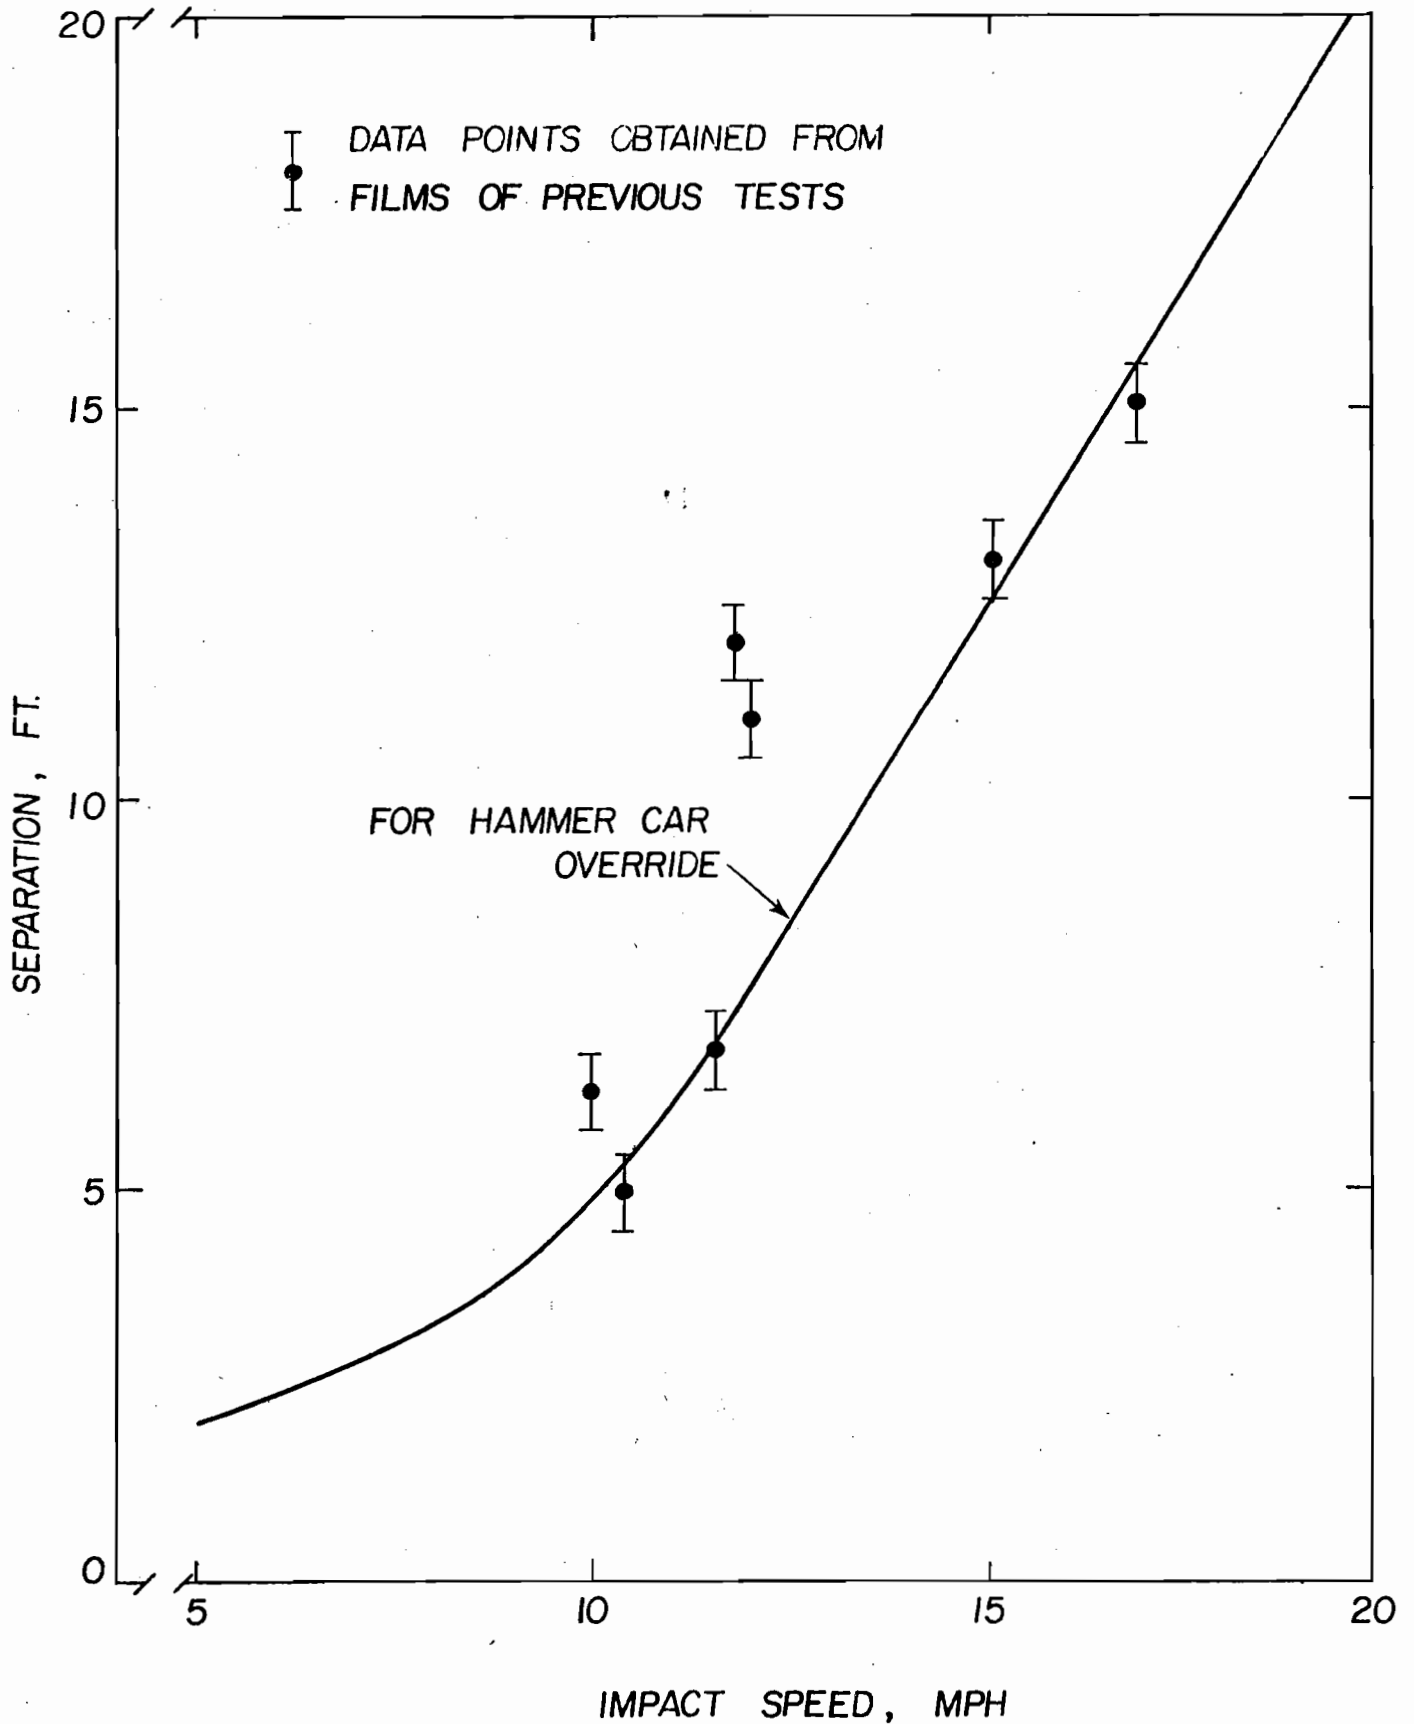
Figure 10 Car spacing for triple impact override

Series 1b was performed without back-up cars in order to generate a curve, similar to Figure 10, that could be used to determine spacing. The results showed that the hopper car exit speed was 10% higher for a full tank than for the sloshing tank. Consequently, the most critical spacing for series 2b was taken to be approximately 10% longer than it was for series 2. The first two impacts in Series 2b, however, showed that the predicted spacings would not result in override. The reason for this is that in tests where sloshing was present the tank car was sufficiently slowed by the first impact for the hopper car to separate from it by about one foot before the second impact. This allowed sufficient time for the hopper coupler to rise before the tank car hit again. When sloshing was eliminated by filling the tank car, however, the tank car was not significantly slowed by the first impact. Therefore, it remained close to the outgoing hopper after impact. The slow separation between tank and hopper resulted in two phenomena. First, the chance of coupling was increased over the sloshing case. Second, at the moment of second impact (hopper into back-up) the cars were so close that the hopper did not have time to rise before the third impact (tank into hopper again). Therefore override was not obtained.

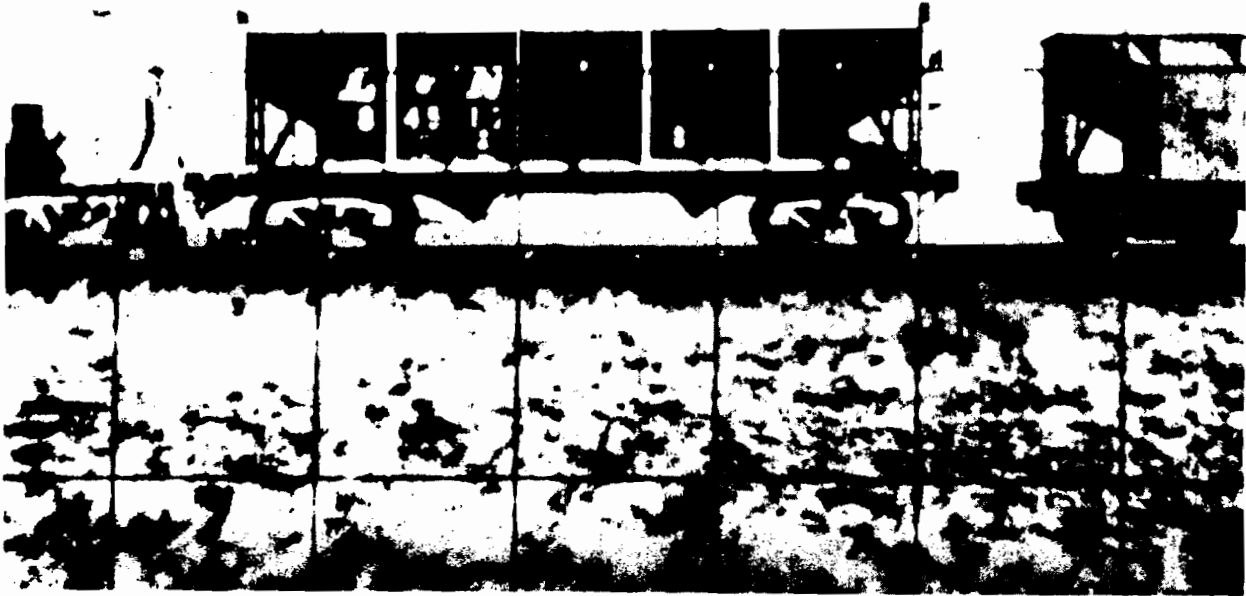
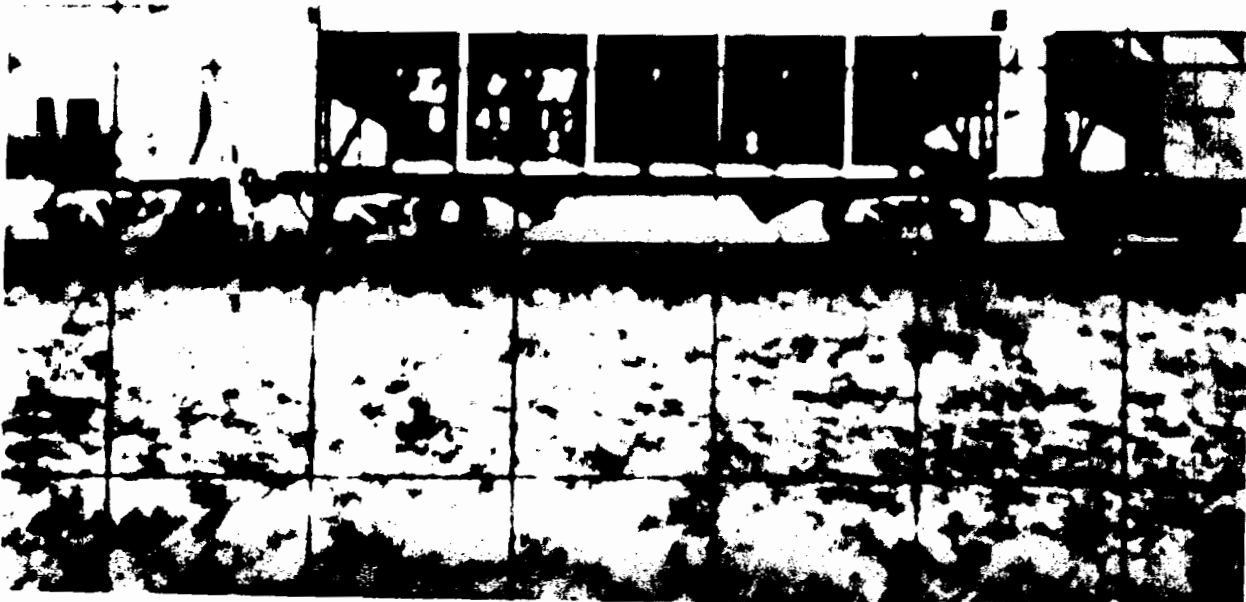
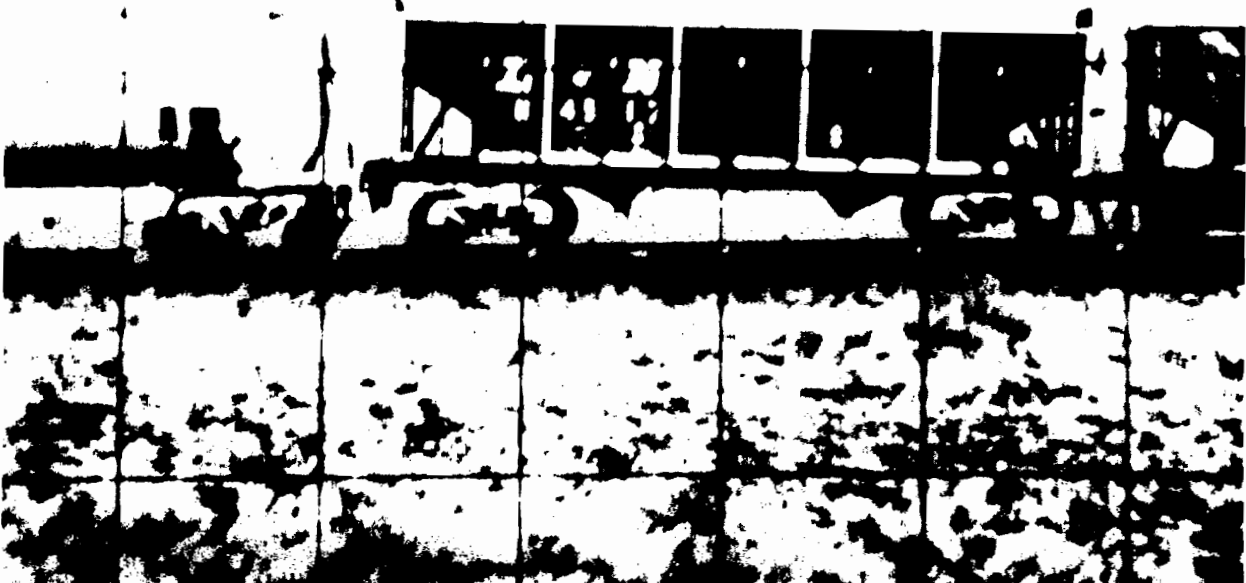
Figure 11 Triple impact mechanism: 11.8 mph first impact

Figure 12 Triple impact mechanism: 11.8 mph second impact

Figure 13 Triple impact mechanism: 11.8 mph third impact

Figure 14 Triple impact mechanism: 11.8 mph override

The first collision to result in coupler override occurred on January 30, 1976. The sequence of events is illustrated in Figures 11-14. Figure 11 shows the tank car impacting from the left, which causes the right end of the light hopper car to pitch up. Figure 12 shows the right end of the hopper car at the low position as it impacts the first back-up car. This second impact then caused the left end of the hopper to pitch up. Figure 13 shows the subsequent third impact (second tank car impact). Dust and metal can be seen coming from the coupler faces as they slide with respect to each other. Figure 14 shows the final position after the hopper car coupler has disengaged and overridden the tank car coupler. This was the first time that a predicted coupler override was experimentally verified. There was not enough energy remaining, however, to cause a puncture or tear in the tank.

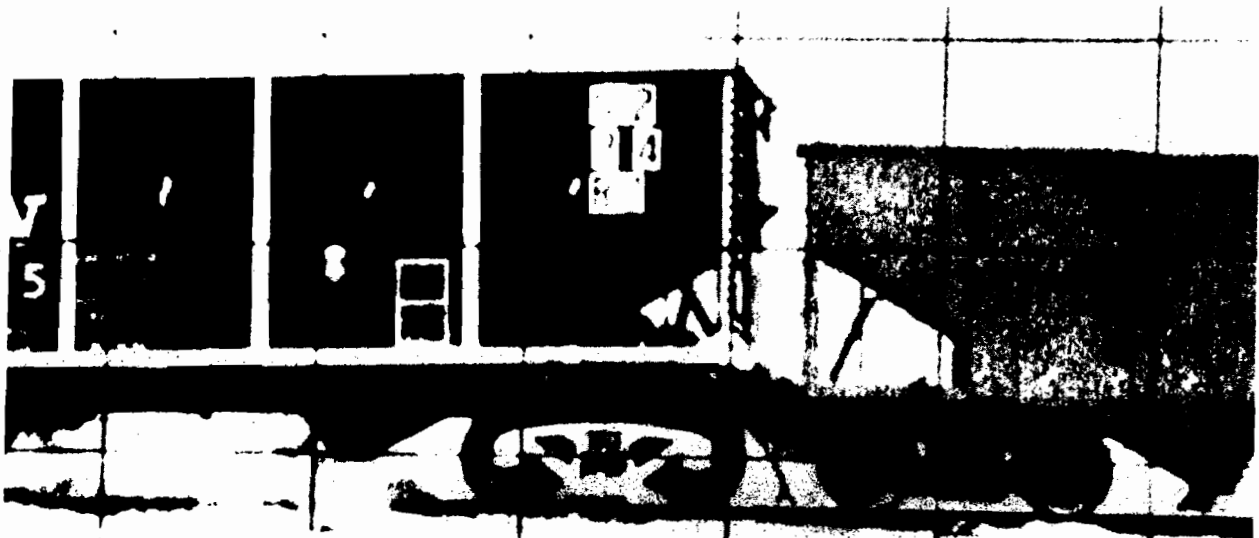
Figure 16 First rise, 13.7 mph

Figure 17 First fall, 13.7 mph

Figure 18 Second rise, 13.7 mph

Figure 19 Second impact, 13.7 mph

Figure 20 Override, 13.7 mph

The final test of series 2b was run with the spacing for a single bounce. In this case, however, the hopper car derailed. The derailment slowed the car so that it experienced a complete pitching oscillation before the second impact. Figures 16-20 show the sequence of events. In Figure 16 the hopper car is pitched up due to the impact from the left, in Figure 17, it comes down, and in Figure 18 it bounces up again. Figure 19 shows that the second impact occurred when the coupler was still elevated from the first bounce. The resultant eccentricity caused the coupler to break, as shown in the figure. After the coupler broke, the light hopper override the back-up car, Figure 20. This was the first photographed override involving a broken coupler. A photo of the broken coupler is shown in Figure 21. The coupler was made of grade C steel.

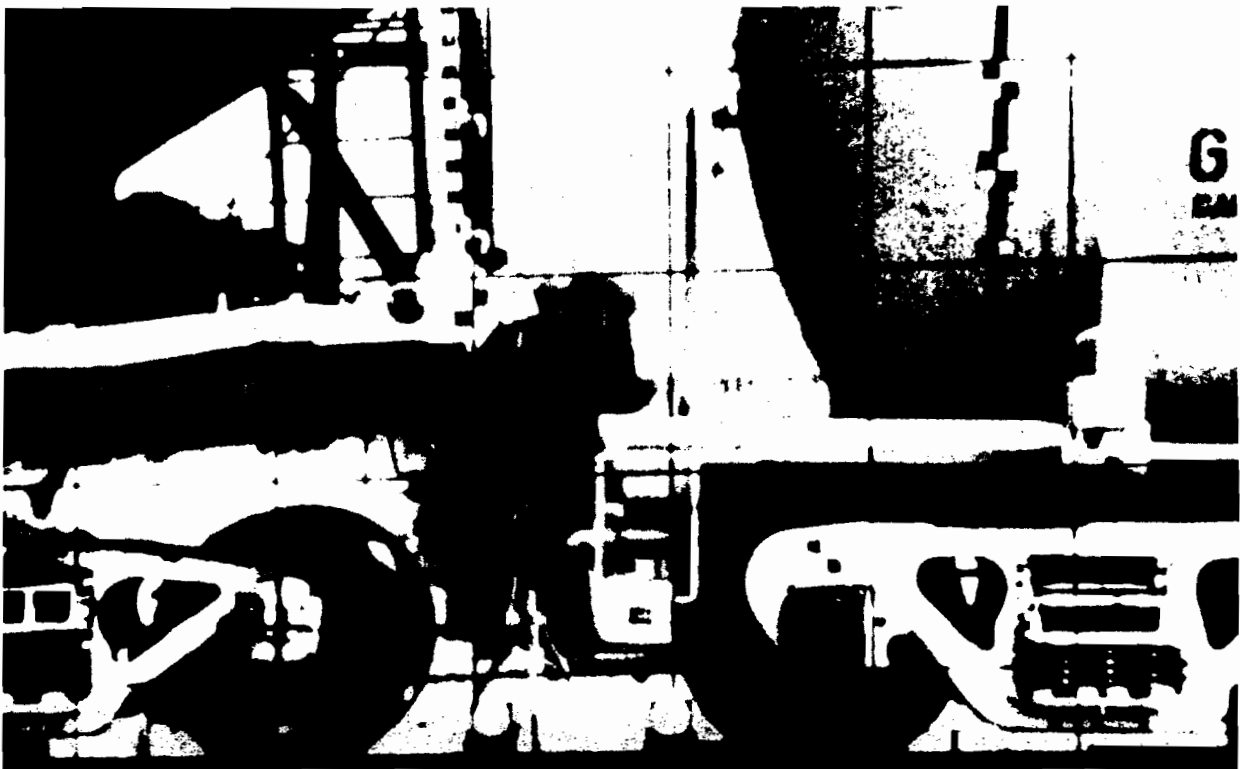
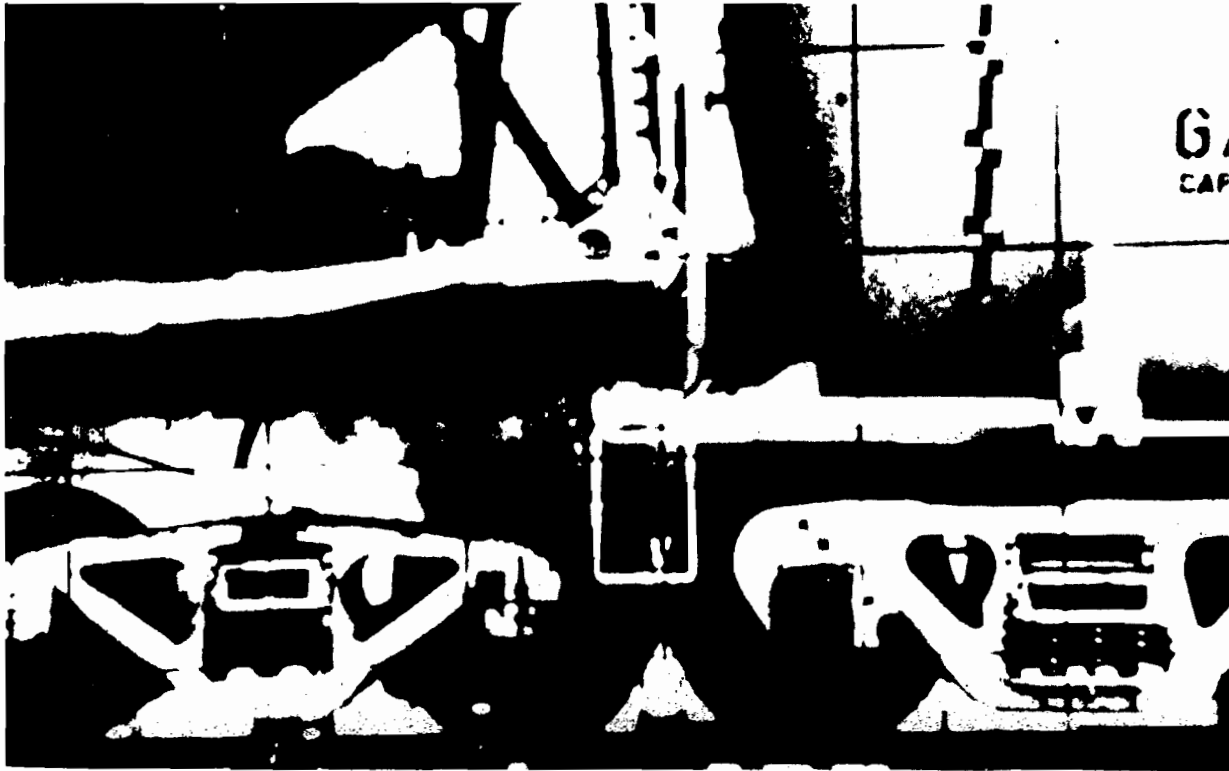
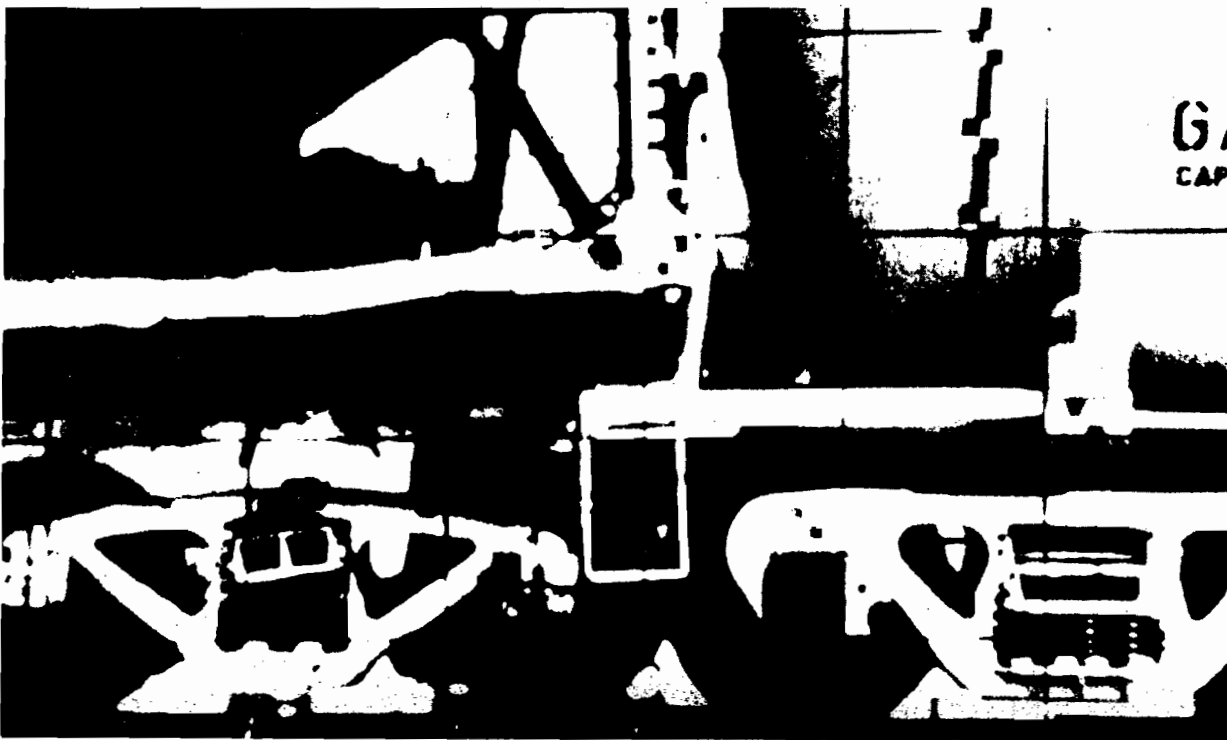
Figure 23 Coupler face slipping, 12.7 mph

Figure 24 Coupler override, 12.7 mph

Figure 25 First hit of tank car head, 12.7 mph

Figure 26 Second hit of tank car head, 12.7 mph

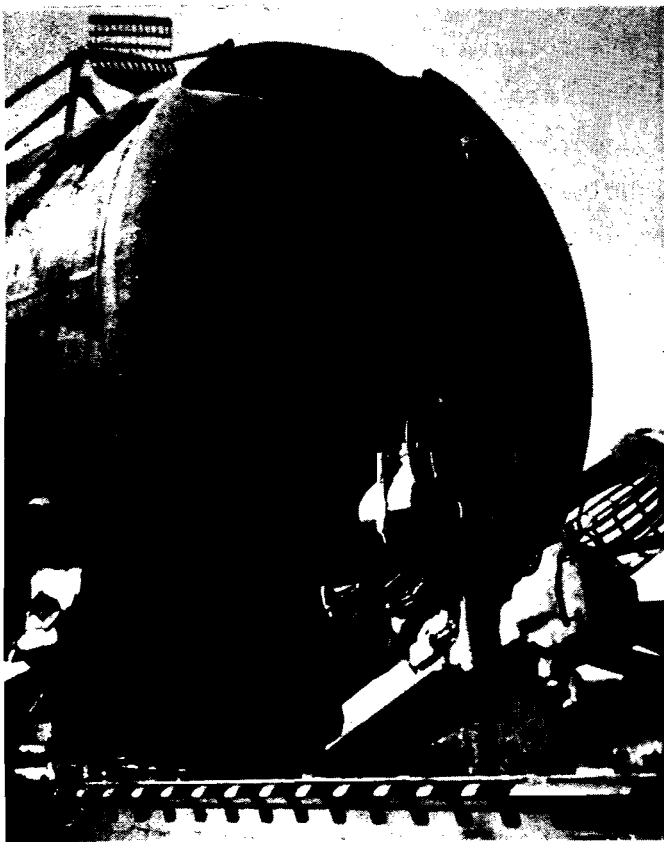
Figure B3

Damage to trailing end
of car 5

The tank head of the trailing end of car 5 has clear marks of a coupler impact approximately half way up the tank, which is approximately five feet above the coupler. The marks made by the coupler are those of the lower edge of the knuckle and guard arm, which progress upward for approximately 18 inches and terminate in a ductile penetration of the tank head. This initiated a brittle fracture which resulted in separation of approximately 20% of the upper left portion of the tank head, see Figure B3. As a result of these observations it was concluded that car 6 overrode car 5. The stub sill of the trailing end of car 5 is bent up to approximately 20 degrees. This allowed car 6 to move upward.
