Report No. FRA-OR&D 75-49

A METALLURGICAL ANALYSIS OF ELEVEN STEEL PLATES TAKEN FROM A TANK CAR ACCIDENT NEAR CALLAO, MISSOURI

**SEPTEMBER 1972
FINAL REPORT**

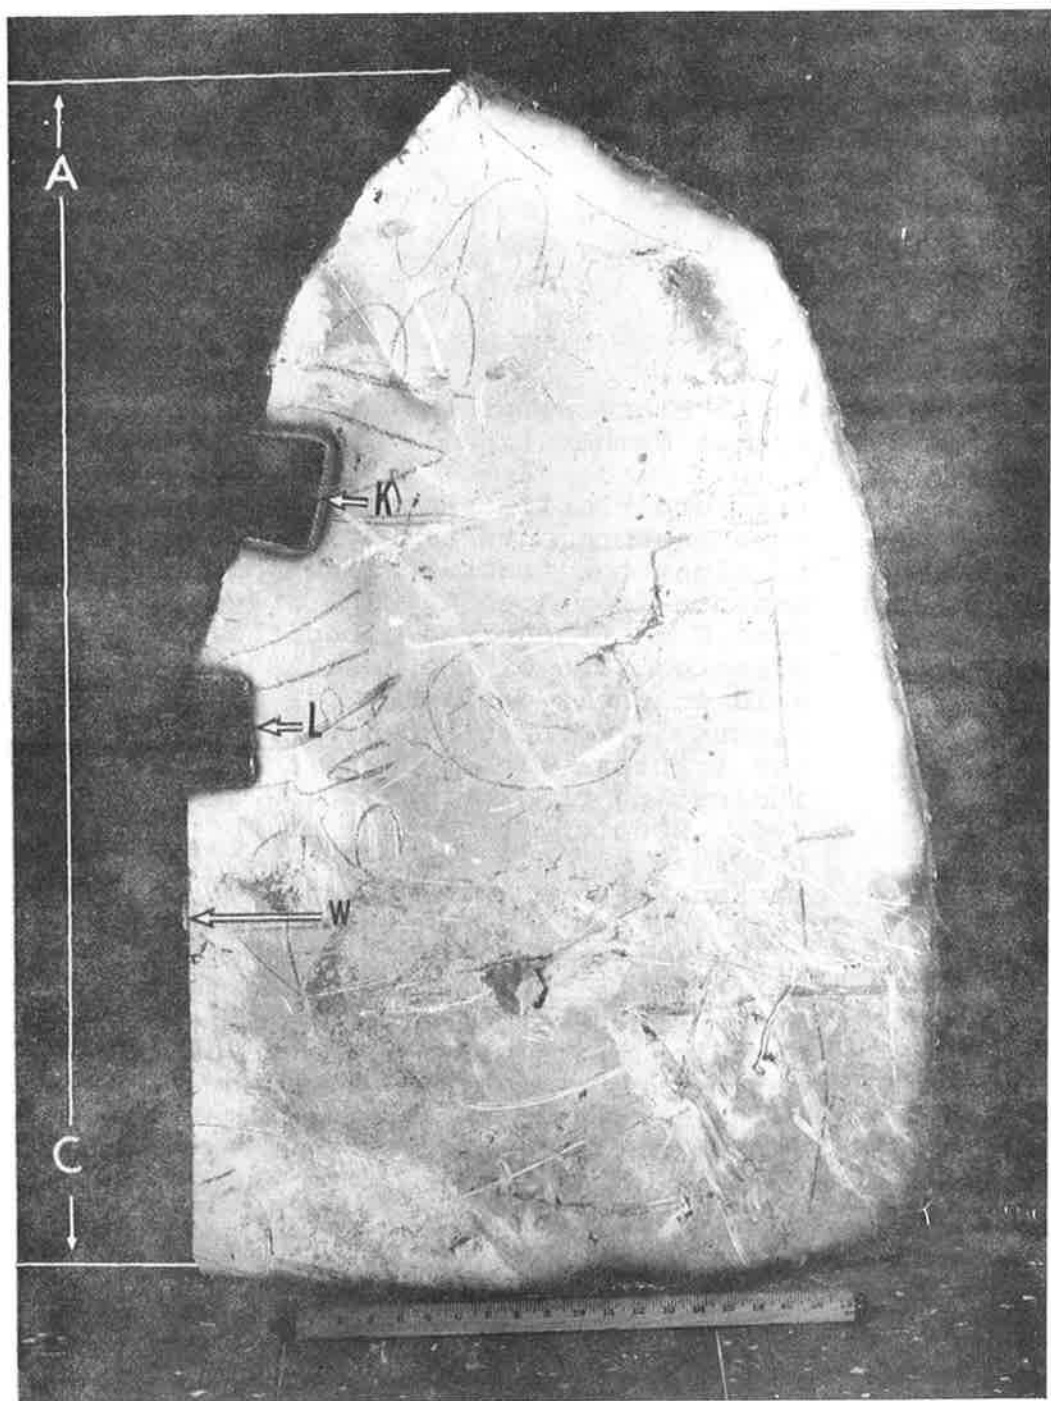
Figure 8. Shell-Plate Sample K-6 Taken from Course Number 1.

Fracture profile photographs and thickness measurements were taken at K and L, along the fracture line which extends from A to C. The fracture from C to L occurred along the heat-affected zone of the longitudinal weld in shell course number 1. In figure 3, we have added plate K-6, the fracture line A-C and the arrows indicating crack propagation in plate K-6. None of these were in the original AAR diagram. The region marked W represents an area of weld metal observed along the fracture line below L. The straight line segment, which contains W, is believed to be a heat-affected zone fracture line. White paint is visible on the plate, abraded but not burnt. Photograph of the inside surface at approximately 1/6 magnification.

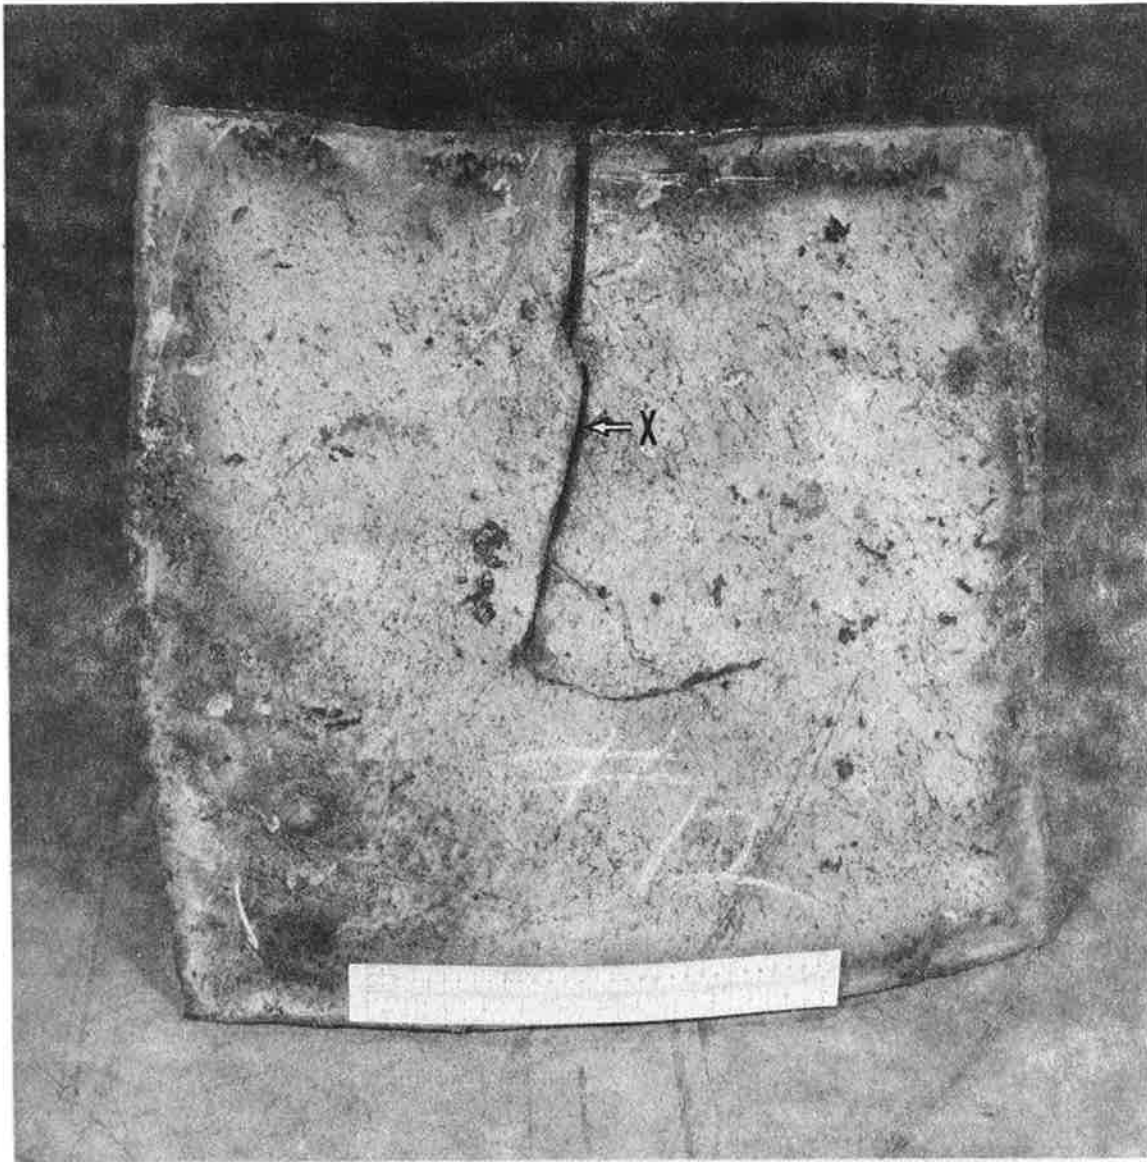
Figure 14. Shell-Plate Sample K-12 Taken from Course Number 4.

The photograph shows a fracture near the dome of the tank car. A fracture-profile photograph and thickness measurements were taken at X. Abraded but unburnt white paint is visible on the sample. Photograph of the outside surface at approximately 1/5 magnification.

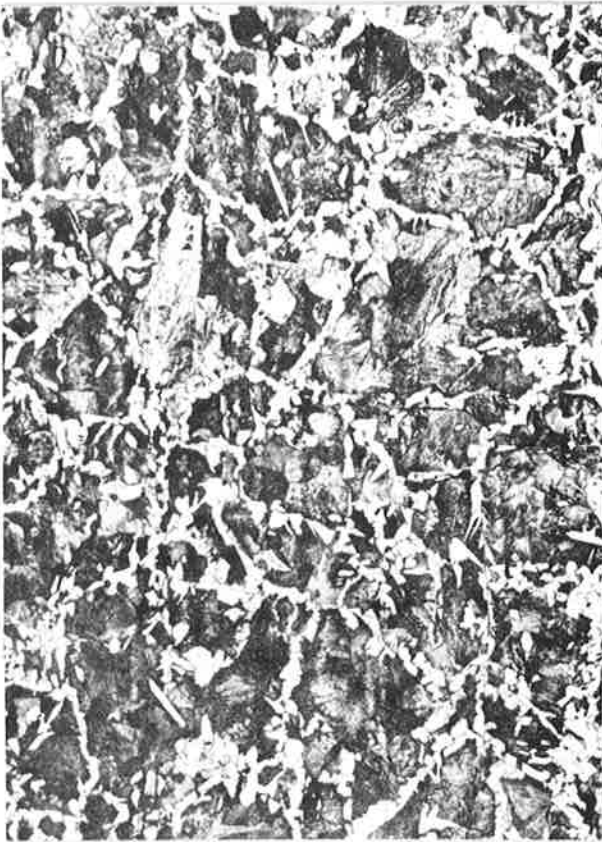
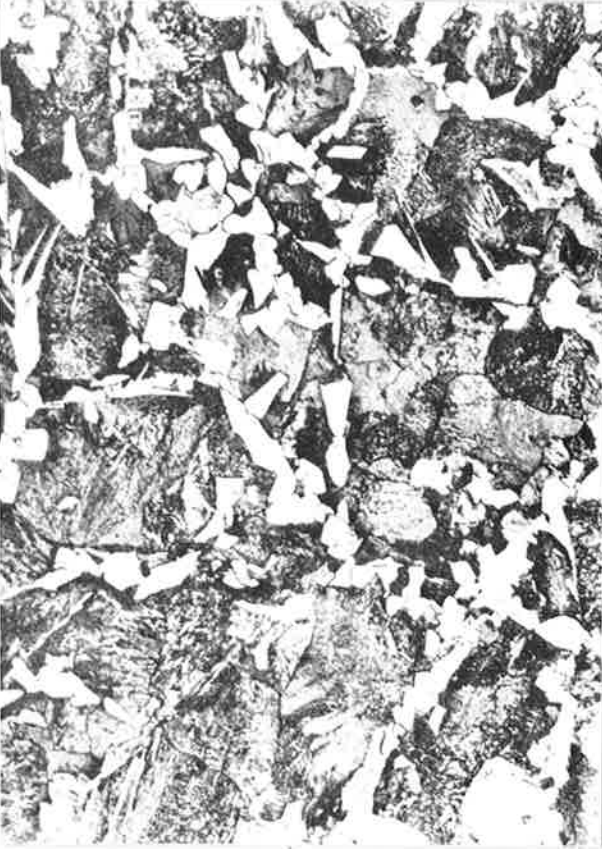
Figure 20. Microstructure of a Longitudinal Section of Head-Plate K-1 Taken at an Inside Plate-Quarterthickness Location of Specimen HDTT-38.

Ferrite grain size number 7. Etched: 1% Nital.

The microstructure observed on a single full-thickness sample taken from plate K-2 is given as Figure 21. This structure, which is similar to that shown in Figure 20, was observed throughout the thickness of this specimen. These figures show the large pearlite colonies and ferrite of about

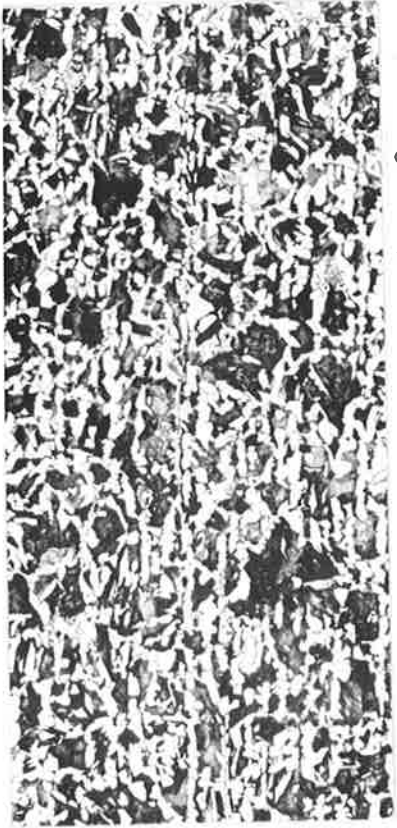
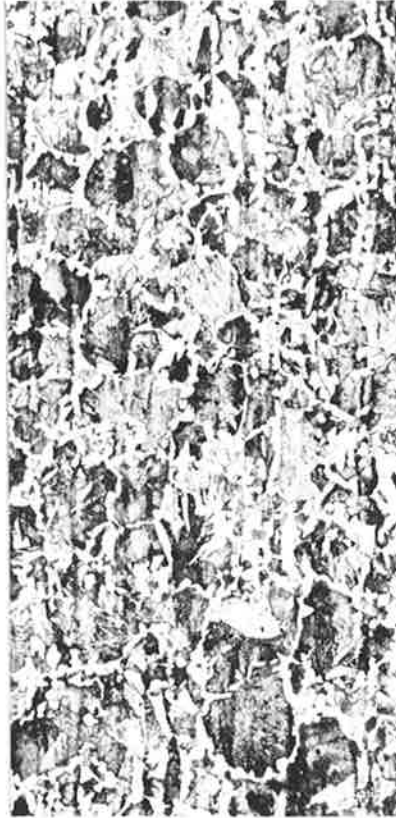
Figure 23. Typical Microstructures of Longitudinal Sections from Shell-Course Numbers 2 and 4.

Shell Course No. 2 — Sample K-7
Ferrite Grain Size No. 8

Shell Course No. 2 — Sample K-8
Ferrite Grain Size No. 7

Shell Course No. 4 — Sample K-12
Ferrite Grain Size No. 7

Etched: 1% Nital. X 100
