IDOT Sequence #: 17551
IDOT Job #: NA

PRELIMINARY ENVIRONMENTAL SITE ASSESSMENT

FINAL REPORT

LOCATION: IDOT High Speed Rail Tier 3, Project 8b (Union Pacific Railroad) from M.P. 161 to 171, Lincoln, Broadwell, Elkhart, and Williamsville, Logan County; Broadwell, Middletown, and Williamsville quadrangles (USGS 7.5-minute topographic maps), T18N, R3W, Sections 5-7, 18; T18N, R4W, Sections 12, 13, 23, 24, 26, 27; T19N, R3W, Sections 15, 21, 22, 28, 29, 32.

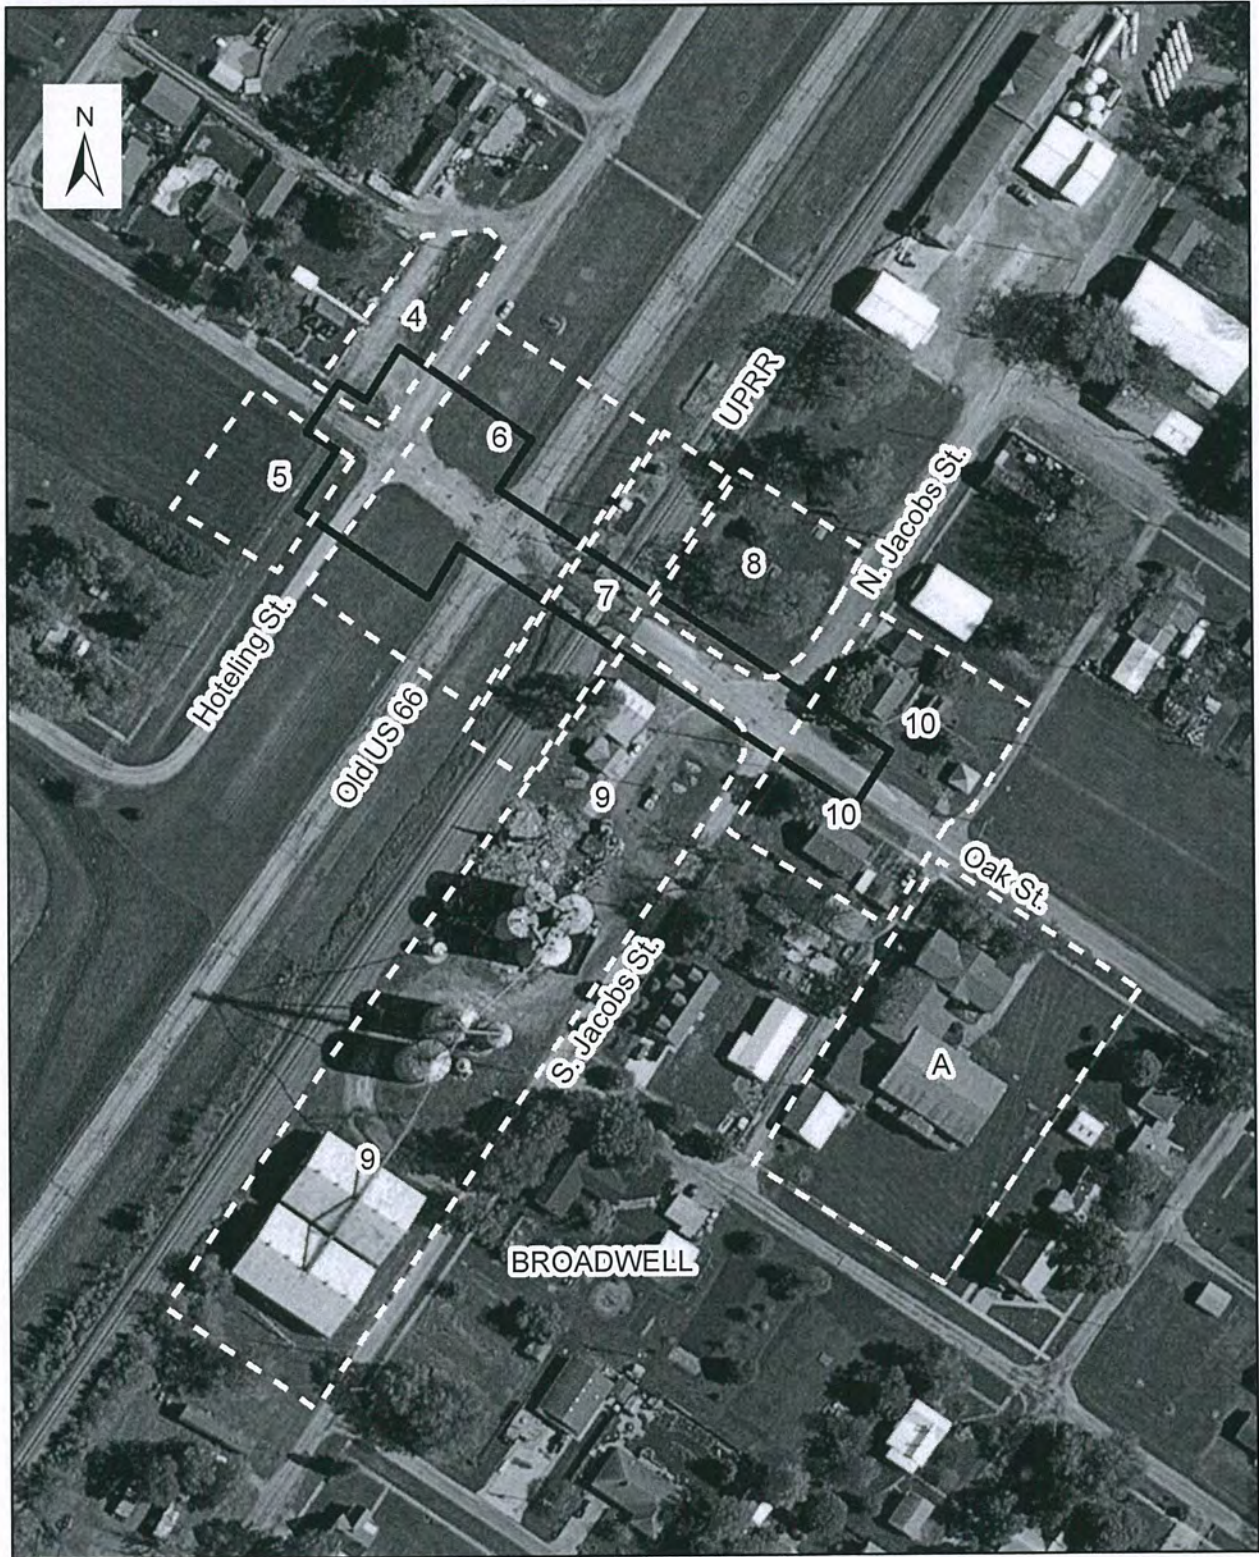
Attachment 2, page 2. Site location map, Sites 2694-4 to 10. Black line marks project area. All site boundaries are approximate and should not be used as actual parcel boundaries.

Site 2694-4. Vacant lot, 107 Hoteling Street, Broadwell (north corner of Hoteling Street and Oak Street; Attachment 2, page 2). This site contains a gravel parking lot, a sign post for the Pig Hip Restaurant, and a commemorative boulder denoting this as the site of the historic Pig Hip restaurant that burned down in 2007. A picture of the Pig Hip restaurant posted on Google Earth

showed two buildings on this site. One was the restaurant in the approximate center of the site, and the second was a small building with a single garage bay that resembled a small gasoline station with a possible dispenser located north of the restaurant. No evidence of any dispensers or USTs were noted at this site during a site visit.

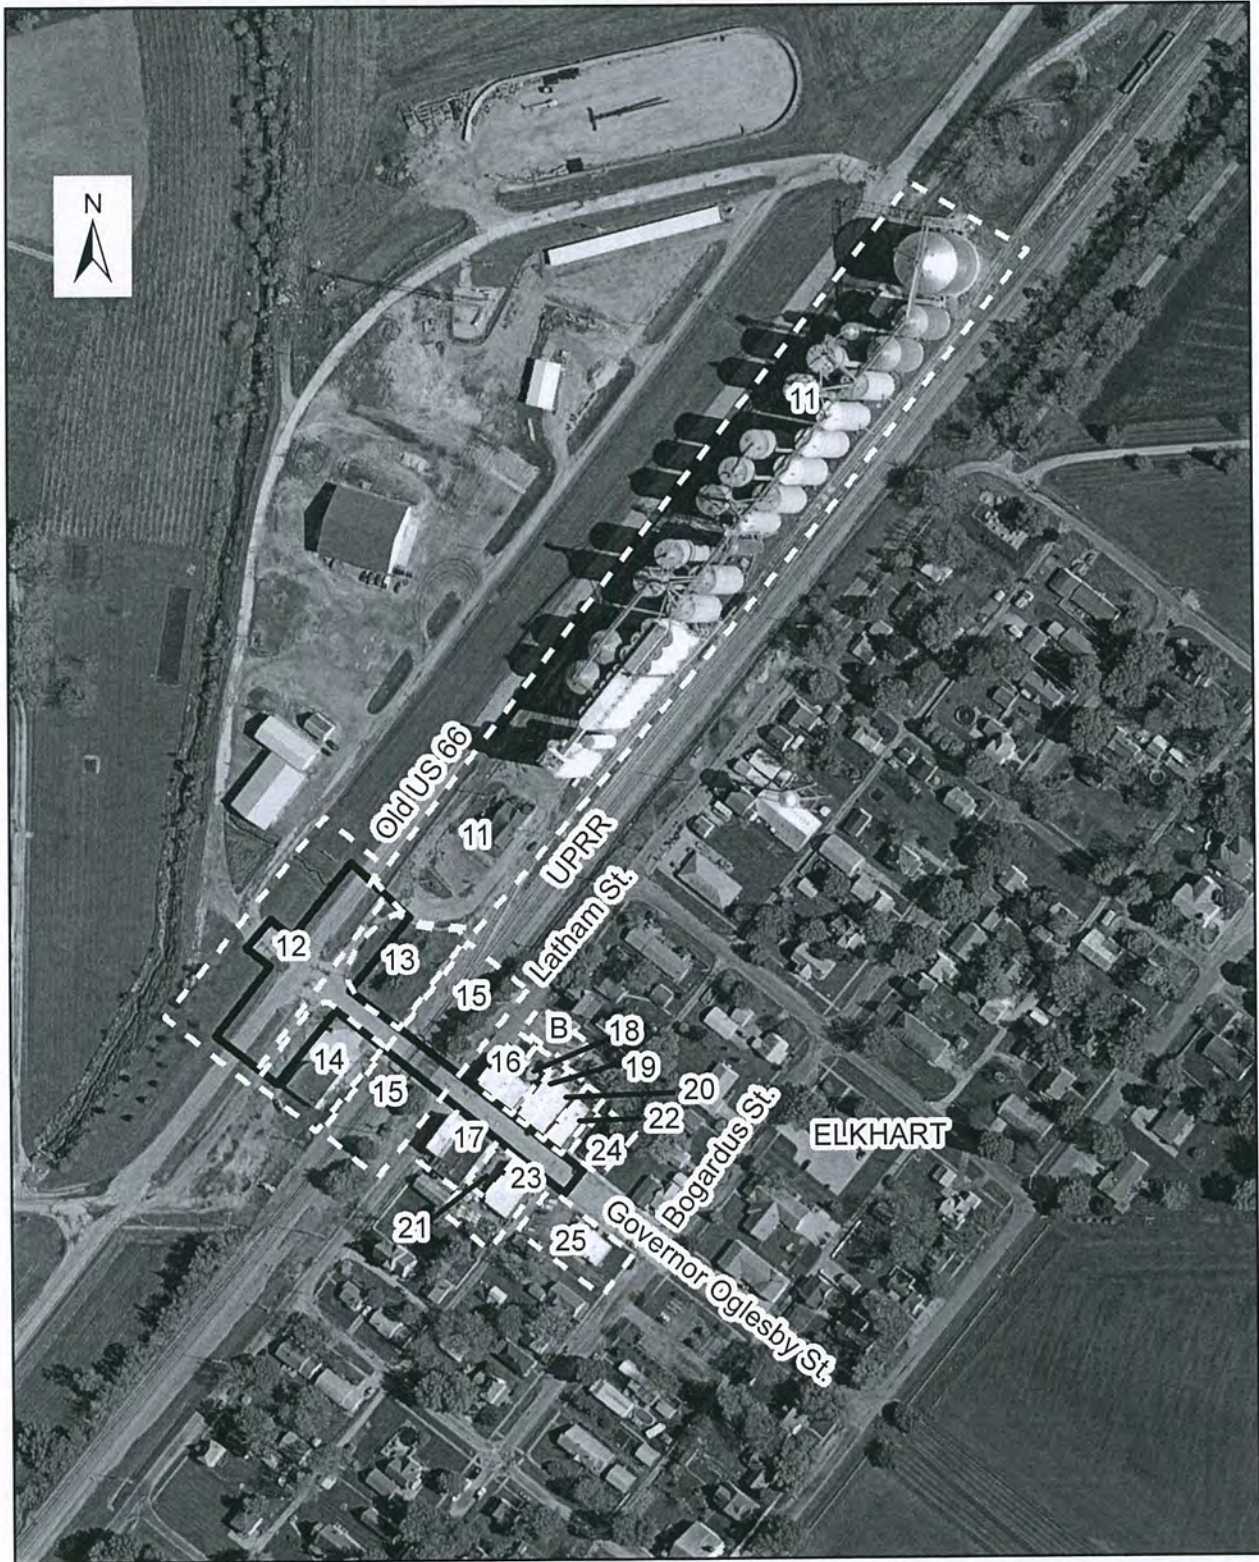
Attachment 2, page 3. Site location map, Sites 2694-11 to 25. Black line marks project area. All site boundaries are approximate and should not be used as actual parcel boundaries.

Site 2694-11. Elkhart Grain Co., 120 N. Old Route 66, Elkhart (southeast side of Old US 66 northeast of Governor Oglesby Street; approximate station 8807+50 RT; Attachment 2, page 3). This site consists of a grain elevator. Site features included an office and truck scale near the southwest end, an approximate 114-liter (30-gallon) drum labeled “flammable” and “hazardous waste” near the office door, a gravel pile south of the office, multiple grain silos of various size northeast of the office, an AST with unknown contents near the south end of the silos, and a fuel AST with a dispenser near the north end of the site. A pole-mounted transformer was located along Old US 66 near the office and three pad-mounted transformers were located on this site, one on the far north side near a small storage building, one in the middle of the site amidst the grain silos, and one near the office. In addition, an apparent vent pipe for a natural gas pipeline was present near the middle of the site along the southeast side. This site did not appear on any of the regulatory lists checked for this project.

Site 2694-23. Simplicity Power Equipment, 112 Governor Oglesby Street, Elkhart (southwest side of Governor Oglesby Street between Latham and Bogardus Streets; Attachment 2, page 3). This site contains a building housing a parts store and small engine sales and repair shop. During a site visit, the southwest side of the building contained an outdoor storage yard with new and used riding mowers, a pile of used riding mower tires, miscellaneous metal scrap related primarily to lawn mowers, and a 208-liter (55-gallon) drum labeled "Heavy Duty engine oil". This
