FR-861
Amtrak General Electric
Transportation
Evaluation of a B-20 Biodiesel in a
General Electric P-32 Locomotive

March 2010 – June 2011

Chevron Oronite Company LLC
Industrial Engine Oils
Richmond, California

ENGINE INSPECTION OF AMTRAK UNIT #500

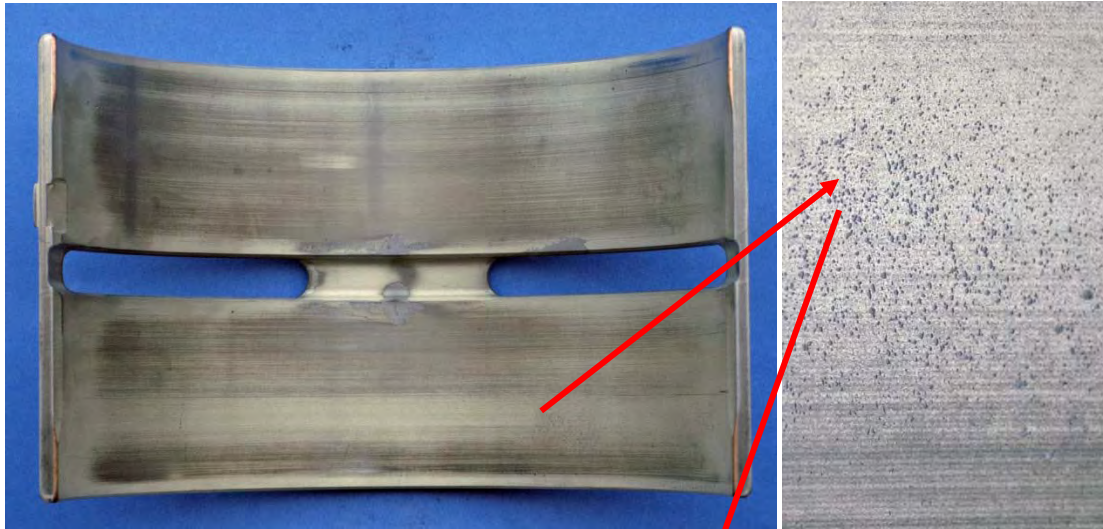
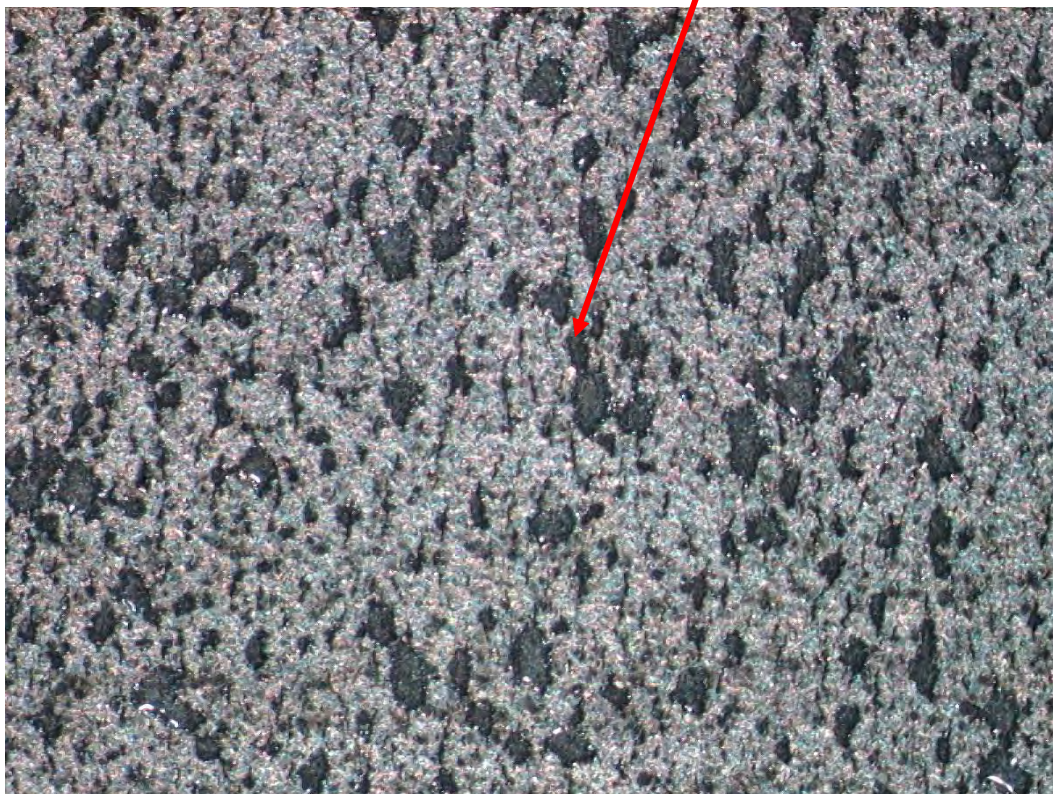
The area of pitting was covered with small cracks and pits and the pits appear to be aligned with the cracks. The cracks appear to be enlarging into pits via fracture of the edge. The examined pits appear to be caused by mechanical rather than chemical action or corrosion. Further investigation is needed as to the cause of the initial cracking. The photographs below show a magnified image of the cracking and pitting of the bearing flashing and overlay surface. See figures below.

The connecting rod bearings from Unit #500 were visually inspected for wear. The bearings showed normal wear patterns and even loading and were in serviceable condition. Closer inspection under magnification showed signs of pitting and metal migration on only the bottom shells of the bearings. Biodiesel has been documented to cause bearing corrosion when there is dilution in the oil sump. There is concern that the pitting may be caused by this corrosive mechanism. The bearings were brought back to Oronite and were analyzed at Oronite’s Tribology lab. After visual inspection bearings were sent to GE for more detailed examination

of the pitting to determine cause. Ratings of the bearing can be found in Appendix 3-4. Photos can be found in Appendix 5-9.

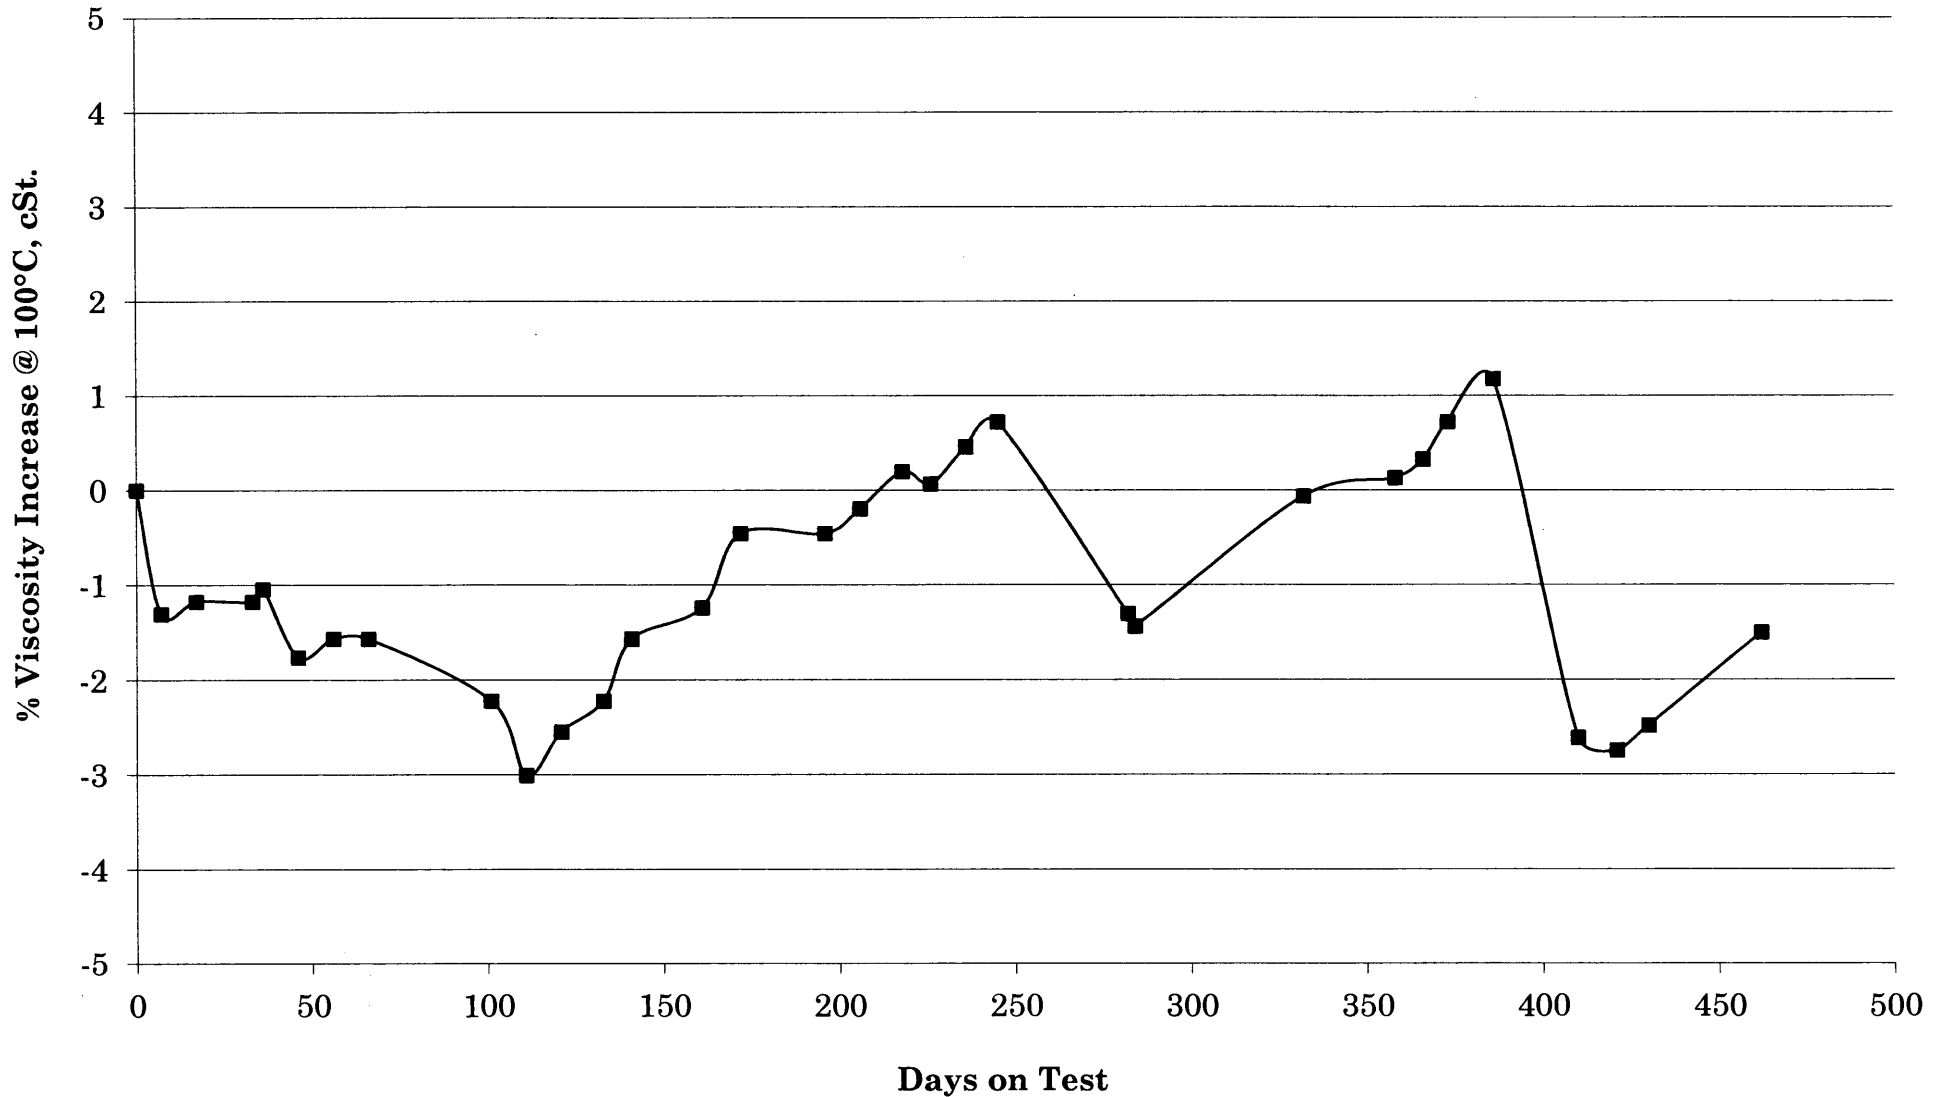
Appendix 4-2
FR-861 Amtrak B-20 Test
Unit 500
Viscosity Increase

The plots of the 100°C viscosity (Appendix 4-2) showed no significant increase in viscosity up to when the oil was changed.

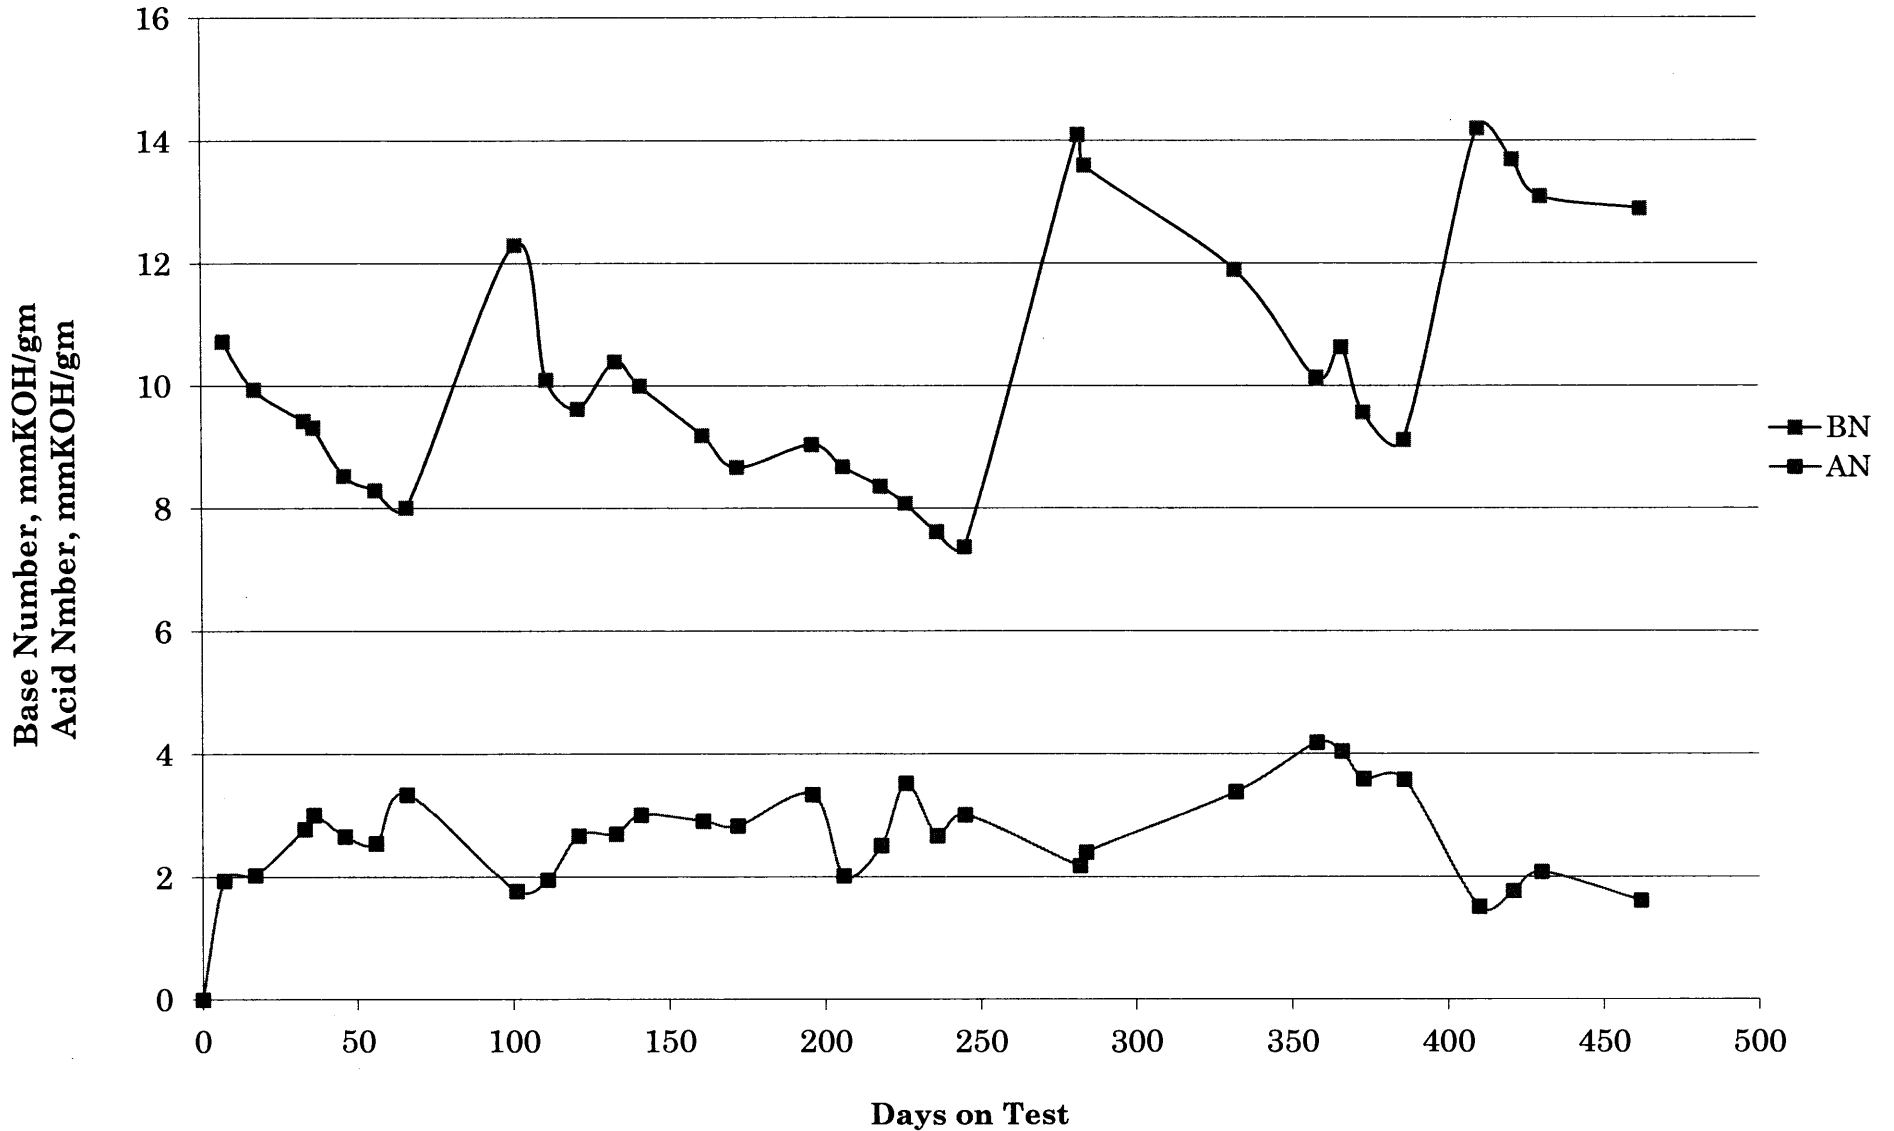
Appendix 4-3
FR-861 Amtrak B-20 Test
Unit 500
Base and Acid Number

Appendix 4-3 plots the AN and BN. The BN retention was good, dropping to a low of 7.37 mm KOH/g. The AN rose slightly over this same time period to 4.18 mm KOH/g before dropping.

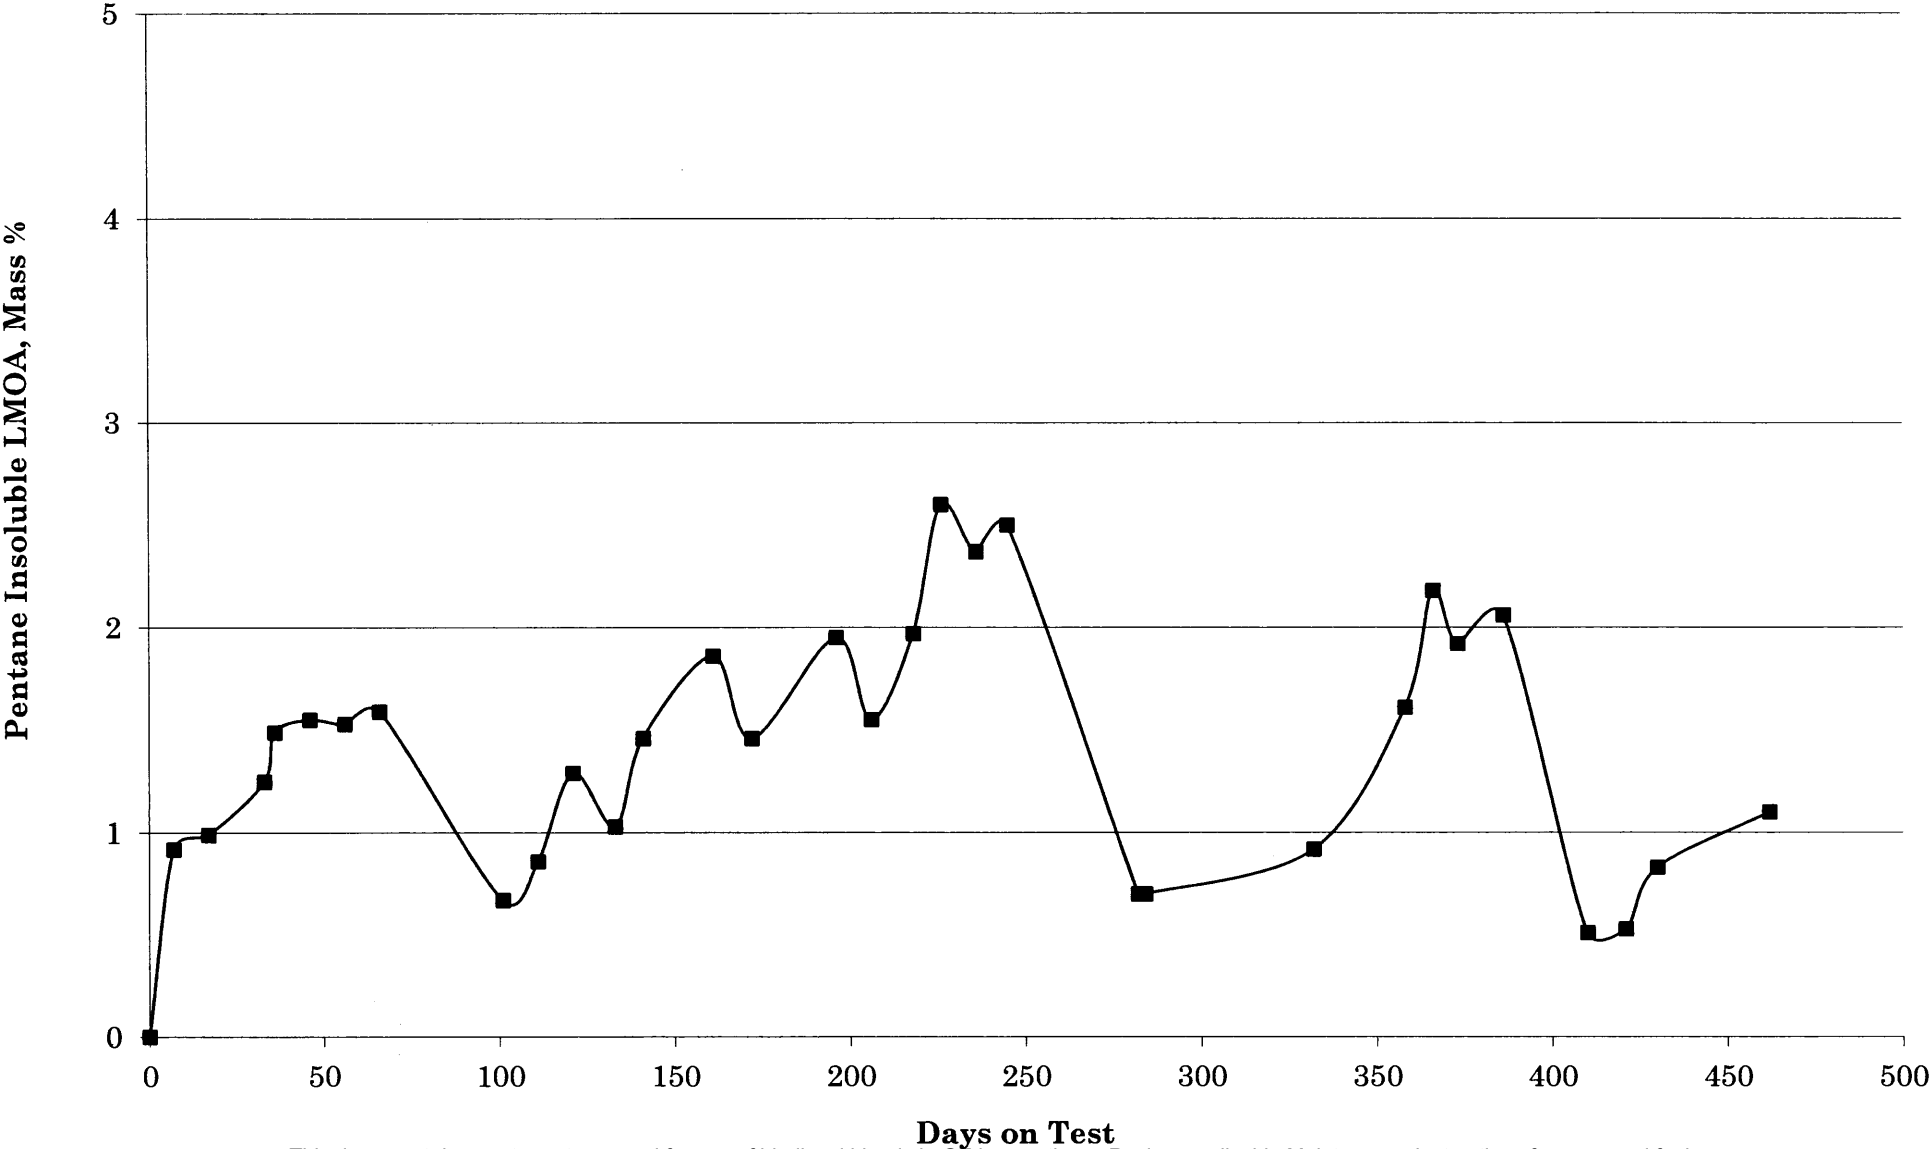
Appendix 4-4
FR-861 Amtrak B-20 Test
Unit 500
LMOA Pentane Insolubles

Coagulated pentane insolubles by the LMOA method are plotted in Appendix 4-4. They remained low with a maximum of 2.6 wt %.

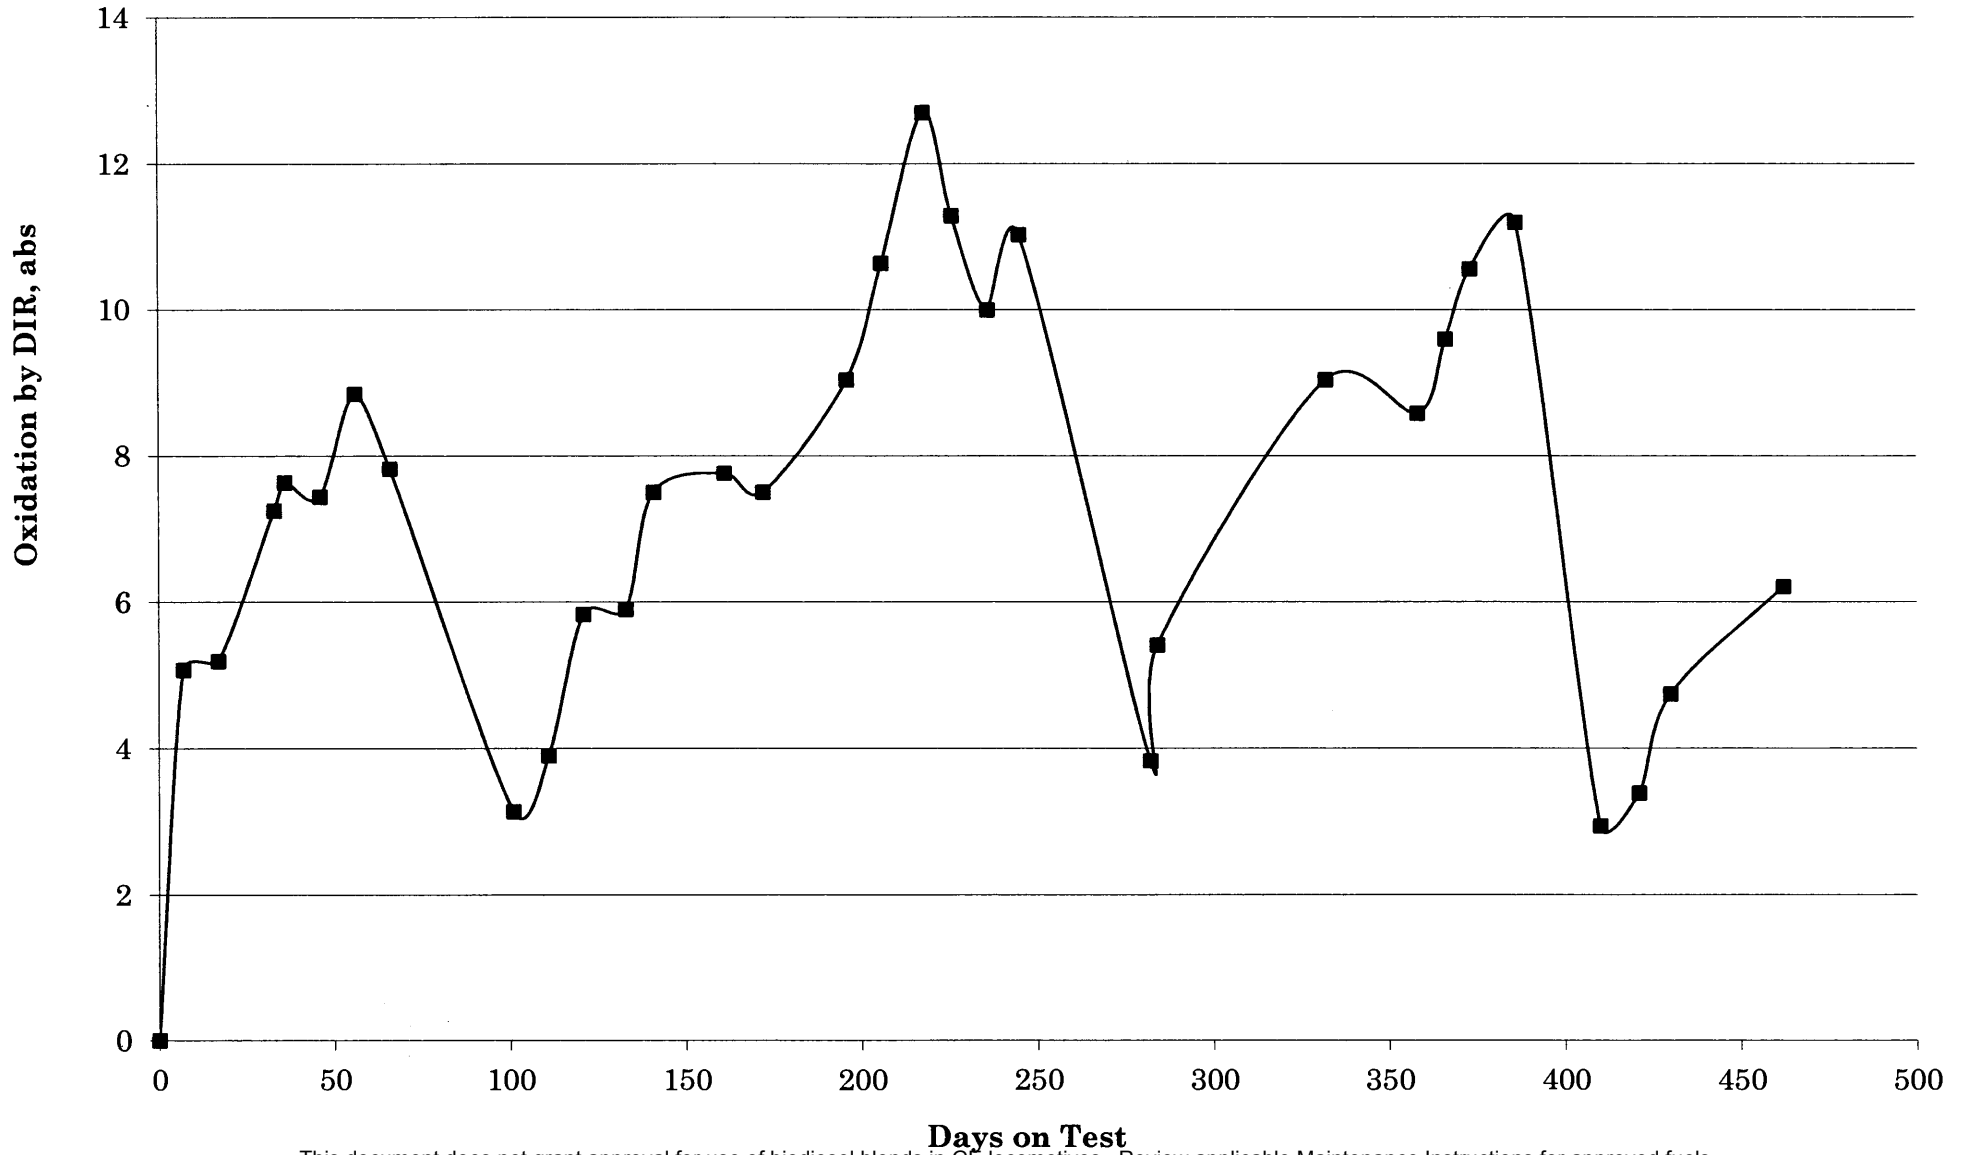
Appendix 4-5
FR-861 Amtrak B-20 Test
Unit 500
Oxidation

Oxidation of the engine oil was measured by DIR method. The graph in Appendix 4-5 show that oxidation was under control and remained low for the entire duration of the test.

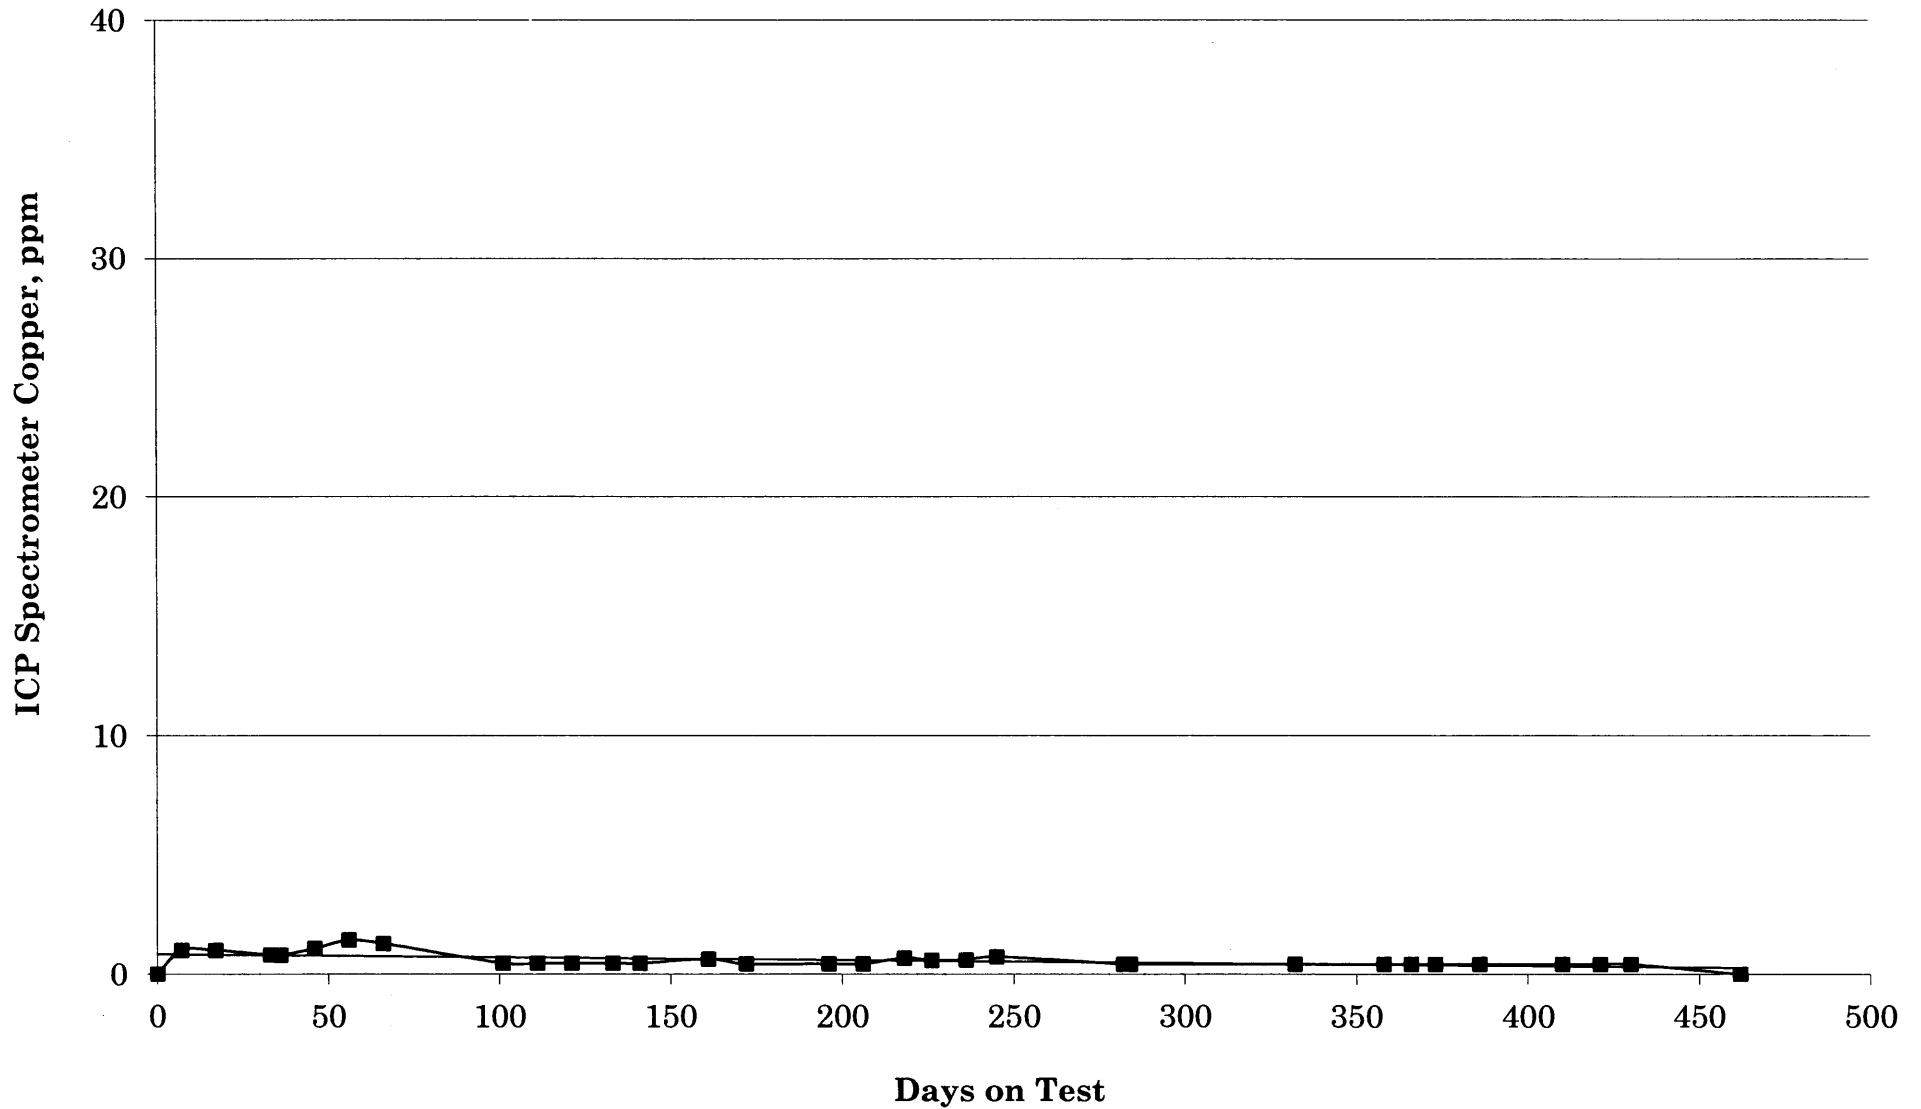
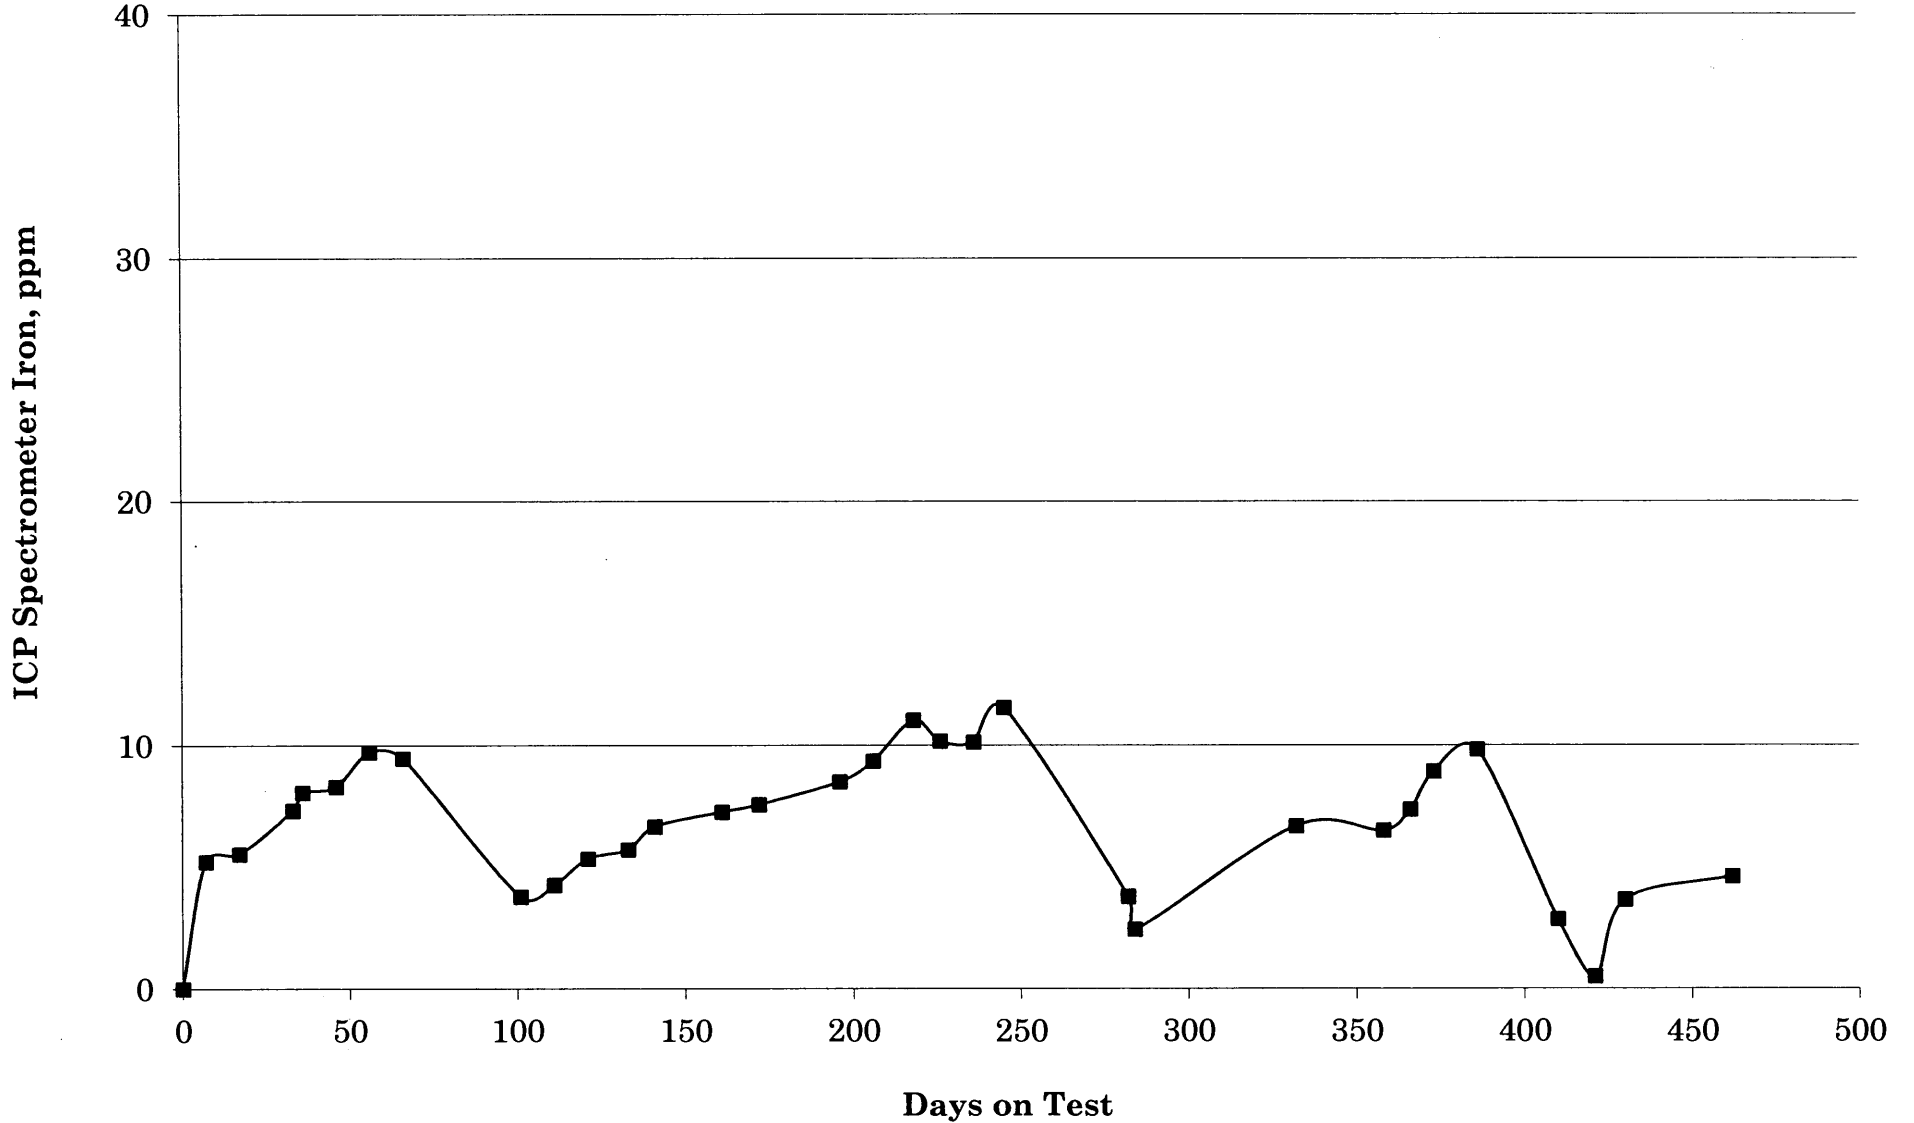
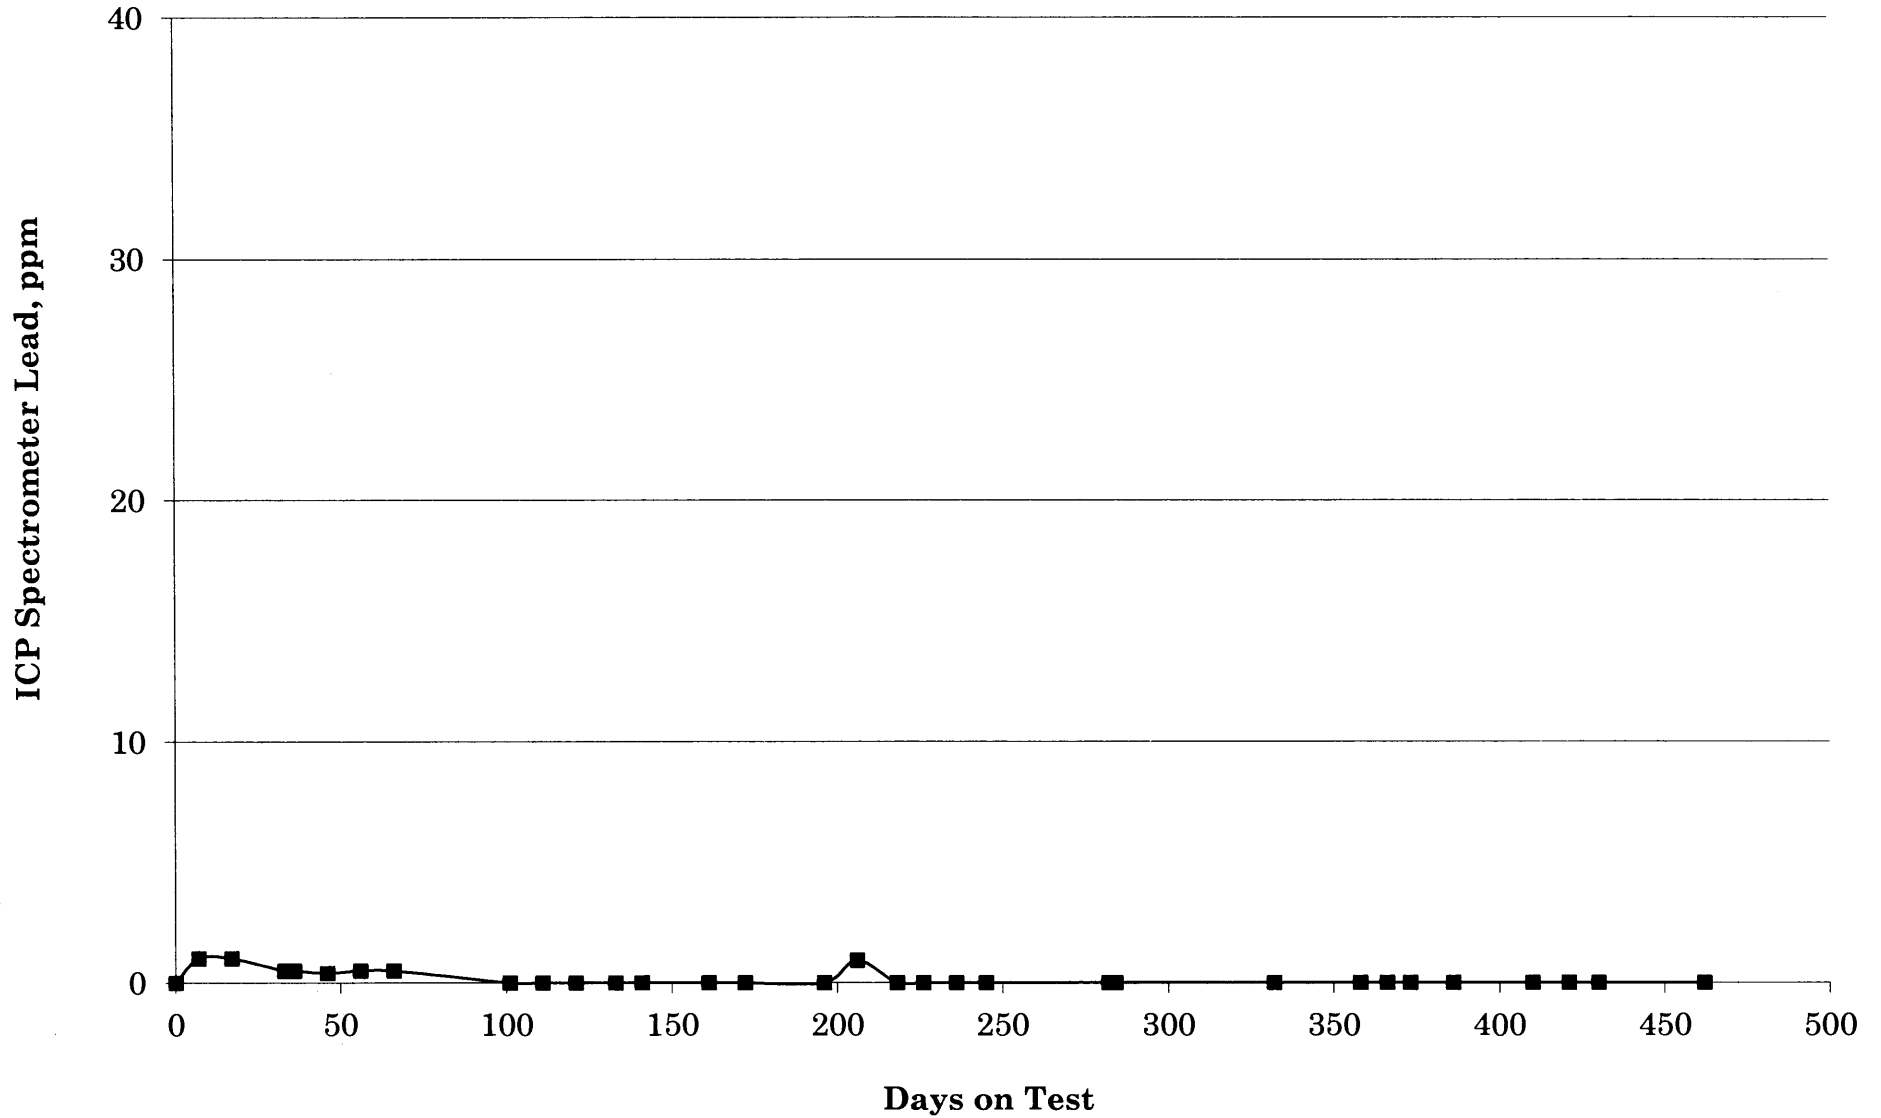
Wear metals (iron, copper, and lead) were measured using the ICP method. For all three, the levels were very low and well within the condemning limits. Appendices 4-6 through 4-8 show the wear metal trends.

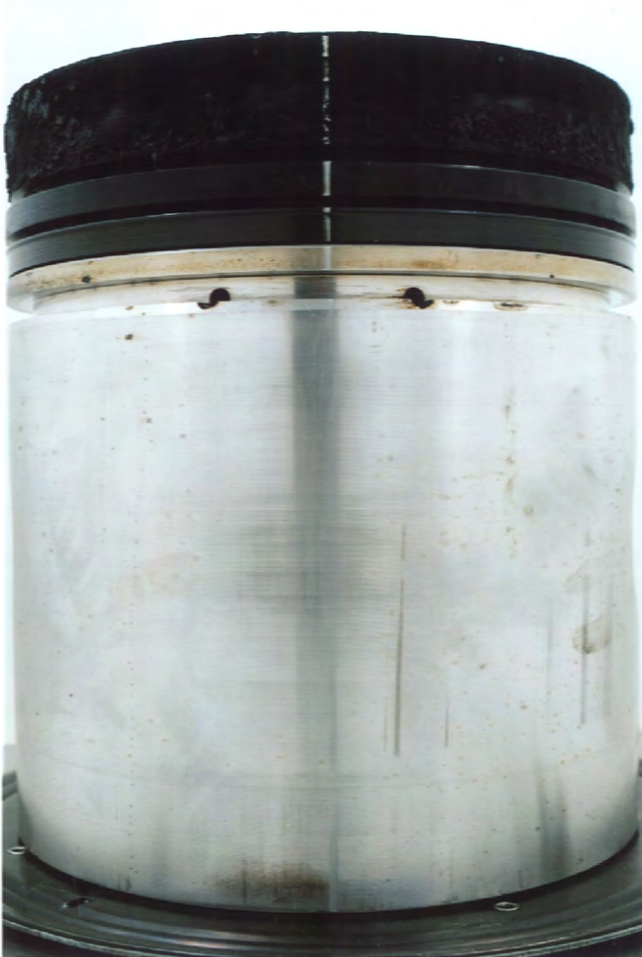
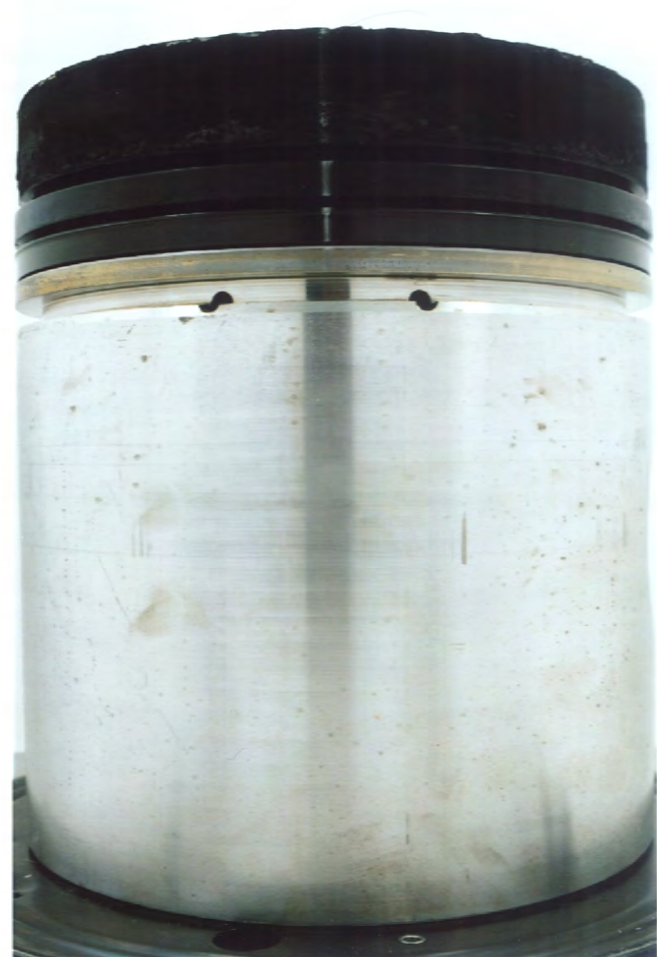
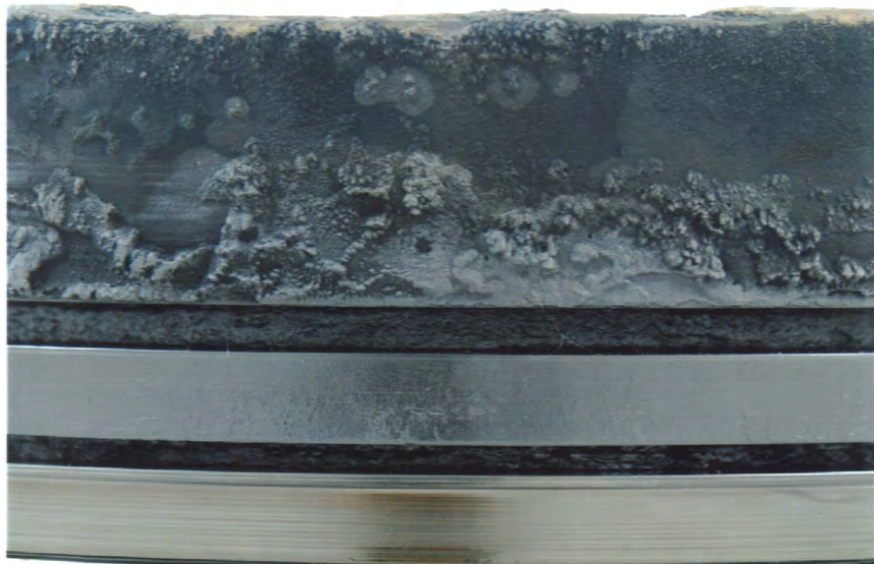
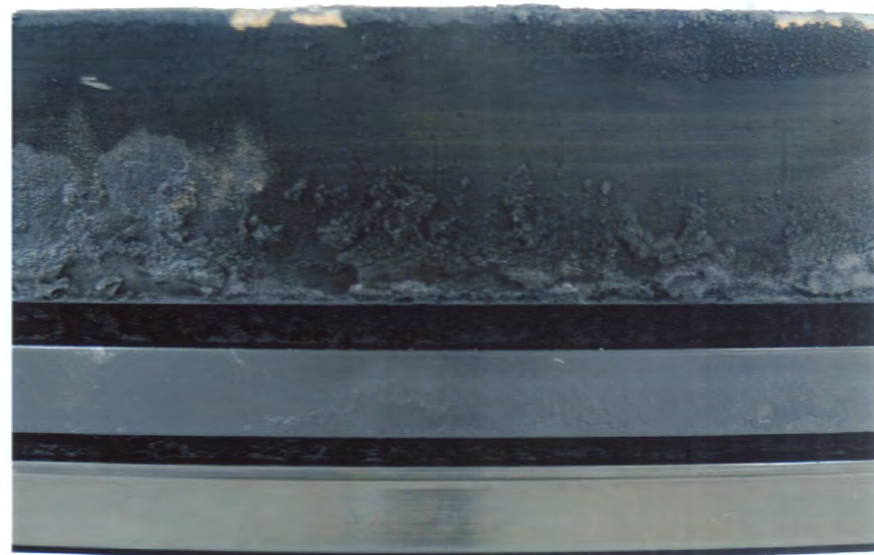
Appendix 5-1
AMTRAK B-20 FIELD TEST - FR861
ORONITE TECHNOLOGY
UNIT 500 GE P32-8 7FDL-12 LOCOMOTIVE

The two pistons were rated using the Coordinating Research Council (CRC) diesel piston rating method. Table 1 summarizes the piston deposits from Amtrak Unit #500. The table below shows that Unit #500 had moderate piston deposits that are consistent with other passenger and freight service. Though the ratings appear to be in alignment with inspection results for locomotives in moderate to severe service (MWH/month), the operational conditions, duty cycle, and MWH usage of Unit #500 was not available at the time of inspection. The detailed rating sheets can be found in Appendix 2-1 and 2-2. Photos can be found in Appendix 5-1 and 5-2.

Piston Zone	2R	2L
Groove #1	45.3	47.2
Groove #2	49.1	49.1
Groove Oil	0.0	0.0
Crownland	35.7	29.1
Land #2	14.9	16.3
Land #3	0.0	0.0
Total Demerits	145	142
