FR-861
Amtrak General Electric
Transportation
Evaluation of a B-20 Biodiesel in a
General Electric P-32 Locomotive

March 2010 – June 2011

Chevron Oronite Company LLC
Industrial Engine Oils
Richmond, California

ENGINE INSPECTION OF AMTRAK UNIT #500

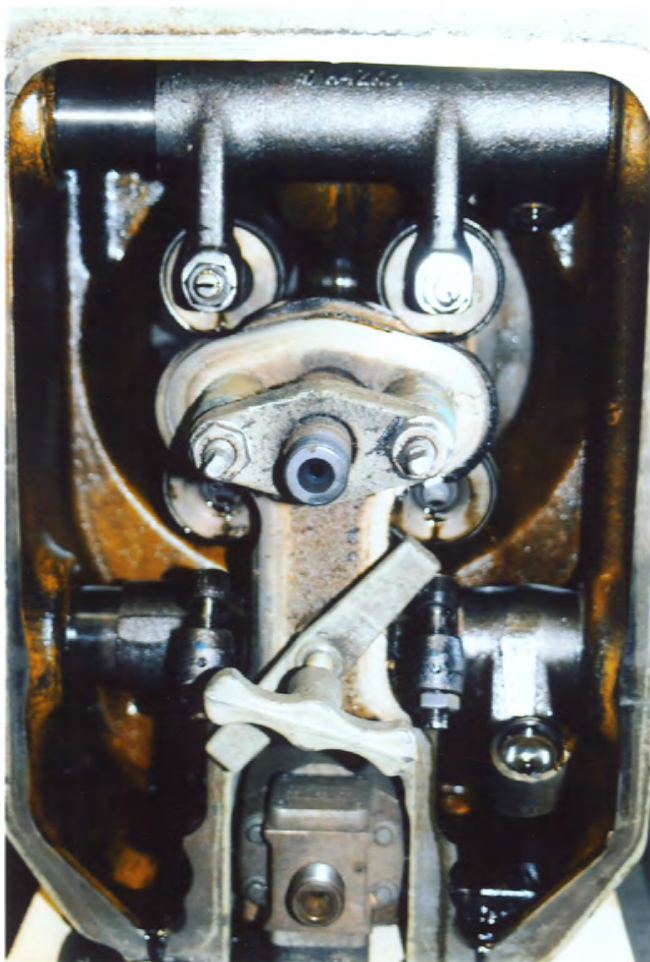
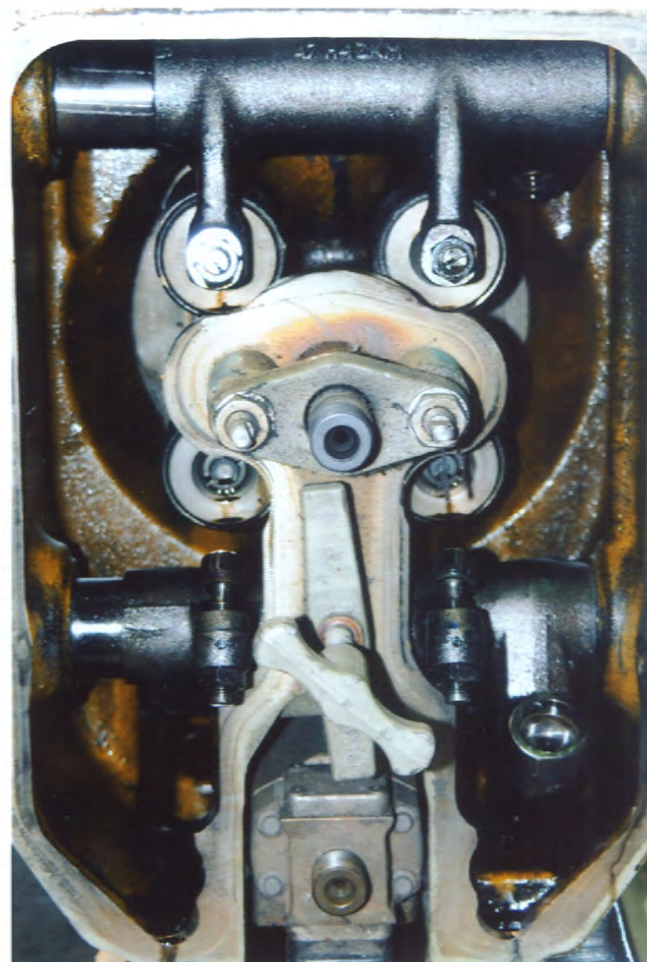
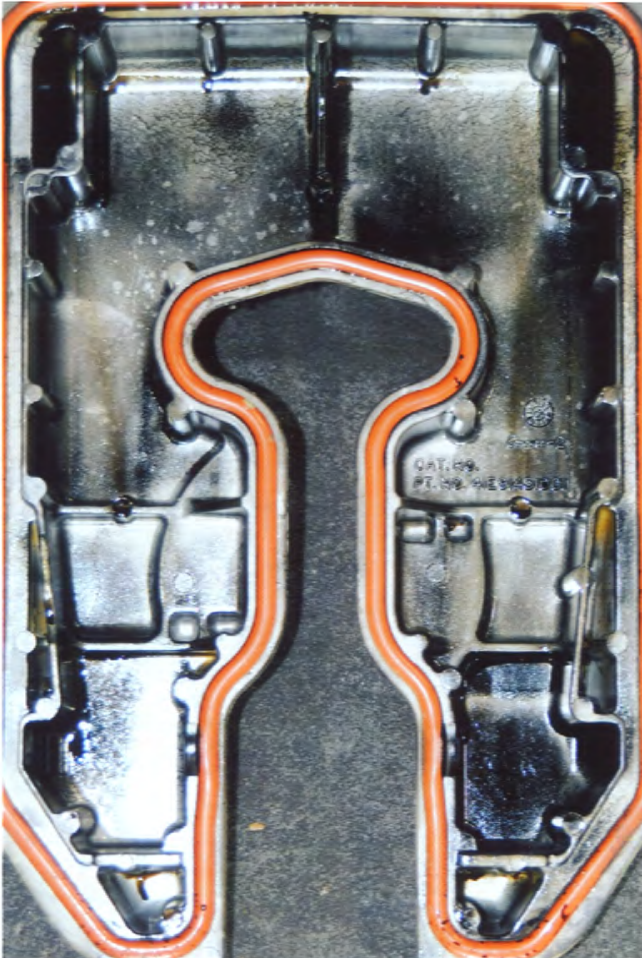
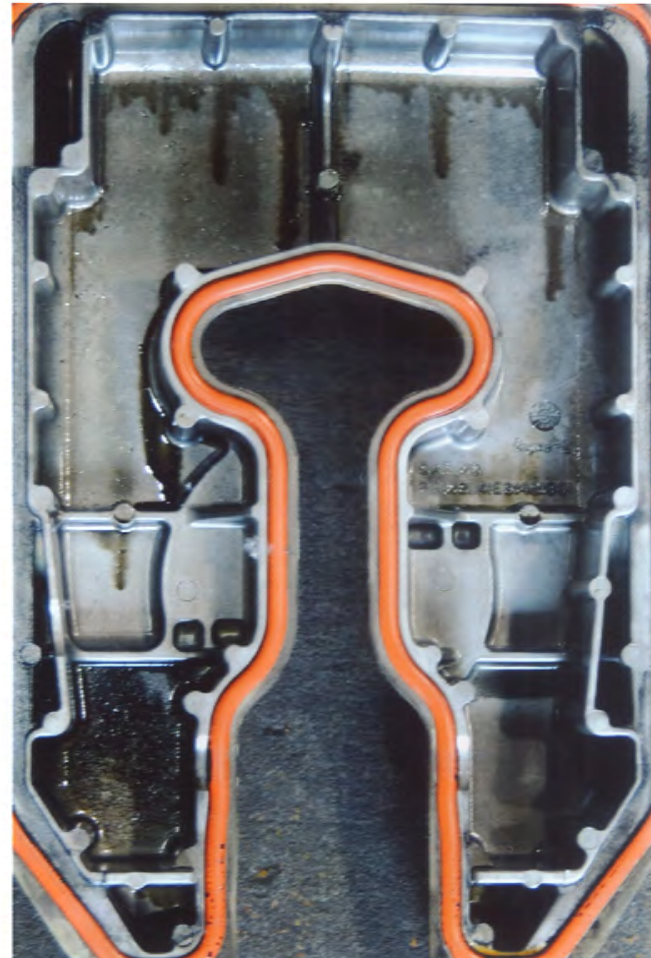
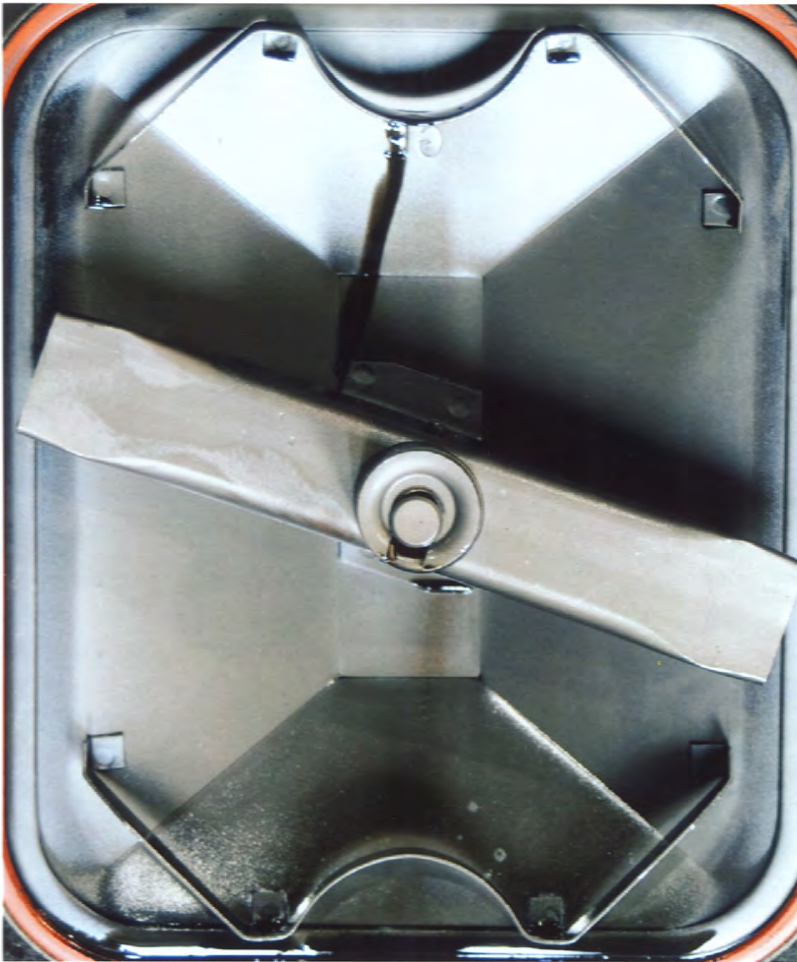
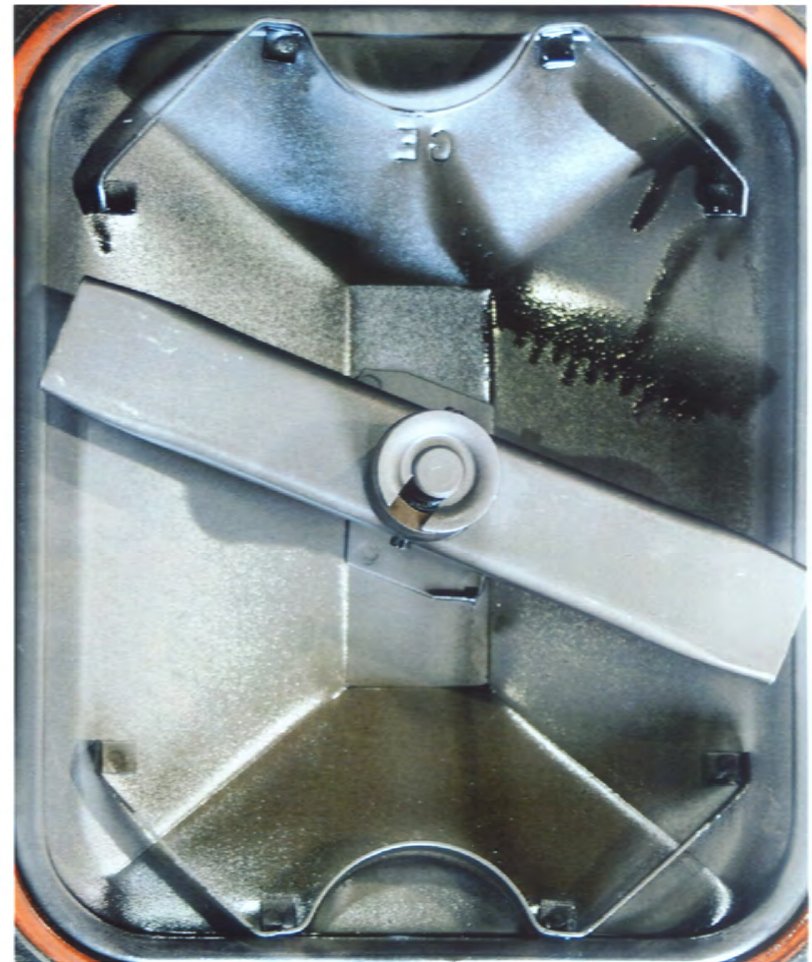
As Table 3 illustrates, the rocker boxes were free of any significant sludge with very little, if any, depth. The table shows the average ratings of both test cylinders. Detailed ratings can be found in Appendix 2-3. Photos can be found in Appendix 5-3, 5-4, and 5-5.

Piston Zone	2R	2L
Crankcase Cover	9.75	9.75
Rocker Cover	9.56	9.56
Crankcase A Frame	9.50	9.50
Rocker Box	9.63	9.63

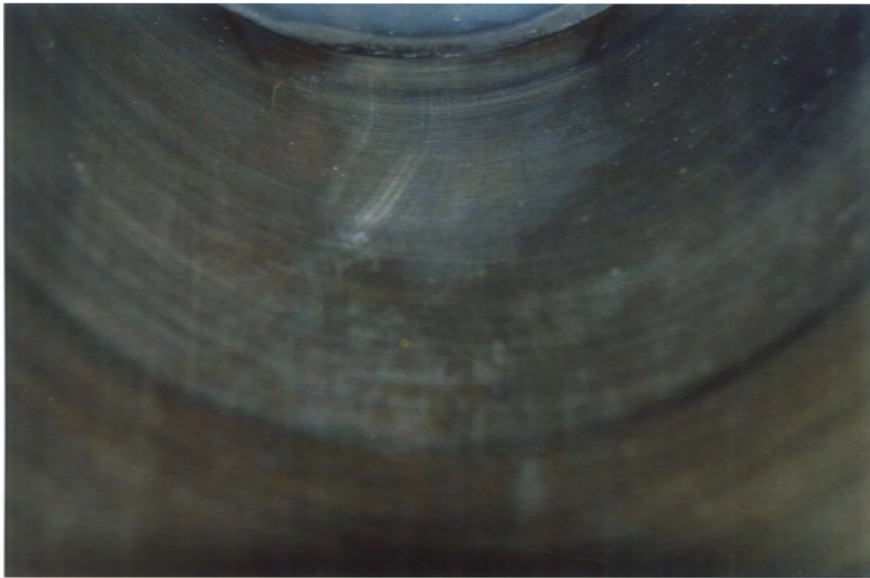
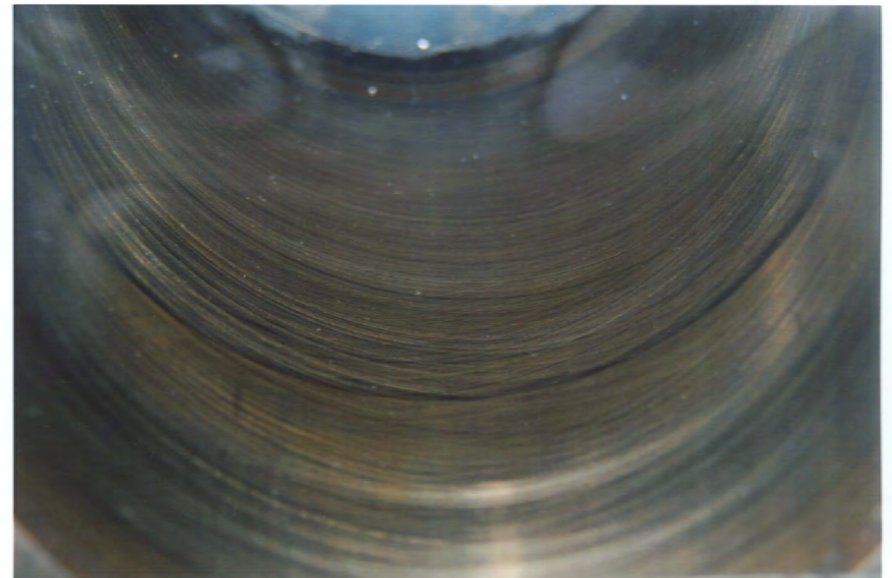
Appendix 5-6
AMTRAK B-20 FIELD TEST - FR861
ORONITE TECHNOLOGY
UNIT 500 GE P32-8 7FDL-12 LOCOMOTIVE

Liner 2R and 2L were visually inspected. They were evaluated at the top and bottom of the piston stroke and on the thrust and anti-thrust sides. The liners were observed for any wear anomalies including scuffing, polishing, and scratching. The liners showed very little wear. No liner showed evidence of scuffing. There was some incipient bore polishing occurring at the top ring reversal area, however, the area of polishing was mild. Overall, the liners were in good, serviceable condition. Detailed ratings can be found in Appendix 3-1. Photos can be found in Appendix 5-6.

Comments: 2R - Light polish on Thrust side @ 6". Light polish at ring reversal, 360°. Amber deposits 2" down from fire face. Good cross hatching on rest of liner. Intake port dry/light carbon. Fire face - clean.
2L - Light polish at ring reversal, 360°. Amber deposits 2" down from fire face. Good cross hatching on rest of liner. Intake port wet/clean.
Fire face - light deposit around intake valve

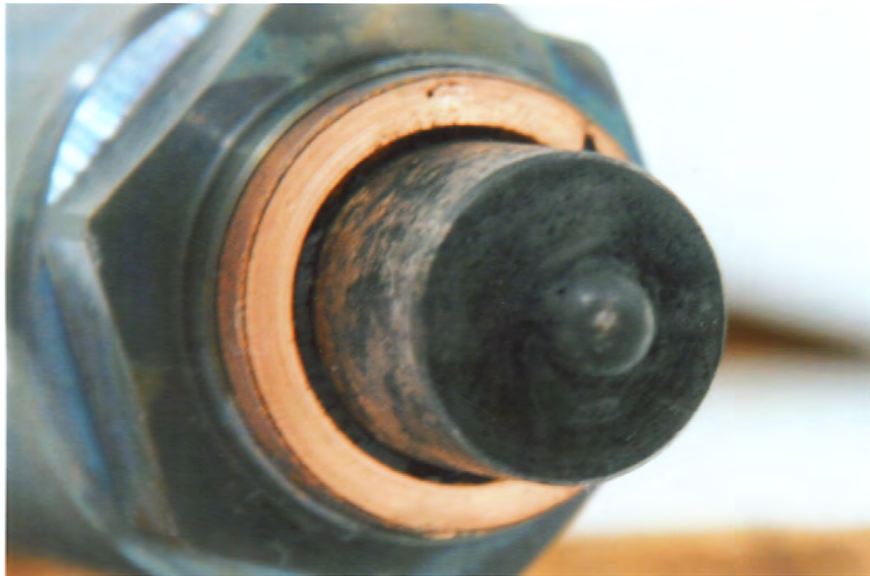
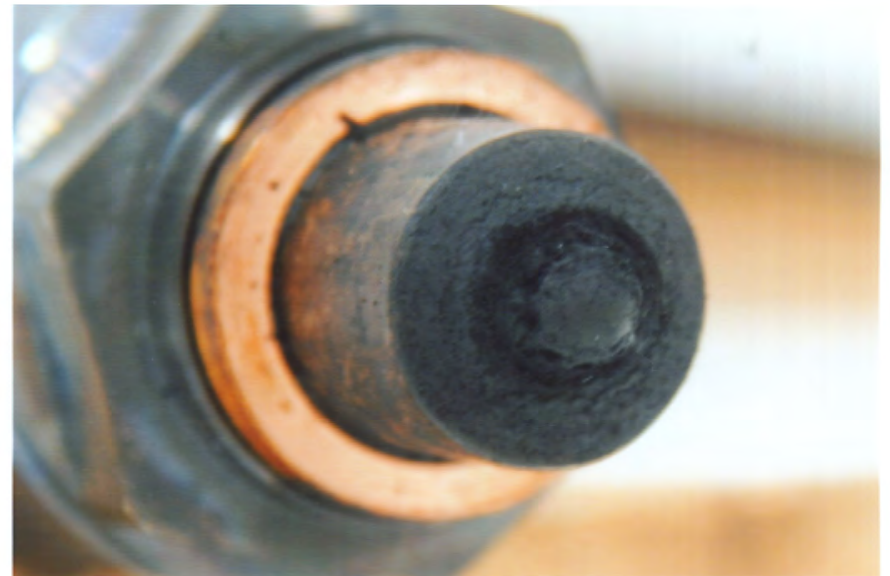
Appendix 5-7
AMTRAK B-20 FIELD TEST - FR861
ORONITE TECHNOLOGY
UNIT 500 GE P32-8 7FDL-12 LOCOMOTIVE

The fuel injectors were removed from cylinders 5R and 5L and a boroscope inspection was performed on the liners through the injector hole. There was evidence of staining, either from rust or corrosion on the liner surfaces. Discussions with the shop foreman determined that the locomotive had experienced a storage-related failure in the past and was most likely the cause of the abnormal appearance of the liners. Engine operation and used oil analysis indicated that there are no operational difficulties as a result. Inspection of the injectors showed that there was a moderate level of carbonaceous deposits on the injector tips. With 5X magnification it appeared that the injector tip spray nozzles were not occluded, however it was indeterminate if there was any loss in injector performance or interruption of the spray pattern as a result of the deposits. Photos of the injector tips are in Appendix 5-7.

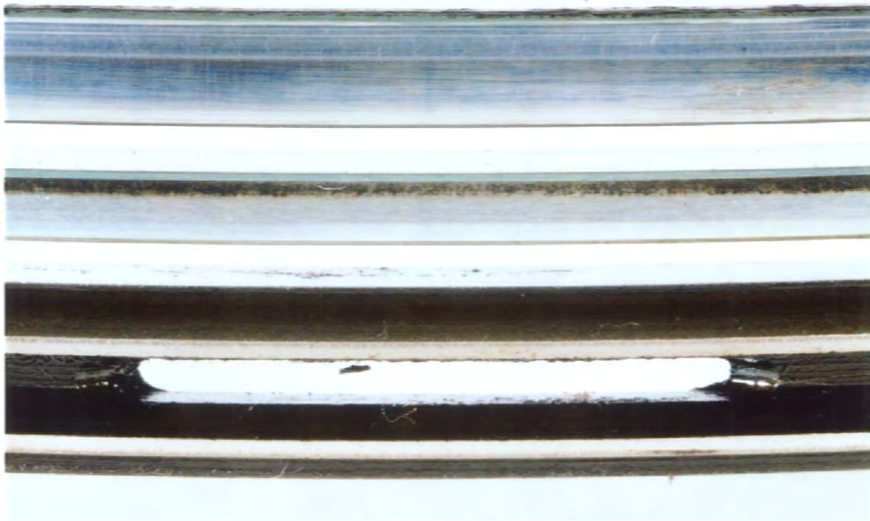
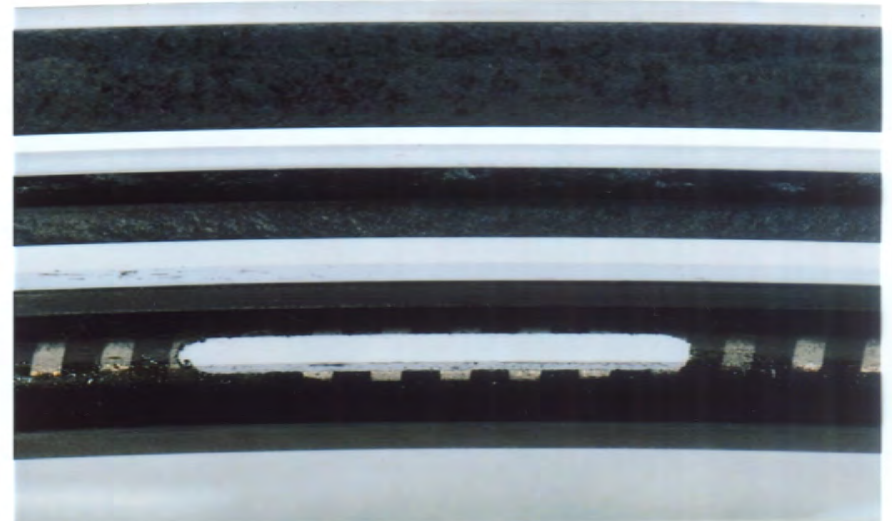
Appendix 5-8
AMTRAK B-20 FIELD TEST - FR861
ORONITE TECHNOLOGY
UNIT 500 GE P32-8 7FDL-12 LOCOMOTIVE

The piston rings were removed from the pistons of both power assemblies removed from Unit #500 and brought back to Oronite’s Richmond facility for inspection. The piston rings were inspected visually for evidence of abnormal wear and deposits and measured in comparison to the pre-test measurements. The ring faces were examined under magnification and showed only signs of normal wear. There was no evidence of scoring or scuffing. Visual evaluation of the carbon deposits were also made on the piston rings. The carbon buildup corresponded to that of the pistons and was in the medium to light range based on the CRC rating system. The measurement data, visual inspection, and deposit ratings showed the rings to be in normal, serviceable condition. Detailed measurements of the piston rings are in Appendix 3-2 and 3-3. Photos can be found in Appendix 5-8

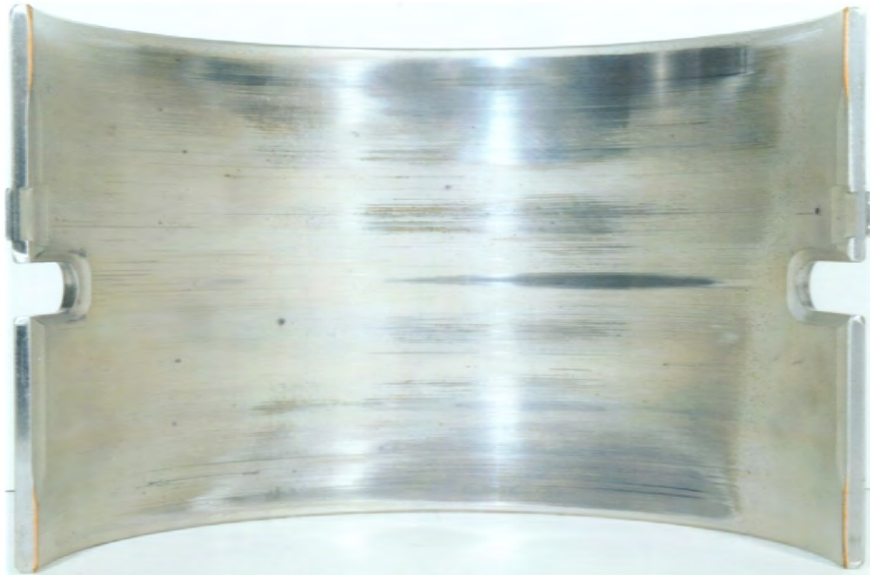
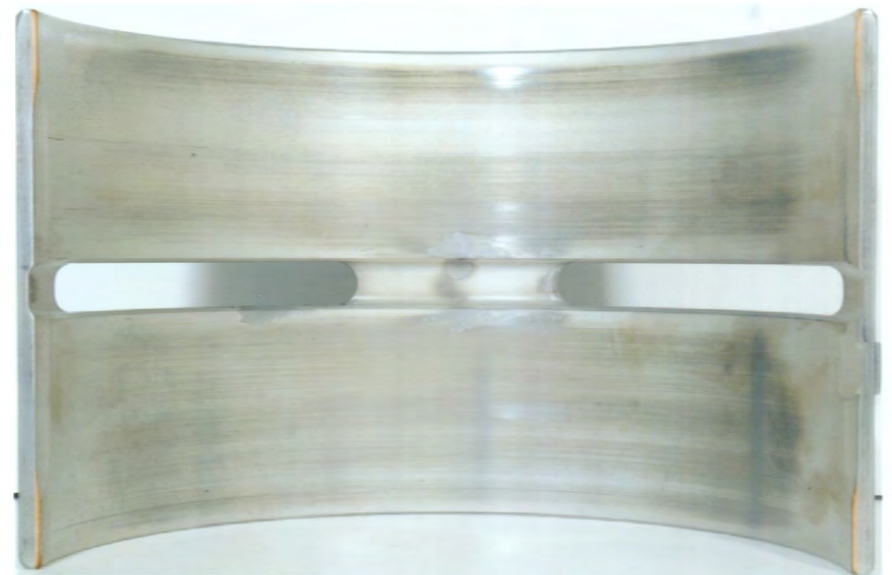
Appendix 5-9
AMTRAK B-20 FIELD TEST - FR861
ORONITE TECHNOLOGY
UNIT 500 GE P32-8 7FDL-12 LOCOMOTIVE

The connecting rod bearings from Unit #500 were visually inspected for wear. The bearings showed normal wear patterns and even loading and were in serviceable condition. Closer inspection under magnification showed signs of pitting and metal migration on only the bottom shells of the bearings. Biodiesel has been documented to cause bearing corrosion when there is dilution in the oil sump. There is concern that the pitting may be caused by this corrosive mechanism. The bearings were brought back to Oronite and were analyzed at Oronite’s Tribology lab. After visual inspection bearings were sent to GE for more detailed examination

of the pitting to determine cause. Ratings of the bearing can be found in Appendix 3-4. Photos can be found in Appendix 5-9.

Bearing	Rod Journal # 2
Top	Appearance of even/normal loading. Good/serviceable condition 50% Flashing remover, no copper showing Light dirt scratching, and small pitting in flashing overlay
Bottom	Appearance of even/normal loading. Good/serviceable condition 70% Flashing removed, no overlay removed and no copper showing 2% Cavitation wear @ oil gallery, and small pitting in flashing overlay
