Salco Quick Inspect

Mike Clark Billings, MT 9-2013

Quick Inspect

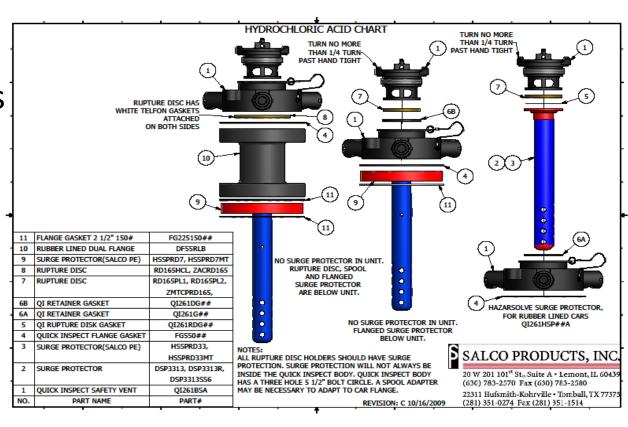
New Style Identification Chart

- •New Chart shows the 3 configurations applicable for HCL
- Broken down intoStyles 1,2and 3.

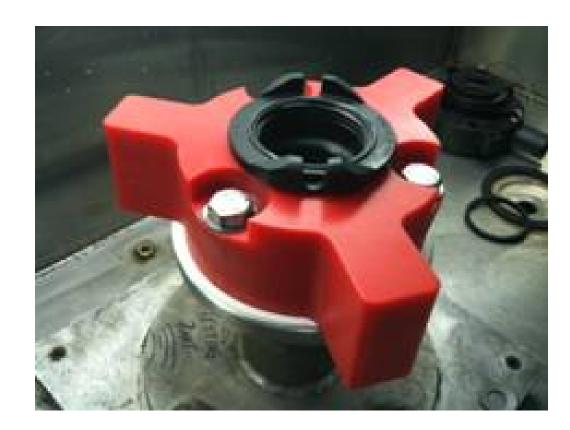
Design Considerations

- Alternative Materials
- •UHMW

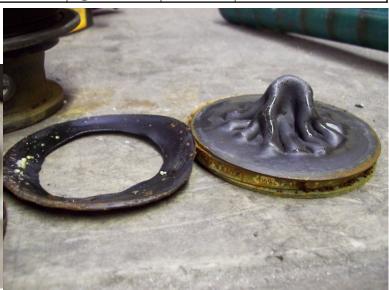
4		
QI Date	Jan-05	Mfg	Condition
QI Body		S	Good
Retainer		S	Good
SSD		HZ	Good
Disc	no date	Zook	Very Bad
Gaskets			very bad
	Retainer		
	over		
Notes	tightened
