Effect of Gate Skirts on Pedestrian Behavior at Highway-Rail Grade Crossings

4. TITLE AND SUBTITLE Effect of Gate Skirts on Pedestrian Behavior at a Highway-Rail Grade Crossing	5. FUNDING NUMBERS RR97A6/KT925
--	------------------------------------

7. PERFORMING ORGANIZATION NAME(S) AND ADDRESS(ES) U.S. Department of Transportation Research and Innovative Technology Administration John A. Volpe National Transportation Systems Center 55 Broadway Cambridge, MA 02142	8. PERFORMING ORGANIZATION REPORT NUMBER DOT-VNTSC-FRA-13-01
--	---

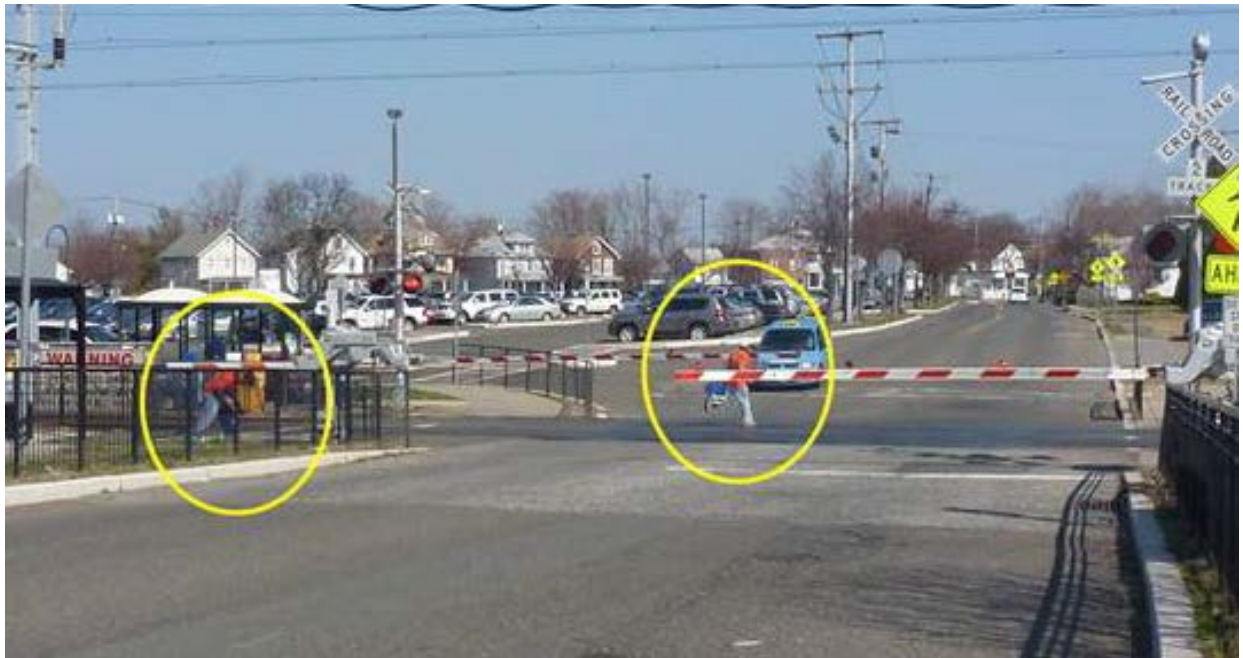
Figure 1. Pedestrians Violating Grade Crossing at Atlantic Ave., Matawan, NJ

NJ Transit Rail selected a high-risk grade crossing (grade crossing ID# 856876H) on Atlantic Avenue in Matawan, NJ, along the systems' North Jersey Coast Line, to pilot this pedestrian gate safety enhancement. The crossing, shown in Figure 1, is adjacent to the NJ Transit Rail Aberdeen Matawan train station.

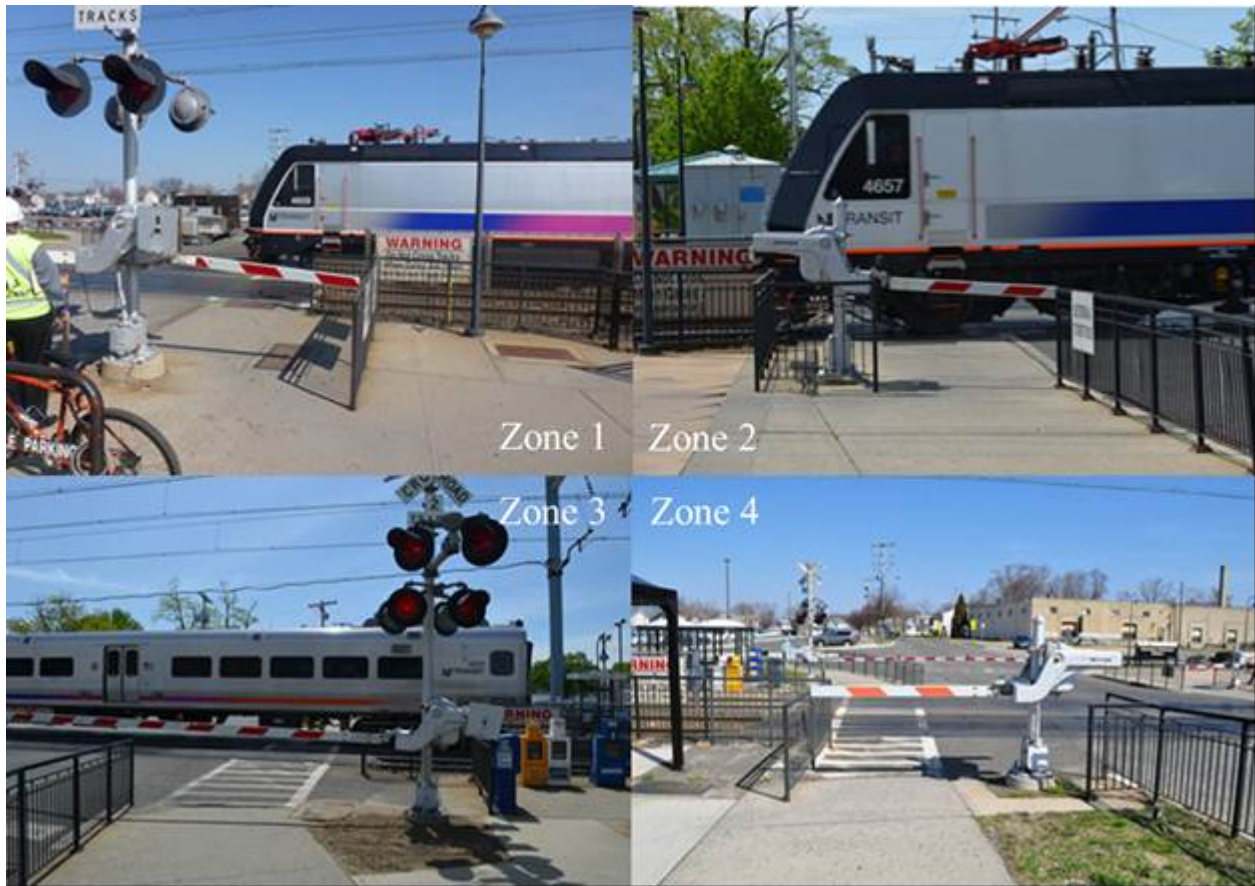
Figure 2. All Four Pedestrian Gates at the Atlantic Ave. Crossing before Installation of Gate Skirts

The grade crossing has two vehicle gates, one of which also serves as a pedestrian gate (Zone 3), and three additional pedestrian gates. The pedestrian gates are located next to the vehicle gates (or if there are no vehicle gates, each pedestrian gate is in line with the pedestrian gate on the other side of the street) so that when an activation occurs, the gate will descend into a position that blocks pedestrian traffic from crossing the tracks from all sidewalks. In one quadrant, composed of Zone 1 (sidewalk) and Zone 5 (street), the pedestrian gate and vehicle gate are actually mounted on the same structure. In the diagonal quadrant, composed of Zone 3 (sidewalk) and Zone 7 (street), a vehicle gate is used to block access across both the sidewalk and street. See Figure 3 for an illustration of the Atlantic Avenue grade crossing site characteristics and zones.

On either side of the sidewalks, across from each of the pedestrian gates, is fencing which prohibits pedestrians from easily going around the gates once they have descended. To better understand the layout of the area, Figure 3 provides an aerial view of the Atlantic Avenue grade crossing. For the purposes of our analysis, the grade crossing is labeled with eight different zones depending on the access and direction a pedestrian will travel through the crossing. There are eight zones in total, labeled from 1 through 8: four zones which cover sidewalk access (Zones 1 through 4) and 4 which cover road access (Zones 5 through 8). Note that the directions provided in Figure 3 are relative to the NJ Transit Rail system and not geographic north. The train that travels eastbound to New York City passes through this crossing from the right to the left. (See the key in the lower left of Figure 3.)

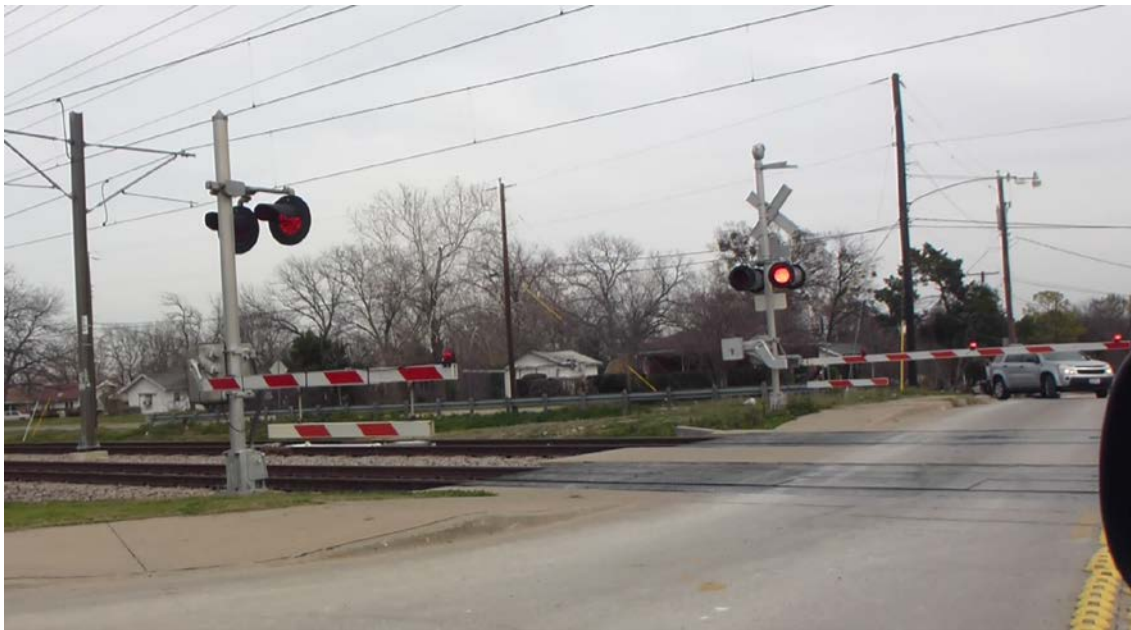
Figure 6. Gate Skirt Installation at Waco Ave., Dallas, TX

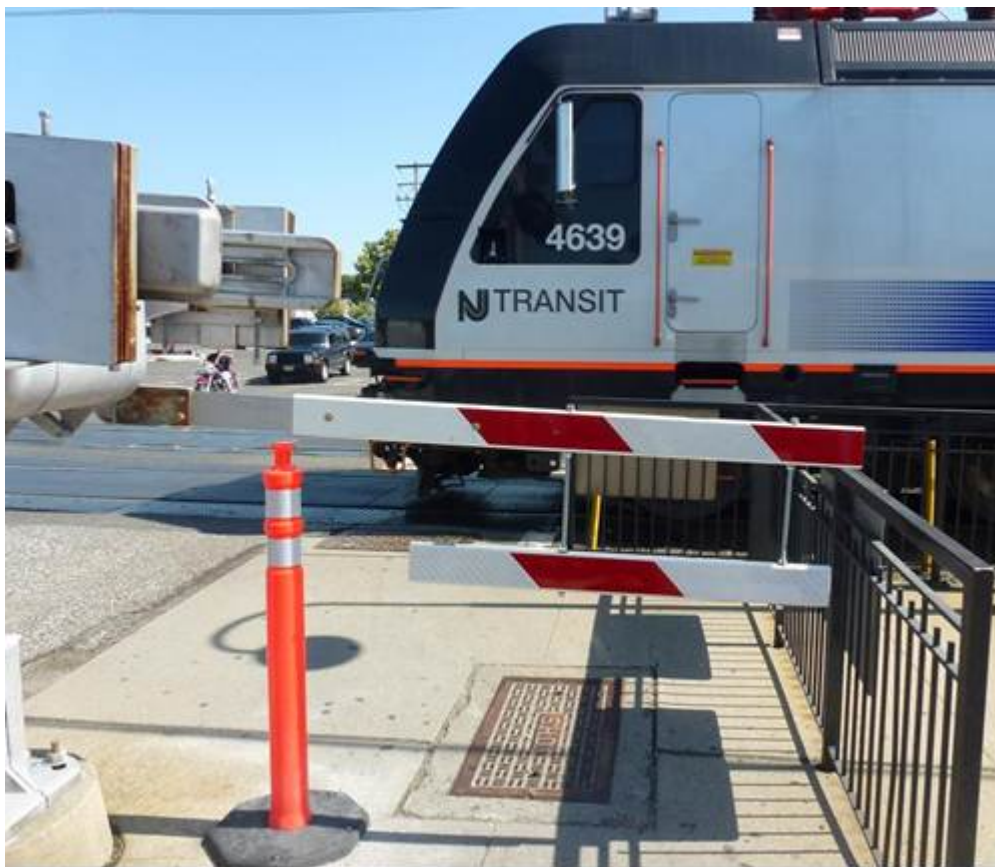
Figure 7 through Figure 10 show the installation on all four pedestrian zones. As shown in Figure 7, gate maintenance and pedestrian access issues forced the secondary gate in Zone 1 to be substantially shorter than the existing gate, thereby leaving an approximately 2-foot gap uncovered by the gate skirt. A bollard was installed to block this area but a significant gap still remained. It should also be noted that the secondary gate in Zone 3, as shown in Figure 9, was installed under the long gate used to block access from both the sidewalk and street.

Figure 7. Prototype Pedestrian Gate Enhancement at Atlantic Ave. – Zone 1.

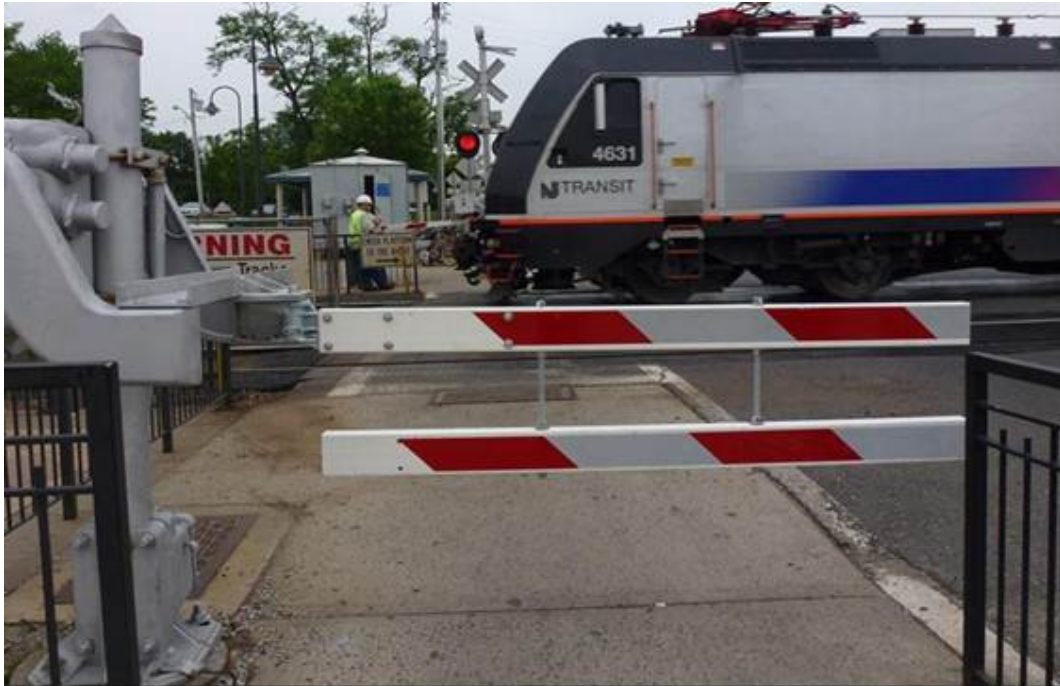
Figure 8. Prototype Pedestrian Gate Enhancement at Atlantic Ave. – Zone 2

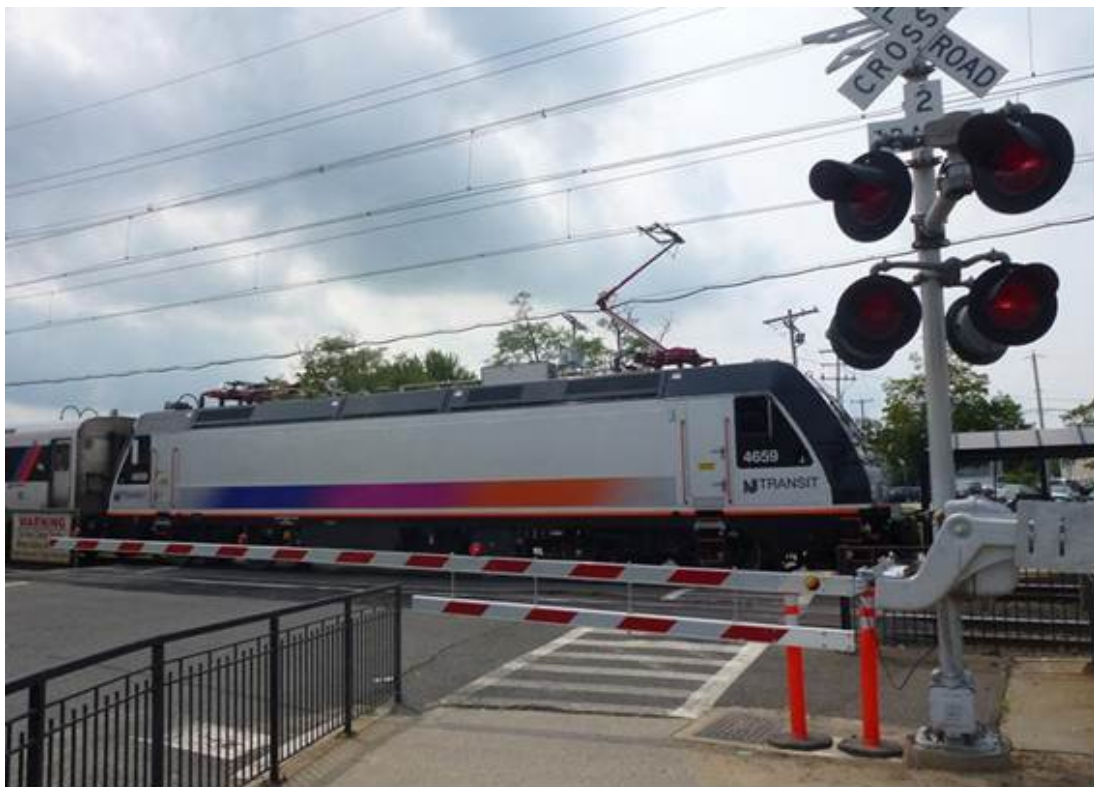
Figure 9. Prototype Pedestrian Gate Enhancement at Atlantic Ave. – Zone 3

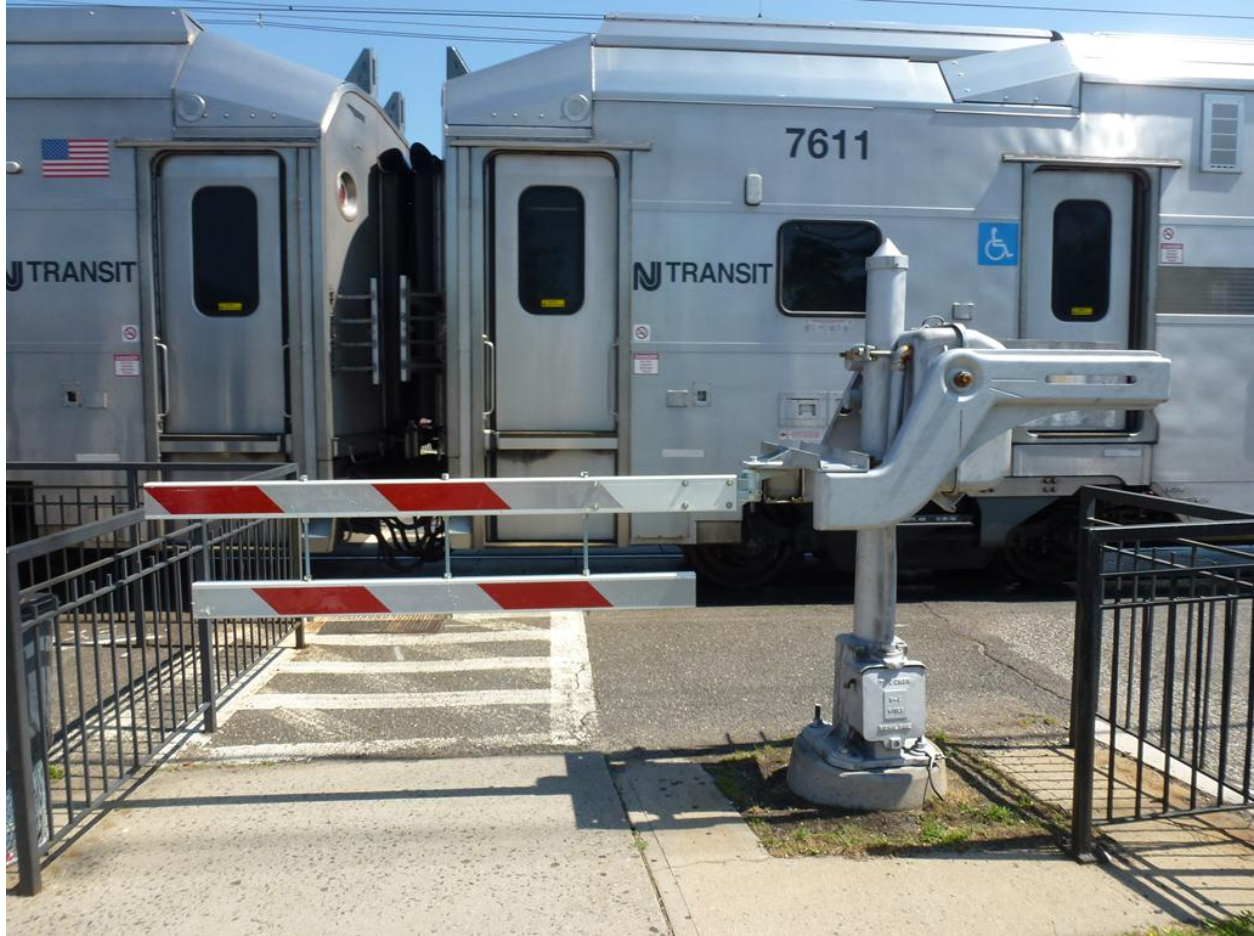
Figure 10. Prototype Pedestrian Gate Enhancement at Atlantic Ave. – Zone 4

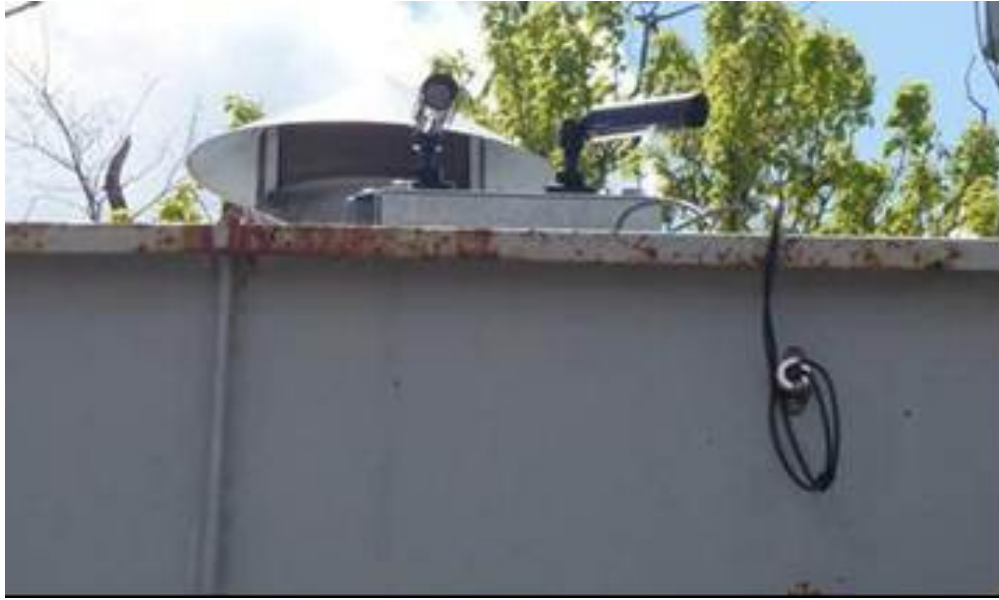
The data collection equipment consisted of two small video cameras magnetically mounted on the roof of the signal bungalow to the northwest (relative to the train movement) of the crossing and closest to Zone 1, as shown in Figure 11, and connected to a digital video recorder installed within the structure, as shown in Figure 12. This vantage point allowed for surveillance of the entire grade crossing and provided a constant power source as well as physical protection for the equipment. Additionally, the visible parts of the surveillance system had a very low profile and were therefore believed not to have any impact on pedestrian behavior.

Figure 11. Video Camera Placement

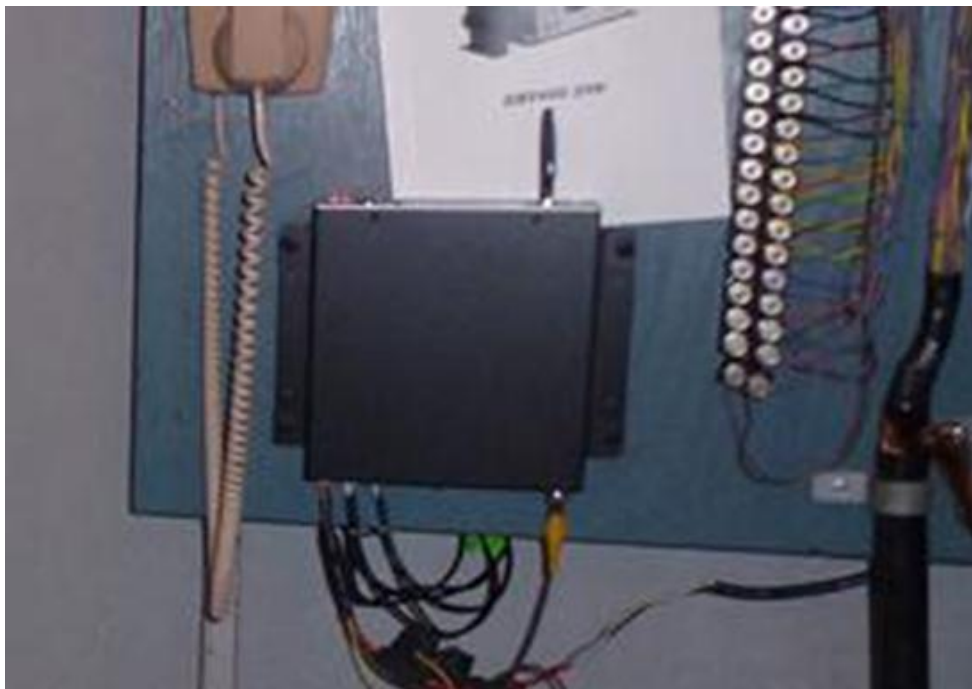
Figure 12. Digital Video Recorder

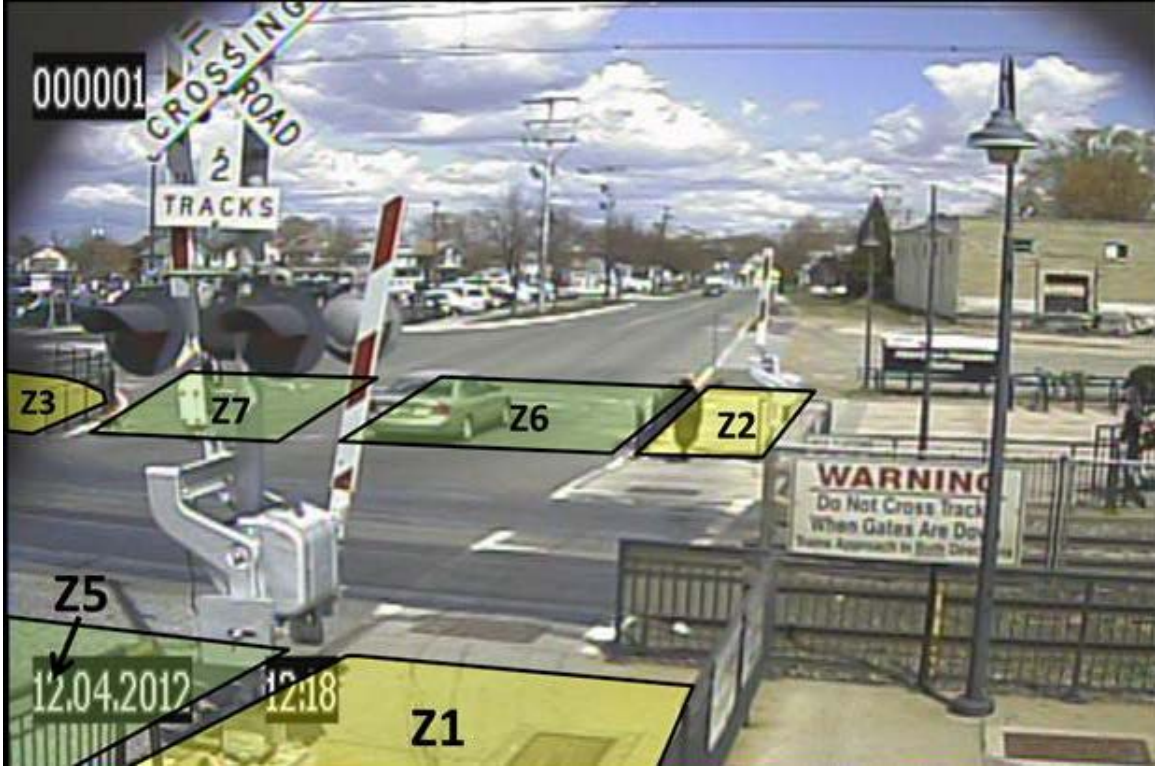
The view from the two cameras can be seen in Figure 13 and Figure 14, below. Figure 13 shows the view from the first camera with each of the visible zones labeled (Zone 4 and Zone 8 are out of the camera's view.). The view from the second camera, as seen in Figure 14, shows the two zones not seen from the first camera (Zone 4 and Zone 8) and a better angle of Zone 3.

Figure 13. View of Zones from First Camera

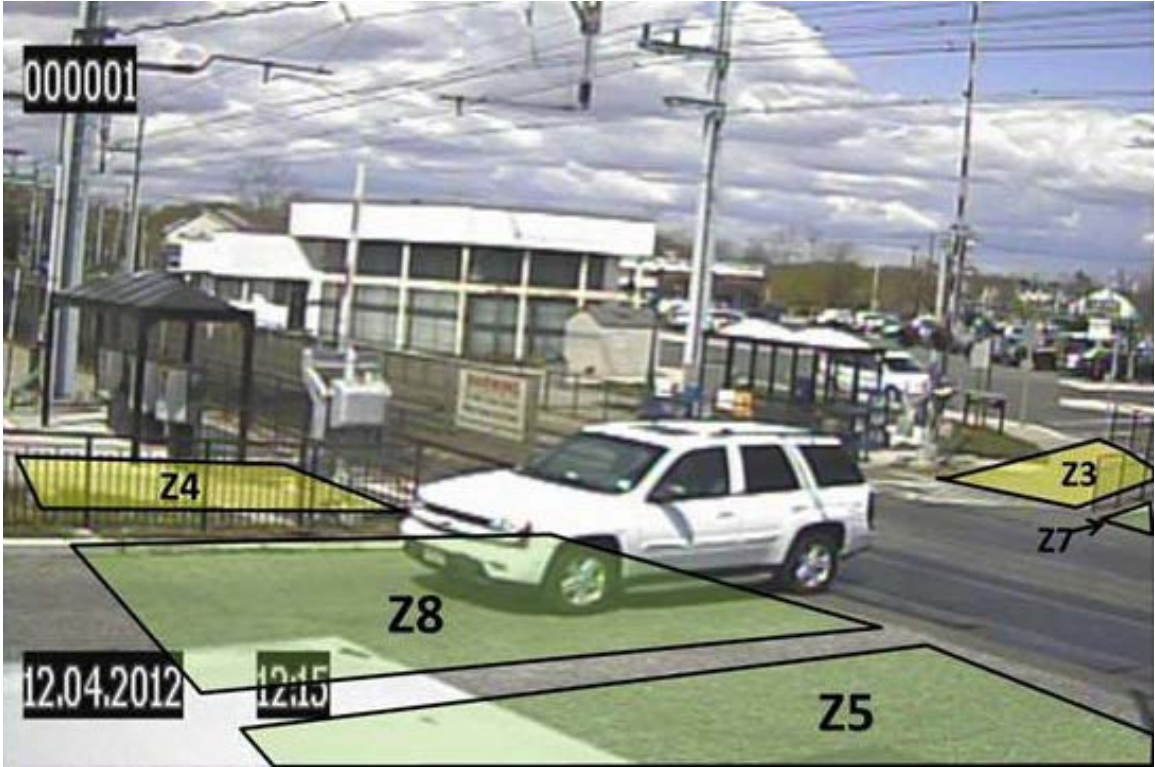
Figure 14. View of Zones from Second Camera

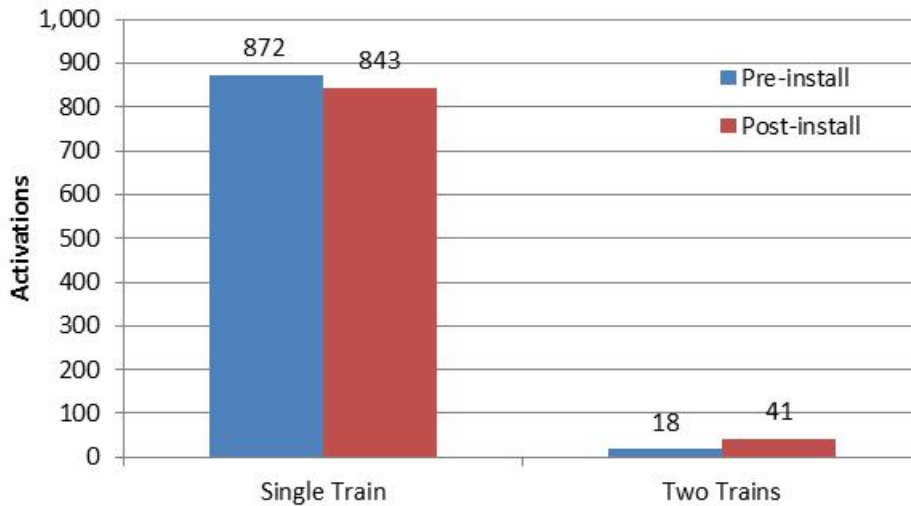
activations, as shown in Figure 15. The direction of the trains was divided almost equally between eastbound and westbound, with no difference by type of activation. Type of train was predominantly commuter, with only 1 percent (n = 10) involving freight train single activations and 11 percent (n = 9) involving freight for second train activations. Overall, there was approximately the same number of activations, with 890 pre-installation and 884 post-installation used in this analysis.

Figure 15. Number of Trains per Activation Pre- and Post-Installation

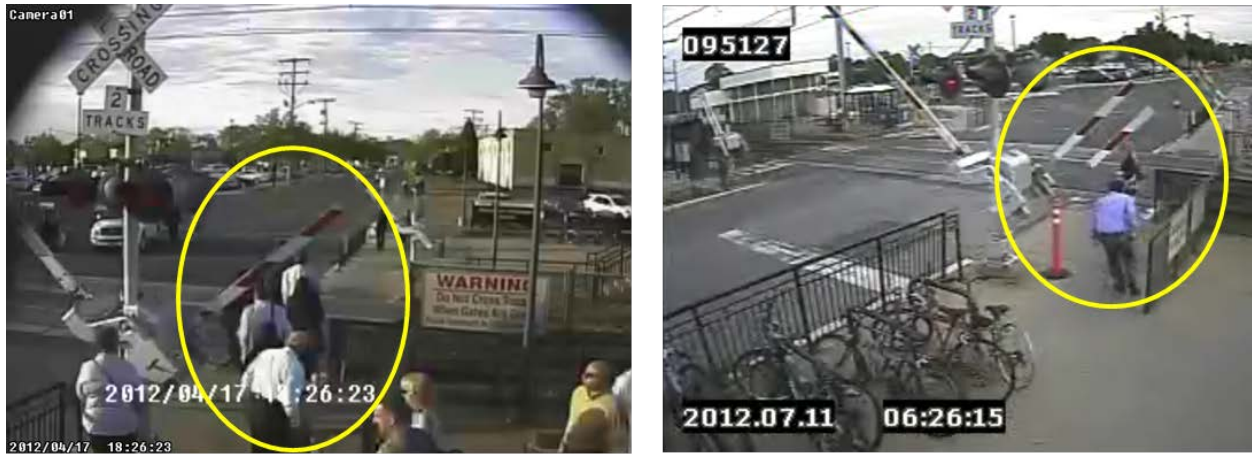
Figure 17. Examples of Descending Violations Pre- and Post-Installation

Example images of each of these types of violations, both with and without gate skirts, can be seen in the examples provided below. Examples of descending violations can be seen in Figure 17. In the pre-installation example (left panel), a total of five pedestrians went under the gate after descent had initiated. The woman on the left arrived at the crossing at the same time as the violating pedestrians, but chose to wait until after the activation had completed. In the post-installation example (right panel), the man in the blue shirt is running underneath the gate as they descend and continues through the crossing, exiting in the street in Zone 6.

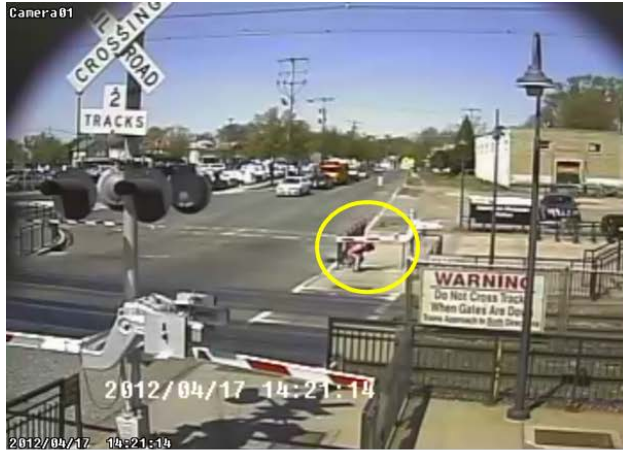
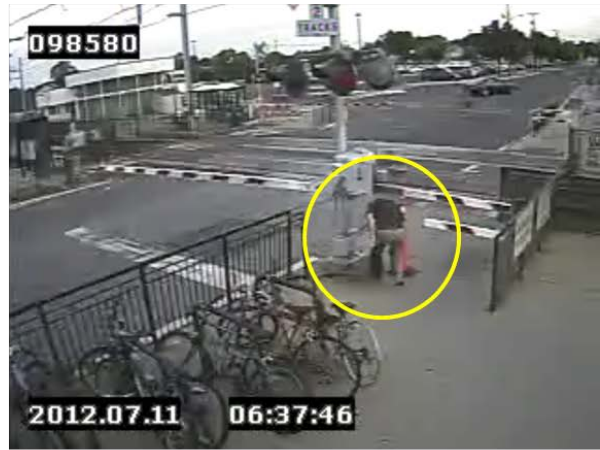
Figure 18. Examples of Horizontal Violations on the Sidewalk Pre- and Post-Installation

Examples of horizontal violations can be seen in Figure 18. In the pre-installation condition (left panel) a pedestrian is going under the horizontal gate in Zone 2. This pedestrian crossed the tracks and exited the crossing by going under the gate in Zone 1. In the post-installation example (right panel), the pedestrian is ducking underneath the original gate in the space where the gate skirt does not extend. This pedestrian, like the man in the post-installation example described above for the descending violation, exited the crossing by walking to the street and exiting in Zone 6.

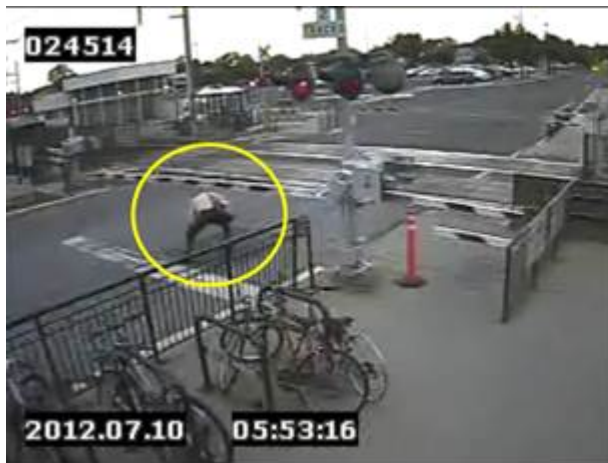
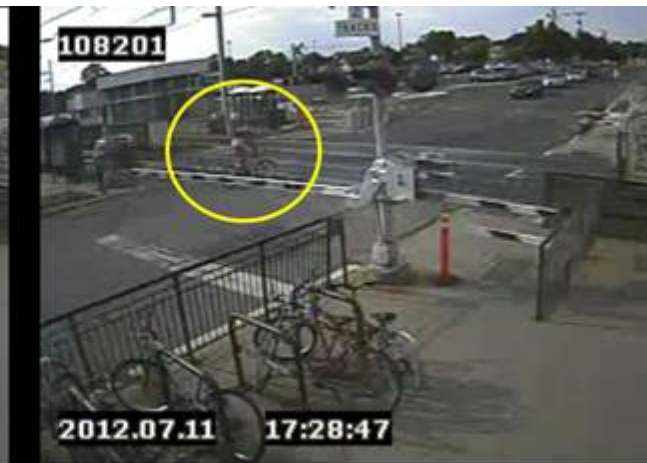
Figure 19. Examples of Horizontal Violations in the Street

During both horizontal and descending violations, it was possible for pedestrians to violate the crossing from the street. During horizontal violations, pedestrians could go around or under the vehicle gate (as seen in the left panel of Figure 19), or they could avoid the gates entirely in Zone 6 or Zone 8, as seen in the right panel of Figure 19 with a cyclist riding from Zone 8 to Zone 6.

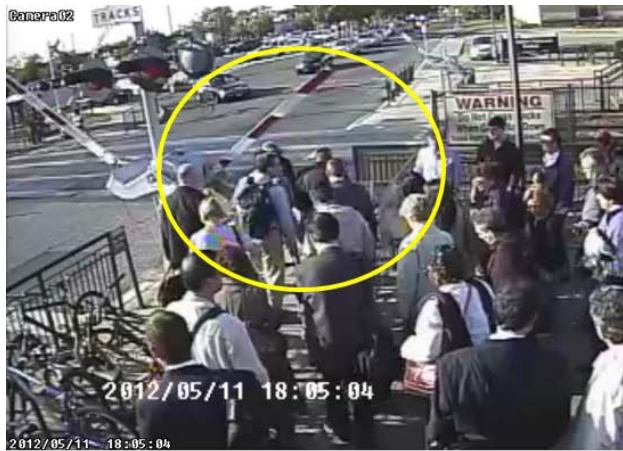
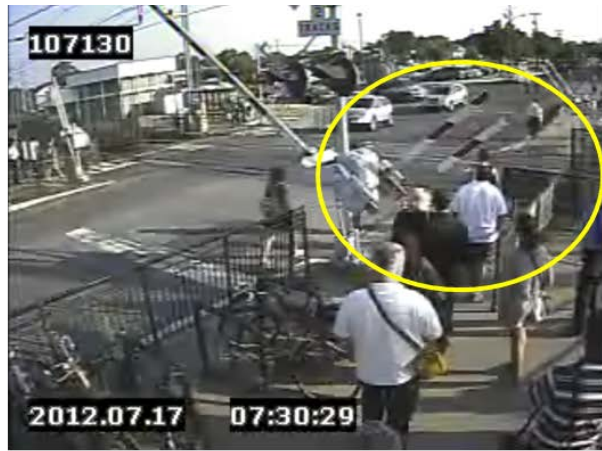
Figure 20. Examples of Ascending Violations Pre- and Post-Installation

Lastly, examples of ascending violations can be seen in Figure 20. In both pre- (left panel) and post- (right panel) installation examples, a large group of pedestrians is going underneath the gates as they ascend after a train passes through the crossing. The gates are all fully raised by the time these pedestrians reach the other side of the crossing, so they were not restricted in any way in terms of how they exited the crossing.

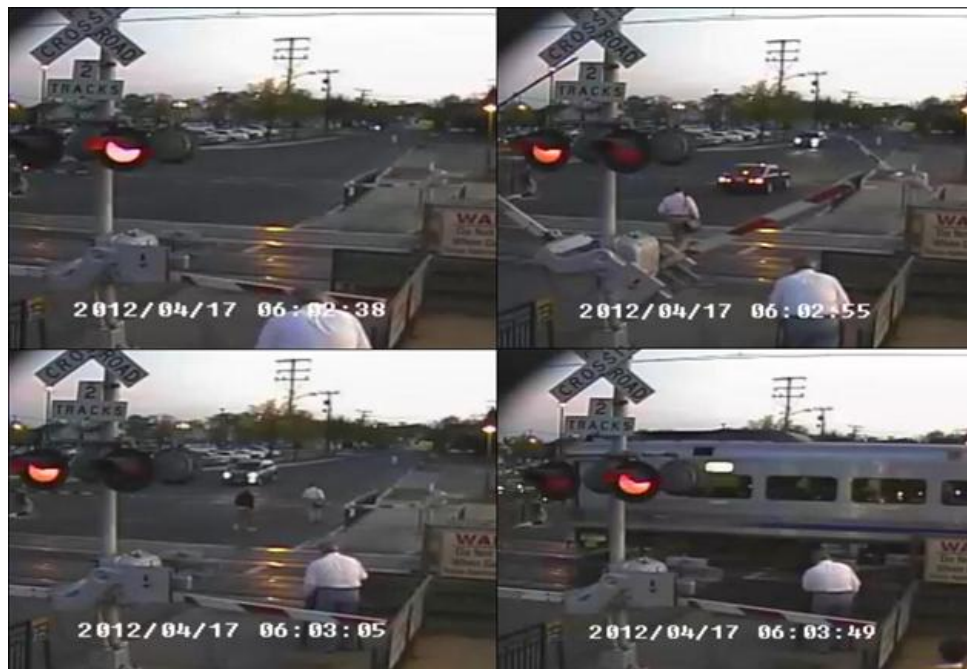
Figure 21. Example of Second Train Activation

Of the three types of violations, the ascending violation is least likely to result in a dangerous situation since the train has in most cases left the crossing area. However, in second train situations where the gates start ascending but reverse direction before fully vertical, the pedestrian may get caught inside of the gates, creating a highly dangerous situation. One such case occurred on April 17, 2012, during the pre-installation phase of observation. In that event, as shown in Figure 21, three pedestrians started to cross after the gates started ascending. However, the gates reversed direction approximately 3 seconds later (at about 45 degrees), and one pedestrian was forced to remain within the crossing past Zone 1 while the train passed.

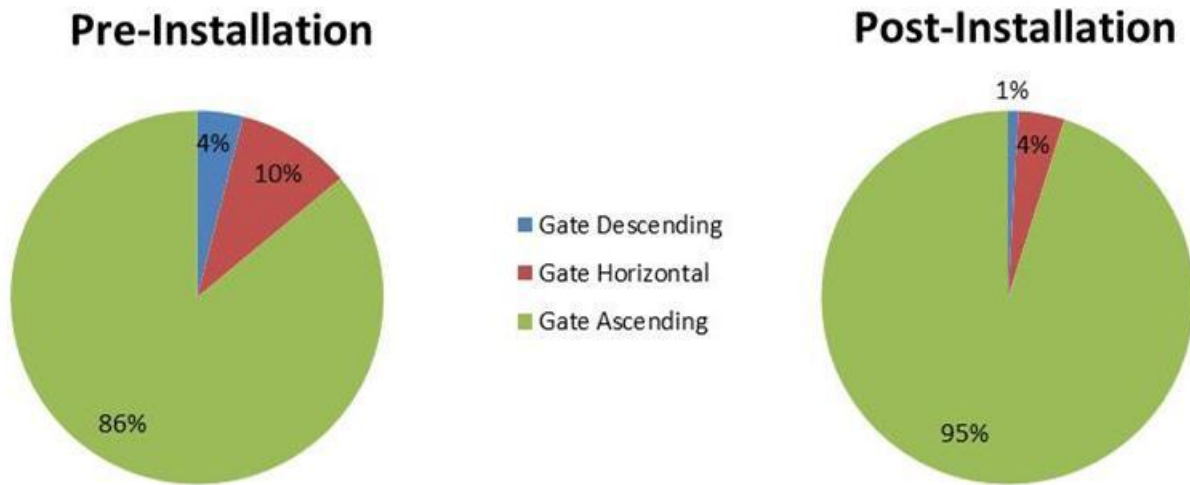
Given the total number of pedestrians who approached the crossing during an activation (2,461 before installation and 2,312 after installation) there was a significant difference in the number of violations that occurred before installation (1918 violations) and after installation (1,988 violations), (χ^2 (2, N = 3904) = 19.23, P < .001). Although the overall number of violations was higher post-installation, there was a statistically significant decrease in the number of descending and horizontal violations after the installation of gate skirts, as shown in Figure 22. Descending violations decreased significantly from 80 (4 percent) violations to 19 (<1 percent) violations (χ^2 (1, N = 96) = 49.27, P < .001). Horizontal violations also decreased significantly from 177 (10 percent) violations to 83 (4 percent) violations (χ^2 (1, N = 268) = 55.01, P < .001). In contrast, ascending violations rose significantly after the installation of gate skirts from 1658 (86 percent) violations to 1887 (95 percent) violations (χ^2 (1, N = 3,904) = 16.52, P < .001).

Figure 22. Frequency of Violations per Activation Phase Pre- and Post-Installation

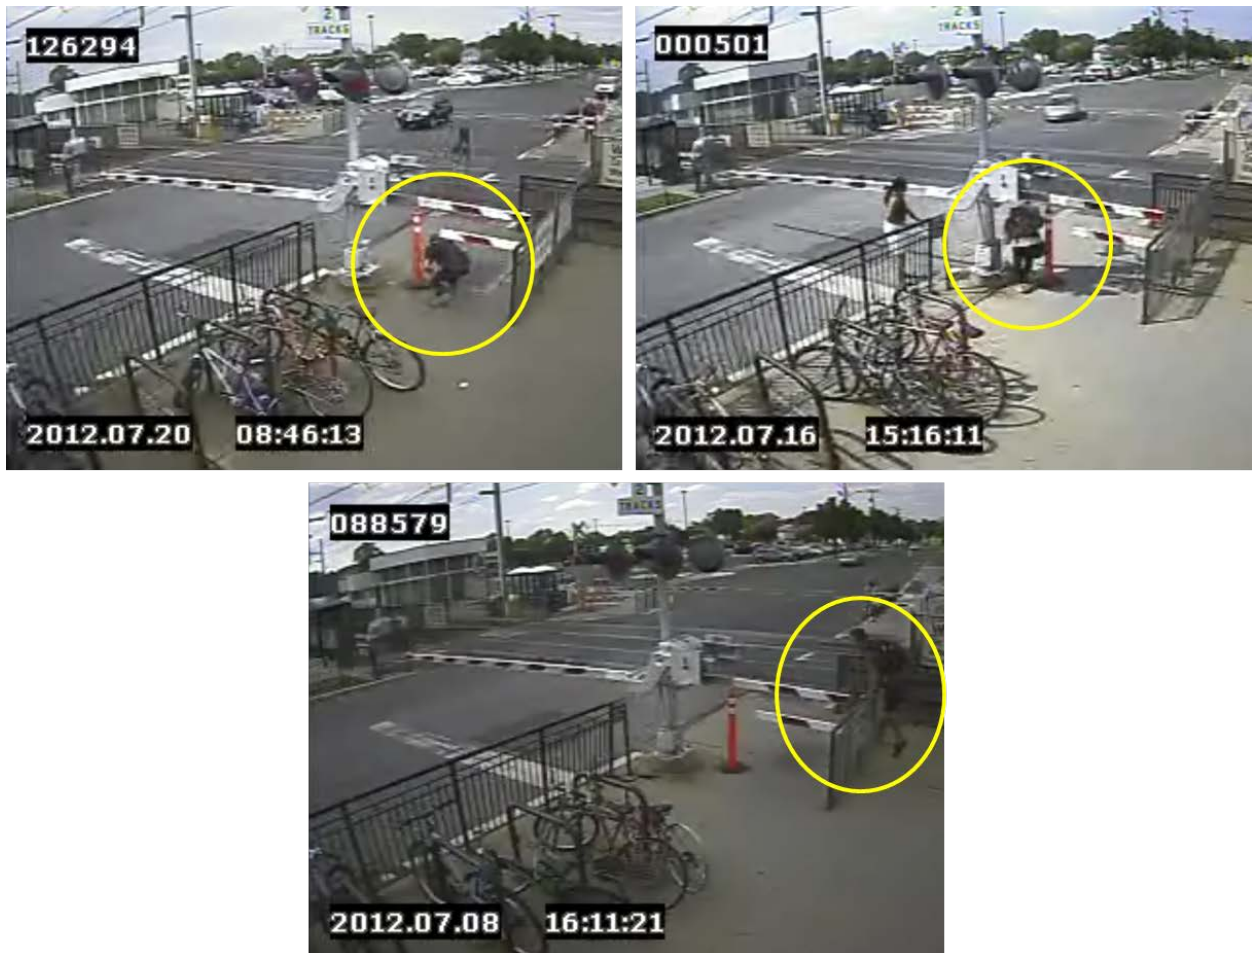
(37 percent) of post-installation violations used Zone 6 to exit the crossing. Despite an overall decrease in the number of violations using Zone 6 to exit, the proportion of violation from Zone 6 to the total number of post-installation violation exits increased by 14%. For horizontal violations, 28 (16 percent) pre-installation violations used Zone 6 to exit the crossing and 33 (41 percent) exited from Zone 6 after installation. This 25 percent pre- to post-installation increase indicates that a larger percentage of pedestrians were using Zone 6 to exit the crossing after installation of the gate skirt. This increase may also in part be explained by a decrease in the adjacent Zone 2: from 35 to 6 percent of pedestrians exiting. Of the 80 post-installation horizontal violations, 38 pedestrians went under the gates to violate and 17 of those violations originated from Zone 1. Of those 17 violations, only 1 pedestrian violated by going under the gate skirt (upper left of Figure 25); the remaining 16 went through the unobstructed area between the gate skirt and the post holding the gate to the left of the cone (upper right of Figure 25). One pedestrian who jumped the fence next to the gate to avoid going under or around (bottom of Figure 25) is not included in the totals above.

Figure 25. Zone 1 Pedestrian Violation Behavior

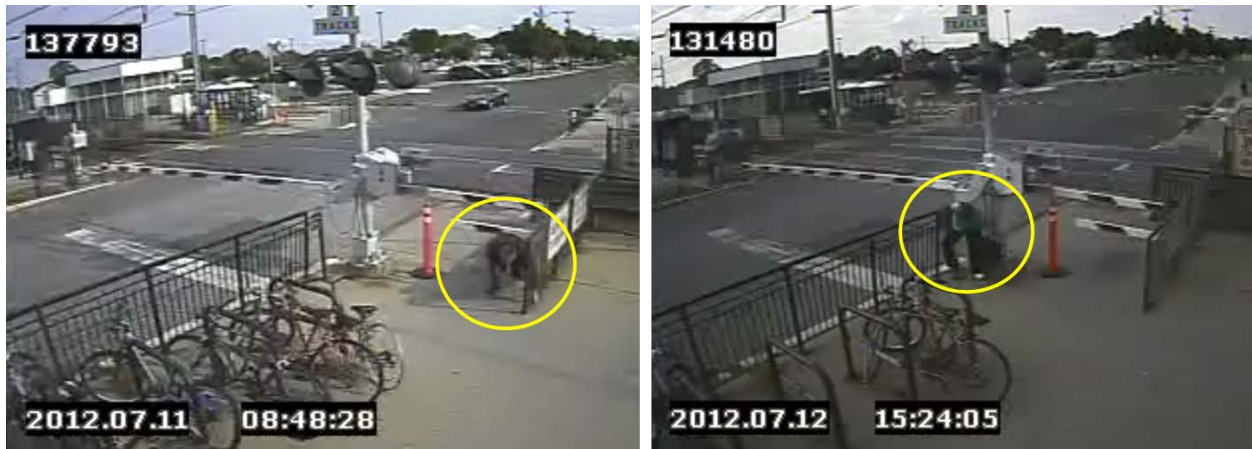
Additionally, there were 10 violations for which the pedestrian exited the crossing in Zone 1 while the gates were horizontal. Of those 10 violations, the pedestrians went around the gate skirt (to the left of the cone) in 7, under the gate skirt in 1 (see left panel of Figure 26), and 2 pedestrians waited until the gates began to ascend to exit. In three additional cases, the pedestrian went under the vehicle gate to exit (Zone 5) and then squeezed between the gate pole and the fencing to get to Zone 1 (see right panel of Figure 26). However, the movement from Zone 5 to Zone 1 occurred on the same side of the crossing.

Figure 26. Zone 1 Pedestrian Violation Exit Behavior

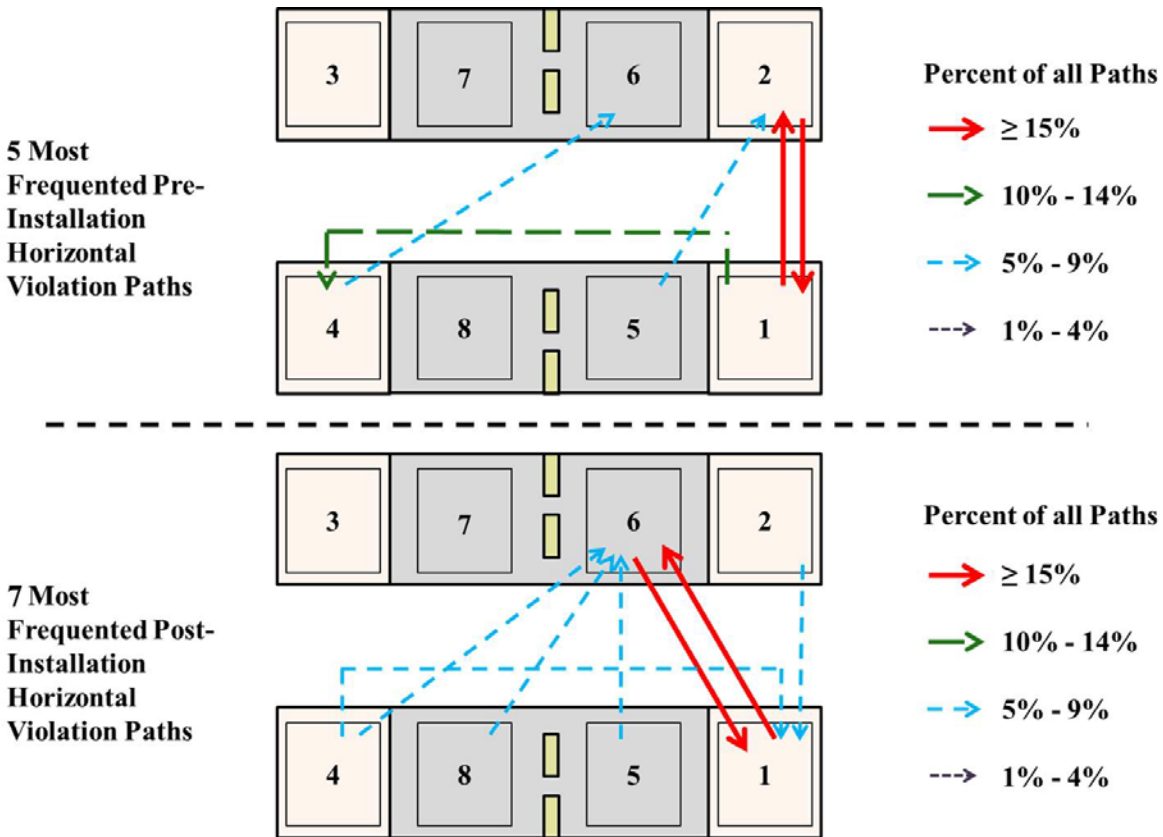
Horizontal violations were found to be similar to descending violations before installation of the gate skirts, with movement from Zones 1 and 2, in both directions, followed by Zone 1 to Zone 4 being the most frequently travelled (see Figure 28). However, after installation of the gate skirts, pedestrian movements (or paths) changed quite dramatically during horizontal violations. The two most frequent paths after installation were Zone 6 to Zone 1 in both directions, with Zone 6 being a street zone. Neither the path from Zone 1 to Zone 6 nor the path from Zone 6 to Zone 1 was among the top five paths before installation of the gate skirts. This indicates a rise in the number of paths that start or end on the street after the installation of the gate skirts. The next most common post-installation paths were from Zone 5 to Zone 6 and from Zone 8 to Zone 6, both of which are paths that exclusively use the street to traverse the crossing. The path from Zone 2 to Zone 1, which was one of the top two paths before the installation of gate skirts, was tied for the fifth most frequented path after installation, which illustrates a reduction in the number of pedestrians traveling from sidewalk to sidewalk and between those zones. (Note: seven paths were included in the post-installation analysis because three paths tied for the position of fifth most popular).

Figure 28. Most Frequent Paths through Crossing during Horizontal Violation

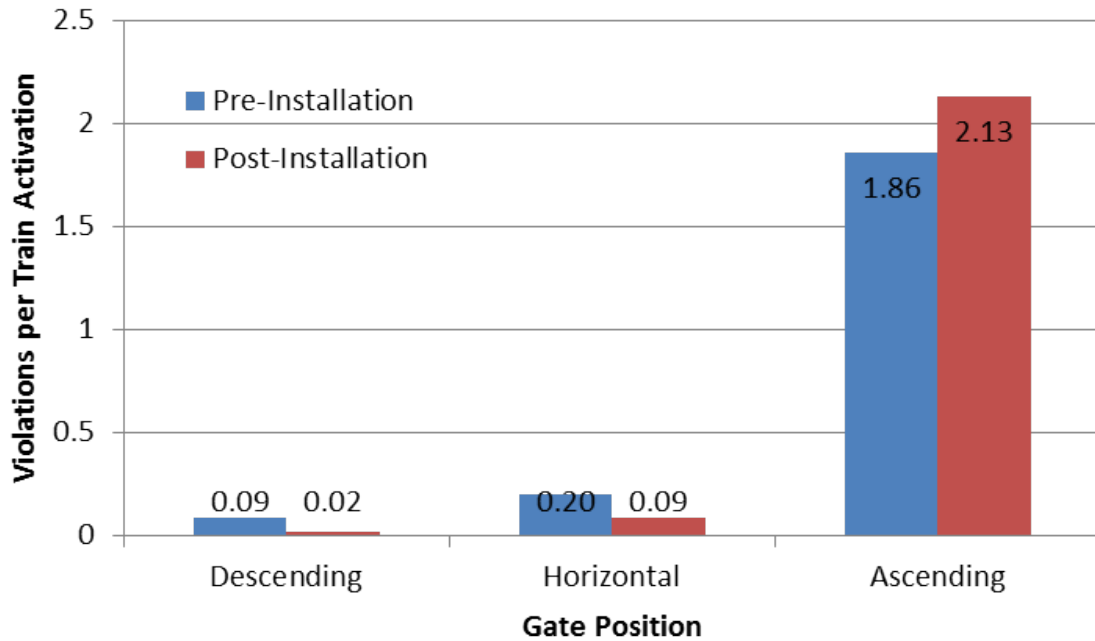
Results showed there was a significant increase in total number of violations after installation of the gate skirts. However, this finding is predominately due to an increase in ascending violations. Ascending violations increased significantly after installation of the gate skirts although both descending and horizontal violations significantly decreased, as shown in Figure 30. Figure 30 depicts the number of descending, horizontal, and ascending violations per train activation, which allows for comparison of the increase or decrease in the rate of each type of violation. The increase in ascending violations may be due to the fact that the gate skirt blocks access to the sidewalk, so pedestrians are more anxious to get across the crossing once the gates start to ascend because they know it will be harder to do so once the gate comes down. Alternatively, this increase could be due to the increased number of pedestrians waiting to cross because fewer pedestrians were violating while the gates were descending or horizontal.

Figure 30. Pedestrian Violation Rate per Grade Crossing Activation

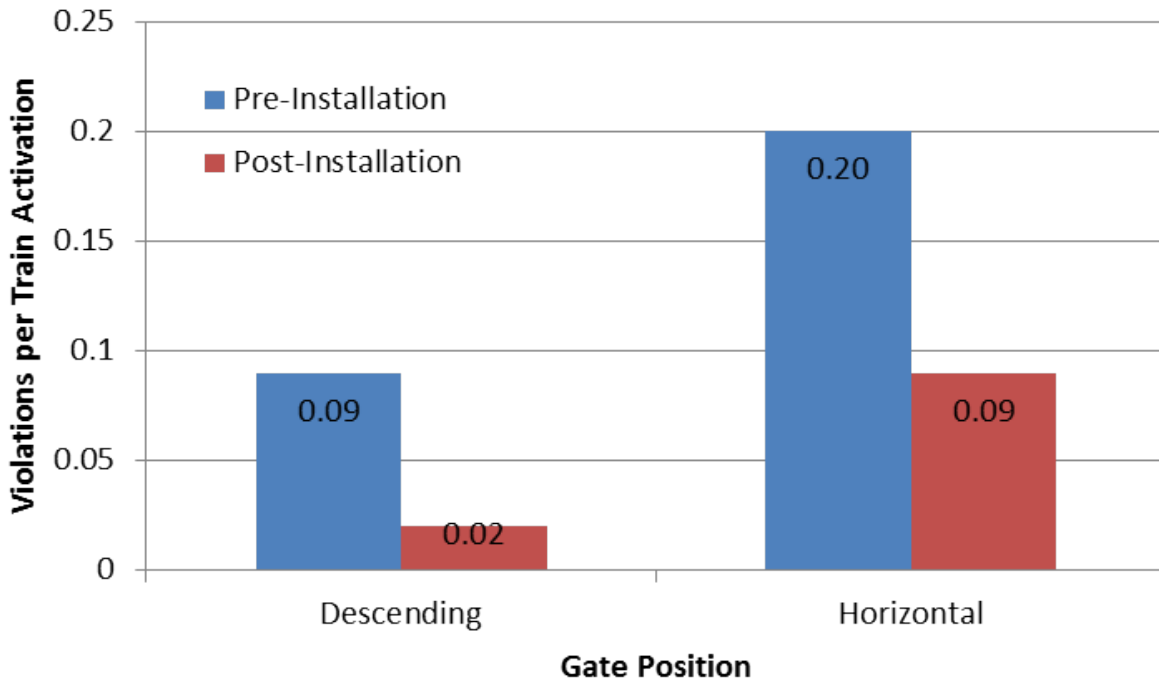
A total of 2,461 pre- and 2,312 post-installation pedestrian observations were made with a total of 890 pre- and 884 post-installation train activations analyzed. There was a statistically significant decrease in the number of descending and horizontal violations after the installation. Descending violations dropped significantly from 79 violations to 17. Horizontal violations also decreased significantly from 185 to 83 violations. In contrast, ascending violations rose significantly after the installation of gate skirts from 1,653 violations to 1,887 violations, though the reason is uncertain. The findings illustrate that the addition of gate skirts in this particular case has reduced the number of violations committed while the gates are descending (78 percent reduction in violation rate) or in the horizontal position (55 percent reduction in violation rate), as shown below in Figure 31. The addition of gate skirts may also have changed pedestrian behavior in that pedestrians may now be more likely to enter and exit the crossing from the street when committing a descending or horizontal violation. Horizontal violations (entering the crossing) on the sidewalk dropped from 82 percent of the violations before installation to 47 percent after installation, while violations that began on the street jumped from 18 percent of the violations before installation to 53 percent after installation. Horizontal violations that exited on the street jumped a significant amount: from 19 percent of the violations before installation to 35 percent after installation, though again the reason for this jump is uncertain.

Figure 31. Descending and Horizontal Gate Violation Rate per Grade Crossing Activation
