**Federal Railroad
Administration**

Performance Evaluation of Concrete Railroad Ties on the Northeast Corridor

13. ABSTRACT (Maximum 200 words) Simpson Gumpertz & Heger Inc. conducted an investigation into the factors that caused widespread failure in prestressed concrete railroad ties on the Northeast Corridor. The problem was apparent in ties manufactured and installed circa 1994–1998. The work included a literature search, review of existing studies, field investigation, laboratory analyses, including petrography and mechanical testing, finite element analysis, and field testing. We evaluated ties that cracked (pre-2003 ties) and ties that did not crack (post-2003 and San-Vel ties). The results show that the predominant mode of cracking, horizontal cracks in the top row of tendons, is a result of a combination of high stresses from prestressing forces and alkali-silica reaction (ASR) induced pressure. Train wheel loading contributes to crack growth but does not appear to be the cause of crack initiation. Delayed Ettringite Formation (DEF) and freeze-thaw cycling do not appear to contribute to the cracking.

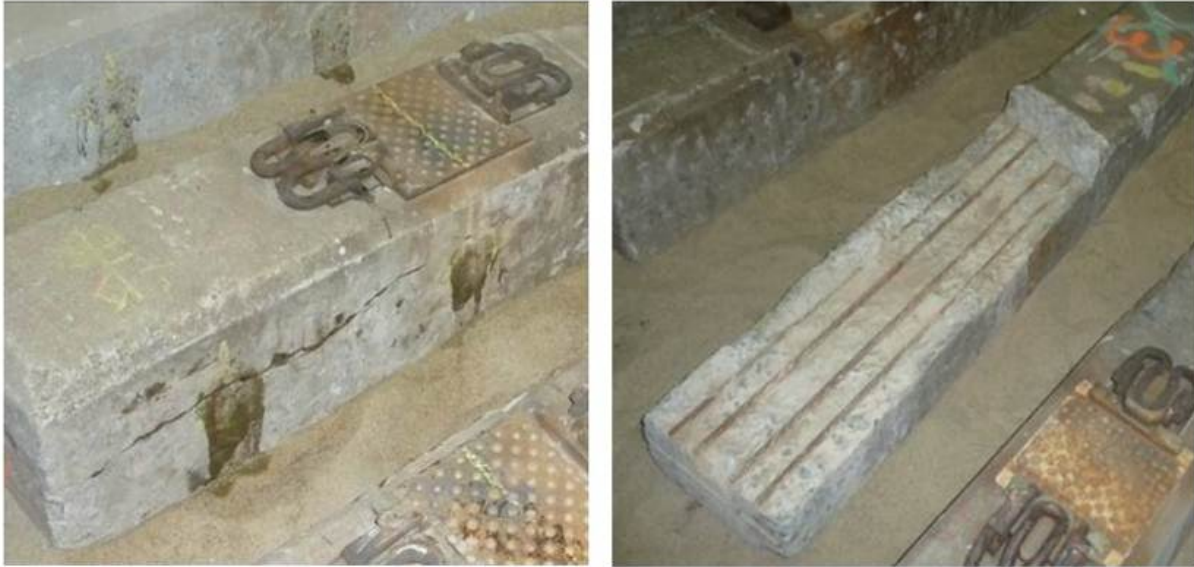
The predominant mode of cracking we observed in these ties from the NEC had a horizontal orientation intersecting the top row of strands, generally near the end or ends of the tie. An example of this cracking mode is shown in two different ties in Figure 2.2. Most of the ties we have examined had a crack on one or both sides. This crack is generally not visible in track because it is covered by ballast. The crack must progress substantially and turn vertically before large pieces of concrete separate from the tie. We rarely observed such severe damage. These cracks required substantial time, approximately 10 years, to become evident.

Figure 2.2. Photographs of the predominant mode of concrete tie cracking we investigated in this study; the crack on the left is revealed by alcohol.

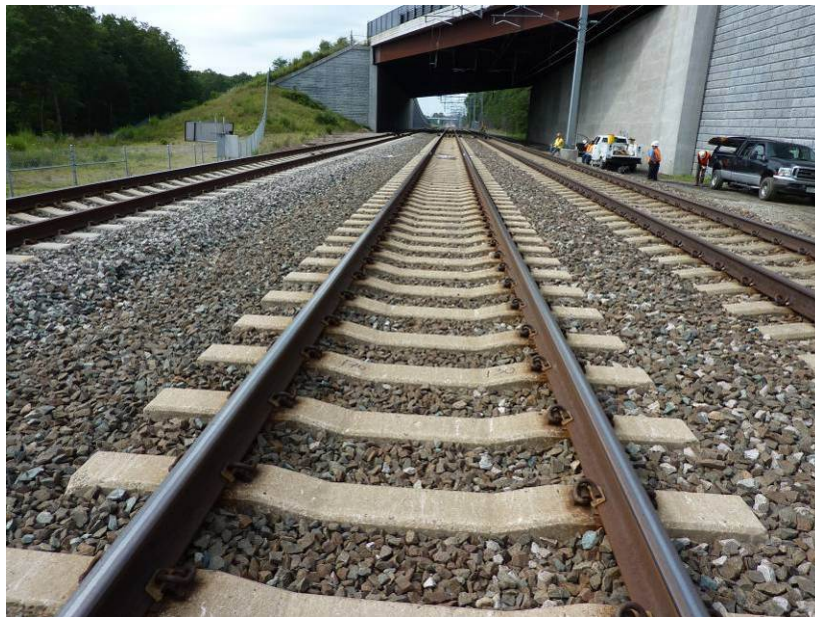
Figure 3.3. A bridge structure near the field test site at which we nondestructively examined ties.

We assessed the condition of each end of approximately 110 concrete ties using the impact echo method. Approximately half of the ties were under the bridge and half were exposed directly to the environment. All of the concrete ties appeared to be manufactured around 1994. We have established through previous programs a correlation between impact echo results and the likelihood of horizontal cracking. Using this correlation, the impact echo results indicated that 96 percent of the concrete ties not sheltered by the bridge structure had horizontal cracks and 58 percent of concrete ties sheltered by the bridge structure had horizontal cracks. We also excavated the tie-end regions at forty-one locations (approximately 20 percent of the ties tested with impact echo) to confirm the impact-echo test results and found that 92 percent of the exposed ties and 53 percent of the under-bridge ties were cracked, agreeing closely with the impact-echo test results. The impact echo data and our excavation observations suggest that at this location (Amtrak MP 168, Track 2), most of the ties are cracked and the condition of the concrete ties sheltered by the bridge structure is better than the unsheltered concrete ties. These

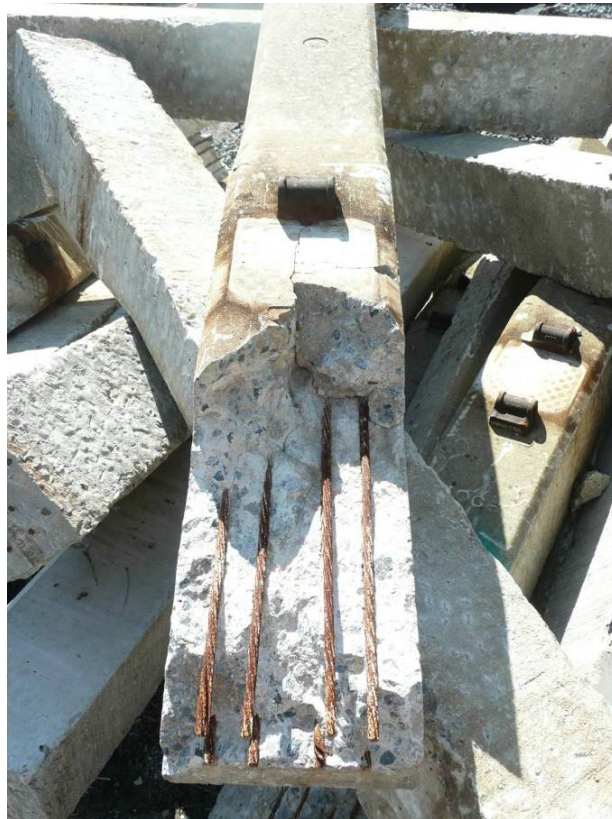
Figure 3.4. An example of a severely cracked tie from the MBTA Old Colony Line.

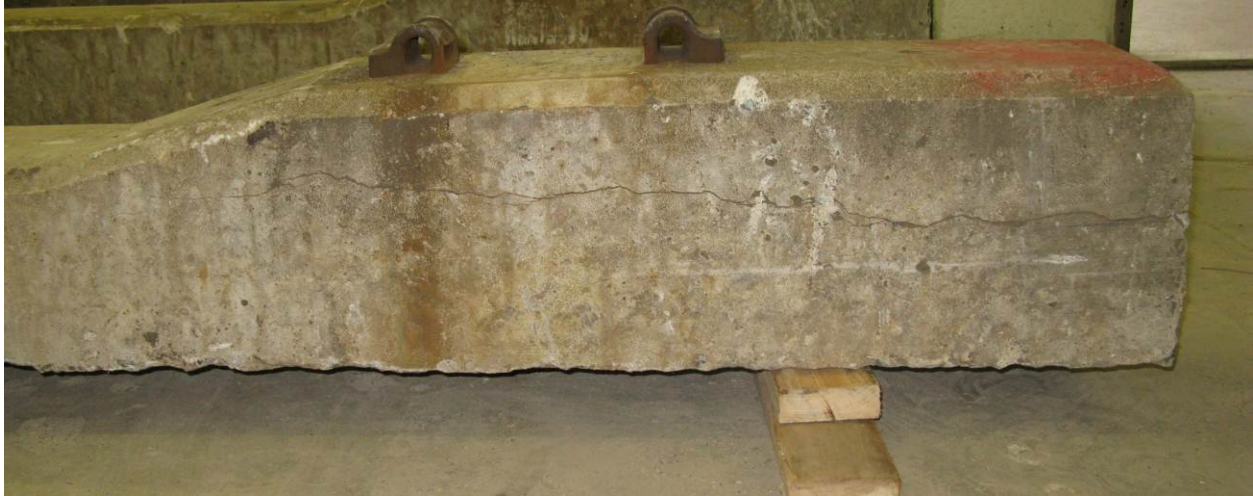
Figure 3.5. An example of a tie with a typical crack from the MBTA Old Colony Line.

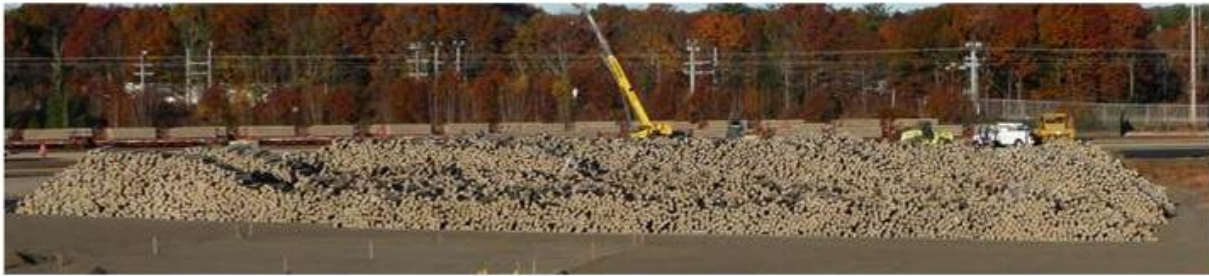
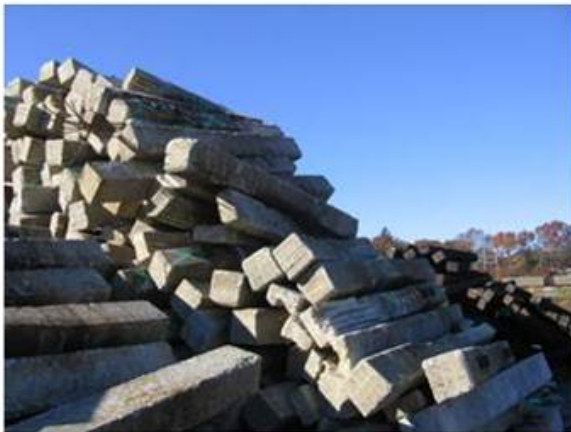
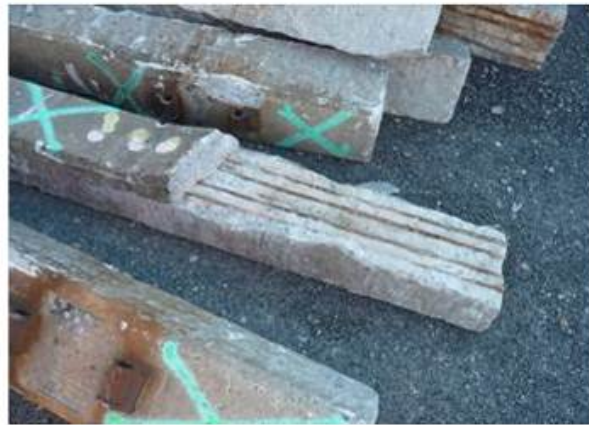
Figure 3.6. Photographs from the Amtrak yard in Davisville, RI, from which some of the case study ties were obtained.

We obtained ties for our NEC case studies from Amtrak’s tie yard in Davisville, RI, and from areas in this neighborhood. The Davisville ties had been removed from the section of track between mileposts 178 and 190 near Providence as part of Amtrak’s tie replacement program. These ties had been stacked in large piles and our team examined accessible ties from the entire lot. Figure 3.6 shows photographs from this examination. It was easy to inspect the sides of these ties, unlike those in track, and we found that more than 70–80 percent had cracks on one or both sides at the ends.

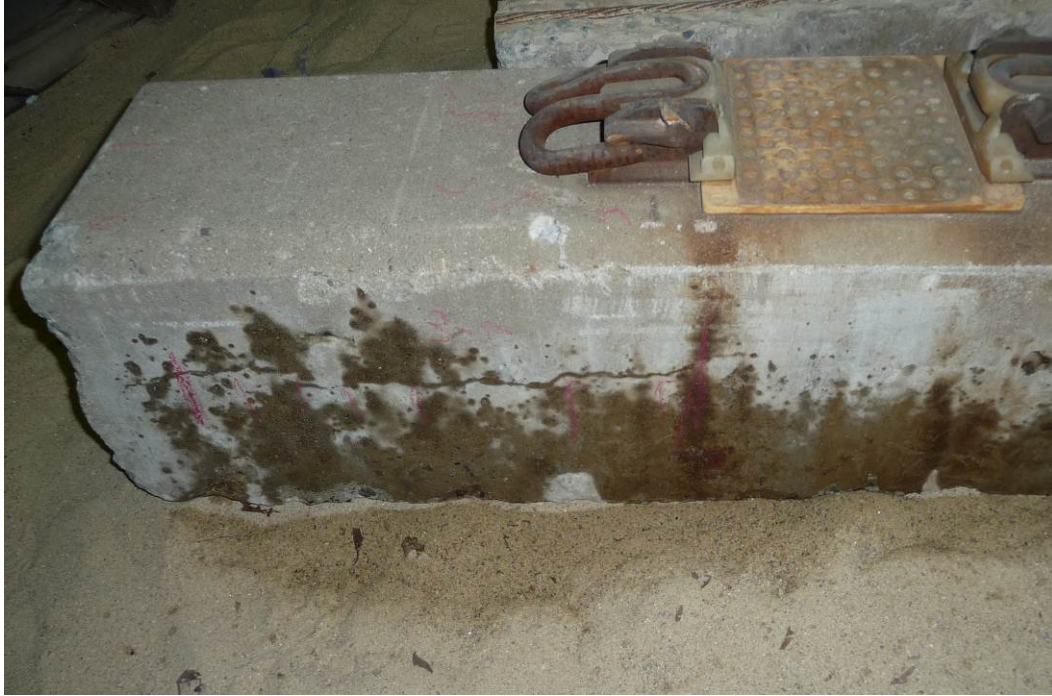
Figure 3.7. Photograph of one of the case study ties showing how the crack is revealed with the use of isopropyl alcohol.

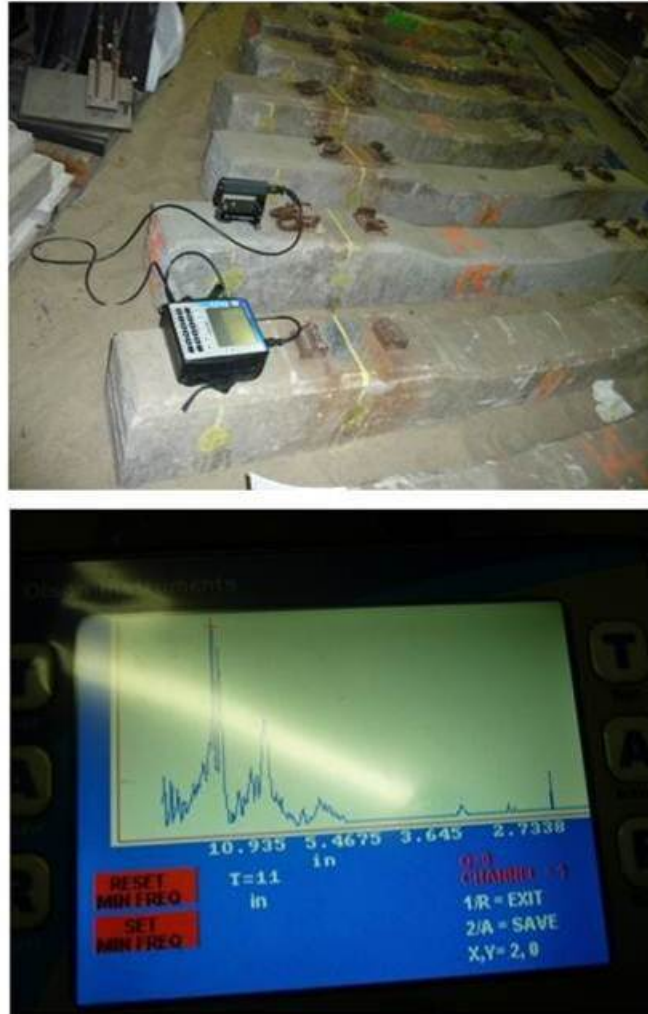
Figure 3.9. The impact echo device and a sample reading.

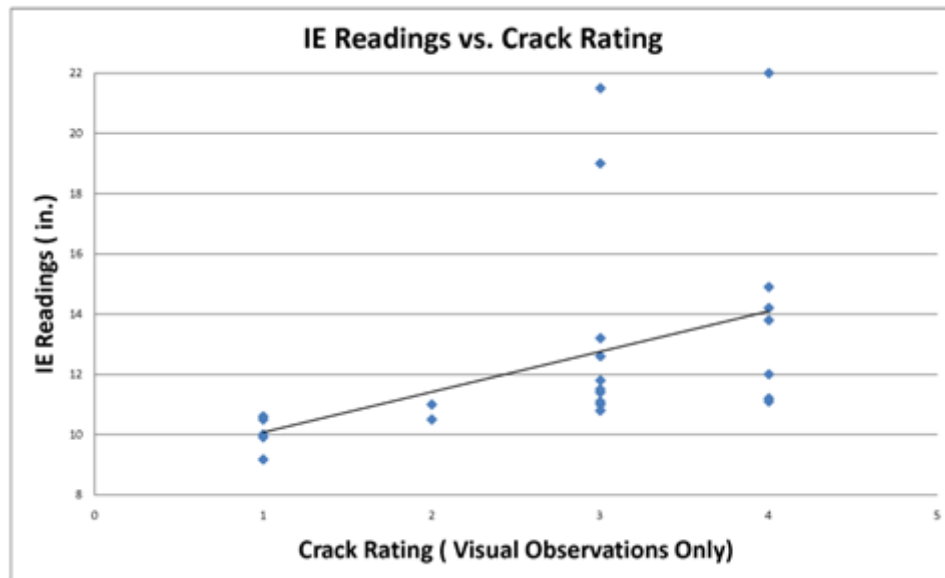
Figure 3.10. The impact echo results vs. our crack rating for the case study ties.

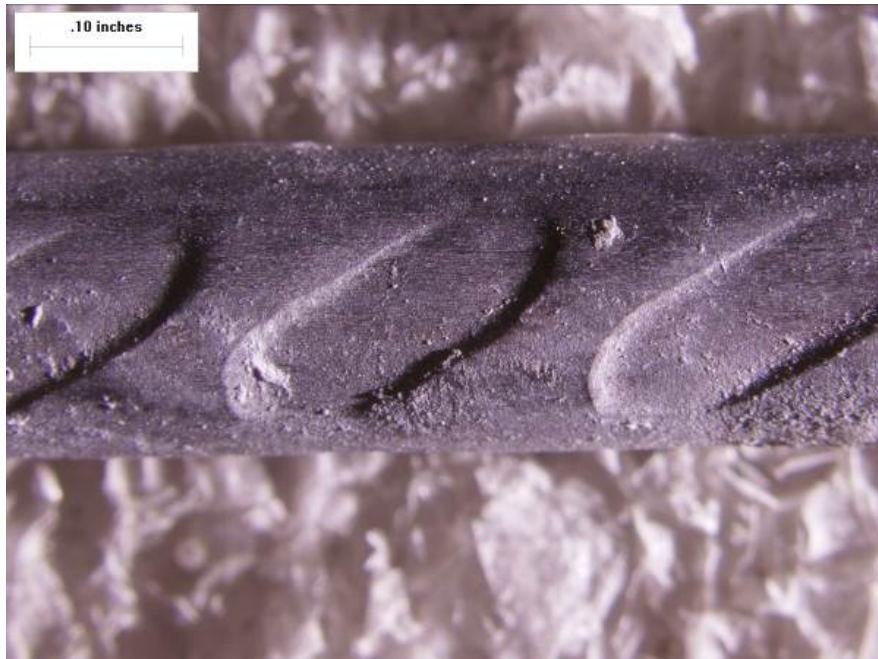
Figure 4.2. Example of elongated elliptical deformations on a single-wire strand from a post-2003 tie.

Figures 4.1-4.3 show examples of the indentations in the wires from the three tie types. There are four lines of longitudinally oriented elliptical indentations around the circumference of the wires for the pre-2003 and San-Vel strands, and there are three lines of indentations oriented at an angle to the longitudinal direction for the post-2003 ties.

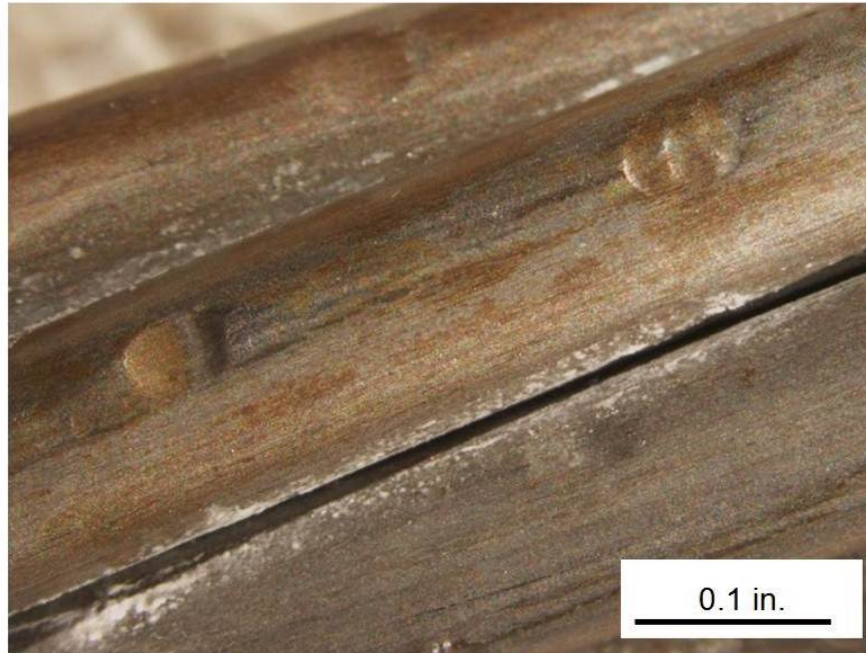
Figure 4.3. Example of elliptical deformations on seven-wire strands from a San-Vel tie.

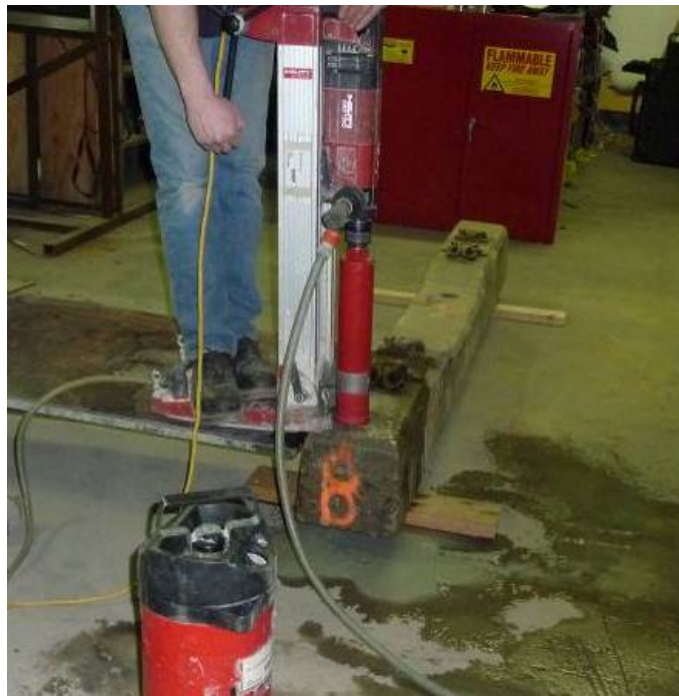
Figure 4.4. SGH retrieving a full-depth vertical core sample from a tie.

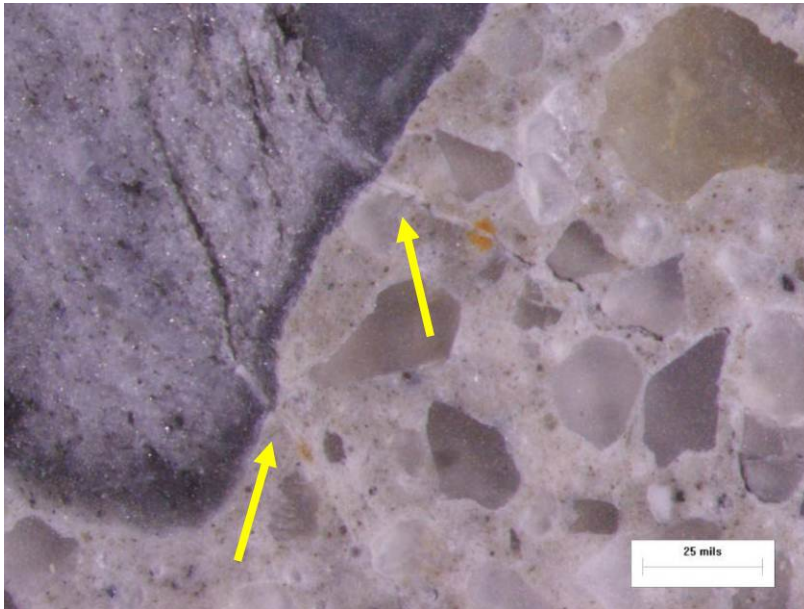
Figure 4.5. A magnified view of the polished cross section in Core C8-1. Note the intersecting fractures that originate in a reactive coarse aggregate particle, extend outward into the surrounding paste structure, and are partially filled with gray, subtranslucent to opaque ASR gel (yellow arrows).

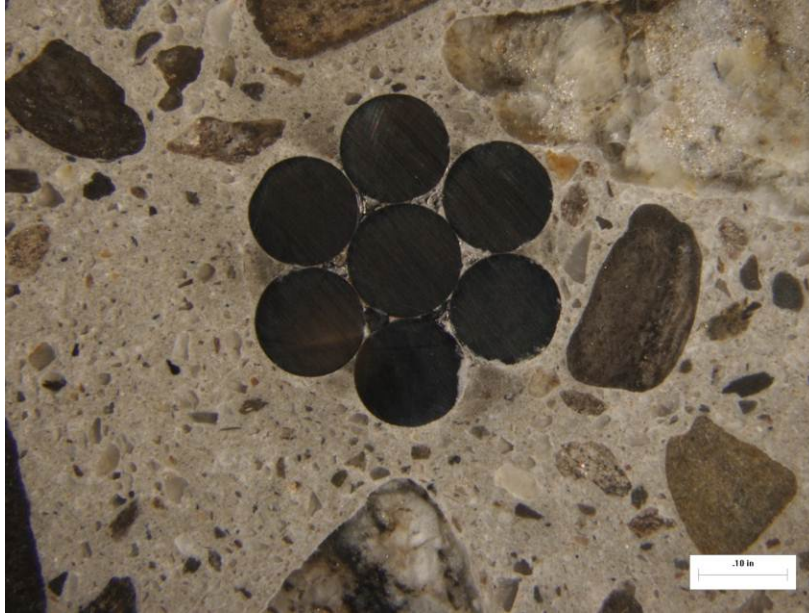
Figure 4.9. A magnified view of the polished cross-section in Core S1-3 showing a tight intimate bond between the tendon strands and the surrounding paste.

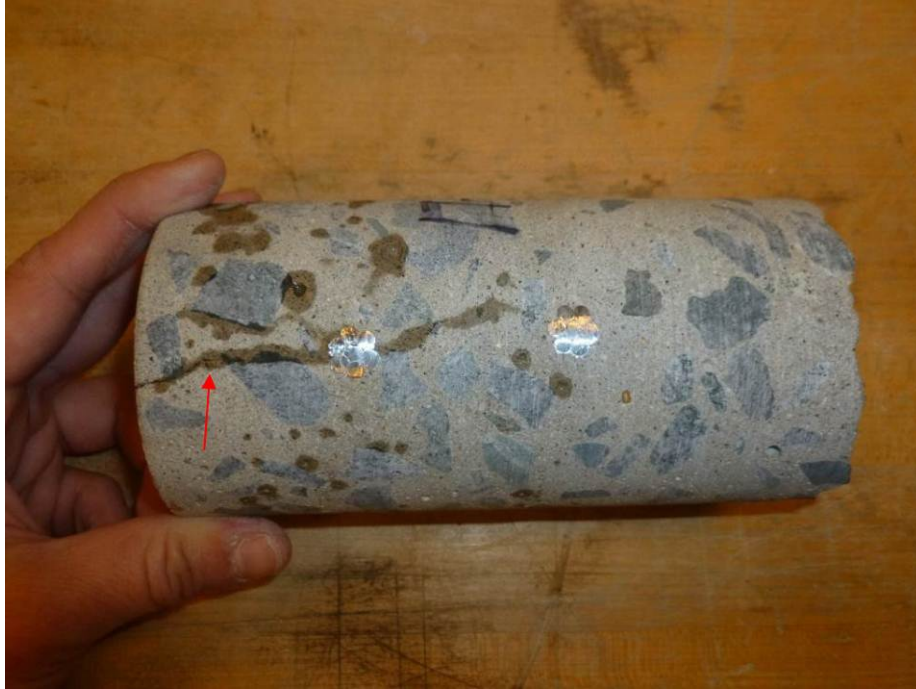
Figure 4.11. Core C17-3- sprayed with alcohol showing the lateral crack on the exterior surface extending into the concrete body and stopping at the second tendon.

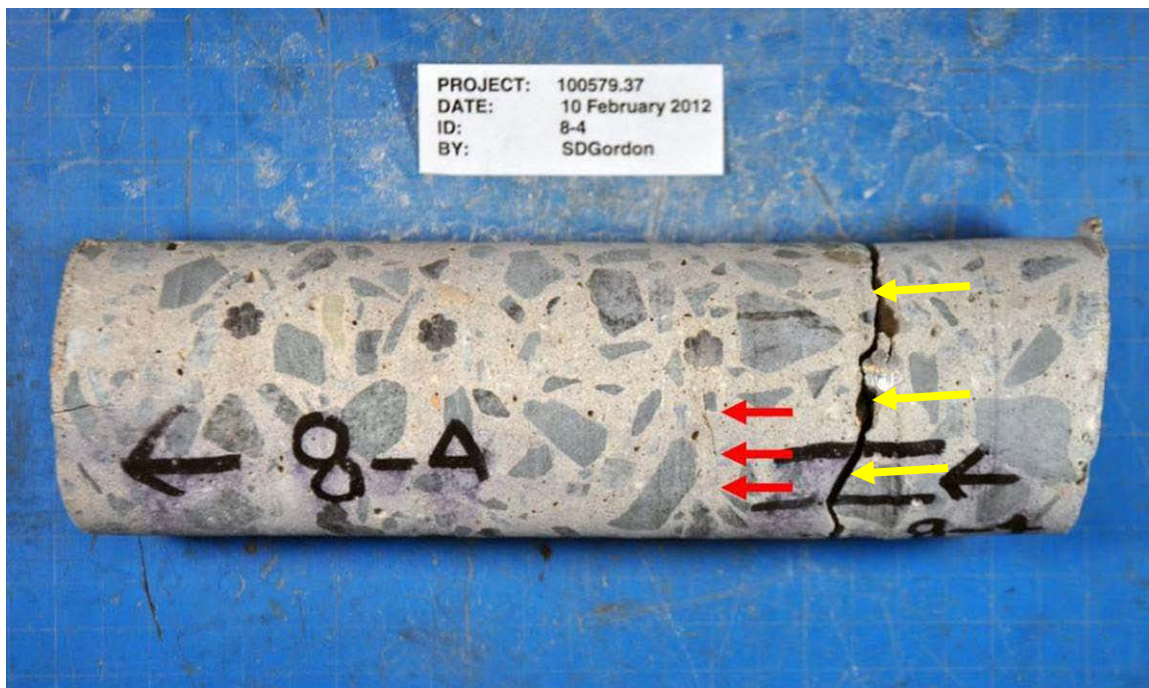
Figure 4.12. Core C8-4 showing the cracks on the circumference of the core sample at tendons (red and yellow arrows). Note: That core fractured at one of the tendons during coring at one of the cracks, thus exaggerating its width (yellow arrows).

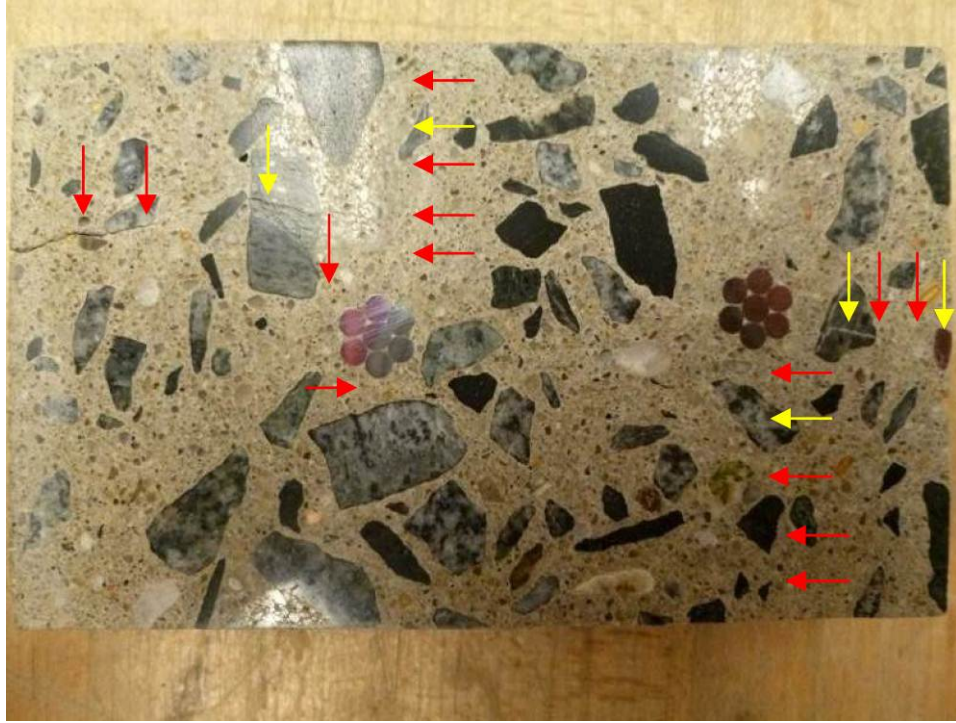
Figure 4.13. Overview of polished section from Core C8-4 showing alignment of cracks.

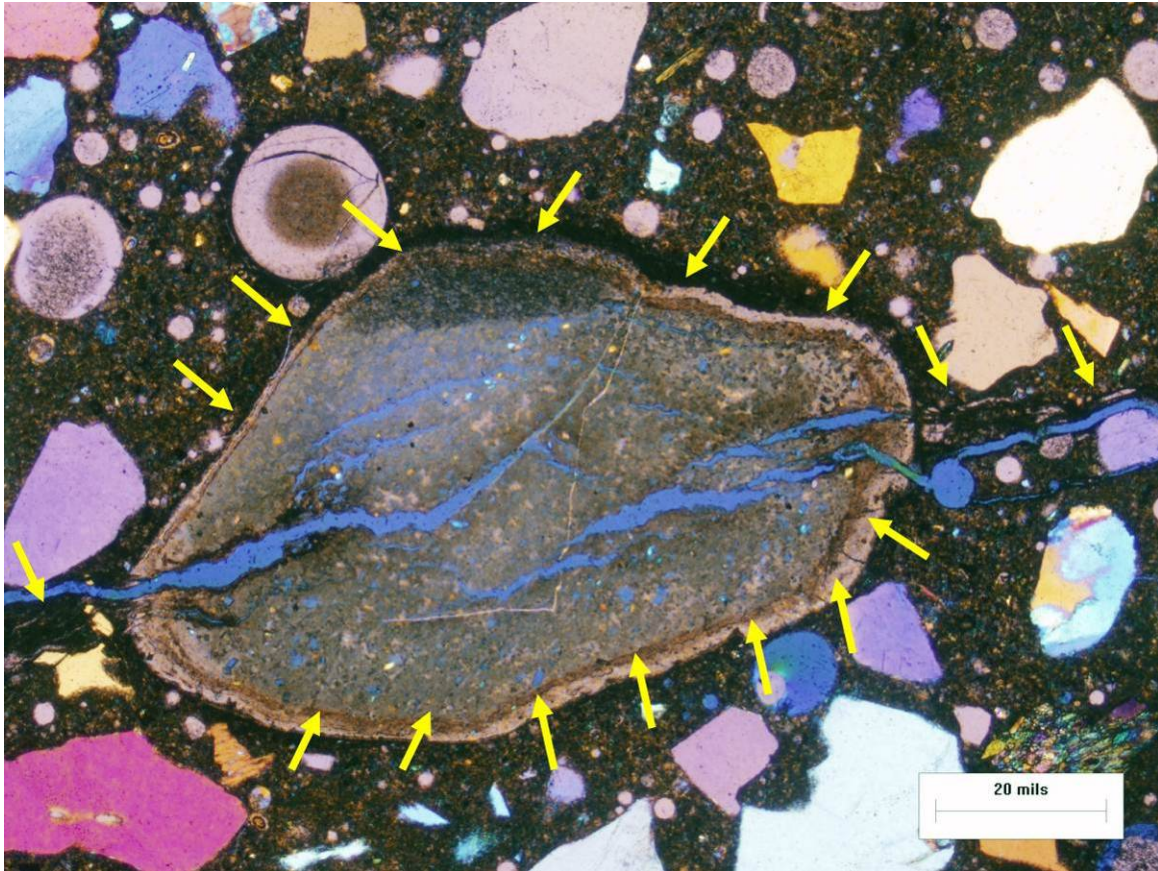
Figure 4.14. Magnified view of the microstructure in the body of Core C8-4 showing a reactive chert aggregate particle with ASR gel. Yellow arrows outline the reaction rim around the perimeter of the aggregate as well as the locations of ASR gel that partially fills cracks that extend outward from the aggregate and partially fills fractures in the surrounding paste structure.

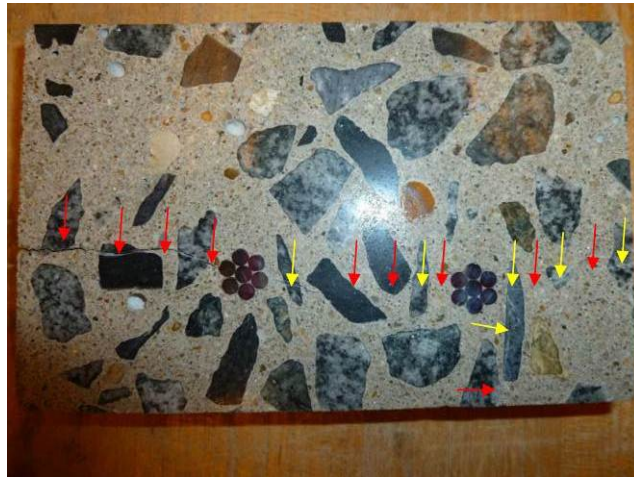
Figure 4.17. Crack condition on the polished section from Core C17-3. Red arrows point to direction and extent of cracks; yellow arrows point to the reactive aggregates.

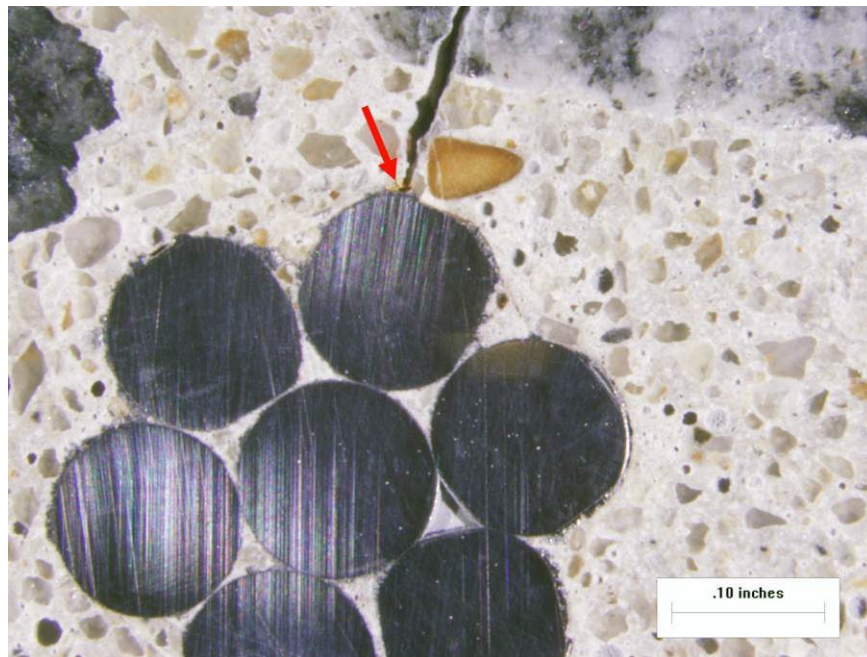
Figure 4.18. A magnified view of the polished cross-section in Core C17-3 at the tendon near the exterior surface. Red arrows point to the minor brown corrosion staining at the tendon.

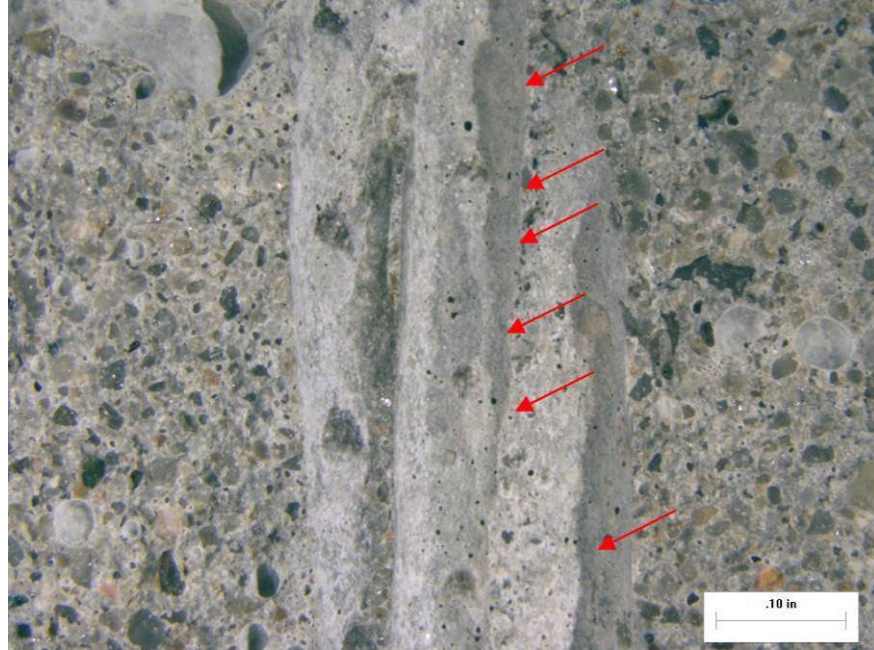
Figure 4.19. A magnified view of the polished cross-section in Core C17-3 showing the fracture surface just above the tendon. Red arrows point to the tear fractures in the fracture surface.

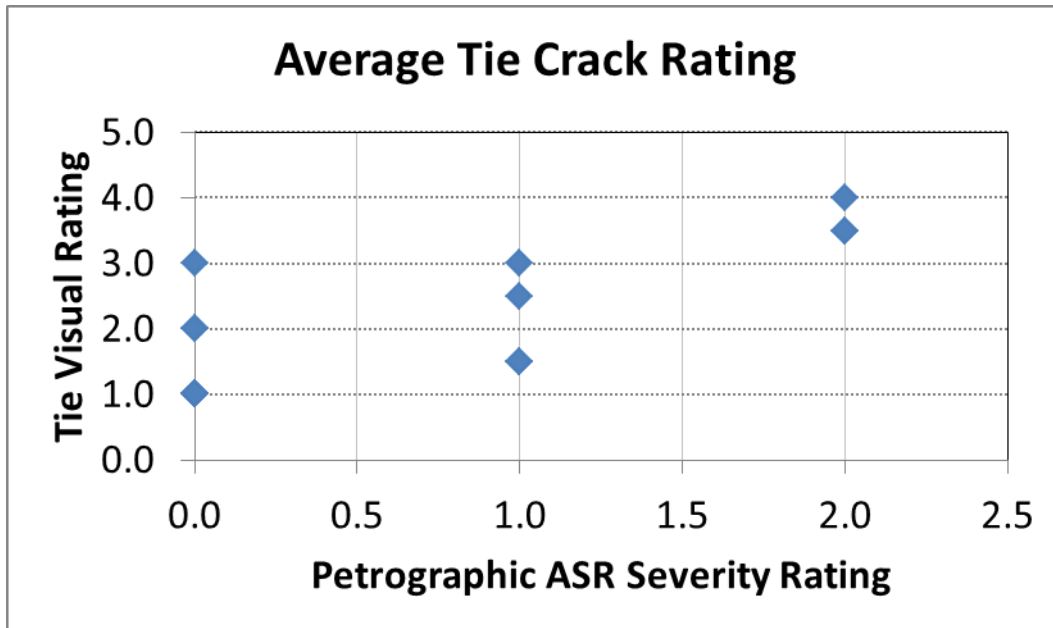
Figure 4.21. Relationship between the severity of ASR distress and the crack rating.

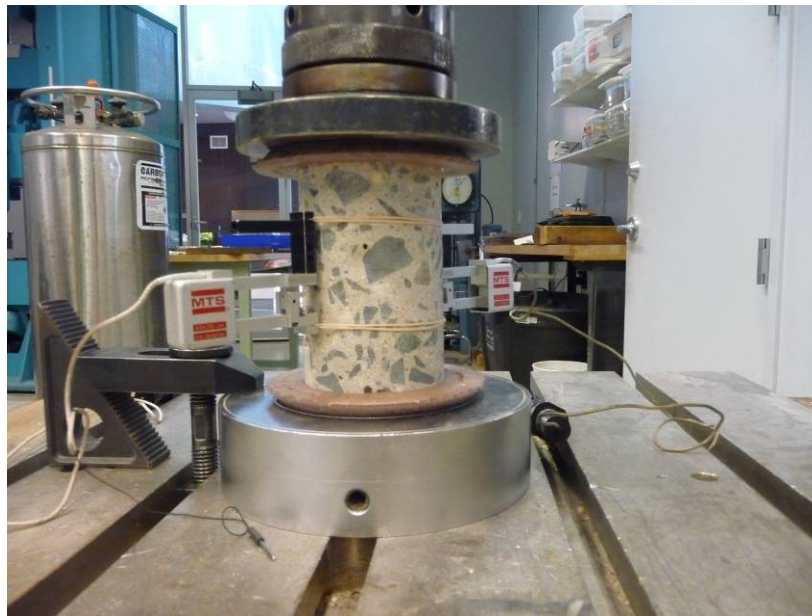
Figure 5.1. Set-up testing for the modulus of elasticity tests.

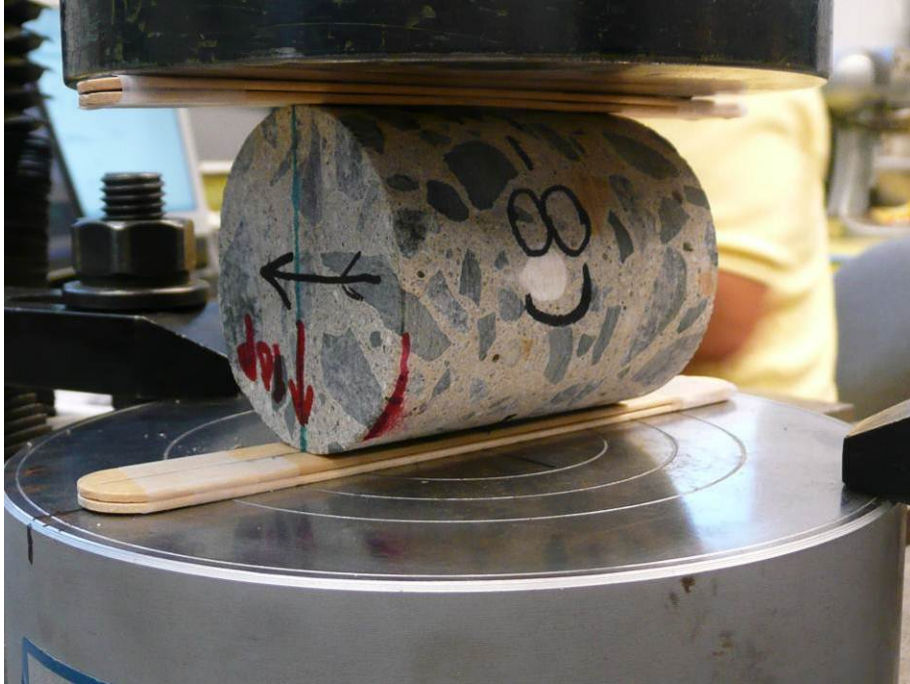
Figure 5.4. Tensile (splitting) test configuration.

We conducted a few tests to measure the tensile strength of the concrete in the ties perpendicular to the plane corresponding to the primary crack orientation we observed in the ties. We wanted to determine whether significant differences in tensile strength could explain the difference in performance. We removed 2.3–3 in diameter, 3–4 in long test samples by coring the ties above the strands at the end opposite the one from which we removed samples for compression and modulus testing. We conducted the tests according to ASTM C496 (Standard Test Method for Splitting Tensile Strength of Cylindrical Concrete Specimens). Figure 5.4 shows a photograph of the test configuration. The direction of maximum tensile stress in this test is perpendicular to the line connecting the loading points. We oriented the test specimen so that the crack plane corresponded to a horizontal plane in the tie, although this plane is above the plane of the top row of tendons. Table 5.2 lists the results of the tests. These tensile strengths are relatively high (see also Section 7) compared with the value obtained from the generally accepted formula:

The split tensile strengths are greater than expected, but there does not appear to be a significant difference between the values from the different case study ties.

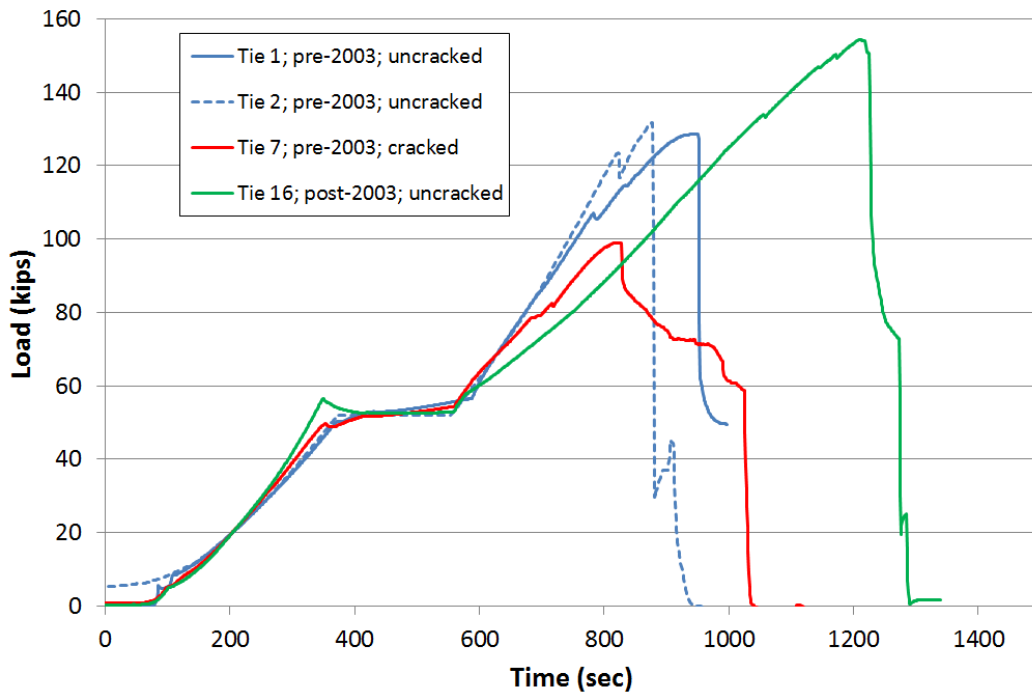
Figure 5.8. The load plots for flexural strength testing of some of the case study ties.

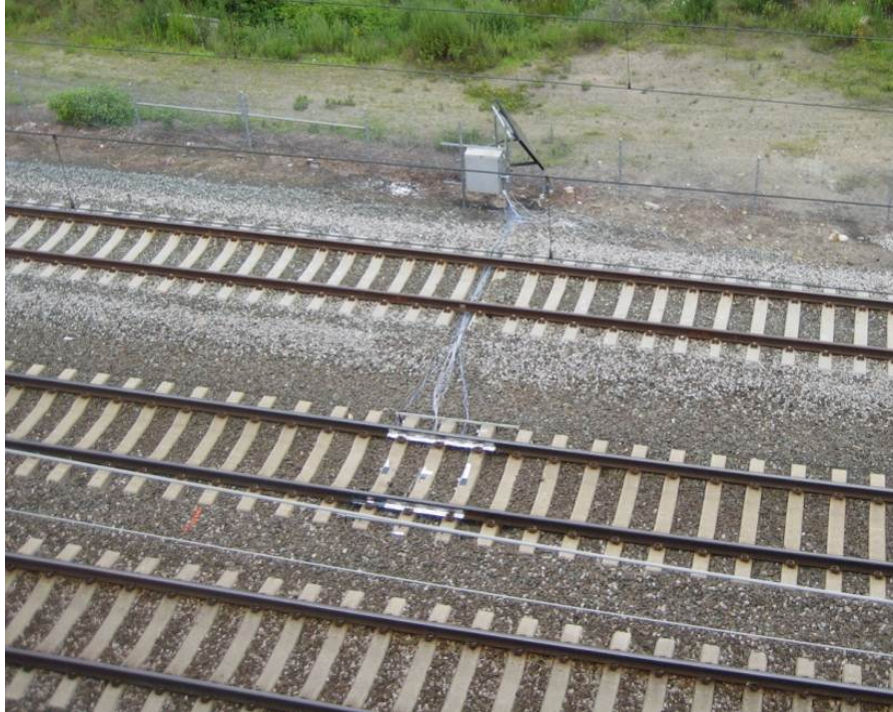
Figure 6.2. View of the test site from an overpass (Track 1 is at the bottom).

Figure 6.1 shows the overall layout of the instrumentation, and Figure 6.2 shows a photograph of the installation. We collected data for several weeks that included operation of different types of trains, including conventional electric trains, the Acela high-speed electric train, diesel trains, and freight trains. We collected data for two track conditions: with existing components and after replacing the tie pads with softer units on the instrumented and adjacent ties. Data were collected with an unattended data collection system.

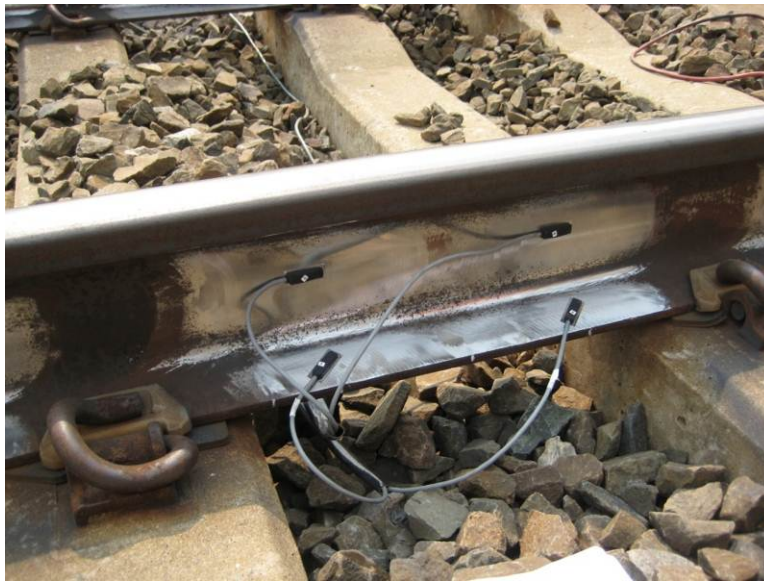
Figure 6.3. Vertical and lateral wheel-rail load strain gages.

Figure 6.3 shows the vertical and lateral wheel-rail load strain gages after they were welded to the rail and before the weatherproofing was applied. The two strain gages on the web of the rail are for the vertical wheel-rail load, and the two strain gages on the base are for the lateral wheel-rail load. We applied this configuration at four locations: the two cribs between the three ties on each side of the track. An identical configuration of strain gages for the tie vertical load was applied over each of the three ties on each side of the track.

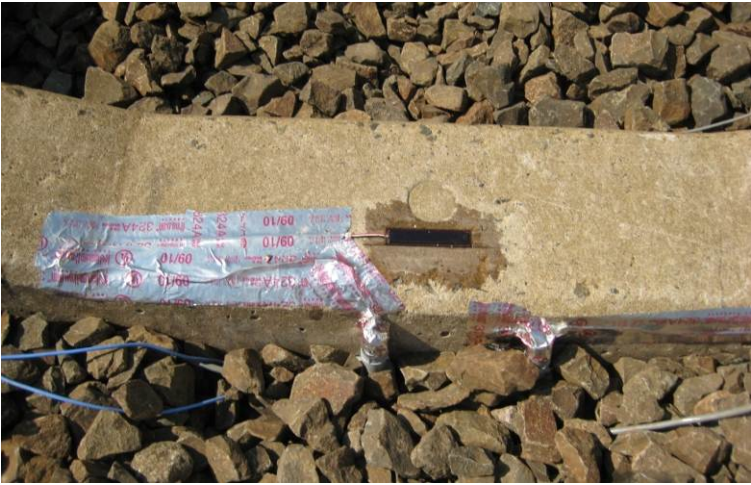
Figure 6.5. Concrete strain gage mounted to the center of a tie

We used a concrete epoxy filler to ensure a smooth surface for bonding of the strain gages. Figure 6.5 shows one of concrete strain gages bonded to the center of the tie.

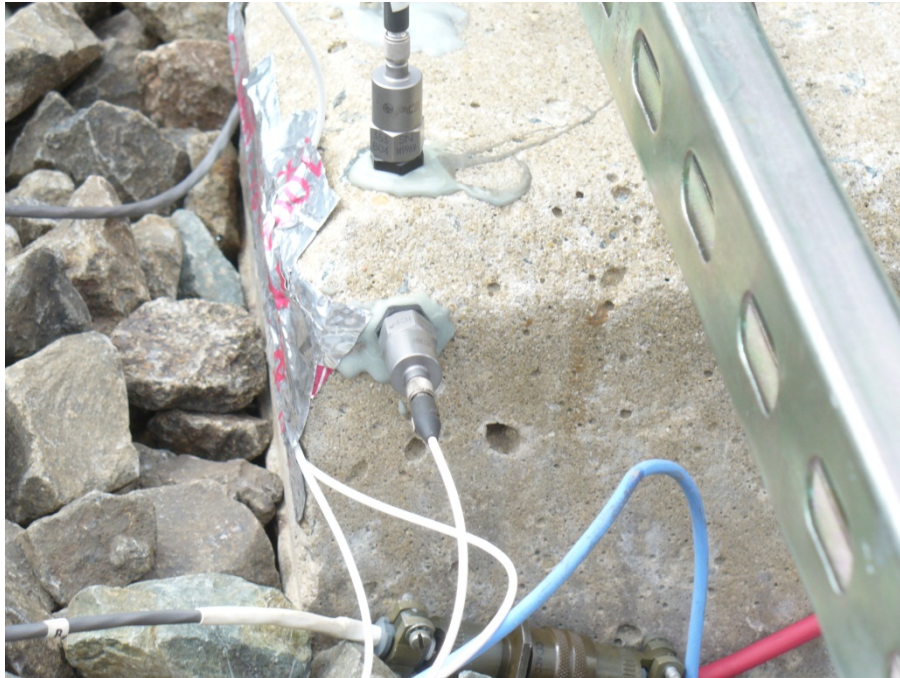
Figure 6.7. Three accelerometers mounted to one end of the tie.

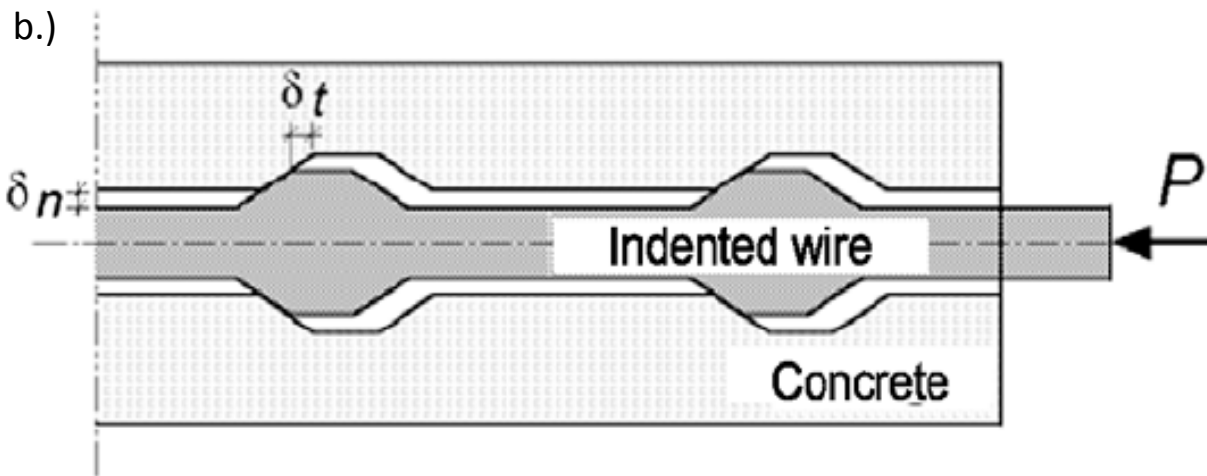
Figure 7.8. Illustration of the outward pressure exerted by an indented strand during slippage.

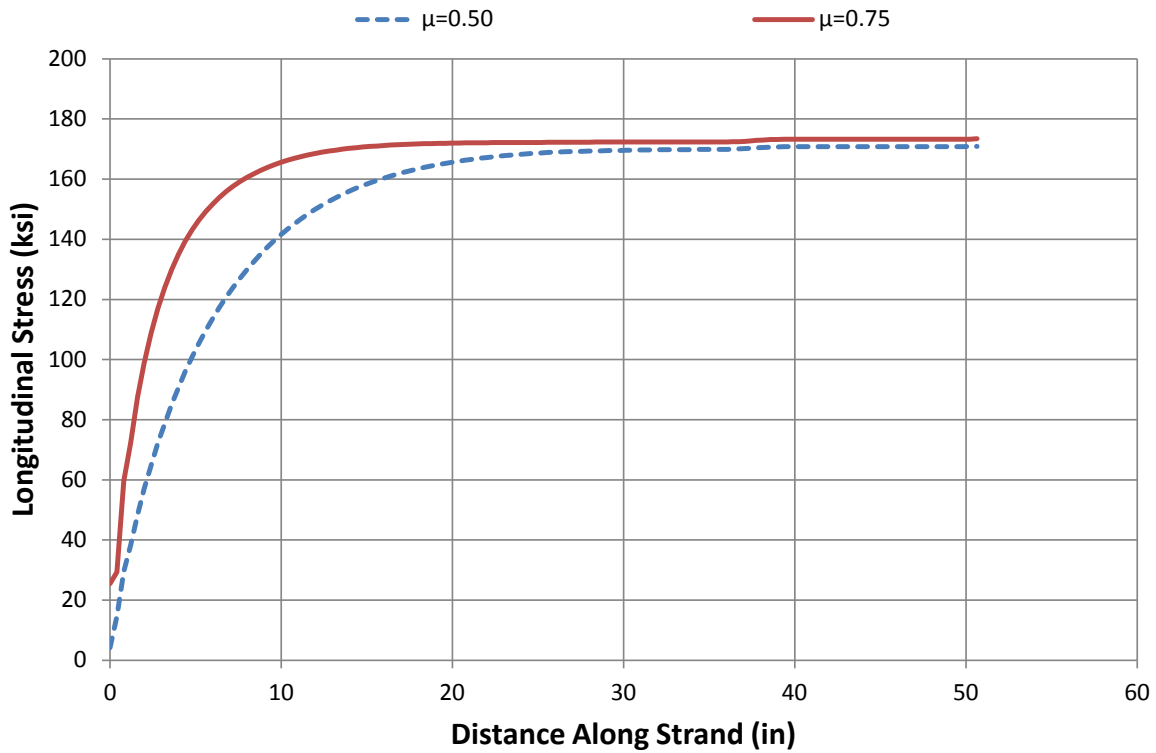
Figure 7.13. The calculated stress along a prestressing strand in a pre-2003 tie for two values of coefficient of friction between strand and concrete.

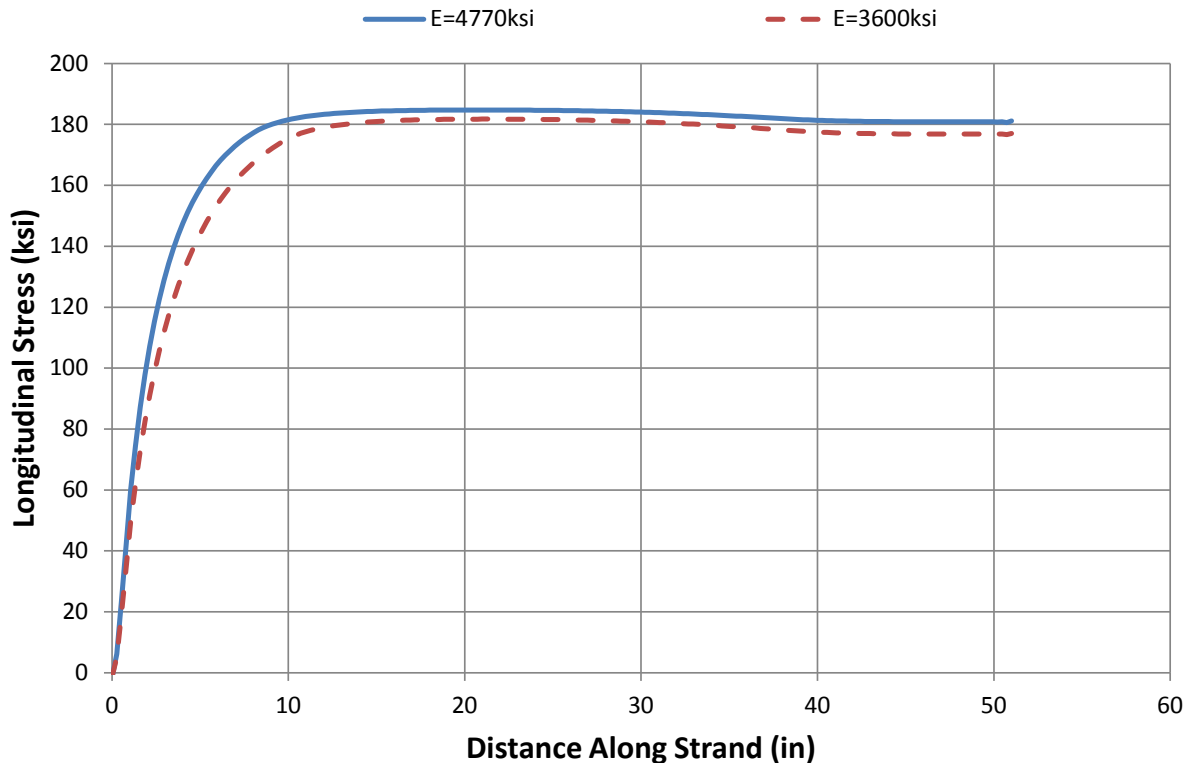
Figure 7.18. The calculated stress along a prestressing strand in a post-2003 tie for two values of concrete modulus.

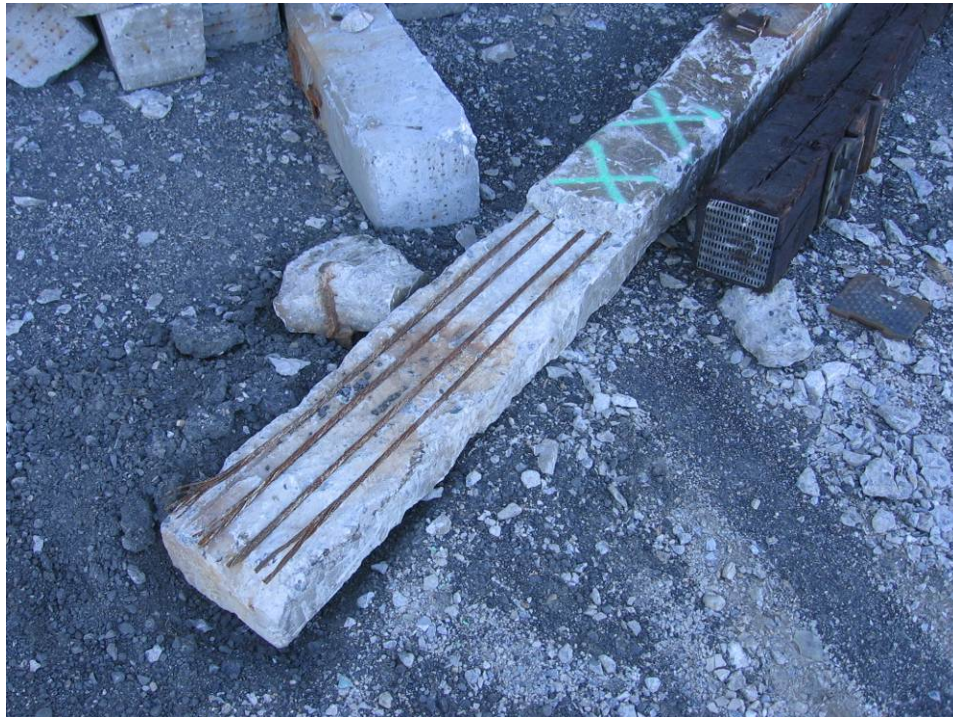
Figure 8.1. A severe example of a tie with the predominant mode of cracking investigated in this study.
