U.S. Department of
Transportation

Federal Railroad
Administration

Effect of Dynamic Envelope Pavement Markings on Vehicle Driver Behavior at a Highway-Rail Grade Crossing

Office of Research
and Development
Washington, DC 20590

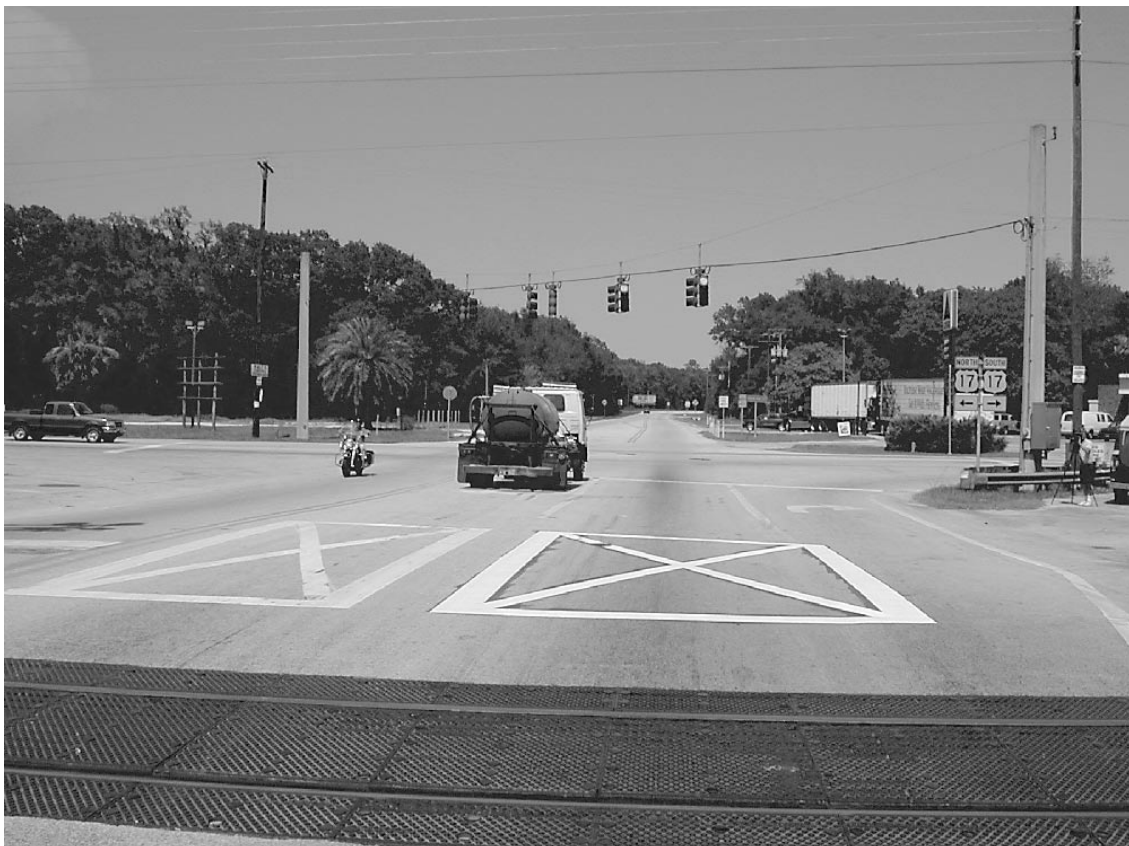
Figure 1. Barberville Rural Crossing with X-Box Markings (excerpted from Stevens and Long, 2003)

The X-box is a 25-foot long rectangle with an “X” inside it that is drawn just beyond the tracks. This marking lets drivers know that if they cannot see the full “X,” there is not enough space for their vehicle to fit beyond the tracks and they should wait until the X-box has cleared before proceeding to cross the tracks. Stevens and Long (2003) studied two X-box installations to evaluate their effect on driver stopping behavior in an urban setting and in a rural setting, neither setting accompanied by signage. The urban environment tested in this study was on Commercial Boulevard in Ft. Lauderdale, FL, the same site being investigated in the current study. They found significant reductions in driver stopping behavior on or adjacent to the tracks in a rural setting, but found no significant change in driver stopping rates in an urban environment.

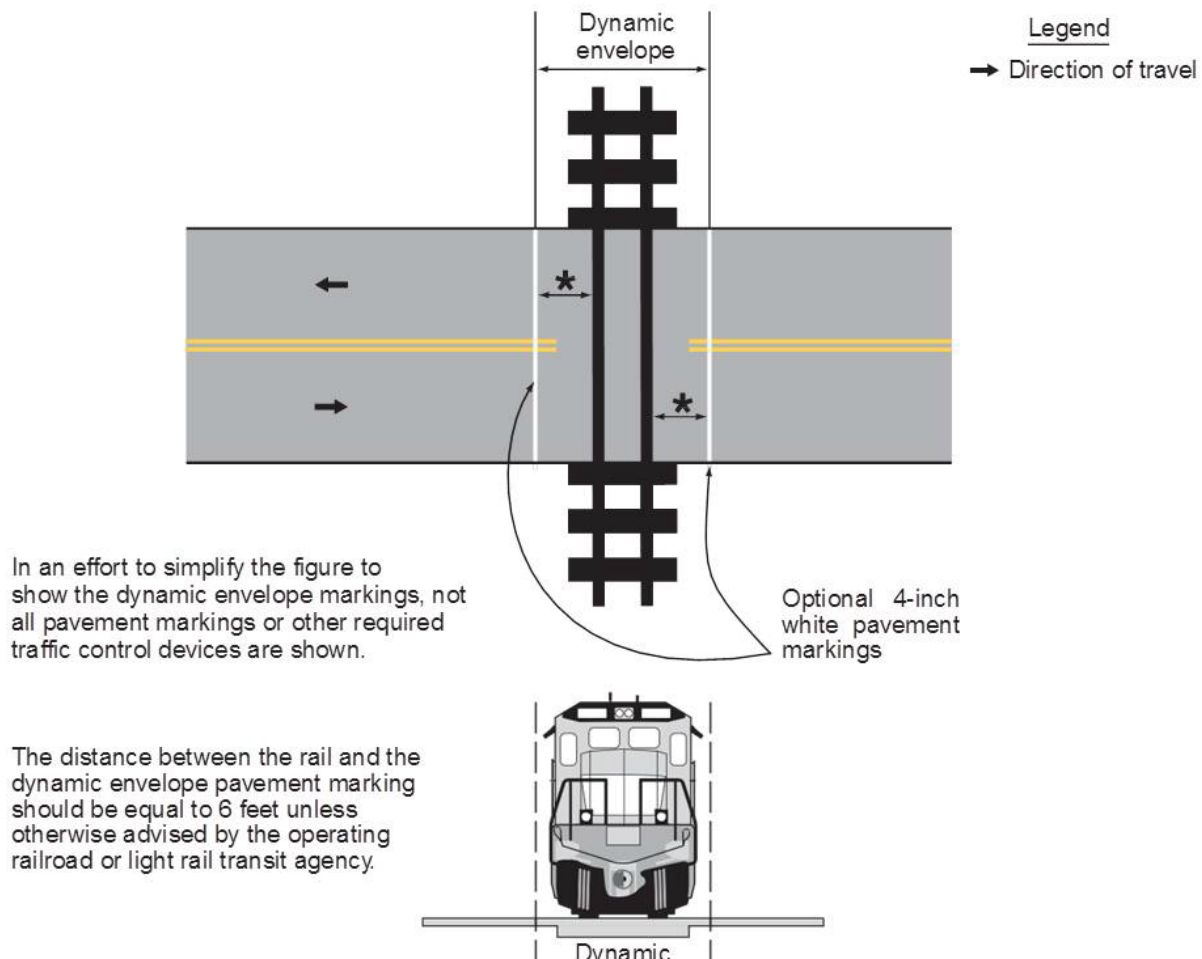
The strategy that was chosen to reduce the number of motorists stopping on the railroad tracks was to paint the dynamic envelope with brightly colored paint and modify existing signage to match this new paint scheme. The MUTCD is a document developed by the Federal Highway Administration (FHWA) under 23 Code of Federal Regulations (CFR), Part 655, Subpart F, which defines standards for the installation and maintenance of traffic control devices⁶. The most recent MUTCD (revised May 2012)⁷ defines the “Dynamic Envelope” as “the clearance required for light rail transit traffic or a train and its cargo overhang due to any combination of loading, lateral motion, or suspension failure.” Any object within the dynamic envelope has the potential to be struck by a train as the train passes through the crossing. Figure 2 shows an example of the dynamic envelope as defined in Figure 8B-8 of the MUTCD.

Figure 2. Example of Dynamic Envelope from MUTCD (Figure 8B-8)

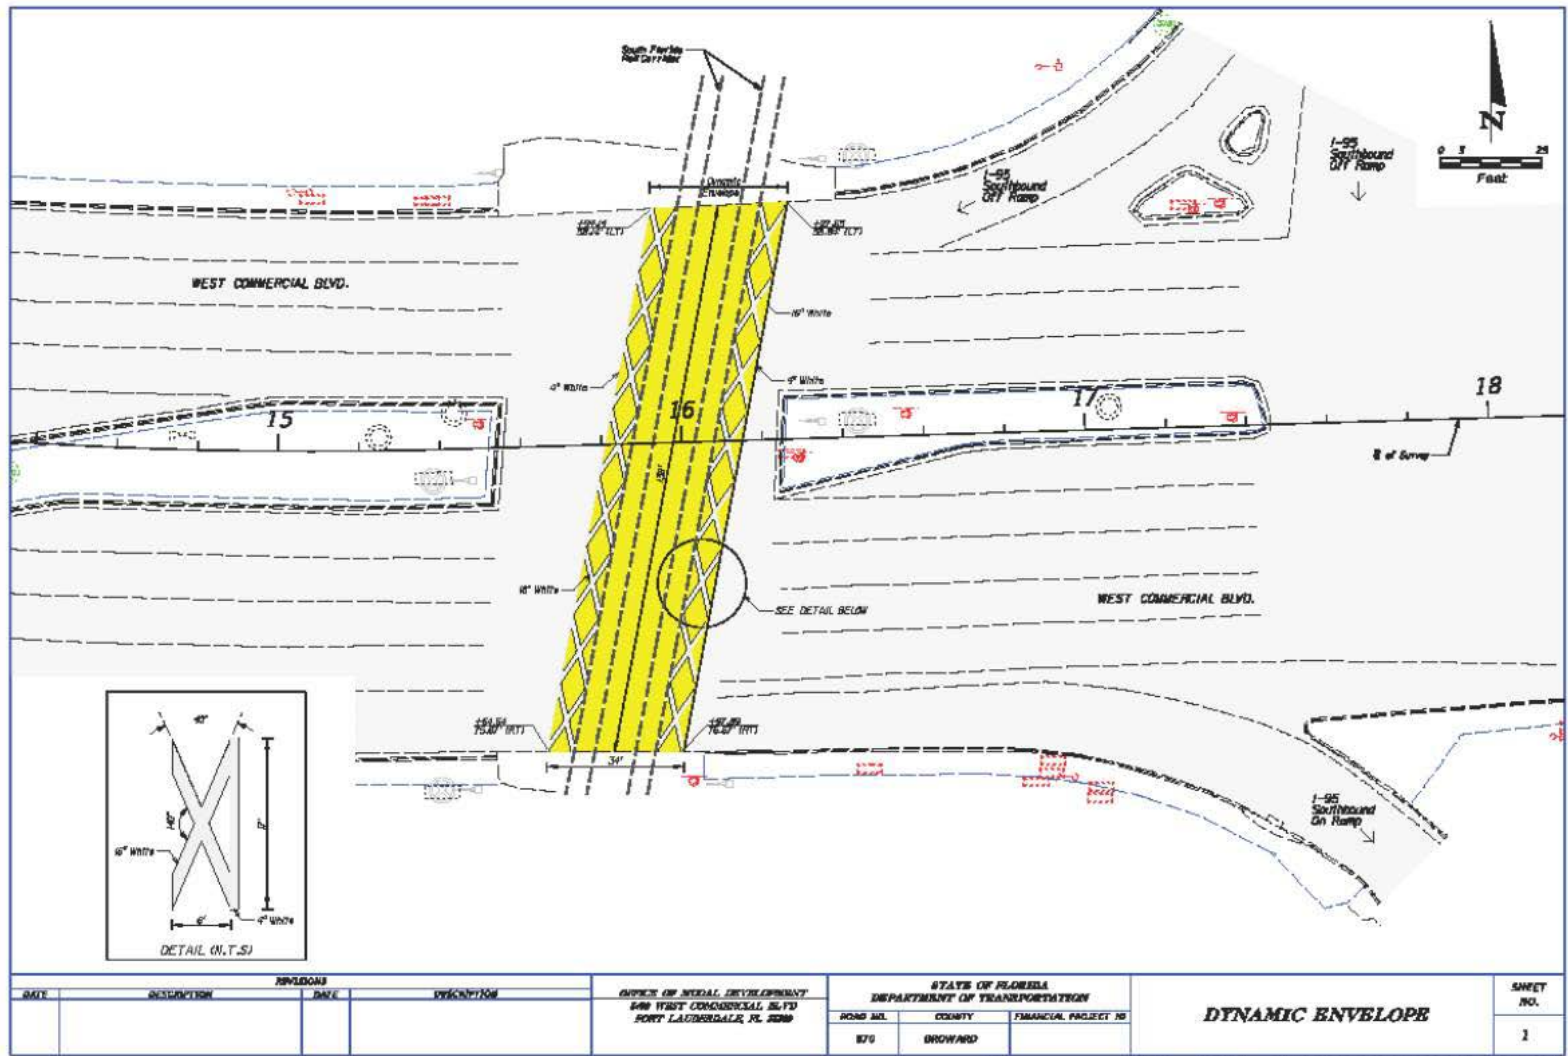
Figure 3. Schematic of Dynamic Envelope Zone Markings at Commercial Boulevard Grade Crossing⁸

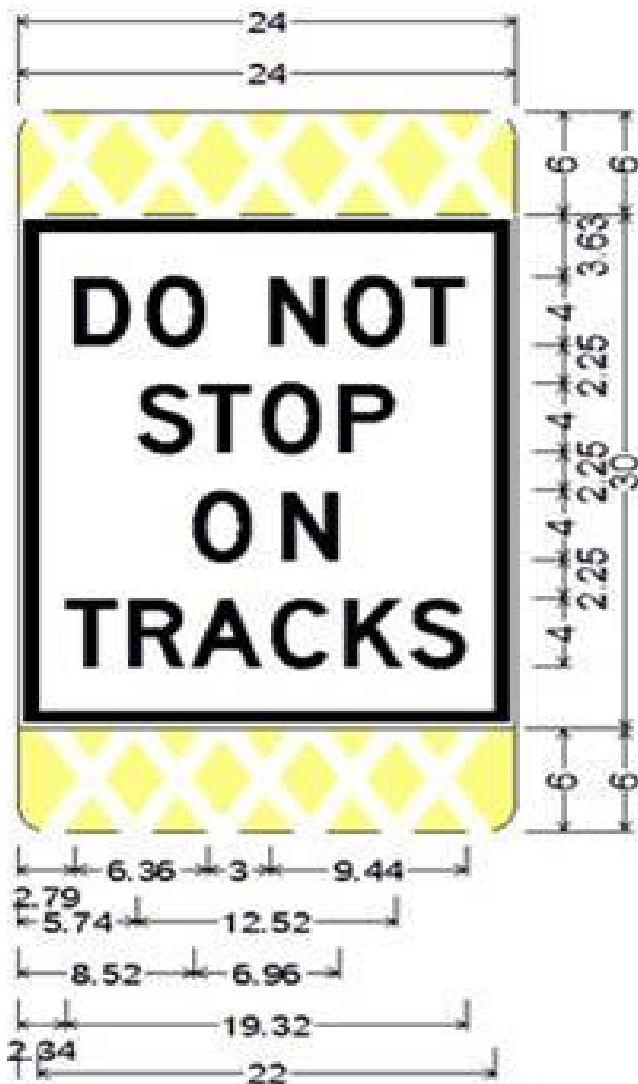
1.50" Radius, No border, Black on Ruler fill;
 "XXXXX" White E 2K specified length;
 R8-8 MIN & STD;
 1.50" Radius, 0.63" Border, 0.38" Indent, Black on White;
 "DO NOT" D 2K;
 "STOP" D 2K 102% spacing;
 "ON" D 2K 160% spacing;
 "TRACKS" D 2K 91% spacing;
 1.50" Radius, No border, Black on Ruler fill;
 "XXXXX" White E 2K specified length;

Figure 4. Accompanying Signage at Commercial Boulevard Grade Crossing⁹

In addition to the pavement markings, existing "DO NOT STOP ON TRACKS" (R8-8) signs were replaced with a modified R8-8 sign with a similar yellow and white pattern added to instruct motorists on how to behave at the crossing. The accompanying sign, which can be seen in Figure 4, displays the text "DO NOT STOP ON TRACKS". This modified signage replaced the existing signs on poles along the median of the boulevard and on the sidewalks on the opposite side of the tracks from the oncoming traffic. The signage facing eastbound traffic was placed at 65 feet (sidewalk sign) and 85 feet (median sign) past the stop line for the crossing. Both sidewalk and median signage facing westbound traffic were placed at 90 feet past the stop line for the crossing. Each newly modified sign was attached to the same poles to which the prior R8-8 sign had been secured. As with the original signage, this pole included flashing yellow lights to increase its conspicuity to approaching motorists. Images of the pavement marking (left and right) and signage (right) installation are shown in Figure 5 and Figure 6, respectively.

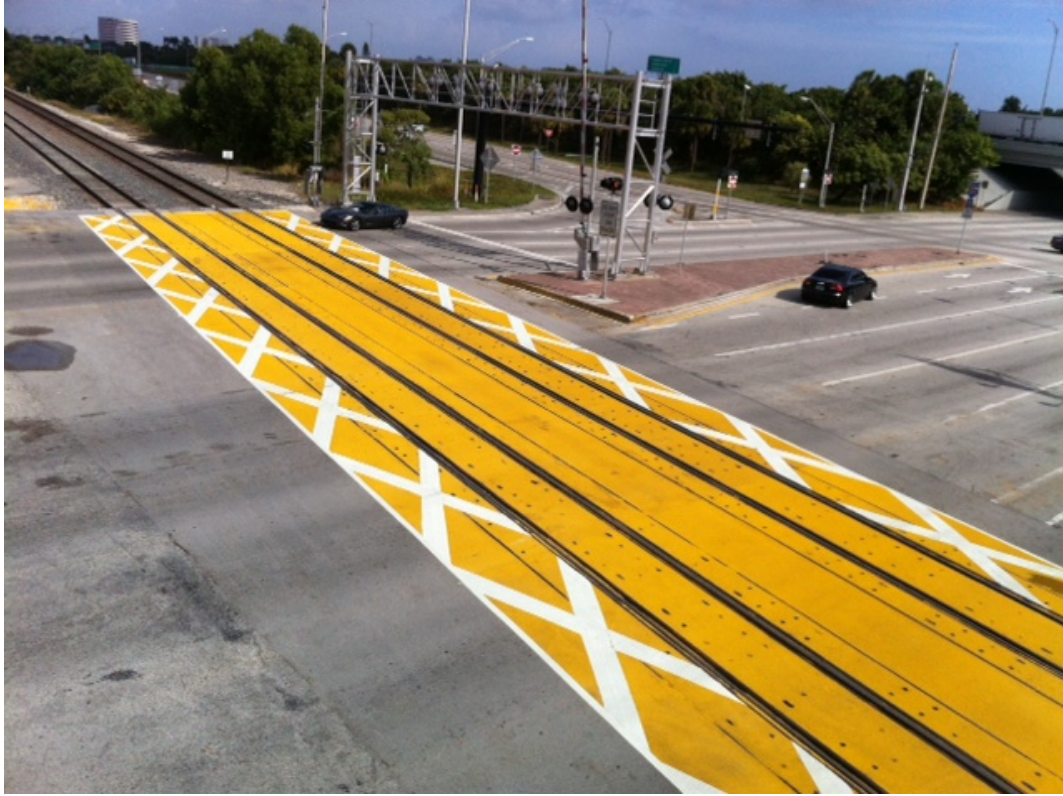
Figure 5. Dynamic Envelope Zone Pavement Markings at Commercial Boulevard

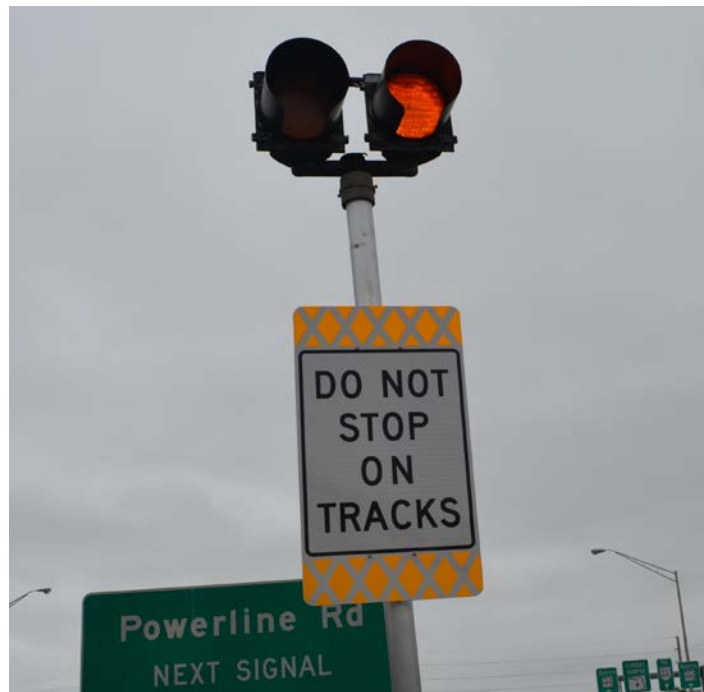
Figure 6. Dynamic Envelope Zone Modified Signage at Commercial Boulevard

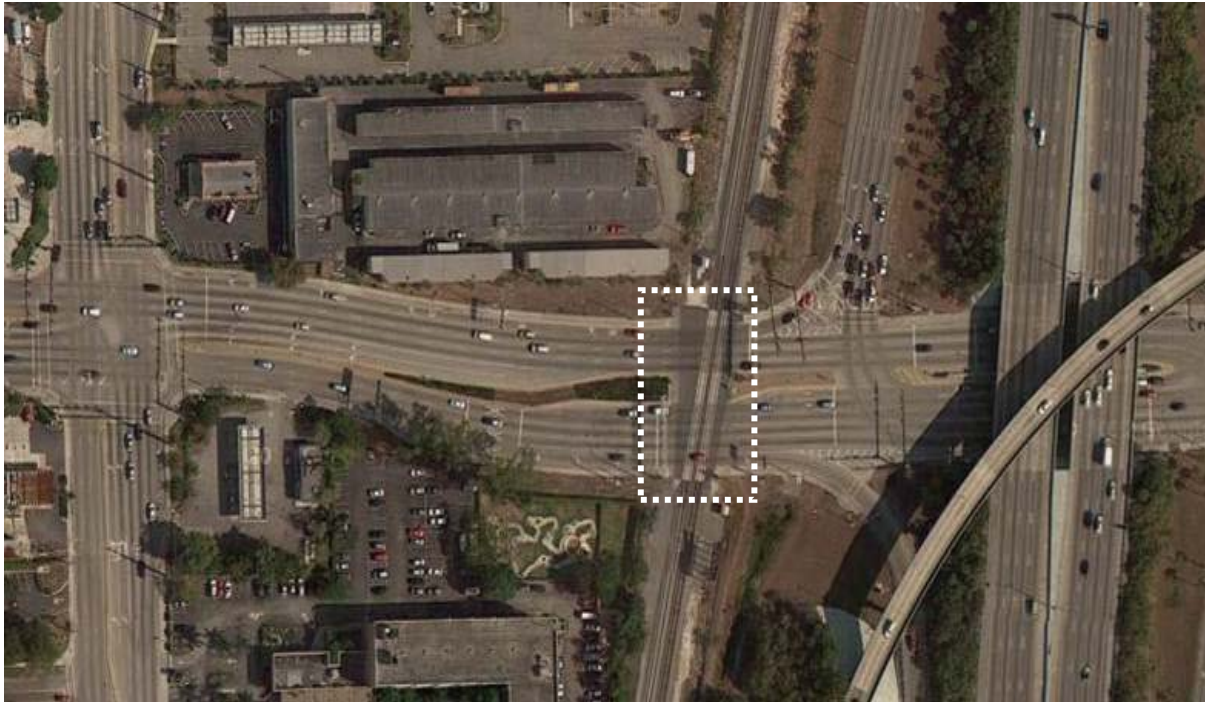
There are two active railroad tracks which intersect with the Commercial Boulevard crossing. According to the U.S. DOT Crossing Inventory data, approximately 51 trains move through this crossing daily at speeds ranging from 74 to 79 mph¹⁰. Both passenger (TriRail and Amtrak) and freight (CSX) trains pass through this crossing. The estimated daily highway user traffic at this crossing is 69,000 vehicles per day with a posted speed limit of 45 miles per hour (mph). Figure 7 shows a satellite image of this area, with the specific crossing outlined by the white dashed box.

Figure 7. Commercial Boulevard Grade Crossing Satellite Image

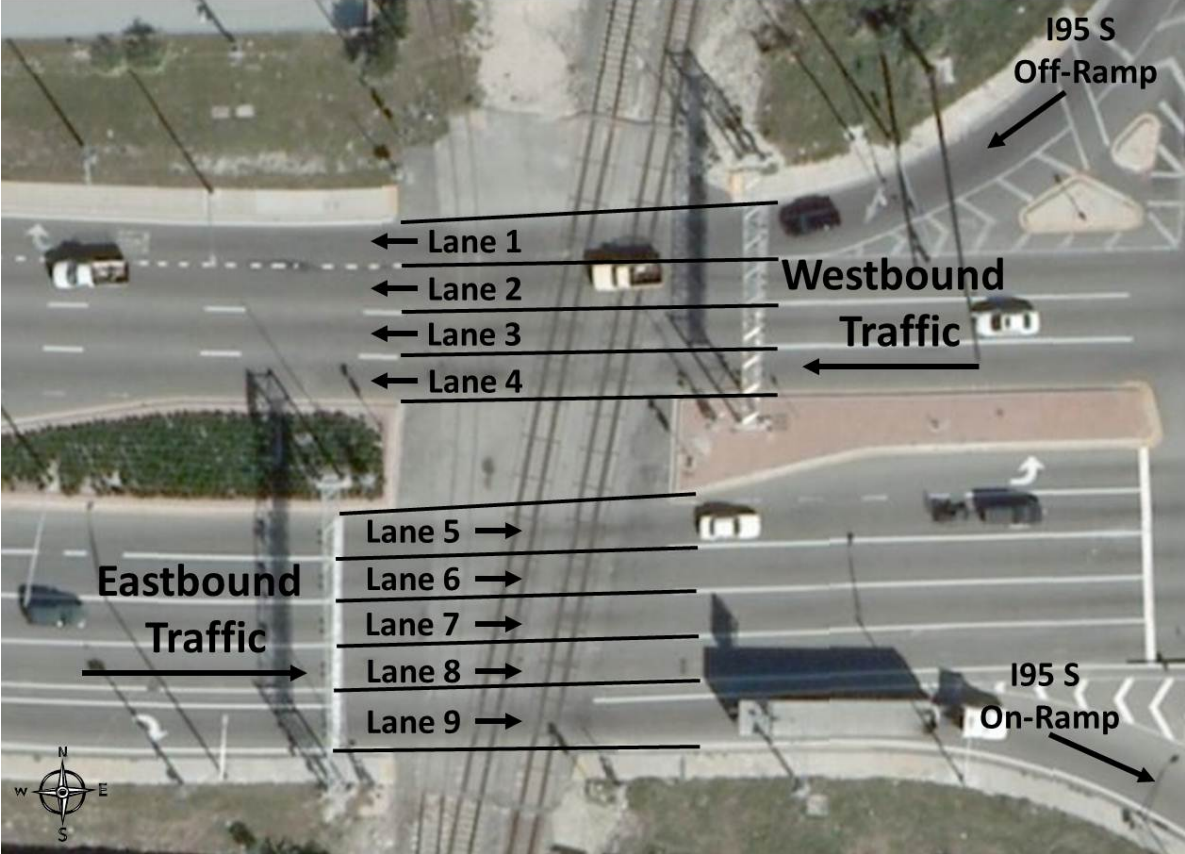
The location of the grade crossing is complex in many ways. First, the westbound traffic through the crossing is on a section of roadway immediately west of the off-ramp from Interstate 95. There are four lanes for traffic traveling westbound through the crossing. Figure 8 shows the nine lanes that cross the tracks (four westbound and five eastbound) were coded numerically and are shown in Figure 8.

Figure 8. Lane Coding Scheme for Commercial Boulevard Grade Crossing

There are five lanes of traffic traveling eastbound through the crossing (see Figure 8 for representation of crossing). Lane 9 primarily includes vehicles entering the on-ramp for I95S. Vehicles typically use Lane 5 and Lane 6 to prepare to turn left after the traffic light to enter the on-ramp to I95N (this left turn is just after the I95 overpass that is to the east of the crossing in Figure 7). A traffic light approximately 150 feet from the grade crossing would likely create a traffic backup with a high volume of traffic pushed into the dynamic envelope for all lanes except Lane 9, which exits before the traffic light. Figure 10 shows an example of a traffic backup situation. No vehicles are stopped directly on the tracks in this example, but all lanes except Lane 9 are backed up and vehicles in Lane 5, Lane 6, and Lane 7 have all pulled past the stop line and risk being stuck inside the crossing if an activation occurs.

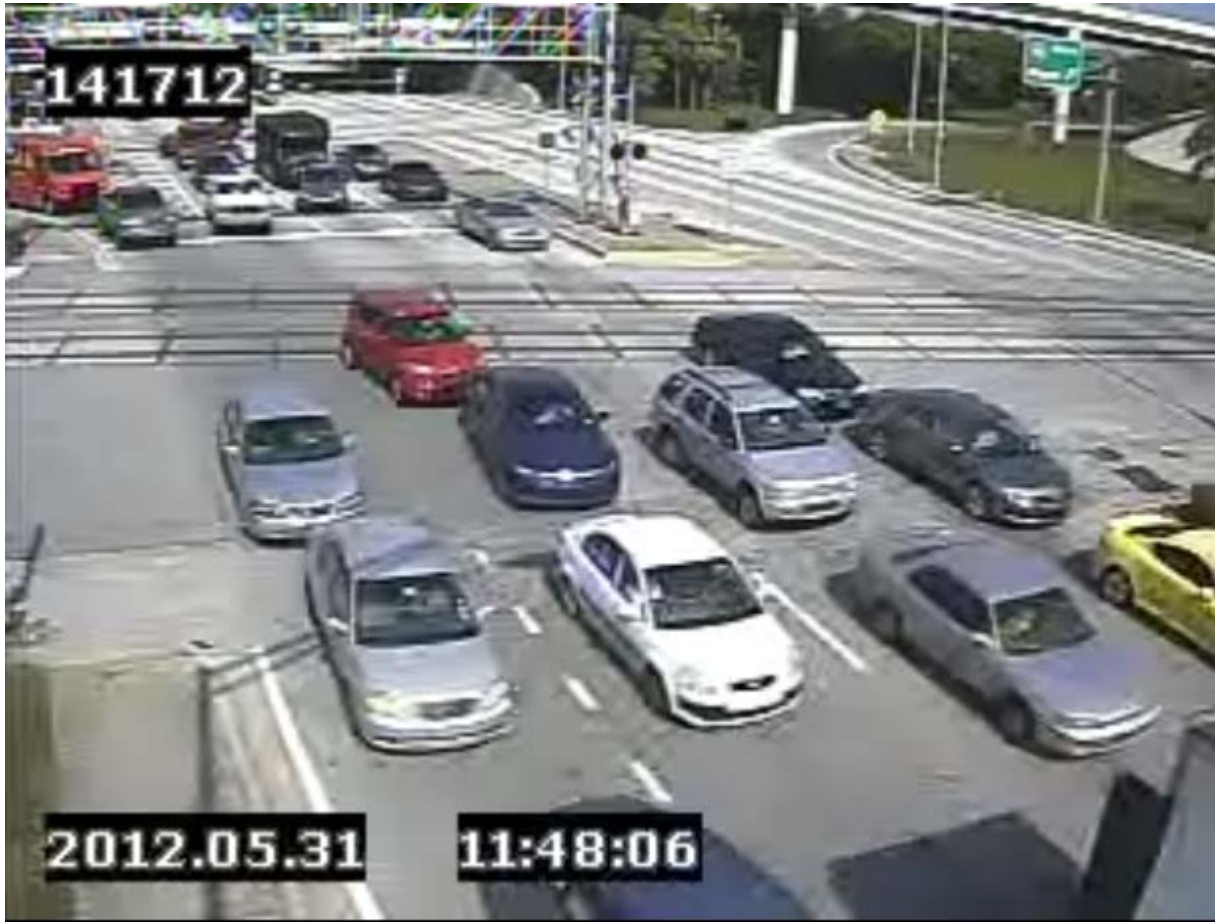
Figure 9. Example of Traffic Backed up on Westbound Lanes

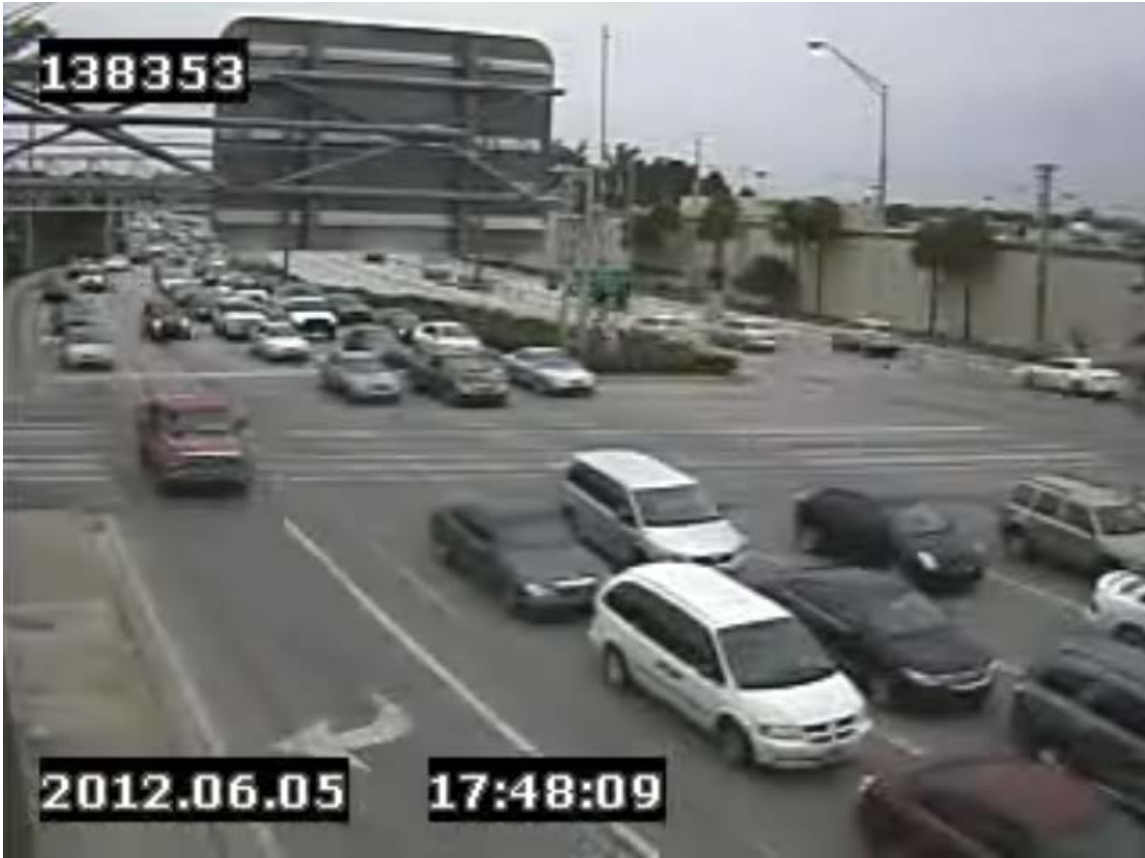
Figure 10. Example of Traffic Backed up on Eastbound Lanes

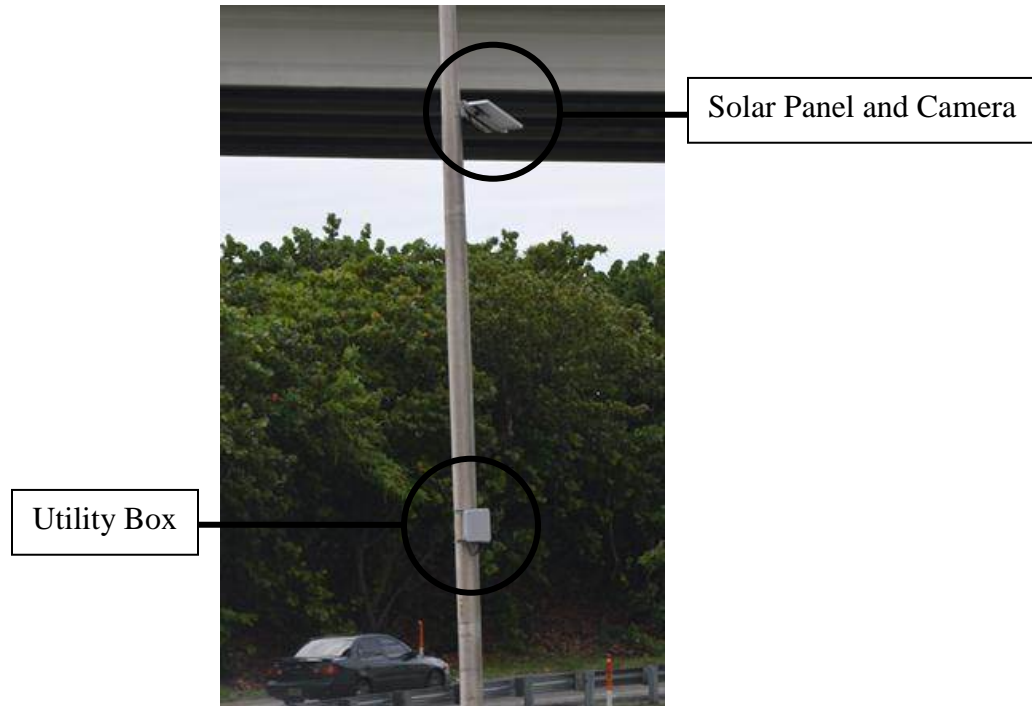
A video-based data collection system was installed at the crossing on May 23, 2012. Two separate systems were mounted on poles adjacent to the roadway to capture video of vehicles travelling in both directions on Commercial Boulevard. Each pole had a solar panel and camera mounted high on the pole to obtain a good vantage point from which to see vehicles passing through the crossing. Figure 11 shows an example of the pole with the solar panel and camera and utility box with battery and digital video recorder. Closer images of the camera and solar panel (left) and utility box (right) can be seen in Figure 12.

Figure 11. Camera Setup on Pole along Commercial Boulevard

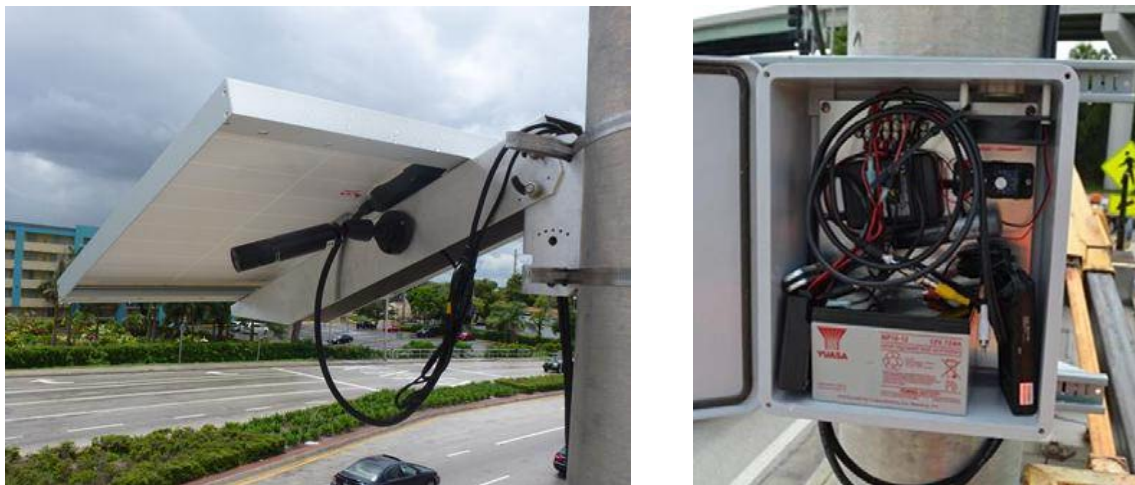
Figure 12. Camera and Solar Panel (left) and Utility Box (right)

The utility box housed the following components: a solar controller, battery, fan, temperature and voltage loggers, temperature switch, and a digital video recorder (DVR).

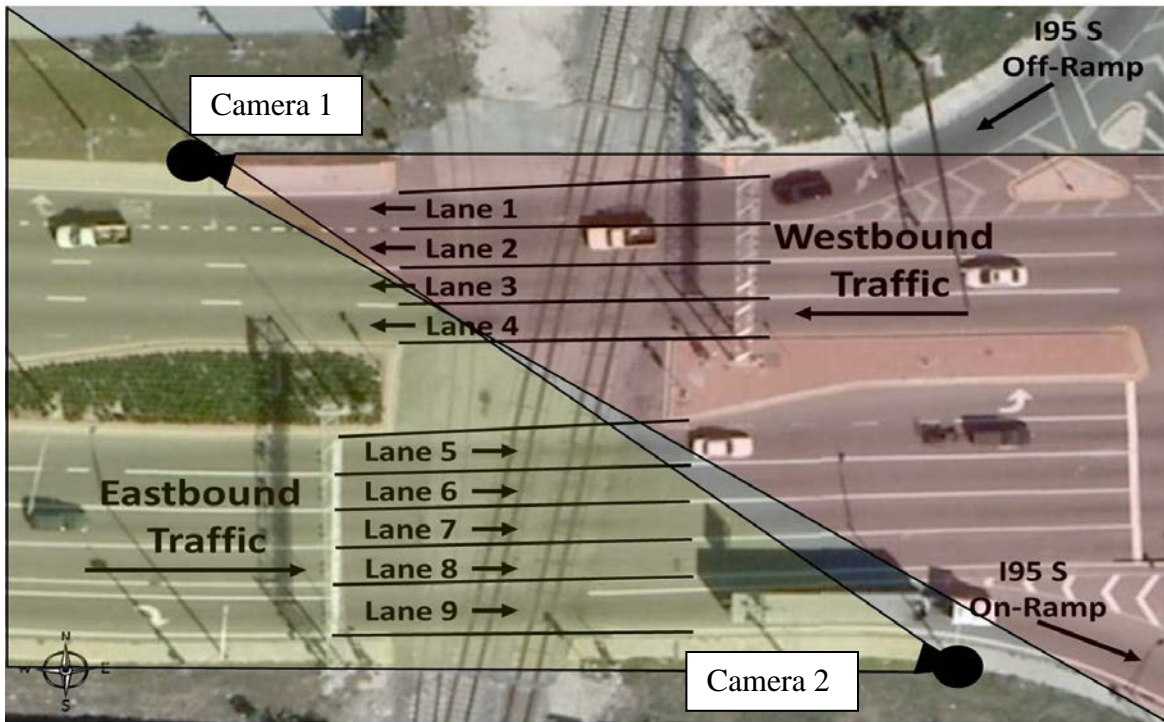
Two of these setups (camera, solar panel, and utility box) were installed to monitor the Commercial Boulevard grade crossing traffic approaching from both sides. The locations of the two cameras can be seen in Figure 13. The red shading indicates the area captured by Camera 1, which was positioned to record westbound traffic, and the yellow shading indicates the area captured by Camera 2, which was positioned to record eastbound traffic.

Figure 13. Camera Setup to Capture Eastbound (red) and Westbound (yellow) Traffic

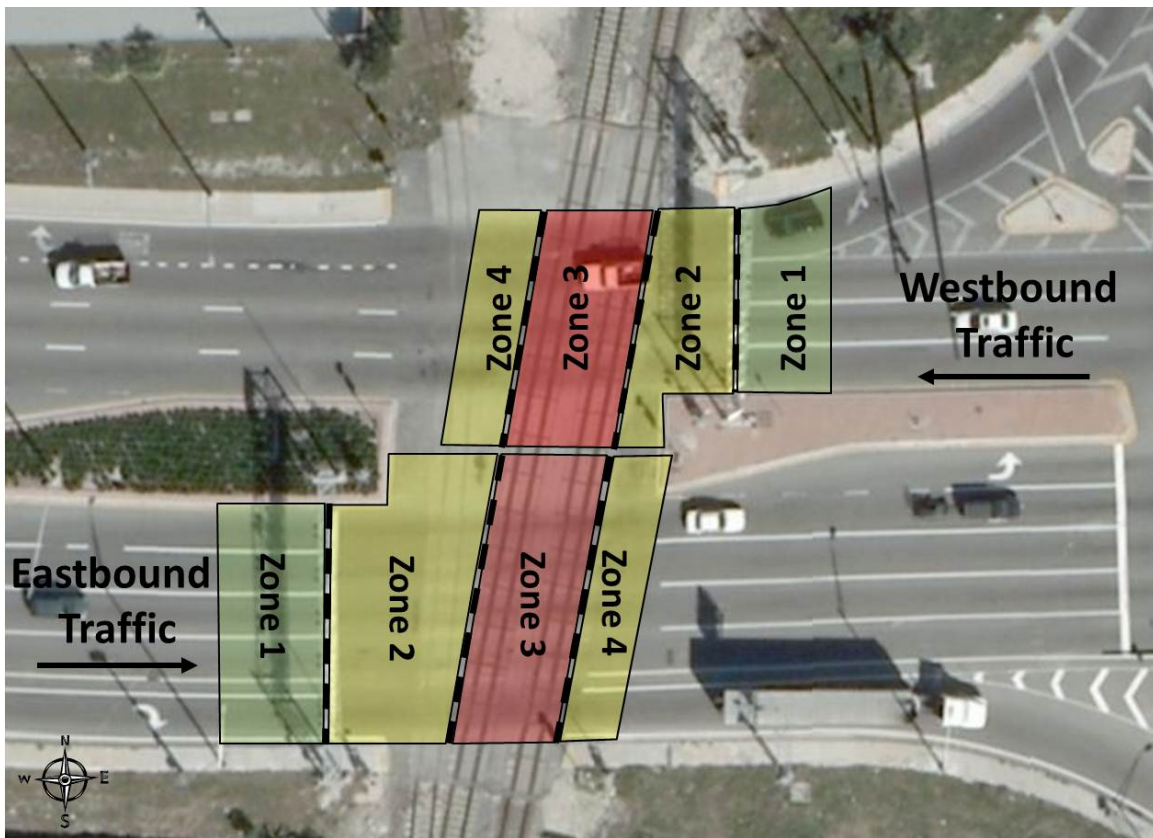
Figure 14. Zone Assignments

The four zones over the crossing represent different levels of danger if the motorist comes to a full stop in that zone:

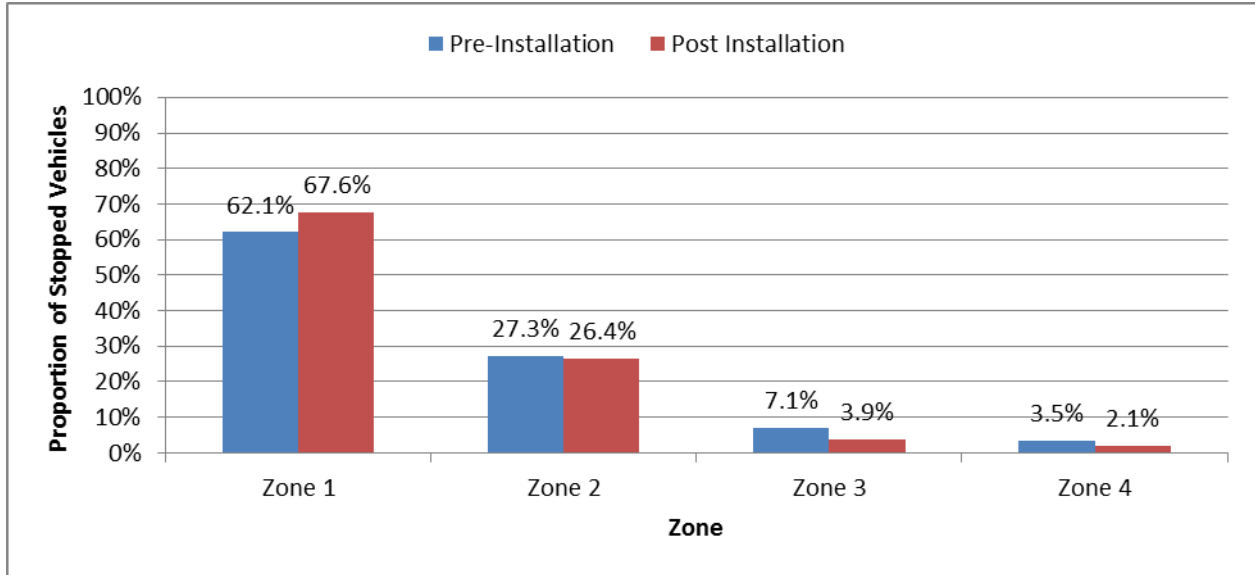
For eastbound traffic, the installation of the pavement markings elicited a significant change in behavior. A chi-square test of independence showed a significant difference between the pre- and post-installation conditions ($\chi^2=82.22$, df = 3, p <0.01). This change in driver behavior is evidenced by a 45 percent reduction in motorists stopping in Zone 3, a 39 percent reduction in motorists stopping in Zone 4, and a 9 percent increase in motorists stopping appropriately in Zone 1. These changes in proportion can be seen graphically in Figure 15.

Figure 15. Proportion of Eastbound Vehicles Stopping by Zone (Pre-Install n = 3,043 and Post-Install n = 3,319)

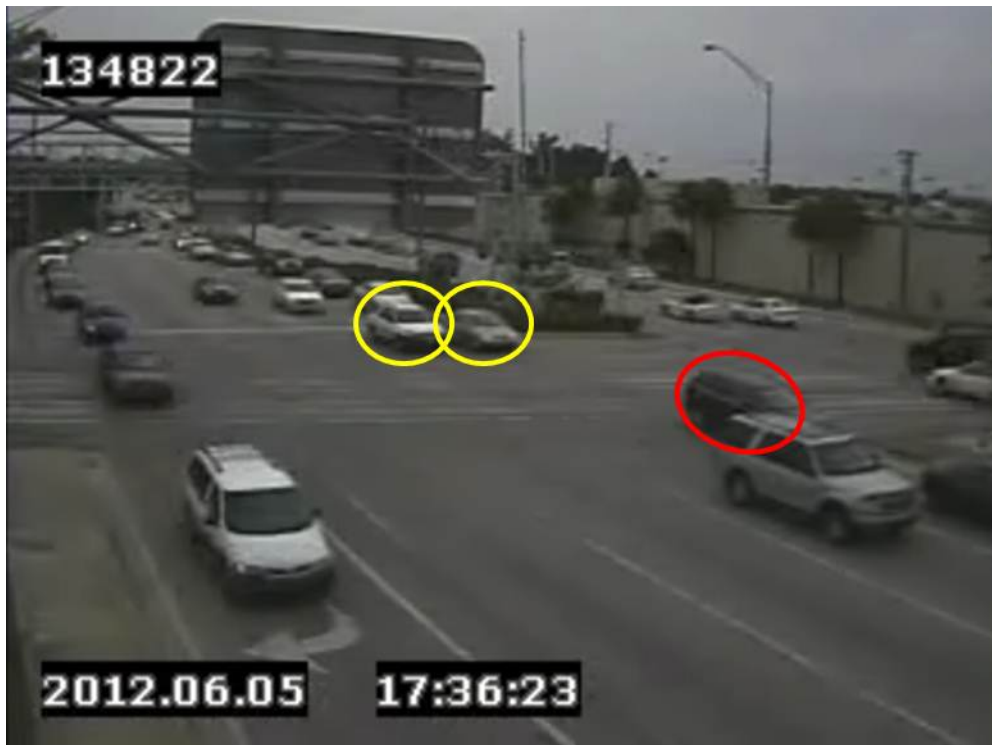
Examples of eastbound vehicles stopped in each of the zones are provided in Figure 16 and Figure 17. In Figure 16, two vehicles (circled in yellow) have come to a stop after the stop line but before the crossing in Zone 2, and one vehicle (circled in red) has come to a stop with its rear bumper still in Zone 3. All other vehicles are moving through the crossing.

Figure 16. Eastbound Zone 2 (yellow circles) and Zone 3 (red circle) Stopping Behaviors

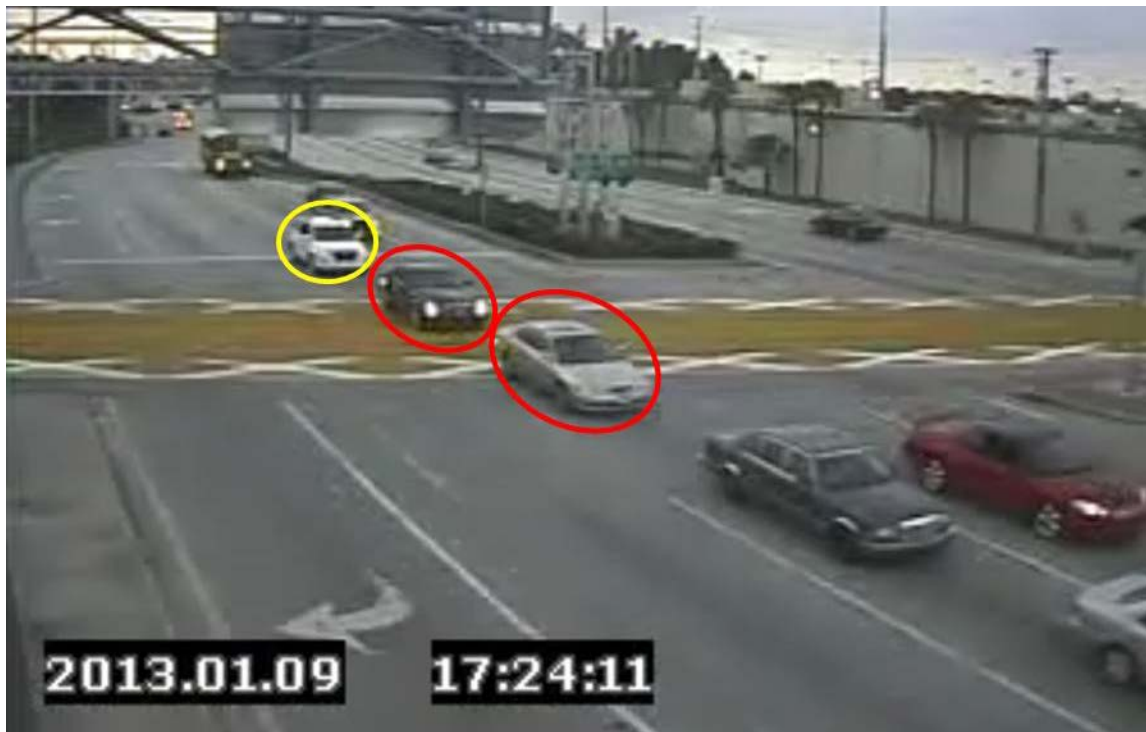
In Figure 17, the two vehicles circled in red are both at least partially in Zone 3, while the vehicle circled in yellow has come to a stop in Zone 2.

Figure 17. Eastbound Zone 2 (yellow circle) and Zone 3 (red circles) Stopping Behaviors

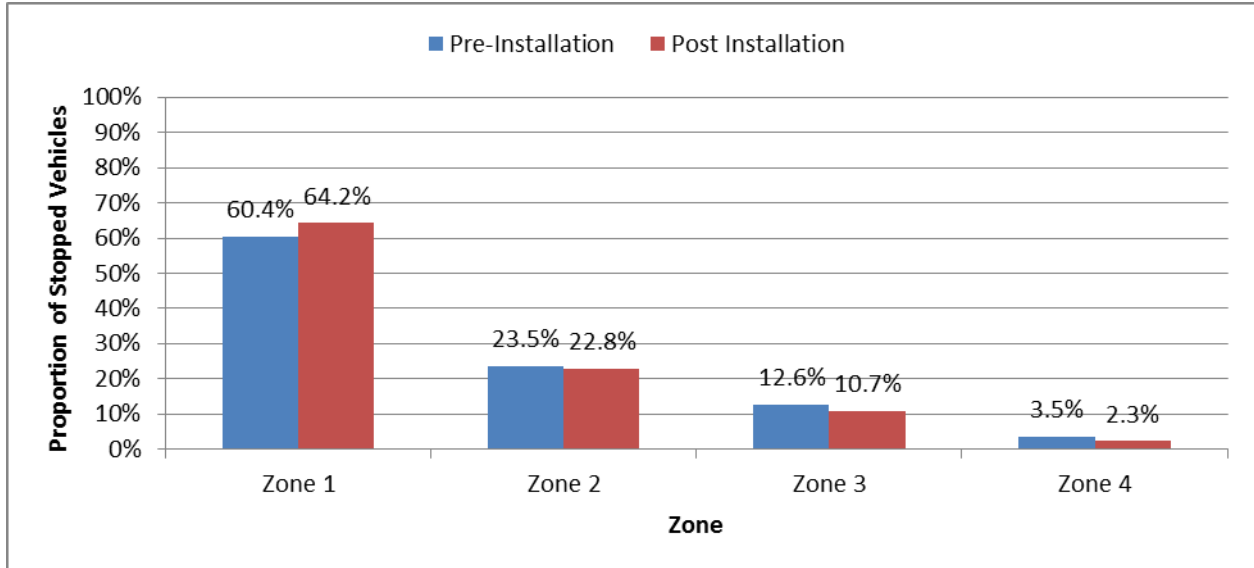
Similar patterns were found for westbound traffic. Significant changes in driver stopping behavior were found from before to after the installation of the pavement markings and signage ($\chi^2=31.72$, $df = 3$, $p < 0.01$). The decrease in vehicles stopping in Zone 3 was 14 percent—less substantial than for eastbound traffic. Further, the coders noted a 6 percent increase in Zone 1 stopping and a 36 percent decrease in Zone 4 stopping. These changes in proportion can be seen graphically in Figure 18.

Figure 18. Proportion of Westbound Vehicles Stopped by Zone (Pre-Install n = 3,187 and Post-Install n = 3,440)

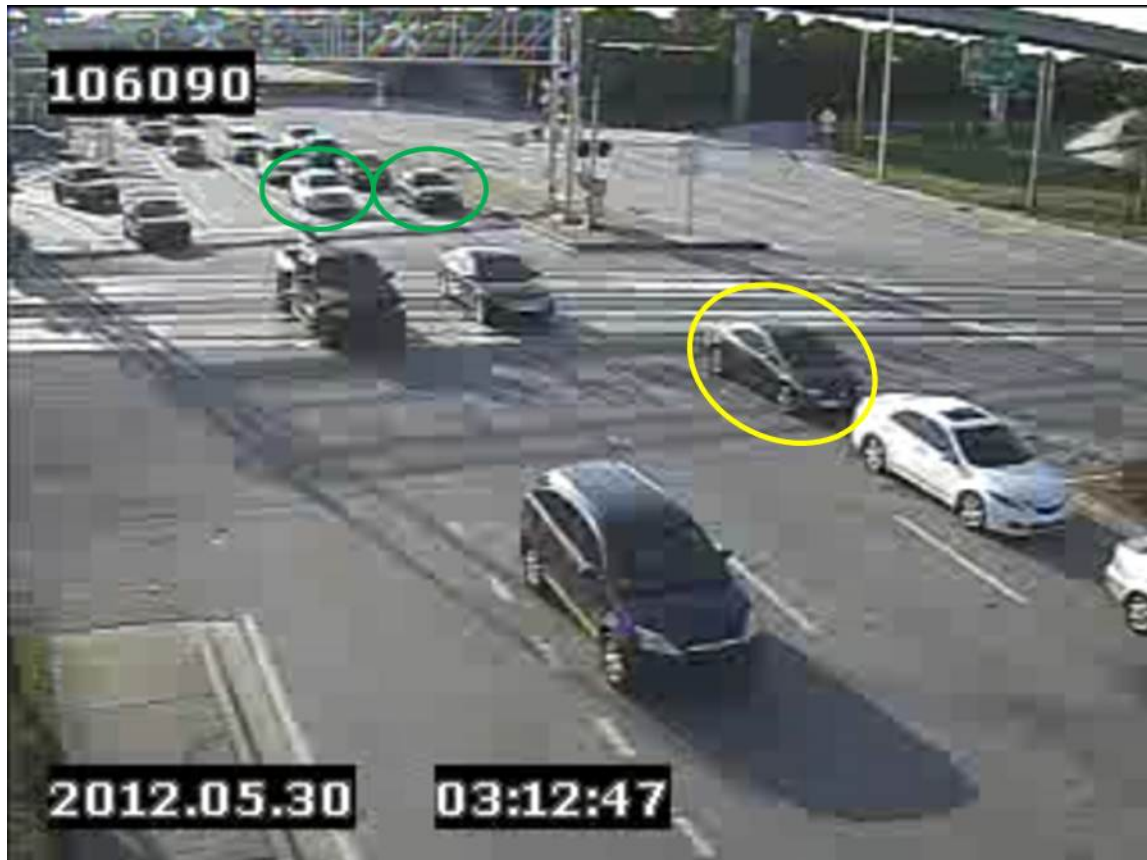
Examples of vehicles stopping in each of the zones are provided in Figure 19 and Figure 20. In Figure 19, the two vehicles circled in green have come to a full stop in Zone 1, behind the stop line. The vehicle circled in yellow has fully exited the crossing; however, it is very close to the tracks and is considered to be in Zone 4. The two vehicles seen on the tracks were moving and never came to a stop in the crossing; thus, they were not coded.

Figure 19. Westbound Zone 1 (green circles) and Zone 4 (yellow circle) Stopping Behaviors

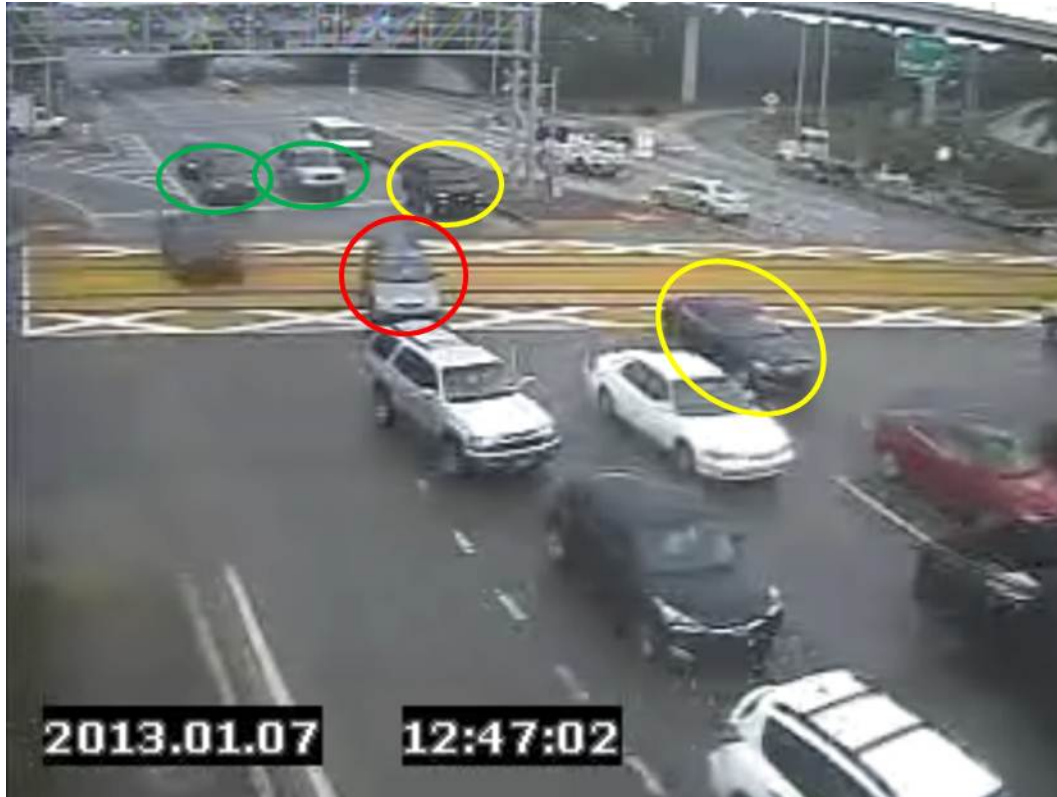
In Figure 20, vehicles stopping in all four zones can be seen. The vehicles circled in green have come to a full stop in Zone 1, behind the stop line. The vehicle circled in red has come to a full stop in Zone 3, on the tracks. The two vehicles circled in yellow stopped in Zone 2 (the uppermost yellow circle) and in Zone 4 (the lower and rightmost yellow circle).

Figure 20. Westbound Zone 1 (green circles), Zone 2 (yellow circle), Zone 3 (red circle), and Zone 4 (rightmost yellow circle) Stopping Behaviors

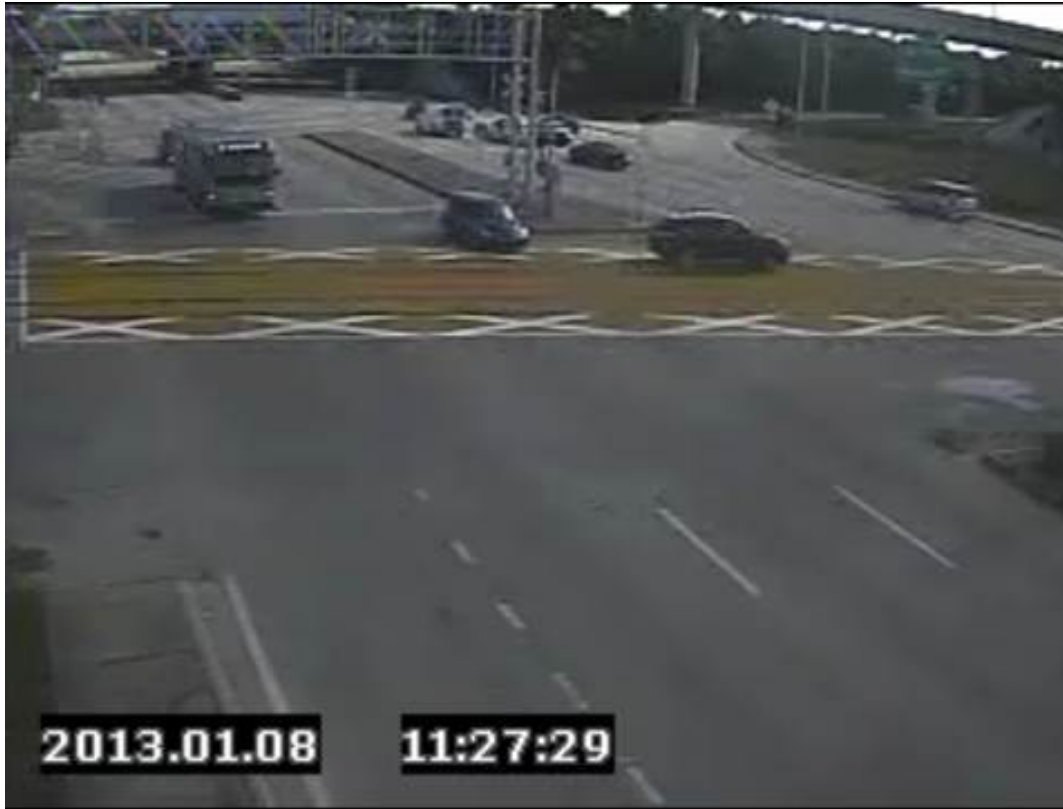
Figure 21. Example of a Vehicle Performing a U-Turn

Neither eastbound nor westbound traffic showed a significant change in vehicle action following the installation of the pavement markings and signage (Eastbound: $\chi^2=3.30$, $df = 3$, $p >0.05$ and Westbound: $\chi^2=1.05$, $df = 3$, $p >0.05$). This indicates that though drivers may have changed their decisionmaking process prior to entering the crossing, once they found themselves in the crossing and at a stop, there was little change in their behaviors. Examples of these behaviors can be seen in Figure 21 (U-turn) and Figure 22 (lane change).

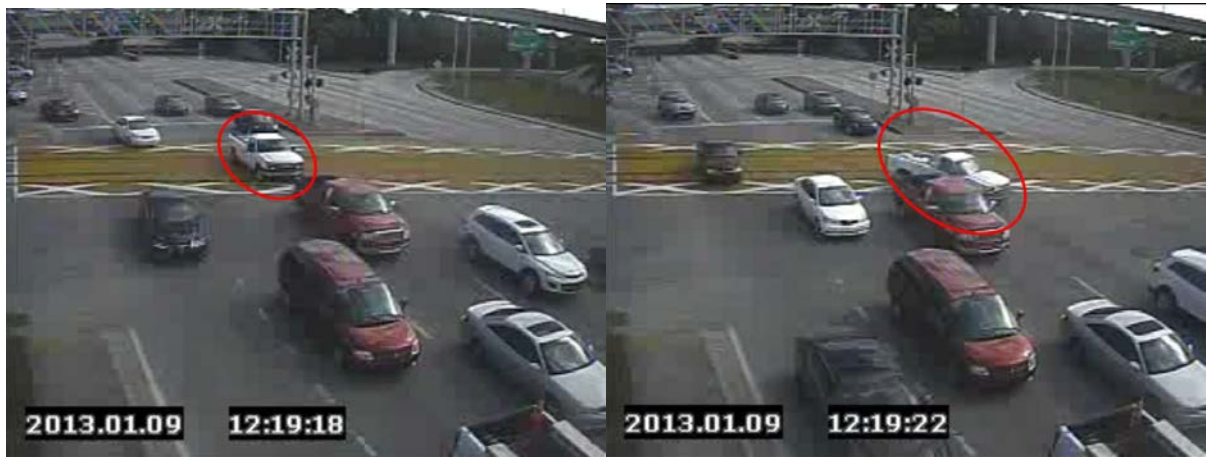
Figure 22. Example of a Vehicle Changing Lanes to Exit Tracks

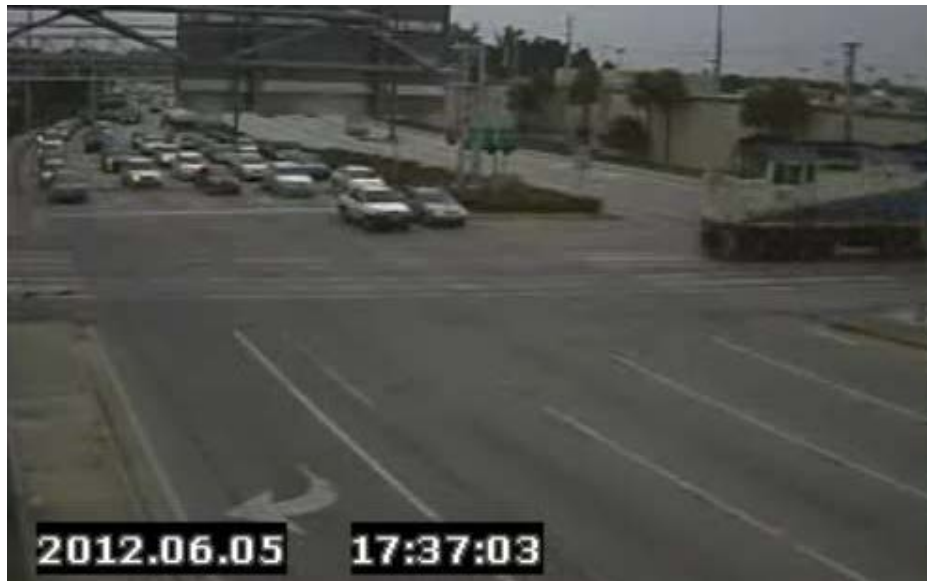
Figure 23. Eastbound Vehicles Trapped Inside Gates during an Activation

These findings are somewhat surprising. The jump from zero westbound incidents in the pre-installation timeframe to three incidents for westbound traffic in the post-installation timeframe is especially surprising. Also unexpected is the fact that at least one adjacent lane was open in each of these incidents, indicating that vehicles could have acted to exit the crossing but chose to remain trapped. An example of a vehicle trapped inside the gates is provided in Figure 23 (eastbound) and Figure 24 (westbound). Appendix A provides additional examples of this type of incident.
