U.S. Department of
Transportation

Federal Railroad
Administration

Effect of Dynamic Envelope Pavement Markings on Vehicle Driver Behavior at a Highway-Rail Grade Crossing

Office of Research
and Development
Washington, DC 20590

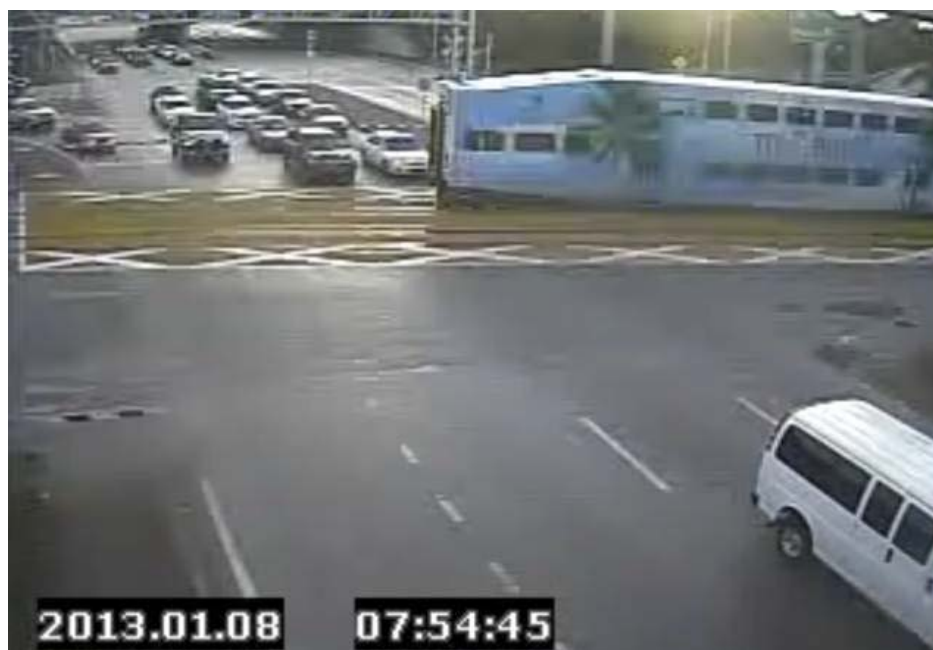
Figure 24. Westbound Vehicles Trapped Inside Gates during an Activation

¹² Vehicle 7 was trapped beyond the gates during the same activation as Vehicle 6. They were in adjacent lanes, as seen in Figure 24.

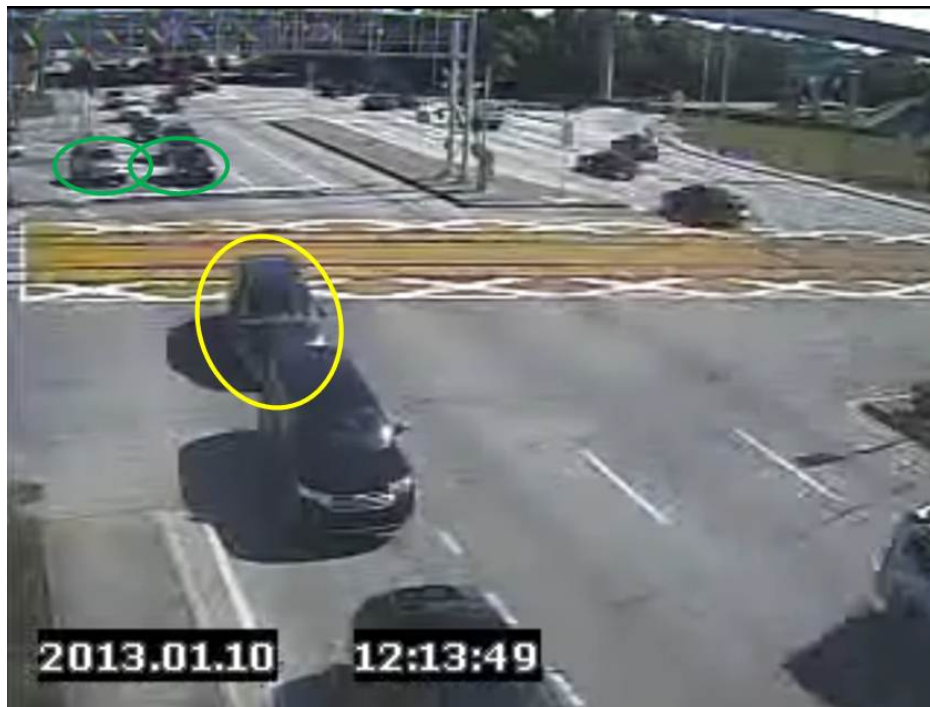
Figure A- 1. Westbound Vehicles Stopped in Zone 1 and Zone 4

Below are additional examples of vehicles that stopped on or near the tracks during the study timeframe. Vehicles circled in green were coded as having stopped in Zone 1. Vehicles circled in red were coded as having stopped in Zone 3. Vehicles circled in yellow were coded as being in Zone 2 if they were yet to cross the tracks and Zone 4 if they were already past the tracks. Not all vehicles were circled (only those that stopped in one of the four zones and were coded as such).

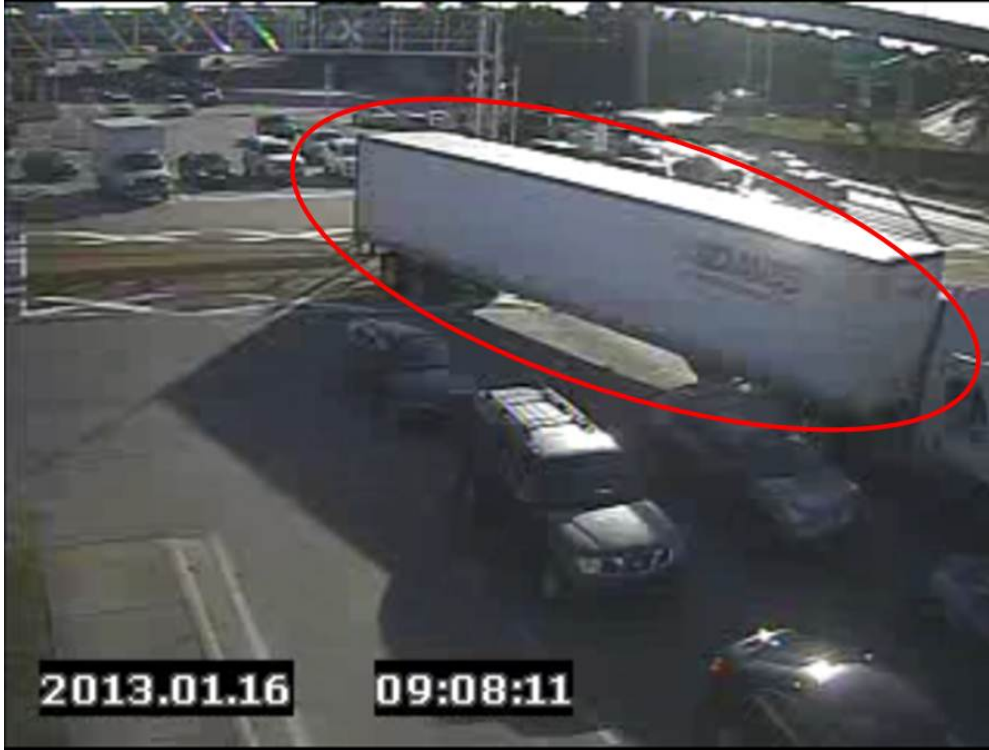
Figure A- 2. Westbound Truck Stopped in Zone 3

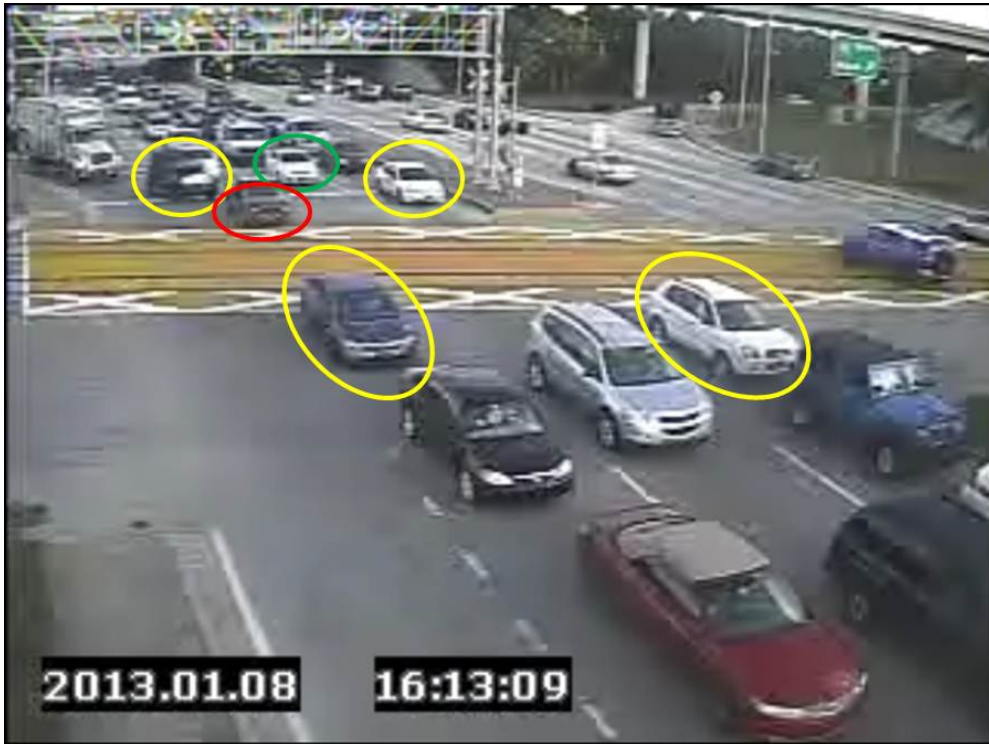
Figure A- 3. Many Westbound Vehicles Stopped on or Near the Tracks

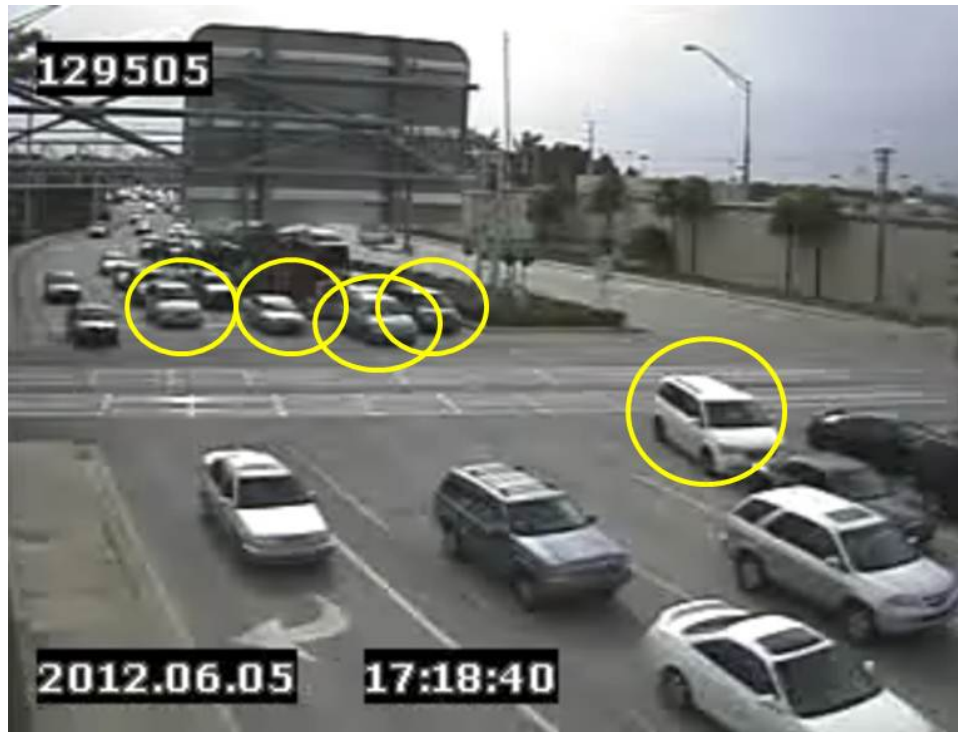
Figure A- 4. Eastbound Vehicles Stopped in Zone 2 and Zone 4

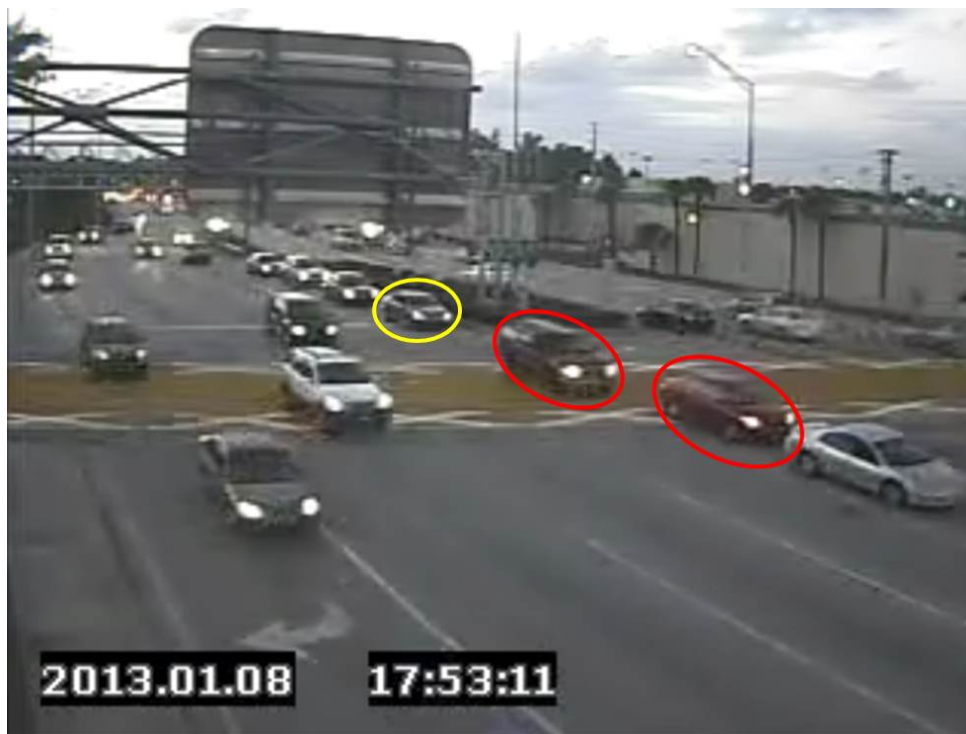
Figure A- 5. Eastbound Vehicles Stopped in Zone 2 and Zone 3
