U.S. Department of
Transportation

Federal Railroad
Administration

Construction Loads Experienced by Plastic Composite Ties

13. ABSTRACT (Maximum 200 words) Damage to plastic composite ties during handling and track installation has been reported by a number of railroads. Results from a survey conducted to identify specific handling issues were used to develop field and laboratory tests to measure the loads plastic composite ties are subjected to during handling and installation. Results suggest ties that would otherwise pass current AREMA Chapter 30 qualification tests and survive in track may fail because of the single, one-time high loads they may experience during installation or handling. For this reason, users and suppliers should critically evaluate existing tests in order to determine if additional tests that apply higher, single-event loads should be added to the screening process. A summary of peak loads is provided in this report, along with suggestions to develop impact and bending tests that simulate those peak load levels for laboratory screening tests.

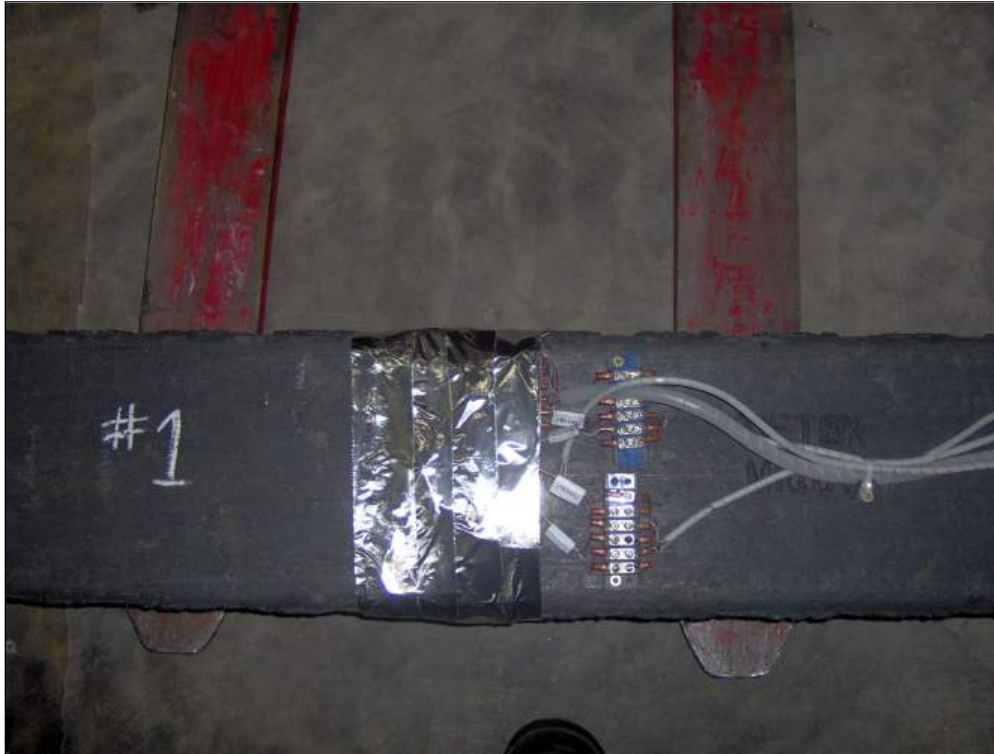
Figure 2. Example of strain gage wiring at the tie center. The strain gages were protected under tape, with the wires leading to the end of the tie to allow data collection.

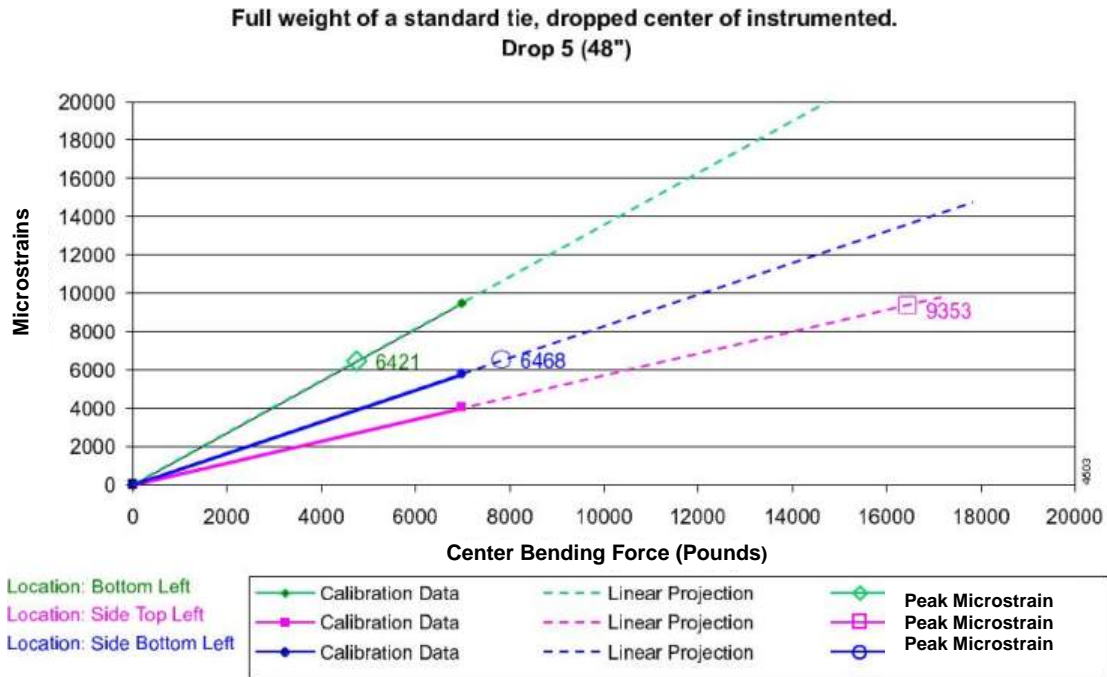
Figure 13. Summary of drop testing strains and corresponding center bending loads. The peak impact generated 9,353 microstrains, producing an equivalent load of 16,460 pounds.

Tie dropping results suggest bending strains approach, and in some instances, exceed the strains measured during the calibration procedures that used typical AREMA guides. The equivalent center bending load for current AREMA testing is 8,000 to 10,000 pounds, whereas the impact loads measured by dropping are at least 16,460 pounds.

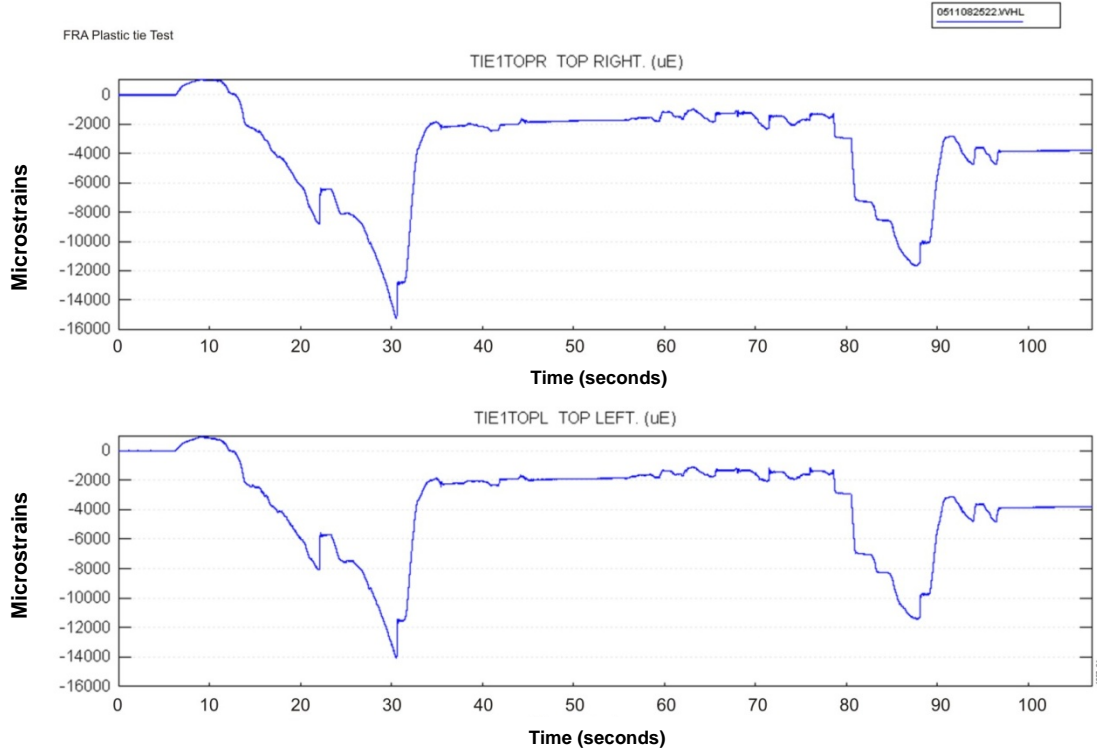
Figure 15. Time history of tie center bending at top of tie during installation. The peak strain is negative due to the tie being pulled up against the bottom of the rail. Peaks of 15,622 microstrains occurred approximately 30 seconds into the insertion activity.

As an example, the center bending strains measured during one insertion are summarized in the time history plot shown in Figure 15. Peaks in bending occurred at about 30 seconds into the event, and again at about 88 seconds. The highest observed peak exhibited a maximum reading of 15,622 microstrains, which is well above the microstrain level of about 9,000 produced during the laboratory center bending test and suggests that this installation generated center bending loads higher than that utilized in the laboratory proof test. Each type of composite tie material may react differently to one-time high loads. Any internal damage may result in accelerated degradation once in track; thus, detrimental effects, if any, on long term performance cannot be determined by this test.

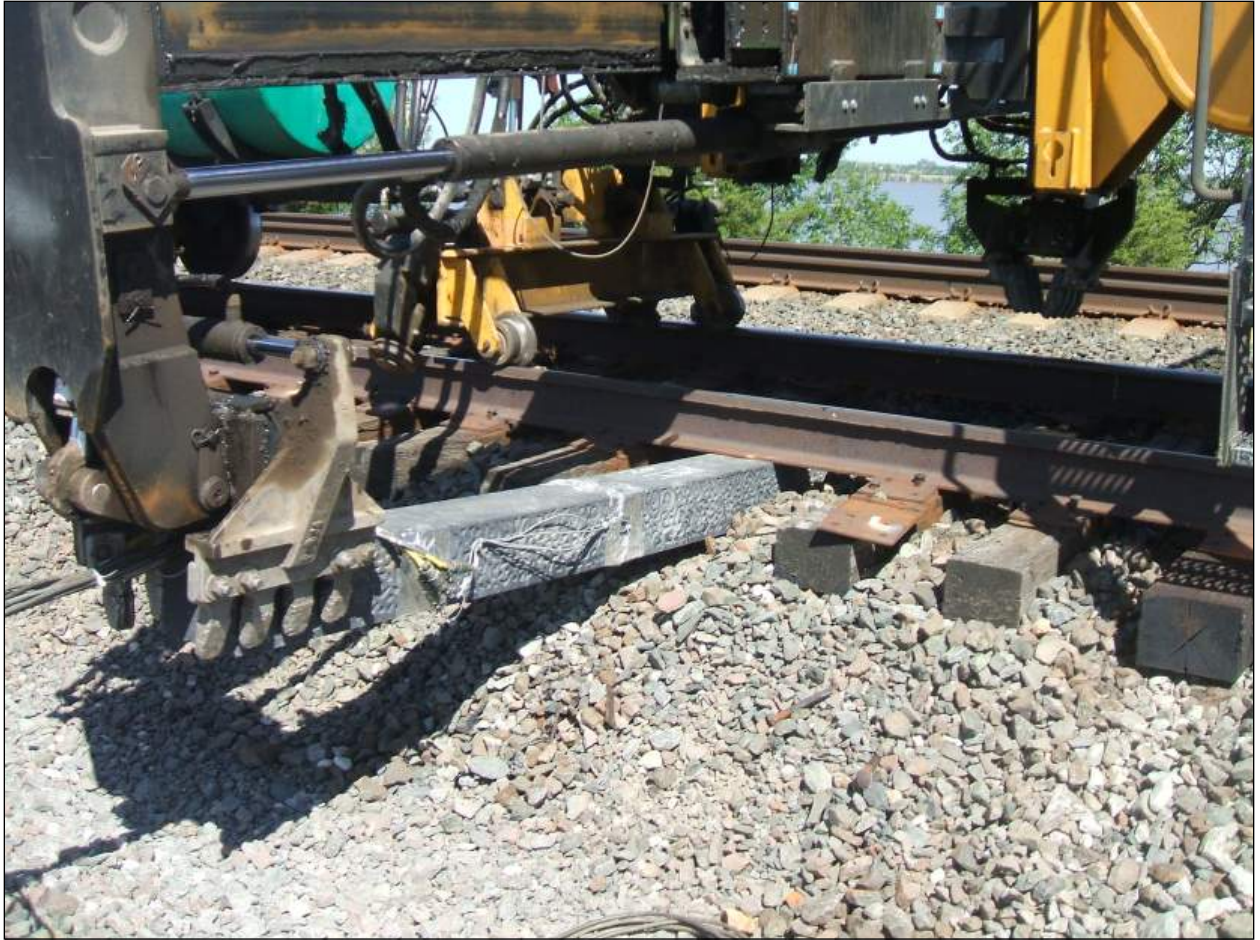
Figure 19. Instrumented tie during insertion at the BNSF site.

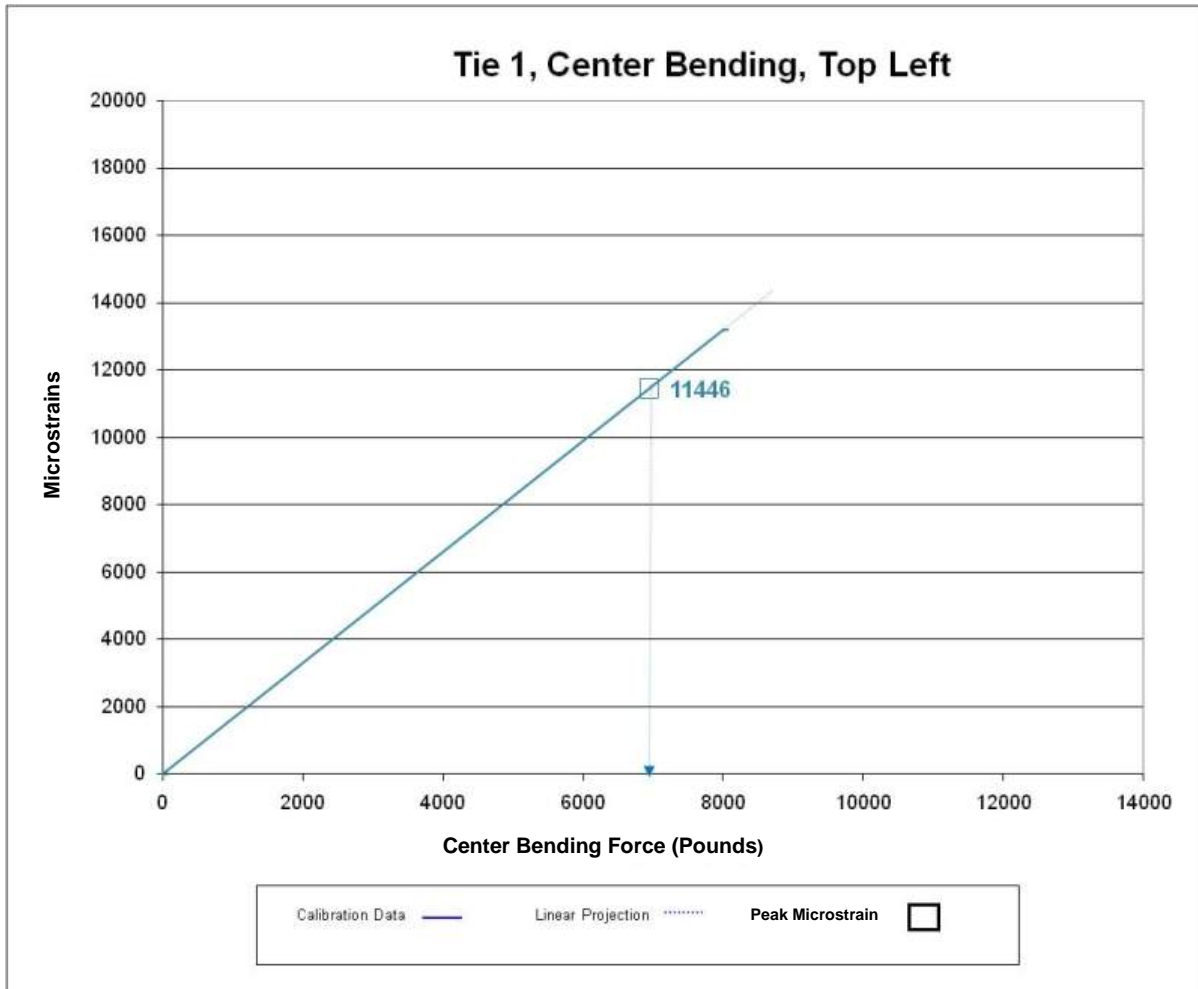
**Figure 22. Peak center bending for tie 1 during installation.
Top left of tie, 11,446 microstrains producing an equivalent load of 7,622 pounds.**

The average peak center bending load for each of the two ties was similar, with an equivalent force of about 7,600 pounds (see Figures 22 and 23). Note that although the forces are similar, the microstrain values recorded at these forces are very different and reflect the difference in calibration curves associated with the strain gages on each tie. This shows the need to use individual calibration files for each strain gage location, as microstrain values alone are insufficient to determine peak loads.

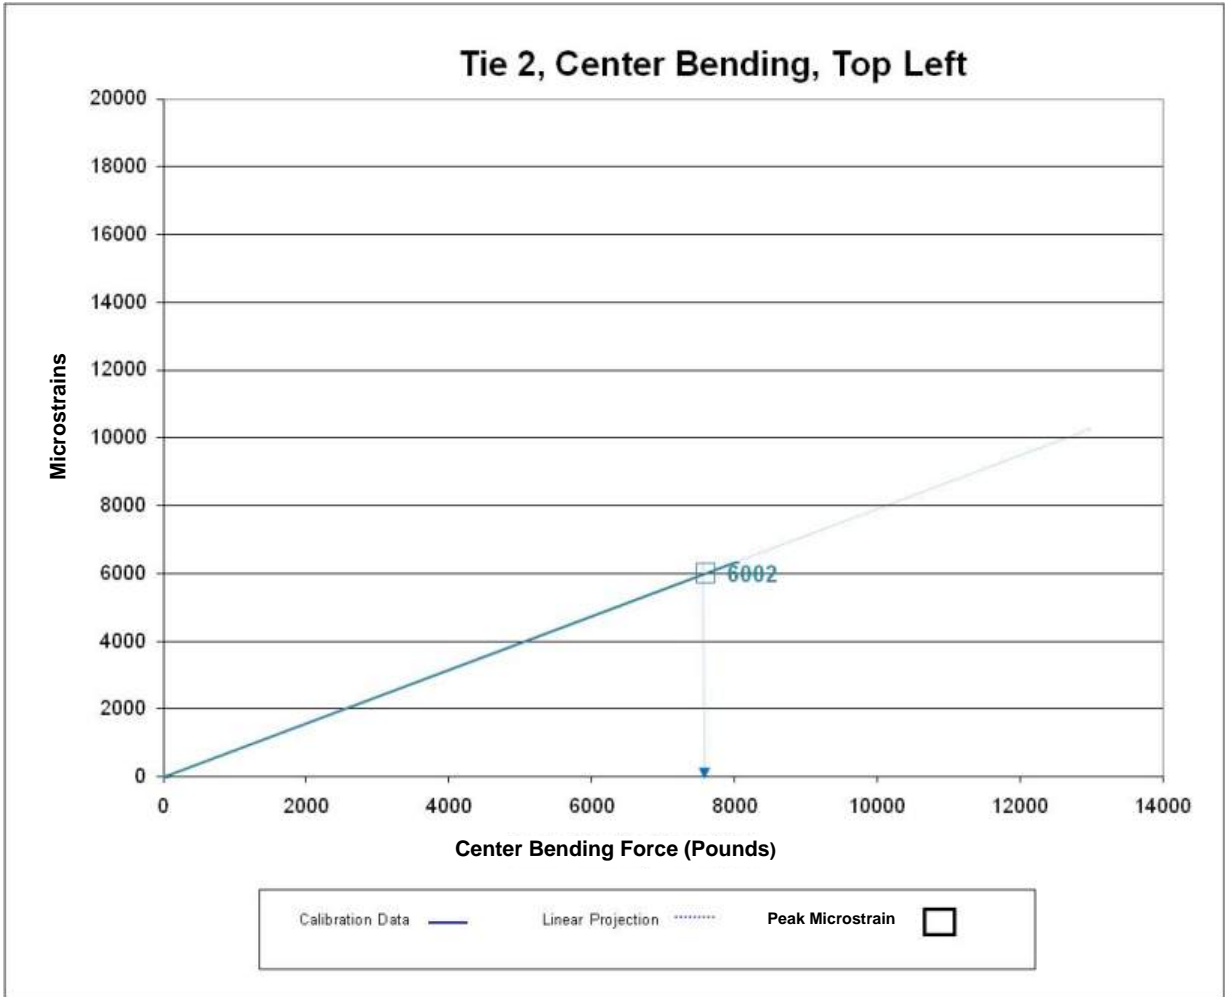
**Figure 23. Peak center bending for tie 2 during installation.
Top left of tie, 6,002 microstrains producing an equivalent load of 7,596 pounds.**

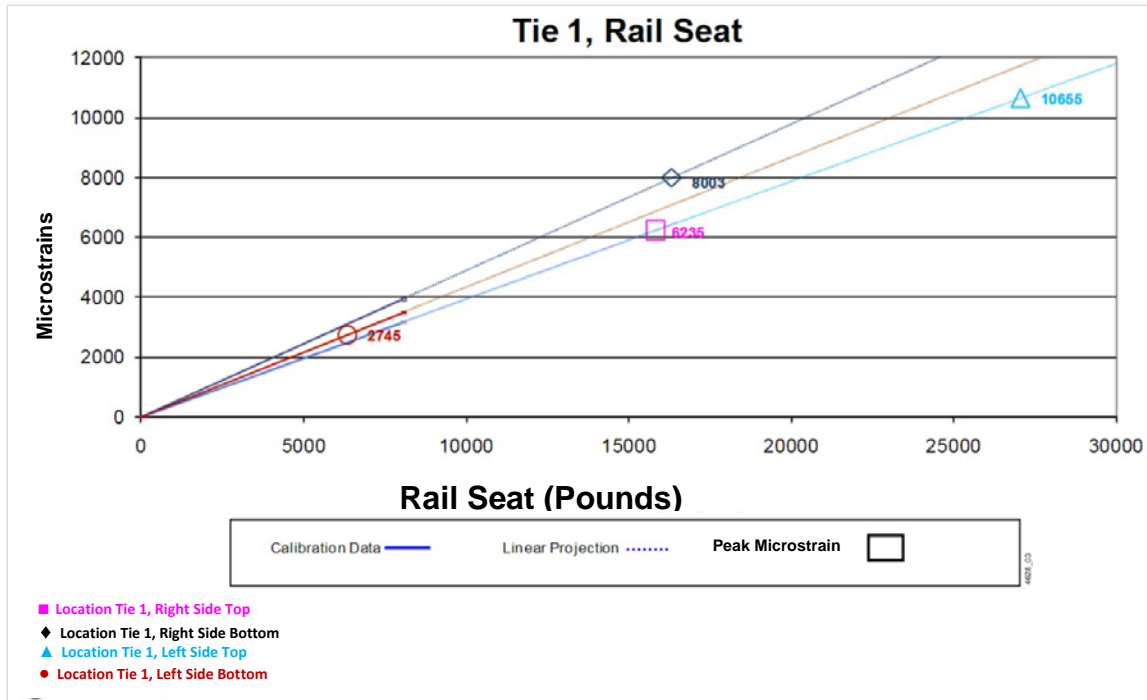
Figure 24. Peak rail seat bending for tie 1 during installation.
 Peak loads of 16,333 and 15,835 pounds were observed on the right side of the tie; a single very high peak of 27,000 pounds was observed on the left top of the tie. Note that right and left side top had virtually identical calibration curves and thus appear as one line.

Figures 24 and 25 show strain data collected at the rail seat during the same time periods. The data show that rail seat peak loads of about 27,000 pounds for tie 1 and 12,400 pounds for tie 2 were attained. The single very high load observed during the installation of tie 1 was originally thought to be the result of debonding of the strain gage; however, subsequent rail seat strain data collected during nipping operations showed that the strain gage was operating normally and producing data within the range of the other strain gages.

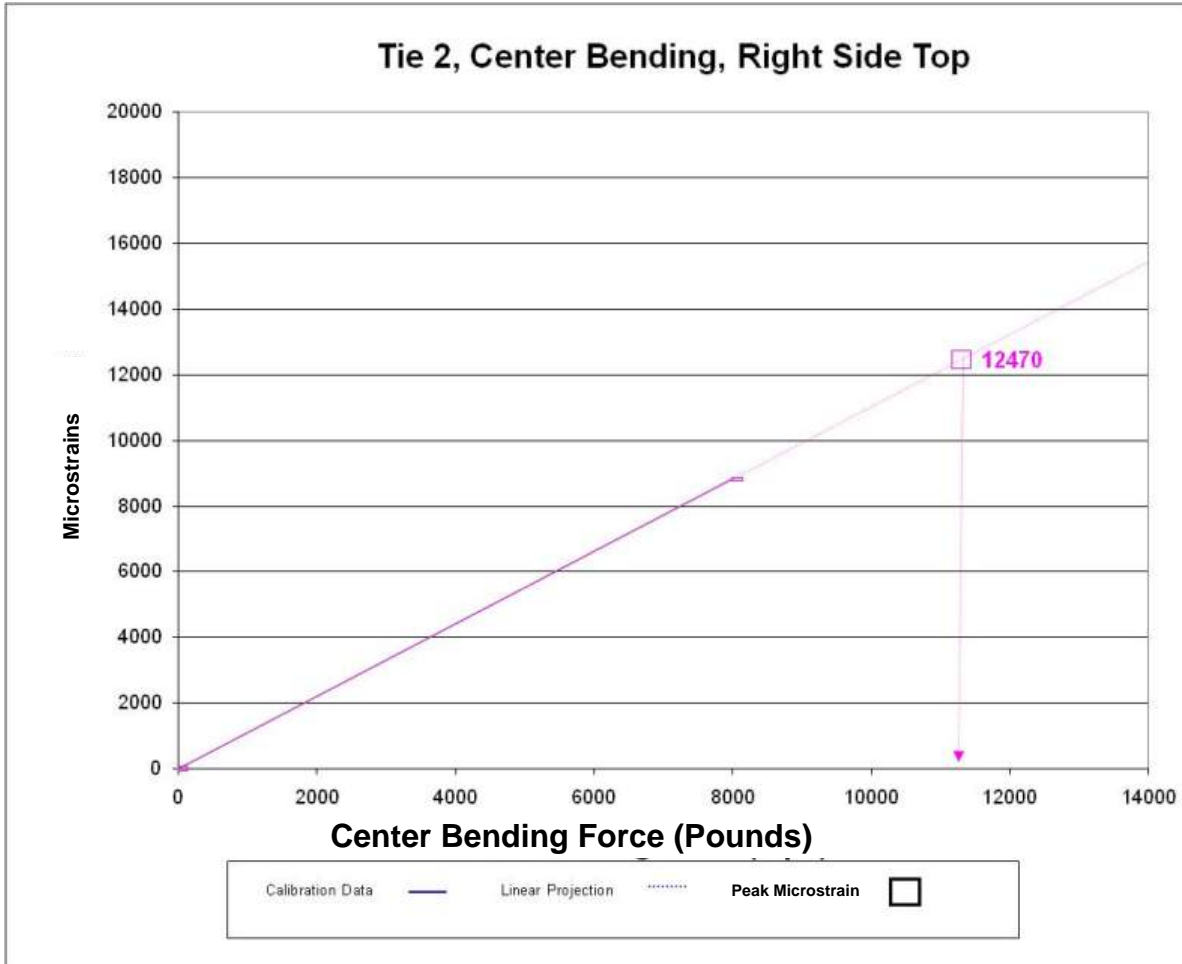
Figure 26. Peak center bending strains for tie 2 during nipping and spiking. A peak load of 11,300 pounds was observed on top right of the tie.

Additional data were collected on these same two ties during follow-up nipping and spiking operations. Figures 26 and 27 show the peak strains measured at each strain gage during nipping of ties, which suggested a peak rail seat bending load of 15,200 pounds for tie 2.

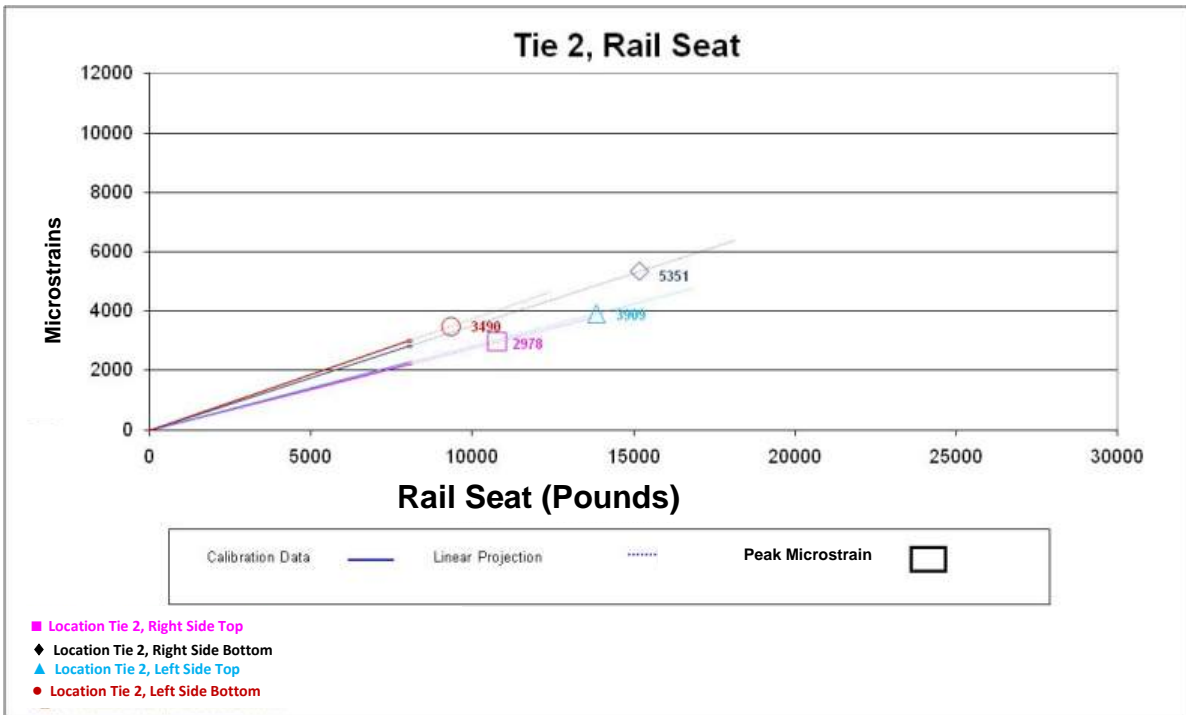
Figure 27. Peak rail seat bending strains for tie 2 during nipping and spiking. A peak load of 15,188 pounds was observed on right bottom of the tie.
