REPORT NO. **FRA-77-20**
FRA/ORD-77/50

FRACTURE RESISTANCE AND
FATIGUE CRACK GROWTH CHARACTERISTICS
OF RAILROAD WHEELS AND AXLES

C. S. Carter
R. G. Caton
J. L. Guthrie

NOVEMBER 1977
FINAL REPORT

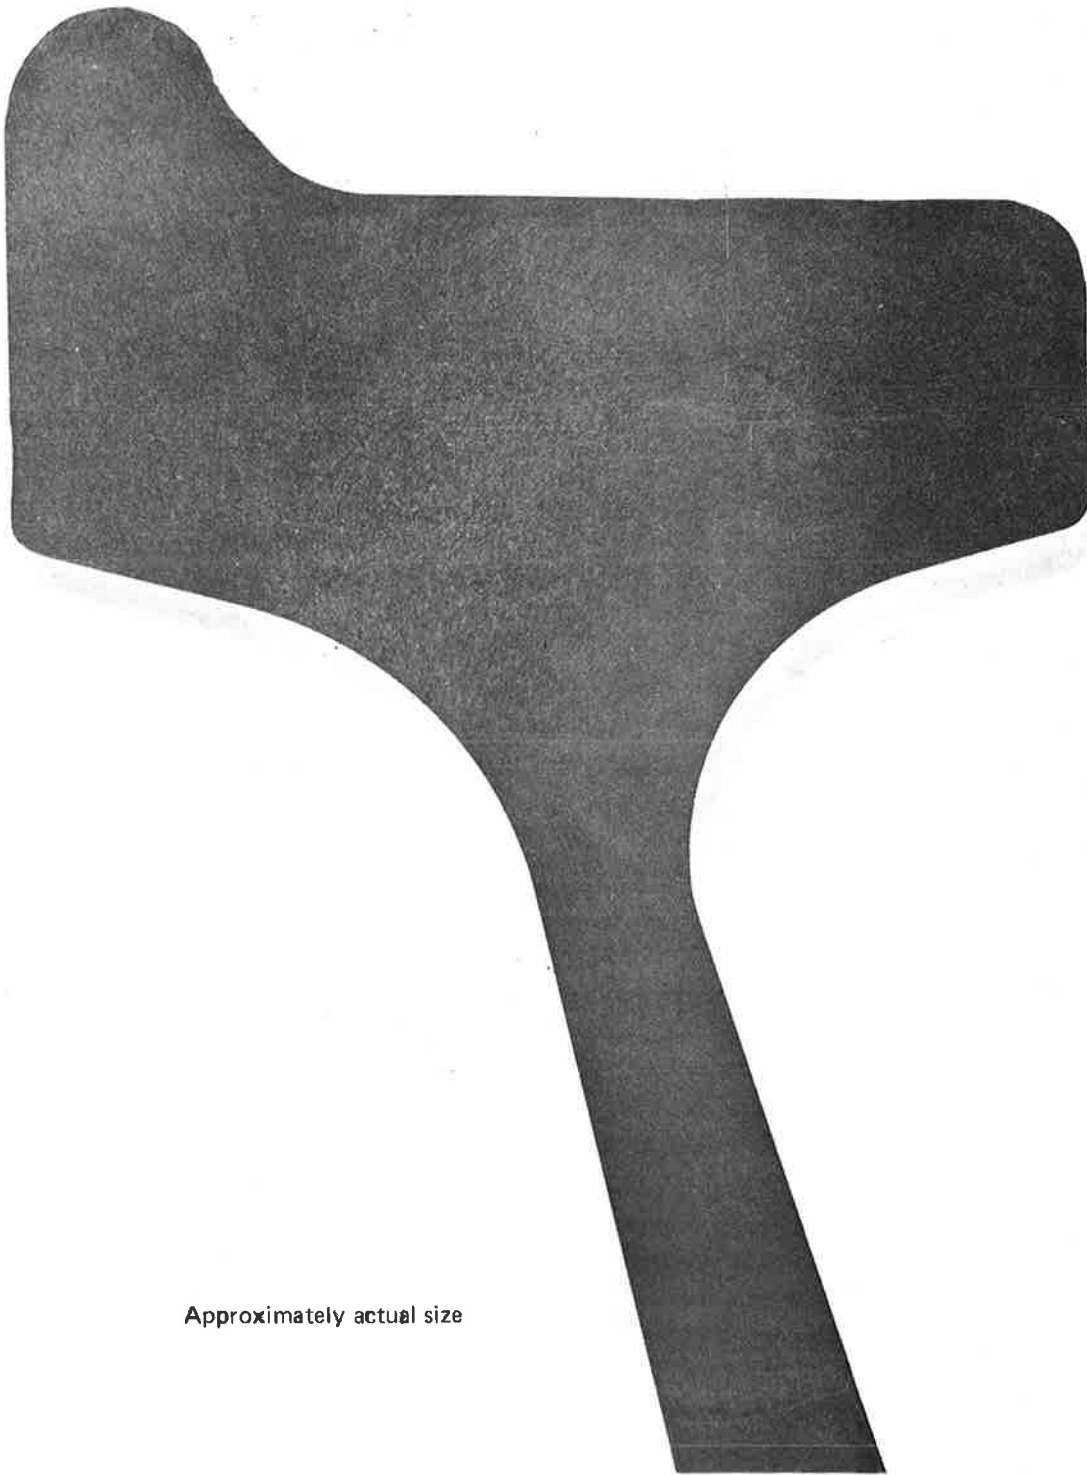
FIGURE 36.—MACROSECTION OF CLASS SUB A WHEEL (WHEEL 8), GRAIN FLOW SECTION GF2 (METROLINER TYPE WHEEL)

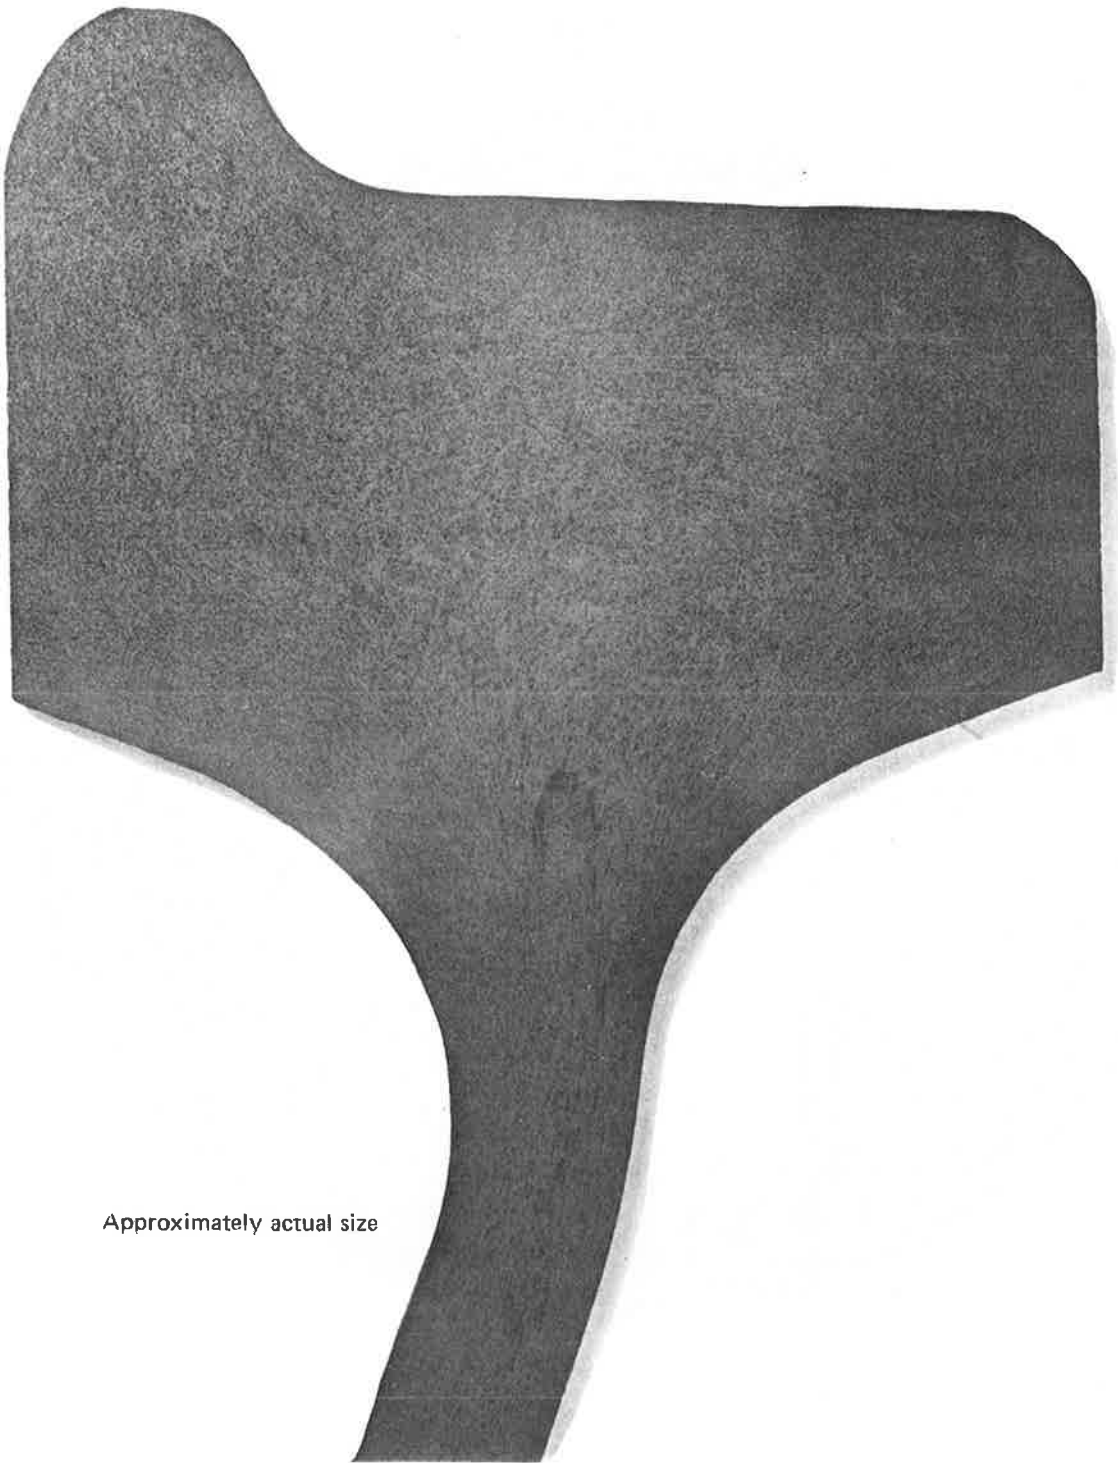
FIGURE 37.—MACROSECTION OF CLASS B WHEEL (WHEEL 9), GRAIN FLOW SECTION GF5

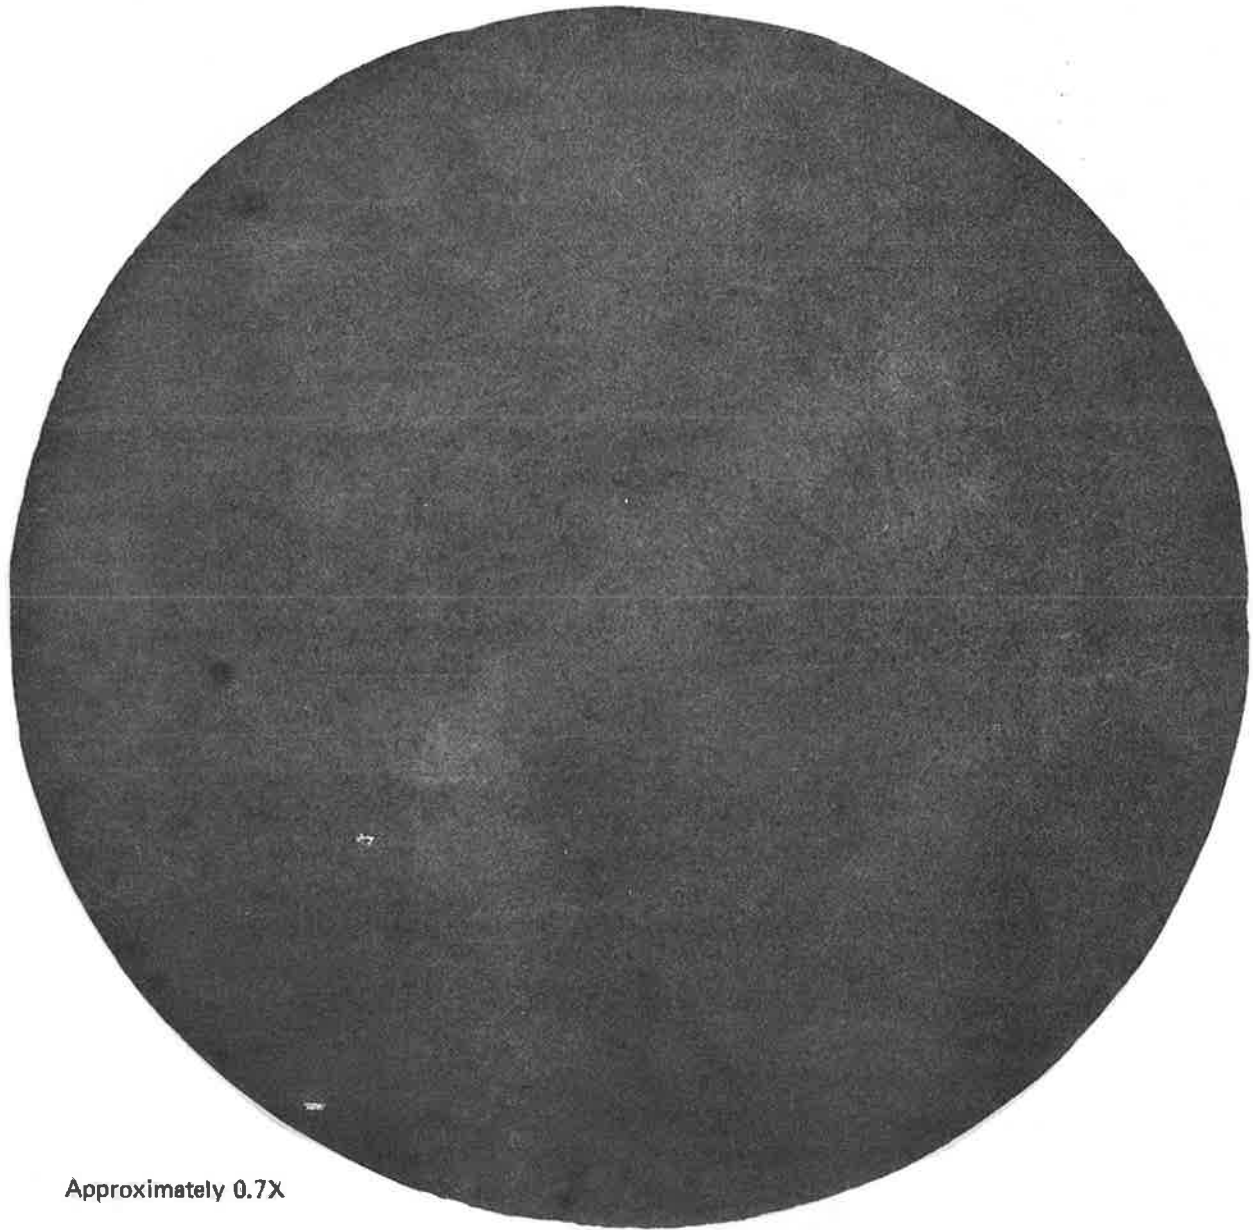
FIGURE 38.—MACROSECTION OF GRADE F AXLE (F1)

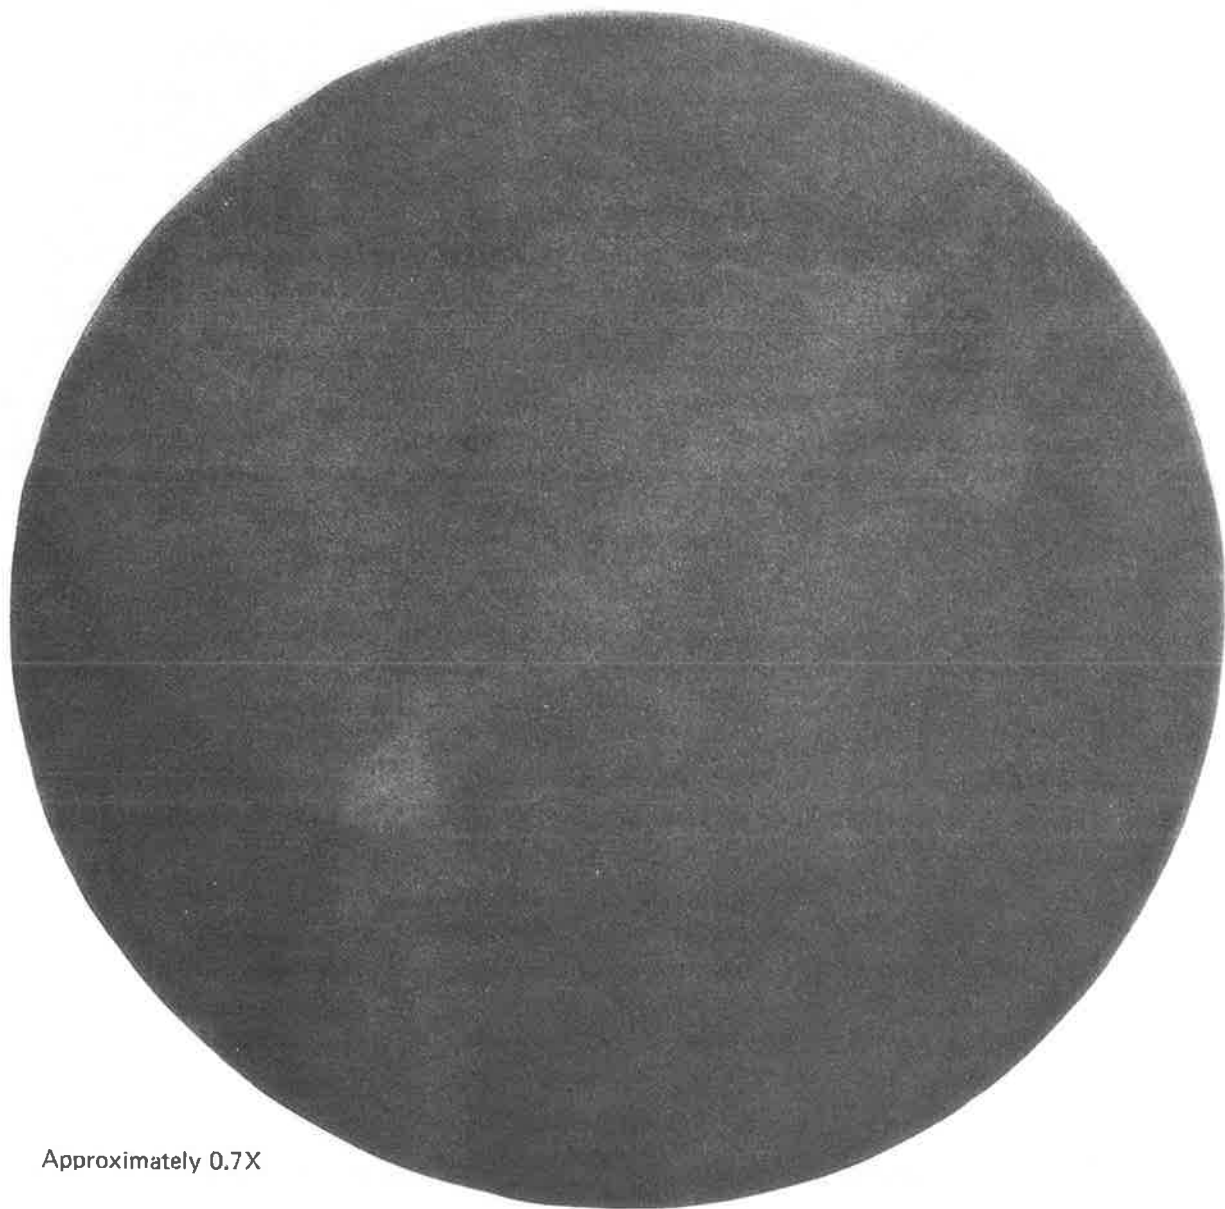
FIGURE 40.—MACROSECTION OF GRADE U AXLES (U)

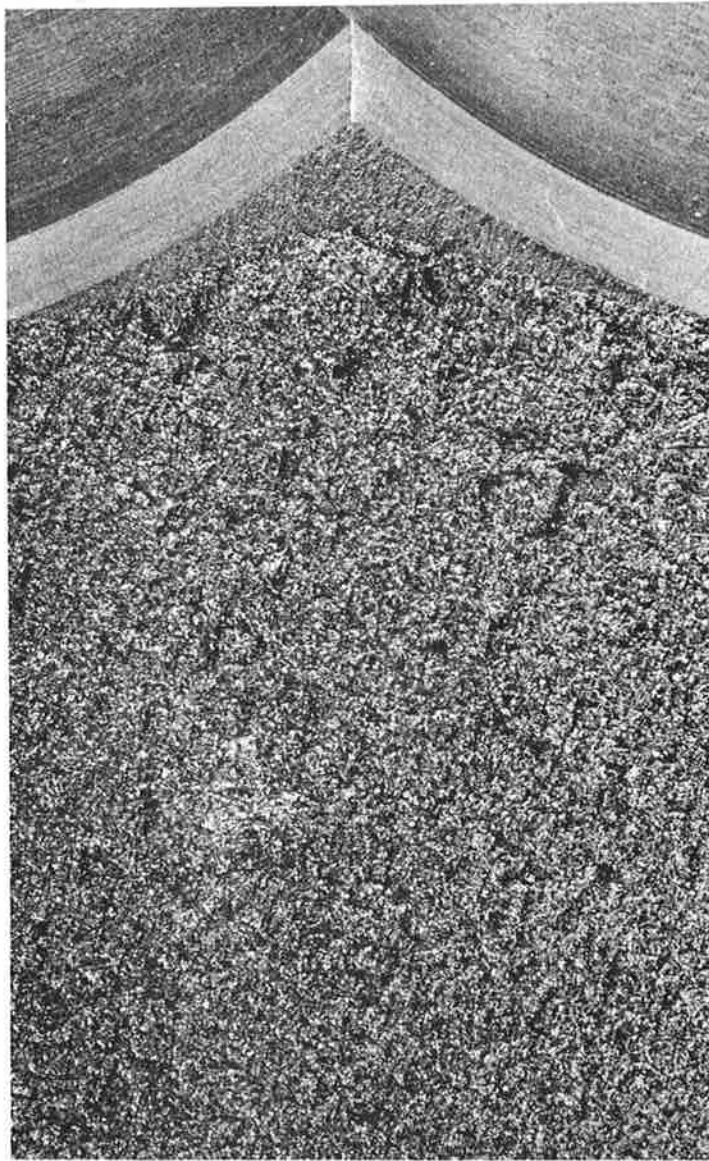
FIGURE 48.—FRACTURE OF COMPACT SPECIMEN UUE-KC4 TAKEN FROM GRADE U AXLE AND TESTED AT -40° F

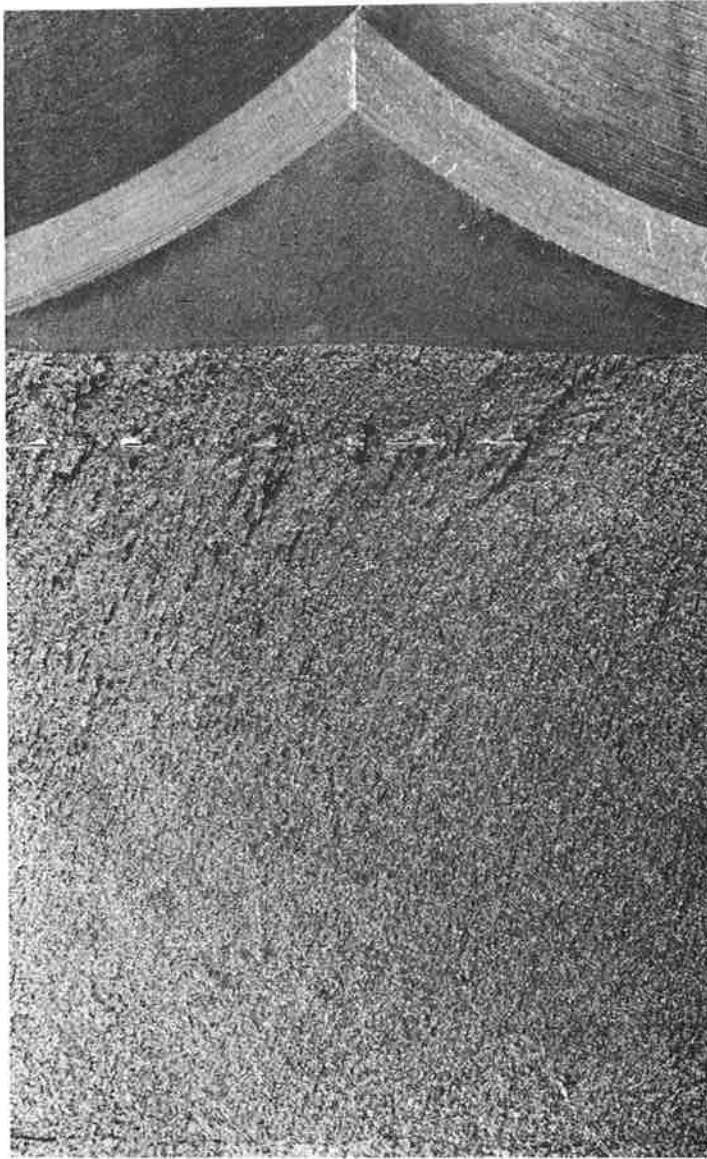
FIGURE 50.—FRACTURE OF COMPACT SPECIMEN FFE-KC4 TAKEN FROM GRADE F AXLE AND TESTED AT -40° F

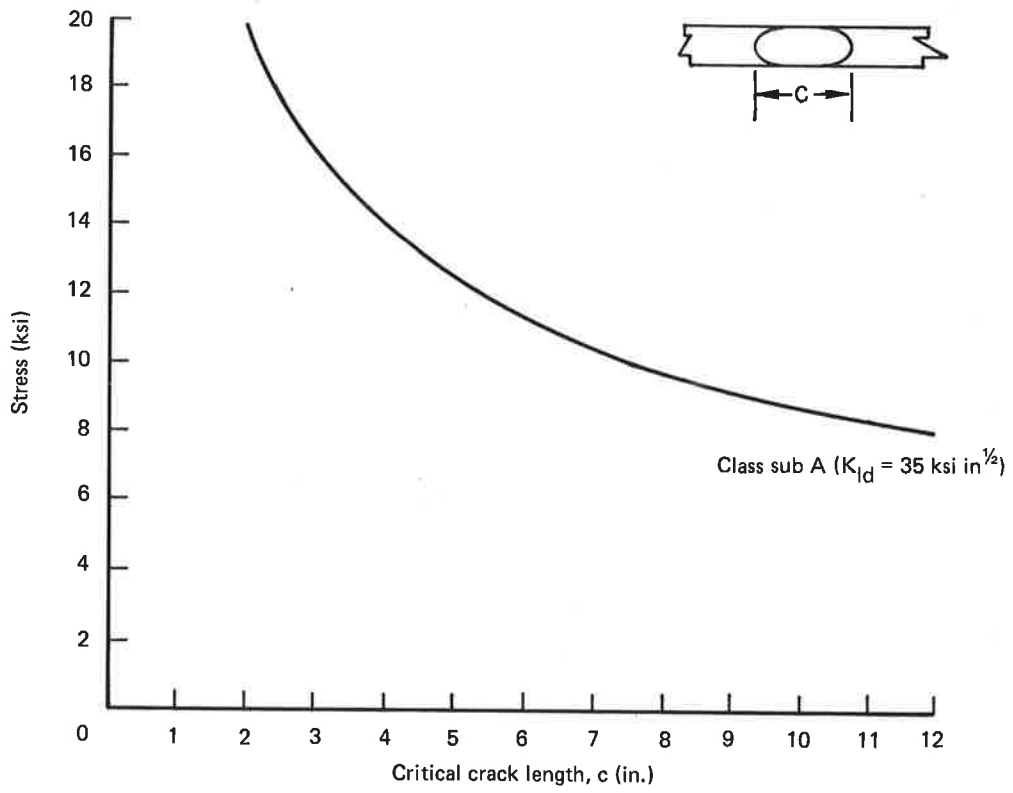
FIGURE 64.—APPLIED STRESS/CRITICAL CRACK LENGTH RELATIONSHIPS FOR THROUGH-THICKNESS CRACKS IN WHEEL PLATES
