U.S. Department
of Transportation
**Federal Railroad
Administration**

THERMAL MEASUREMENTS OF COMMUTER RAIL WHEELS UNDER REVENUE SERVICE CONDITIONS

1. AGENCY USE ONLY (Leave blank)	2. REPORT DATE September 1993	3. REPORT TYPE AND DATES COVERED	
4. TITLE AND SUBTITLE Thermal Measurements of Commuter Rail Wheels Under Revenue Service Conditions		5. FUNDING NUMBERS

6. AUTHOR(S) Cameron D. Stuart		8. PERFORMING ORGANIZATION REPORT NUMBER DOT-FR-94-01	
7. PERFORMING ORGANIZATION NAME(S) AND ADDRESS(ES) ENSCO, Inc. 5400 Port Royal Road Springfield, Virginia 22151		10. SPONSORING / MONITORING AGENCY REPORT NUMBER FRA/ORD-93/19

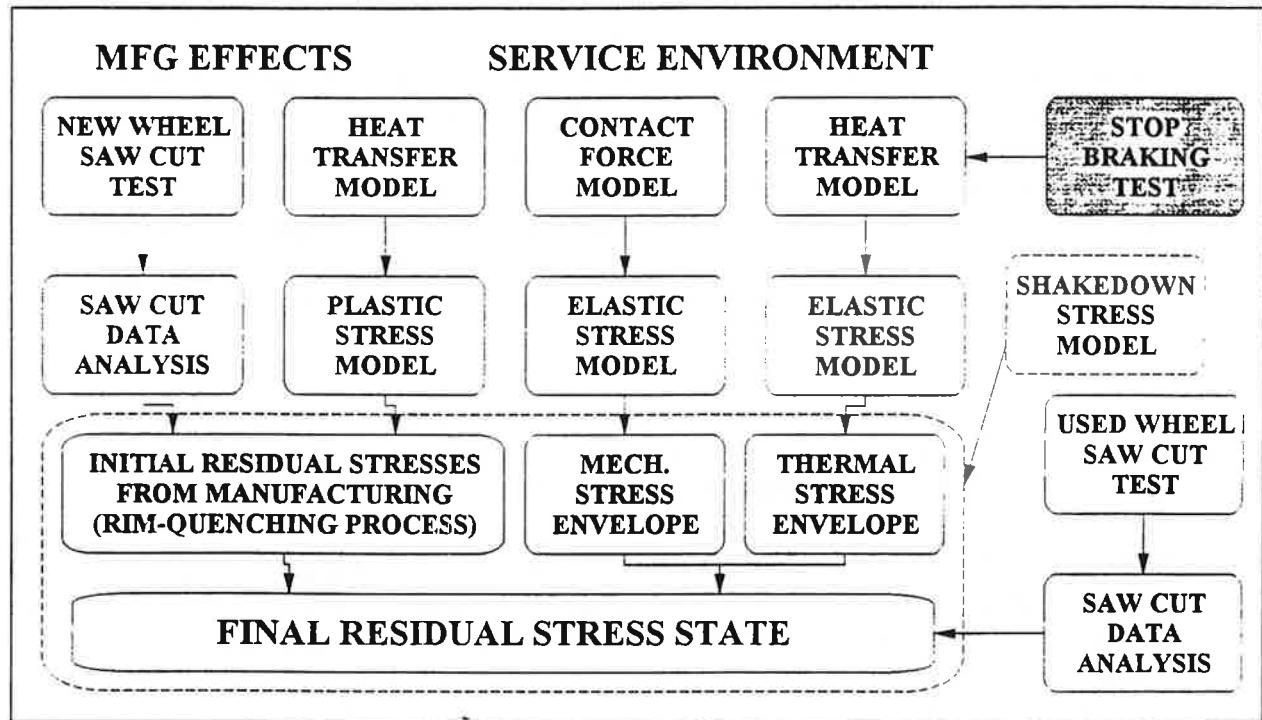
Chart 1 Analysis Diagram

Previous engineering tests include a review of wheel maintenance records of the affected railroads to confirm the general nature of the crack occurrence patterns, destructive testing of two service-worn, thermally cracked wheels to obtain quantitative data on the number and size of the cracks, and destructive saw-cutting of new and service-worn wheels for purposes of estimating the residual stresses in their rims. Reports covering the saw-cutting and the wheel crack census tests are being published separately. Metallurgical examinations of wheel samples, including metallographic and fractographic studies as well as hardness tests, were also conducted. The results from these tests were used as empirical references in the formulation of finite element computer modeling programs designed to analyze the thermal and mechanical stress state of railroad wheels and to evaluate the potential for different types of wheels to resist cracking under various combinations of service conditions. Chart 1 illustrates the organization of models and tests required to develop a procedure to estimate wheel stresses. The shaded block denotes the test covered in this report.

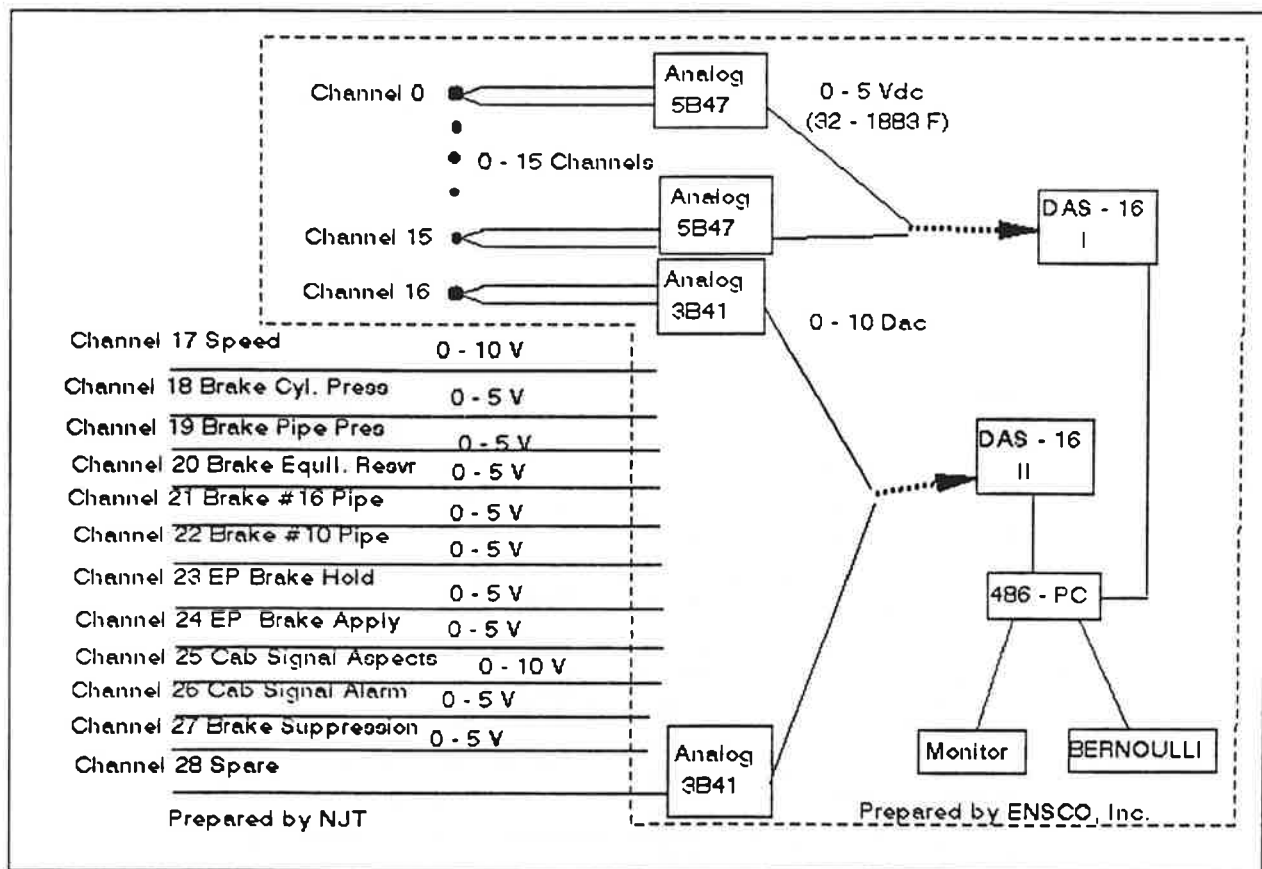
Figure 6 Instrumentation Diagram

The data acquisition system used in this experiment was based around an IBM-compatible 486/33MHZ PC running specially designed software which read, displayed, and stored all the data. The computer received the data signals via two, 16-channel, Metrabyte analog-to-digital (A/D) cards which were connected to a custom-made signal conditioning unit. This unit housed all the analog signal conditioning modules and filtering (4 Hz, low pass) equipment necessary to process all the raw data signals, both for the thermocouple channels as well as for the speed and air pressure channels. All signal conditioning equipment was manufactured by Analog Devices. The data sampling frequency of the acquisition system was 4 Hz. The instrumentation system flow-chart is displayed in Figure 6.

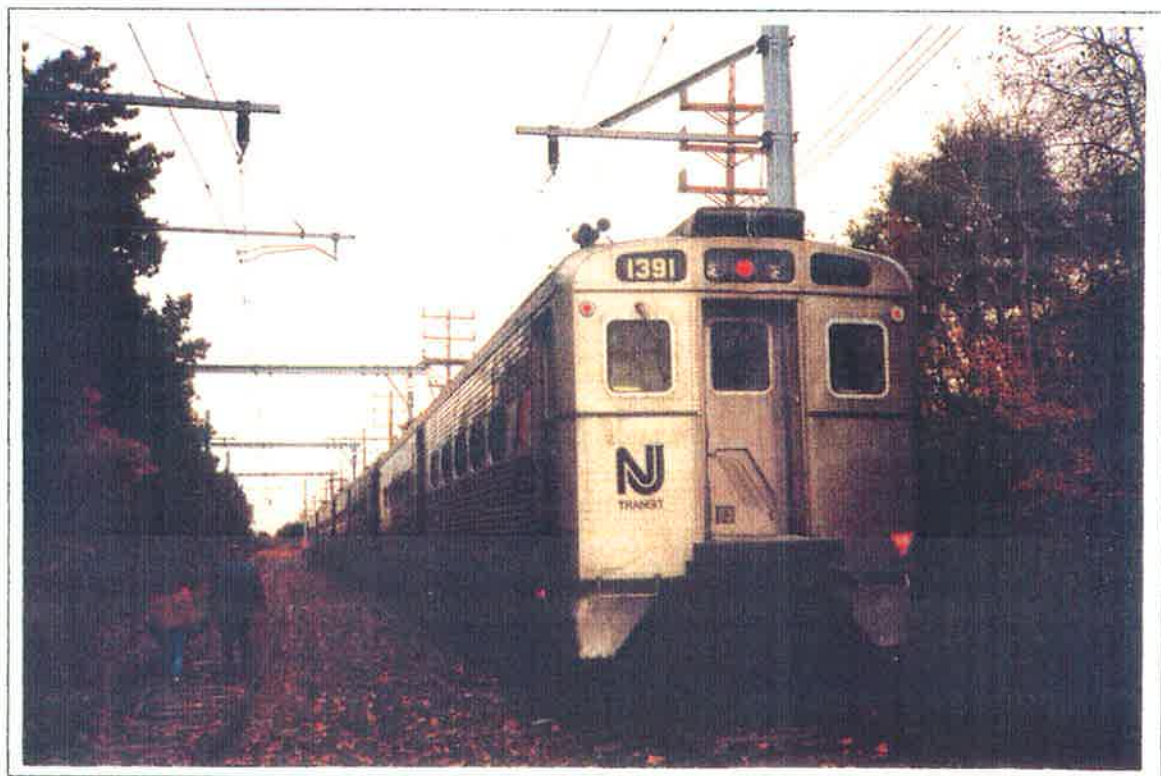
Figure 7 Consist at Matawan

Car #1391:	Instrumentation car Instrumented wheels L1 and L2 (B-end, handbrake position) New "S" plate wheels (L1 and L2) Good, worn, brake shoes on test wheels Weight: Total = 120,400 lbs A - end = 59,700 lbs B - end = 60,700 lbs
Car #1390:	Weight: Total = 122,800 lbs A - end = 59,200 lbs B - end = 63,600 lbs
Car #1412:	Weight: Total = 122,500 lbs A - end = 59,100 lbs B - end = 63,400 lbs
Car #1413:	Weight: Total = 120,400 lbs A - end = 60,200 lbs B - end = 60,200 lbs

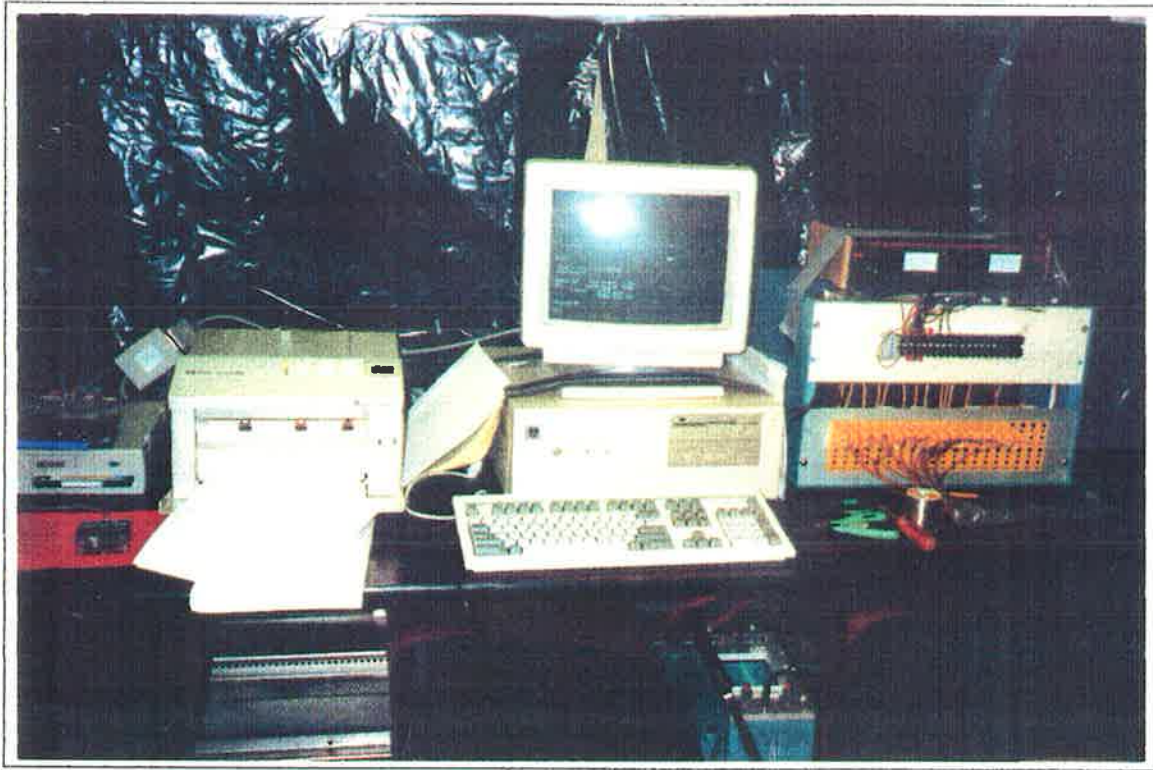
Figure 8 Data Acquisition System

and stored on Bernoulli 44 megabyte diskettes. Figure 8 shows the data acquisition system on car #1391.

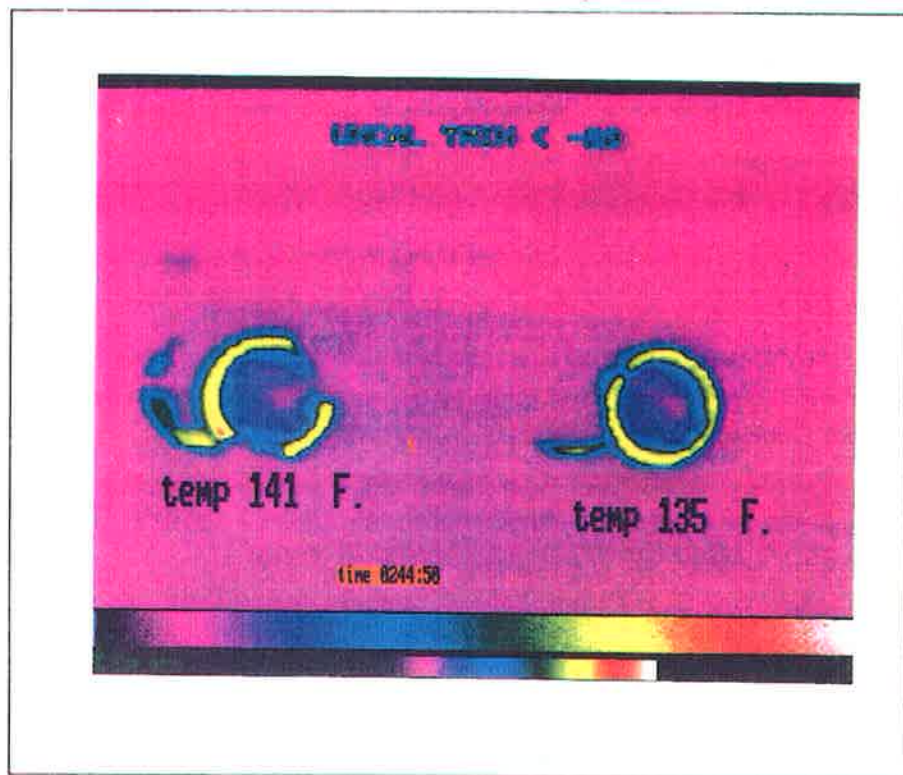
Figure 11 Thermal Imaging Data

The objectives of the thermal imaging portion of the field test (Section 2.5.1) were accomplished during the test procedure. The results satisfying the first objective, quantifying the relationship between internal and surface wheel temperatures, are illustrated in Graph 9 and Figure 11; both report wheel temperatures on the test train at the same moment in time. Thermocouple measured internal wheel temperatures, Graph 9, after the consist had stopped at Princeton Junction, are around 275 deg. F (Time 475 - 500 sec.). Figure 11, thermal imaging data taken at the same time, shows an average surface wheel temperature of around 140 deg. F. Unfortunately, the test train was traveling east bound at the time these images were recorded and, therefore, the primary images in the figure are of the wheels on the opposite side of the train from the test wheels. The test wheels are partially visible (rear rim faces) in the background and are seen to be at the same temperature range as the primary wheels. Annotated data is available for all the wheels on this side of the test train (see Appendix III) and reveals an order-of-magnitude similarity between all wheel temperatures. The mean temperature for all 20 wheels measured on

this side of the consist is 128 °F and the standard deviation between this data set, using the population standard deviation method, is 17.1 °F.
