2012 **R&D**
REVIEW

Train Occupant Protection

Federal Railroad
Administration

JOHN PUNWANI
Program Manager
Office of Research and Development
Office of Railroad Policy and Development

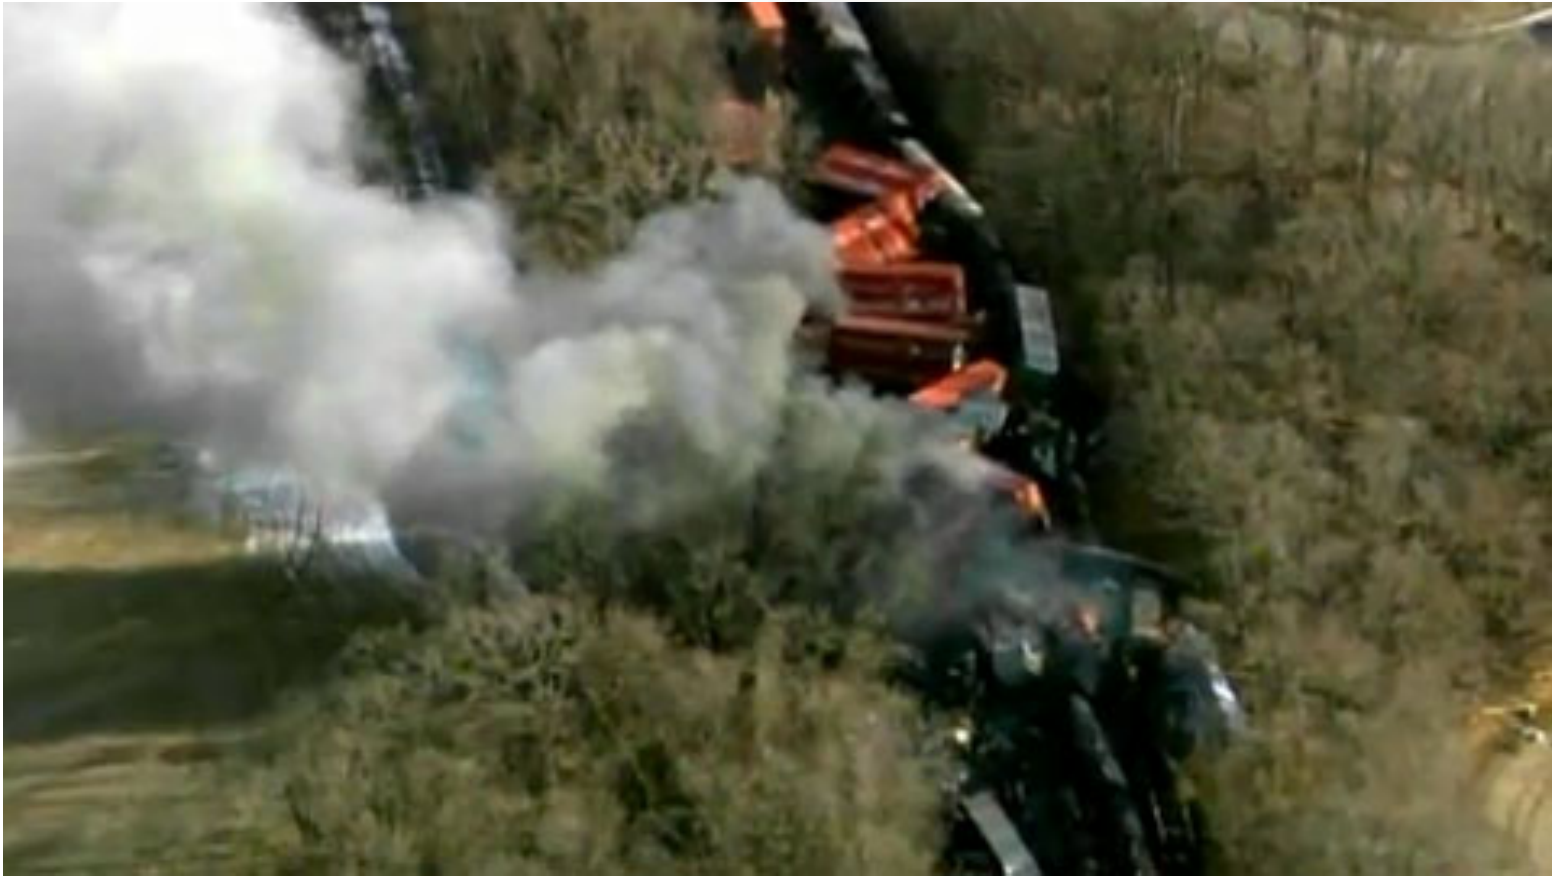
Three CSX trains collided in Northern Indiana

- In order to evaluate the crashworthiness of freight locomotives involved in the accident, inline collision between two trains was simulated using finite element method (FEM) and LS-DYNA software package that also included dummies for crew injury evaluation.
- The results of finite element analysis (FEA) revealed that the anti-climber and the collision posts of the lead EMD SD-70ACe locomotive functioned properly and met with their design objectives.
- The resulting crash forces acting on the collision posts were found to be of lower magnitudes than the permissible design limit values specified in the AAR Standard S-580, revision date 2004.
- The collision posts further prevented loss of occupant survival space in the cab of SD70 locomotive.
- The anti-climber contributed toward preventing override and therefore ensured safety of SD70 crew.

On January 9, 2012 three CSX trains collided in Northern Indiana and everyone survived. It is my understanding that the locomotives involved in this accident were all wide body enhance locomotives. It is nice to know that we all made a difference. It allowed the crews on these trains to go home to their families.

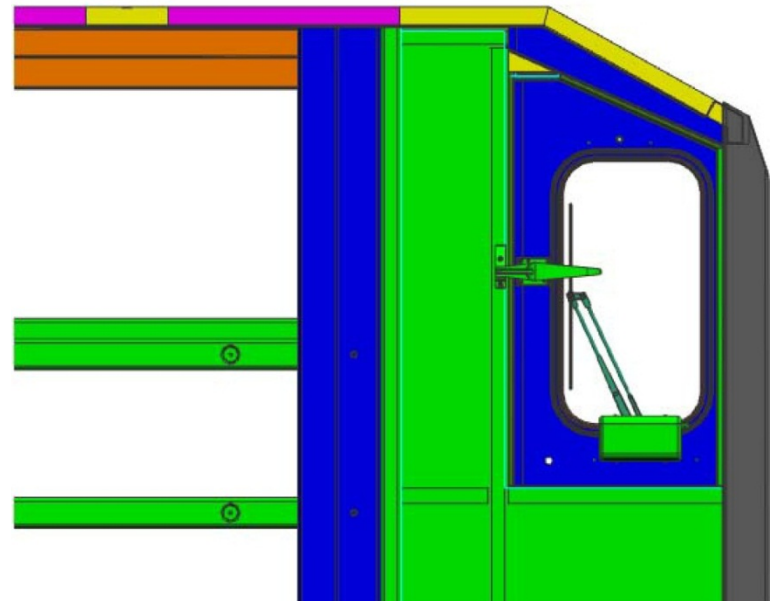
Escape Opening Width Door-To-Frame 19.5 in

- An emergency escape route can be designed into the left rear wall of the cab.
- The escape route will incorporate a ½ door mirror image of the right rear door
- The door will provide a 19 ½ inch wide escape route.
- The rear door window width will be reduced 2 inches to 13 ½ inches.
- An inside only release handle will be required.
- The wiper motor is relocated to the bottom of the door.
