## Full-Scale Locomotive Dynamic Crash Testing and Correlations: C-39 Type Locomotive Colliding with a Loaded Hopper Car (Test 7)

1. AGENCY USE ONLY (Leave blank)		2. REPORT DATE September 2011		3. REPORT TYPE AND DATES COVERED Technical Report
4. TITLE AND SUBTITLE Full-Scale Locomotive Dynamic Crash Testing and Correlations: C-39 Type Locomotive Colliding with a Loaded Hopper Car (Test 7)			5. FUNDING NUMBERS

9. SPONSORING/MONITORING AGENCY NAME(S) AND ADDRESS(ES) U.S. Department of Transportation Federal Railroad Administration Office of Railroad Policy and Development Washington, DC 20590			10. SPONSORING/MONITORING AGENCY REPORT NUMBER  DOT/FRA/ORD-11/16.III

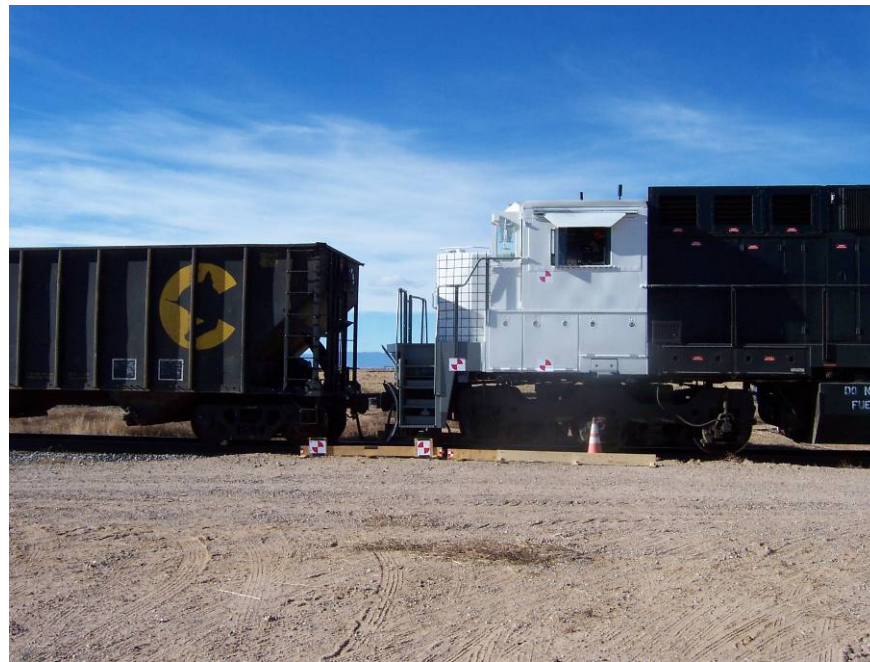
**Figure 9. Alignment of Locomotive and Covered Hopper Car at Point of Impact**

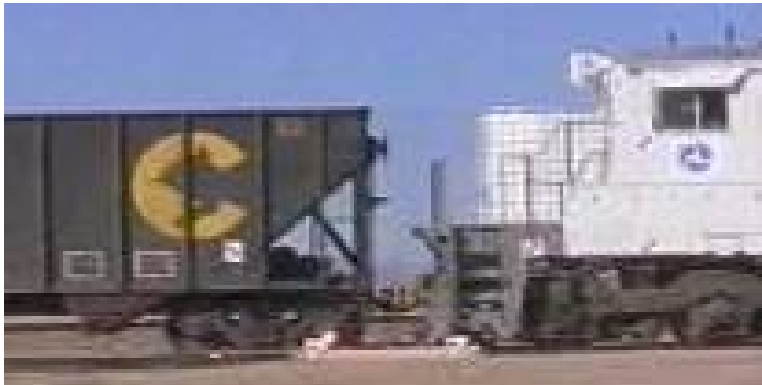
**Figure 10. Initial Contact of Collision**

The initial contact between the moving locomotive and the stationary hopper car occurred at the couplers. The draft gears then fully compressed and forced downward as the draft gear housings failed.

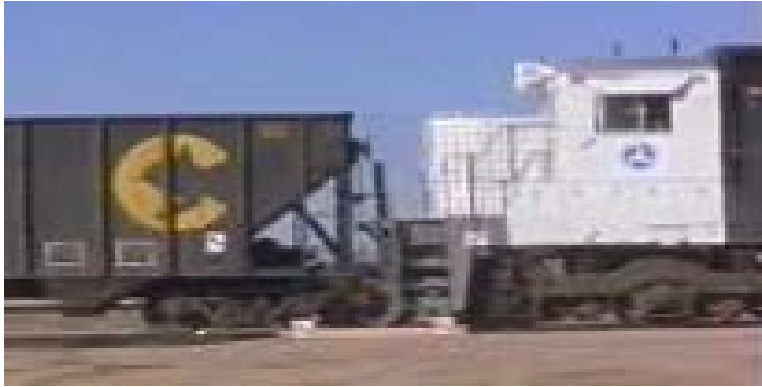
**Figure 11. Locomotive Coupler Failure**

The pilot plate was forced downward because of the coupler/draft gear movement, which in turn, deformed the locomotive underframe and compressed the suspension of the front bogie.

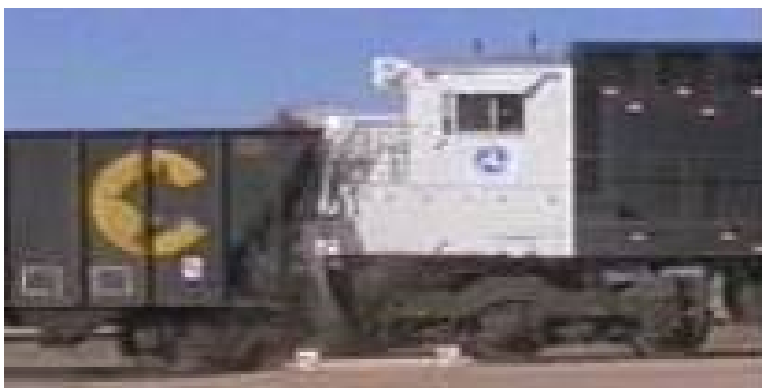
**Figure 13. Locomotive Intruded into Hopper Car**

Then, the locomotive nose pushed into the interior of the hopper car. The pilot plate, coupler/draft gear, and front bogie of the locomotive shoved the end of the hopper car toward the center of the car.

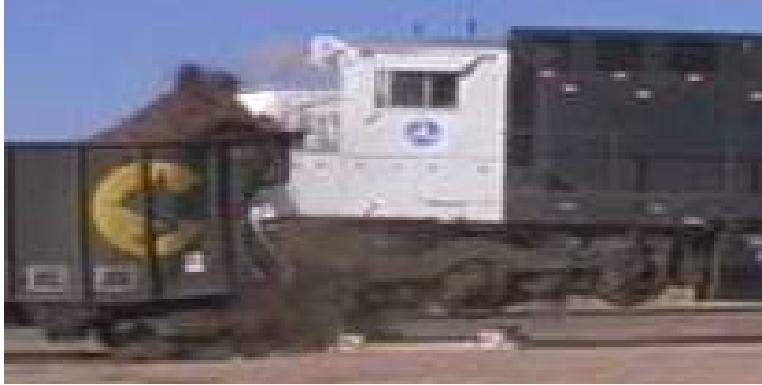
**Figure 14. Locomotive Began to Override Hopper Car**

The front of the locomotive began to rise because of the anticlimber and associated bracing overriding the hopper's car bogie and main sill.

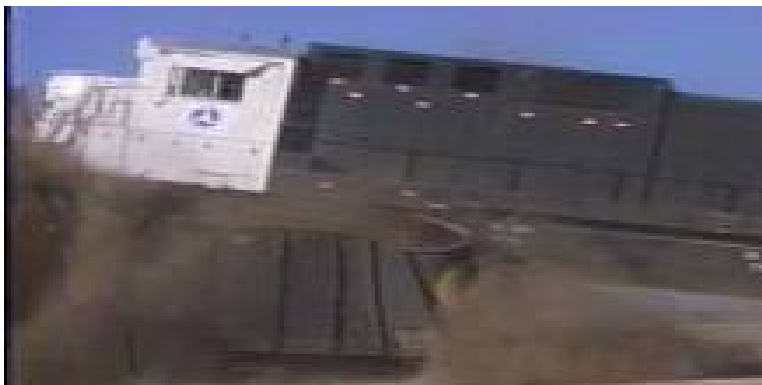
**Figure 16. Locomotive Came to Rest Atop Hopper Car**

The rear and side walls of the hopper car were destroyed as the locomotive moved into and above the hopper car. The fuel tank was breached during the collision.

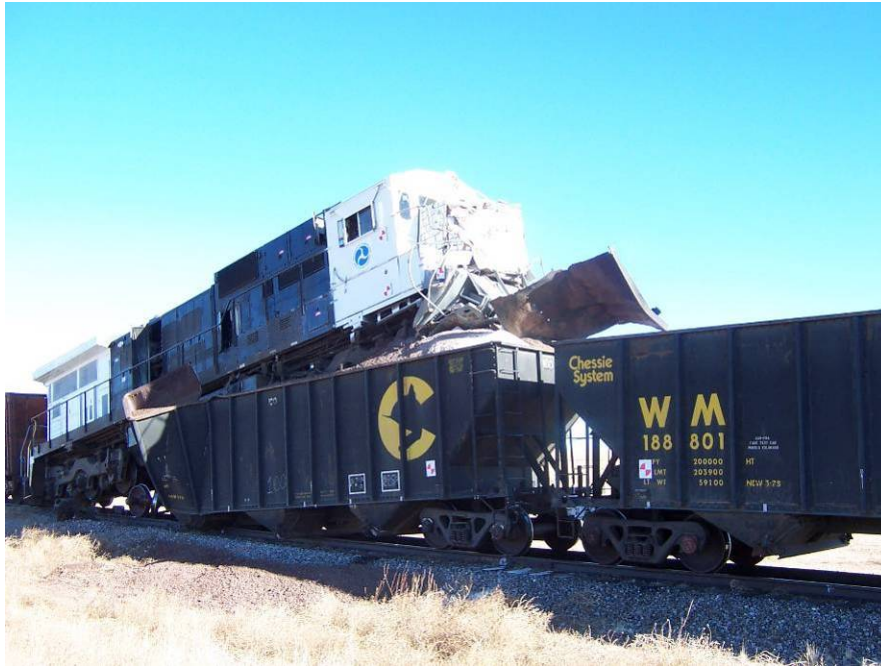
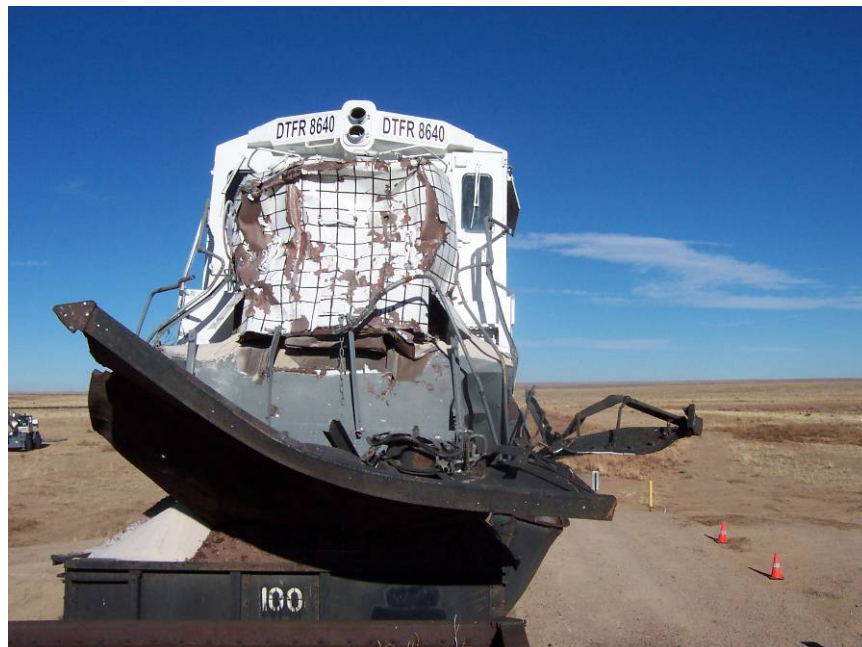
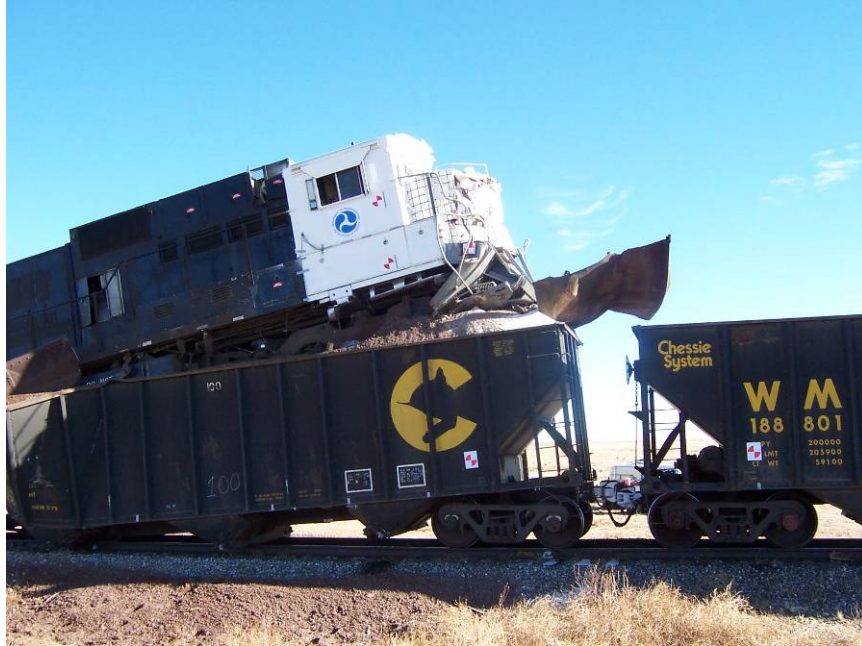
Figures 17–19 show the damages and final positions of the locomotive and the hopper car.

**Figure 17. Locomotive after Collision**

**Figure 18. Damage to Locomotive**

**Figure 19. Hopper Car after Collision**

- Damage to the locomotive front was massive in this test, including the draft gear pocket shearing off and the anticlimber failure. No intrusion into the cab occurred because of the locomotive override onto the hopper car.
- The locomotive fuel tank was breached during the override of the hopper car. This situation could result in a fuel spill, increasing the risks of a fire and a hazardous materials spill.
- In a similar previous test, under akin impact conditions between a SD-70MAC locomotive and a loaded hopper car consist and a stationary, loaded hopper car consist, the collision resulted in locomotive override. The collision posts in the SD-70 played no role once override took place.

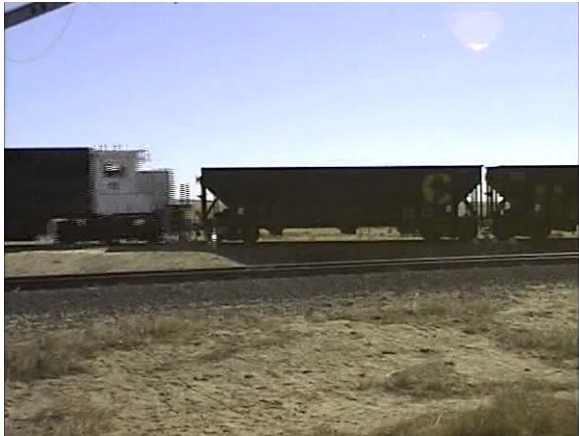
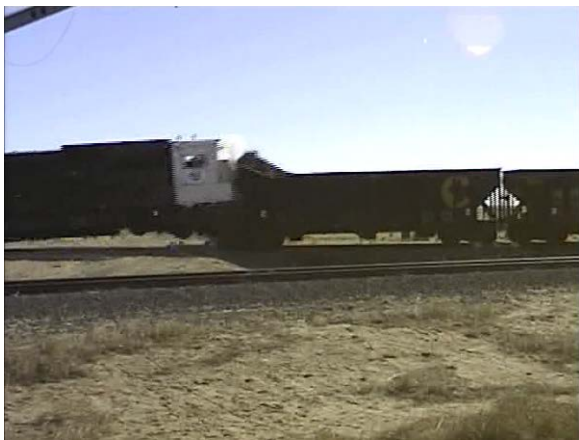
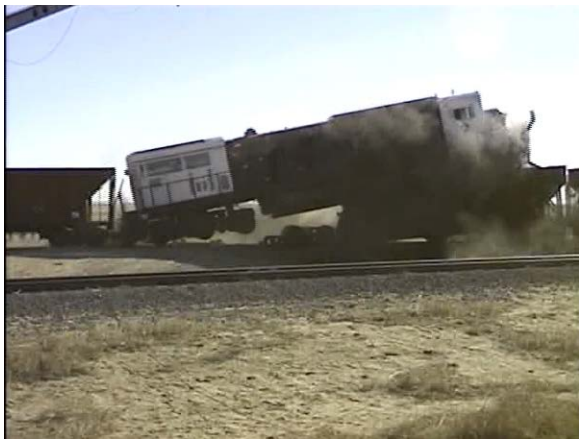
**Figure 20. Kinematic Comparison between Test and Simulation**

Figure 20 shows the dynamic sequence correlations between the test and the simulation captured at time equaling 0.06, 0.39, and 1.01 s. The dynamic sequence as captured from the high-speed video was in agreement with the simulations from the finite element analysis.

The agreement between the actual dynamic sequences (from high-speed video) and the finite element analysis simulation (computer generated) was reasonable as shown in Figure 20. The damages seen in the simulations were also in reasonable agreement.

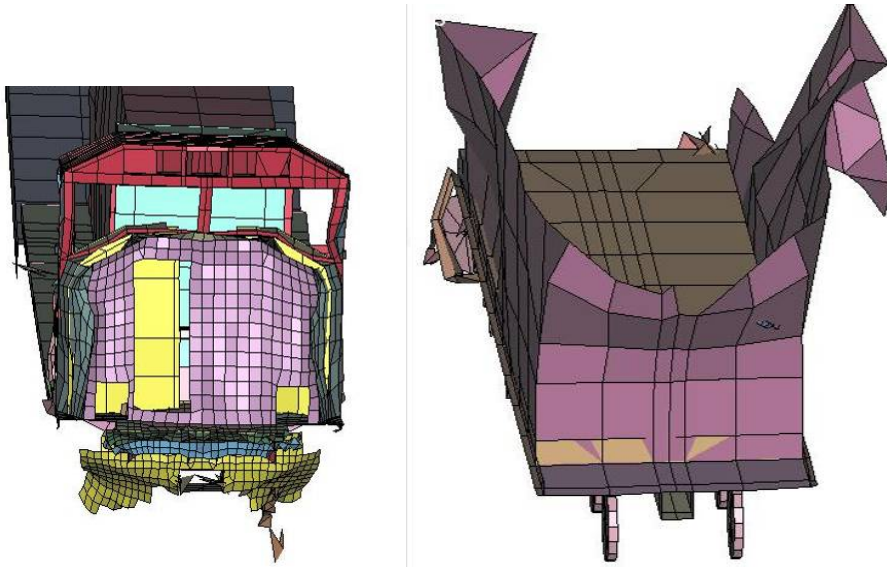
**Figure 23. Locomotive and Hopper Car Damage from Simulation**

Figure 23 illustrates the damage to the locomotive and hopper car from the simulated collision.

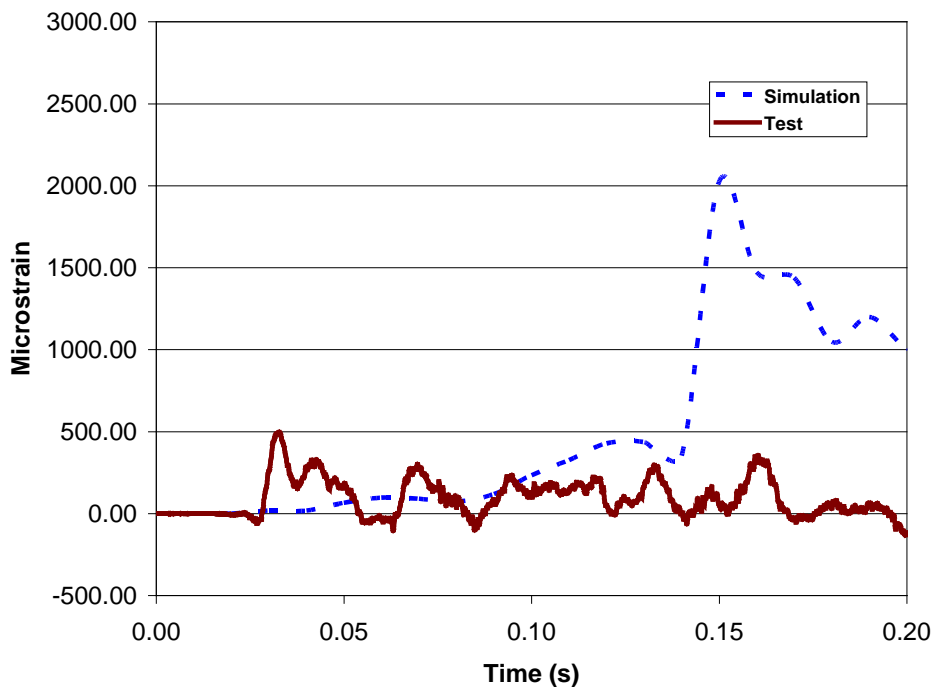
**Figure 26. Windshield Strain–Location 5**

Table 3 describes element locations and the identified strains chosen for correlation. Figure 26 and Figure 27 show the windshield strain correlations.

The largest measured strain on the windshield area was 200 microstrain and occurred on the right beam of the windshield (location 5).

The correlations between the simulation and the test used strain data for the center windshield posts of the locomotive. The underframe and windshield post did not suffer any significant damage from the collision.
