Side Impact Test and Analyses of a DOT-111 (CPC-1232) Tank Car

1. REPORT DATE *(DD-MM-YYYY)* October 2020	2. REPORT TYPE Technical Report		3. DATES COVERED *(From - To)* October 30, 2018
4. TITLE AND SUBTITLE Side Impact Test and Analyses of a DOT-111 (CPC-1232) Tank Car		**5a. CONTRACT NUMBER** DTFR53-11-D-00008	
		5b. GRANT NUMBER	
		5c. PROGRAM ELEMENT NUMBER

11. SPONSOR/MONITOR'S REPORT NUMBER(S) DOT/FRA/ORD-20/43

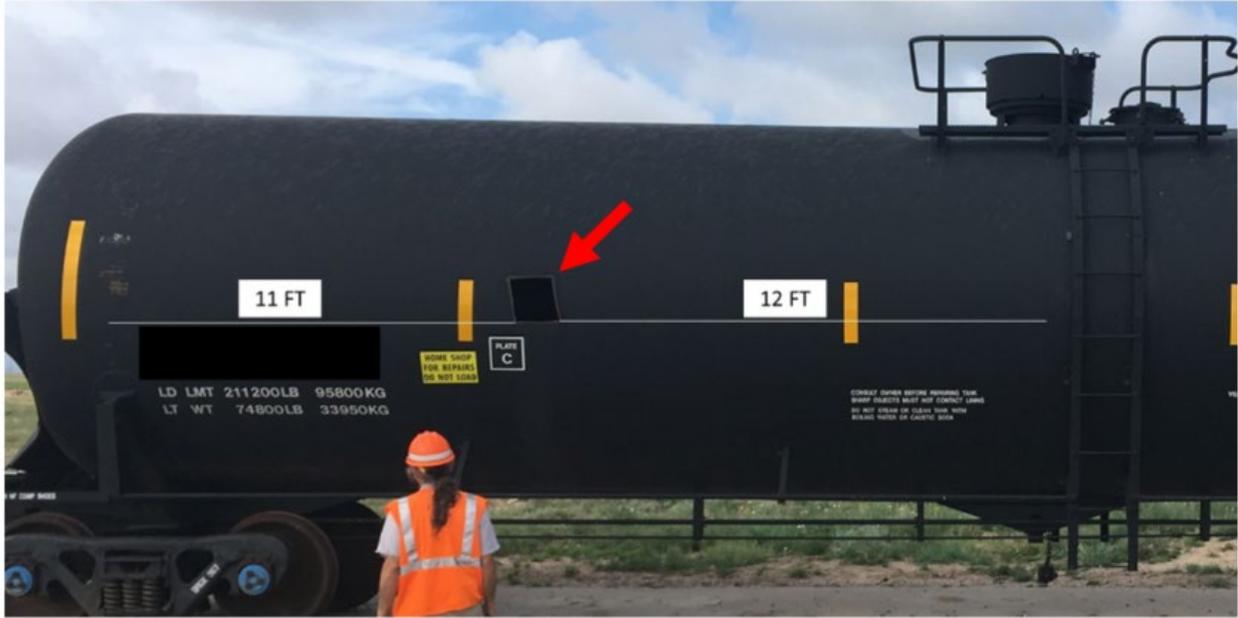
Figure 4. Location of Cutout in Tank Shell (see red arrow)

Figure 4 shows the tank car used for this test. This tank car had been involved in a derailment which resulted in significant damage to the tank head at the A-end of the car. To ensure the integrity of the test, a visual inspection and a magnetic particle scan of the head were performed. The inspections found no indication of cracks in the metal. In addition to the damage to the head, a small rectangular section had been cut out of the tank wall about halfway between the A-end of the car and the manway. This damage was repaired on-site, at the Transportation Technology Center (TTC) near Pueblo, CO. An oversized rectangular piece of 0.5-inch TC-128 Grade B steel plate, which had been rolled to match the inside diameter of the tank car, was purchased. The hole in the tank car was opened (red arrow in Figure 4) to match the dimensions of the patch, and

then the edges of the patch and the hole in the tank car were beveled to ensure complete weld penetration. The patch was welded in, and then the area around the weld was heat treated.

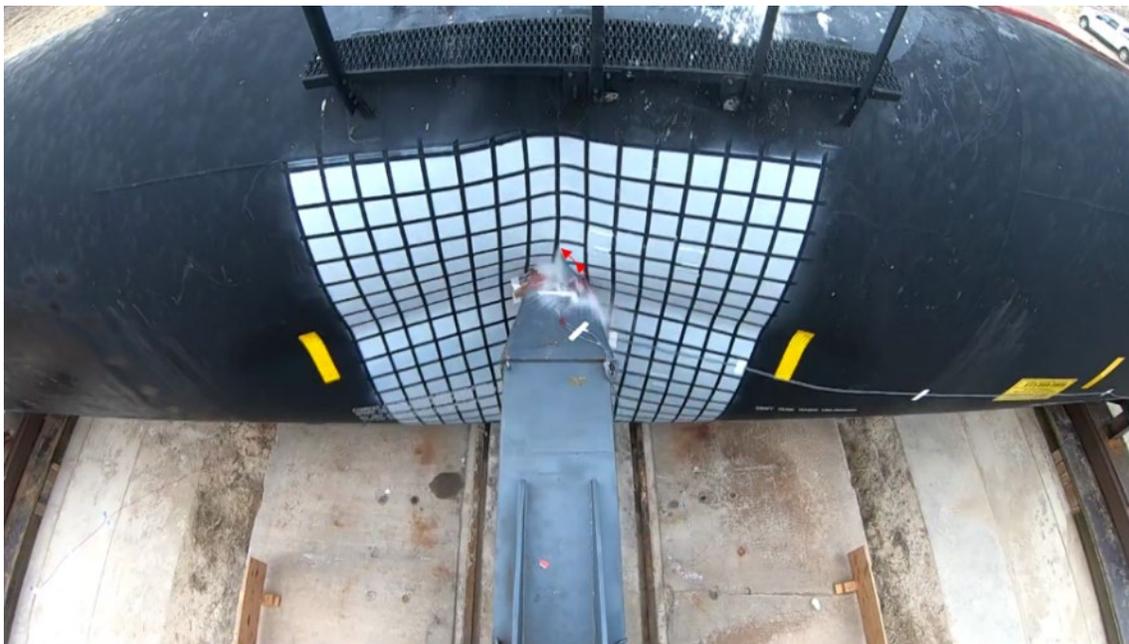
Figure 19. Subsequent Frame Extracted from Onboard Ram Car Video Showing Direction of Tear Propagation

A subsequent frame extracted from the video camera onboard the ram car (Figure 19) shows the crack had begun to propagate from the top-right corner. The crack was propagating inboard (toward the centerline of the car) and upward. A larger quantity of water is visible in this frame compared to the last extracted frame, as the now-pressurized tank shell propels water through the growing tear in the tank's shell.

Taken together, these video frames indicate that the puncture initiated in the base material of the tank car shell beneath the corner of the impactor, approximately 6 inches from the center weld. The presence of the weld did not appear to influence the initial puncture of the tank beneath the corner of the impactor. However, the presence of the weld did influence the propagation behavior of the crack once it had already formed.

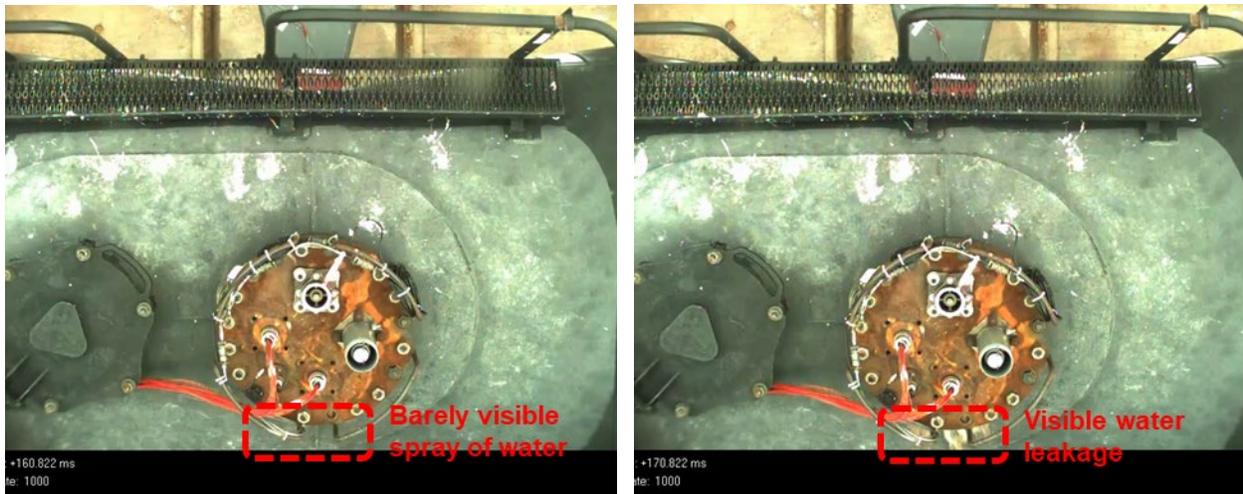
**Figure 21. Two Frames Captured from the Overhead HS Camera
at 160 ms (left) and 170 ms (right)**

Examination of the HS video showing the top fittings of the tank car revealed water leakage from three different locations at three different periods between impact and puncture. Beginning at approximately 160 ms, water visibly escaped from the gasket to the manway cover plate through which the valves are attached to the car. This leakage was observable until the cover plate begins to move out of the overhead camera's view starting at approximately 210 ms. Figure 21 shows two frames captured from the overhead HS camera where a barely visible spray of water is observed at 160 ms (left) and water leakage is clearly seen at 170 ms (right).

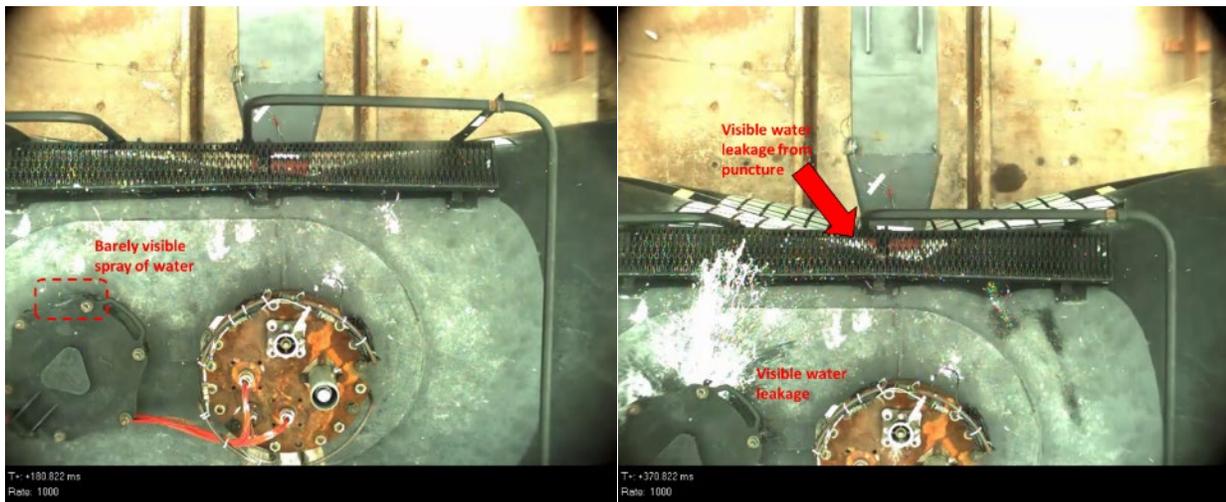
**Figure 22. Two Frames Captured from Overhead HS Camera
at 180 ms (left) and 370 ms (right) Showing Leakage from Bolted Manway**

Starting at approximately 180 ms, water was also observed to be escaping through the bolted manway. This manway leakage could be observed through the time of tank puncture at approximately 360 to 370 ms. Figure 22 shows a frame extracted from the HS video at approximately 180 ms on the left, and a frame taken at approximately 370 ms on the right. The frame on the right is also annotated to show the visible water leakage from the puncture under the corner of the impactor as previously described in Section 4.3.1.

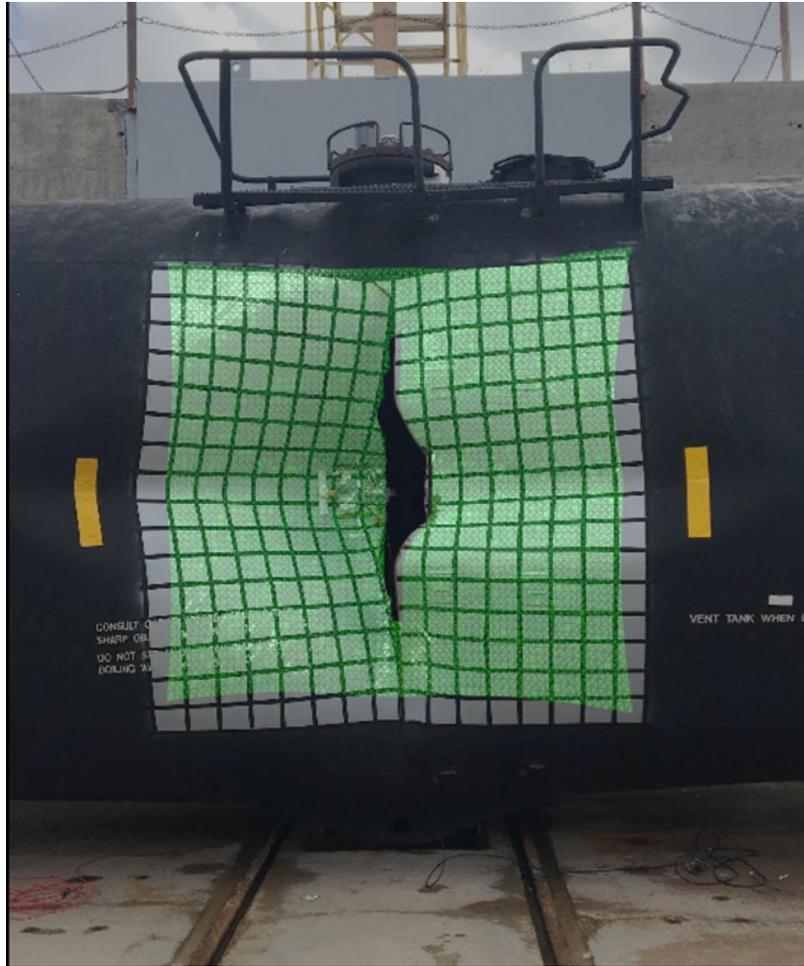
Figure 24. **Composite Image of Scan Geometry Overlaid on Photograph of Post-test Tank Car**

TTCI laser-scanned a surface of the tank car in the impact zone measuring approximately 8-foot by 8-foot. Scans were performed before and after the impact test. Figure 24 shows a composite image where the geometry from the scan was overlaid on a photograph of the punctured tank car to show the extents of the scan geometry. Figure 25 shows two exterior views of the deformed shape surface from the post-test geometry scan.

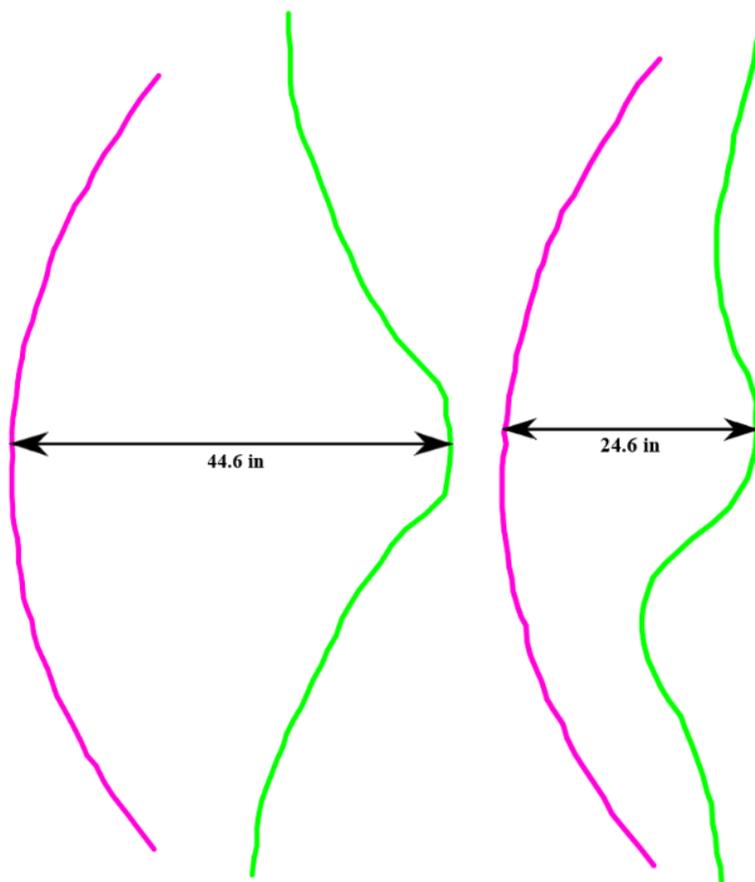
Figure 26. Comparison of Pre-test and Post-test Surface Scans—Cross-section at the Impact

Figure 26 shows a comparison of the cross-sections of the impact location from the pre- and post-test scans aligned using reference points located on the tank car. The image on the left corresponds to the section of the tank that was on the left side of the impact area, and the image on the right corresponds to the section of the tank that was to the right of the impact.

It is clear from the figure that the deformation of the shell is much larger to the left of the point of impact. This is also apparent in the post impact picture of the tank car (Figure 16) above. The reason for this difference was the way in which the tank tore during impact. The section of the tank under the right edge of the impactor sheared, allowing the impactor to slide by. The left side, which was still in contact with the impactor, remained intact, resulting in that side undergoing more deformation. The maximum permanent (plastic) deformation on the impact surface was approximately 44.6 inches.

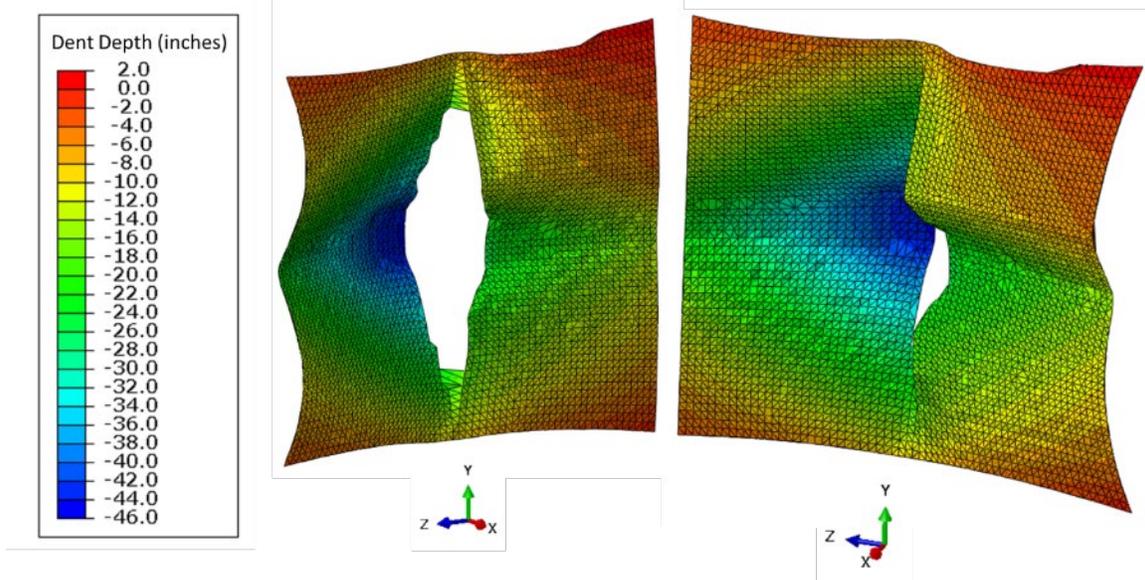
Figure 27. Two Views of Deformed Shape Surface from Post-test Scan with Overlaid Contours of Residual Dent Depth

between the X-coordinate in the deformed point cloud and the calculated X-coordinate on the surface of the undeformed tank equals the depth of the dent at that point. These dent depths were then overlaid onto the scan geometry using the Abaqus/CAE preprocessor to import the dent depth values as an analytical field.[2] Figure 27 shows two views of the deformed tank scan with overlaid contours of residual dent depth.

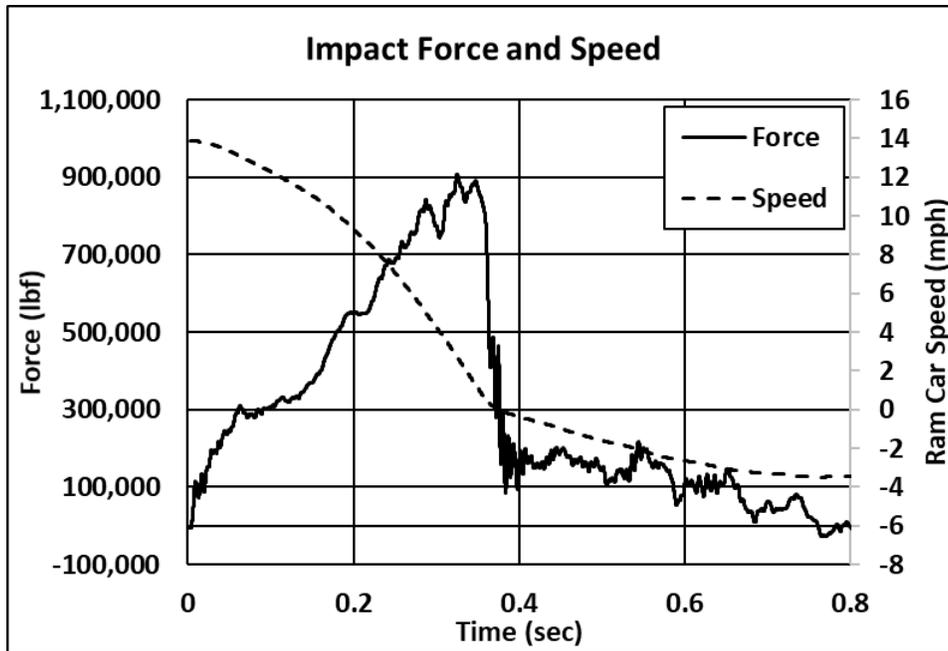
Figure 29. Impact Force and Ram Car Speed

The ram car velocity-time history in the test was calculated by integrating the average longitudinal acceleration of the ram car and using the impact speed measurement as an initial condition. Contact forces between the ram and target tank car were calculated as the product of the average acceleration and the mass of the ram car. Figure 29 shows both the force-time and velocity-time histories, where negative velocity is the speed of the rebounding ram car. This data shows that the ram car was traveling at less than 1 mph at the time of the force drop that corresponds to puncture.

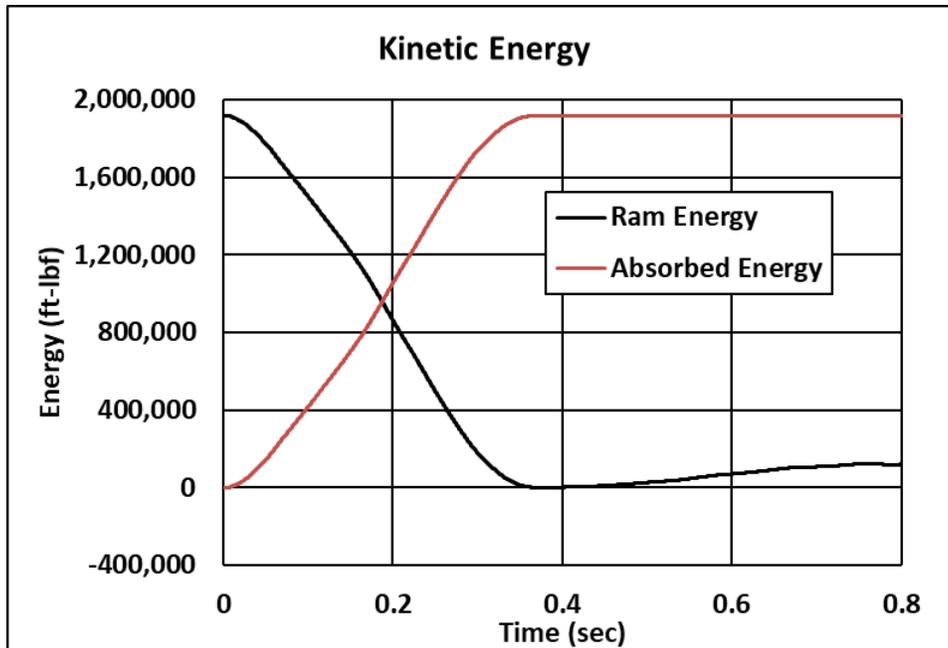
Figure 30. Kinetic Energy

Similarly, the kinetic energy of the ram car was calculated from its speed-time history and weight. Figure 30 shows the kinetic energy time history of the ram car and energy absorbed by the tank car. The energy absorbed by the tank car was capped at the time when the puncture occurred at approximately 0.36 second.

The total kinetic energy of the ram car was approximately 1,917,000 ft.-lbf and the energy absorbed by the tank car before puncture 1,913,000 ft.-lbf. The difference between the initial kinetic energy and the energy absorbed by the tank before puncture was only 4,000 ft-lbf of excessive energy, or

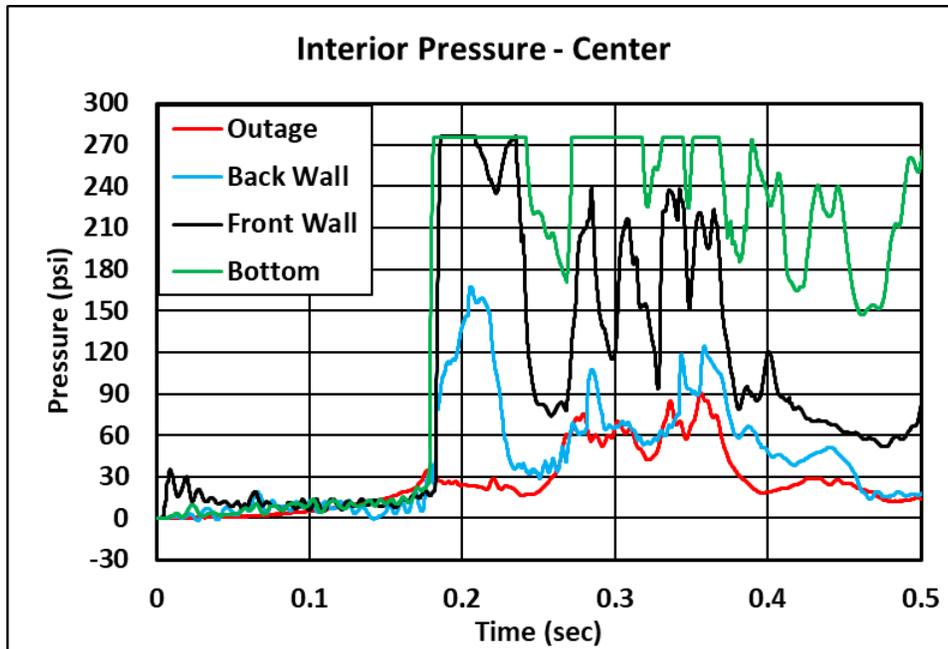
Figure 31. Pressure Data Measured at the Center of the Tank Car

Figure 31 shows pressure data from the center of the tank car (i.e., transducers TP3090 shown as Back Wall, TP3180 shown as Bottom, TP3270 shown as Front Wall, and TPMH shown as Outage). At about 0.18 second there was a sudden jump in the readings from several of the pressure transducers. Due to the tank's "ovalization" (i.e., increase in tank diameter at the top and bottom as a result of indentation on the side) upon impact, a gap formed between the back of the car and the support wall. By approximately 0.18 second, the car was pushed back and impacts against the support wall. While most of the pressure transducers recovered, TP3180 (center Bottom) and TP3270 (center Front Wall) appeared to have been permanently damaged by the shock of the impact. It is believed that the test car's lack of a jacket and insulation contributed to the severity of the response, because a jacket and insulation would have absorbed part of the energy of the collision and would have reduced the severity of the shock to the tank.

Prior to puncture, the overall pressure in the tank rose to about 80 psi. Additionally, the sloshing motions of the water in the tank created local pressure variations of up to 60 psi.

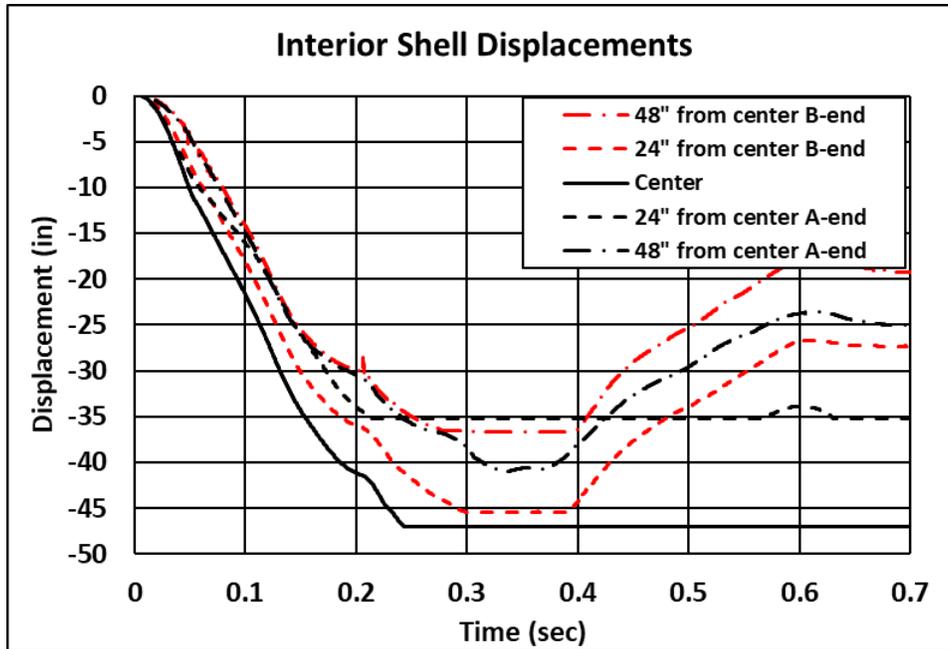
Figure 32. Internal Displacements

Figure 32 shows the measured displacements for the tank internal string potentiometers (DY1Y through TD5Y). Note that all but one of the string potentiometers reached the limit of their range before the longitudinal crush deformation reached its maximum. Larger-range string potentiometers were not available for this test. TD5Y (48 inches from center A-end) was the only string potentiometer to provide a complete record of the longitudinal crush displacements. TD3Y (Center) and TD4Y (24 inches from center A-end) appeared to have been damaged. The data from TD1Y (48 inches from center B-end) and TD5Y (inches from center A-end) indicated that tank deformation was greater on the side of the tear in the tank wall toward the B-end, which was also evident in the post impact photos of the tank car. Figure 33 shows the vertical tank deformation during impact recorded by TD3Z. There does not appear to have been any problems with this channel.

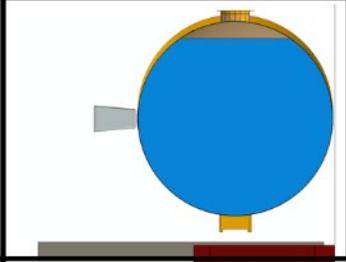
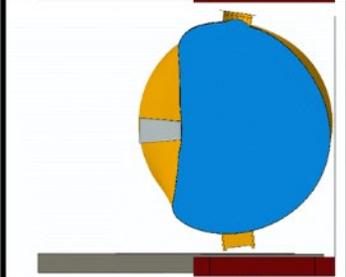
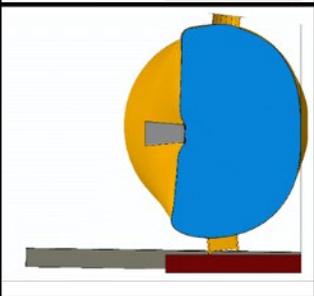
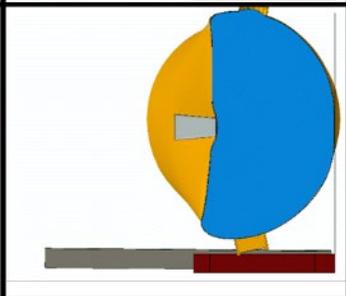
Figure 48. Side View of Impact Progression, Post-Test FE Models with Sealed Tank (left) and Open Tank (right)

Figure 48 shows three side cut frames from the impact progression spaced 0.125 seconds apart for both post-test FE models. The open tank FE model had a visibly larger amount of deformation, and the water swelled higher due to the lack of a pneumatic cavity. In the sealed tank FE model, the pneumatic cavity pushed back against the water surface resulting in a stiffer overall response. From both FE models, it is apparent that the water has been displaced up into the manway by 0.125 seconds. This response is consistent with the test observations, where water was visibly escaping the cover plate by approximately 0.160 seconds (see Section 4.3.2).

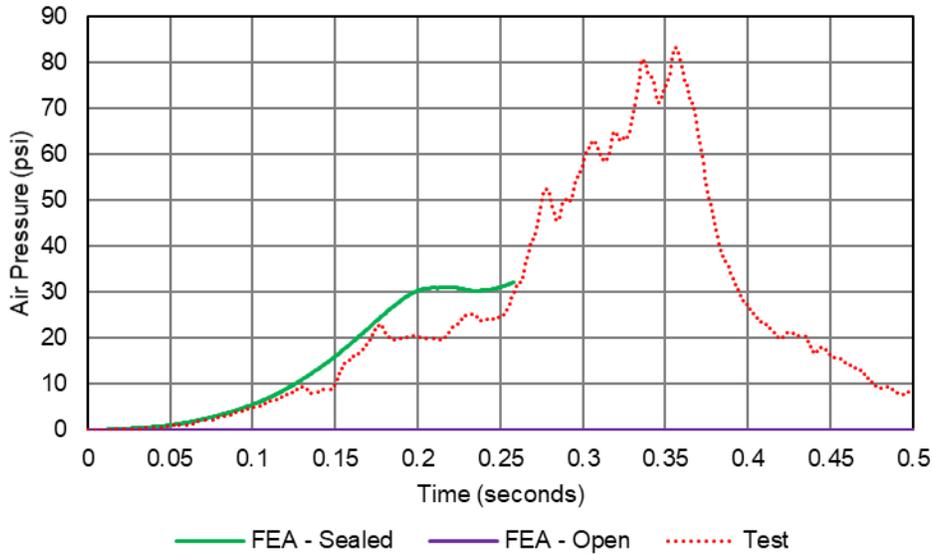
Figure 49. Outage Air Pressure vs. Time, Post-Test FEA with Sealed and Open Tank and Test Measurement Data

Figure 49 is a plot of the average air pressure within the outage of the DOT-111 tank car measured during the test compared with the sealed and open tank post-test FE models. The open tank FE model has a constant pressure of 0 psi because the pneumatic cavity representing the air has been removed. The sealed tank FE model agrees with the test results up to approximately 0.13 seconds of impact time. The discrepancy after 0.13 seconds is attributed to leakage of air and water through the manway seal (see Figure 21). While water leakage was not observed in the HS video until 0.16 seconds, it is reasonable to infer that air was able to leak out of the manway earlier.

Overall, the post-test FE results with the open tank model were in better agreement with the peak test measurements than the closed tank FE model. Neither FE model captured the air pressure response from the test (see Figure 49) because the observed leakage of air and water out of the tank's manway was not modeled. It should be noted that all the longitudinal string potentiometers, except for one 48-inch offset string potentiometer (TD5Y), reached their measurement limits, and thus they did not capture the actual peak displacements in the tank.

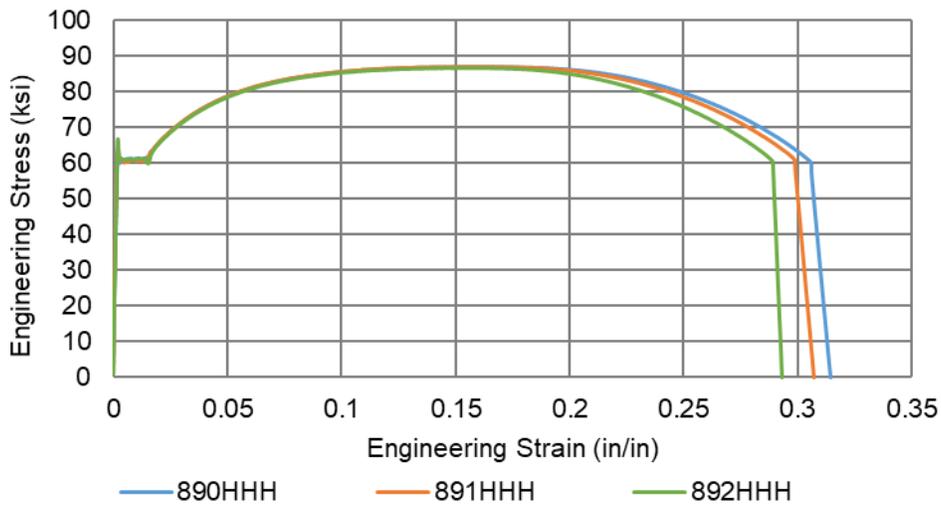
Following the test, material coupons were excised from the tested DOT-111 tank car and sent off for tensile testing. The material was cut into 1.4-inch gage length smooth round bars for tensile testing. The results of the tensile tests are included in Section B4. Additionally, the raw stress-strain data was provided to Volpe for use in developing a material response for the material in the tested tank car. Figure F8 contains a plot of the three-nominal stress-strain responses from the tested tank car. The straight lines at the end of each curve represent linear interpolation from the last data point measured by the load cell and extensometer to the reported EB from the test lab.

Figure F8. Smooth Round Bar (1.4-inch gage length) Test Results of Three Samples Extracted from Tested DOT-111 Tank Car

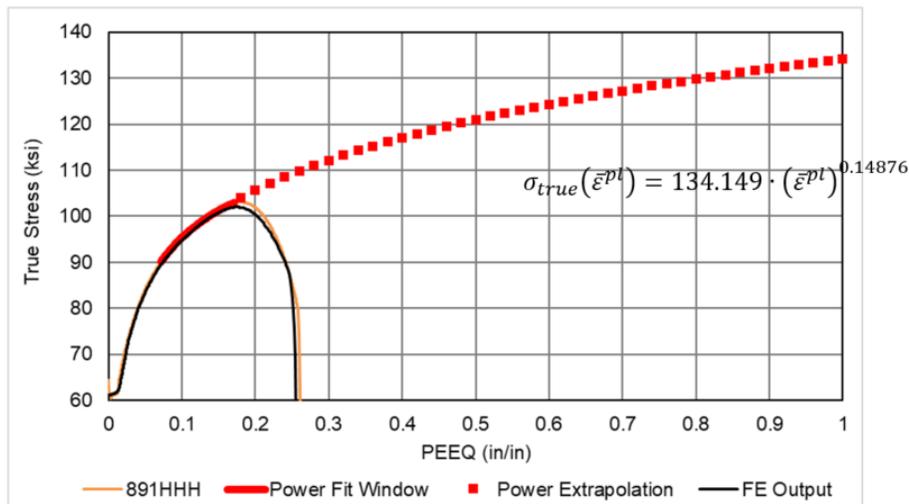
The start of the window was adjusted manually until the extrapolated plasticity input curve resulted in an output from the tensile coupon FE model that accurately represented the necking behavior observed in the test data. Figure F9 shows: (1) the calculated true stress-strain curve from tensile coupon 891HHH, (2) the windowed test data where regression was applied, (3) the extrapolated plasticity using the power fit equation, and (4) the calculated true-stress strain response from the tensile coupon FE model, which can be compared with the test data.

Figure F9. Calculated True Stress-Strain Characteristic of a Post-Test Tensile Coupon 891HHH (solid orange), Power Fit Window (solid red), Power Law Extrapolation (red squares), and FE Results (solid black)

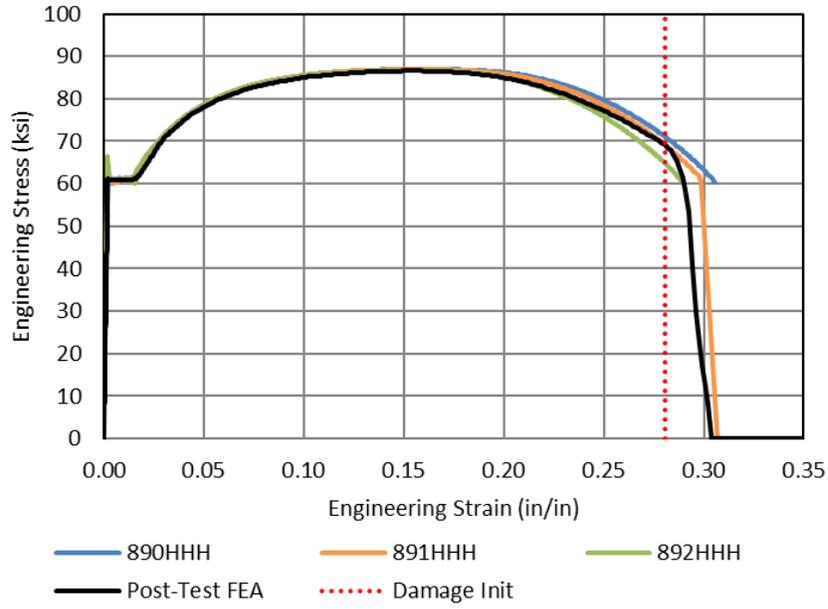
Figure F12 shows the engineering stress-strain response from a simulation of a uniaxial tension smooth round bar simulation with a 1.4-inch gage length. By comparing the simulation result (solid black line) with the uniaxial test results (solid color lines), it was observed that the true stress-PEEQ input resulted in an engineering stress-strain output that agreed with the test data up to crack initiation, and the quick calibration procedure resulted in a suitable threshold for damage initiation (dashed red line).

Figure F12. Engineering Stress-Strain Response from the Post-Test Smooth Round Bars (1.4-inch gage length); FE Model (solid black); Test Data for Comparison (solid colors); FE Model Damage Initiation also Shown (dashed red)
