A Feasibility Study on Advanced Nondestructive Evaluation (NDE) Methods to Characterize Weld Defects in Railroad Tank Cars

DOT/FRA/ORD-23/02

Final Report | January 2023

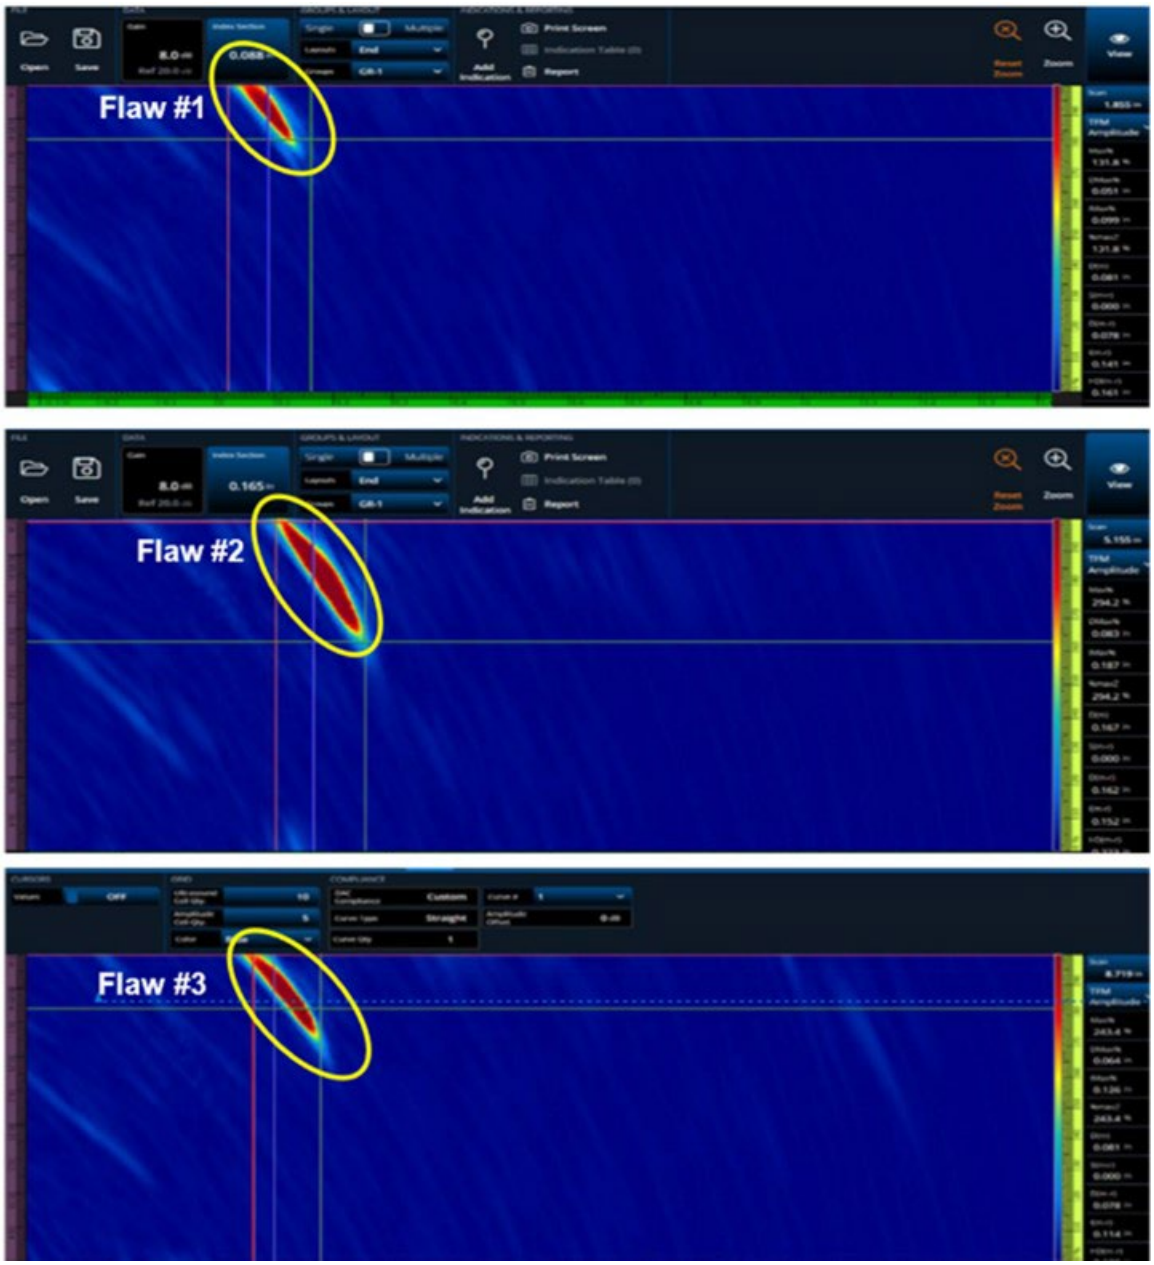
Figure 13. FMC/TFM indication of all three flaws in the MG-13 plates

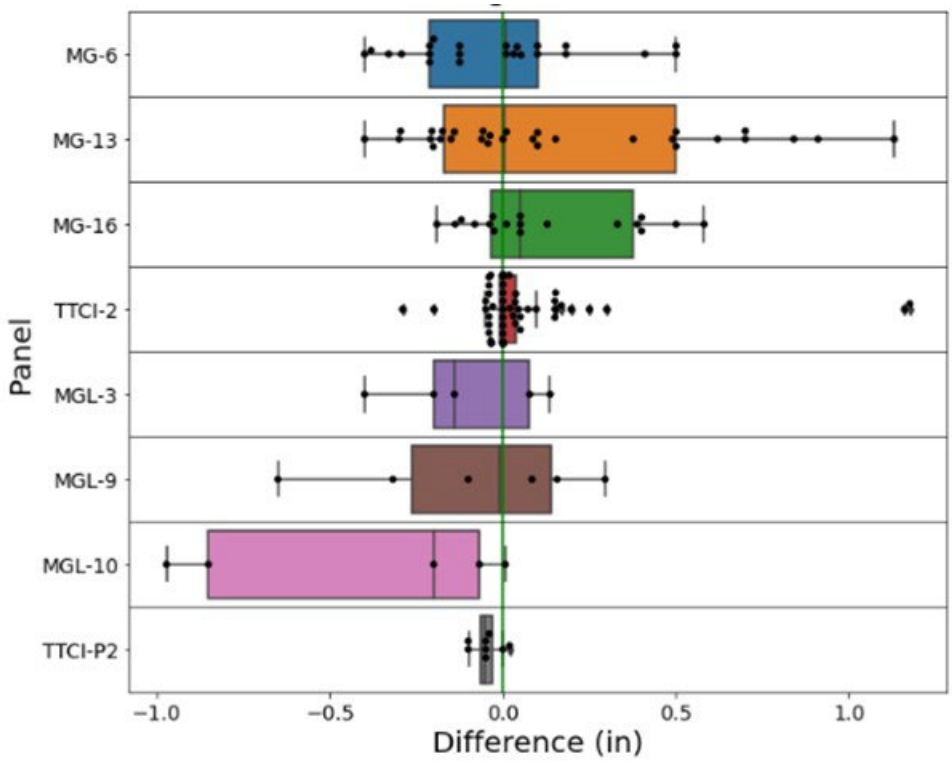
Figure 29 shows the notch length difference results similar to Figure 28 but grouped instead by MG panel. TTCI-2 had a median closest to zero with most of the data close to the median. Most other MG panels have medians at zero difference but with more variation (larger Q25-Q75 box). The top four MG panels contained butt welds and the bottom four contained fillet welds. The largest differences for NDE methods that measured the crack long (longer than +0.5 inch) occurred for panels with butt welds. The smallest differences for NDE methods that measured the crack short (shorter than -0.5 inch) occurred on the panels with fillet welds.

Figure 29. Crack/notch length difference by test panel

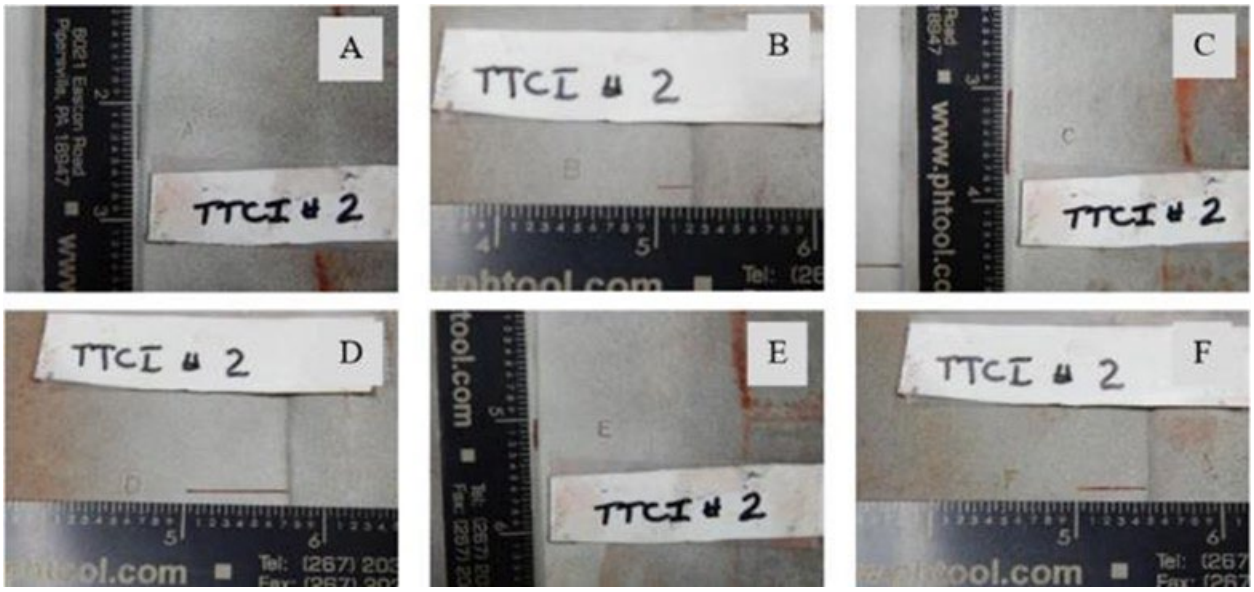
Figure 1. TTCI-2 EDM notch butt weld mg panel

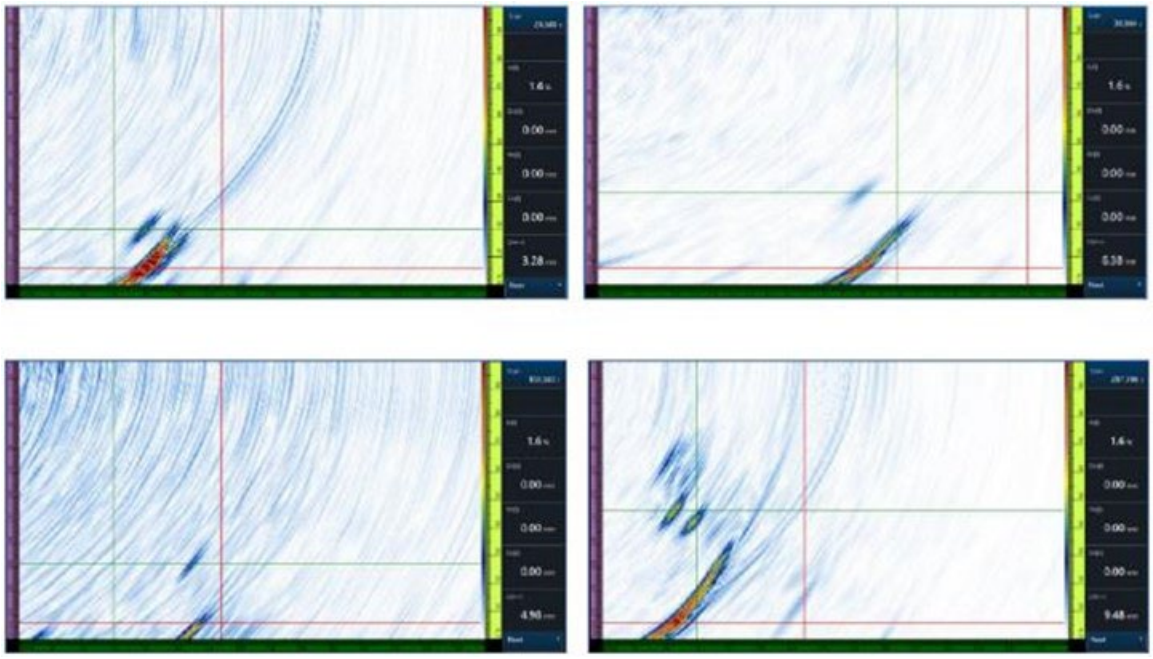
Figure 6. FMC/TFM Results showing the indication of the embedded defects in different test panels

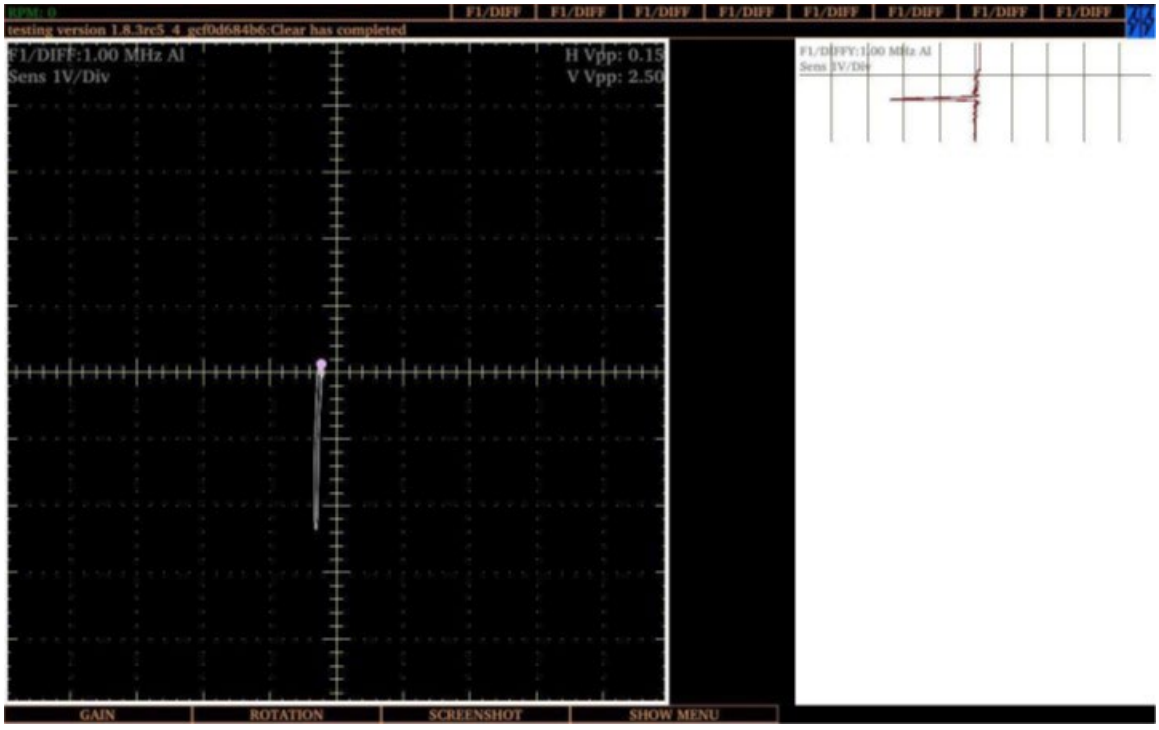
Figure 33. ET indication of defect at Location B in butt weld test panel TTCI-2

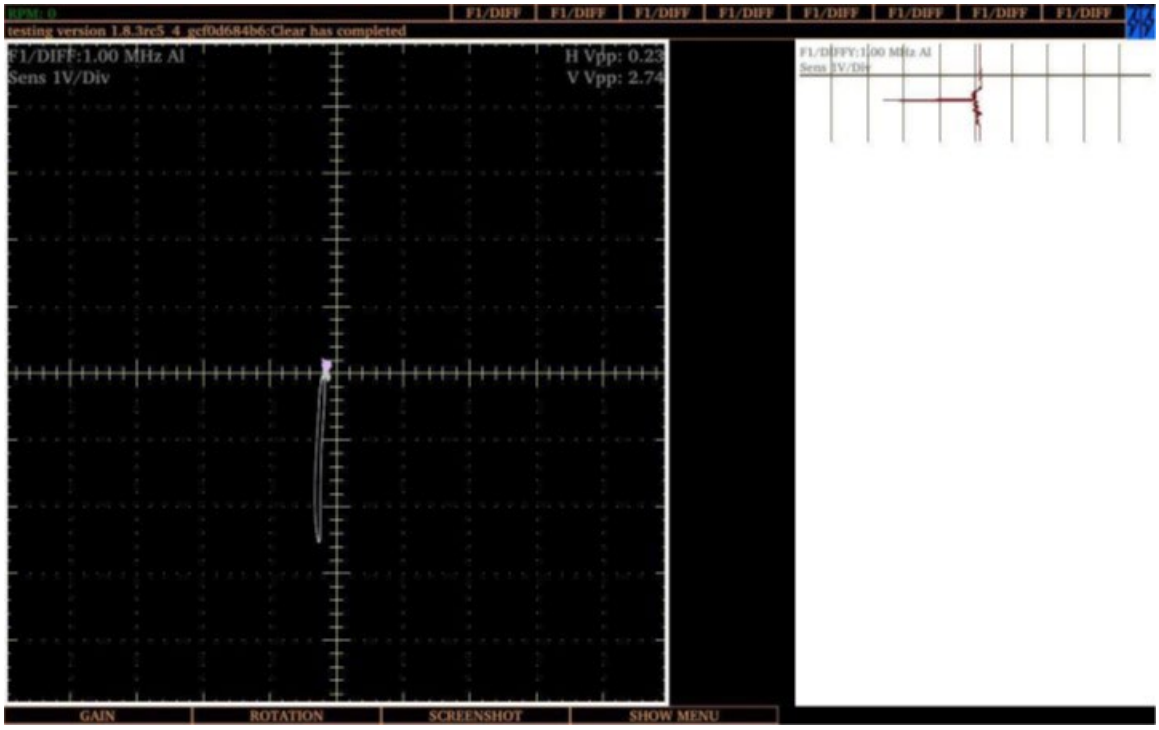
Figure 37. ET indication of defect at Location F in butt weld test panel TTCI-2

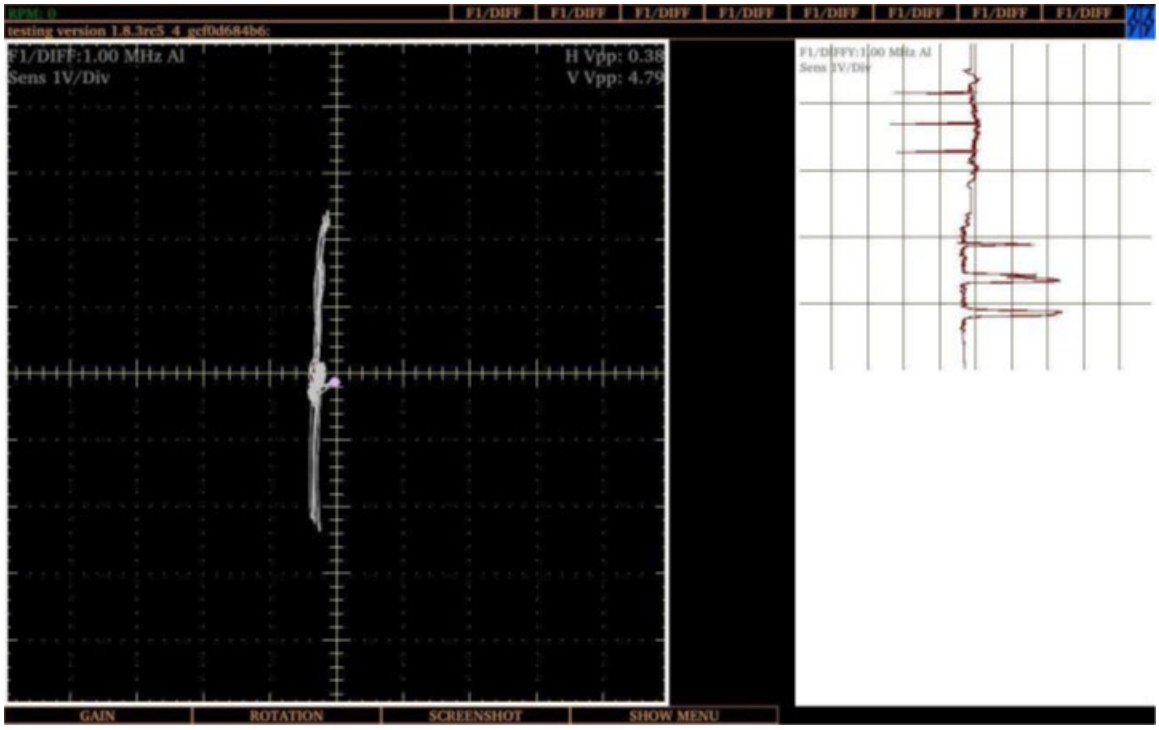
Figure 38. ET indication of all the notches in butt weld test panel TTCI-2

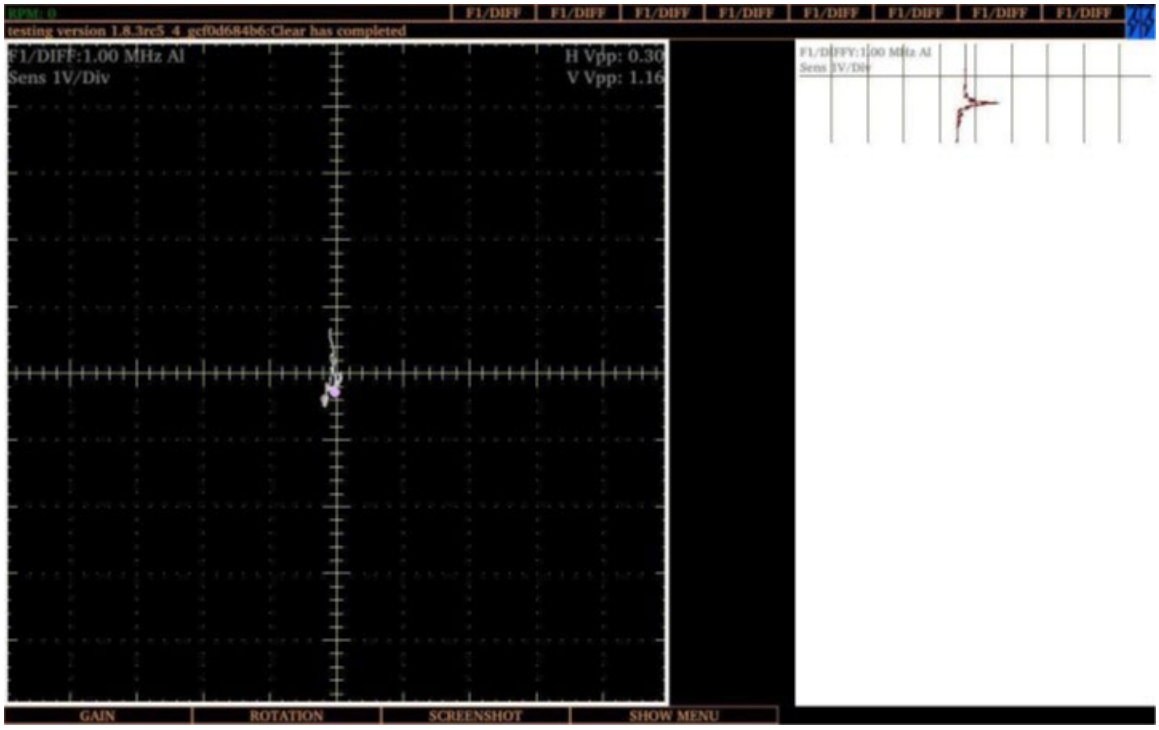
Figure 39. ET indication of defect at Location 1 in butt weld test panel MG-6

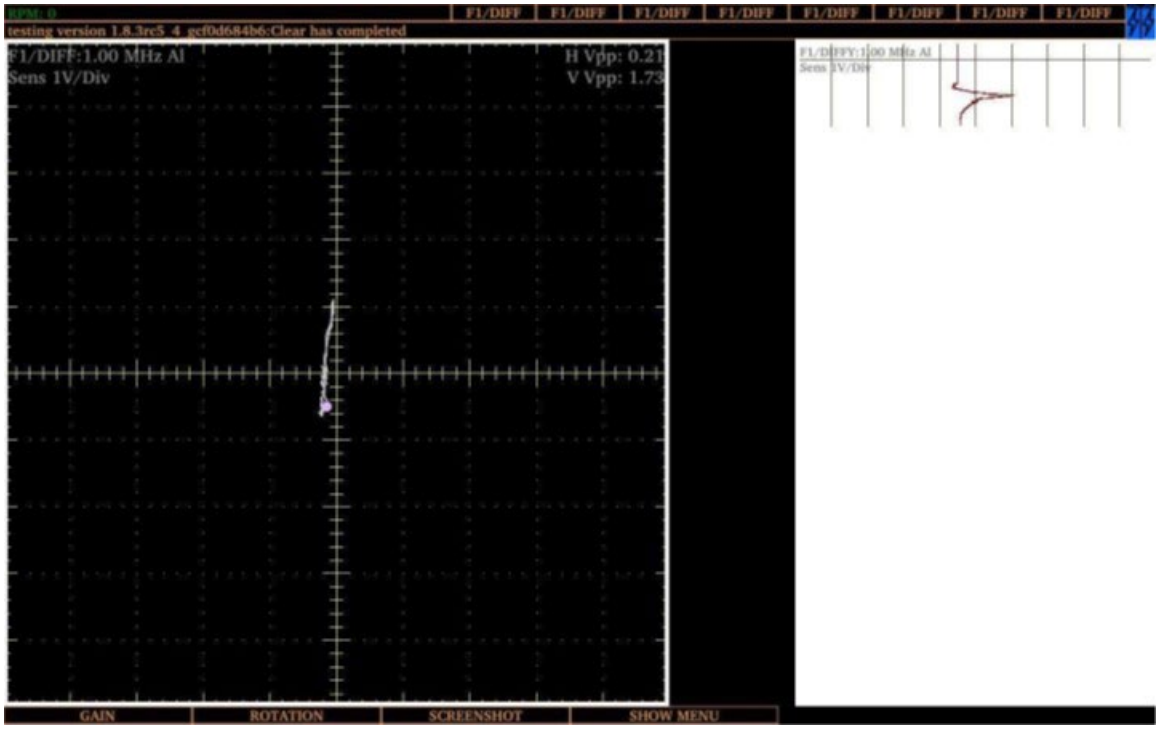
Figure 40. ET indication of defect at Location 2 in butt weld test panel MG-6

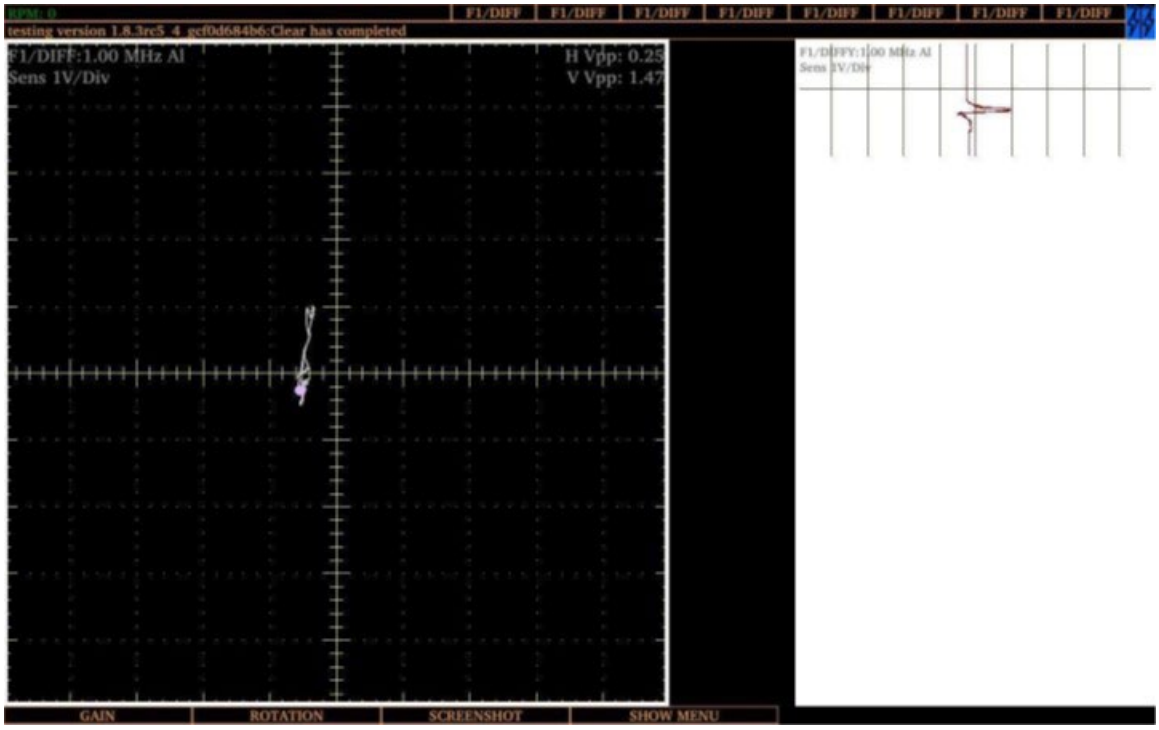
Figure 42. ET indication of defect at Location 1 in butt weld test panel MG-13

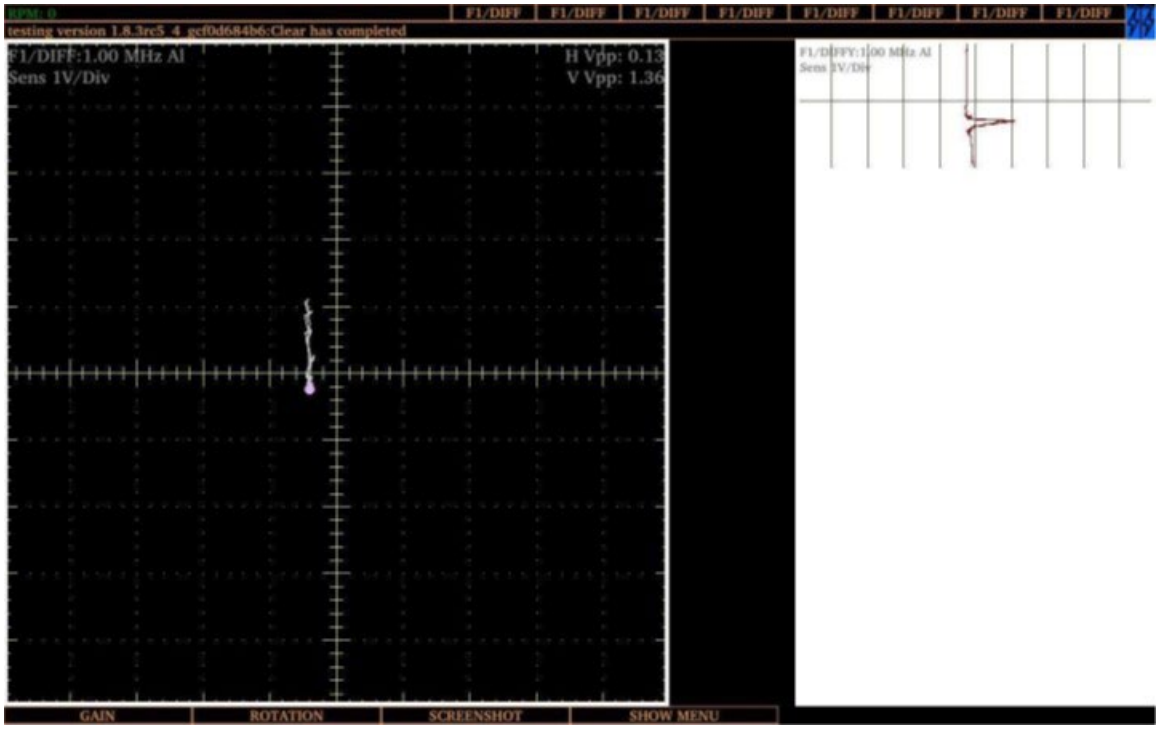
Figure 43. ET indication of defect at Location 2 in butt weld test panel MG-13

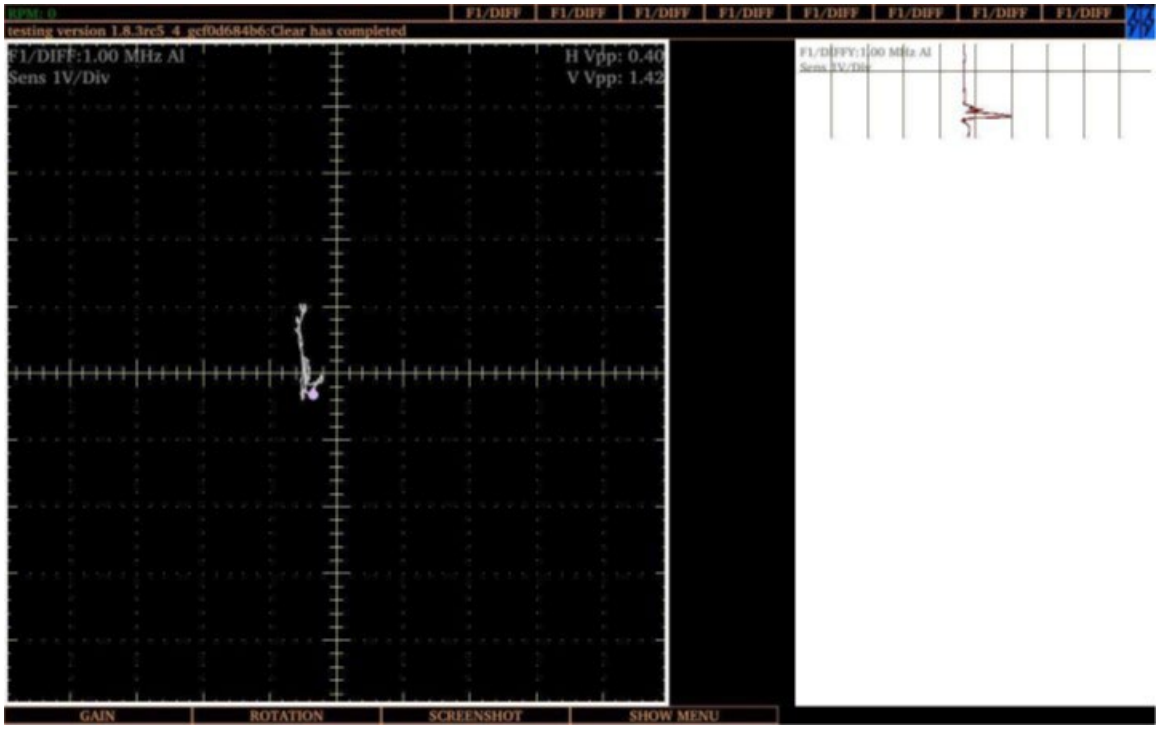
Figure 44. ET indication of defect at Location 3 in butt weld test panel MG-13

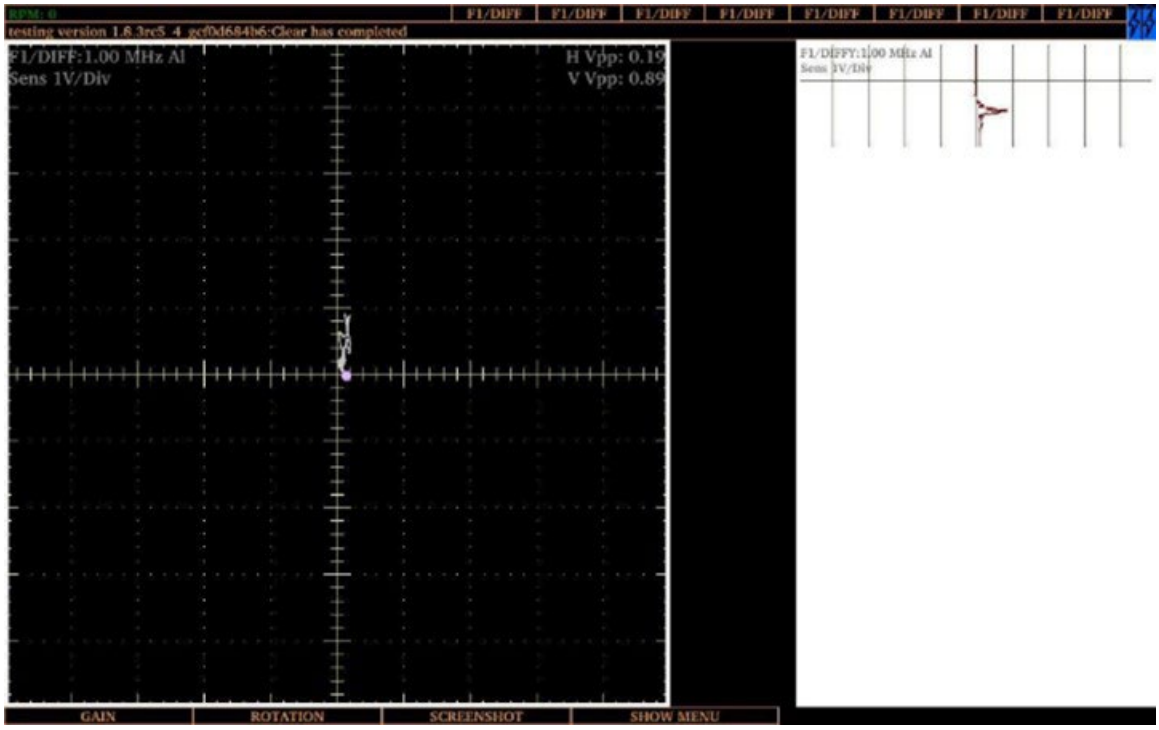
Figure 45. ET indication of defect at Location 1 in butt weld test panel MG-16

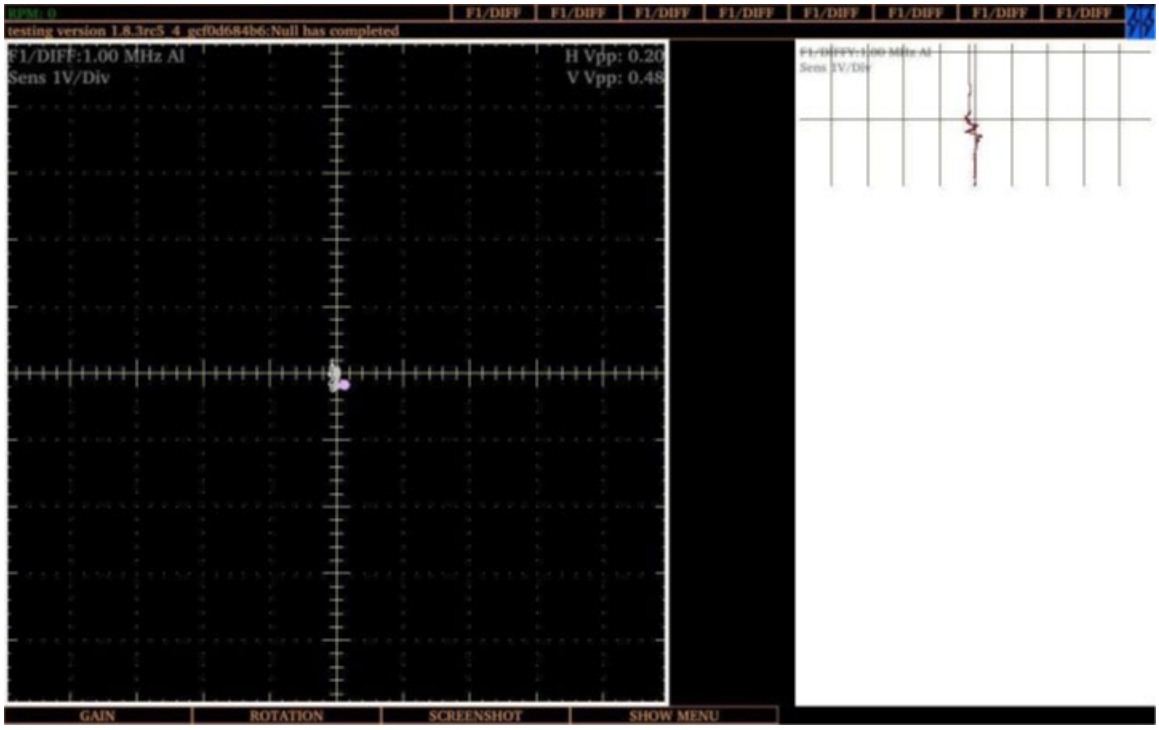
Figure 46. ET indication of defect at Location 2 in butt weld test panel MG-16

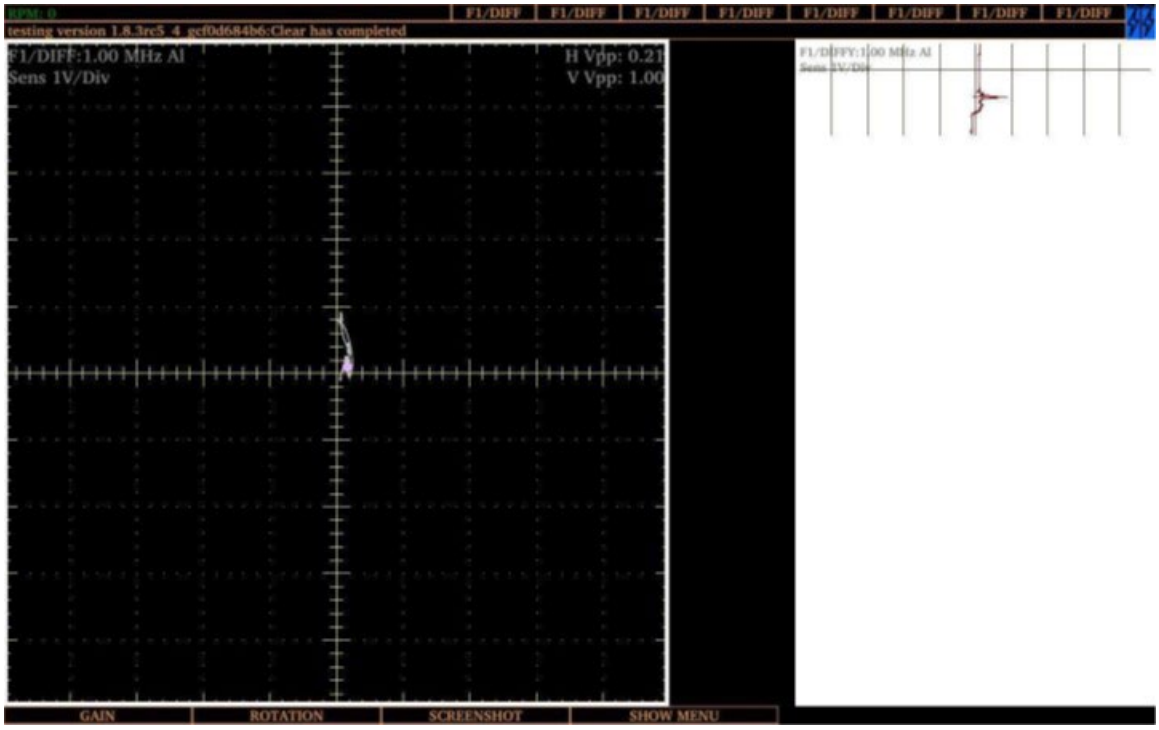
Figure 47. ET indication of defect at Location 3 in butt weld test panel MG-16

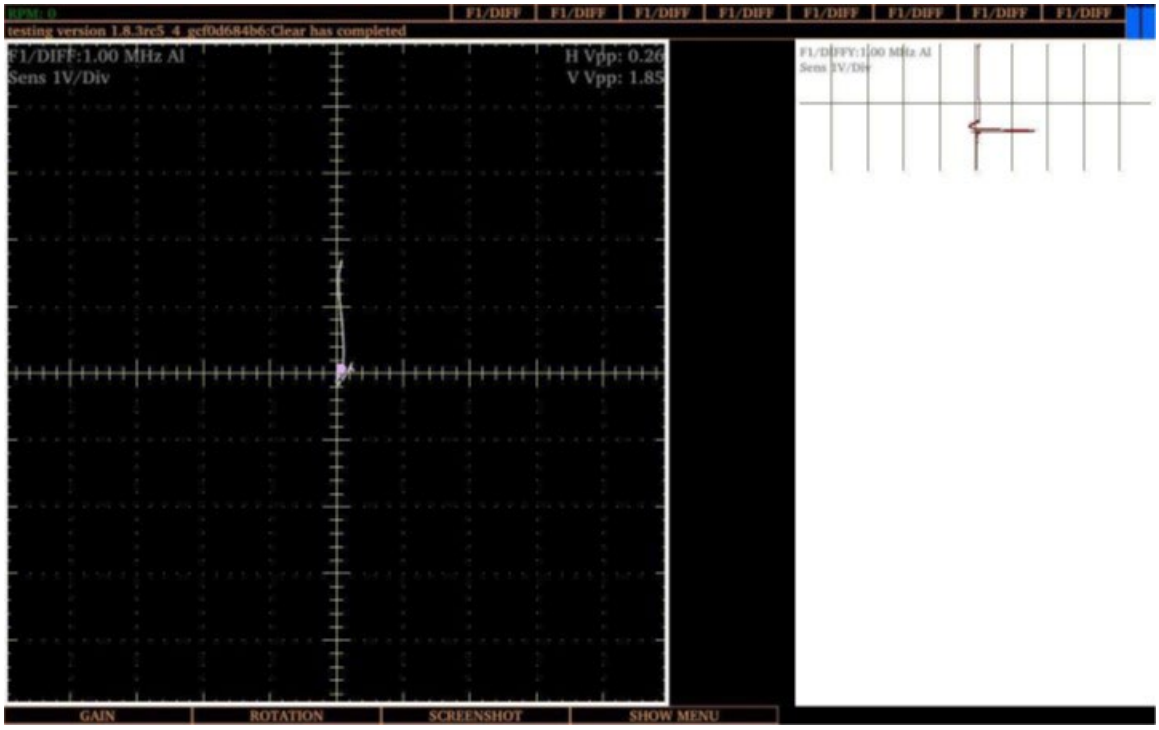
Figure 48. ET indication of defect at Location A in fillet weld test panel TTCI-P2

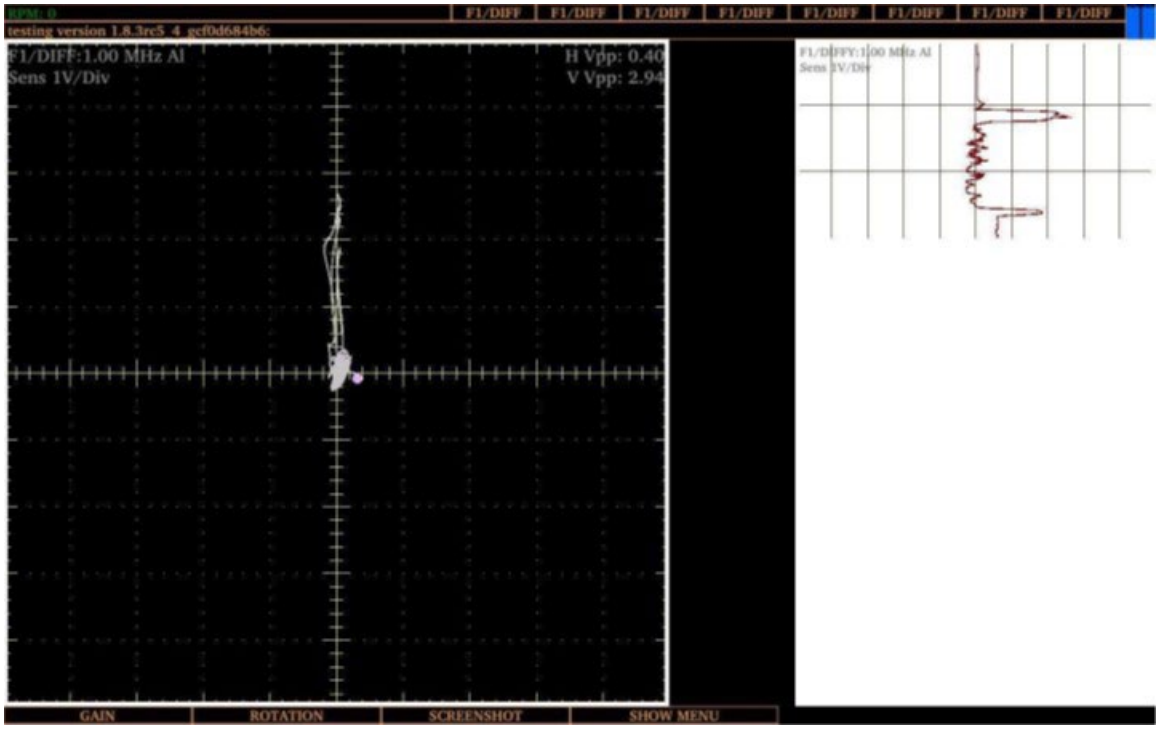
Figure 50. ET indication of defects at Location A and B in fillet weld test panel TTCI-P2

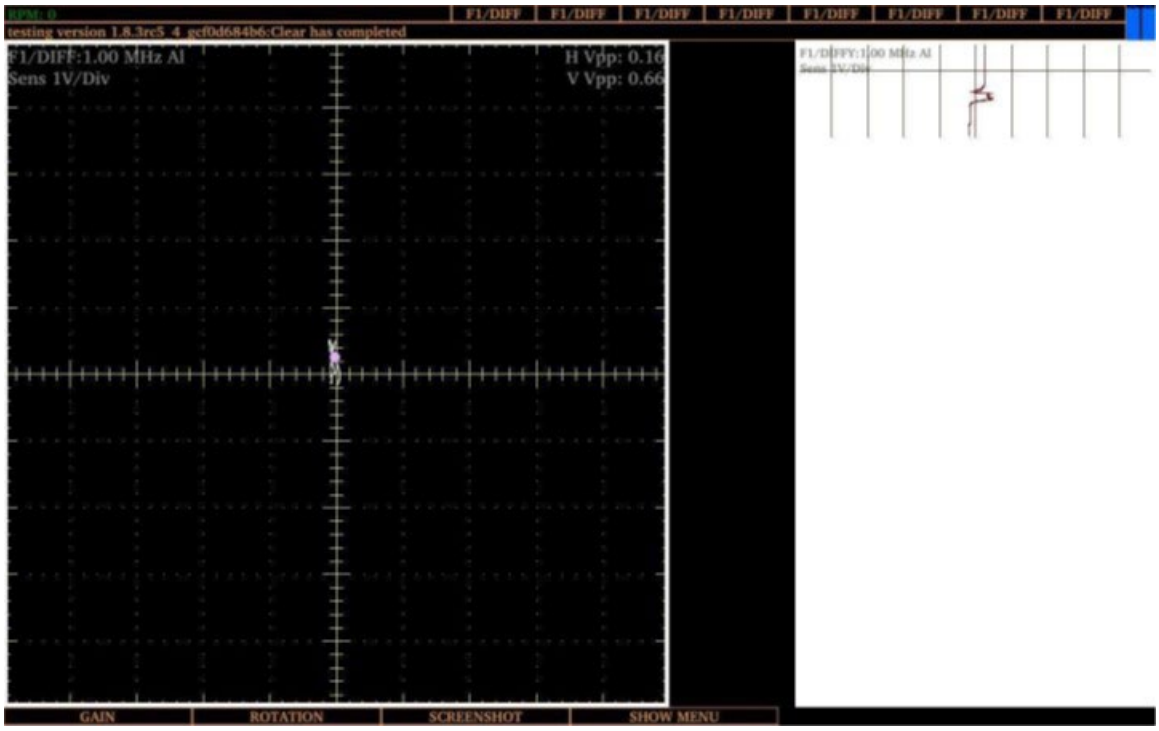
Figure 51. ET indication of defect at Location A in fillet weld test panel MGL-3

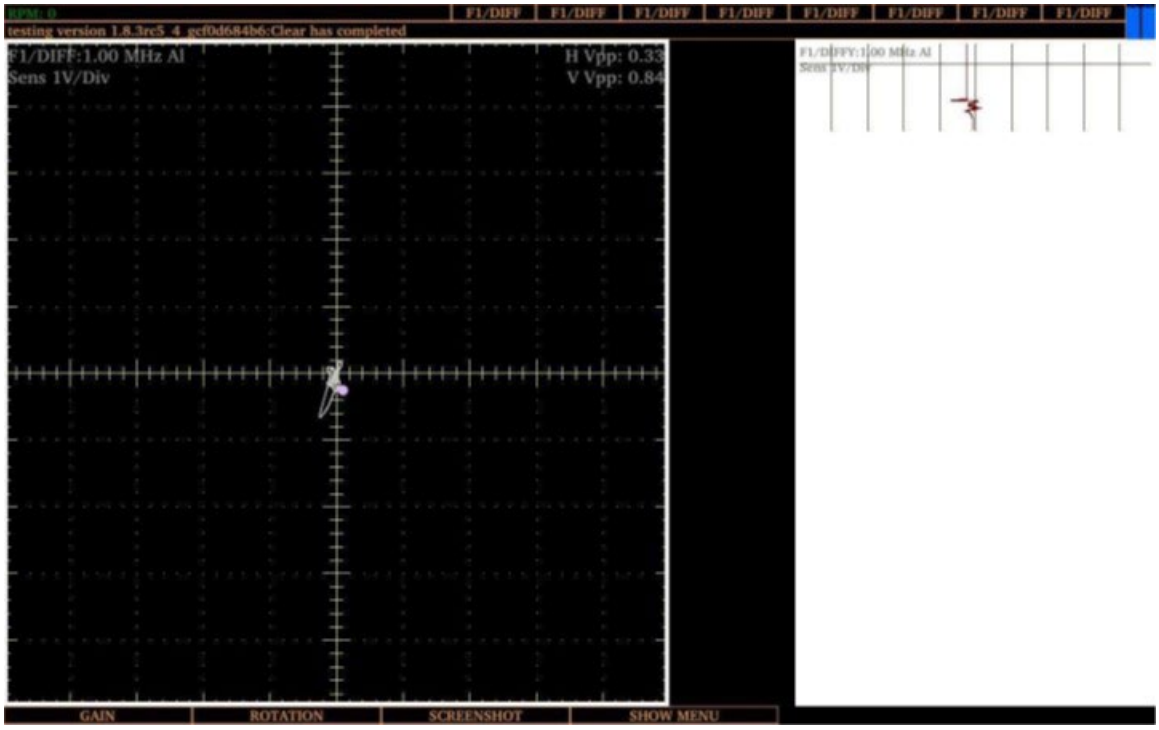
Figure 52. ET indication of defect at Location B in fillet weld test panel MGL-3

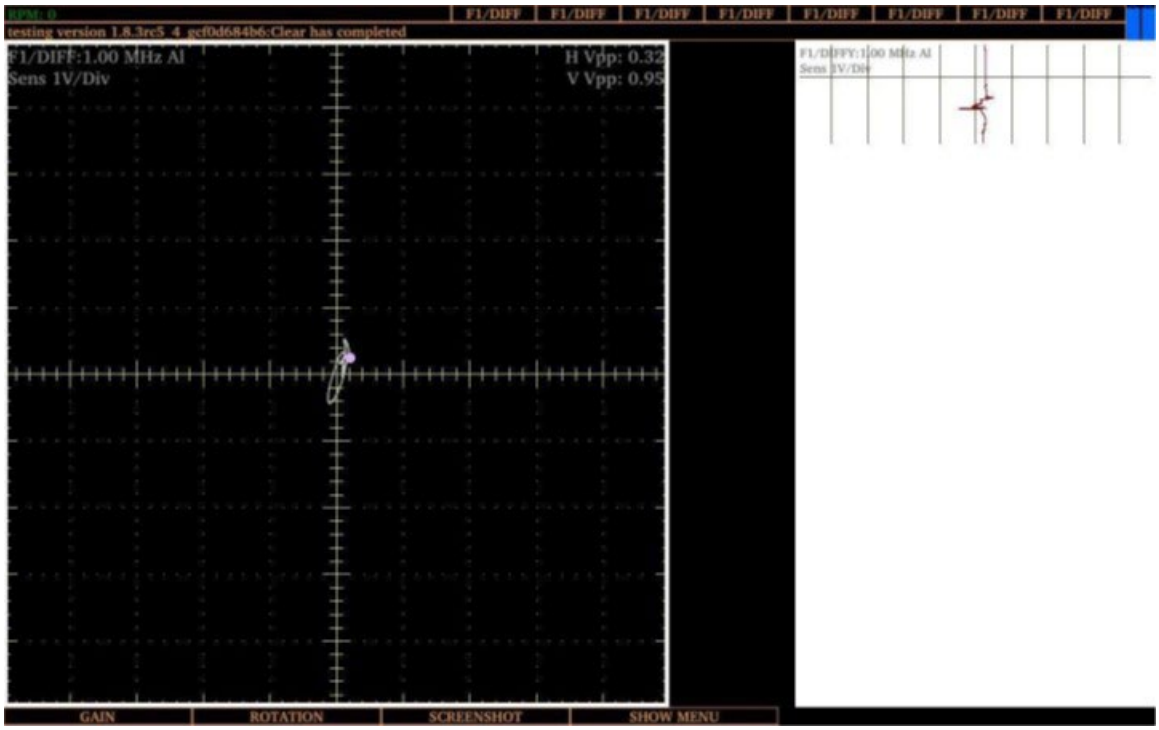
Figure 53. ET indication of defect at Location A in fillet weld test panel MGL-9

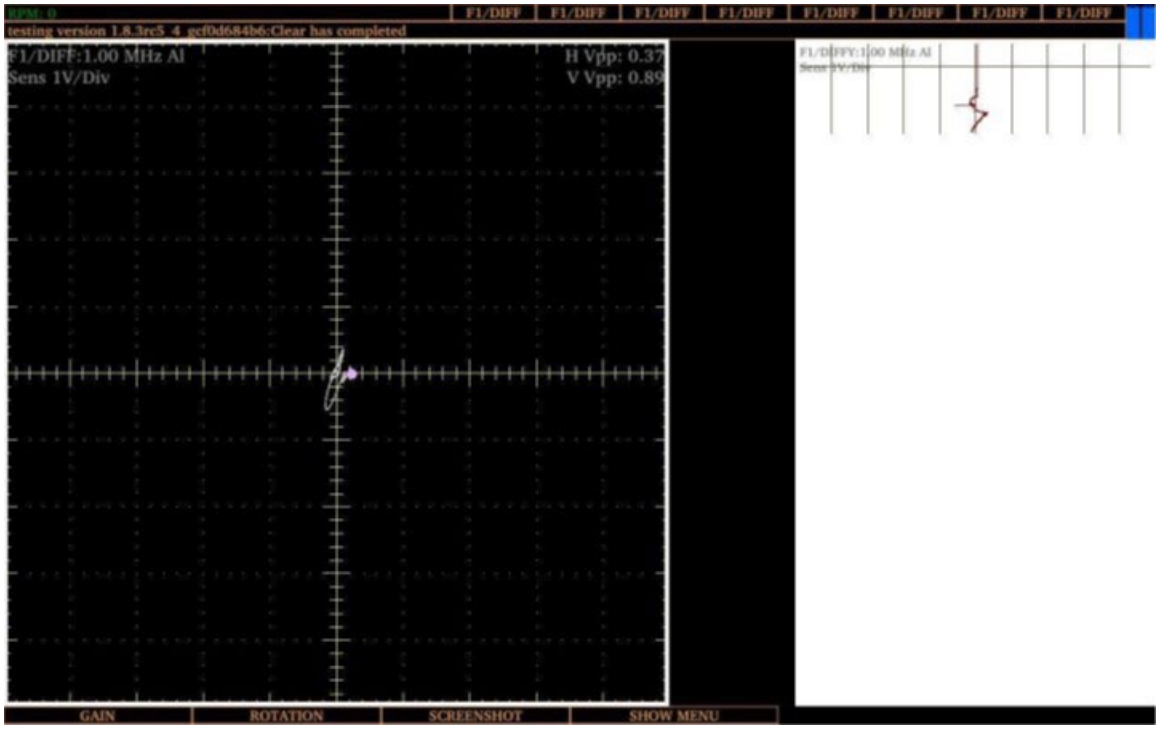
Figure 54. ET indication of defect at Location B in fillet weld test panel MGL-9

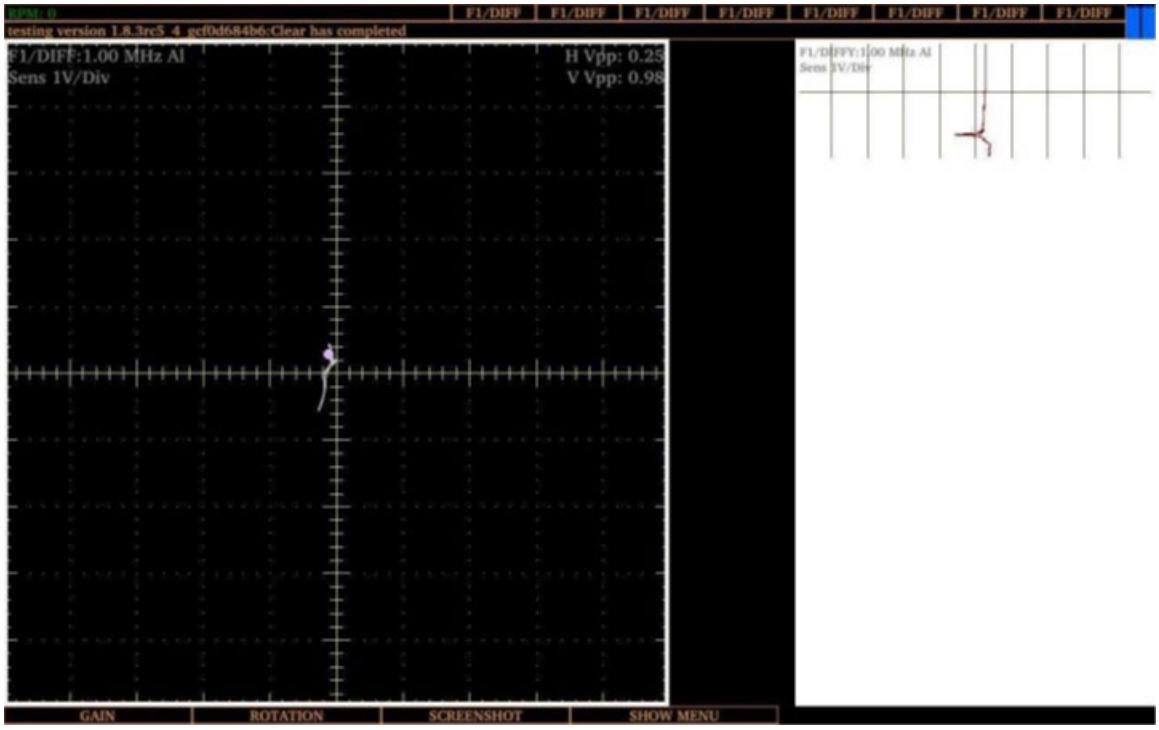
Figure 56. ET indication of defect at Location D in fillet weld test panel MGL-10

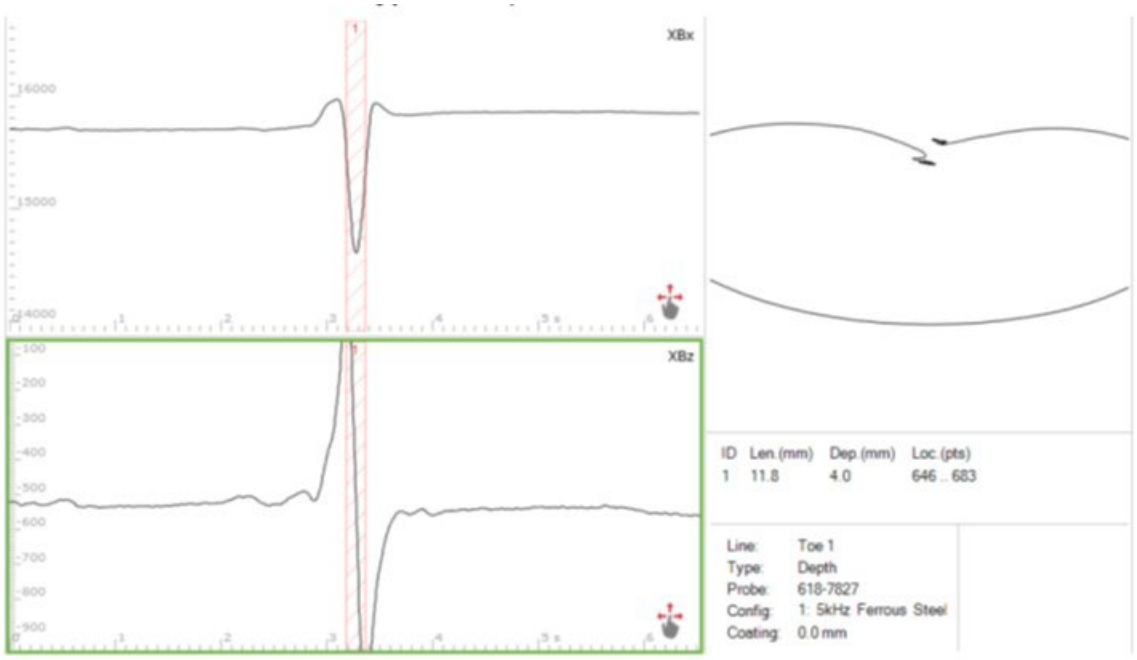
Figure 57. ACFM indication of defect at Location A in test panel TTCI-2

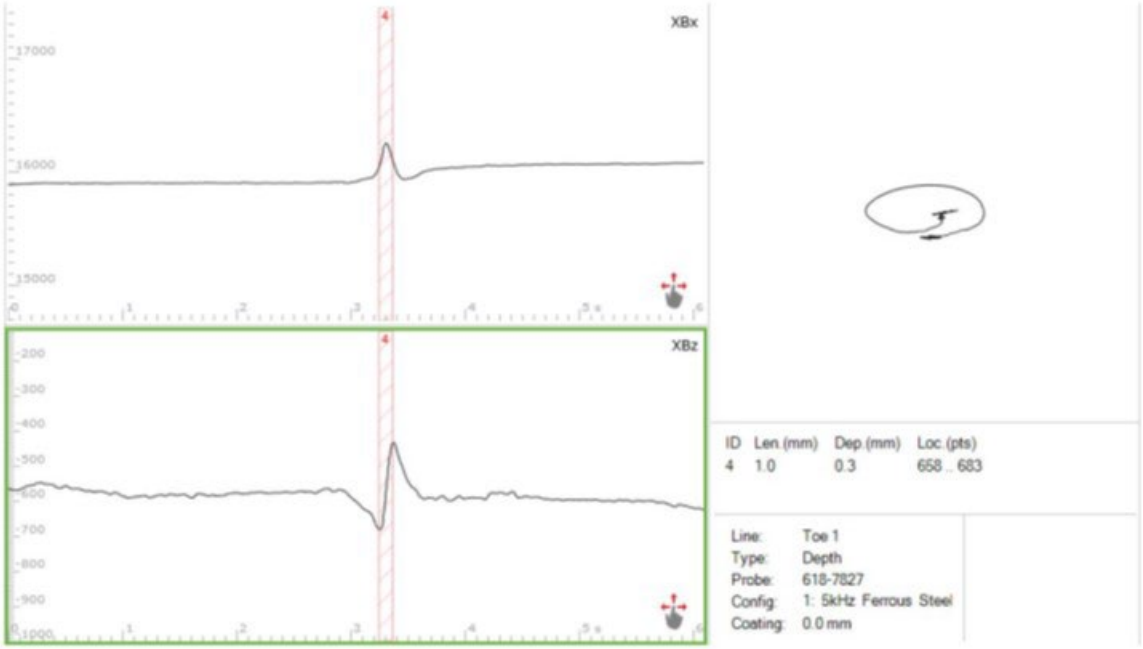
Figure 58. ACFM indication of defect at Location B in test panel TTCI-2

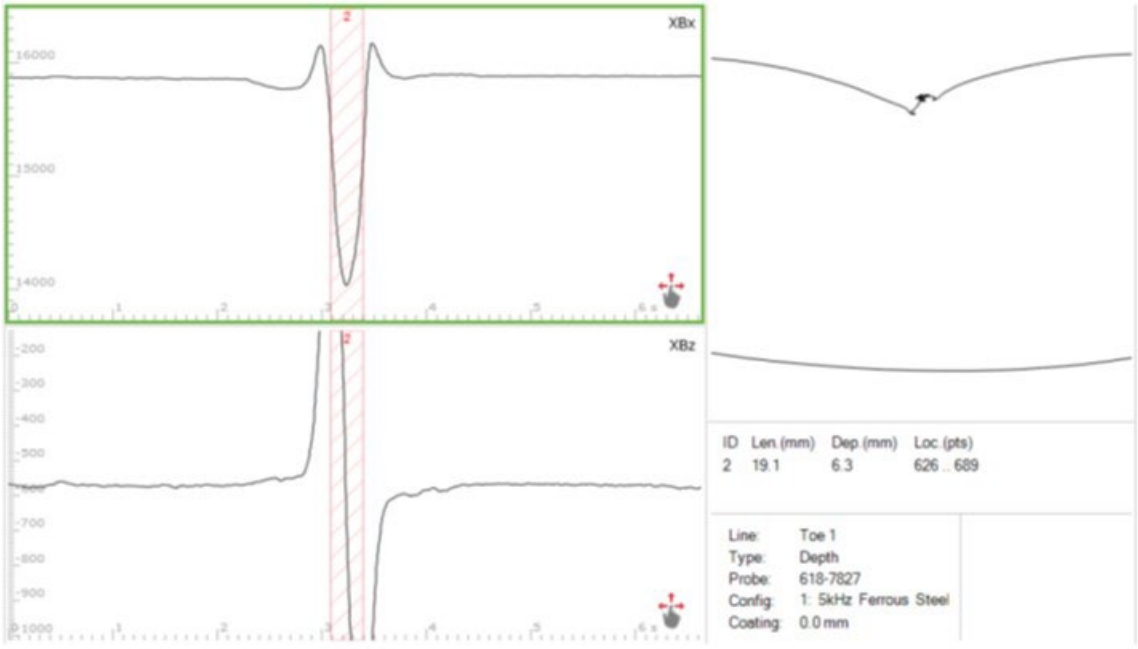
Figure 59. ACFM indication of defect at Location C in test panel TTCI-2

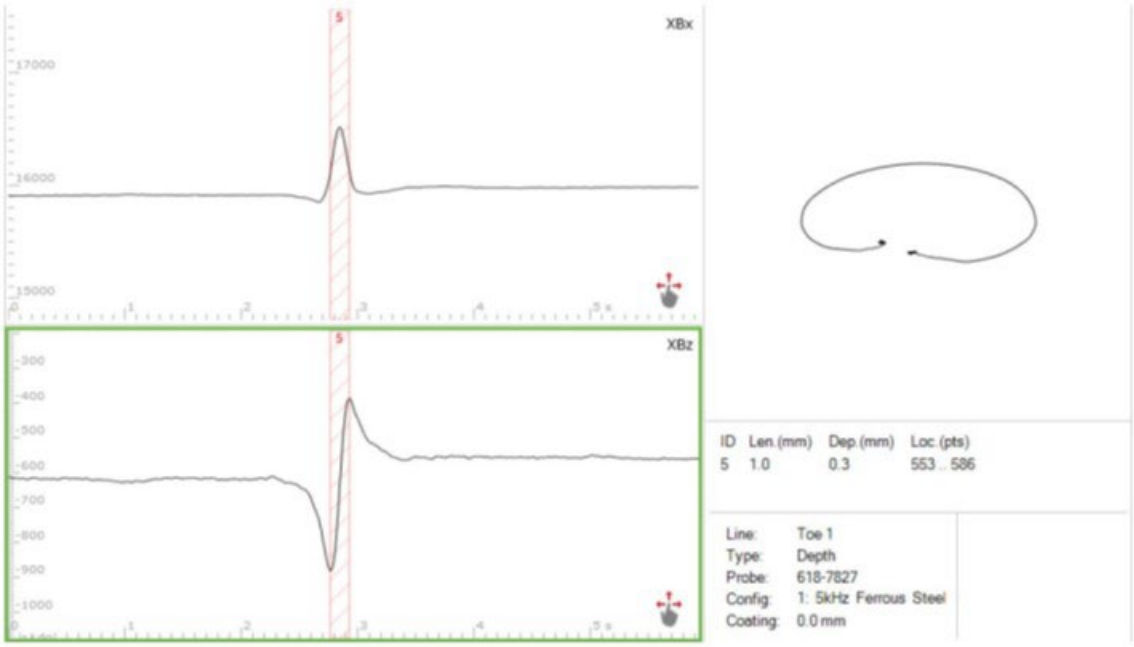
Figure 60. ACFM indication of defect at Location D in test panel TTCI-2
