A Feasibility Study on Advanced Nondestructive Evaluation (NDE) Methods to Characterize Weld Defects in Railroad Tank Cars

DOT/FRA/ORD-23/02

Final Report | January 2023

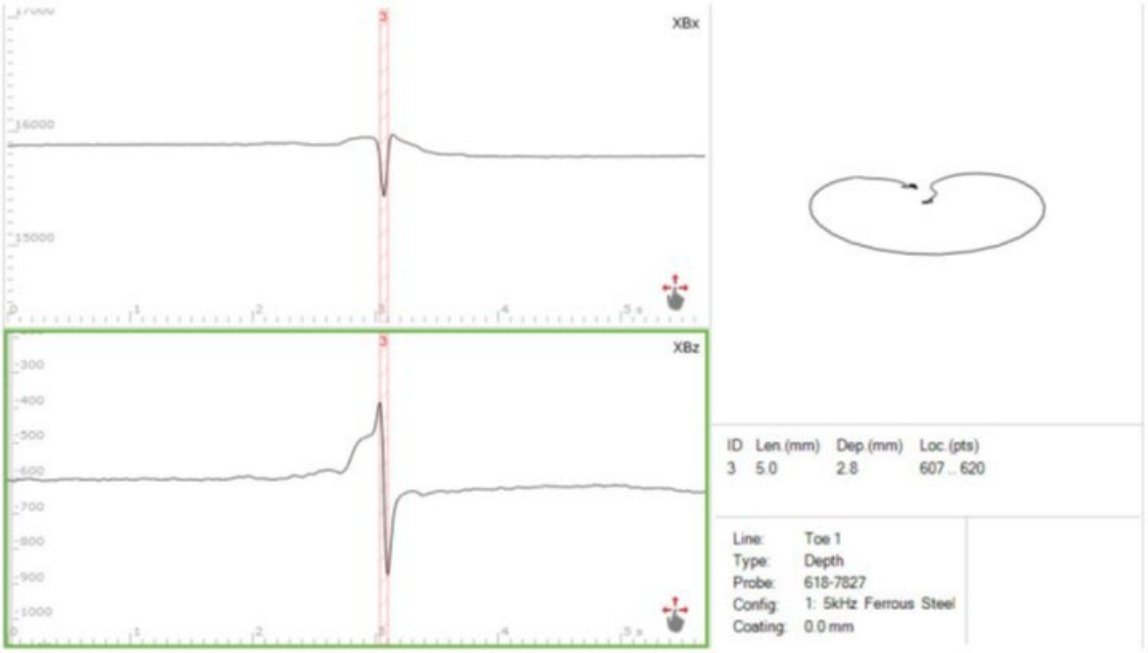
Figure 61. ACFM indication of defect at Location E in test panel TTCI-2

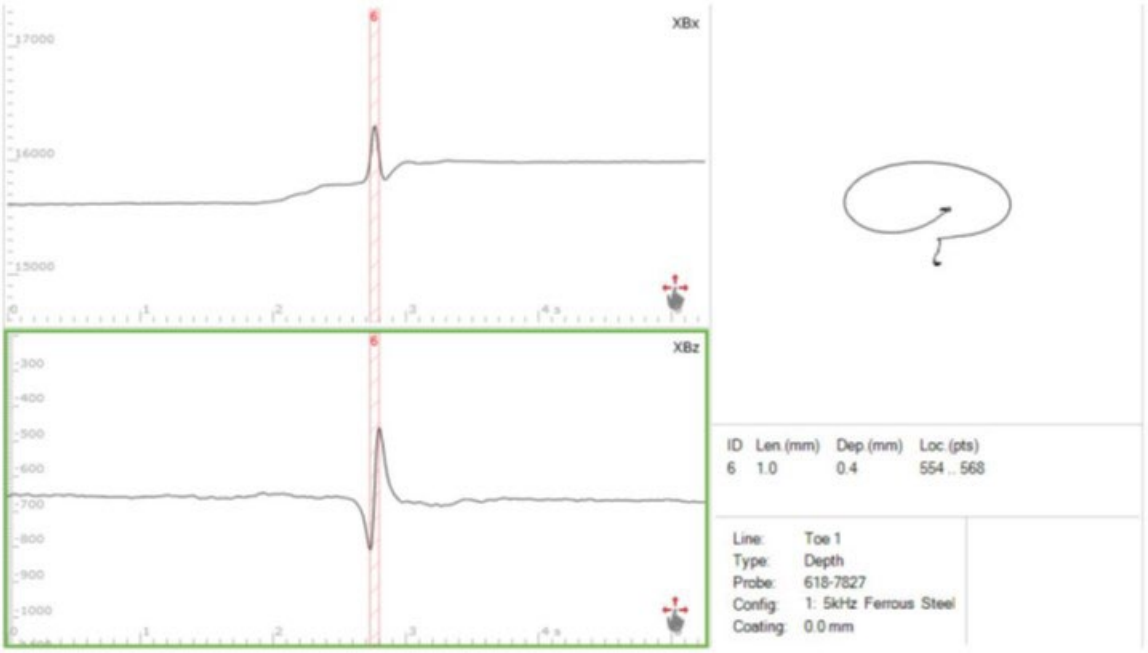
Figure 62. ACFM indication of defect at Location F in test panel TTCI-2

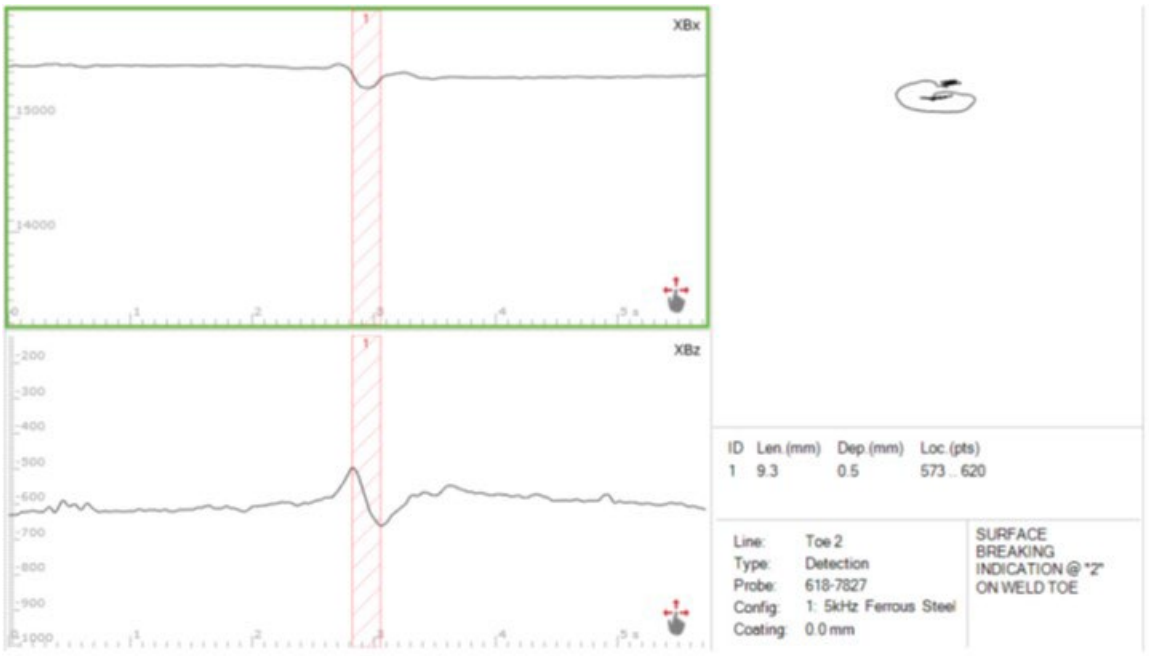
Figure 63. ACFM indication of defect at Location 2 in test panel MG-6

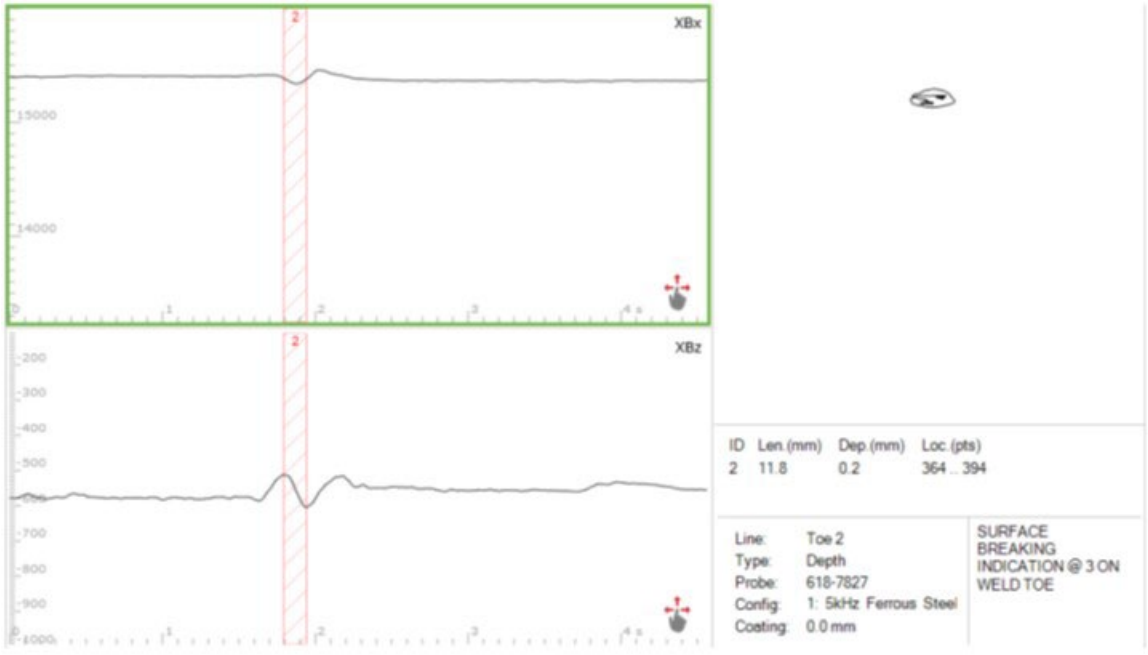
Figure 64. ACFM indication of defect at Location 3 in test panel MG-6

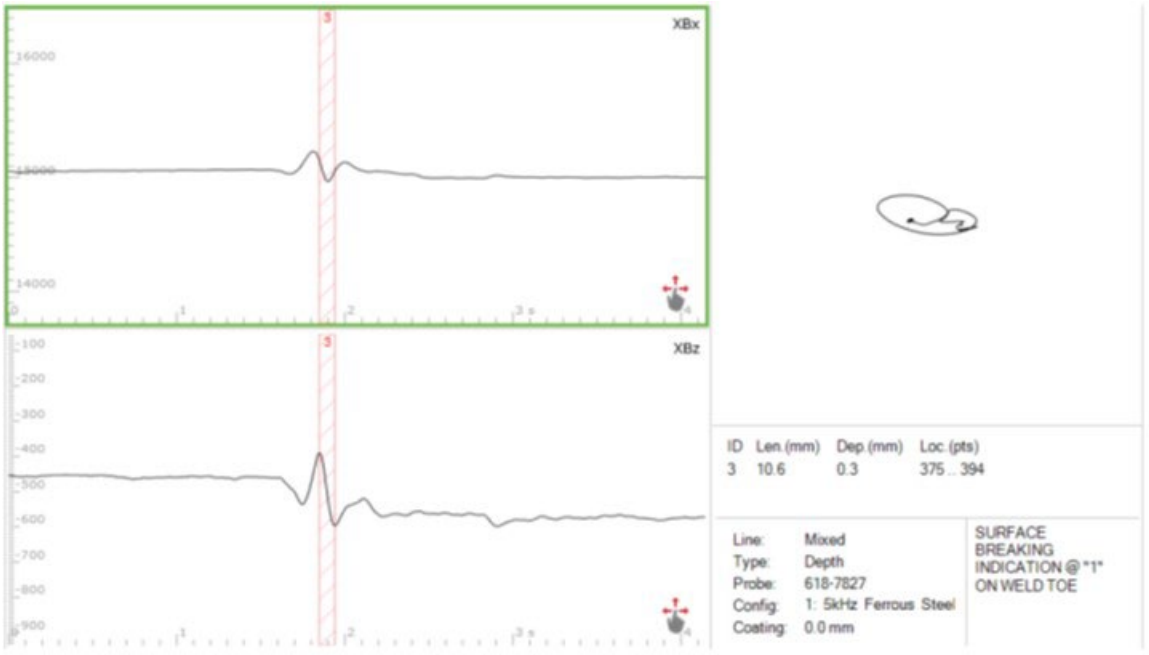
Figure 65. ACFM indication of defect at Location 1 in test panel MG-13

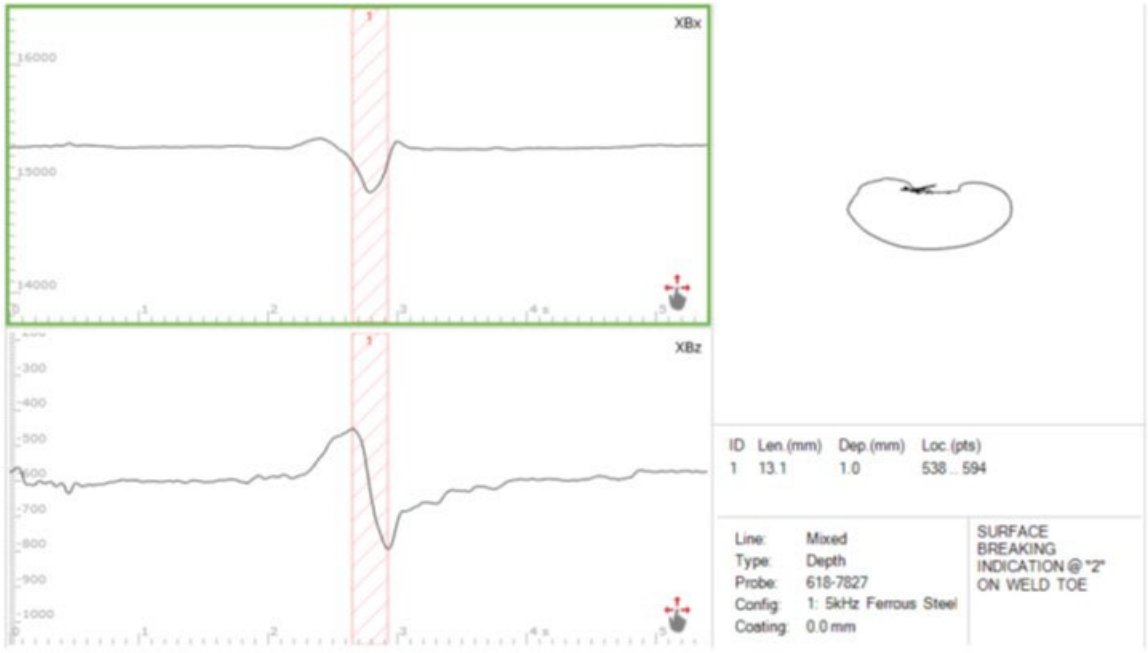
Figure 66. ACFM indication of defect at Location 2 in test panel MG-13

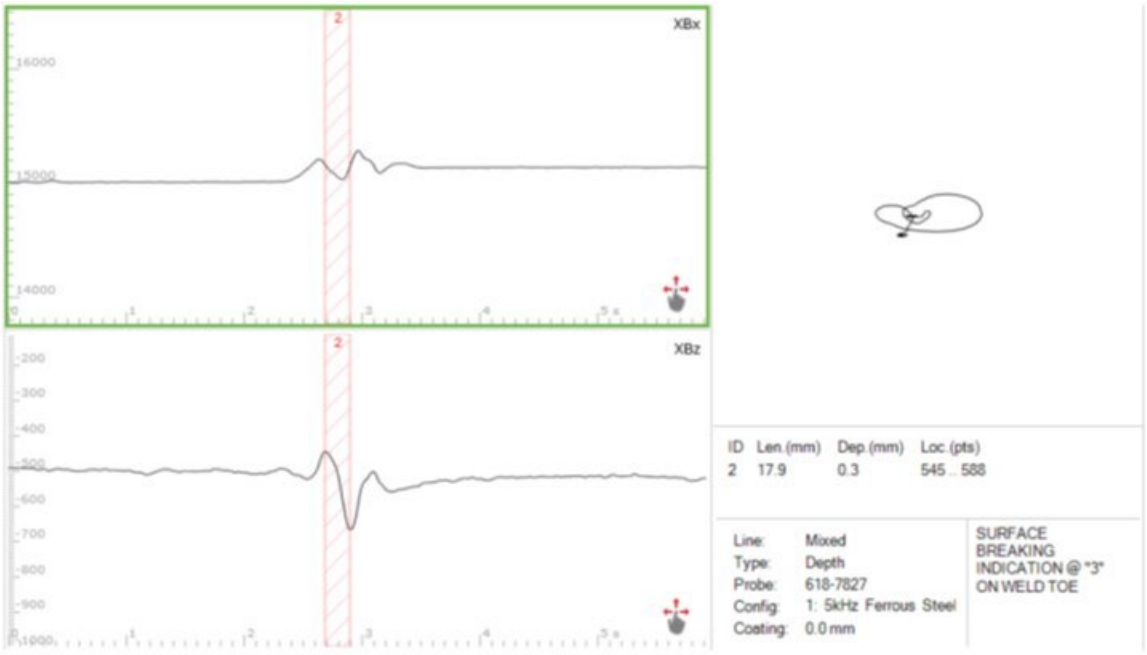
Figure 67. ACFM indication of defect at Location 3 in test panel MG-13

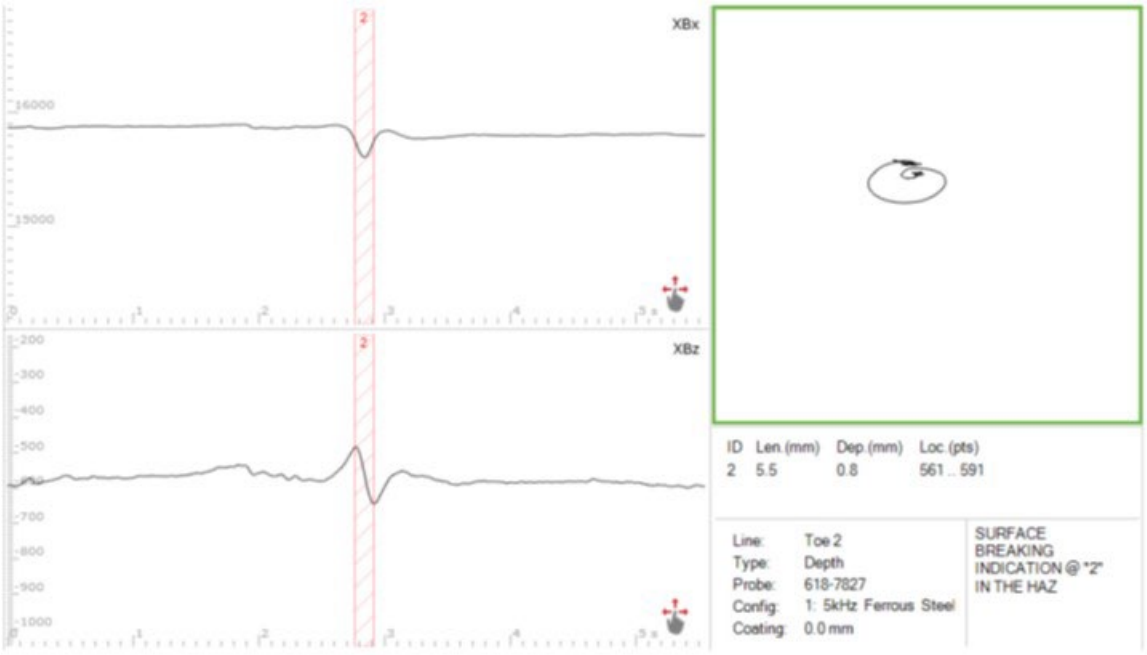
Figure 68. ACFM indication of defect at Location 2 in test panel MG-16

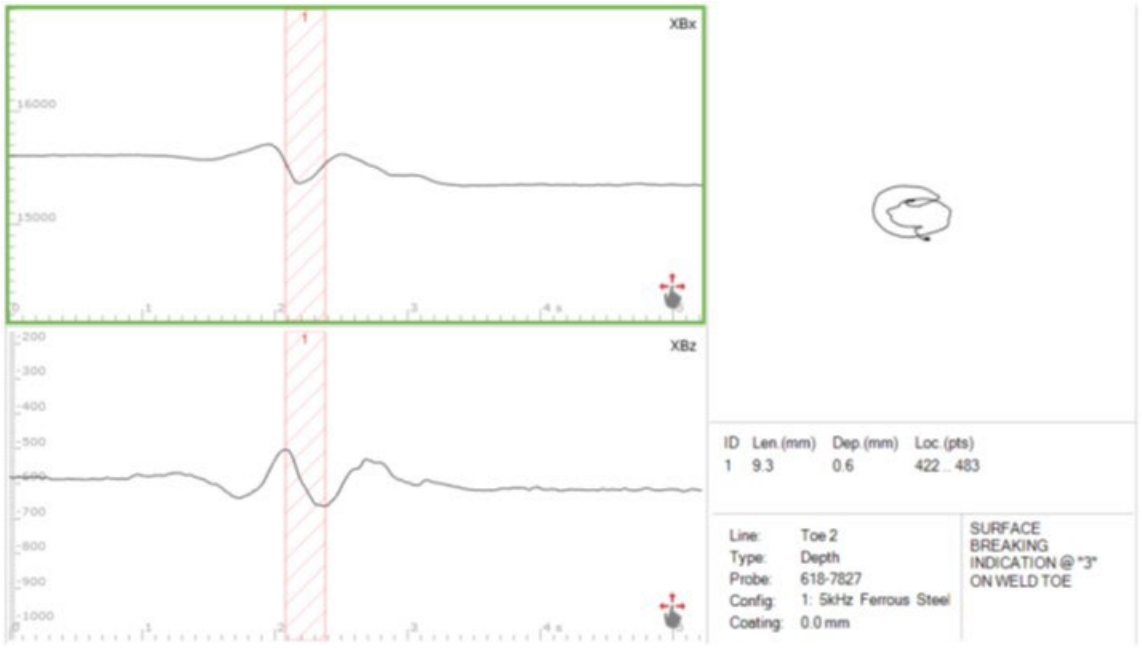
Figure 69. ACFM indication of defect at Location 3 in test panel MG-16

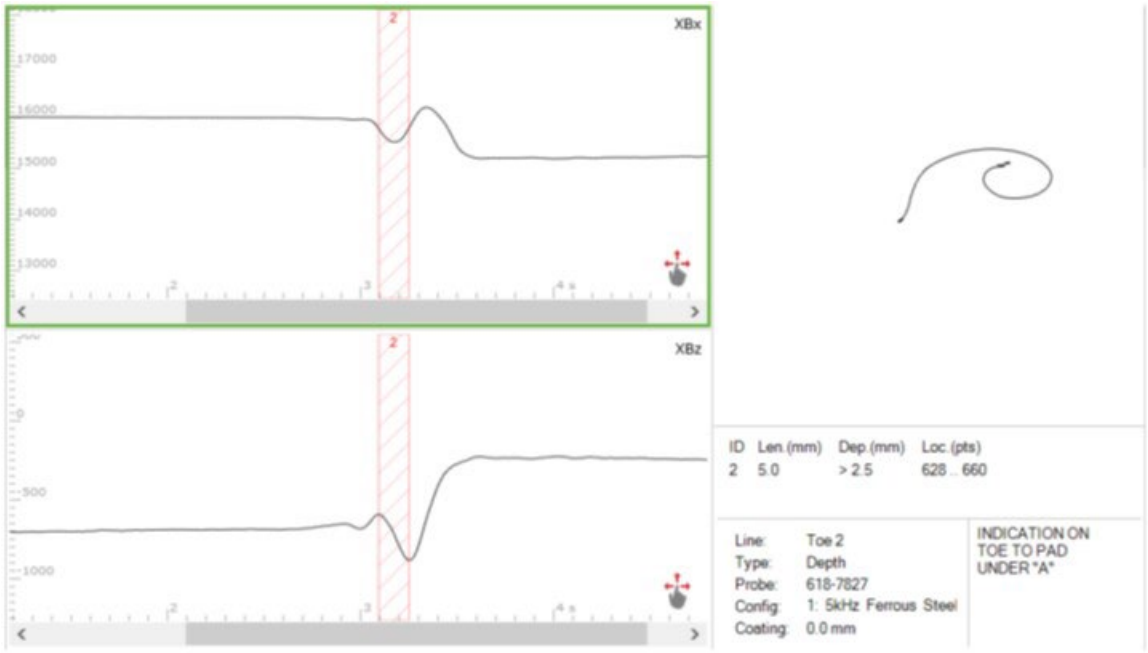
Figure 70. ACFM indication of defect at Location A in test panel TTCI-P2

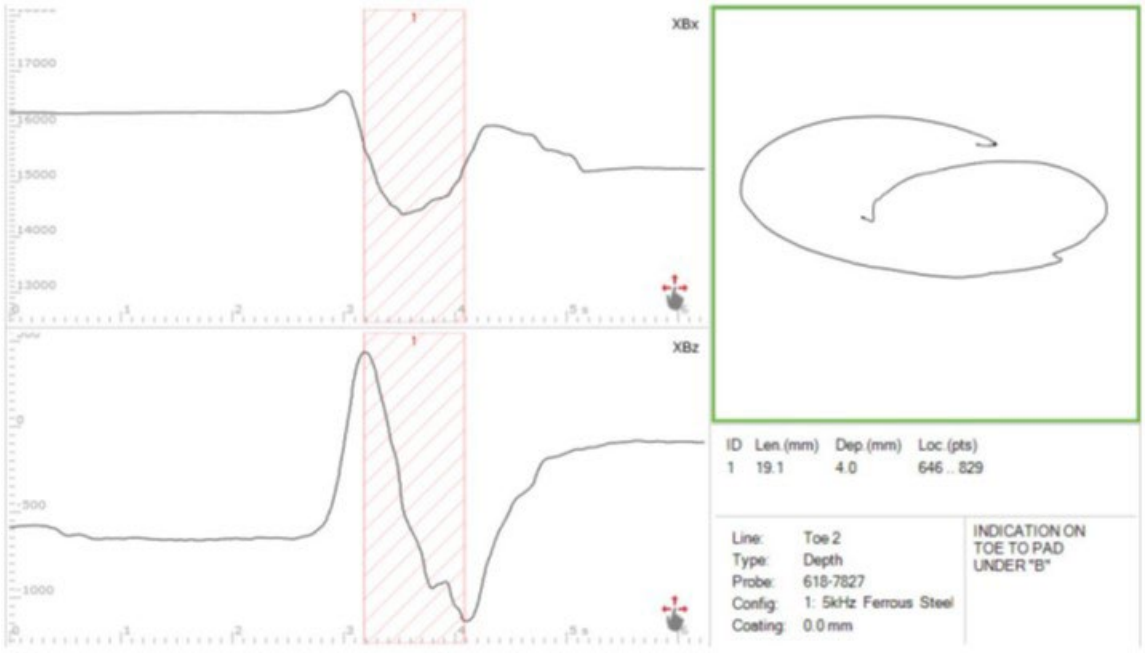
Figure 71. ACFM indication of defect at Location B in test panel TTCI-P2

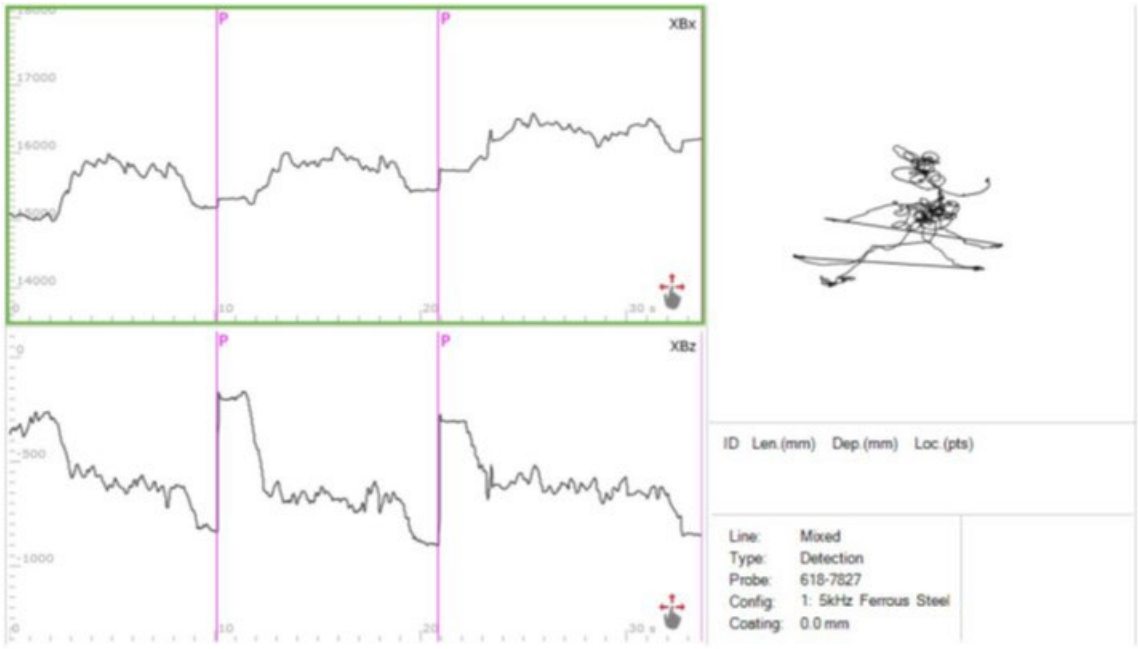
Figure 72. ACFM single probe scan of test panel MGL-3

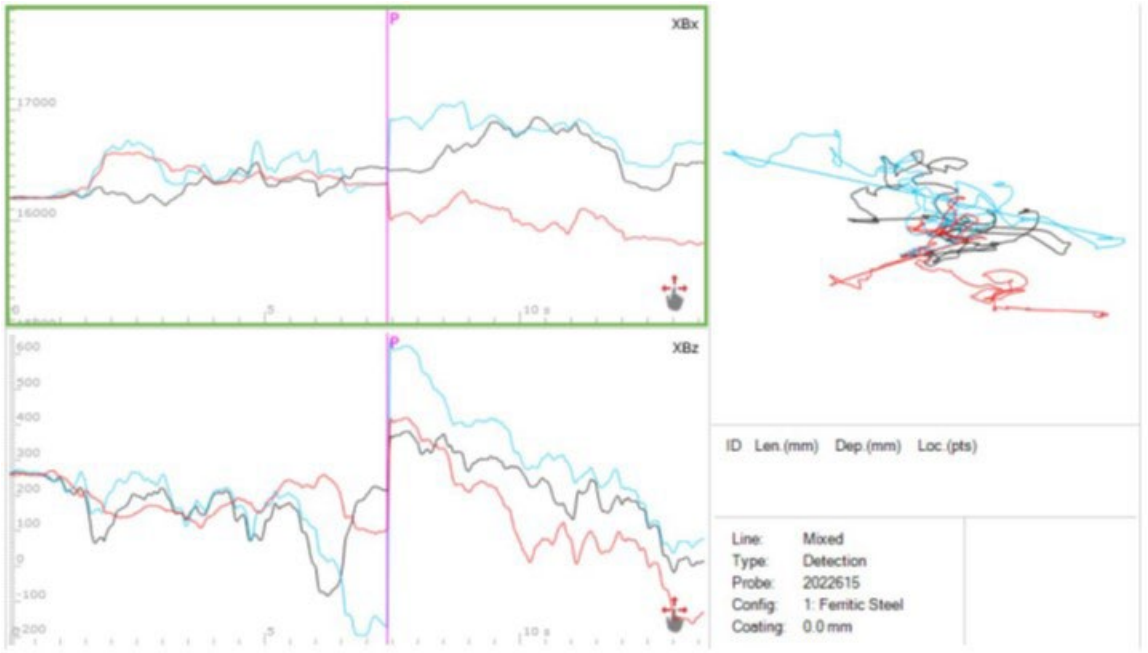
Figure 77. ACFM array probe scan of test panel MGL-10

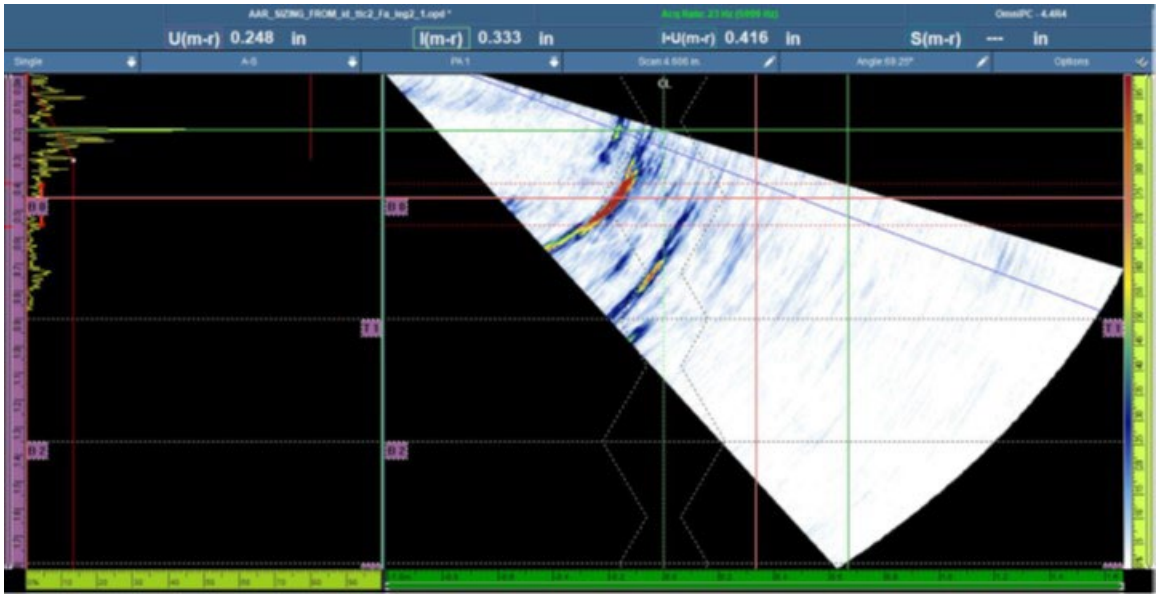
Figure 110. PAUT defect indication at Location A in test panel TTCI-2 from ID-raster scan

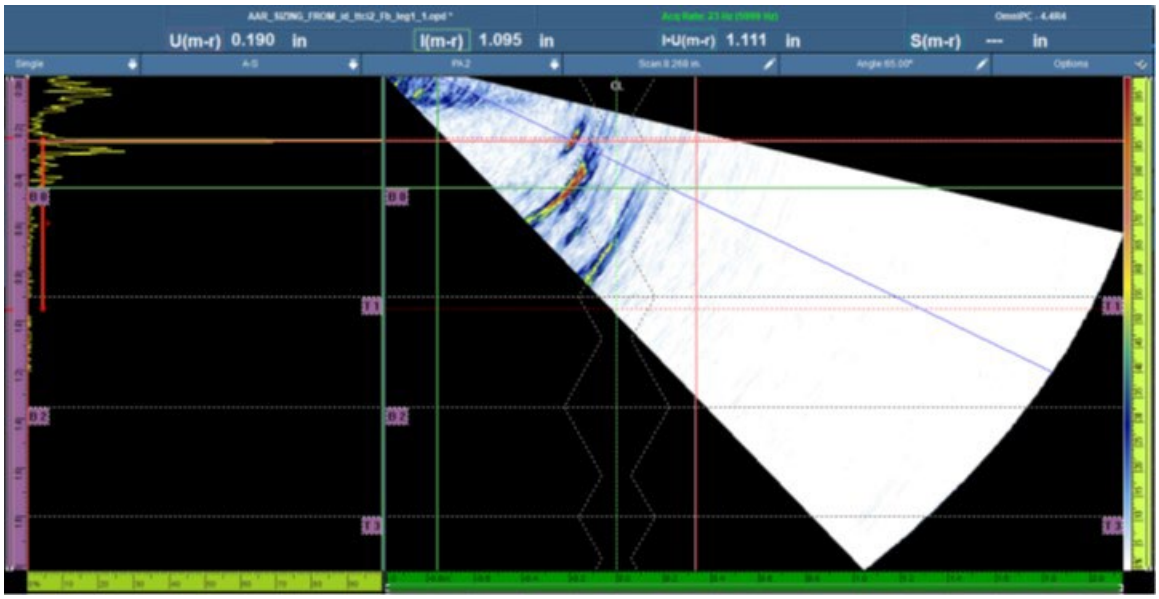
Figure 111. PAUT defect indication at Location B in test panel TTCI-2 from ID-raster scan

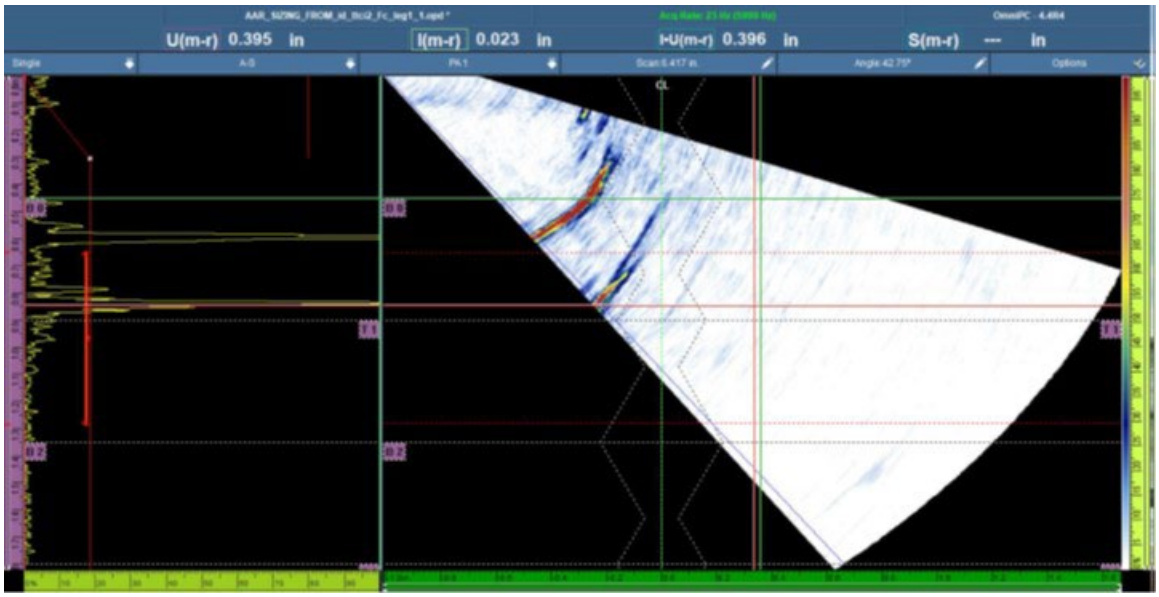
Figure 112. PAUT defect indication at Location C in test panel TTCI-2 from ID-raster scan

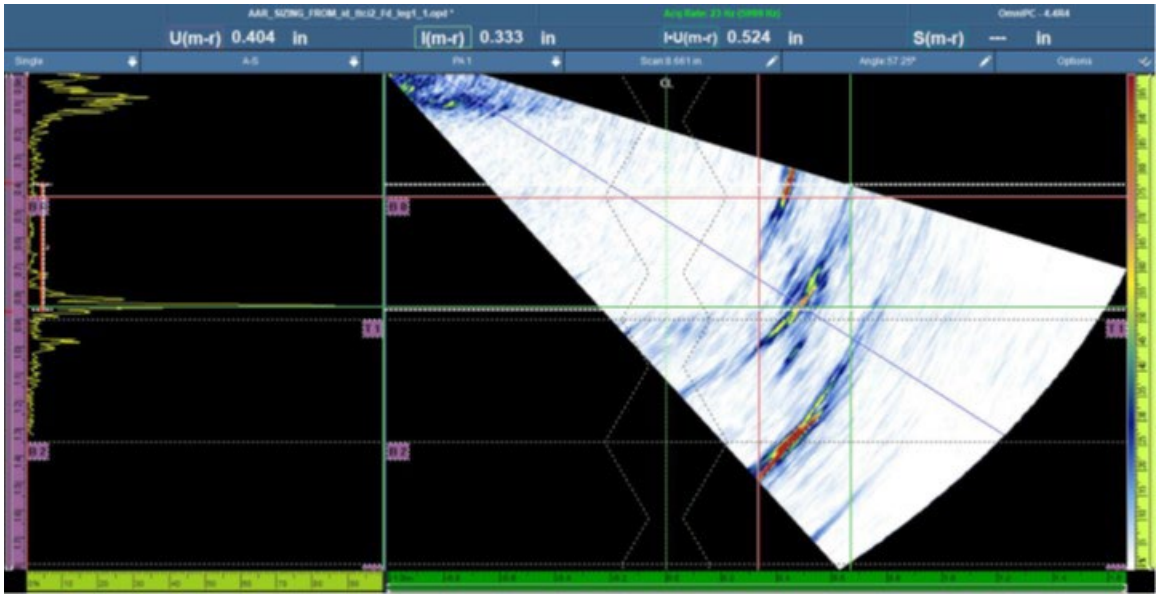
Figure 113. PAUT defect indication at Location D in test panel TTCI-2 from ID-raster scan

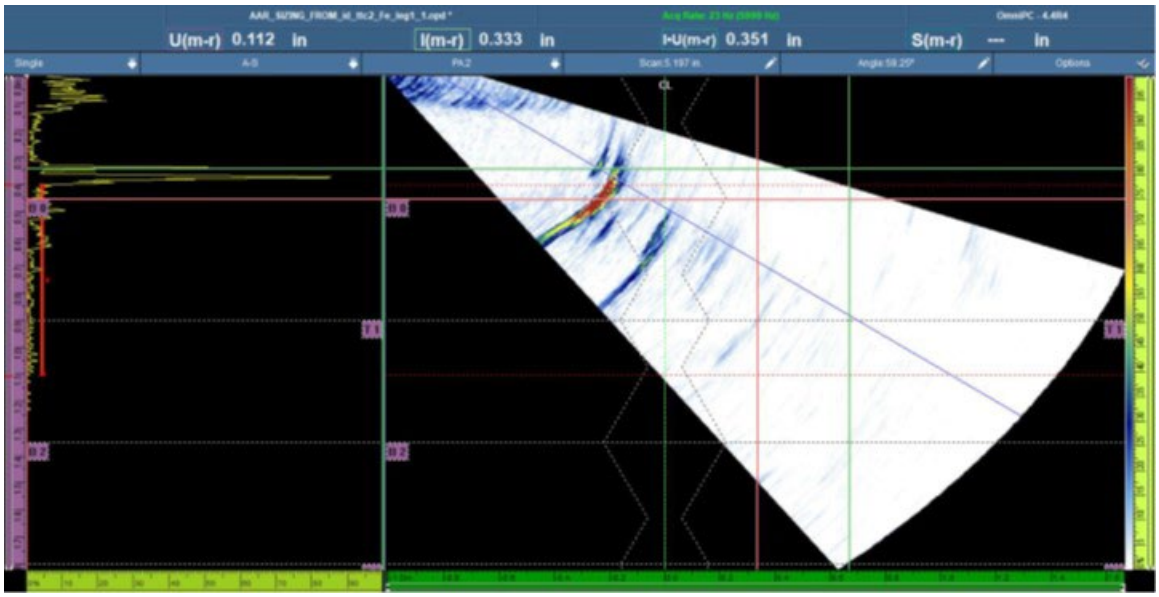
Figure 114. PAUT defect indication at Location E in test panel TTCI-2 from ID-raster scan

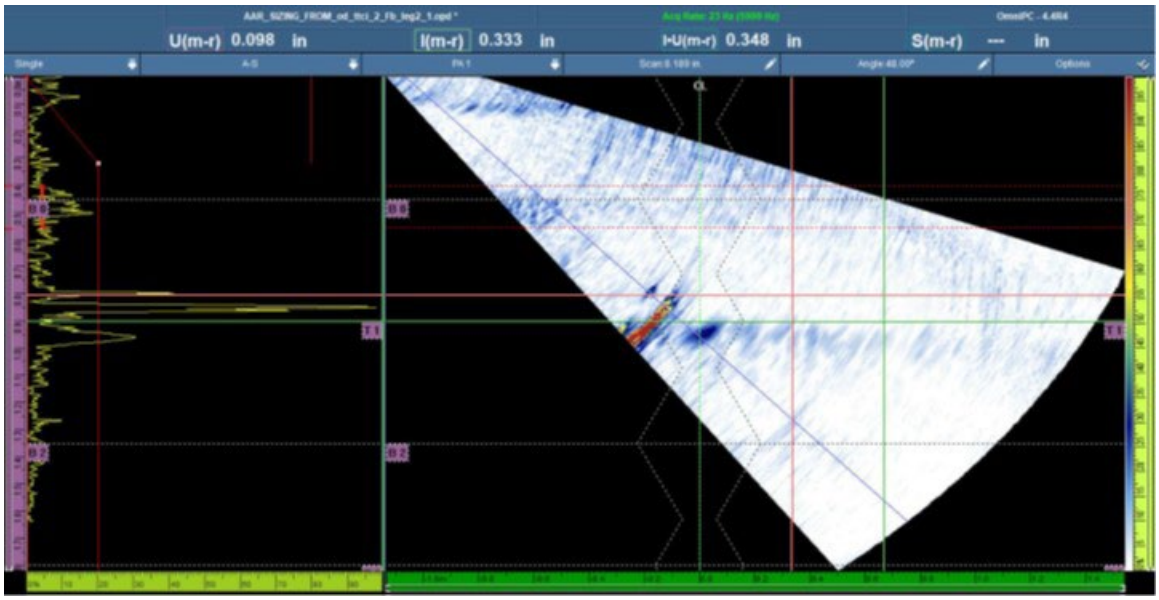
Figure 120. PAUT defect indication at Location B in test panel TTCI-2 from OD-raster scan

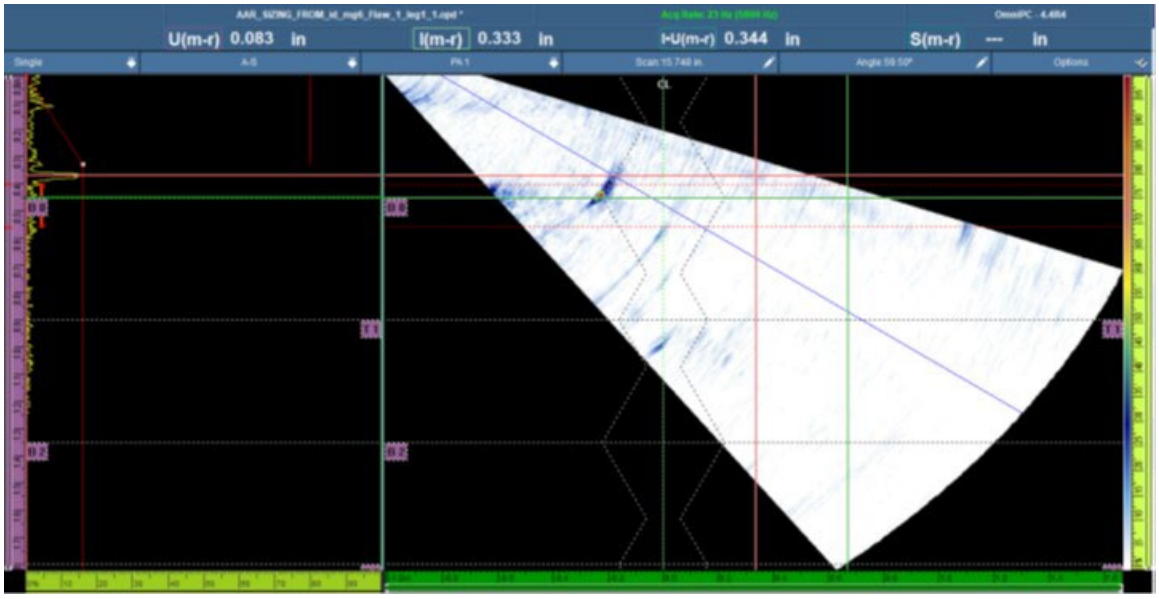
Figure 128. PAUT defect indication at Location 1 in test panel MG-6 from ID-raster scan

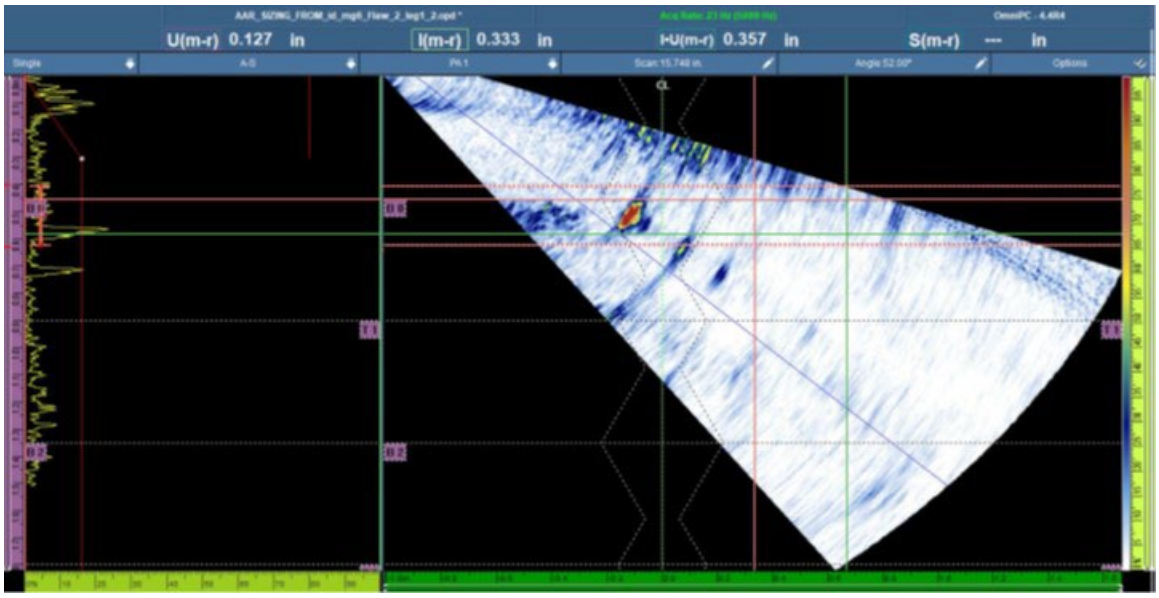
Figure 129. PAUT defect indication at Location 2 in test panel MG-6 from ID-raster scan

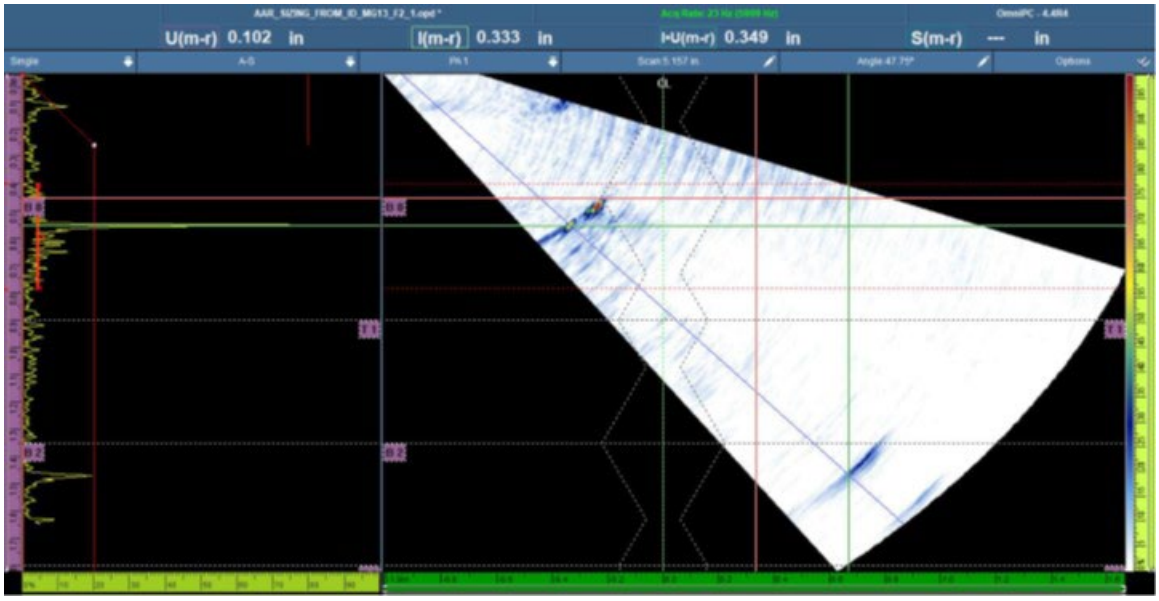
Figure 141. PAUT indication of defect at Location 2 in test panel MG-13 from ID-raster scan

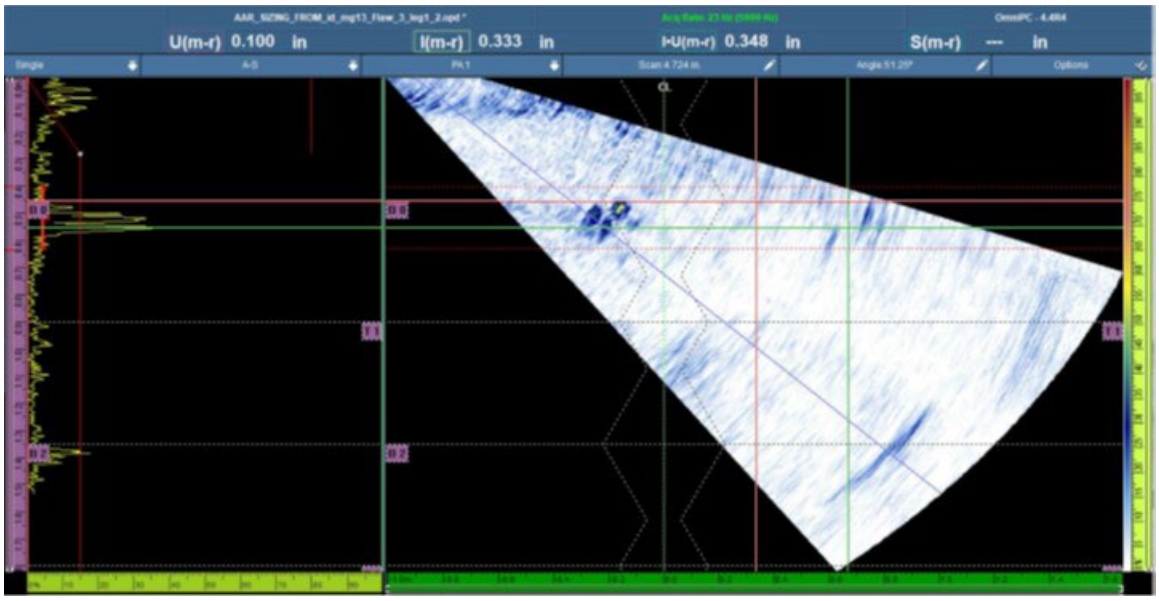
Figure 142. PAUT indication of defect at Location 3 in test panel MG-13 from ID-raster scan

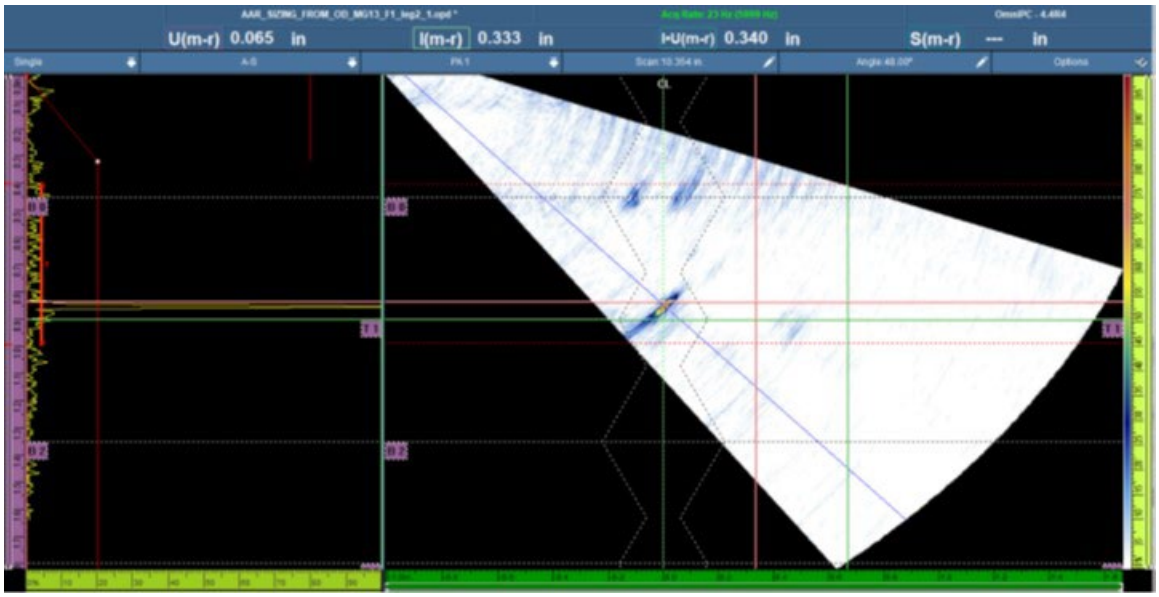
Figure 146. PAUT indication of defect at Location 1 in test panel MG-13 from OD-raster scan

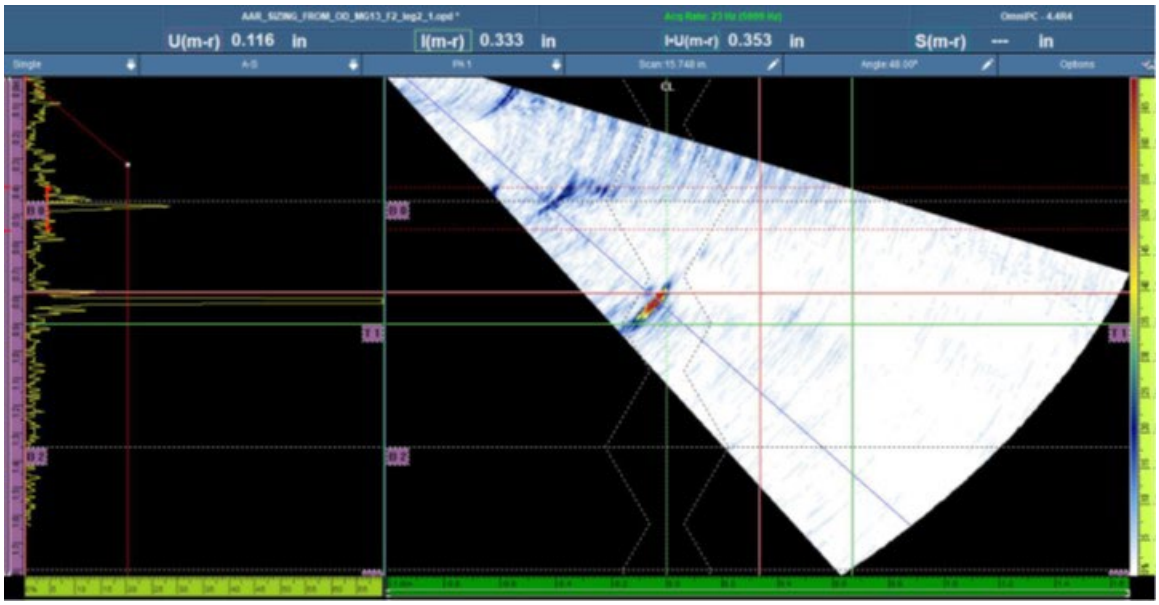
Figure 147. PAUT indication of defect at Location 2 in test panel MG-13 from OD-raster scan

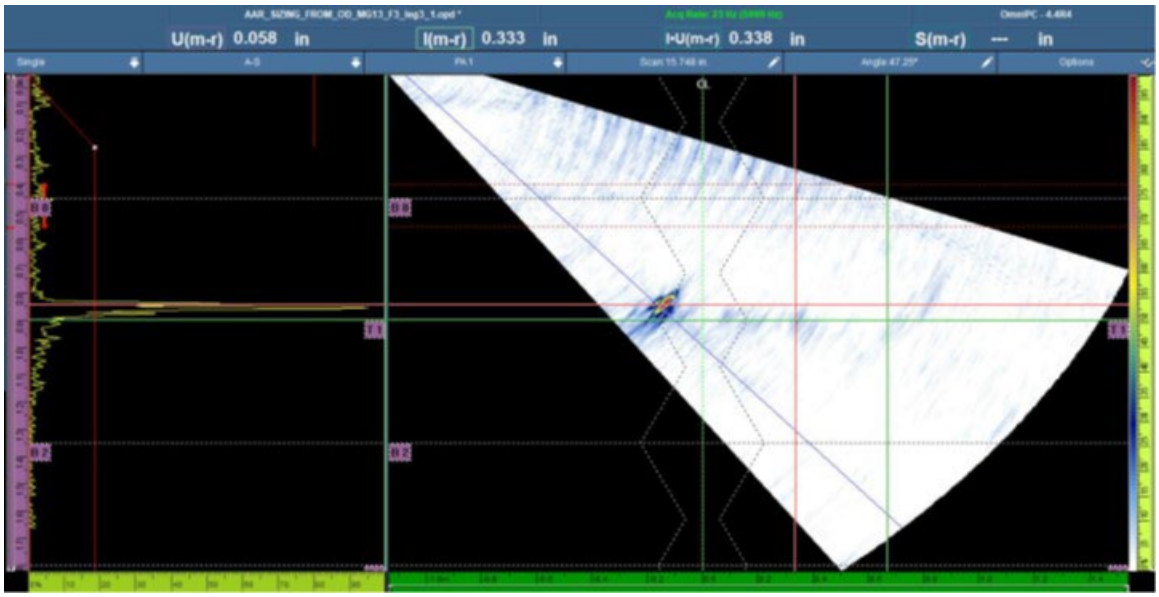
Figure 148. PAUT indication of defect at Location 3 in test panel MG-13 from OD-raster scan

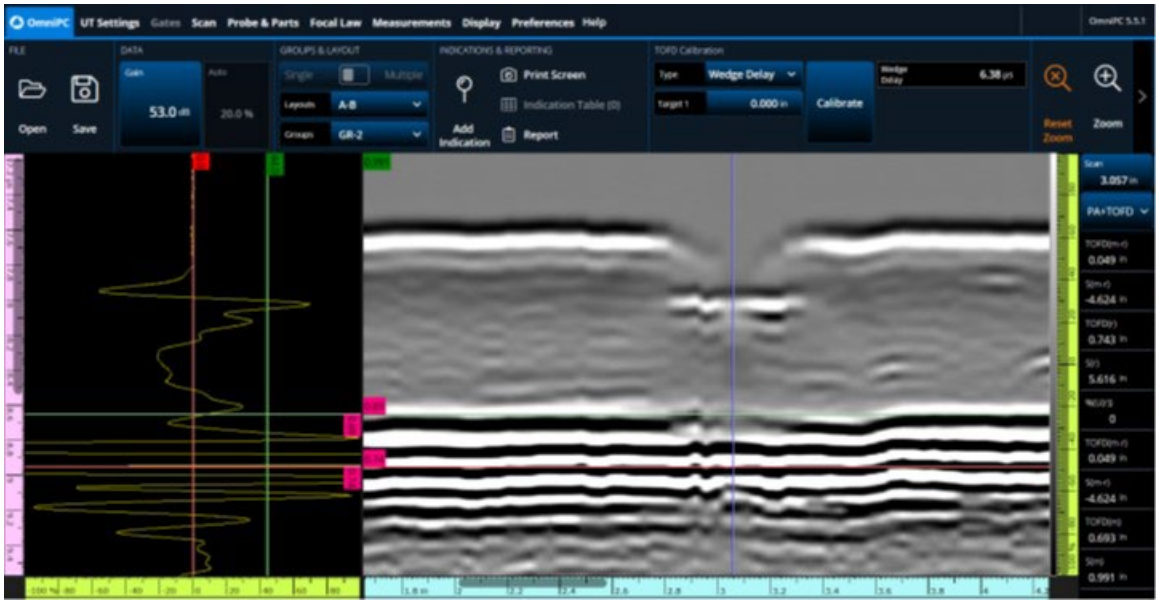
Figure 185. TOFD indication of defect at Location A in test panel TTCI-2

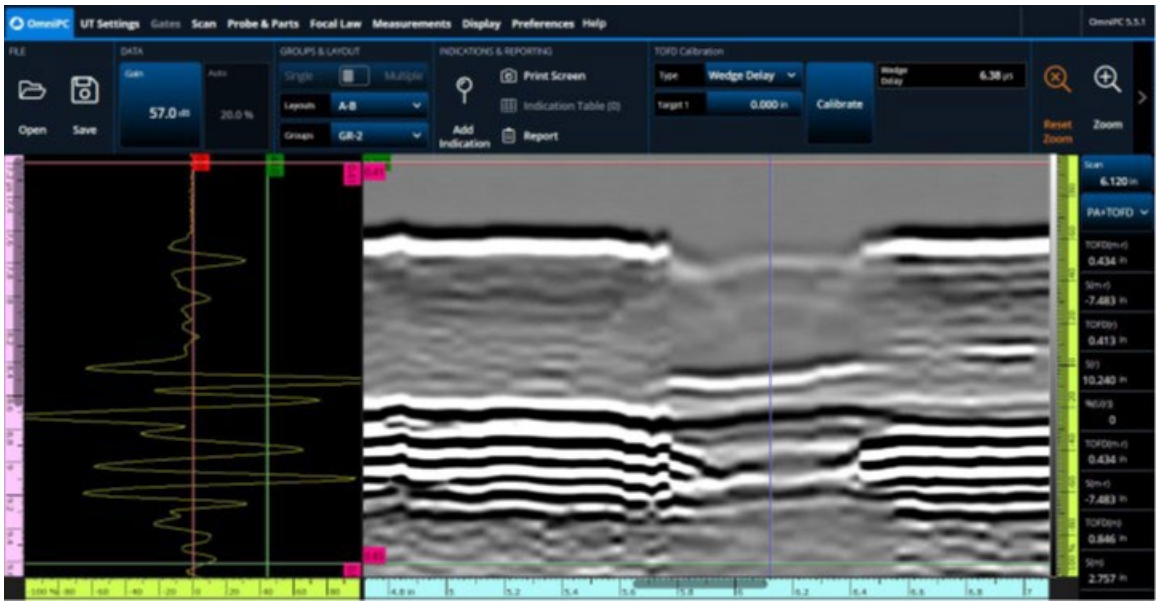
Figure 187. TOFD indication of defect at Location C in test panel TTCI-2

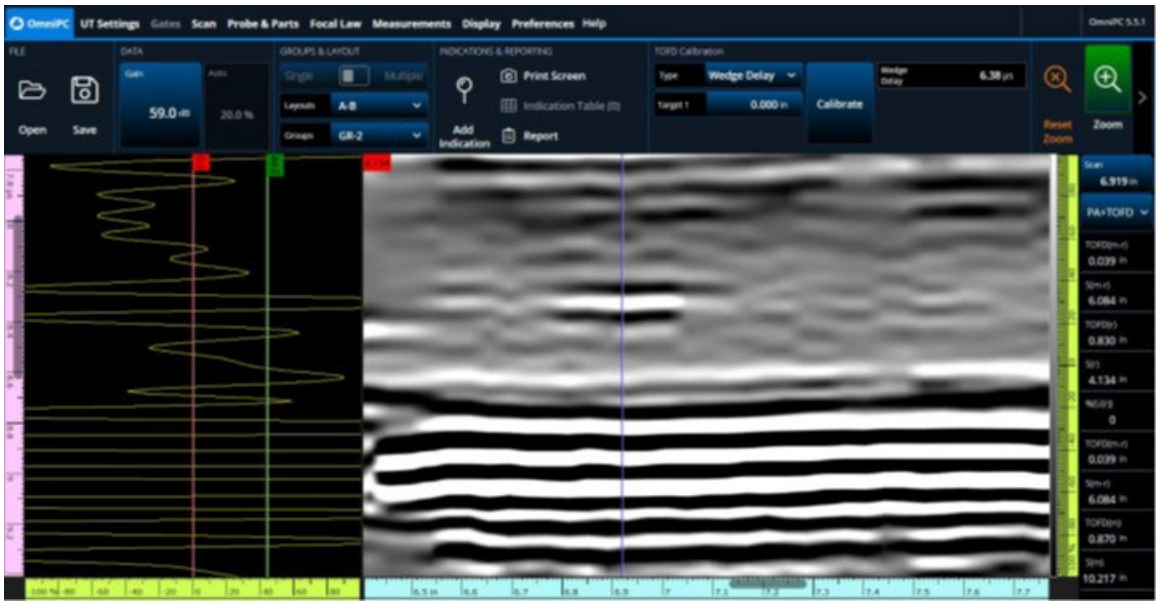
Figure 188. TOFD indication of defect at Location D in test panel TTCI-2

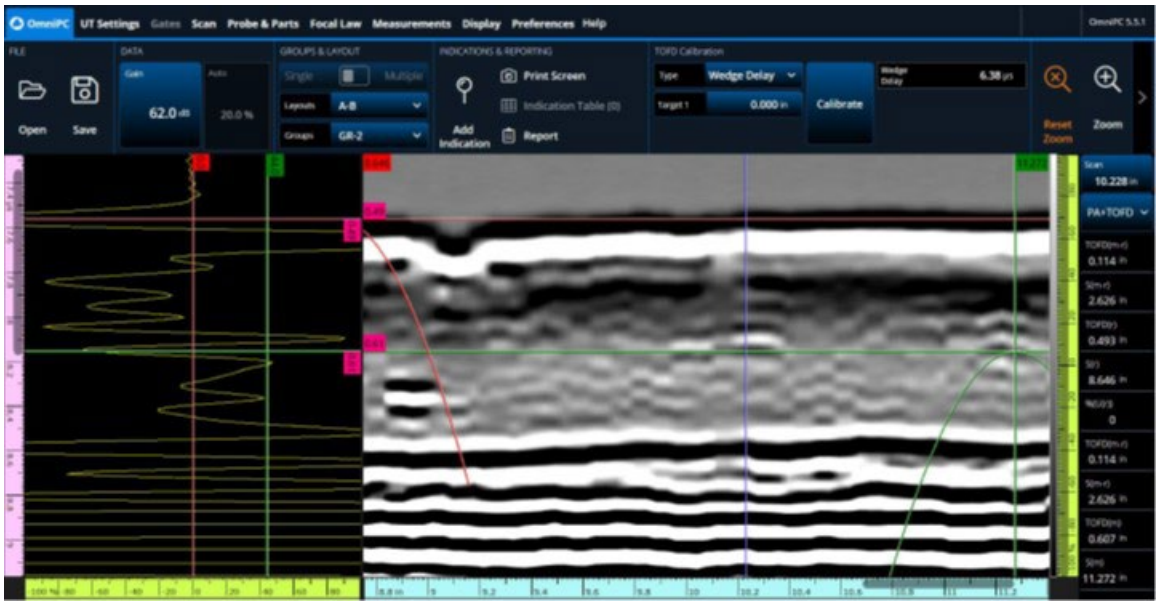
Figure 190. TOFD indication of defect at Location F in test panel TTCI-2

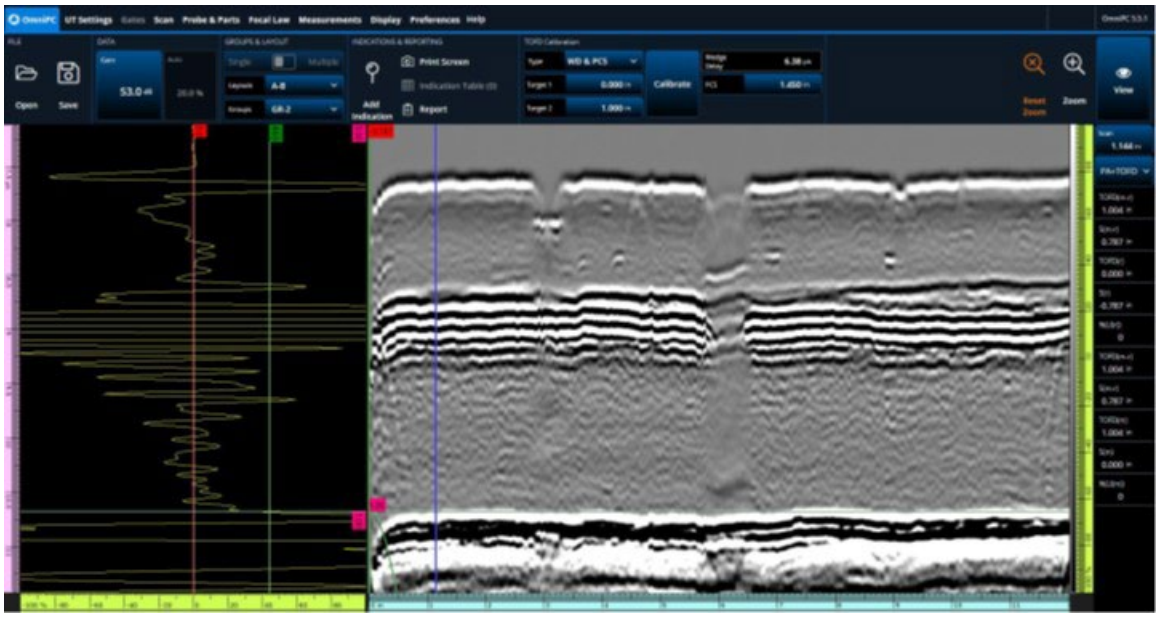
Figure 191. TOFD indication of defect at Location G in test panel TTCI-2
