A Feasibility Study on Advanced Nondestructive Evaluation (NDE) Methods to Characterize Weld Defects in Railroad Tank Cars

DOT/FRA/ORD-23/02

Final Report | January 2023

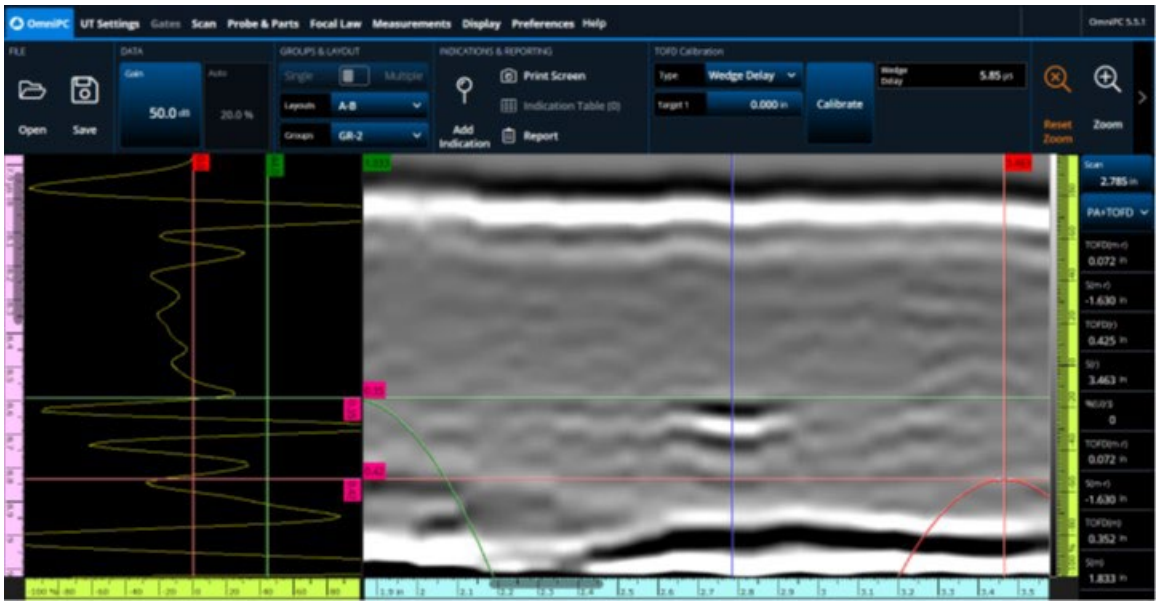
Figure 192. TOFD indication of defect at Location 1 in test panel MG-6

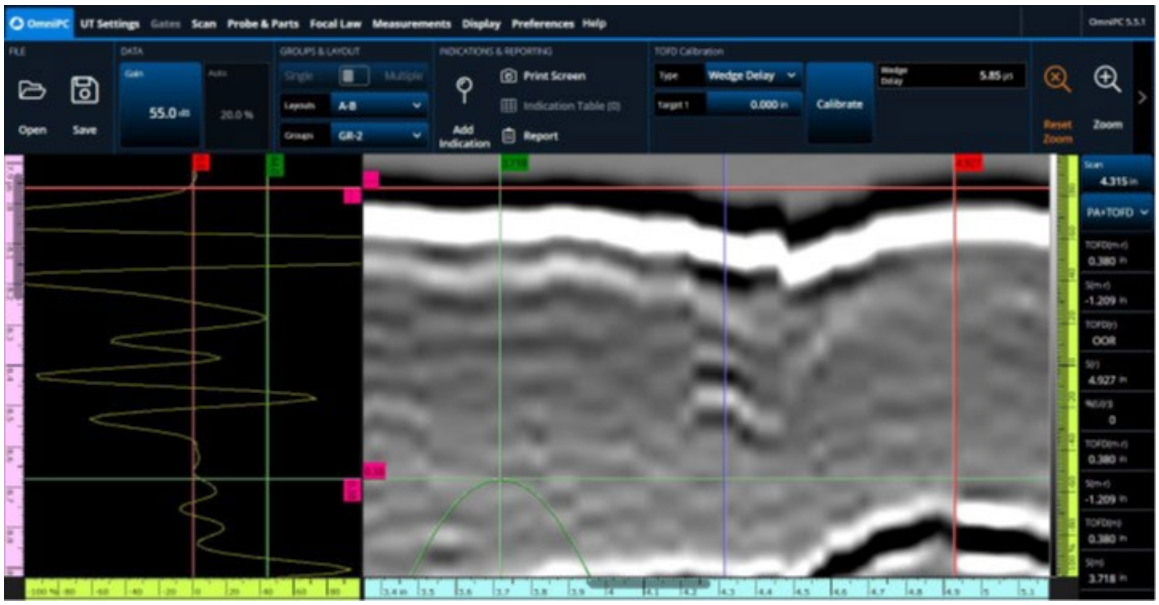
Figure 193. TOFD indication of defect at Location 2 in test panel MG-6

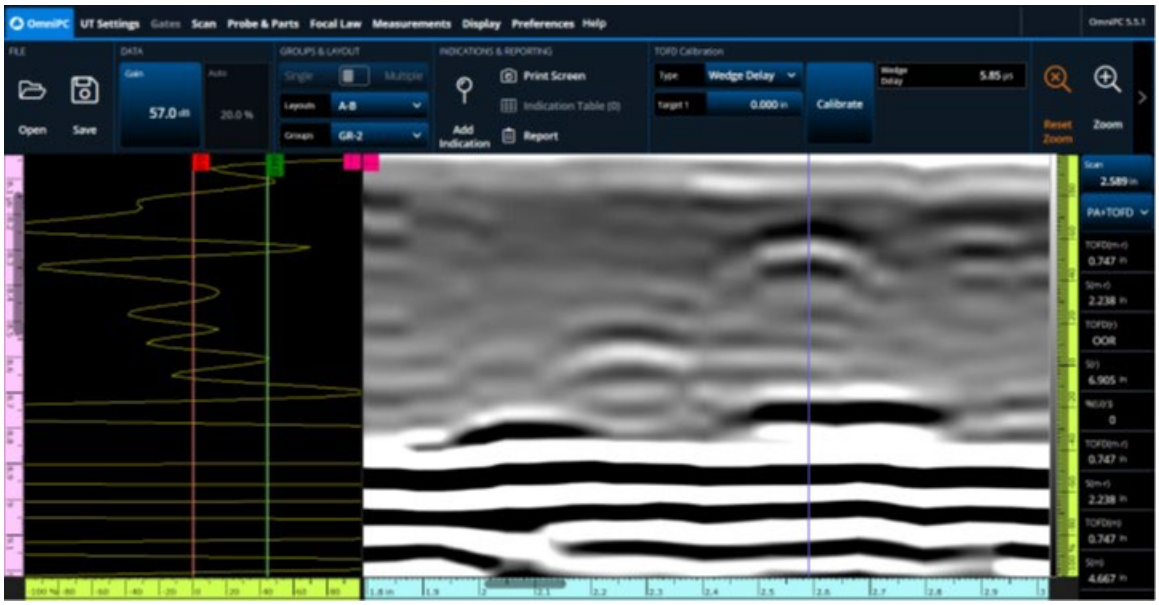
Figure 196. TOFD indication of defect at Location 1 in test panel MG-13

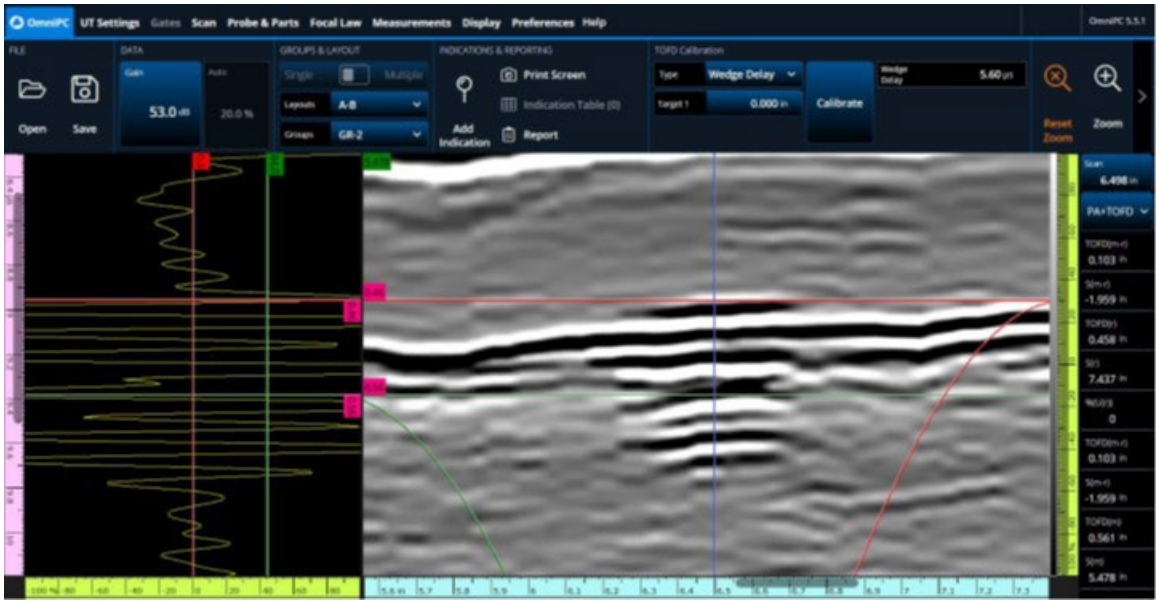
Figure 197. TOFD indication of defect at Location 2 in test panel MG-13

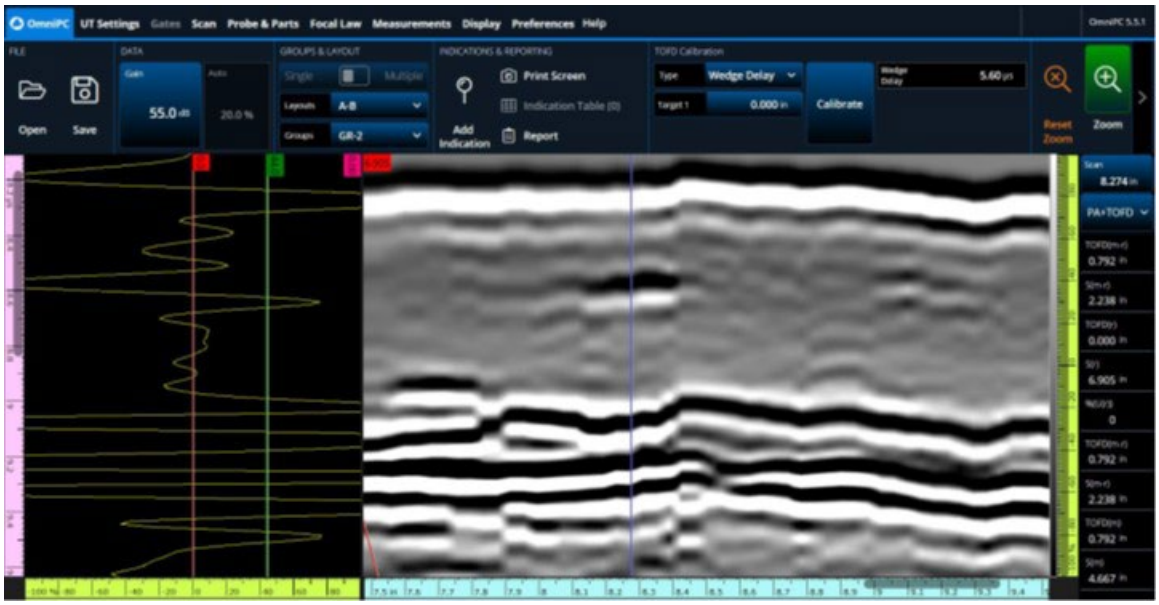
Figure 198. TOFD indication of defect at Location 3 in test panel MG-13

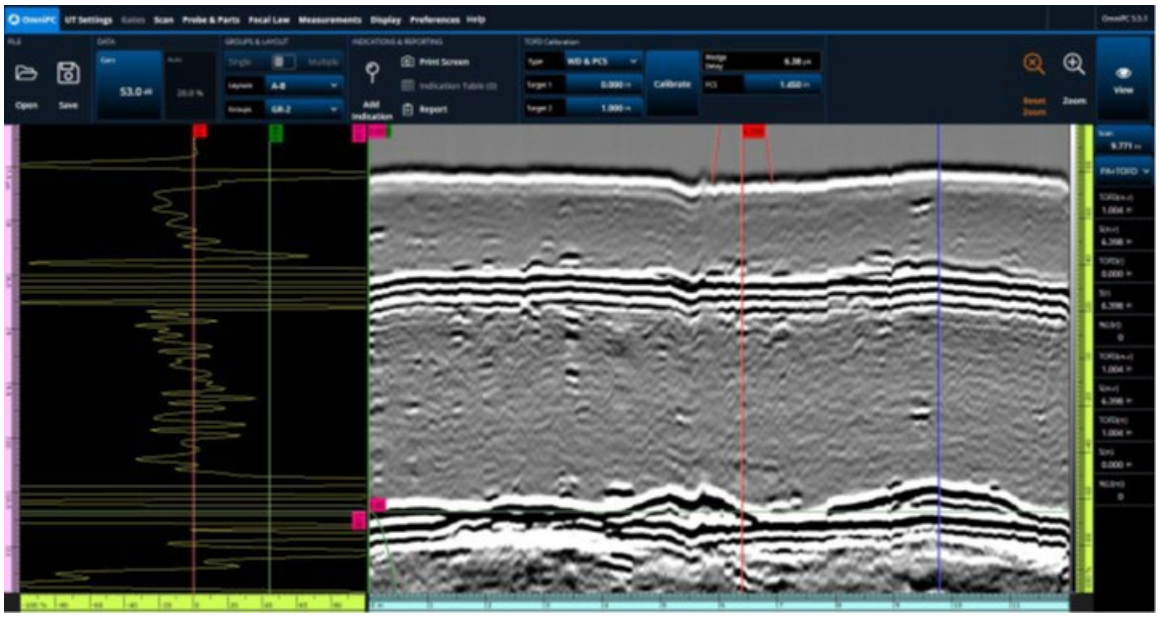
Figure 199. TOFD full scan of the test panel MG-13

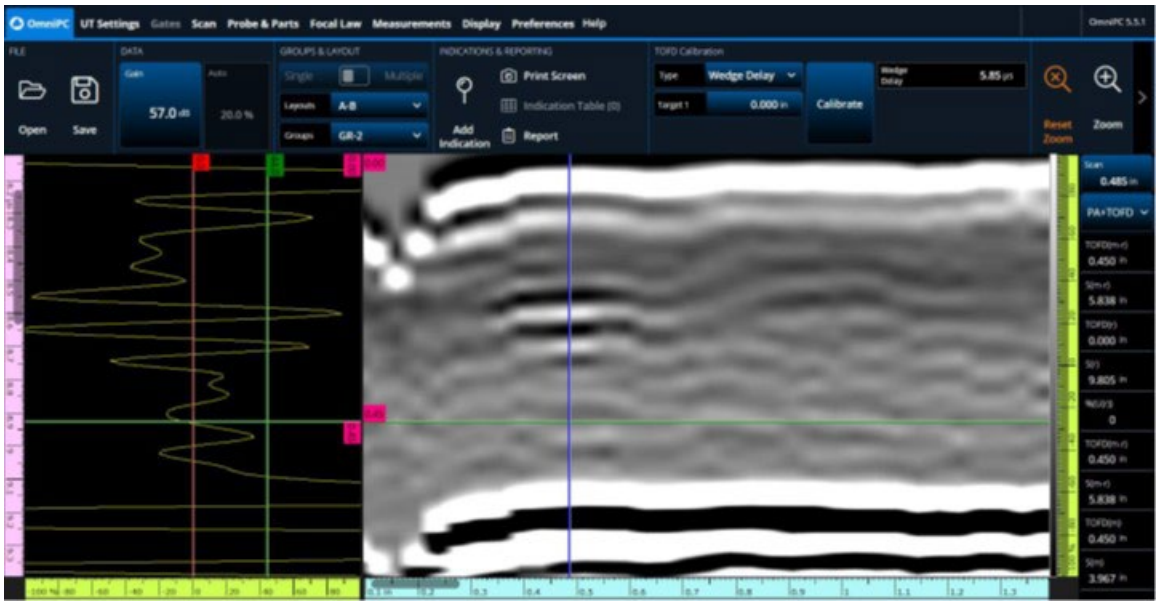
Figure 200. TOFD indication of defect at Location 1 in test panel MG-16

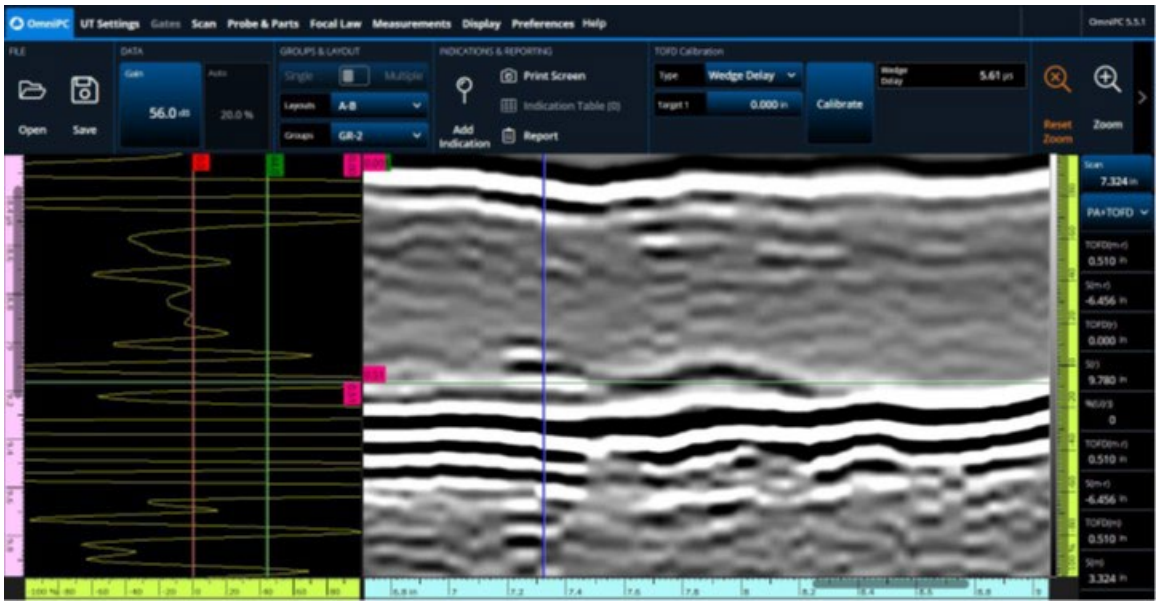
Figure 202. TOFD indication of defect at Location 3 in test panel MG-16
