Quantifying and Enhancing Puncture Resistance in Railroad Tank Cars Carrying Hazardous Materials

Phase I: Preliminary Study

September 1, 2006

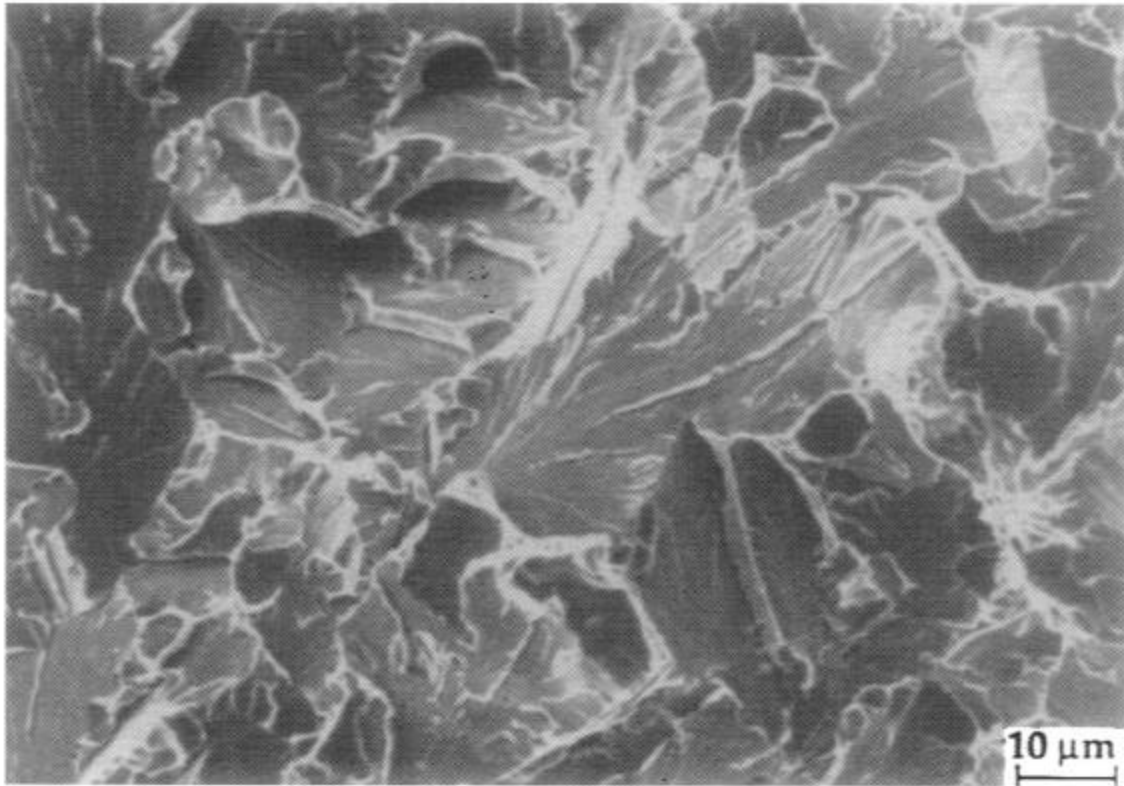
A photograph of a brittle fracture in a tank car is shown in Figure 2.2 [1]. The fracture surface in a typical brittle failure is flat and is perpendicular to the principal stress direction. In coarse-grained steels, shiny facets can be seen at low magnifications. Higher magnifications are necessary to discern cleavage facets in fine-grained steels. Figure 2.3 is a scanning electron microscope (SEM) photograph of cleavage in a low-alloy steel. The lines on each facet are called *river patterns*.

**FIGURE 2.2 Brittle fracture in an anhydrous ammonia tank car that derailed near Minot, ND [1].**

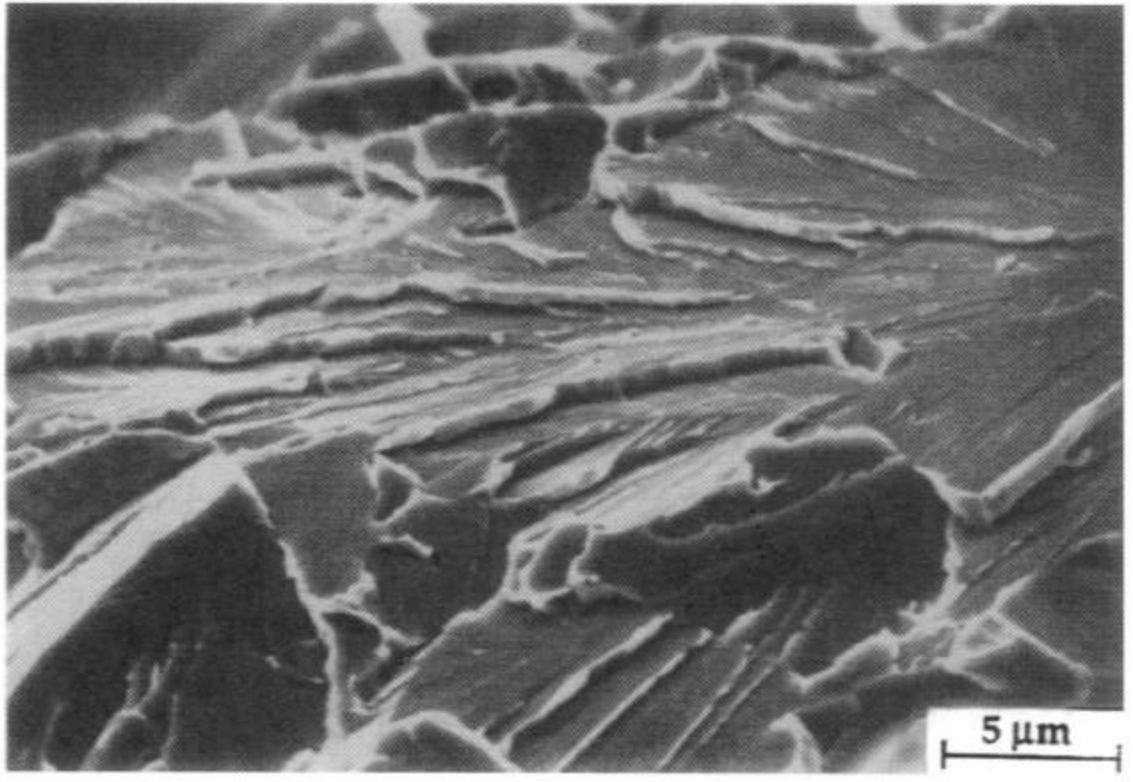
The formation of river patterns as a result of the twist angle between cleavage planes in adjoining grains is illustrated in Figure 2.4. When the crack reaches a grain boundary, it must immediately change orientations to accommodate the nearest cleavage plane on the adjoining grain. This causes the crack to split into a number of parallel fracture planes. These parallel planes link up by tearing. As the fracture propagates across the grain, the parallel fracture planes merge. This process is repeated when the cleavage crack reaches another grain boundary. The river patterns can be used to infer the crack propagation direction on the microscopic scale. Figure 2.5 is an SEM photograph that shows a close-up of river patterns in a low-alloy steel. The resistance to cleavage fracture increases with decreasing grain size, due in large part to the energy dissipation that occurs when cleavage cracks cross grain boundaries.

**FIGURE 2.4 Formation of river patterns as a result of cleavage fracture crossing a twist boundary [6].**

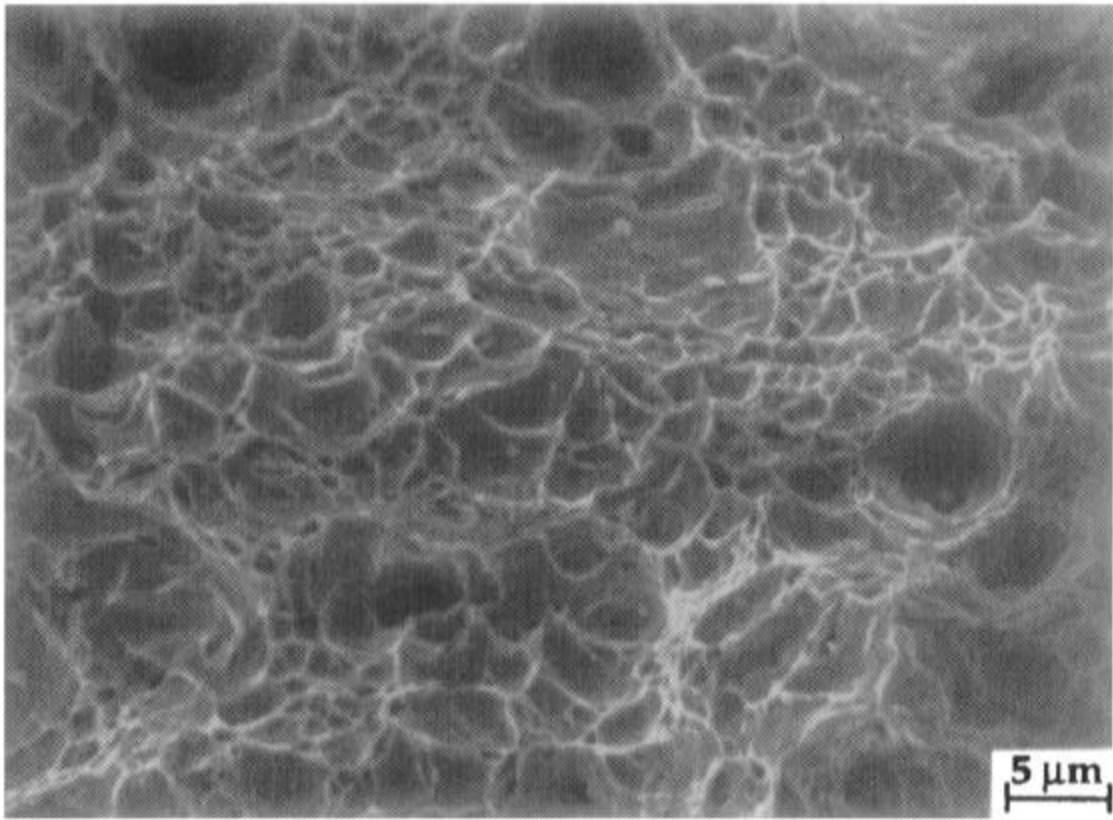
The microscopic processes that result in ductile fracture are illustrated in Figure 2.6 [6]. Microvoids that nucleate at inclusions grow as a result of plastic strain. Plastic strain concentrates between voids, resulting in local necking and coalescence (fracture). Figure 2.7 is an SEM photograph of the fracture surface of a material that failed by microvoid coalescence.

**FIGURE 2.6 Void nucleation, growth, and coalescence in metals [6].**

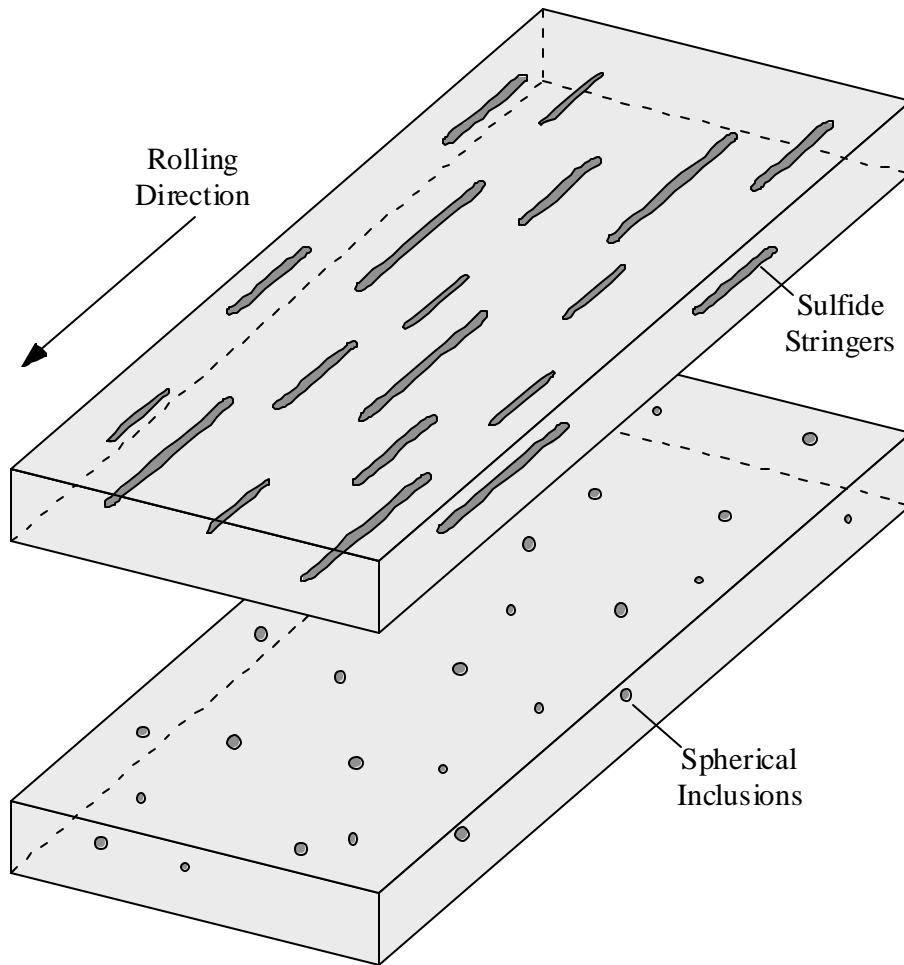
Figure 2.11 illustrates two inclusion morphologies in steel. When a steel plate is hot rolled, inclusions tend to elongate into sulfide stringers, as the upper sketch in Fig. 2.11 illustrates. The goal of sulfide shape control is to create spherical inclusions, as illustrated in the lower sketch. In the past, sulfide shape control was accomplished by adding small amounts of rare earth metals to the molten steel. This practice tended to result in weldability problems, however. More recently, sulfide shape control has typically been achieved through CaSi additions, which have the added benefit of reducing the sulfur content in the steel.

FIGURE 2.11 Sulfide shape control results in spherical inclusions instead of sulfide stringers.

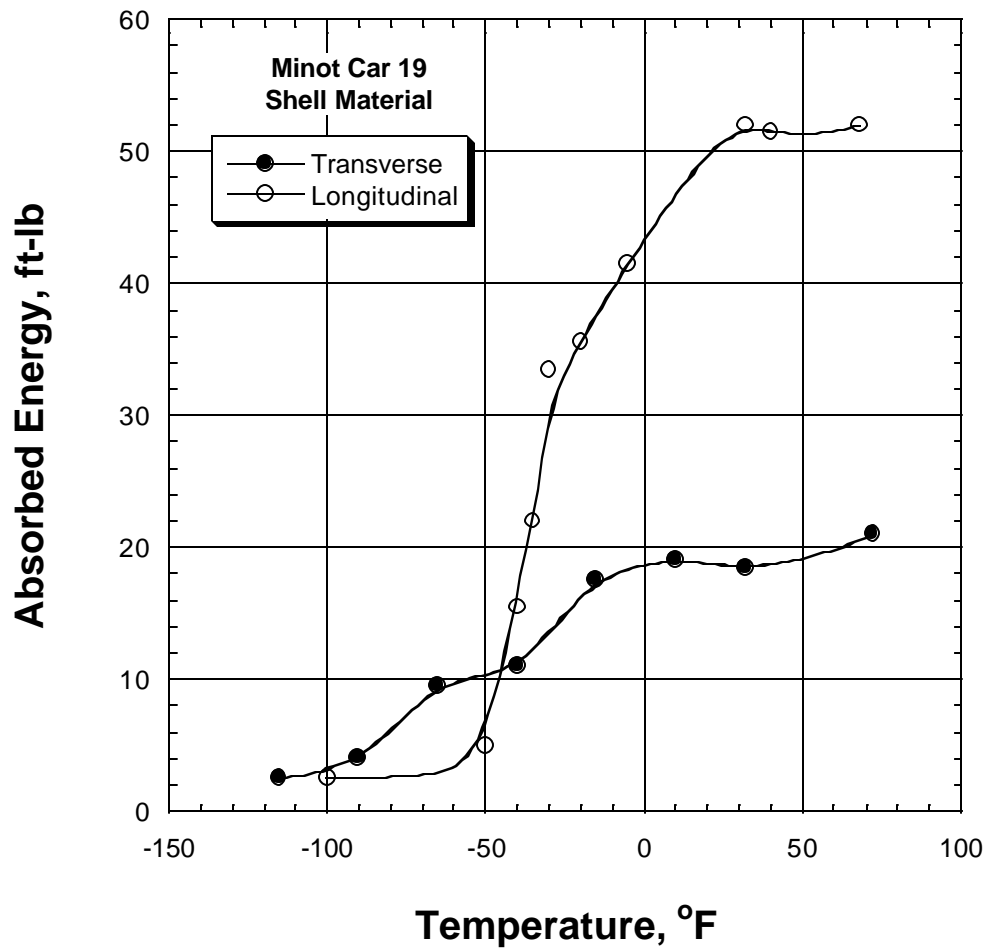
As a result of the Minot derailment, a total of 7 anhydrous ammonia cars lost all of their lading due to punctures and fractures through the head and/or shell. Each of these cars was built in the 1970s. Testing on head and shell samples extracted from the damaged cars indicated that the steel met the tensile and chemistry requirements of the TC 128B specification that existed at the time of construction [1, 2]. The current TC 128B specification limits the sulfur content to 0.015%, while the limit was 0.040% when the Minot cars were built. Another substantial change in the specification for tank car steels over this period occurred in 1989, when a requirement to normalize the head and shell steel was introduced. To this day, the TC 128B specification does not require sulfide shape control in the steelmaking process.

FIGURE 2.13 Effect of CVN specimen orientation on toughness in an ammonia tank car that derailed near Minot, ND [2].

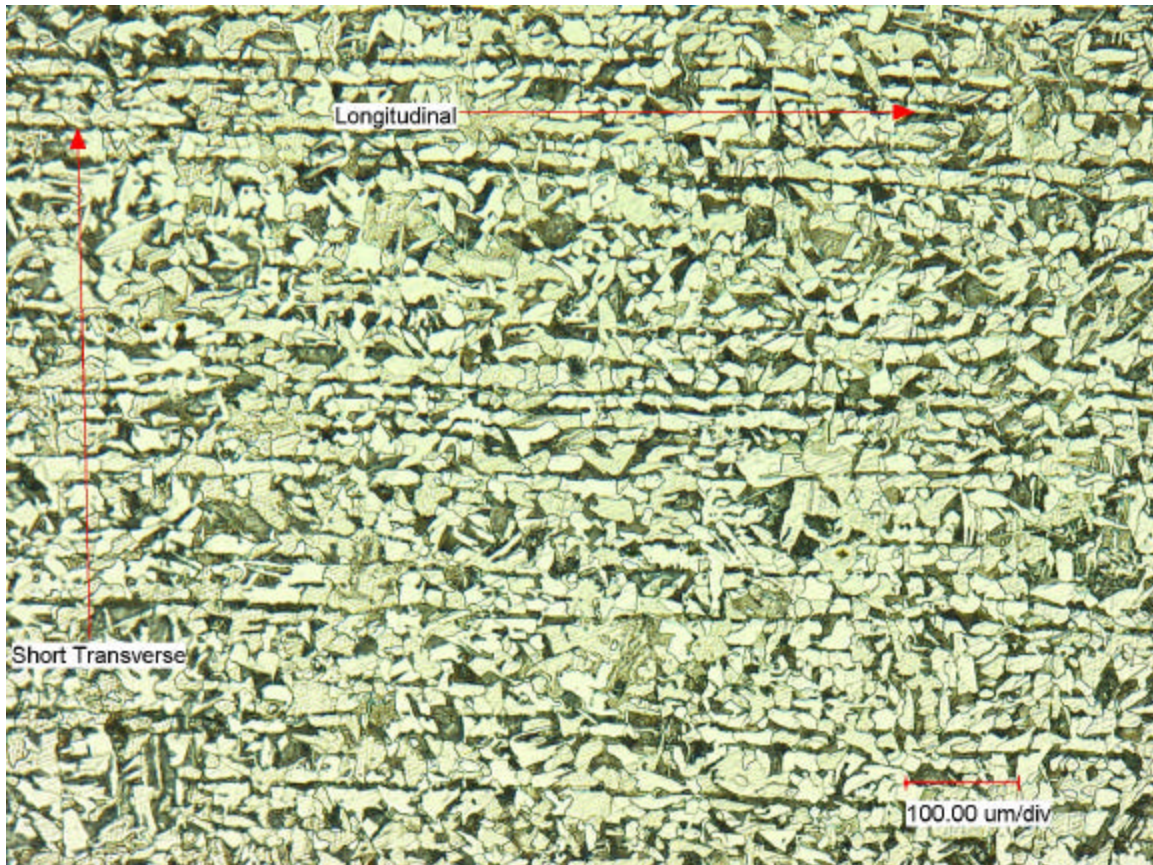
FIGURE 2.15 Microstructure of a 1970s vintage TC 128 B steel sample taken from the shell of Minot Car 22 [11].

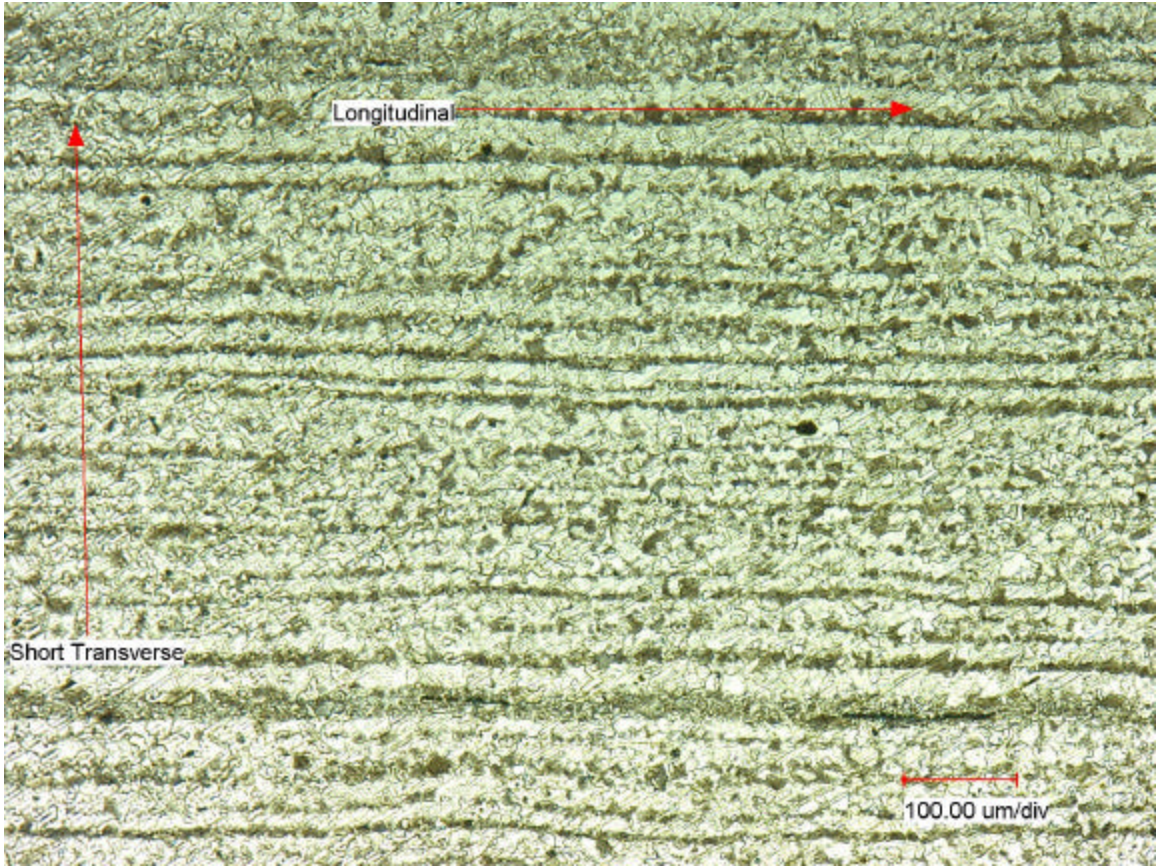
During the Minot investigation, various tests were performed on steels from the subject cars, as well as on exemplar tank car steels. One of the exemplar materials was a 1999 vintage normalized TC 128B plate. Figures 2.15 and 2.16 compare the microstructures of a 1970s vintage steel from the Minot derailment with the modern steel plate. The most obvious difference is that the modern normalized plate has a finer ferrite grain size than the older steel, as expected. The modern plate also has a lower sulfur content than the older steel. Apparently, neither plate was manufactured with sulfide shape control, as discussed below.

FIGURE 2.16 Microstructure of a 1999 vintage normalized plate of TC 128B steel [11].

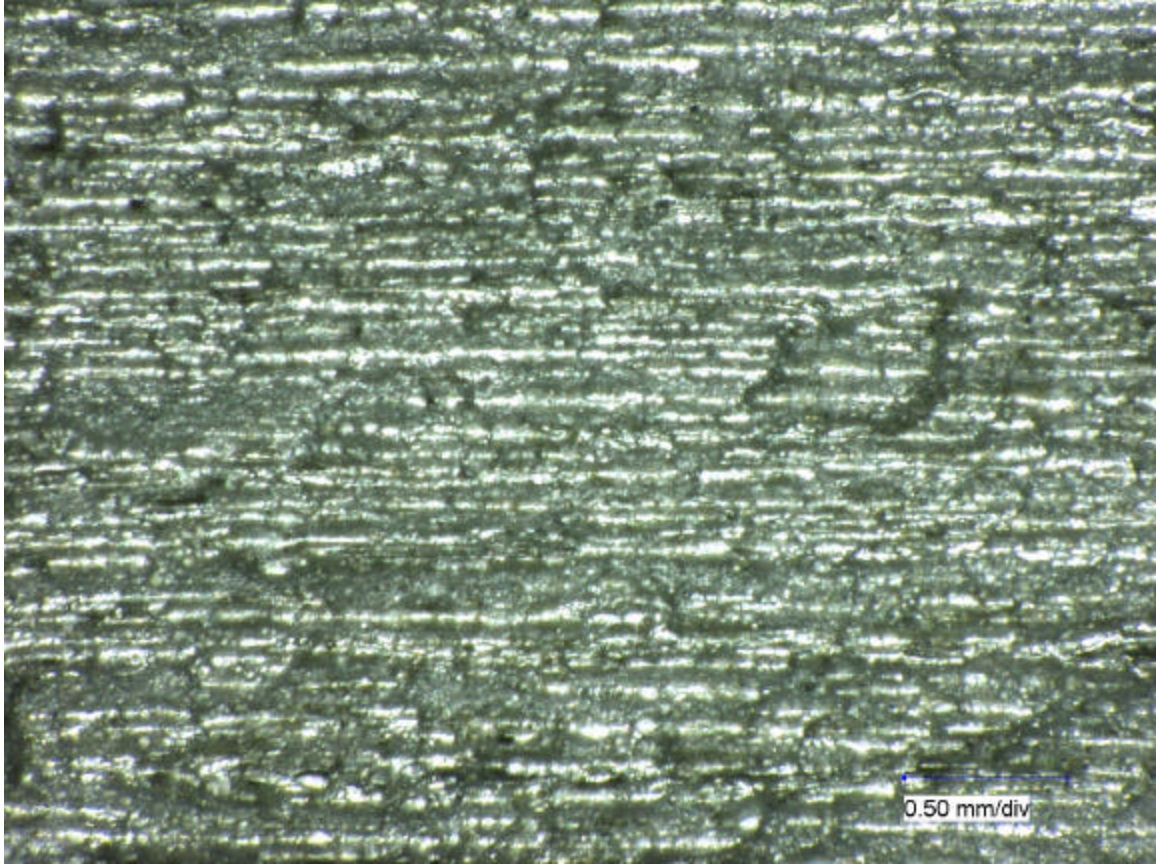
The Minot testing program included high-rate fracture mechanics tests, which were performed at Southwest Research Institute in San Antonio [11]. Figures 2.17 and 2.18 compare the fracture surfaces of specimens extracted from the two plates whose microstructures are shown in Figs. 2.15 and 2.16, respectively. The crack propagation direction was longitudinal in both cases. The fracture surface in Fig. 2.17 has a "corrugated roof" appearance. Fracture along sulfide stringers created troughs, which reflect the light in the photograph. The fracture surface of the modern plate (Fig. 2.18) also shows troughs, which are indicative of sulfide stringers. There are fewer such features on Fig. 2.18 than on Fig. 2.17, which is due to lower sulfur content in the former case. Nevertheless, the upper-shelf toughness of modern tank car steels could be significantly improved through sulfide shape control.

FIGURE 2.17 Fracture surface from a high-rate toughness test on the shell steel from Minot Car 22 (Fig. 2.15), tested at 37°F [11]. The shiny areas correspond to troughs that formerly contained sulfide stringers.

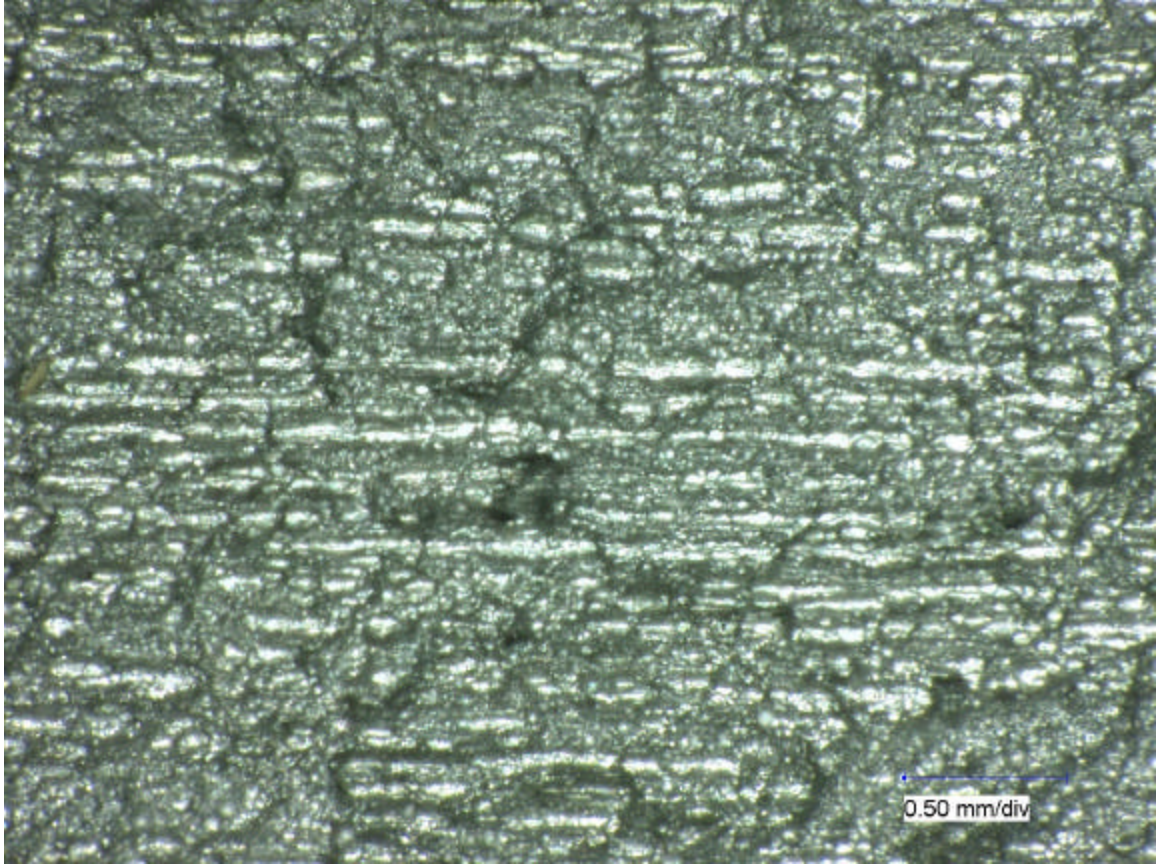
FIGURE 2.18 Fracture surface from a high-rate toughness test on a modern normalized TC 128B plate (Fig. 2.16), tested at ambient temperature [11]. Although the sulfur content is lower than in the 1970s vintage steel from Minot Car 22, numerous sulfide stringers are evident. Currently, the TC 128 B specification does not require sulfide shape control.

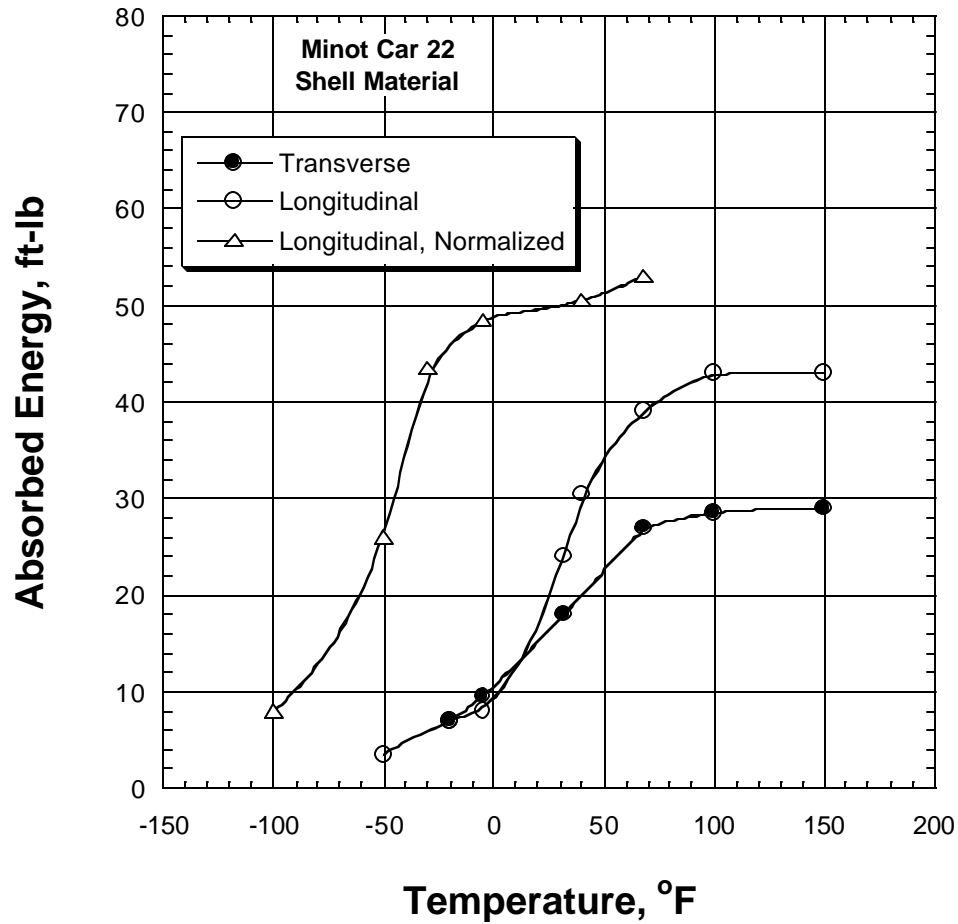
In order to demonstrate the effect of normalization on toughness, the NTSB heat treated a sample extracted from one of the cars damaged in the Minot derailment [1, 2]. The resulting toughness comparison is plotted in Fig. 2.19. There is a difference in upper-shelf toughness between longitudinal and transverse CVN specimens, as was the case in Fig. 2.13. When this plate was subject to a normalizing heat treatment, the expected leftward shift in the transition curve occurred. Moreover, there was a slight improvement

FIGURE 2.19 Effect of specimen orientation and normalization on impact toughness in a 1970s vintage TC 128B steel from an ammonia tank car that derailed near Minot, ND [1].

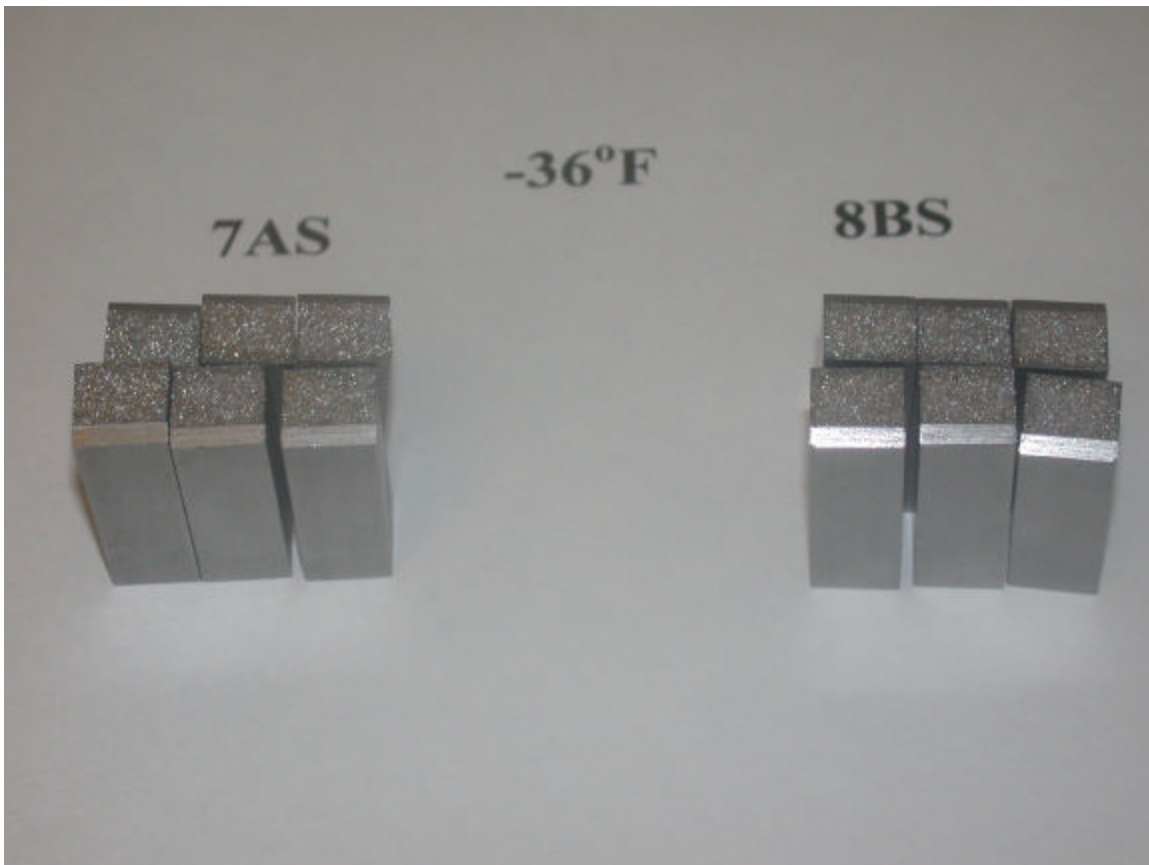
The effect of a pre-existing notch on fracture behavior is demonstrated in Figs. 2.22 and 2.23. During the Minot investigation conducted by the authors, Charpy testing was performed on exemplar steels taken from two retired tank cars that were built in 1967 and 1971 [11]. Standard CVN specimens tested at -36^{o}F absorbed energies ranging from 3 to 6 ft-lb, and all fracture surfaces were 100% brittle. Figure 2.22 is a photograph of the broken specimens. Figure 2.23 is a photograph of two unnotched specimens impact tested at -36^{o}F in a Charpy machine with a 300-ft-lb capacity. Both specimens bent but did not break, which indicates that the fracture energy for the unnotched specimens is at least two orders of magnitude higher than for notched specimens at this temperature. These specimens absorbed a significant amount of energy without fracturing, despite being at a temperature that is on the lower shelf of the CVN toughness curve.

FIGURE 2.22 Charpy specimens tested at -36°F, where the fracture is 100% brittle. Coupons 7AS and 8BS were taken from retired tank cars built in 1967 and 1971, respectively.

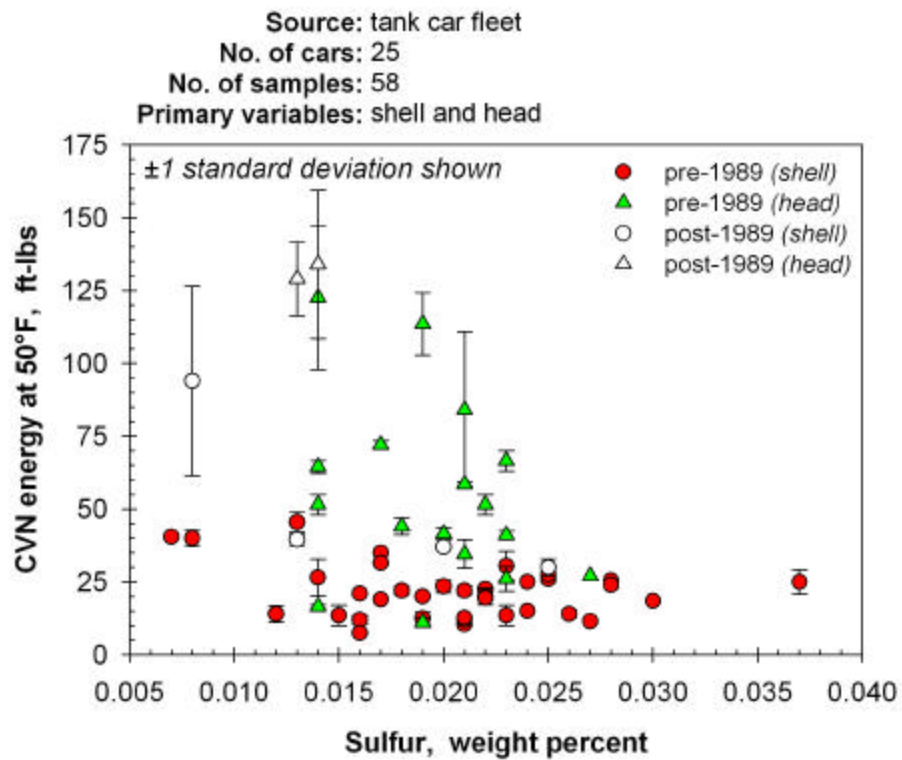
An ongoing project at Southwest Research Institute [14] is evaluating the properties of various generations of tank car steels. Figure 2.27 is a plot of transverse Charpy energy at +50°F as a function of sulfur content. There is considerable scatter, and a well-defined trend in the data is not readily apparent. However, the data for pre-1989 shells correspond to steels that have not been normalized, so the Charpy energies do not necessarily reflect upper shelf behavior. Figure 2.28 is a re-plot of the data with these points removed. The trend of increasing upper shelf toughness with decreasing sulfur content is much clearer, although there is still significant scatter. Two data points for pre-1989 heads have Charpy energies below 25 ft-lb, so these materials are probably not on the upper shelf at +50°F. Much of the scatter in upper-shelf transverse toughness is likely caused by variability in the sulfide stringer shape. Sulfide shape control should reduce this scatter and improve the toughness in the transverse orientation.

FIGURE 2.27 Charpy energy at +50°F versus sulfur content for tank car steels [14].

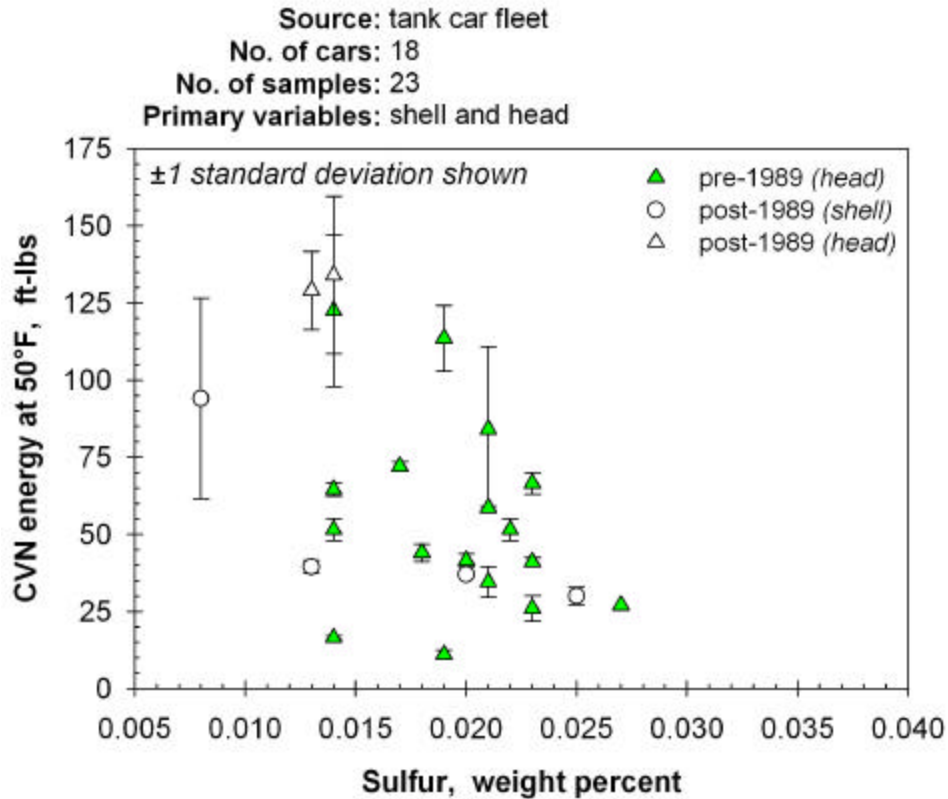
FIGURE 2.28 Same as Fig. 2.27 but with data points removed for non-normalized shell material [14].
