Federal Railroad Administration
Office of Safety
Headquarters Assigned
Accident Investigation Report
HQ-2008-30

Amtrak (ATK)
Windsor Locks, CT
March 17, 2008

FRA FACTUAL RAILROAD ACCIDENT REPORT

FRA File # HQ-2008-30

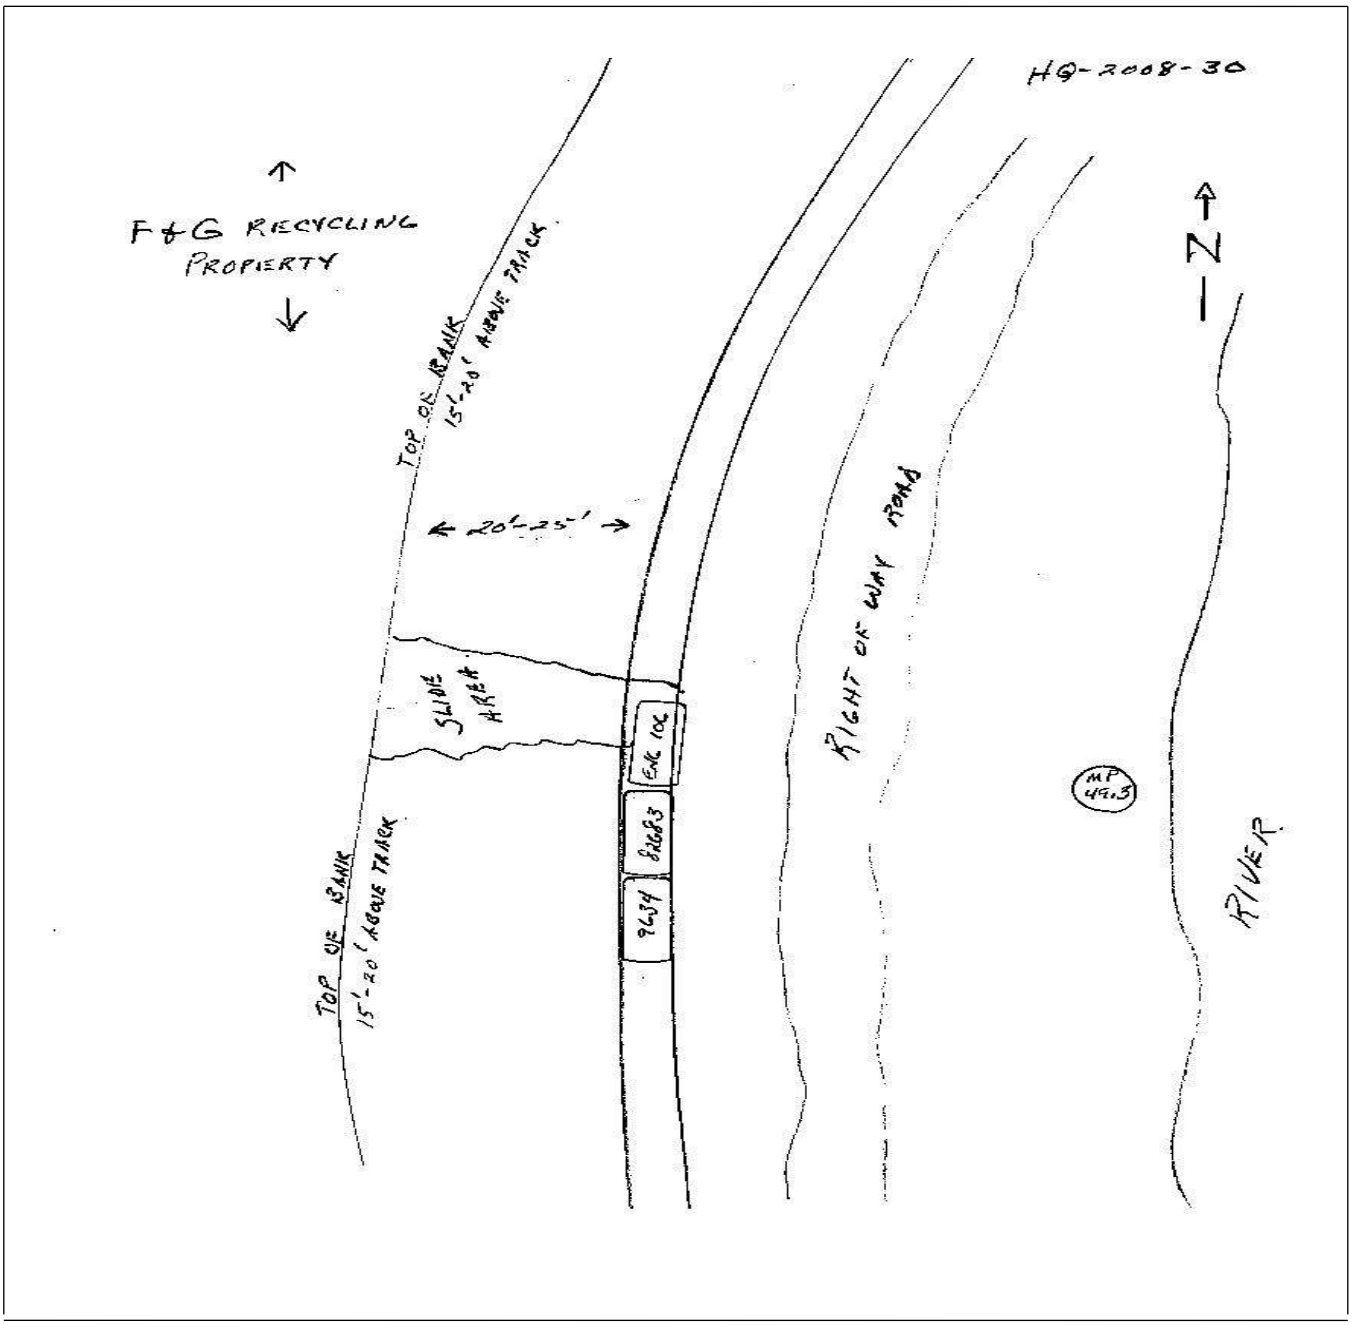
136. DRAW A SKETCH OF ACCIDENT AREA INCLUDING ALL TRACKS, SIGNALS, SWITCHES, STRUCTURES, OBJECTS, ETC., INVOLVED.

On March 17, 2008, at approximately 9:56 a.m. EST Amtrak (ATK) Passenger Train # 490 operating northbound on the Amtrak Springfield Line at milepost 49.3 north of Windsor Locks, CT in Hartford County derailed locomotive # AMT 106. The engineer of northbound ATK Train # 490 approached the area and slowed for a speed restriction of 30 mph beginning at milepost 49.3. He observed tree branches covering the track ahead and as he got closer, he noticed a mud slide with large trees on the track. The engineer put the train into emergency and told the Conductor to brace himself for impact. The locomotive hit the mudslide and derailed upright to the east side in line with the track.

The F & G Recycling facility is located on the west side of the track in the vicinity of milepost 49.3. Over an extended period of time an earth berm has been constructed about 15 to 20 feet above the track level and approximately 20 to 25 feet from the track to the west. This bank runs parallel to the track for about a quarter of a mile in this area.

This bank location apparently became saturated by the piles of snow and the recent heavy rains and allowed the bank to become saturated and unstable. The cause of the derailment was a mudslide on the track.
