Federal Railroad Administration
Office of Safety
Headquarters Assigned
Accident Investigation Report
HQ-2008-34

CSX Transportation (CSX)
Richmond, VA
March 27, 2008

FRA FACTUAL RAILROAD ACCIDENT REPORT

FRA File # HQ-2008-34

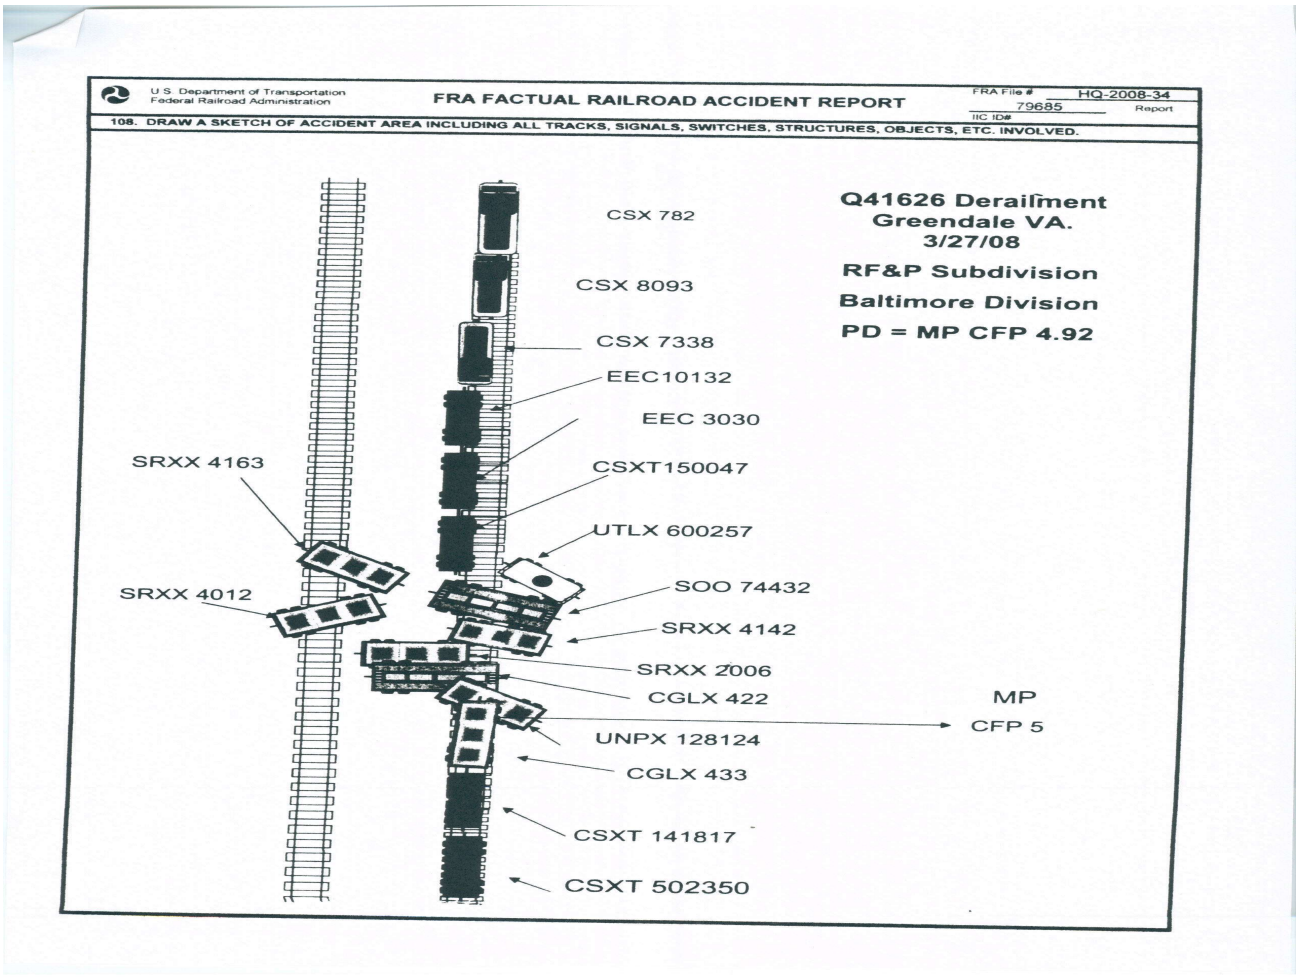
136. DRAW A SKETCH OF ACCIDENT AREA INCLUDING ALL TRACKS, SIGNALS, SWITCHES, STRUCTURES, OBJECTS, ETC., INVOLVED.

The probable cause of the accident was the bolts holding the coupler pin retainer plate became either loose or were missing allowing the retainer plate to move, drop, or swing out which allowed the vertical pin to fall out of the rail car (DETX994371). This in turn caused the coupler to fall out causing the train to derail. FRA Code E39C.
