FOURTH FIVE-YEAR REVIEW REPORT FOR ORMET CORP. SUPERFUND SITE MONROE COUNTY, OHIO

U.S. Environmental Protection Agency Region 5 Chicago, Illinois

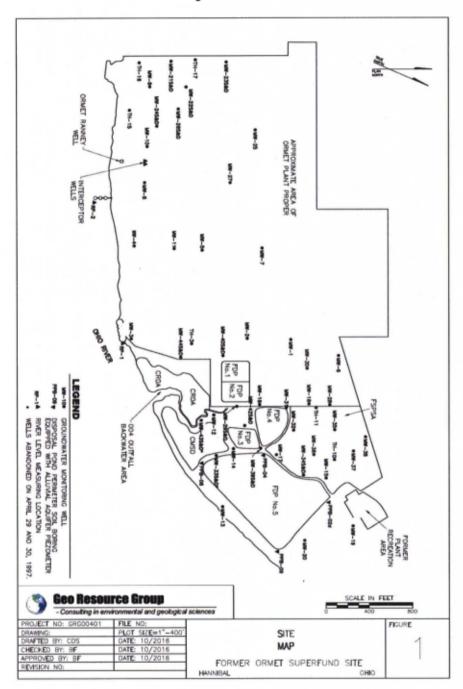
Figure 1. Base Site map of Ormet Corp. Superfund Site (modified from 2016 Remedial Action Groundwater Monitoring Report) showing Former Spent Potliner Storage Area (FSPSA), Construction Materials Scrap Dump (CMSD), CRDA (Carbon Runoff and Deposition Area), Former Disposal Ponds (FDP) No. 1-5, former Ormet Plant Proper, and all monitoring well locations.

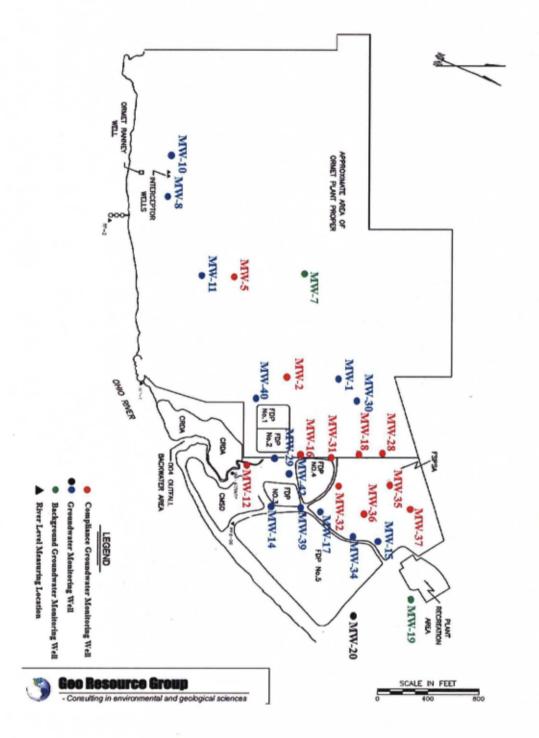
Figure 2. Site Map of Ormet Corp. Superfund Site and former Ormet facility (modified from 2016 Remedial Action Groundwater Monitoring Report) showing compliance wells (red); groundwater monitoring wells: sampled (blue), background (green), additional wells of interested (black).

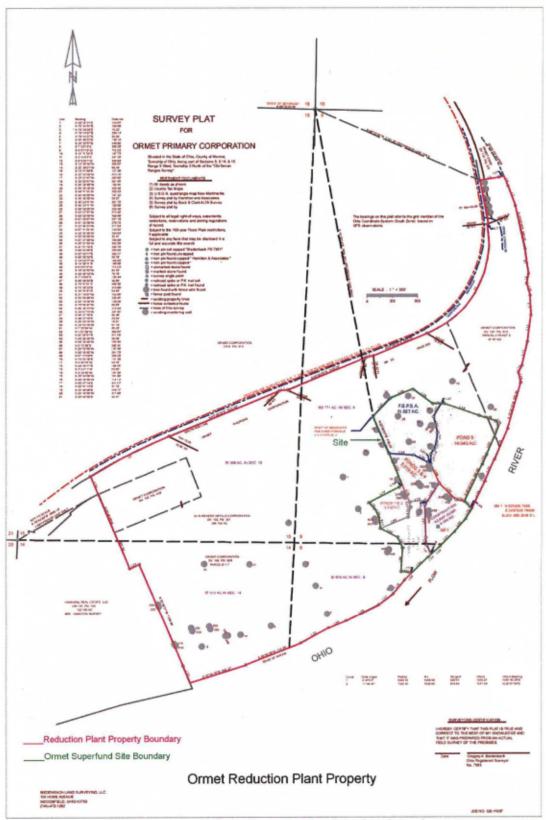
Figure 6. Ormet Corp. ICs map showing Superfund Site and reduction plant boundary.
