U.S. Department of  
Transportation  
Federal Railroad  
Administration

## Retrofit and Full-Scale Testing of a State-of-the-Art End Structure on a Budd M1 Cab Car

1. AGENCY USE ONLY (Leave blank)		2. REPORT DATE August 2021		3. REPORT TYPE AND DATES COVERED Final Report July 2007 – July 2009
4. TITLE AND SUBTITLE Retrofit and Full-Scale Testing of a State-of-the-Art End Structure on a Budd M1 Cab Car			5. FUNDING NUMBERS DTRS57-04-D-30008

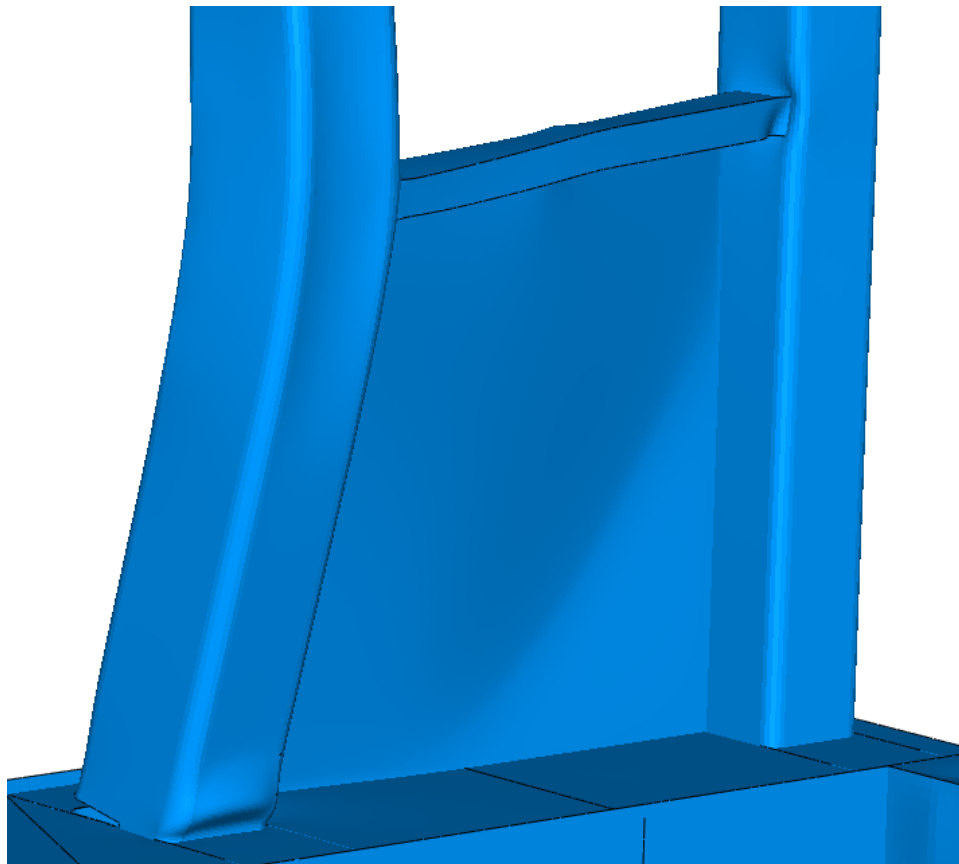
The dynamic collision post impact test was conducted in April 2008. Pre-test model predictions of this test indicated that fracture would occur at the front base of the collision post, at its connection to the end frame, much like what occurred in the corner post test. The deformed post is shown in Figure 29. Deformation of the post into the occupied volume was predicted to be 6.4 inches.

**Figure 29. Pre-test prediction of collision post deformation following the dynamic collision post impact**

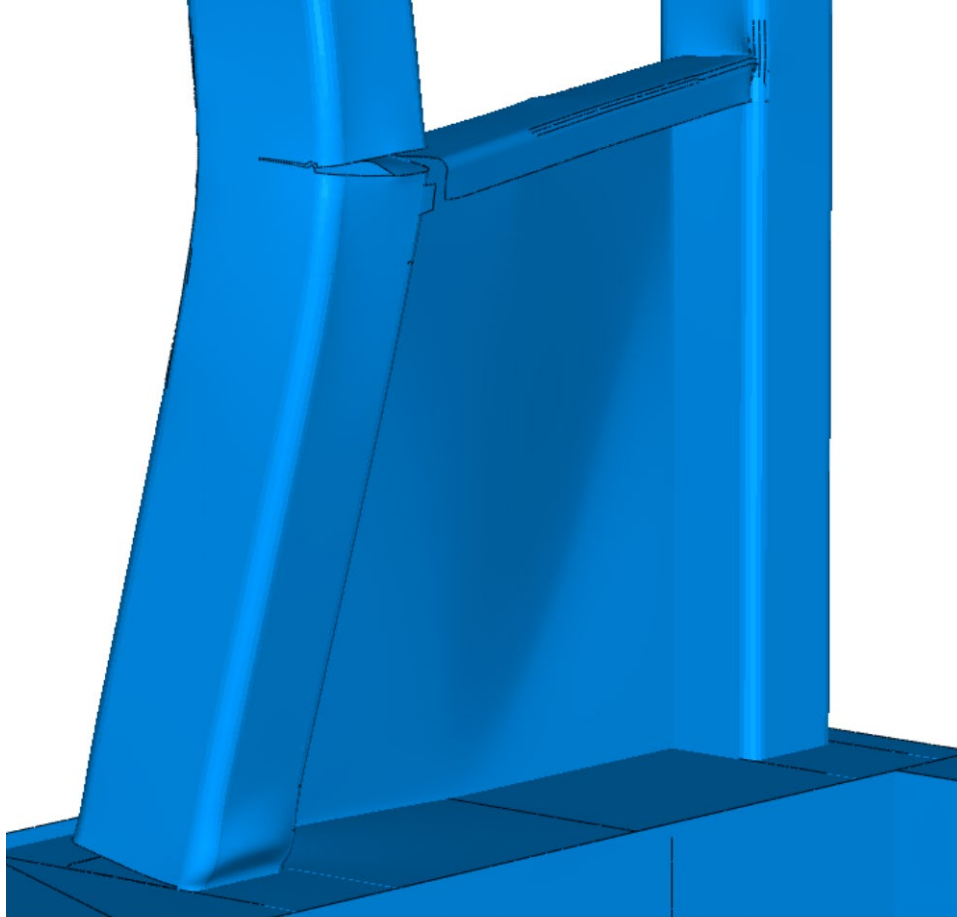
With these changes to the failure parameters used in the FE model of the collision post impact, the calculated extent of fracture and deformation of the post was consistent with test results, as illustrated in [Figure 32](#). The predicted extent of collision post permanent deformation was found to be 6.9 inches. This was an increase from 6.4 inches for the baseline model and compared favorably to the measured deformation of 7.4 inches.

**Figure 32. Predicted deformation of the collision post following the dynamic collision post impact (revised model)**

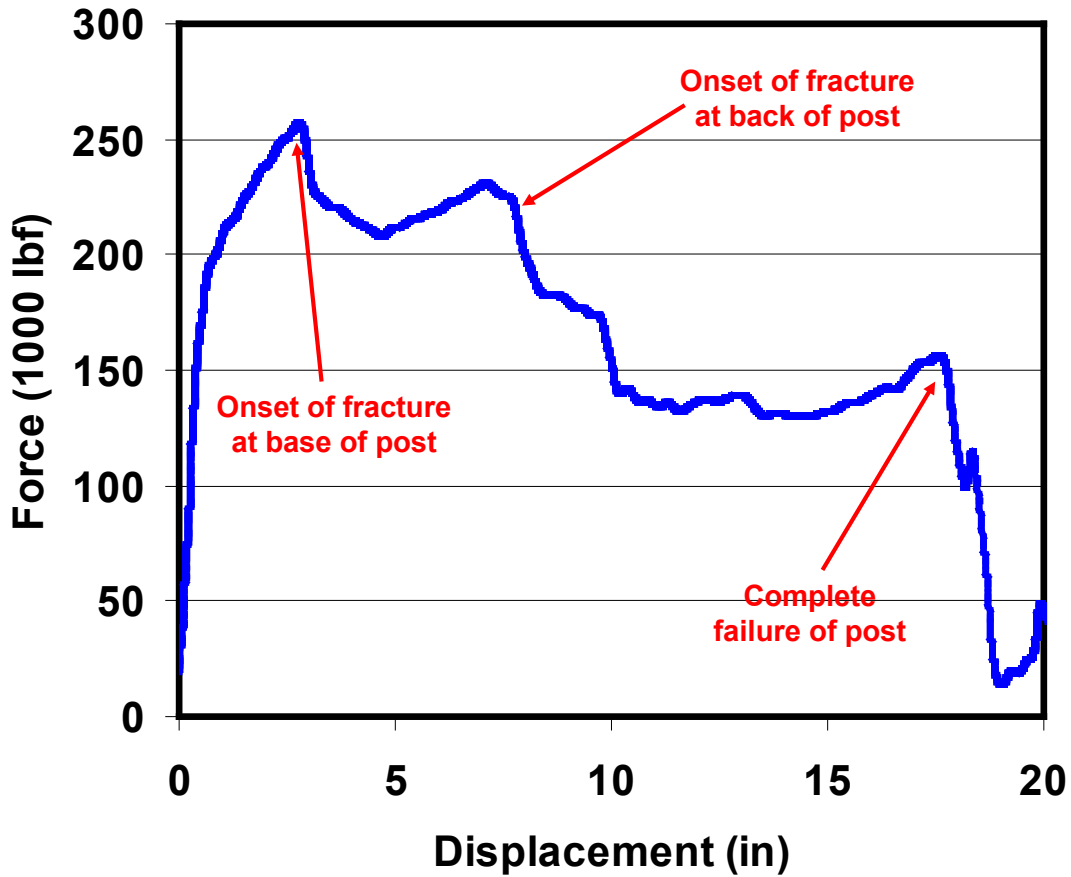
The FE model was next used to predict the results of the quasi-static collision post test. As shown in [Figure 33](#), the model predicted that the load would rise to about 260,000 lbf after 3 inches of post displacement, whereupon fracture would initiate at the front base of the post. Fracture at the back of the post was not expected to occur until after about 8 inches of post displacement. The required 135,000 ft-lbf of energy absorption was predicted to be reached after only 7.7 inches of crush. [Figure 34](#) shows the predicted deformation of the end frame after loading ram displacement of 8 inches (failure initiation behind post) and 14 inches (complete failure of post).

Figure 33. Predicted deformation of the collision post during the quasi-static load test

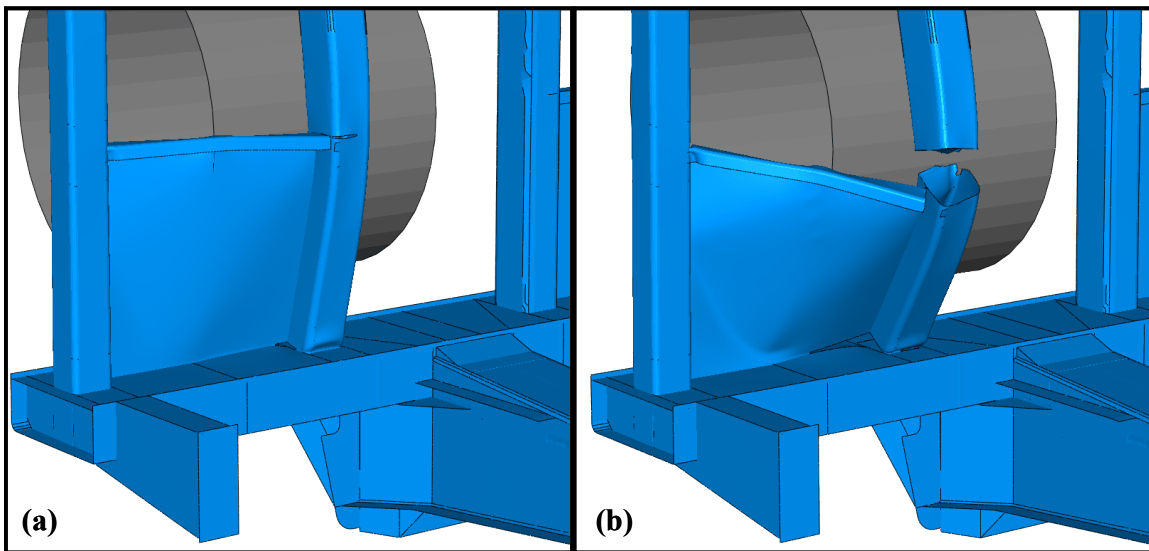
Figure 34. Predicted deformation of the SOA end frame after: (a) 8 inches of ram displacement (failure initiation behind the post and (b) 14 inches of ram displacement (complete separation of post)

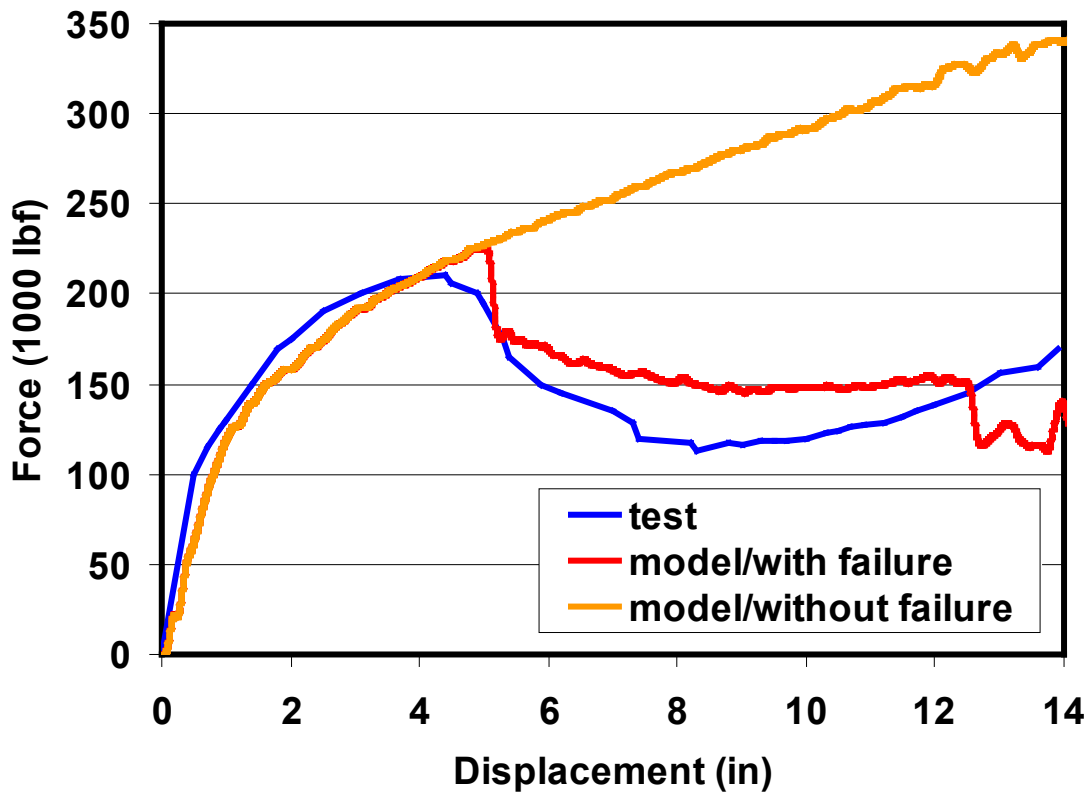
Predictions of force-displacement behavior are compared to test results in Figure 42. Also plotted in this figure is the prediction of force-displacement behavior using a model that did not include material failure. Failure at the front base of the post was predicted to occur after 5 inches of crush. Test results indicated that the failure occurred at this location after about 4.5 inches of crush. Following the initiation of the failure, the load continued to decrease for several inches of displacement before beginning to rise again. The actual drop in load was more significant than the model predicted. This was likely due to differences between the assumed post-initiation response of the material and the actual behavior. Despite this difference, the overall agreement between the predicted curve and the measured curve was excellent. The difference between these two curves and the curve that corresponds to the model prediction without failure clearly illustrated the advantages of accounting for material failure.

**Figure 42. Measured deformation of the collision post following the dynamic collision post impact**

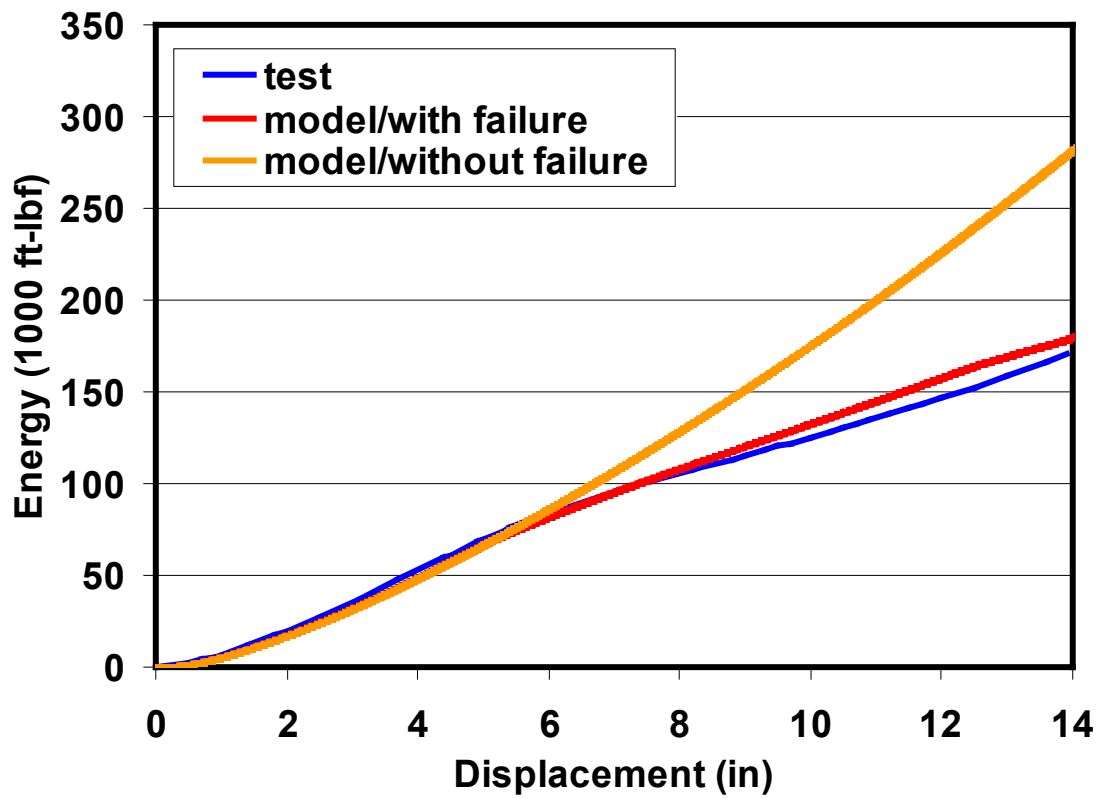
Predictions of energy-displacement behavior are compared to test results in Figure 43. The measured energy absorption after 10 inches of post crush (125,000 ft-lbf) was just a few percent less than the value (133,000 ft-lbf) predicted by the model. This difference was probably attributable to the greater drop in force following the initiation of failure observed in the test. Once again, the difference between these two curves and that for the model without failure highlighted the advantages of material failure modeling.

Figure 43. Energy absorption of the collision post following the dynamic collision post impact

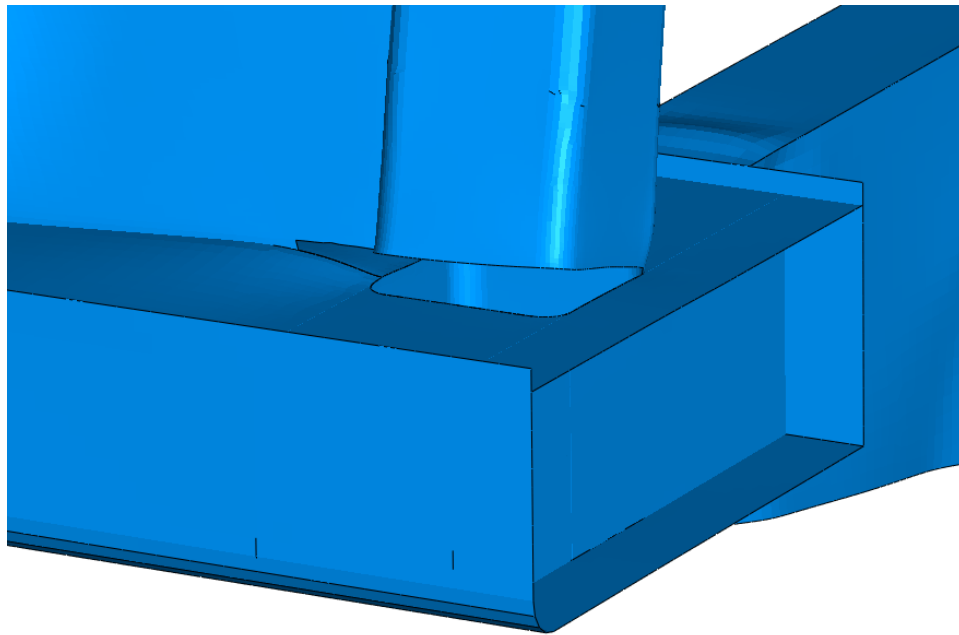
Using measured strength parameters for A710, the steel from which the end frame was constructed, material failure parameters (namely, failure initiation parameters  $C_1$  and  $C_2$ , and the plastic deformation at failure parameter,  $u_f$ ) were modified to best capture the extent of fracture at the base of the post. The deformed end frame mesh following the simulated impact is shown in [Figure D-11](#) and is consistent with the actual extent of fracture and deformation shown in [Figure D-10](#).

**Figure D-11. Predicted deformation of end frame following coil impact**

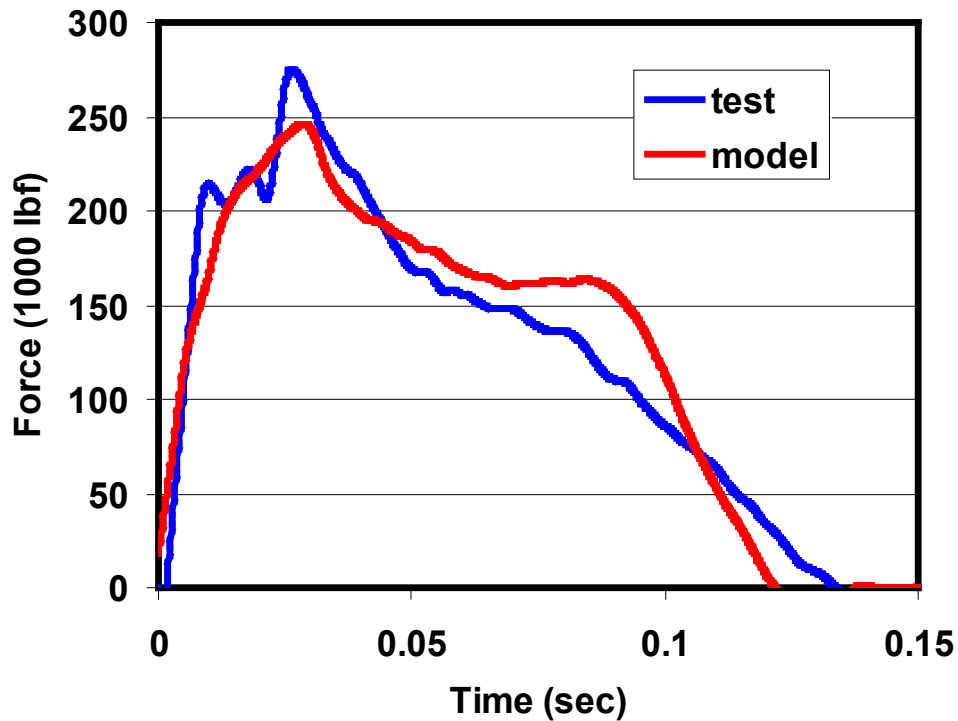
The predicted force-time history is compared with measured data in [Figure D-12](#) and appears to be consistent with test results. The predicted penetration of the coil is about 10.8 inches, as compared with 10.2 inches that were measured.

Figure D-12. Comparison of predicted and measured coil force-time histories
