U.S. Department
of Transportation
Federal Railroad
Administration

Wheel Failure Investigation Program: Phase 2

1. REPORT DATE (DD-MM-YYYY) December 2021		2. REPORT TYPE Technical Report		3. DATES COVERED (From - To) September 2017 – March 2020	
4. TITLE AND SUBTITLE Wheel Failure Investigation Program: Phase 2				5a. CONTRACT NUMBER DTFR53-12-D-00001L	
				5b. GRANT NUMBER	
				5c. PROGRAM ELEMENT NUMBER

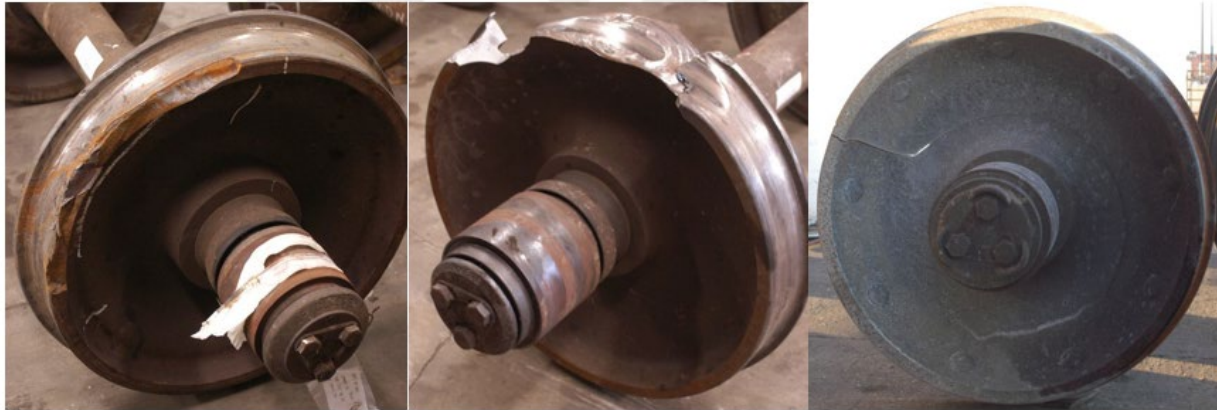
- **Thermal Crack Extended Into Plate:** A thermal crack is a transverse fatigue crack initiated at the surface of the tread or flange that occurs when the rim hoop residual stress is transformed from the beneficial compressive stress to the detrimental tensile stress. This stress reversal occurs due to significant tread braking. If the fatigue crack grows during repeated heating cycles to the point where it eventually reaches the critical size, a large transverse overload fracture will propagate into the plate and can turn to remove a large portion of the rim and plate, or go to the hub and cause the wheel to become loose on the axle.

Vertical Split Rim

Shattered Rim

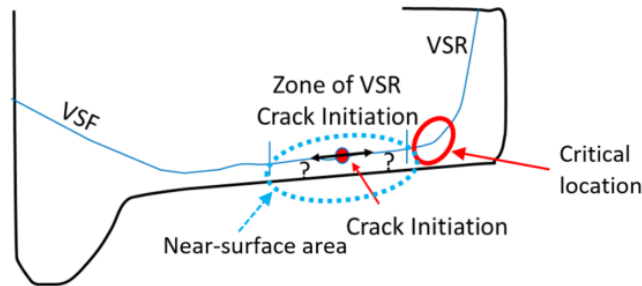
Figure 3. Potential Directions of Propagation from the Zone of Origin for a Subsurface Initiated Crack and Subsequent VSR Failure

There are still several competing theories regarding how VSR failures develop. Referring to [Figure 3](#), the questions related to VSR failure can be divided into: 1) how the crack originates and starts propagating transversely (i.e., axially to the wheel), and 2) what drives the crack to turn “downward” radially to the rim surface and grow toward failure. An understanding of how the cracks leading to VSRs are formed and propagate is essential so that improved inspection mitigation practices can be identified and implemented. The expectation is that there is more than one process involved in producing VSR failures, but successful mitigation strategies require that the most prevalent, and their relative influence, be identified.

Research has established that the crack initiation zone for VSR failures typically extends over the region shown in Figure 3 [2]. A tread surface or subsurface horizontal crack is initiated and grows. The horizontal cracks can be surface initiated (i.e., shelling/spalling/RCF/thermal cracking) or subsurface initiated (i.e., delamination) [1]. The clustering of initiation points on the field side of the treads studied by Cummings (2014) could be due to the low rail in curves contacting the tread in this area and often generating large lateral traction forces and associated rolling contact fatigue (RCF) damage (see Figure 4). Additionally, brake heating predominantly occurs to the field side of the tread which could promote crack initiation and propagation in this region [3].

In the wheels studied by Cummings (2014), the direction of crack growth is usually toward the field side but occasionally it grows toward the flange (see Figure 3). These are both classified as VSR failures, although the failure toward the flange side is sometimes referred to as a vertical split flange (VSF) to distinguish this mode of failure. A broken flange is a separate failure mode with its own Why Made Code⁵ designation where the failure is largely confined to the flange itself.

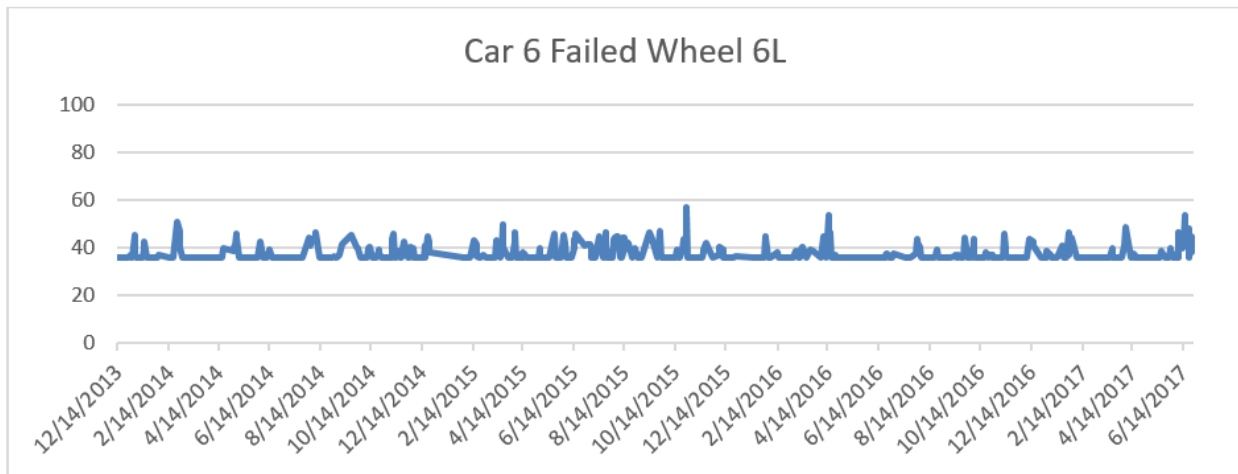
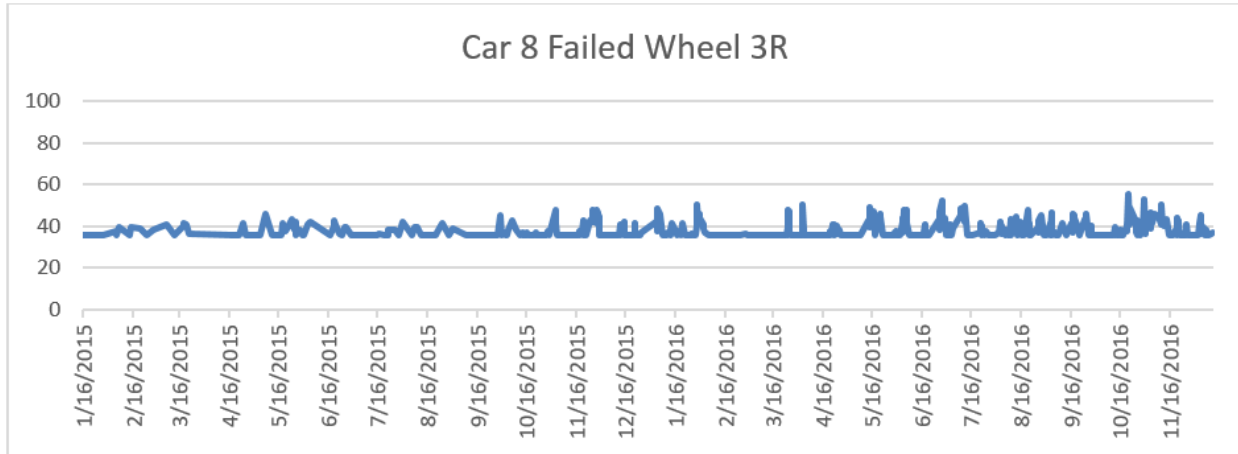
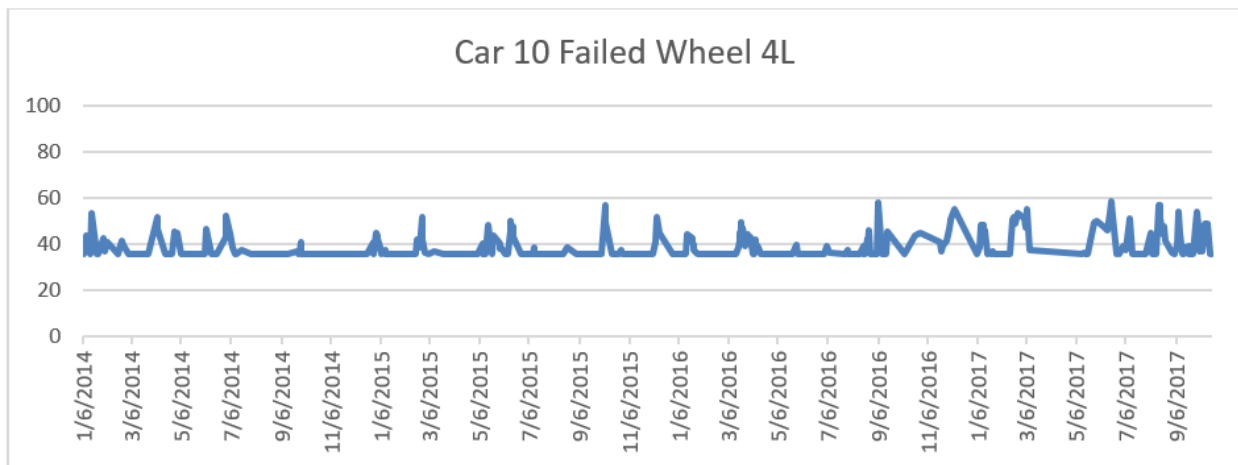
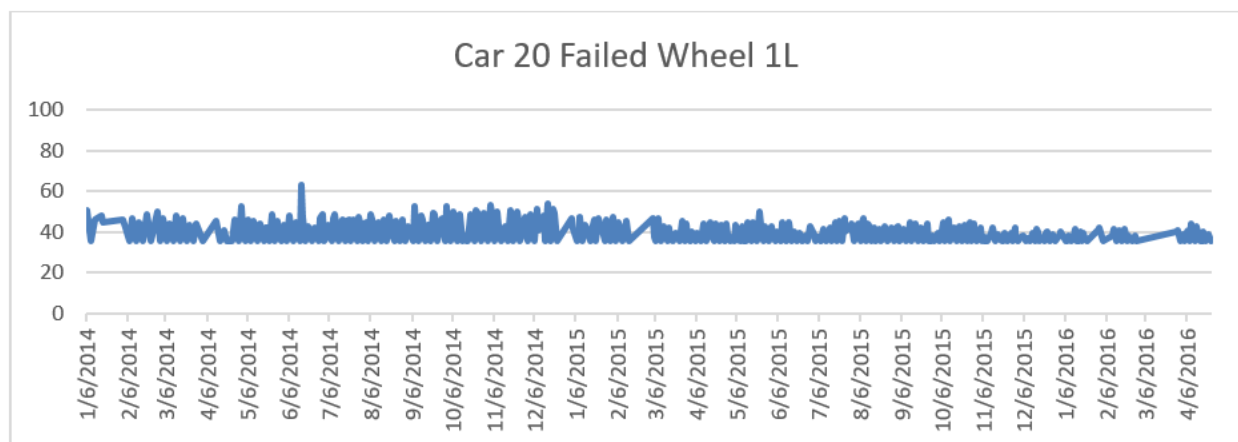
During Phase 2, Railinc personnel provided the research team with WILD data histories for a set of 21 failed wheels. Eleven of the wheels were identified as VSRs failures, 8 were identified as broken flange failures and 2 wheels failed from cracked plates. Of the 11 VSR wheels, 7 exhibited increasing impact loads towards the end of the wheel data history. Four of the VSR wheels did not exhibit any appreciable change in WILD impact data throughout the impact history. Figure 5 through Figure 8 shows four examples of VSR wheels with uniformly small impact loads.

Figure 5. Example of WILD Data for VSR Failure with Small Impact Loads—Car 6

Figure 6. Example of WILD Data for VSR Failure with Small Impact Loads—Car 8

Figure 7. Example of WILD Data for VSR Failure with Small Impact Loads—Car 10

Figure 8. Example of WILD Data for VSR Failure with Small Impact Loads—Car 20

Thus, WILD data history considering only the impact loads as collected from the sites is not a reliable indicator of the imminence of a VSR. Efforts employing WILD data may be warranted if they reduce at least a portion of these failures. However, when considering WILD data, care must be taken to understand the limitations in the data prior to drawing erroneous conclusions.

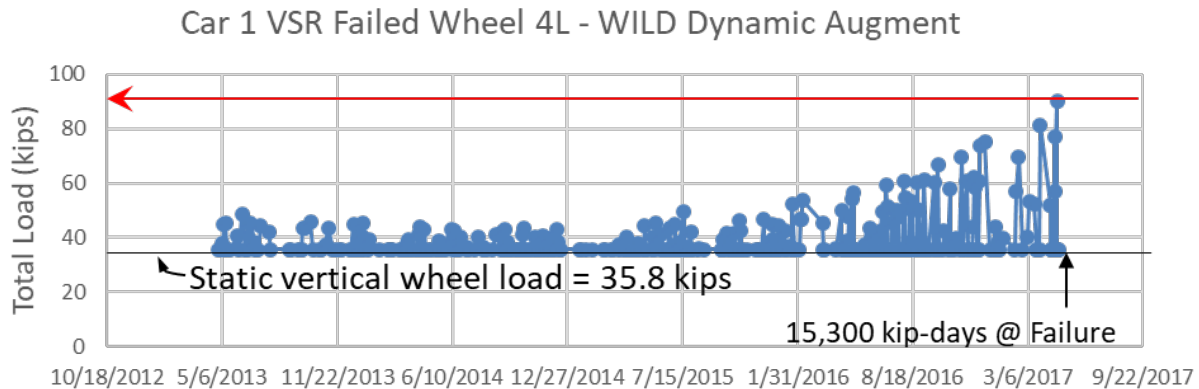
Figure 10. Example of WILD Data for a VSR Failed Wheel Showing Increasing Dynamic Augment

For a wheel with increasing impact loads, Cummings recommends representing the cumulative damage as the cumulative sum of each increasing impact load magnitude, in kips, multiplied by the number of days until the next higher impact load occurs [2]. The result is a value of “kip-days.” Figure 10 and Figure 11 show example calculations of kip-days for a VSR failed wheel using data that was anonymized by Railinc as part of a preliminary consideration of WILD data for this study. Figure 10 shows only the impact load above the static vertical nominal wheel load, or dynamic augment, to illustrate the increasing trend of impact load for a fully loaded 110-ton car.

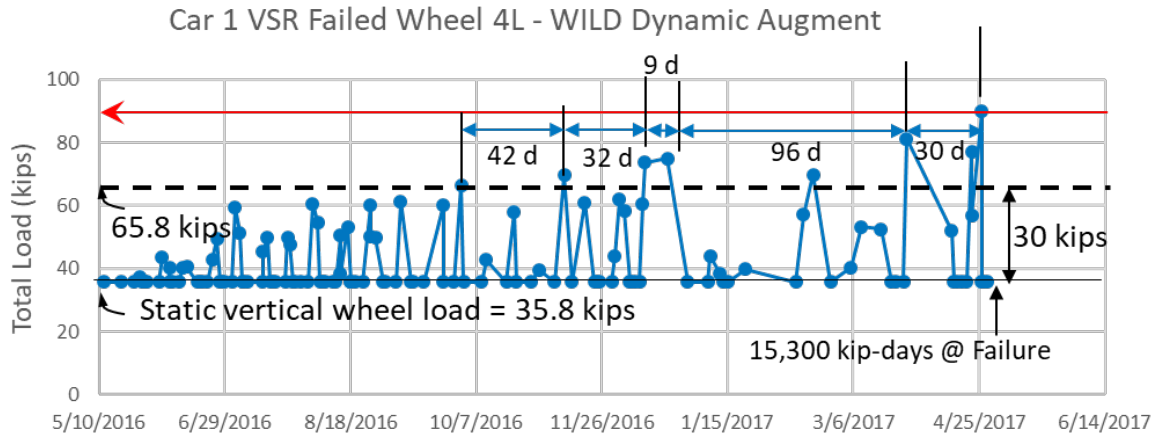
Figure 11. Example Calculation of “kip-days” at Time of VSR Failure

According to the method described by Cummings (2014), the counting of kip-days should start at the first impact load greater than 30 kips plus the static vertical wheel load. This corresponds to 65.8 kips for the wheel impact history shown in Figure 11. The first total impact load, which equals static load plus dynamic augment, above this threshold is 66.6 kips; there are 42 days until the next higher load of 69.7 kips. Therefore, the incremental kip-days for the 66.6 kips load is 66.6×42 , or 2,797 kip-days. This is rounded to the nearest hundred days to 2,800 kip-days, as are the other values of kip-days in Table 1 calculated for the example shown in Figure 11. The counting starts again for the next higher load of 69.7 kips for 32 days and the cumulative sum is calculated until wheel failure, as indicated by an impact load of 90 kips,⁶ is reached at a total of 15,300 kips-days.

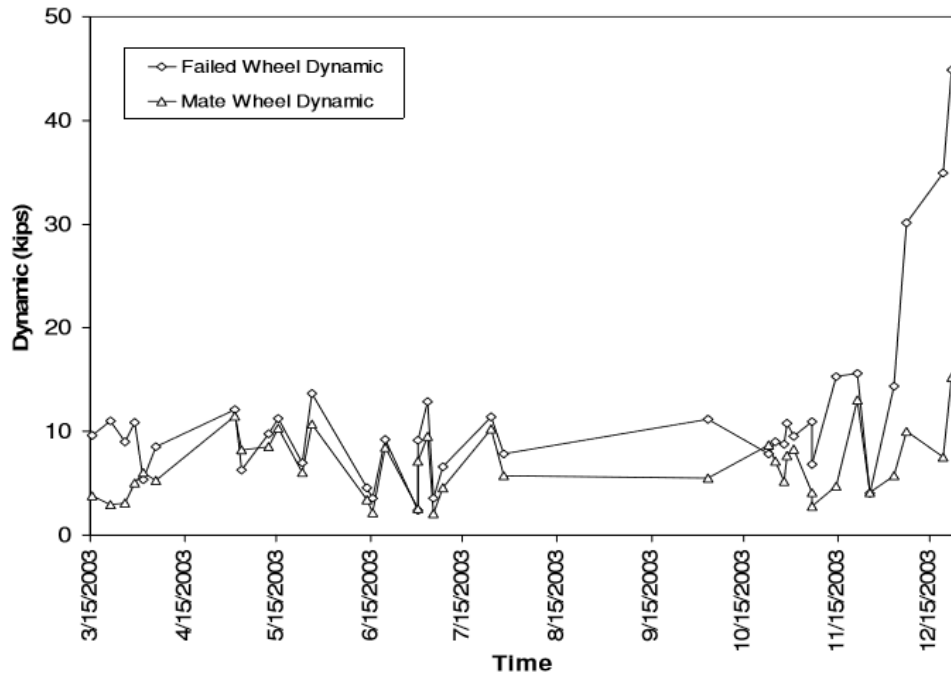
Figure 15. WILD Data for a VSR Wheel with a Small to Moderate Impact Load Before Failure [9]

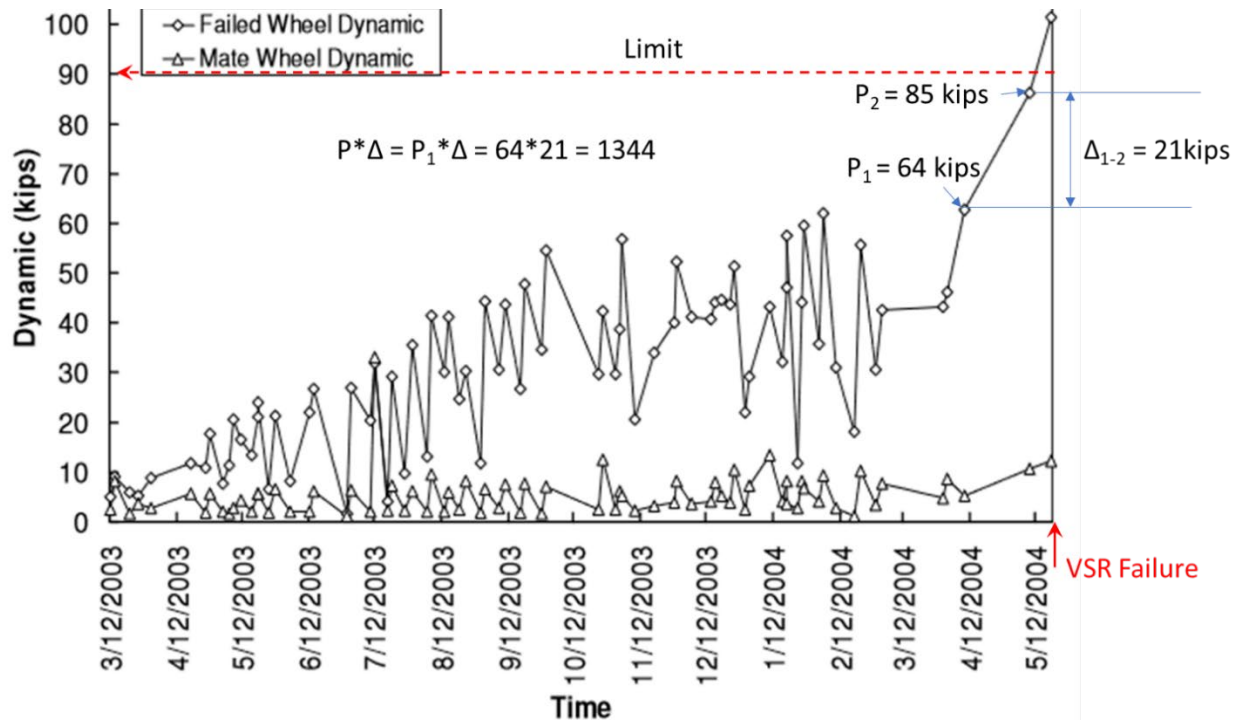
Figure 18. Example Calculation of $P^*\Delta$ for Rapid Increase of Initially Large Impact Load

Figure 18 shows a proposed method of calculating the rate of increase in impact loads. The most recent peak load (P_2) is compared with the one before that (P_1) and if $P_2 > P_1$ the amount of increase is calculated as $P_1 * (P_2 - P_1)$. This multiplicative “ $P * \Delta$ ” form of the data is weighted appropriately to produce a higher, more critical value for larger impact loads (P) and for larger increases (Δ) above that impact load. Assuming a threshold $P * \Delta$ value of 1,000 is found to indicate pending failure, the wheel with the $P * \Delta$ of 1,344 in Figure 8 would be pulled from service based on the incremental increase in impact load from 64 kips to 85 kips.

If the value of $P_1 * (P_2 - P_1)$ was less than the assumed threshold value of 1,000, the calculation would continue if the impact load prior to P_1 was less than 64 kips which indicates a trend of increasing impact load over at least three data points. Continuing backward in this fashion allows identification of a rapid increase in the data. Quantifying the rate of increase as described here provides a severity ranking when it is compared to an established threshold. For the case in Figure 18, there is an impact load data point on the upward trend line of less than 64 kips, which would require the calculation to continue. Because the $P * \Delta$ of the first analyzed segment from 64 to 85 kips exceeded 1,000, the limiting criterion is already exceeded and there is no need to go further.

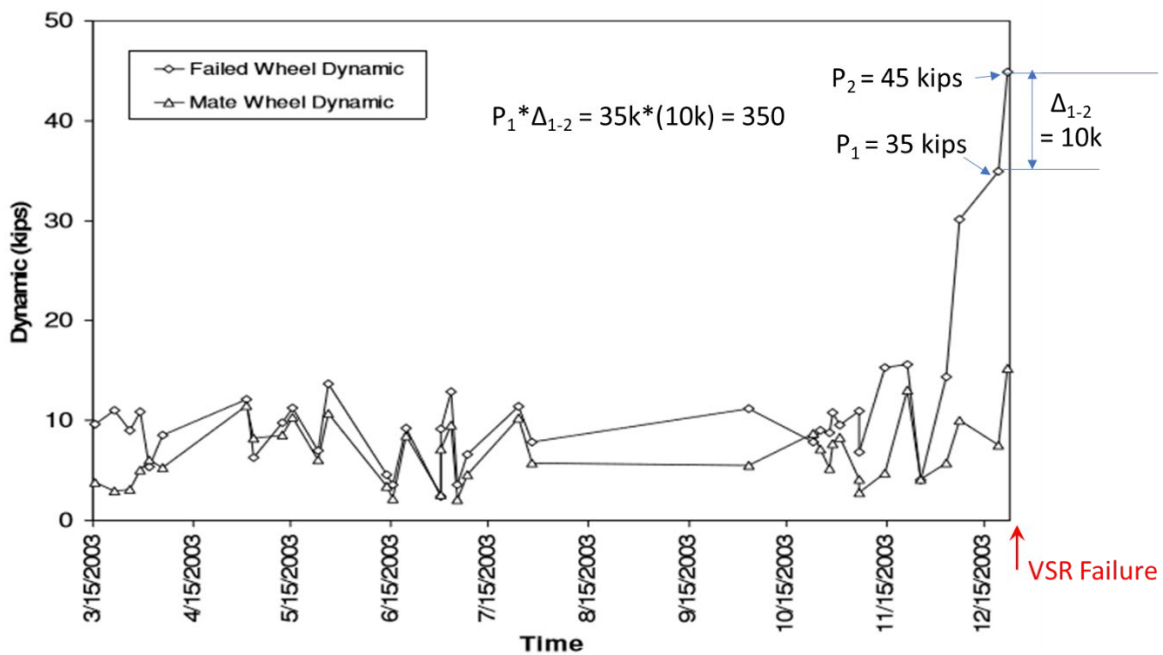
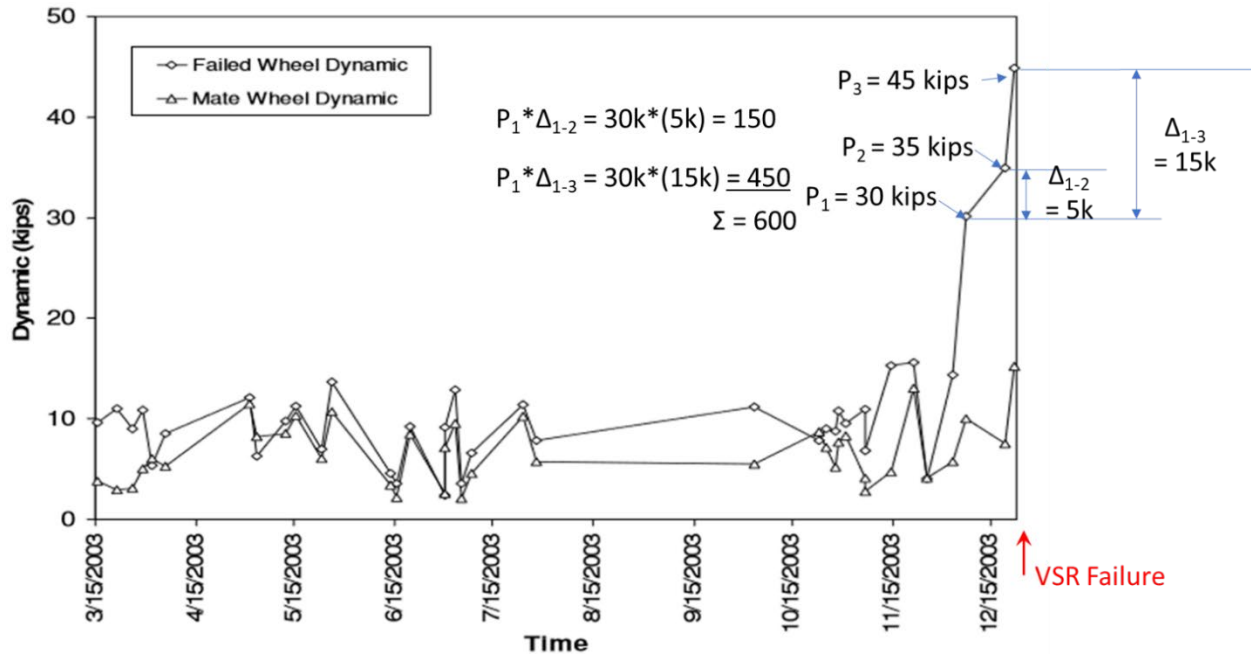
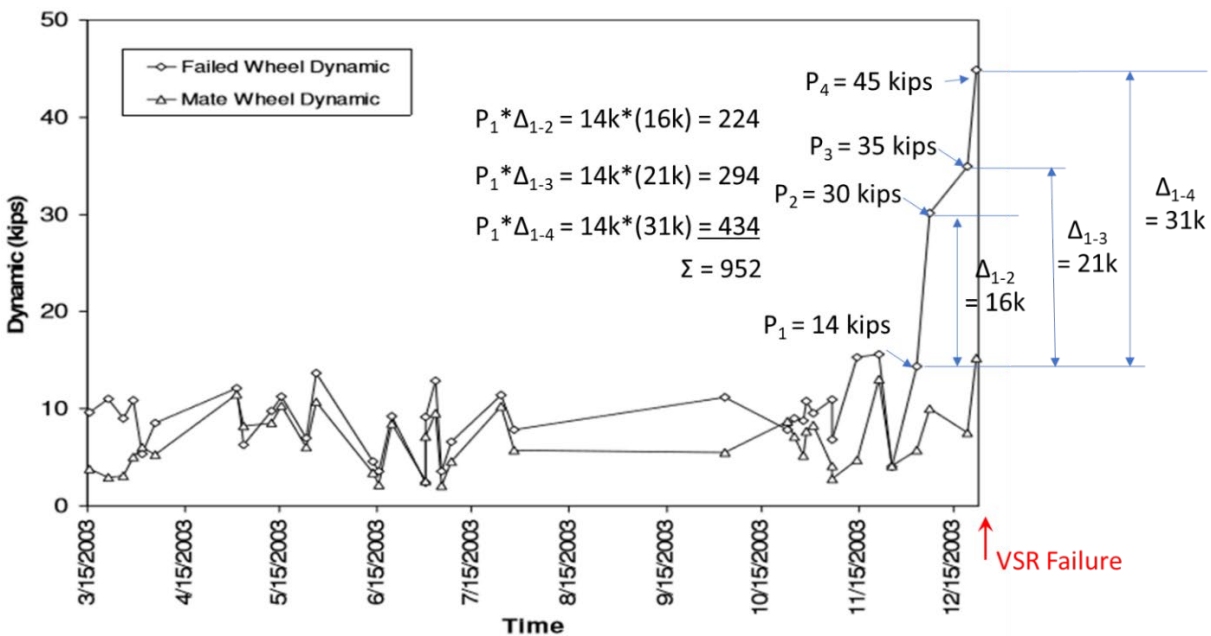
Figure 19 through Figure 21 show examples where the calculation must proceed to three data points to quantify the upward trend of impact $P^*\Delta$ load to determine if the sudden increase poses a danger [9].

Figure 19. Example Calculation 1 of $P^*\Delta$ for Rapid Increase of Initially Small Impact Load

Figure 20. Example Calculation 2 of $P * \Delta$ for Rapid Increase of Initially Small Impact Load

Figure 21. Example Calculation 3 of $P * \Delta$ for Rapid Increase of Initially Small Impact Load

If the $P * \Delta$ value of 952 is rounded to the nearest hundred, this rapid increase of impact load is correctly identified as a wheel that requires removal from service to avoid a VSR failure.

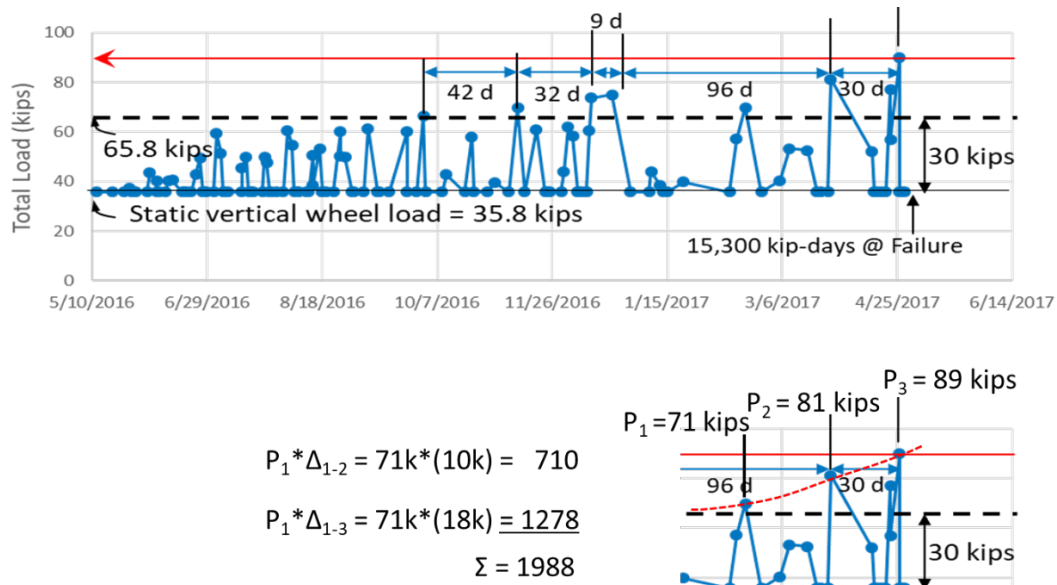
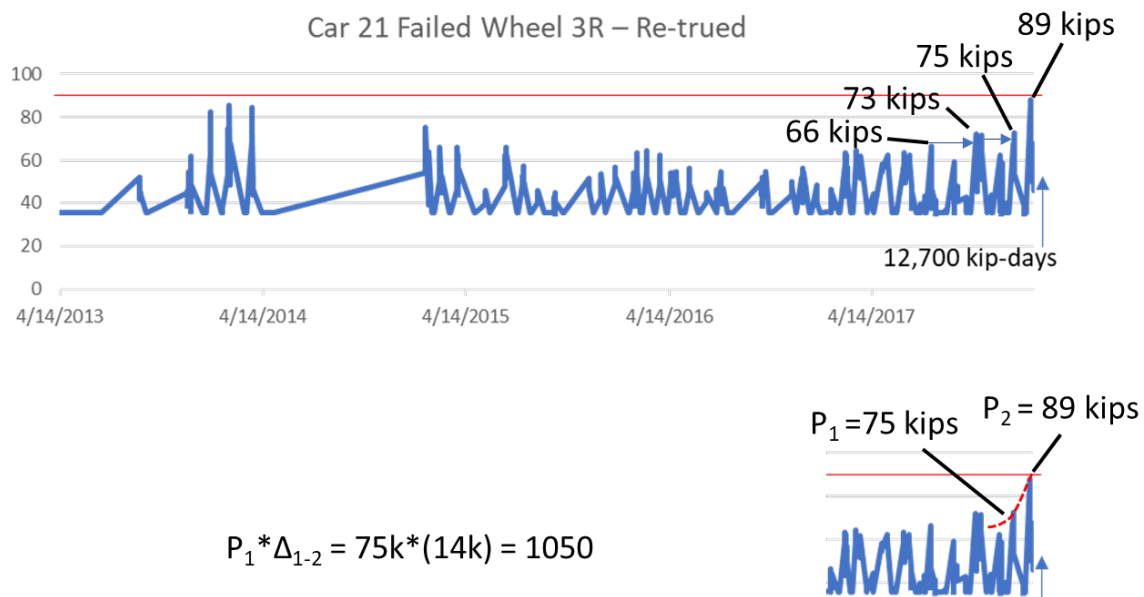
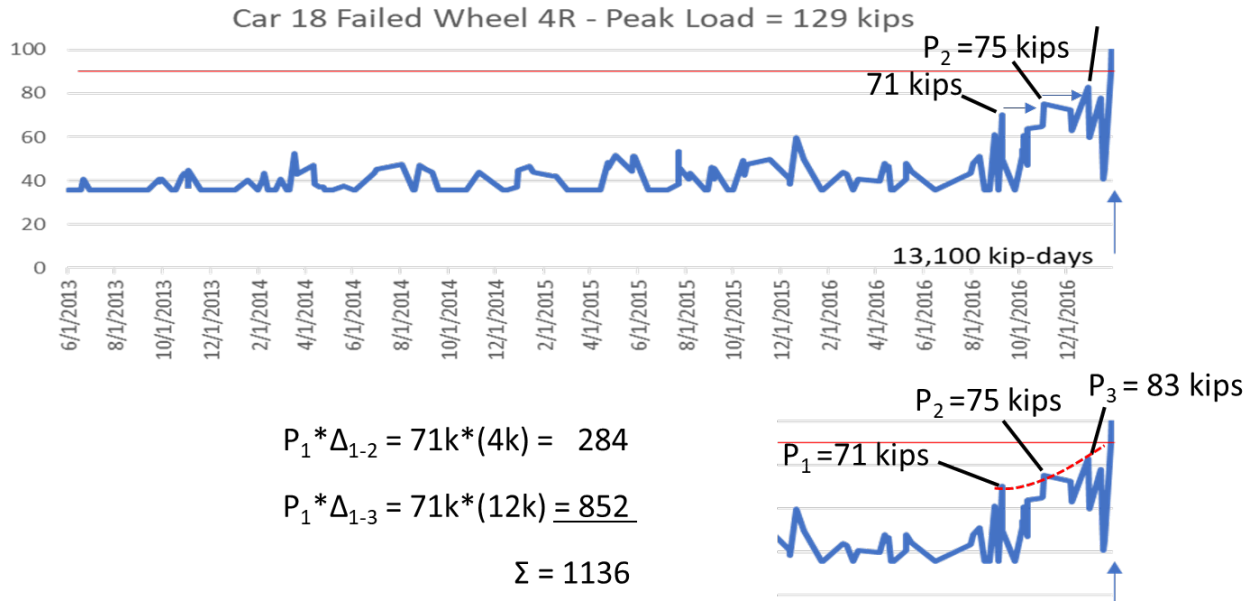
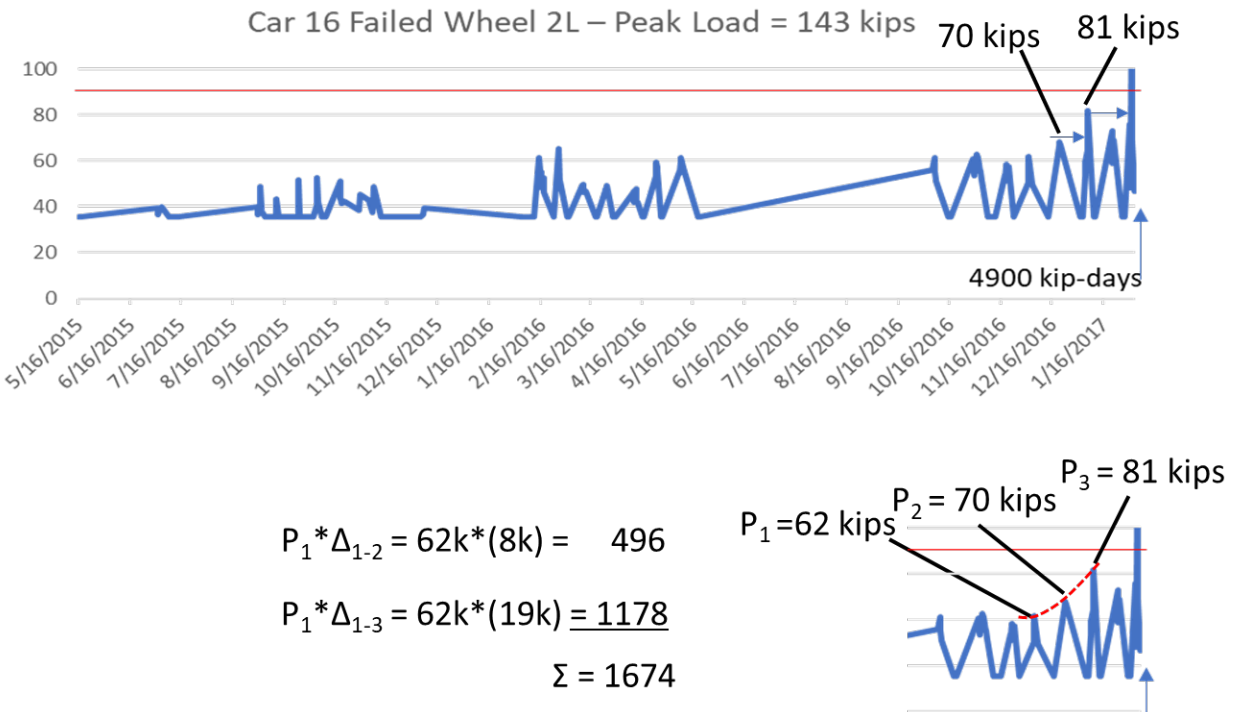
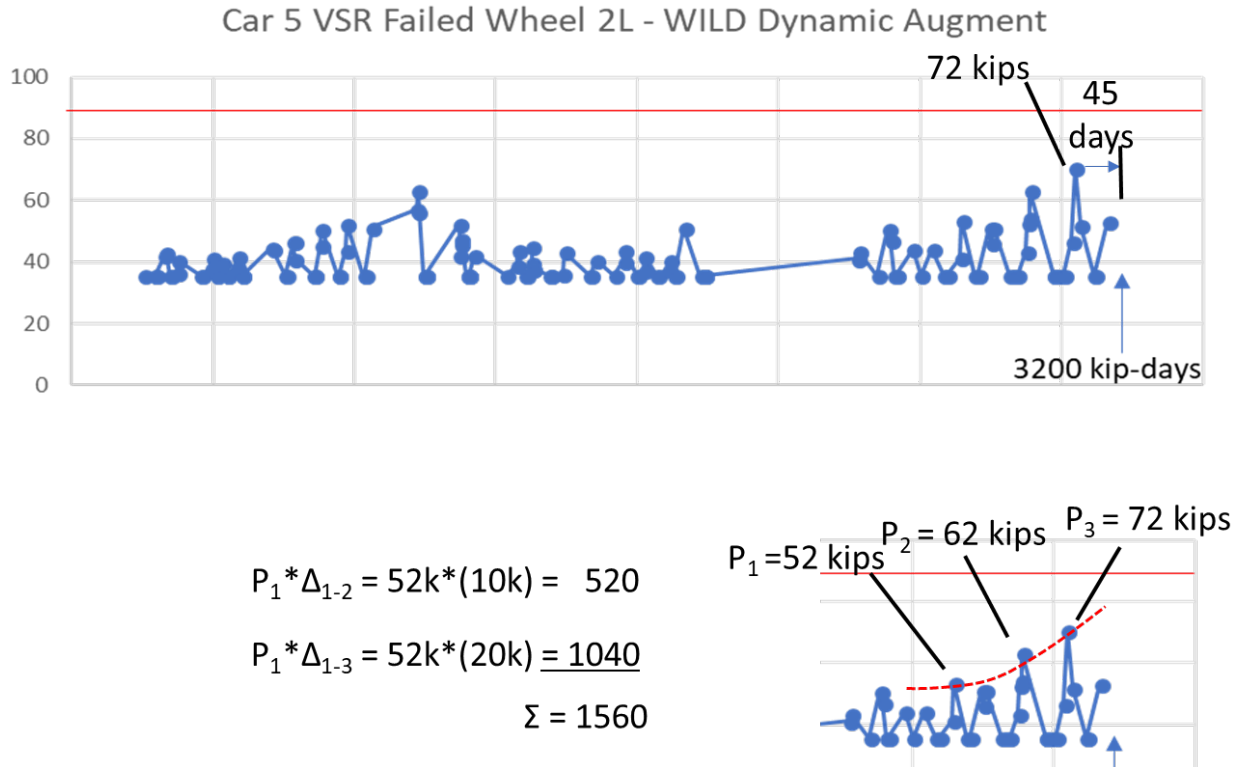
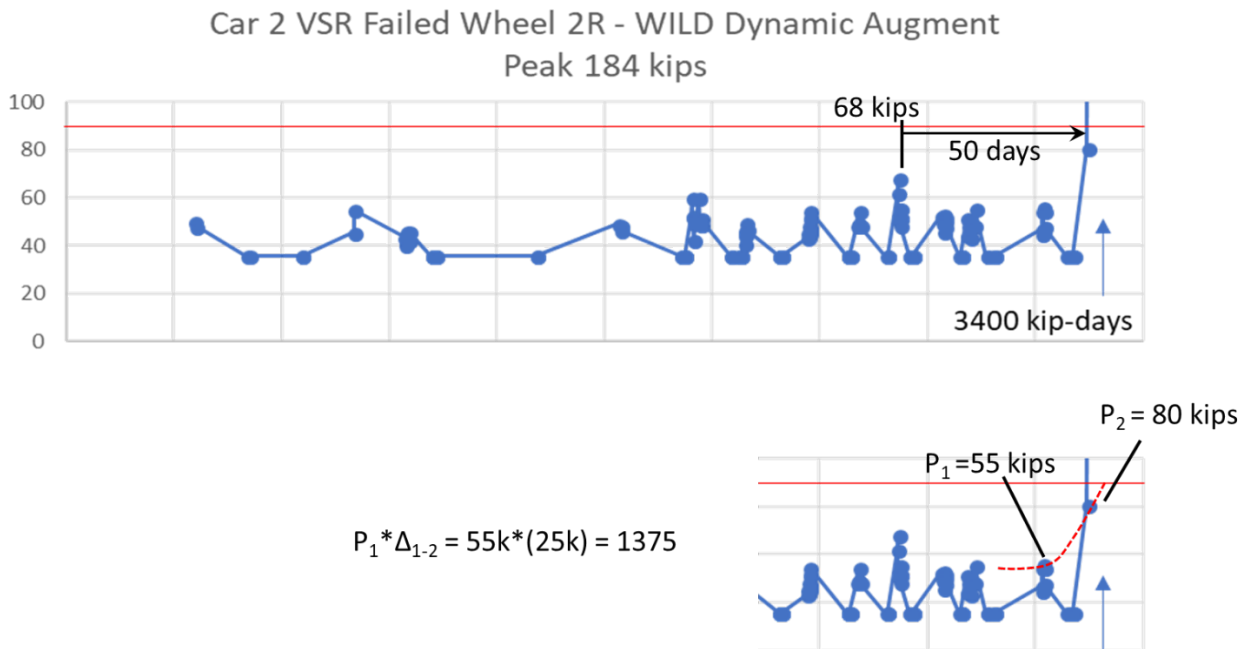
The two criteria of kip-days and $P * \Delta$, with their respective proposed limits, are compared to determine their ability to indicate a wheel that develops a VSR. Figure 22 through Figure 24 show three cases where both rating methods correctly predicted wheel failure, and Figure 25

through Figure 27 show three cases where the P*Δ method predicted failure but kip-days did not. Further exploration of the P*Δ method may be warranted.

Figure 22. Comparing Kip-Days with P*Δ for a VSR Failed Wheel for Car 1

Figure 23. Comparing Kip-Days with P*Δ for a VSR Failed Wheel for Car 21

Figure 24. Comparing Kip-Days with $P * \Delta$ for a VSR Failed Wheel for Car 18

Figure 25. Comparing Kip-Days with $P * \Delta$ for a VSR Failed Wheel for Car 16

Figure 26. Comparing Kip-Days with P*Δ for a VSR Failed Wheel for Car 5

Figure 27. Comparing Kip-Days with P*Δ for a VSR Failed Wheel for Car 2

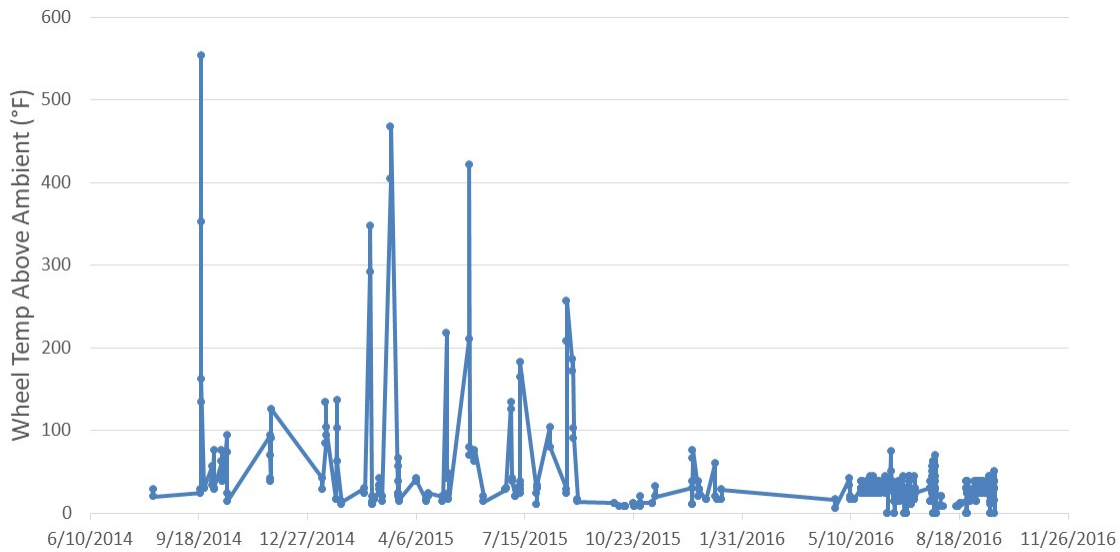
Figure 28. Wheel Temperature Above Ambient History for Sample VSR Failed Wheel

A review of a small sample of HWD data provided for preliminary analysis by Railinc found that some VSR failed wheels had histories of maximum tread temperatures in the moderate range of 500 to 600 °F (above-ambient) while others had maximum measured temperatures less than 100 °F.⁷ The maximum measured wheel temperatures from various HWD sites for the 11 VSR failures and 8 broken flange failures provided by Railinc for this study are shown in [Table 2](#). [Figure 28](#) shows the wheel temperature history for the VSR wheel with the highest measured wheel temperature above ambient. No trend is apparent in either dataset.

Despite the expected strong correlation between elevated wheel temperatures and VSR formation, the data observed did not support such a conclusion. Dedmon’s observation that heat damage on VSR wheels is much more common than indicated by HWDs may support the contention that HWDs are under-reporting high temperature events [15]. This under-reporting may be due, in part, to the fact that railroad employ different practices in placing HWD throughout their systems.

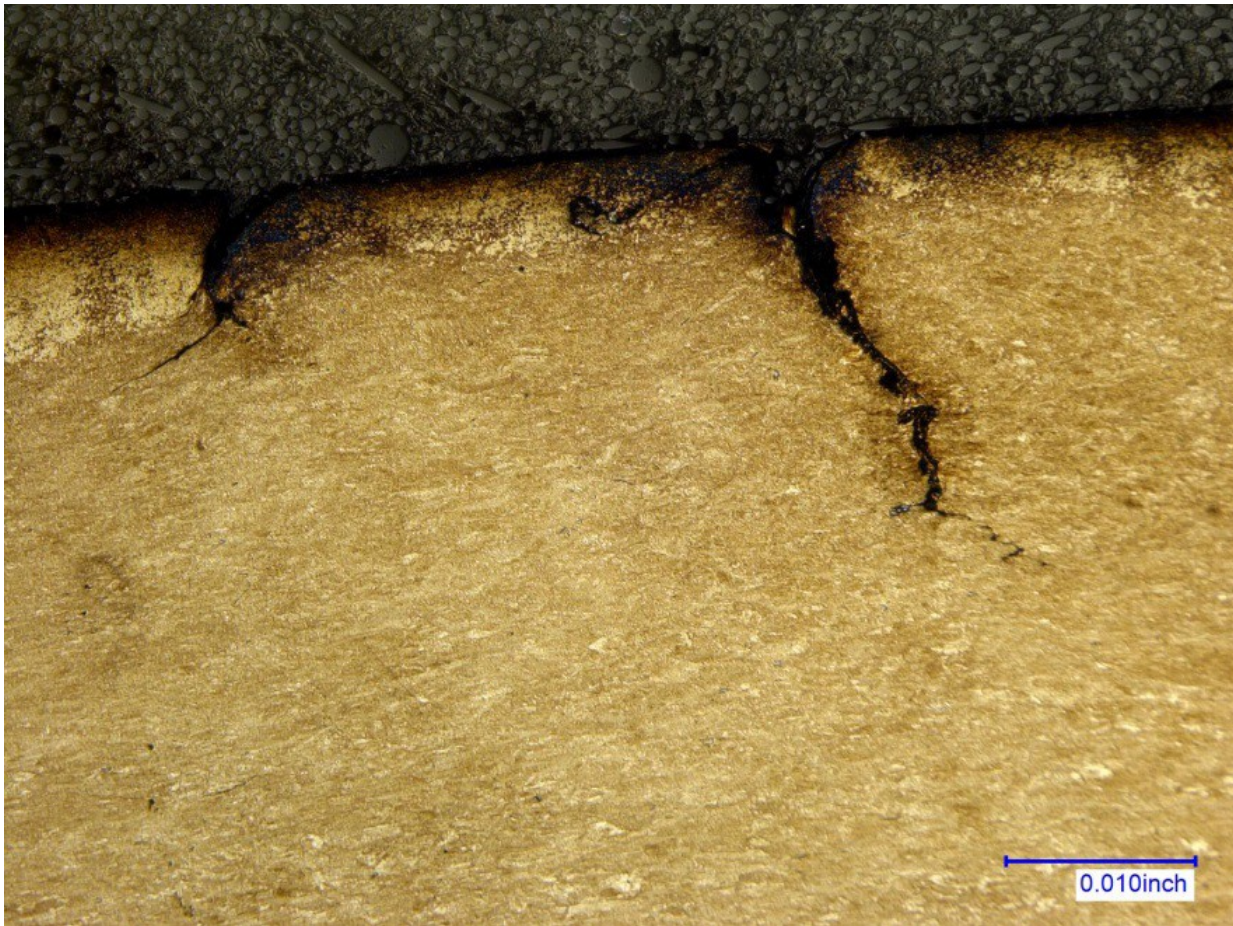
Figure A-7. UP1 Microstructure at Shell Surface, Original Magnification x200, Nital Etch

Metallographic analysis of the shell surface, Figure A-7, shows a layer of white etching material on the shell surface. The nature of white etching zones is not well understood. Some researchers suggest that they are the result of dissolved carbides, while others suggest that they are the result of martensite formation. However, both mechanisms involve heating. Additionally, several short axial cracks have developed from the surface.

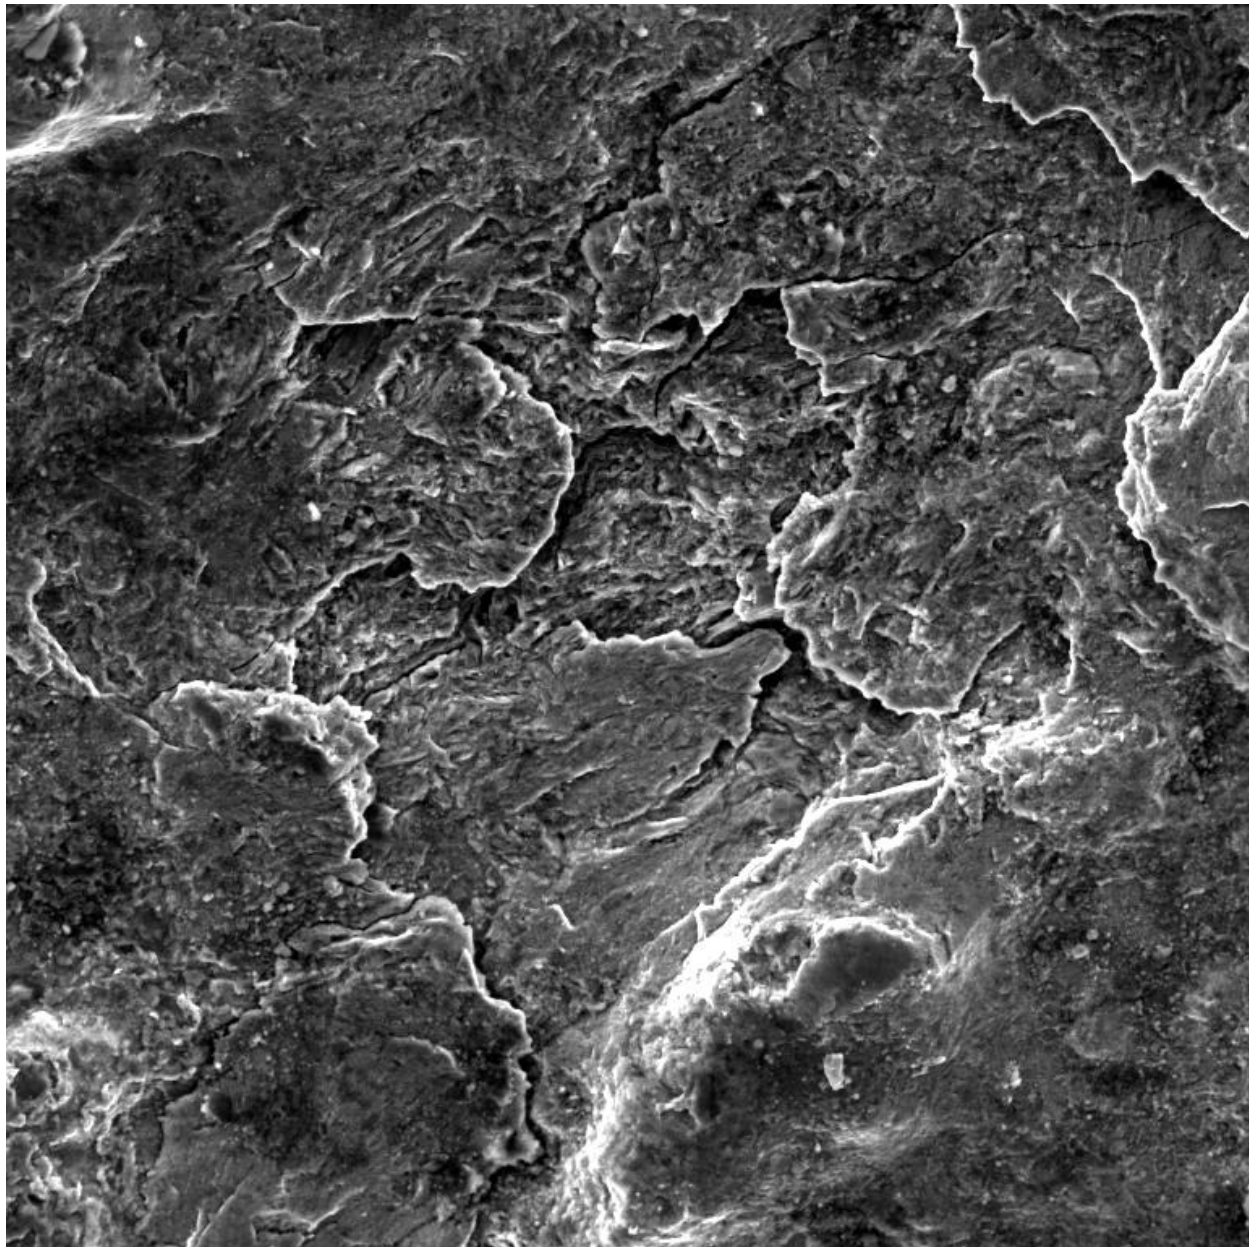
Figure A-8. Scanning Electron Microscope Image of UP1 Shell Fracture Surface, Original Magnification x2,000

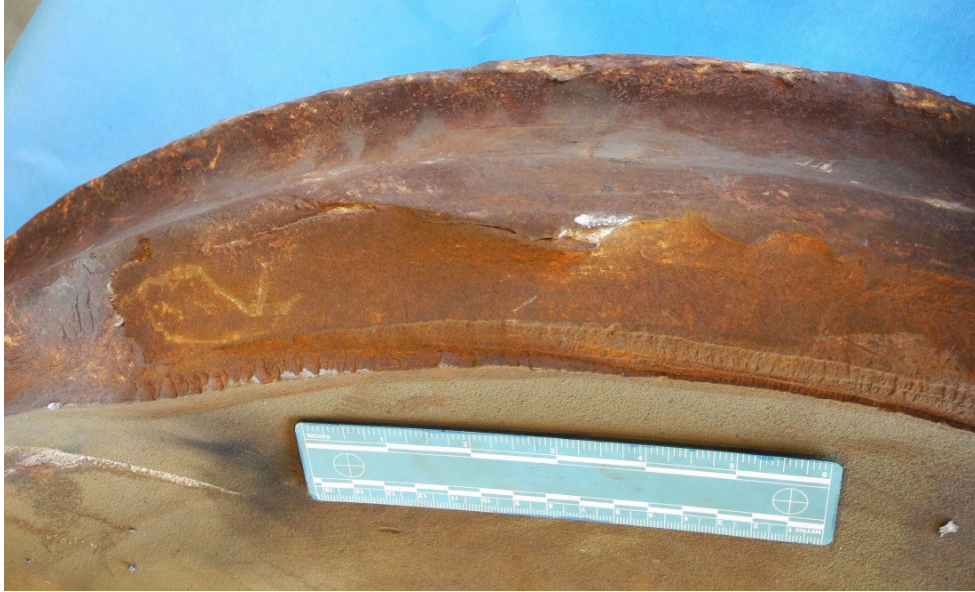
The majority of VSRs fracture along the front rim face (field side) of the wheel, while a smaller number of VSR fractures break away the back rim face (gauge side) of the wheel. Wheel BNSF3 is unusual in that VSRs were identified on the back rim face and the front rim face. Figure A-16 shows the front face VSR, and Figure A-17 shows the back rim face VSR. The relative locations of the two VSRs are seen in Figure A-18. Sectioning of the rim between the two VSRs demonstrated that the two failures were not continuous or connected.

Figure A-16. VSR on Front Face of Wheel BNSF3

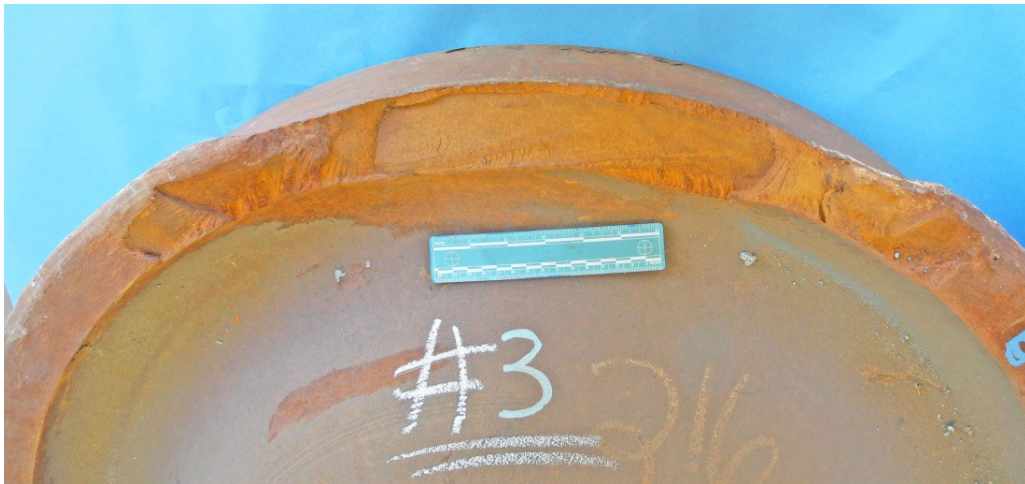
Figure A-17. VSR on Flange Side of Wheel BNSF3

The back rim face fracture surface was coated with a layer of rust, while the front rim face fracture was not, indicating that the back rim face VSR occurred at some time before the VSR on the front face. The microstructures of the surface shelled area and VSR initiation surface were evaluated and are shown in Figure A-19 and Figure A-20. Figure A-19 shows that a surface layer of martensite had developed, indicating application of an unusually high brake shoe force or wheel slide. Figure A-20 shows that the subsurface cracks are coated with a high temperature oxide that is typical of most of the other VSR and shell cracks that have been observed. However, an approximately 0.003-mm diameter, non-metallic inclusion is present at the shell-VSR transition. Analysis of the inclusion indicated that it was iron oxide (i.e., rust).

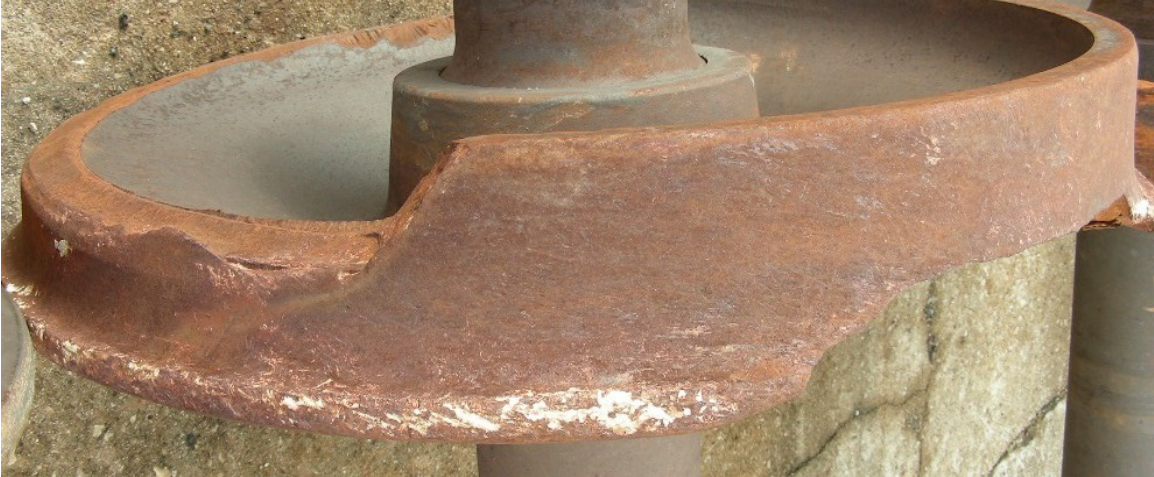
Figure A-18. Location of VSRs on Front and Rear Wheel BNSF3

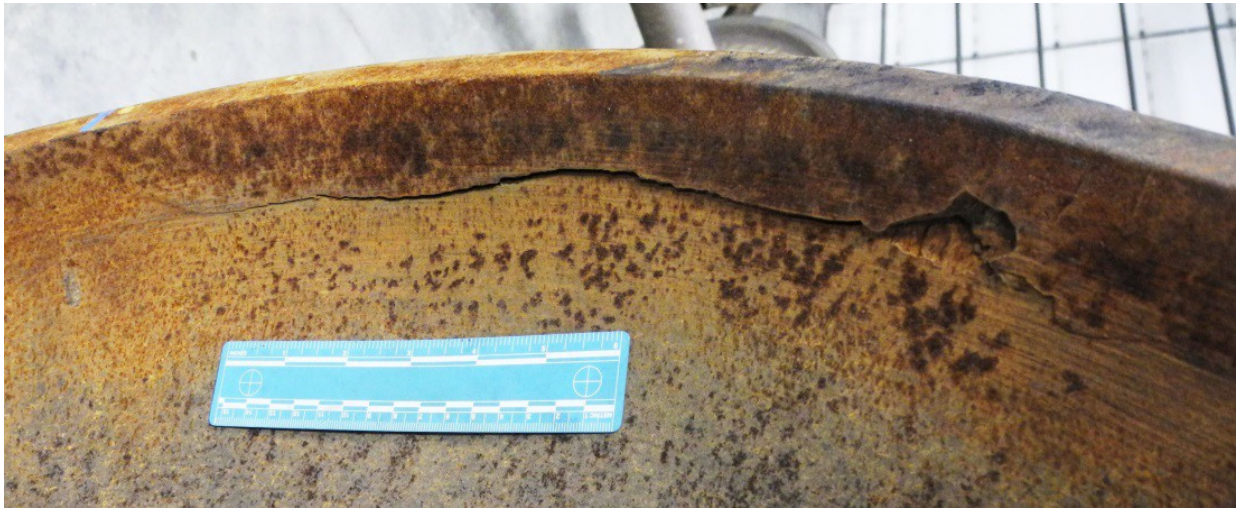
The wheel contained a VSR that had developed for a distance of approximately 10 inches around the tread toward the front rim face of the wheel, as shown in Figure A-35. The VSR had extended completely through the rim, Figure A-36. The wheel tread contained discontinuous shelling around the circumference. Figure A-37 shows the fracture surface of the VSR after numerous attempts to remove the as-received rust layer.

Figure A-36. Wheel BNSF7 VSR on Rim Plate Fillet

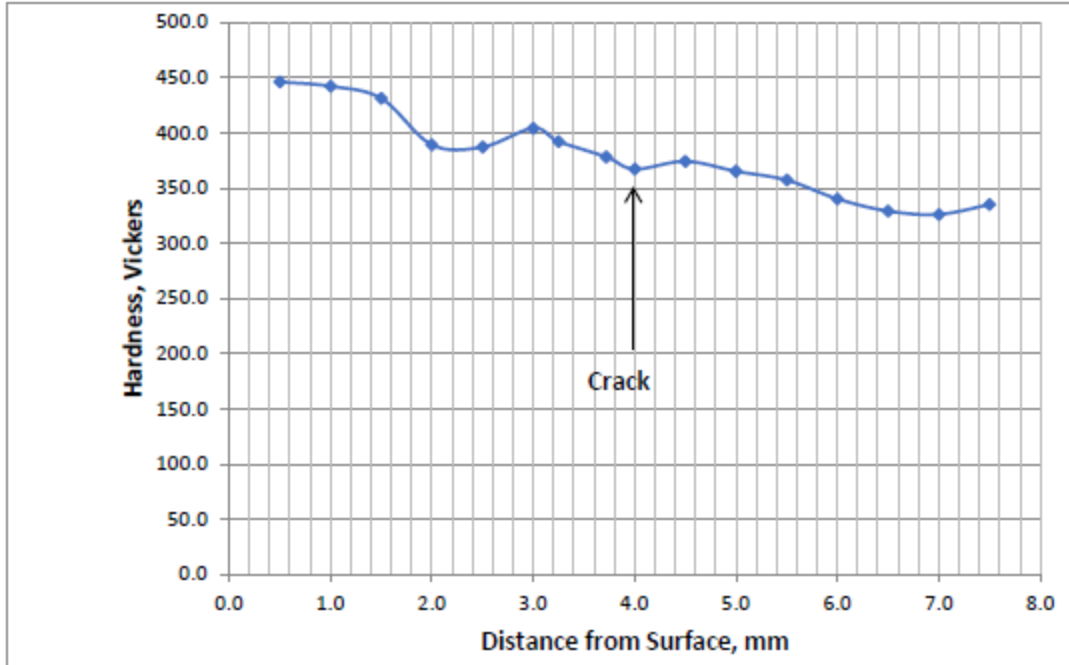
Microhardness measurements were made on a specimen cut adjacent to the fractured area in the radial direction from the surface to a depth of half of an inch. The results of hardness to depth suggest the possible presence of an area work softening, Figure A-41.

Figure A-40. BNSF7 Microhardness Variation from Surface
