U.S. Department
of Transportation
Federal Railroad
Administration

Wheel Failure Investigation Program: Phase 2

1. REPORT DATE (DD-MM-YYYY) December 2021		2. REPORT TYPE Technical Report		3. DATES COVERED (From - To) September 2017 – March 2020	
4. TITLE AND SUBTITLE Wheel Failure Investigation Program: Phase 2				5a. CONTRACT NUMBER DTFR53-12-D-00001L	
				5b. GRANT NUMBER	
				5c. PROGRAM ELEMENT NUMBER

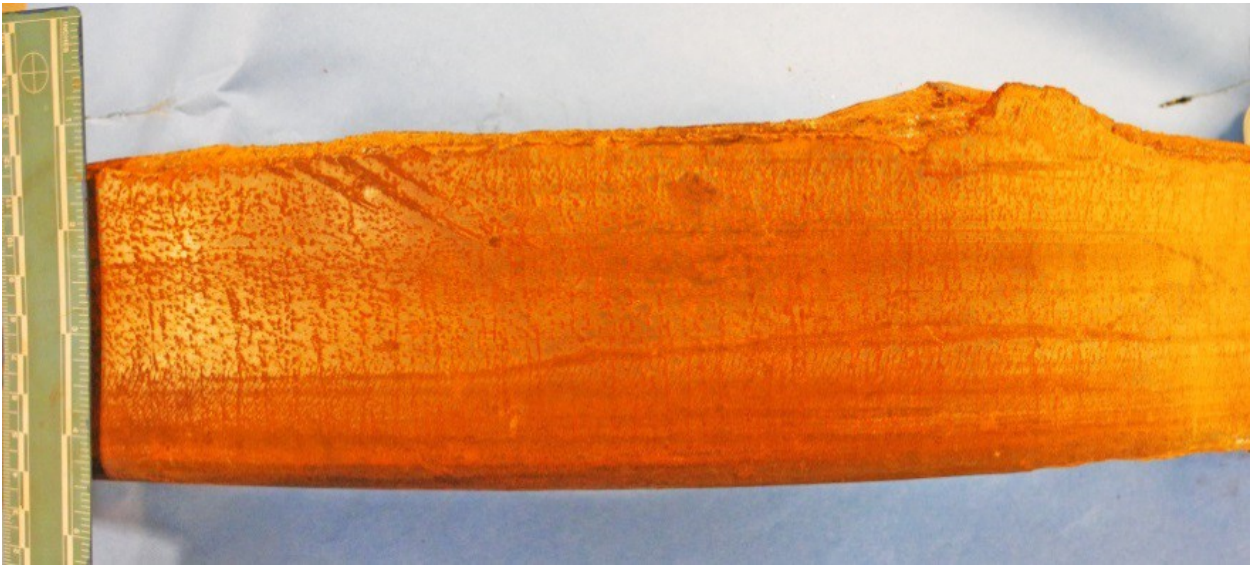
The wheel fractured due to a VSR that lost a section of the rim at least four feet long by three inches wide. The as-received wheelset and an approximately 4-foot long section of the tread are shown in Figure A-41 and Figure A-43, respectively. The fracture, shown in Figure A-43 and Figure A-44, was atypical of most VSR failures because of the absence of extensive tread shelling.

Figure A-43. Field Side Section of CSX8 Tread without Surface Shelling

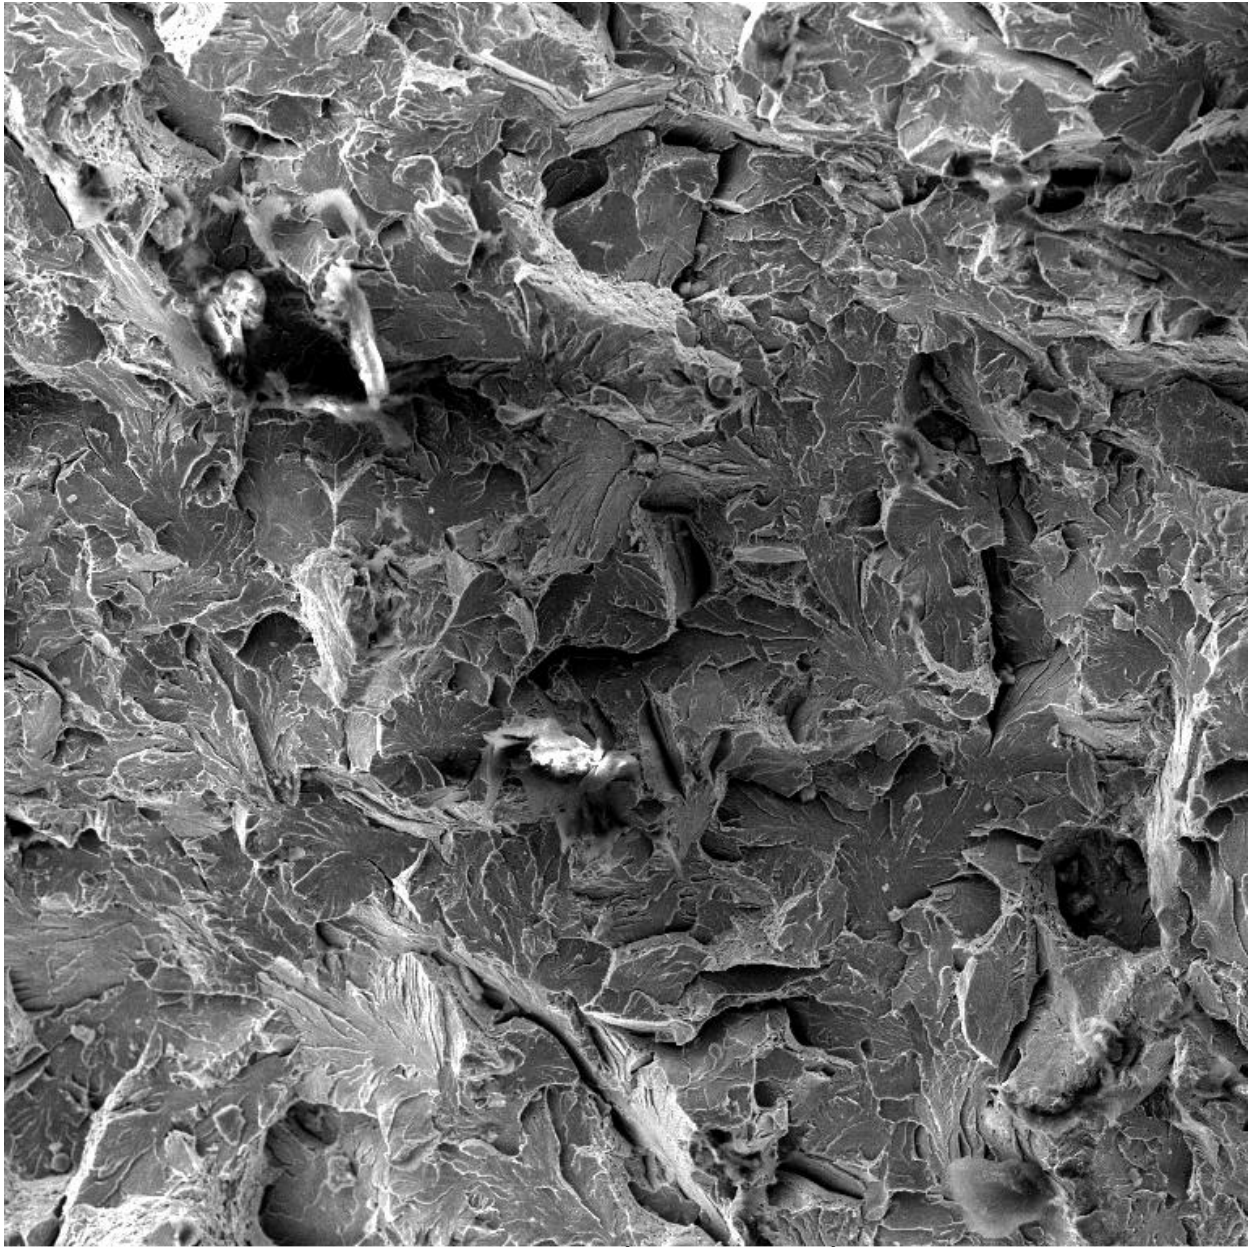
The fracture surface of the VSR is typical of rapid or overload fractures (quasi-cleavage), Figure A-47. The VSR origin fracture surface shown in Figure A-48 also shows rapid fracture. The transition of the shell fracture surface to the VSR origin is shown in Figure A-49.

Figure A-47. Scanning Electron Microscope Image of CSX8 VSR Fracture Surface, Original Magnification x500

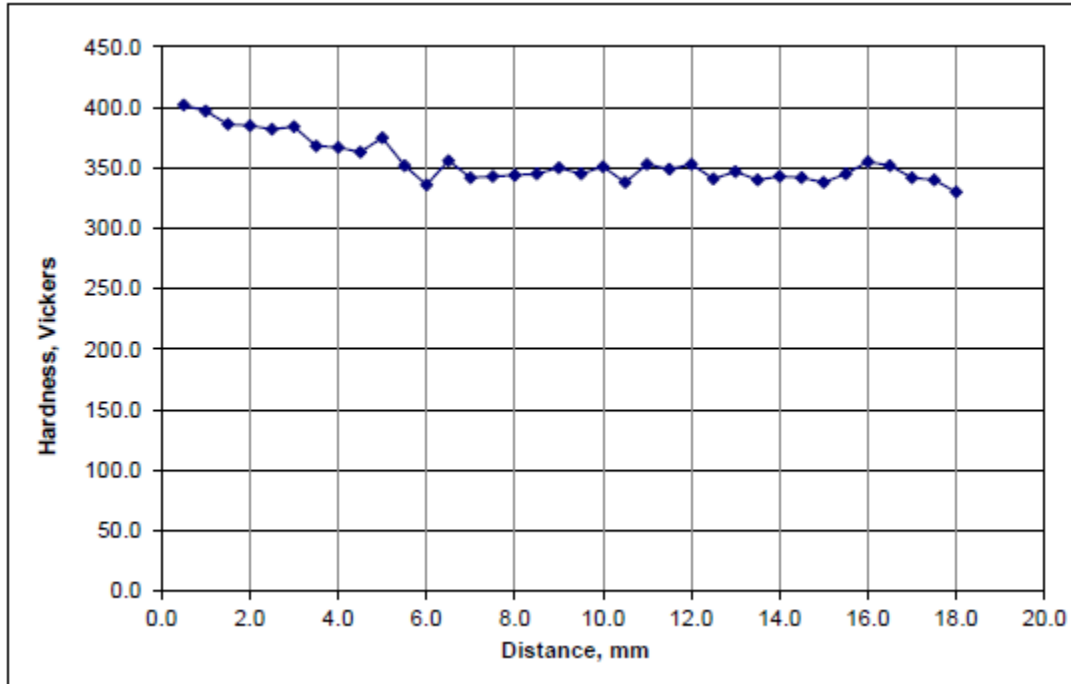
Microhardness measurements were performed on a specimen cut adjacent to the fractured area, the in the radial direction from the surface to a depth of half of an inch. The results of the measurements versus depth in Figure A-51 suggest the possible presence of an area of work softening.

Figure A-51. CSX8 Microhardness in Radial Direction

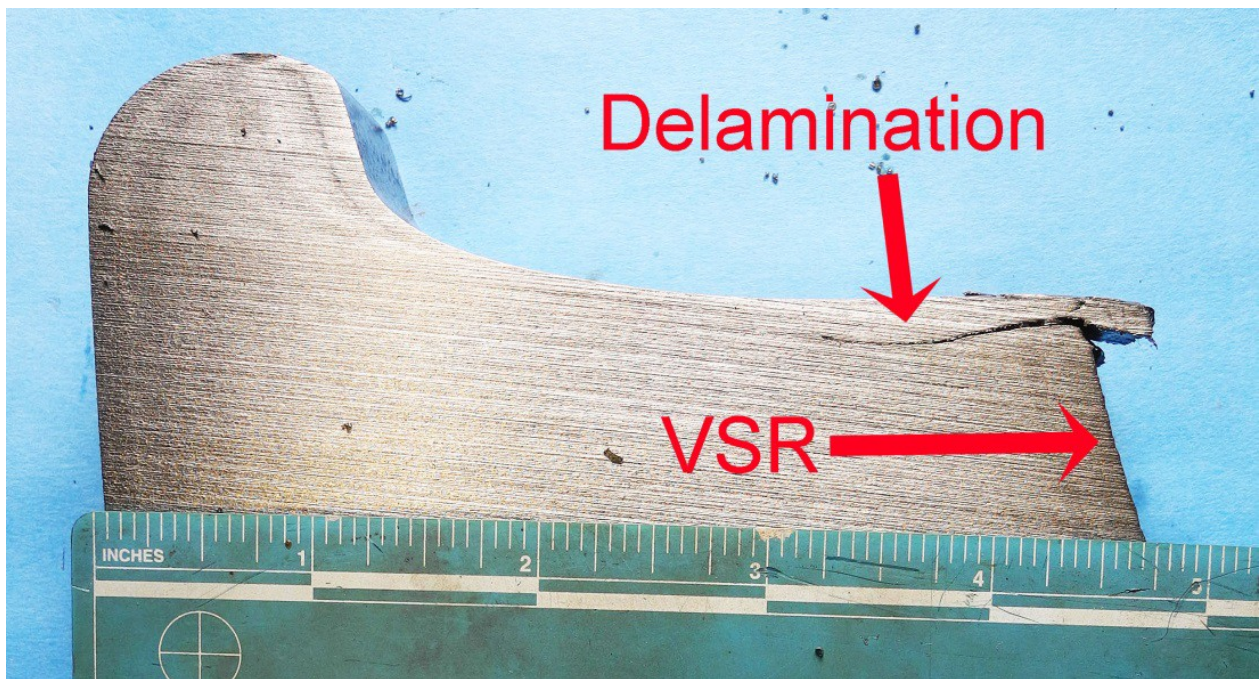
The failure occurred in two steps. First, a large layer of separation or delamination, approximately 3/16 of an inch below the tread surface, formed and the initial VSR grew from the tread shell, as shown in Figure A-54. A fatigue crack then initiated and grew until the VSR caused unstable crack growth that separated a portion of the rim, Figure A-55.

Figure A-54. Cross Section of Wheel UP9 Tread Area

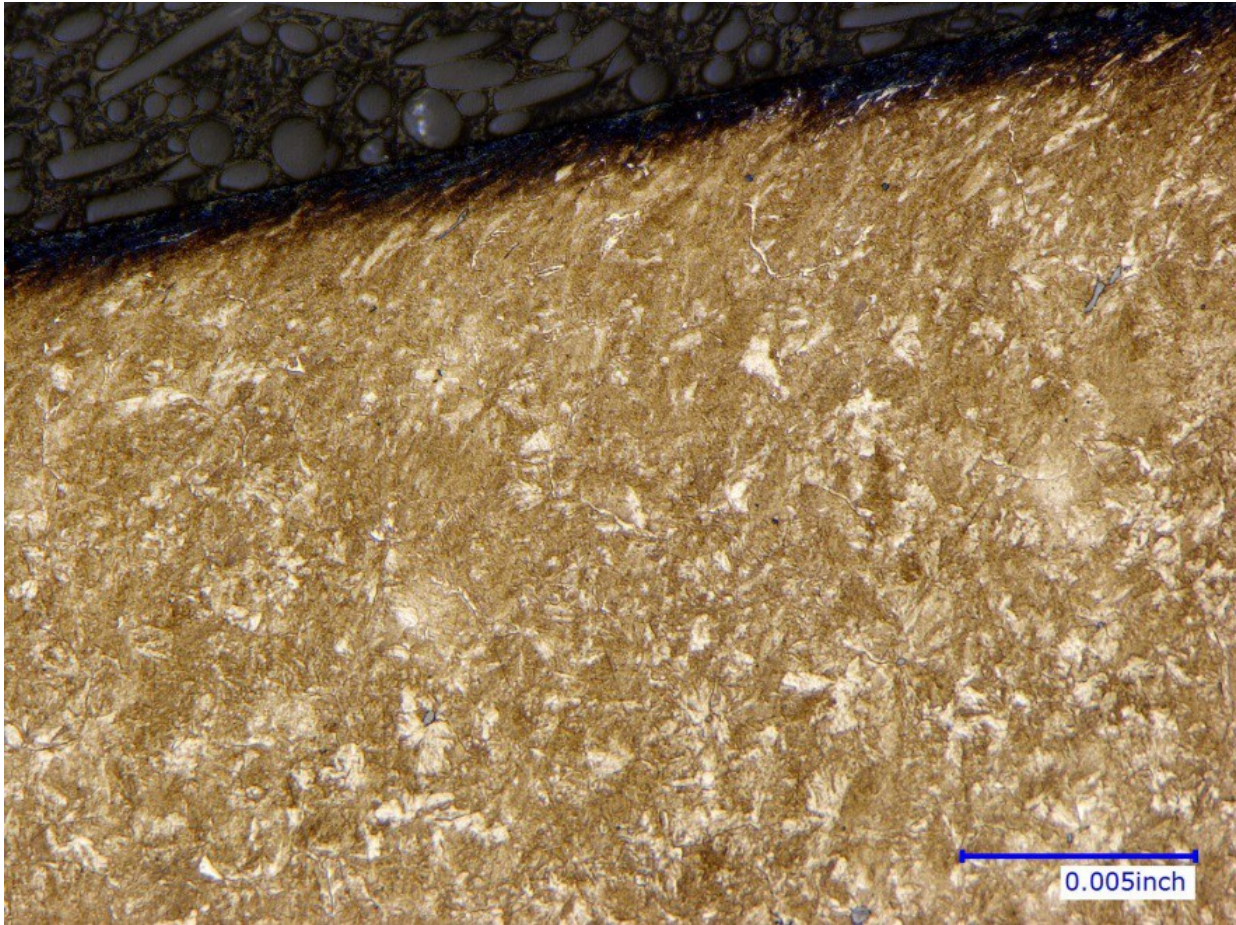
Figure A-57. Microstructure of UP9's Mate Wheel Tread Surface with Plastic Flow to a Depth of Approximately 0.005-Inch, Original Magnification x500, Nital Etch

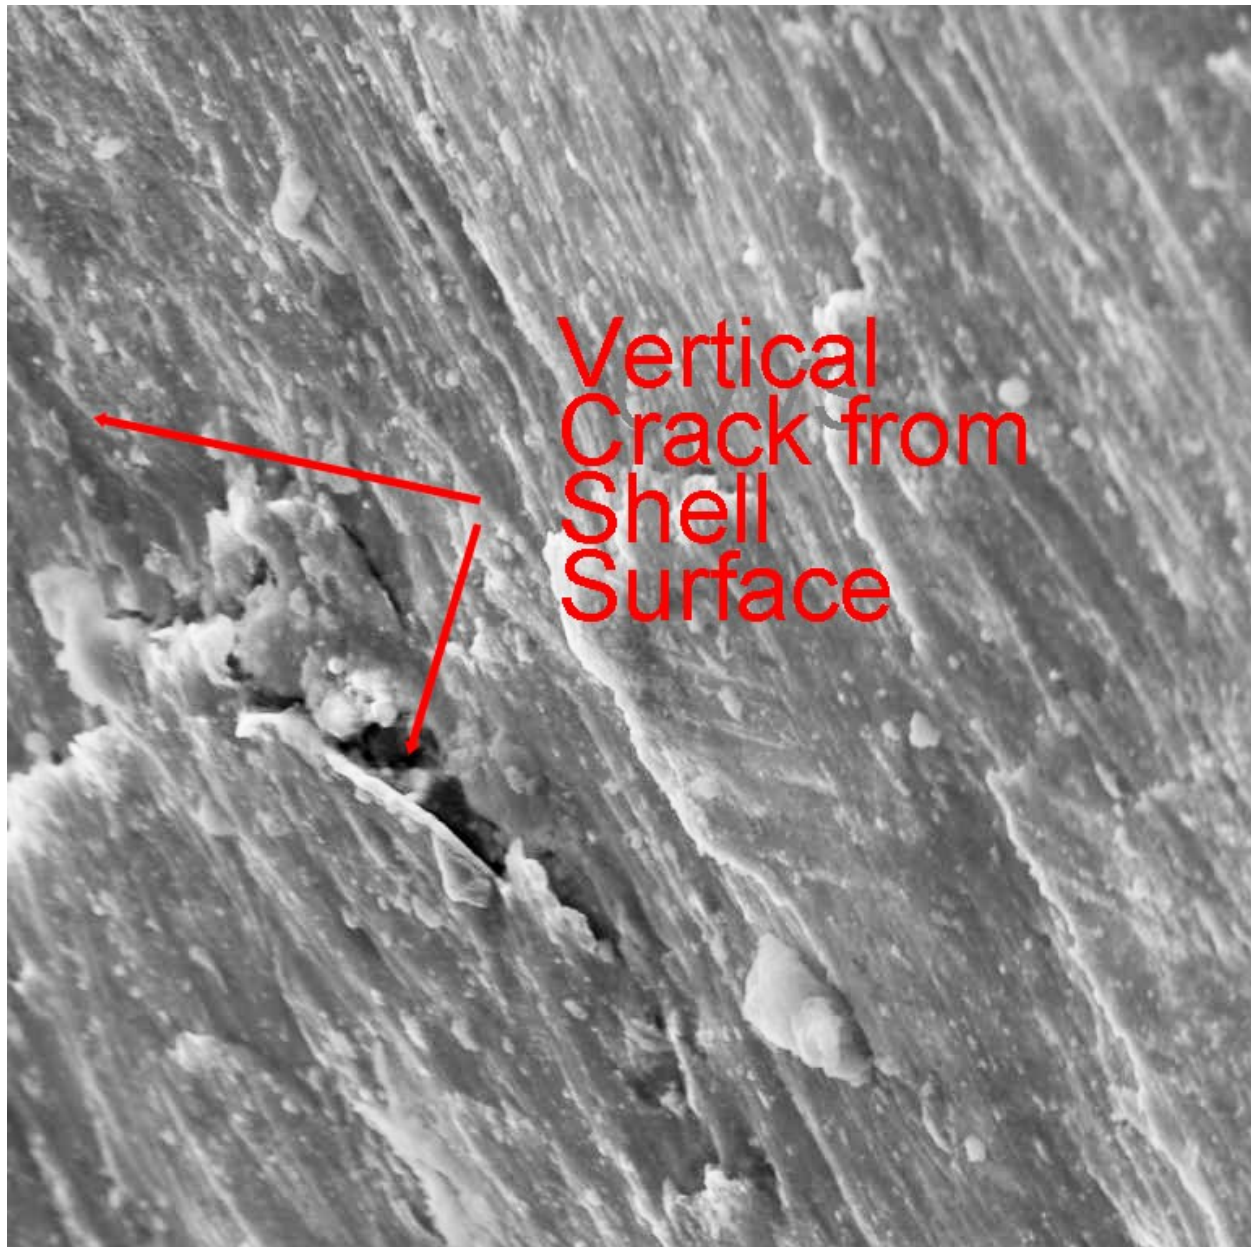
Figure A-59. Scanning Electron Microscope Image of UP9's Delamination Surface, Original Magnification x1,000

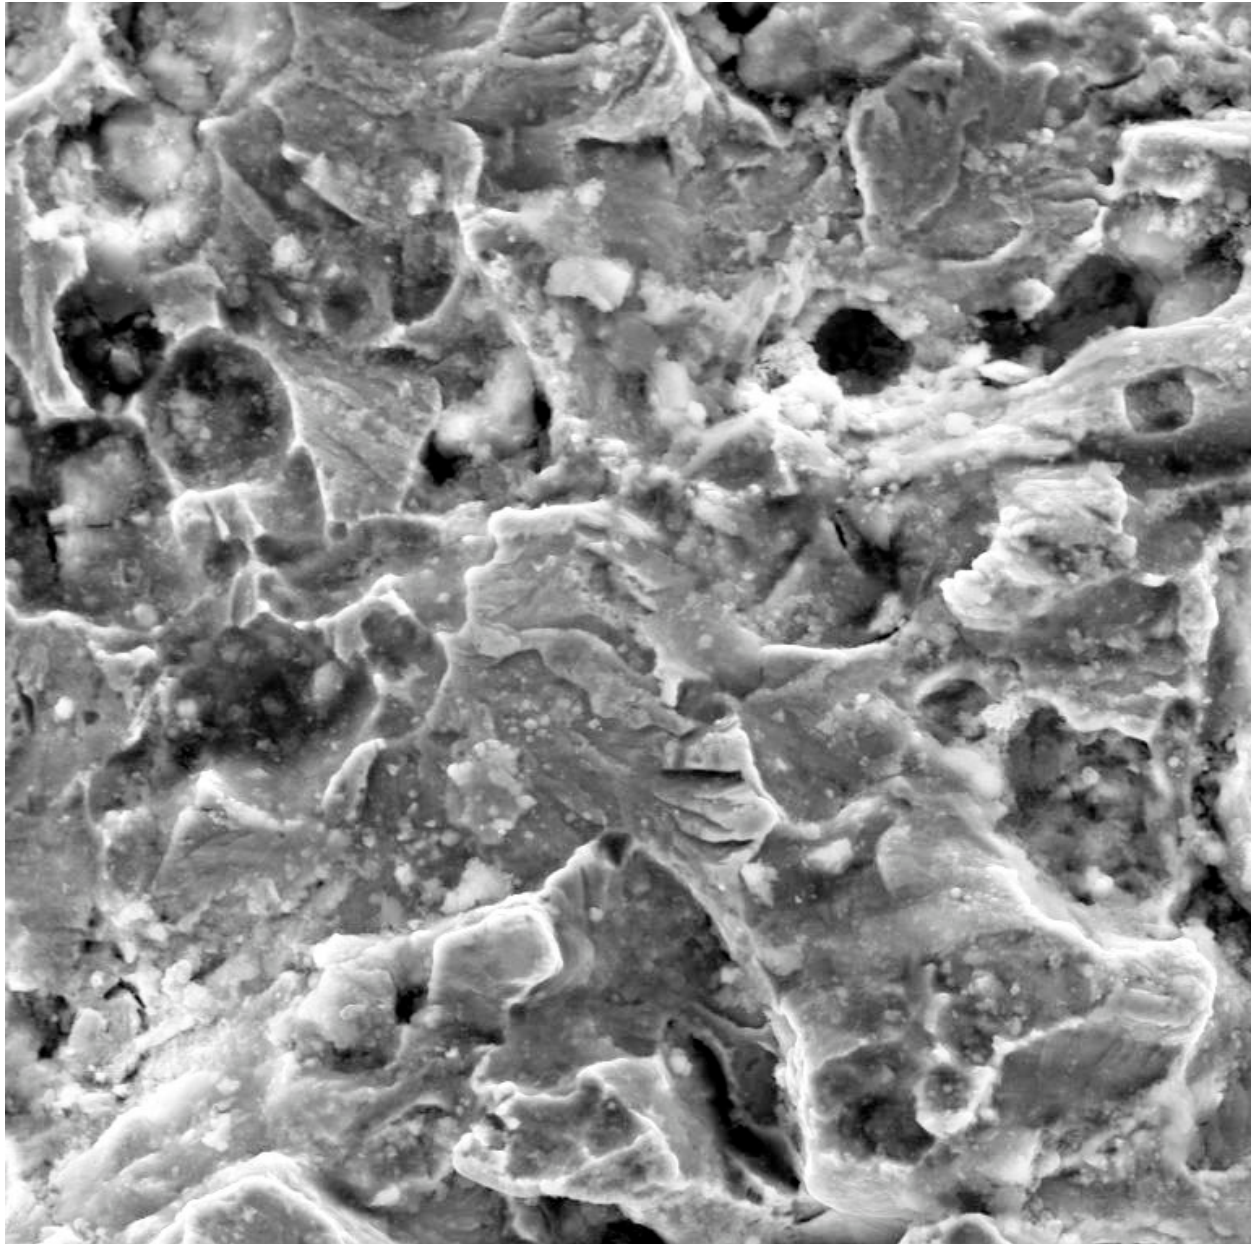
Figure A-60. Scanning Electron Microscope Image of Quasi-Cleavage UP9's VSR Fracture Surface. Original Magnification x1,000

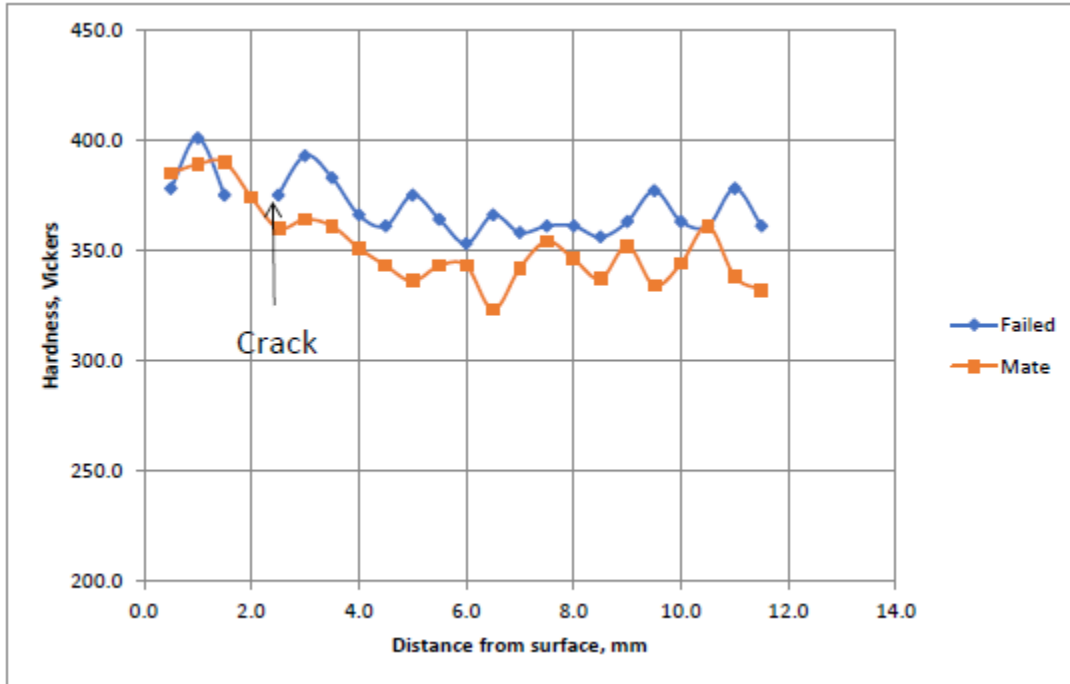
A radial microhardness traverse was made from the tread surface to a depth of half of an inch. The results, Figure A-61, show that the surface was work-hardened by approximately 40 Vickers hardness numbers.

Figure A-61. Radial Microhardness Traverse from UP9 and Mate Tread Surface
