Fouled Ballast Waiver Operations and Results

1. REPORT DATE January 2022		2. REPORT TYPE Technical Report		3. DATES COVERED June 12, 2017–January 31, 2019	
4. TITLE AND SUBTITLE Fouled Ballast Waiver Operations and Results			5a. CONTRACT NUMBER 693JJ6-18-D-000005		
			5b. GRANT NUMBER		
			5c. PROGRAM ELEMENT NUMBER

11. SPONSOR/MONITOR'S REPORT NUMBER(S) DOT/FRA/ORD-22/01	
12. DISTRIBUTION/AVAILABILITY STATEMENT This document is available to the public through the FRA website .

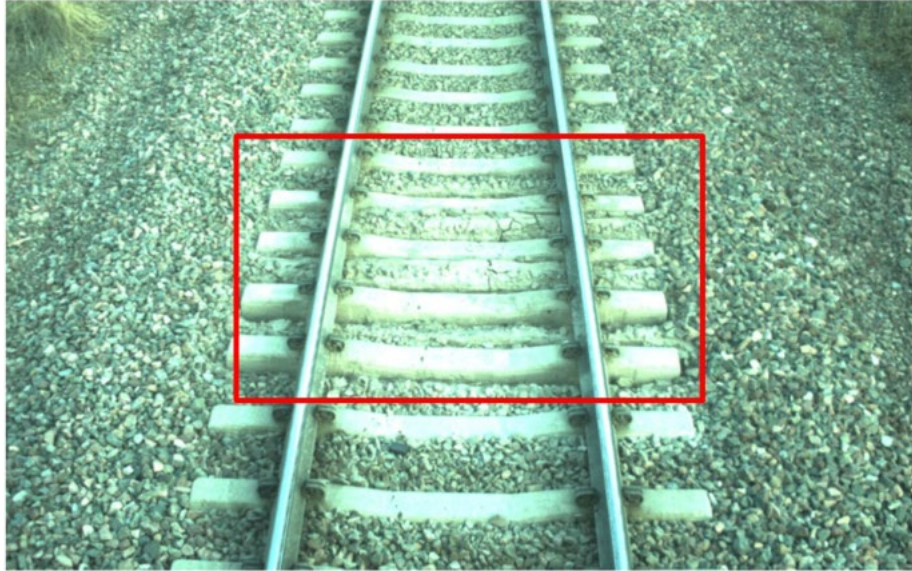
Figure 4. Fouled Ballast Location Identified in DOTX 220/218 Trackbed

ENSCO also amended the master list based on reviews of track bed images. FRA’s DOTX 220/218 manned track inspection consist collected the images during its surveys of the waiver territory as part of the ATIP. [Figure 4](#) shows highlighted an example of a fouled ballast location identified during such a review.

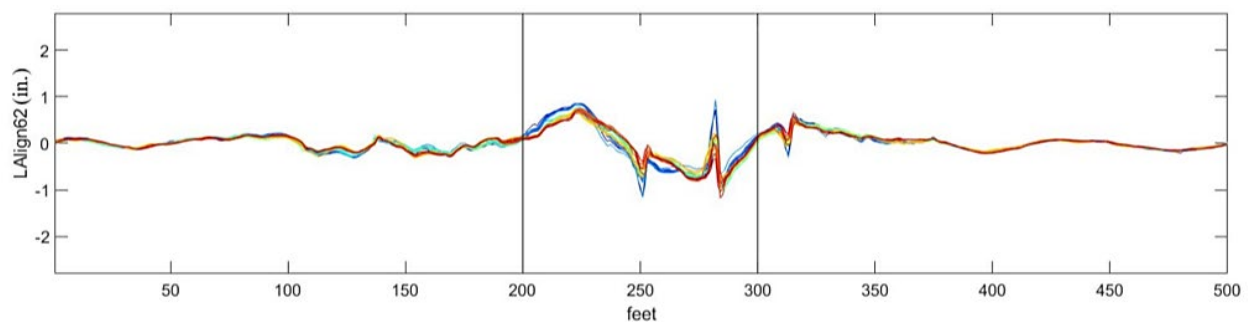
Figure 9. Example of Unfiltered and Unedited Track Geometry Data

[Figure 9](#) shows an example of unfiltered and unedited track geometry. Forty recordings of the mid-point offset on a 62-foot chord for the alignment of the left rail (LAlign62) are superimposed. Fouled ballast was present at this location between 200 and 300 feet.

[Figure 9](#) shows a pattern of noise in several of the recordings. This was found to be caused by variation in measurements through a turnout. [Figure 10](#) shows the same data after median filtering and manual editing.

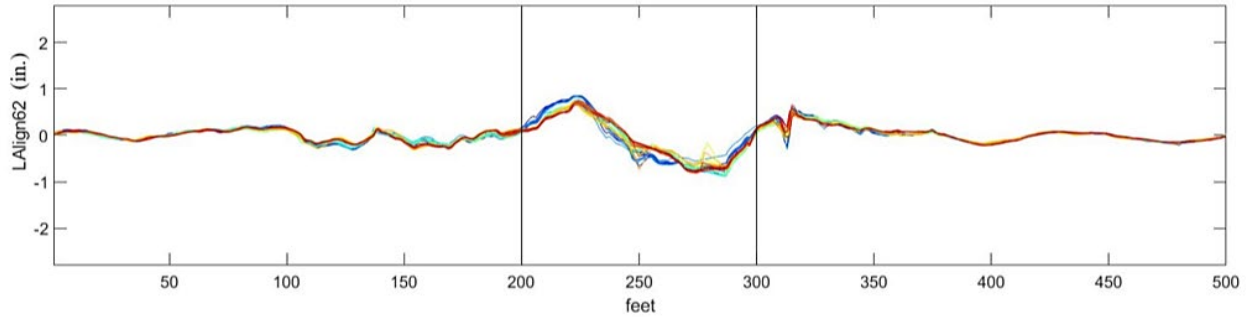
Figure 10. Example of Filtered and Edited Track Geometry Data

Figure 10 shows the noise in the original recordings has been reduced or removed by filtering and editing between 200 and 300 feet. The remaining variation between recordings could be due to real changes in track geometry during the monitoring period.

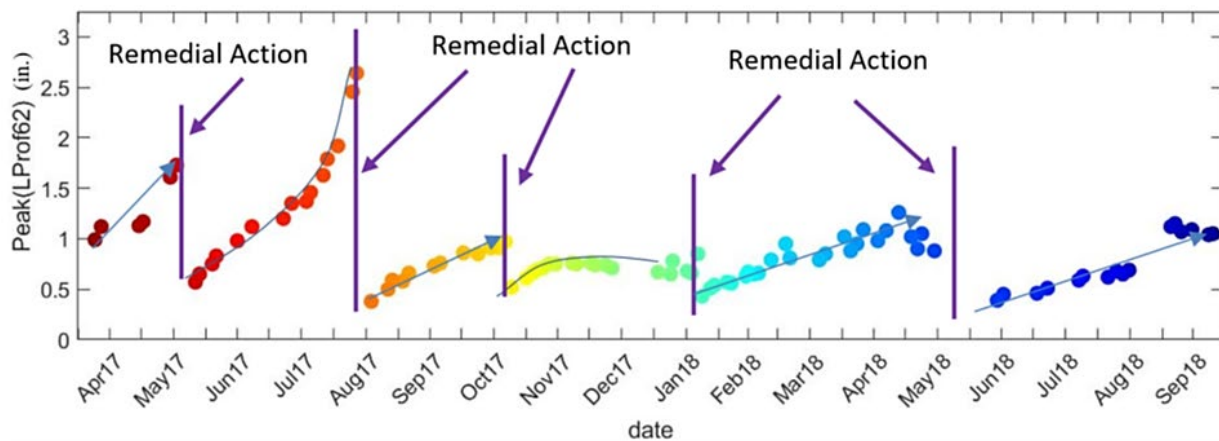
Figure 11. Example Track Geometry Peak Time History

Figure 11 shows an example of a track geometry peak time history. This graph plots the peaks in 80 recordings against the test date. The peaks are for the 62-foot mid-chord offset for profile of the left rail (LProf62).

The vertical lines in Figure 11 show the dates when remedial action was taken to improve track geometry. This example clearly shows a repeated pattern of degradation and improvement.

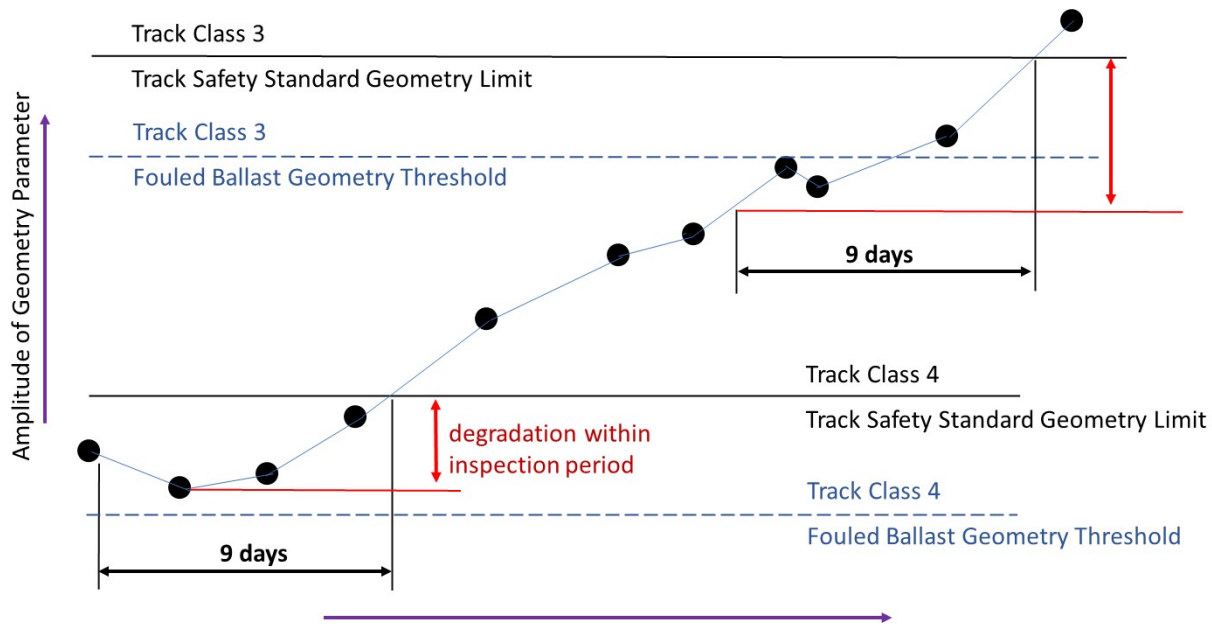
Figure 12. Determination of Track Geometry Deterioration Rates

Figure 12 shows the peak in the track geometry parameter crossed the track class 4 safety limit sometime between the fourth and fifth recording. The estimated time this occurred is found by linear extrapolation between the fourth and fifth recorded values. The 9-day period prior to this time is shown. The degradation during the inspection period is the change from the lowest value (in this case the second recording) to the track class 4 safety limit. In this case the degradation is less than the difference between the track class 4 safety limit and the threshold set by the fouled ballast waiver.

The top right of Figure 12 shows a case when the peak in the track geometry parameter crossed the track class 3 safety limit. The lowest value in the 9 days prior to this event is found by linear interpolation between the seventh and eighth recorded values. In this case the degradation is more than the difference between the track class 3 safety limit and the threshold set by the fouled ballast waiver.

As Figure 12 shows, the recorded geometry at a single location can cross more than one safety limit. Thus, although the waiver territory was posted as track class 4, the data allowed degradation to be evaluated at the safety limits for track classes 1 through 5. The results for track classes other than 4 are of interest since they allow analysis of the ballast specific thresholds proposed in the waiver. This analysis is limited because the traffic, maintenance and operations on the waiver corridor is representative of posted track class 4. The degradation rates it generates may not be typical conditions in other posted track classes. This is especially true for results observed at track class 5 safety levels. Trains at posted track class 5 territories would operate at higher speeds than on the waiver territory.

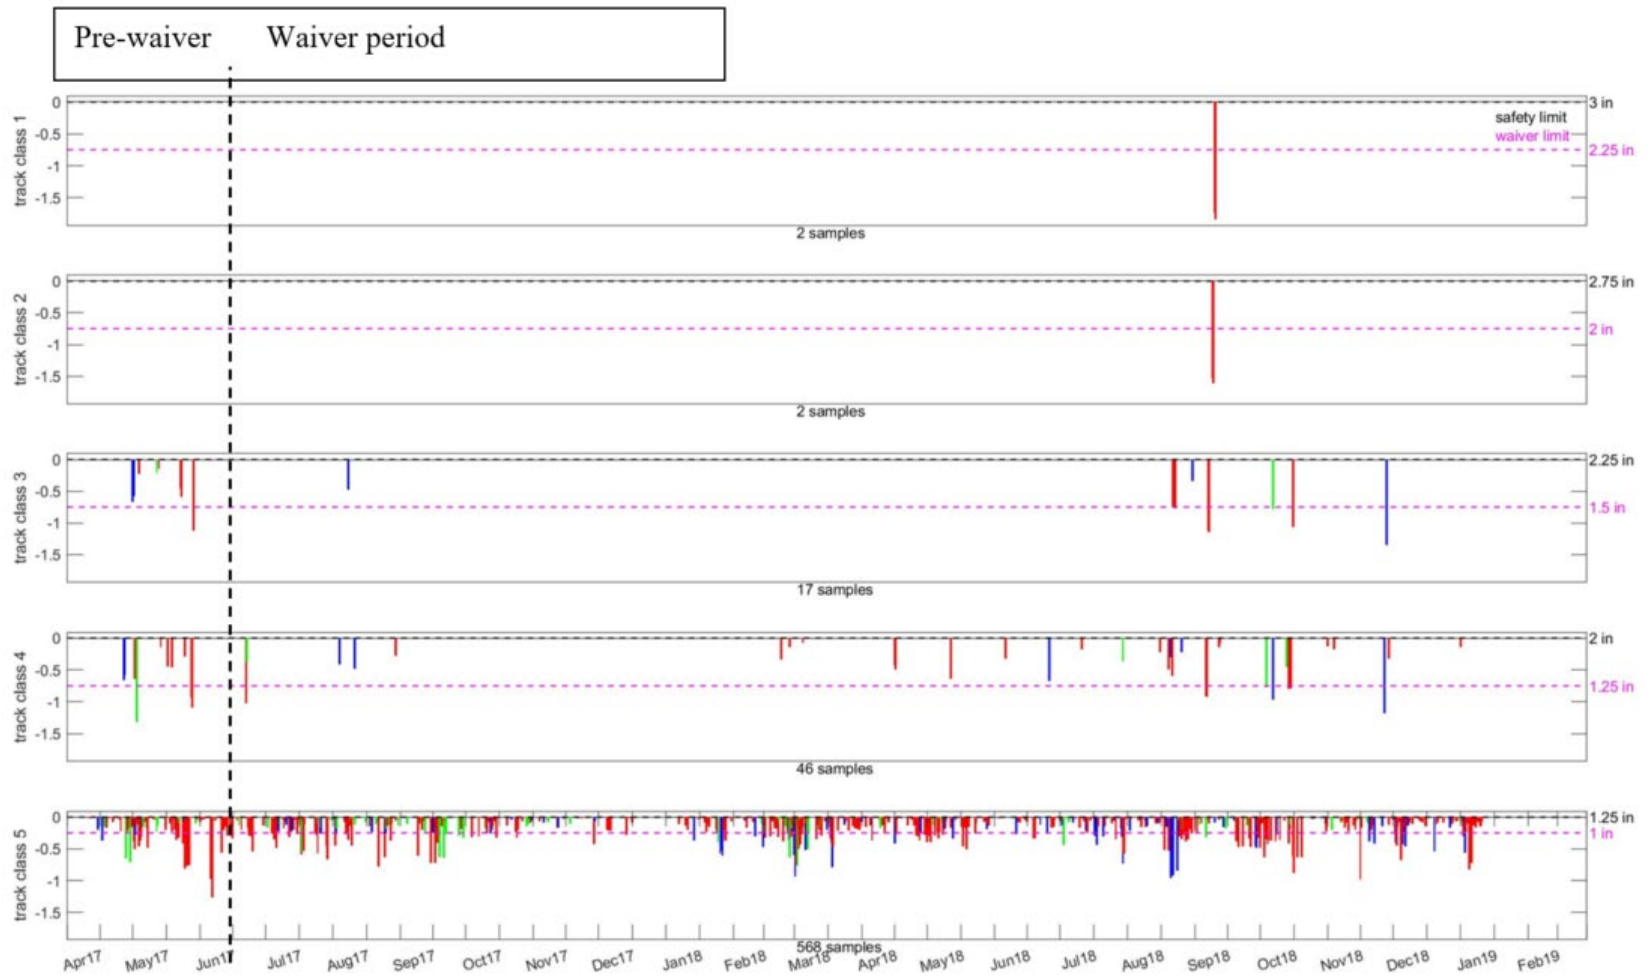
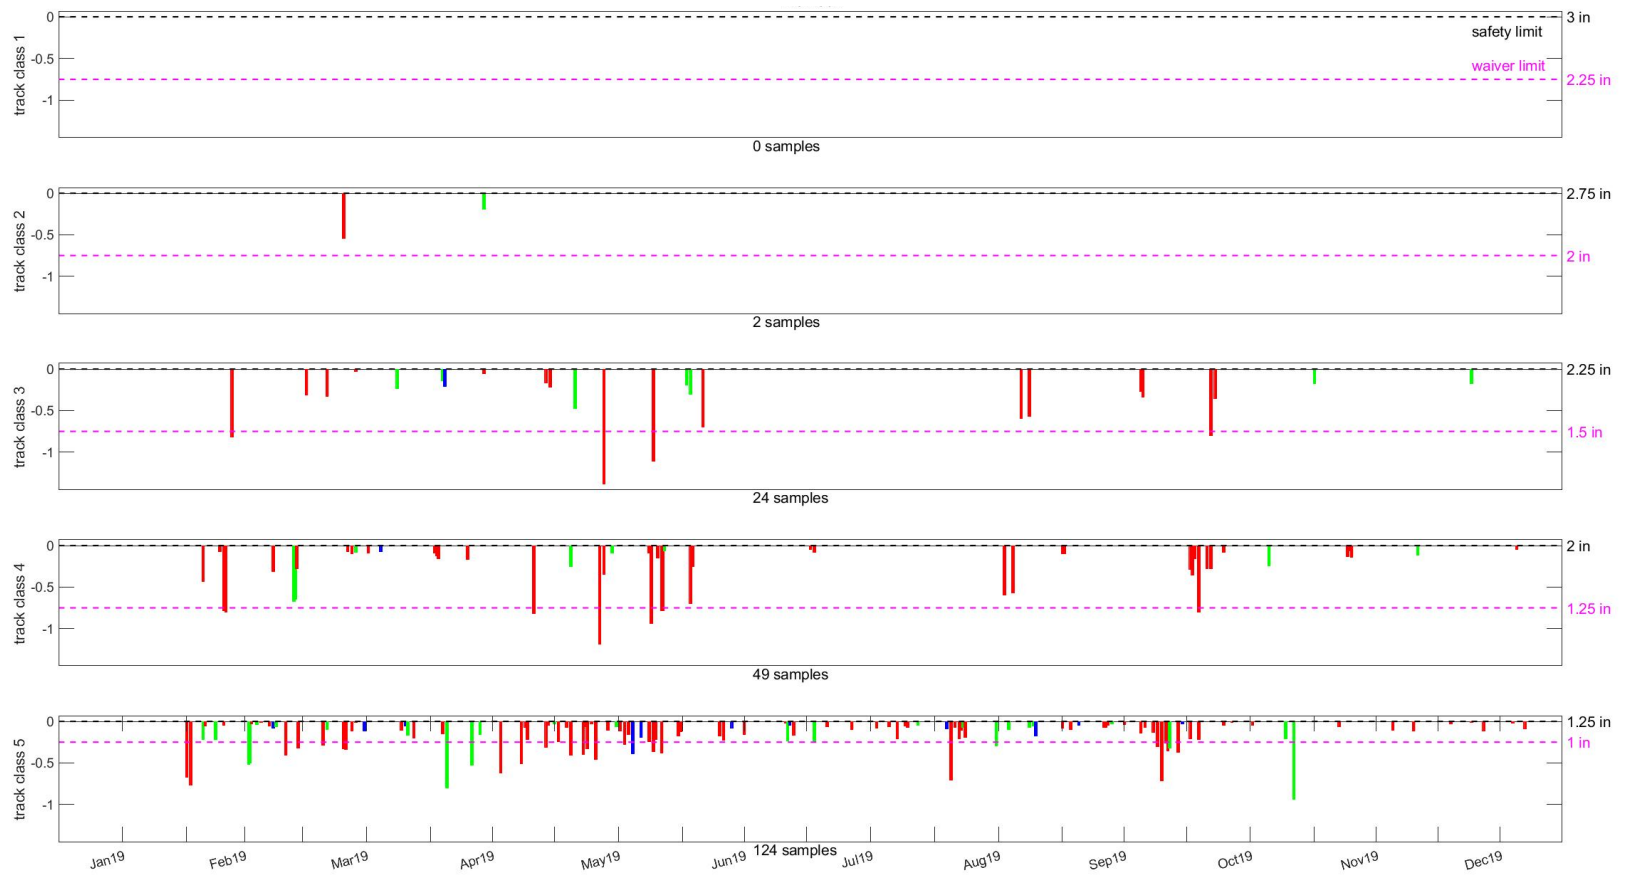
Figure 13. Degradation Results for Profile 62 During the Pre-waiver and Waiver Periods

Figure 14. Degradation Results for Profile 62 During the Post-waiver Period

The results in [Figure 13](#) and [Figure 14](#) are grouped by track class. The dashed horizontal lines in these figures show the safety limit and waiver thresholds for track parameter Profile 62. [Figure 13](#) and [Figure 14](#) show most of the calculated degradation results occurred on tangent track. Some results were on curves and a few were on spirals. This is consistent with the lengths of tangents and curves on the waiver territory. The results show some degradation results exceeded the additional safety margin between the waiver threshold and the track safety limit.

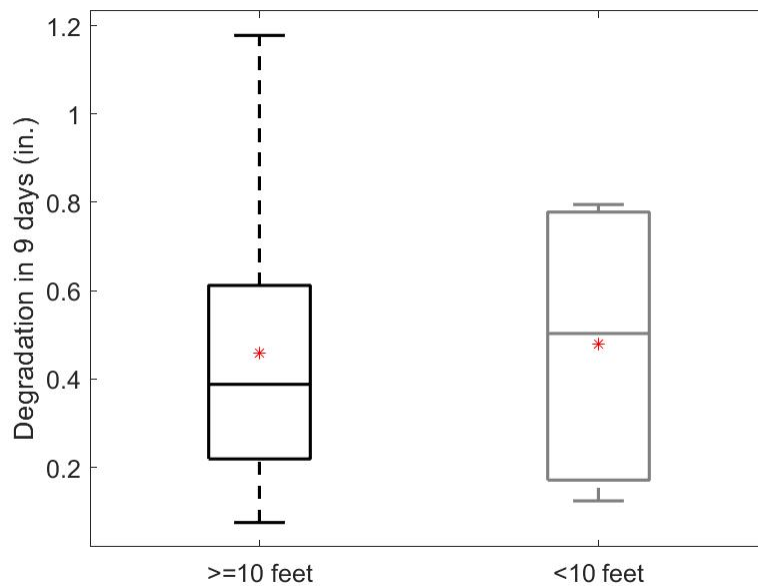
Figure 15. Profile 62 Degradation by Fouled Ballast Location Length – Track Class 4 Safety Limit – Waiver Period

Figure 15 shows box and whisker plots for both categories of fouled ballast length. The means are also shown for comparison with the medians. The mean degradation for locations equal to or greater than 10 feet (28 results) is similar to that for locations less than 10 feet (6 results).

A statistical analysis confirmed that there is no reason to conclude the degradation is different for these two datasets. Short sections of fouled ballast can be considered together with long sections.

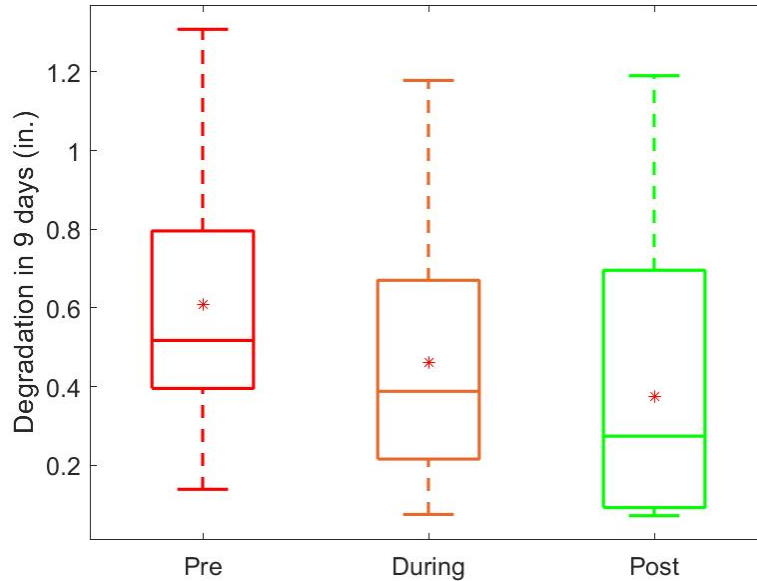
Figure 16. Profile 62 Degradation by Time Period – Track Class 4 Safety Limit

Figure 16 shows box and whisker plots for the pre-waiver, waiver, and post-waiver periods. The means are also shown for comparison with the medians. The degradation in the pre-waiver period (12 results) appears to be greater than in the waiver period (34 results) and the post-waiver period (23 results). However, a statistical analysis of variation did not give any reason to conclude degradation depends on the time period.

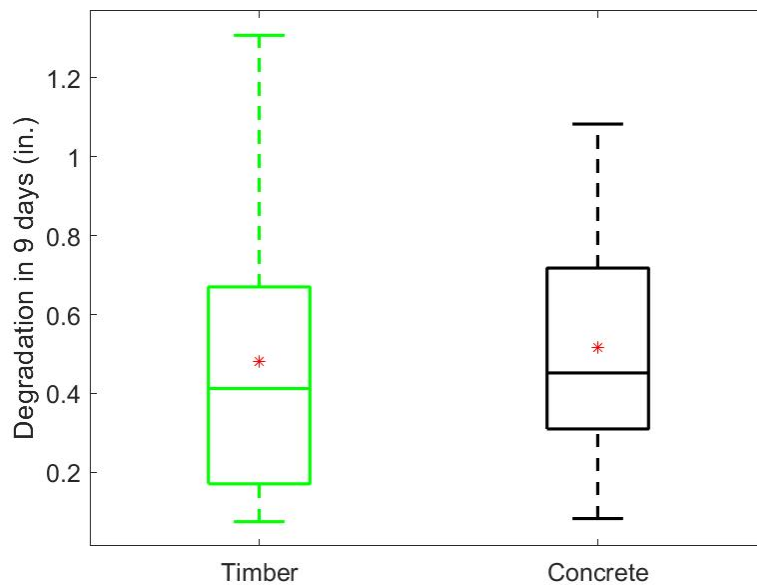
Figure 17. Profile 62 Degradation by Tie Type – Track Class 4 Safety Limit

Figure 17 shows box and whisker plots for both tie types. The means are also shown for comparison with the medians. The mean degradation for timber ties (22 results) is similar to that for concrete ties (24 results). A statistical test confirmed there is no evidence that the degradation is different for these two types of tie.

The maximum degradation for the timber ties, 1.31 inches, is slightly larger than that for the concrete ties, 1.08 inches.

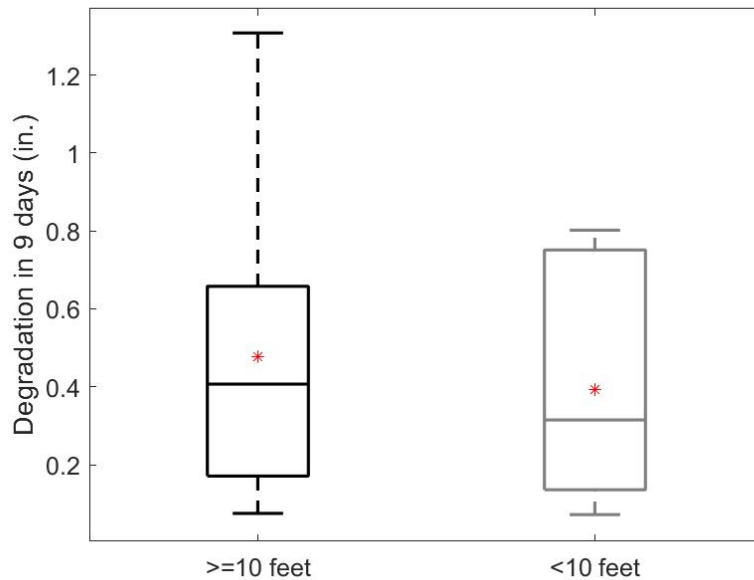
Figure 18. Profile 62 Degradation by Fouled Ballast Location Length – Track Class 4 Safety Limit – All Periods and Tie Types

Figure 18 shows box and whisker plots for both categories of fouled ballast length. The means are also shown for comparison with the medians. The mean degradation for locations equal to or greater than 10 feet (54 results) is similar to that for locations less than 10 feet (15 results). A statistical test showed there is no reason to conclude the degradation is different for these two datasets.

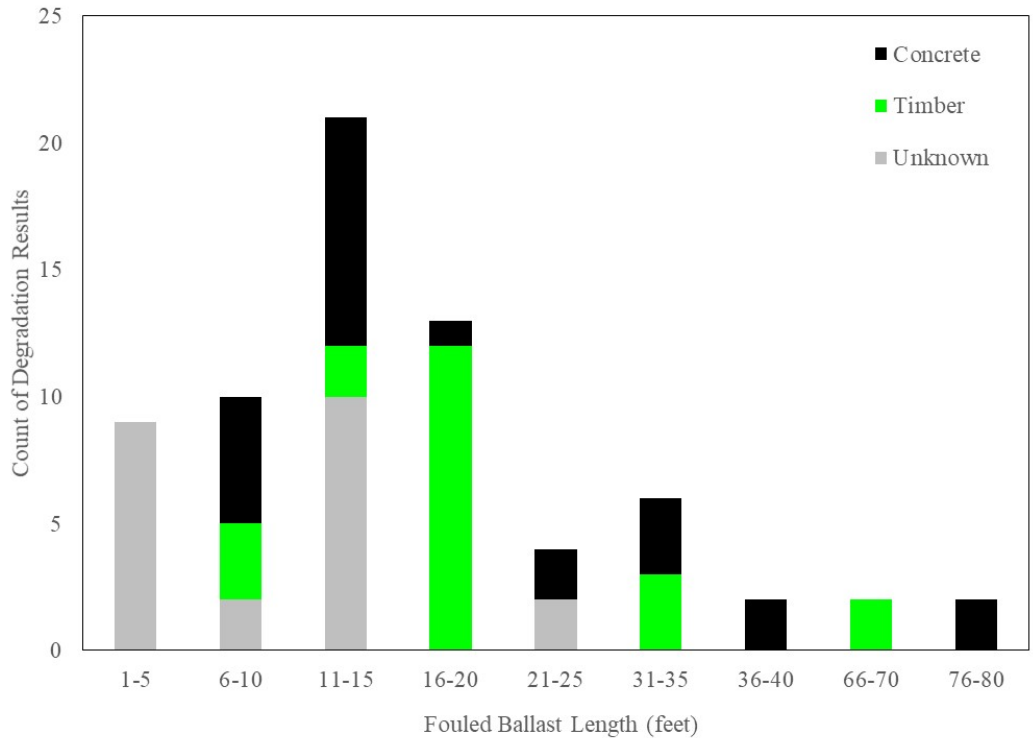
Figure 19. Histogram of Fouled Ballast Lengths – Profile 62 Track Class 4 Safety Limit – All Periods and Tie Types

Figure 19 shows sections of fouled ballast that crossed the track class 4 safety limit varied in length from 5 feet or less up to 80 feet. There does not appear to be any correlation between tie type and fouled ballast length.

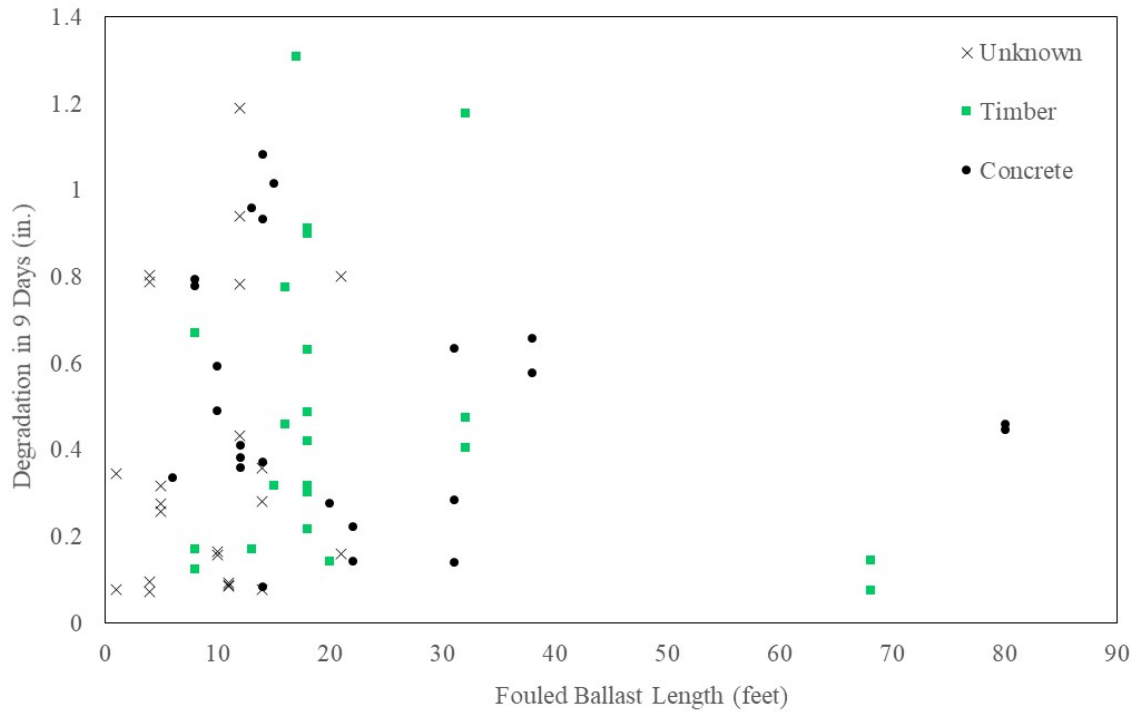
Figure 20. Profile 62 Degradation Statistics by Fouled Ballast Length – Track Class 4 Safety Limit – All Periods and Tie Types

Figure 20 shows the maximum value of Profile 62 degradation at short sections of fouled ballast can be as large as at some longer sections. It also shows no correlation between Profile 62 degradation and tie type.

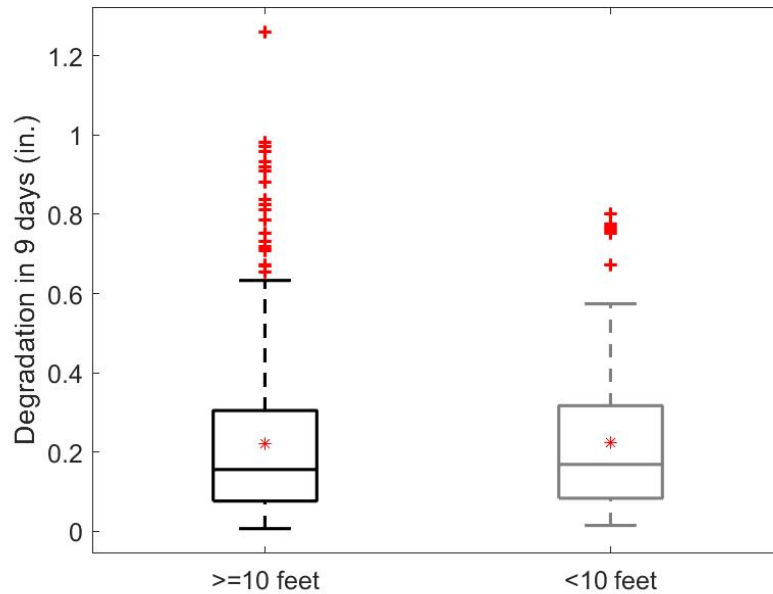
Figure 21. Profile 62 Degradation by Fouled Ballast Location Length – Track Class 5 Safety Limit – All Periods and Tie Types

Figure 21 shows box and whisker plots for both categories of fouled ballast length. The means are also shown for comparison with the medians. Data points that lie outside the fence are also shown. They indicate several locations with exceptionally high degradation. (Note that the previous box plots showed these outliers were not present in the track class 4 Profile 62 degradation results.)

Comparing Figure 21 with Figure 18 shows mean degradation before crossing the track class 5 safety limit is less than that before crossing the safety limit for track class 4. The variation is similar for short and long locations of fouled ballast.

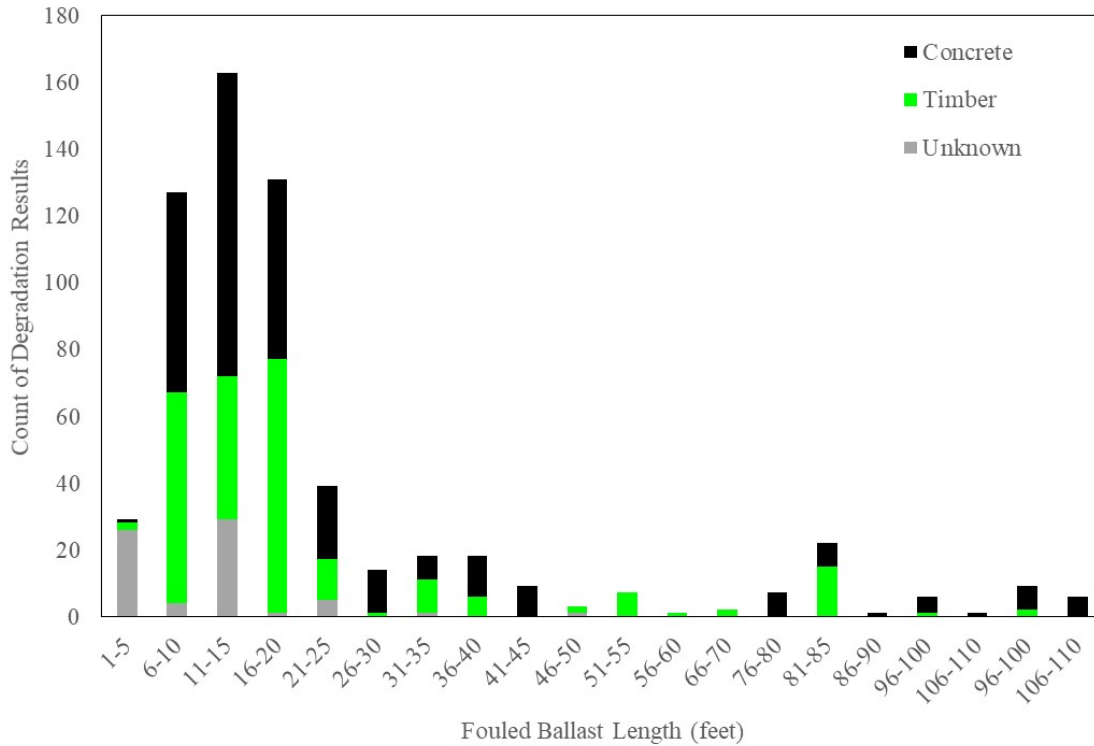
Figure 22. Histogram of Fouled Ballast Lengths – Profile 62 Track Class 5 Safety Limit – All Periods and Tie Types

Figure 22 shows sections of fouled ballast that crossed the track class 5 safety limit varied in length from 5 feet or less up to 110 feet. There does not appear to be any correlation between tie type and fouled ballast length.

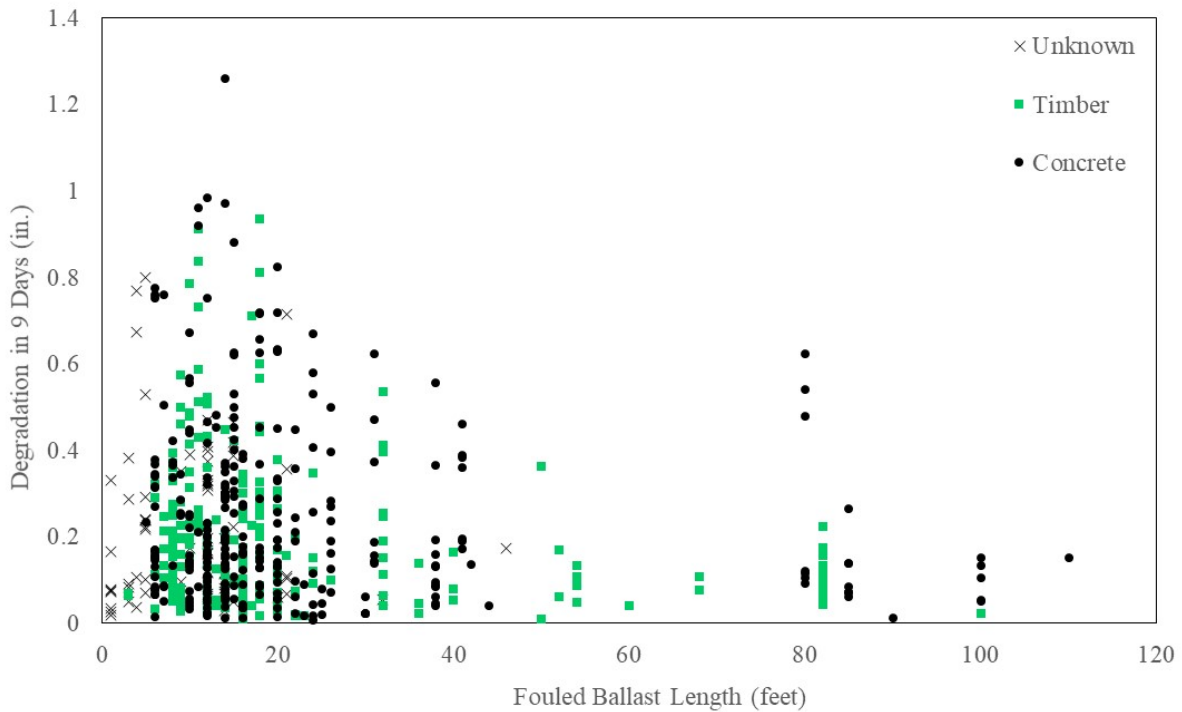
Figure 23. Profile 62 Degradation Statistics by Fouled Ballast Length – Track Class 5 Safety Limit – All Periods and Tie Types

Figure 23 shows the maximum value of Profile 62 degradation at short sections of fouled ballast can be as large as at some longer sections. It also shows no correlation between Profile 62 degradation and tie type.

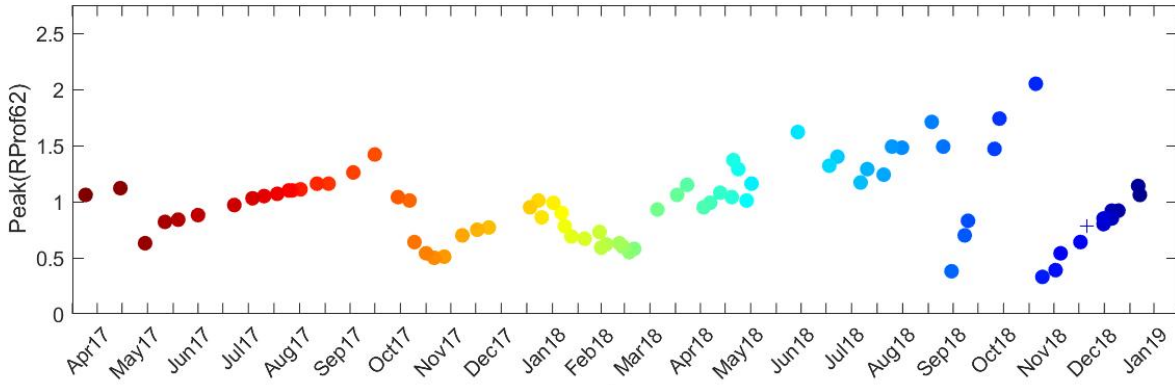
b) 8-foot Section of Fouled Ballast at MP 106

Figure 24 shows similar patterns of degradation and improvement for the long and short locations of fouled ballast. In both cases the Profile 62 track geometry parameter crosses the track class 5 and 4 safety limits (1.25 and 2.0 inches respectively).

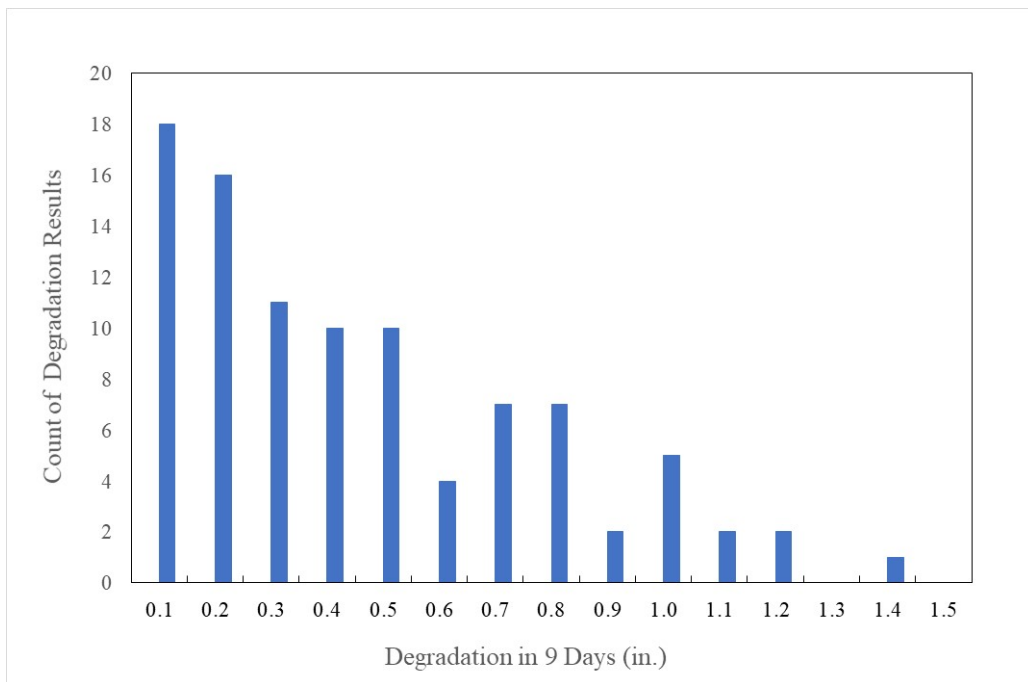
Figure 25. Histogram of Profile 62 Degradation Results – Track Class 4 Safety Limit – All Periods and Tie Types

The additional safety margin between the waiver threshold and the safety limit is 0.75 inches. [Figure 25](#) shows 18 of the total 95 degradation results exceeded this additional safety margin. This means that in 19 percent of cases the degradation in the 9 days prior to the Profile 62 parameter crossing the track safety limit was greater than the additional safety margin included in the waiver.

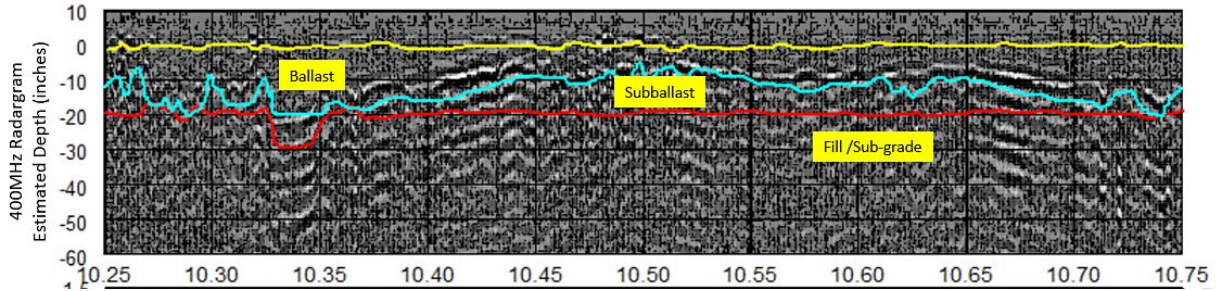
Figure 44. Example Grayscale Plots of GPR Data

Figure 44 shows shallow ballast in similar locations to the locations of degraded track quality shown in Figure 43. In these locations, the ballast extends barely below the bottom of the ties (i.e., typically 8 inches deep).

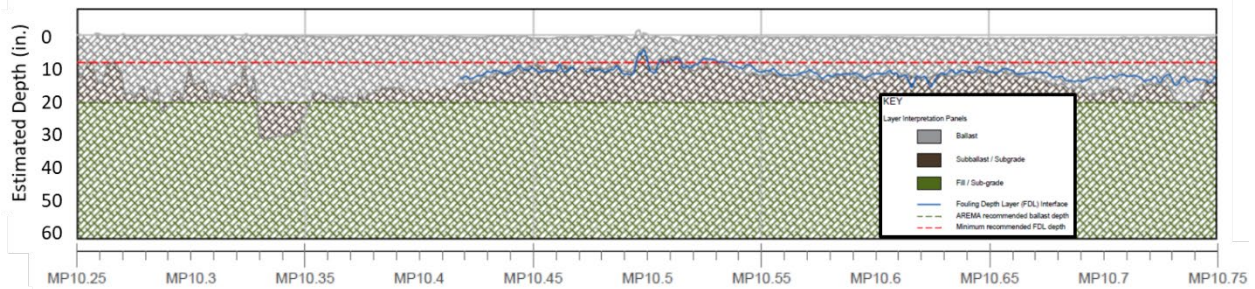
Figure 45. Example Layer Interpretation Plot

Figure 45 shows an example of a layer interpretation plot. This is an alternative method to Figure 44 of displaying the boundaries between the layers.

The Fouling Depth Layer (FDL) is the depth to a fouled layer, which represents the depth of relatively clean ballast identified by GPR. Table 6 shows the definitions used for FDL. Brown indicates fouling at or above the bottom of the tie, meaning that no clean ballast is expected to be supporting the tie. The horizontal red line at 8 inches in Figure 45 is the typical depth of ties. The horizontal blue line at 20 inches in Figure 45 is the depth of ballast recommended by AREMA.

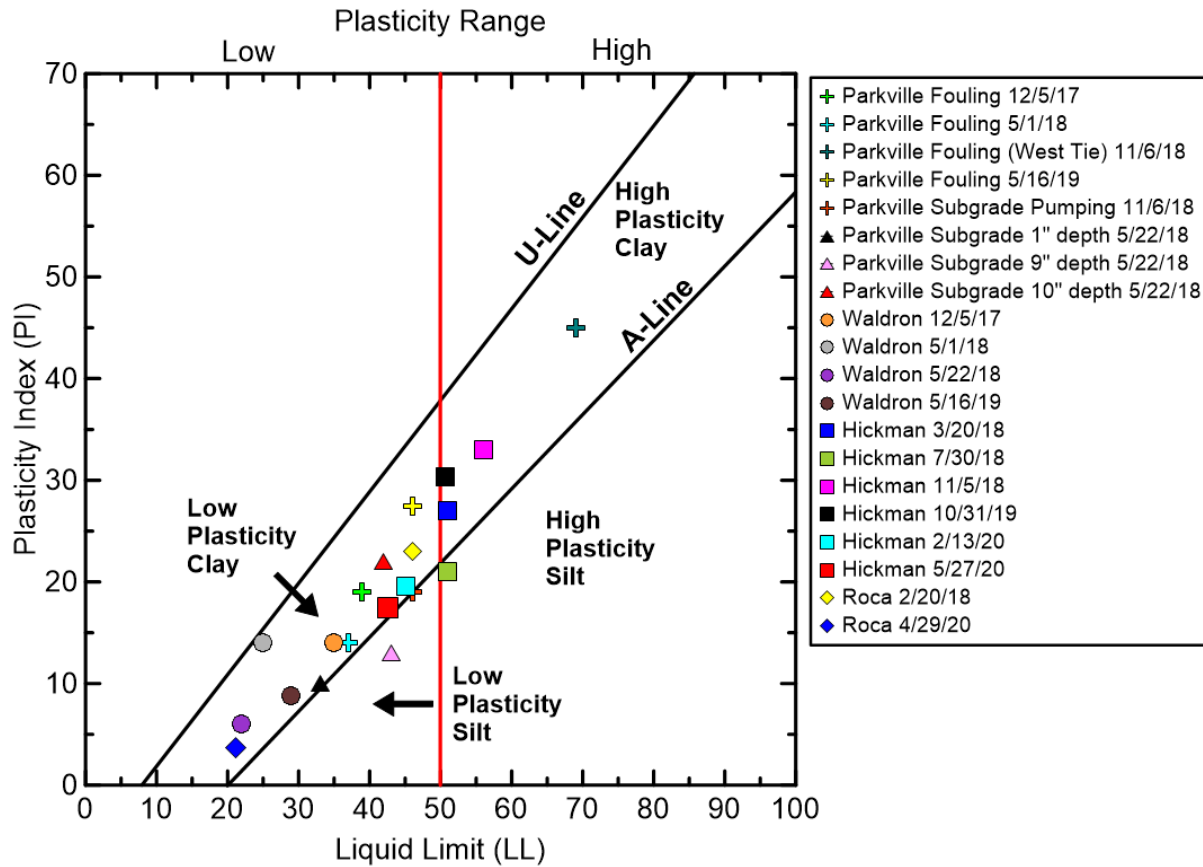
Figure 47. Plasticity Chart for all Sites and Dates

Figure 47 shows a plasticity chart with the results for the 20 fouled ballast samples in Table 9.

The classification of most fouling samples is a low plasticity clay except for three samples collected from Hickman and one from Parkville, which classify as a high plasticity clay. The classification of high plasticity indicates the soil behaves in a plastic manner over a large range of water contents. The characterization of plastic behavior is by large deformations at constant stress and generally low shear strength.

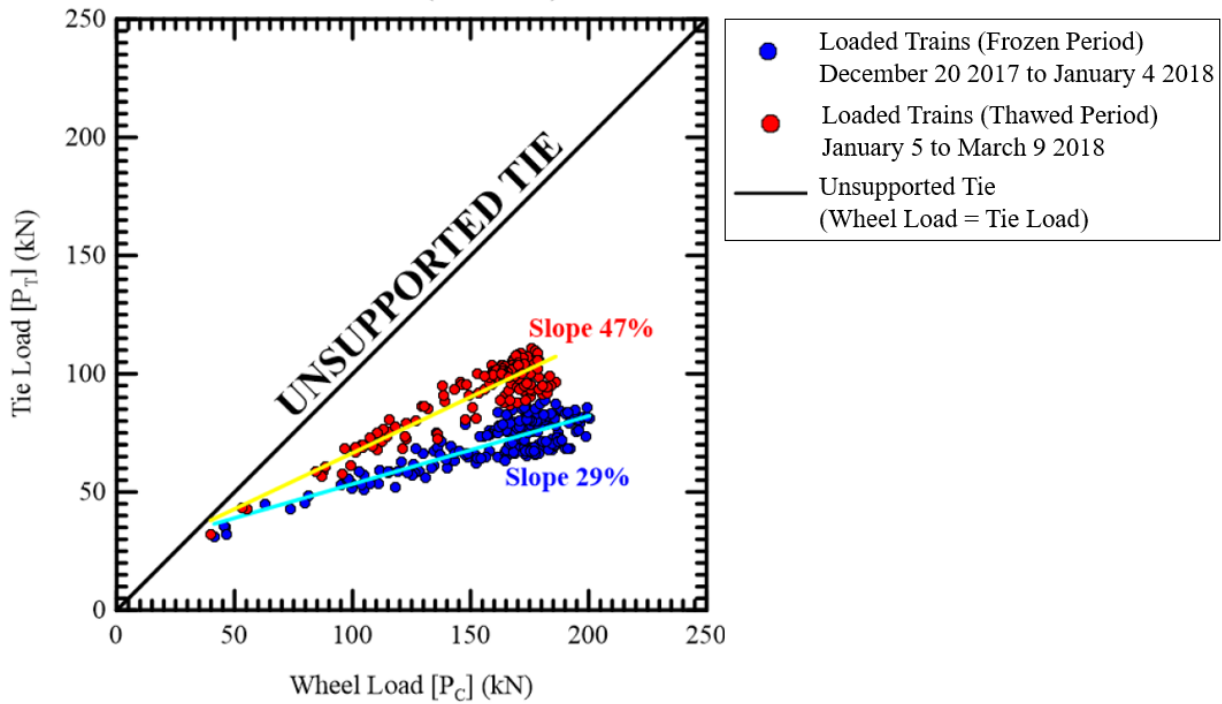
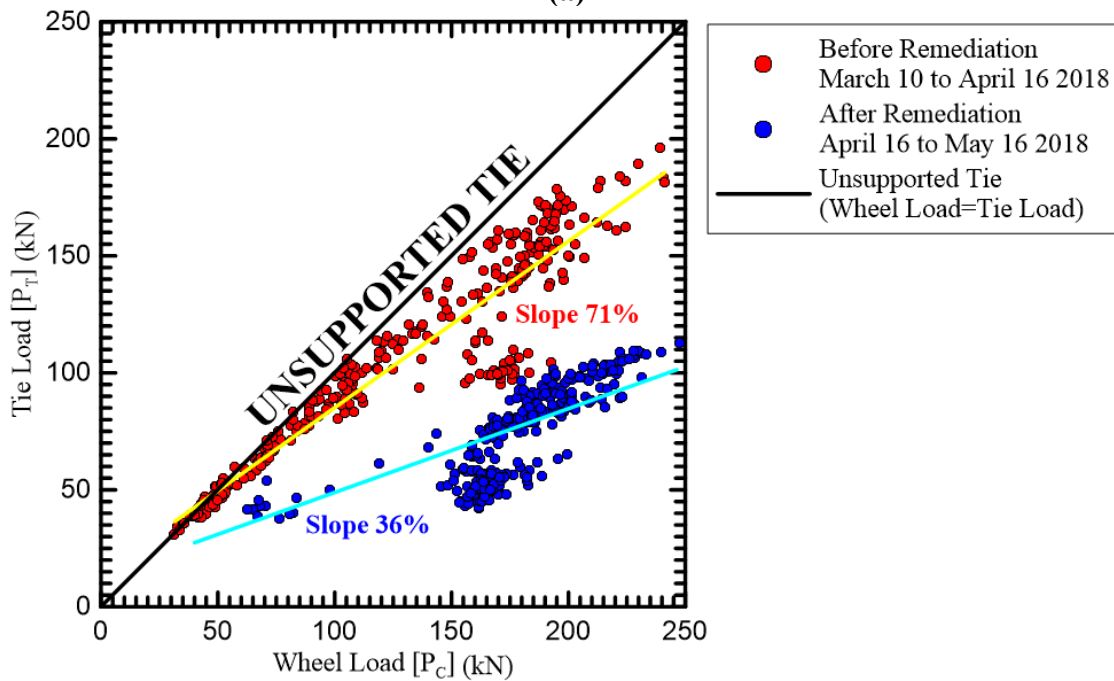
Figure 52. Tie Load vs. Wheel Load Change due to Seasonal Variation (a), Tie Load vs. Wheel Load Change due to Ballast Remediation (b)

Researchers analyzed DE at the Parkville long-term monitoring site to investigate the effects of traffic loading and ballast condition on track stiffness. Figure 52 shows charts of the distributed tie load (P_T) against the wheel load measured at the crib (P_C). DE is the slope of the line in these charts. The diagonal line in the charts represents an unsupported tie for which P_T equals P_C and DE = 100%.

Figure 52(a) shows the DE when the ballast was frozen (from December 20, 2017, to January 4, 2018) was 29 percent. It changed to 47 percent when the ballast thawed (from January 5, 2018, to March 9, 2018). Frozen fouling material causes a high overall track stiffness as the ballast is

On March 8, 2018, in a period when ambient temperature was above freezing, the site at Parkville was remediated by surfacing. Comparing the data plotted in red in [Figure 52\(a\)](#) with [Figure 52\(b\)](#) shows that remediation changed DE from 47 to 71 percent. This increase in DE means the track stiffness reduced indicating reduced track support and more load distributed to adjacent ties.

Ambient temperature dipped below freezing in late March and early April 2018. On April 16, 2018, after the spring thaw, the site at Parkville was remediated again by surfacing. [Figure 52\(b\)](#) shows that before remediation the DE was 71 percent. After remediation, the DE changed to 36 percent. The reduction in DE means the ballast support improved and the track stiffness increased.

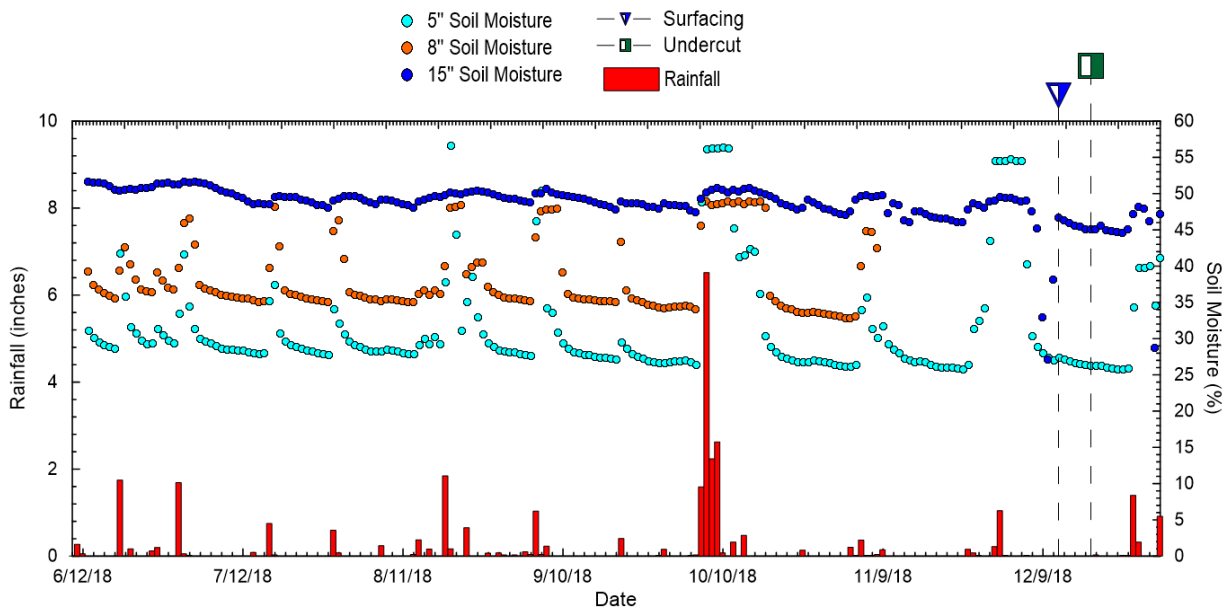
Figure 53. Effects of Rainfall on Soil Moisture at Waldron (concrete ties)

[Figure 53](#) shows rainfall and soil moisture from May 2018 to December 2018 at the Waldron long-term monitoring site. This site had concrete ties. Daily rainfall is plotted on a linear scale with rainfall events noted as bars with a peak of 6.5 inches on October 9, 2018. The vertical lines in [Figure 53](#) note the dates of performance when undercutting and surfacing. The filled circles depict the subsurface moisture sensor readings.

[Figure 53](#) clearly show increases in soil moisture after rainfall followed by gradual drying out until the next rainfall. The rate of reduction in soil moisture at different depths indicates the ballast’s ability to drain. In this case the moisture content increases with depth below the surface of the ballast. The increase in soil moisture and rate of reduction after rain are highest near the surface and lowest at the deepest location.

Three time periods in Figure 53 give insights into the effects of rainfall on moisture in the ballast:

- Before and during August 20, 2018, there was moderate rainfall (1.8 inches). Soil moisture measured at depths of 5, 8, and 11.5 inches increased sharply and stayed relatively high for a few days and then decreased gradually over the following days.
- Around September 5, 2018, there was light rainfall (1 inch). This caused soil moisture to increase and stay relatively high for approximately 4 days.
- Starting on October 7, 2018, heavy rainfall occurred for several days. Soil moisture measured at all depths increased and stayed high for 5 days.

This variation in behavior indicates that moisture content in the fouled ballast depends on more than rainfall.

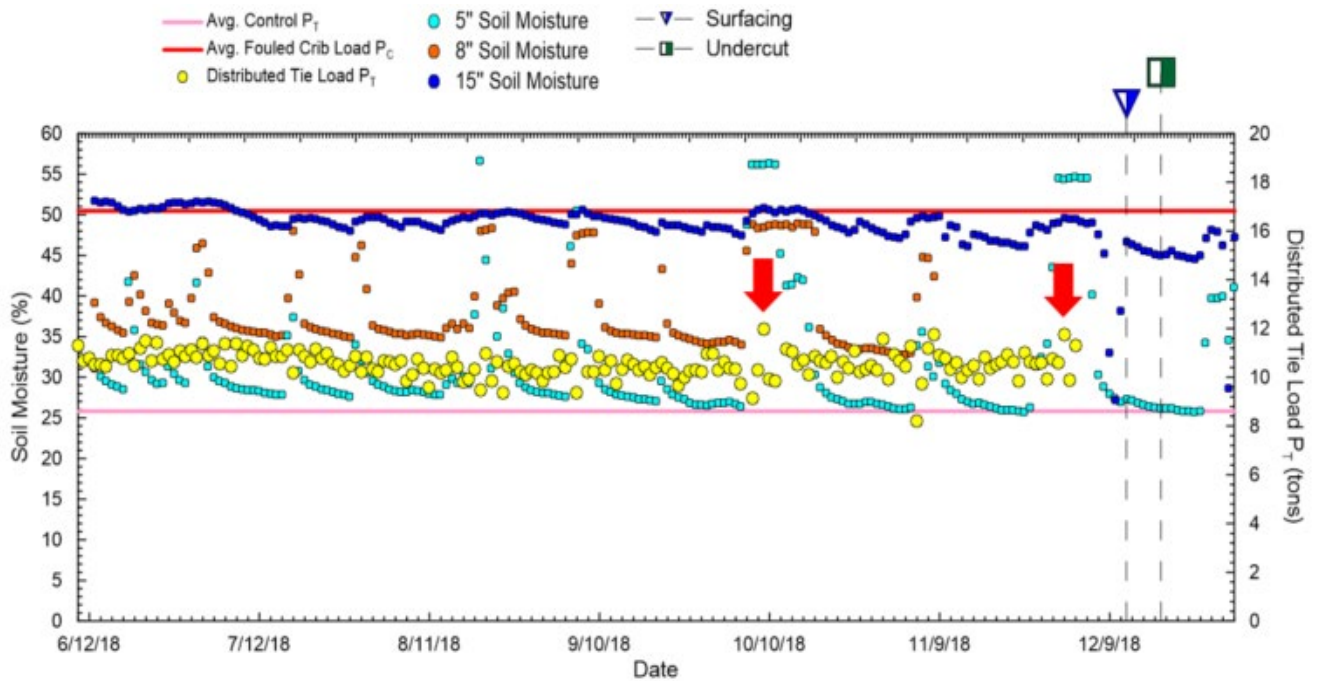
Figure 54. Effects of Soil Moisture on Distributed Tie Loads at Waldron (concrete ties)

Figure 54 shows changes in soil moisture and distributed tie loads, P_T , at the Waldron long-term monitoring site for the same time period as that shown in Figure 53. The solid pink line in Figure 54 is the average distributed tie load for the control site at Roca, which also has concrete ties. It indicates the support expected at a concrete tie site with clean ballast. The red line is the average wheel load (i.e., measured in the crib) at Waldron. It indicates the distributed tie load for an unsupported tie at this site.

Figure 54 shows sustained increase in soil moisture will result in an increase in distributed tie load and hence decrease in support provided by the ballast. This can be observed in the rainfall events in early October 2018 and late November 2018. The distributed tie load increases indicated by the red arrows in Figure 54 correspond to a sustained soil moisture increase measured at 5 inch depth.

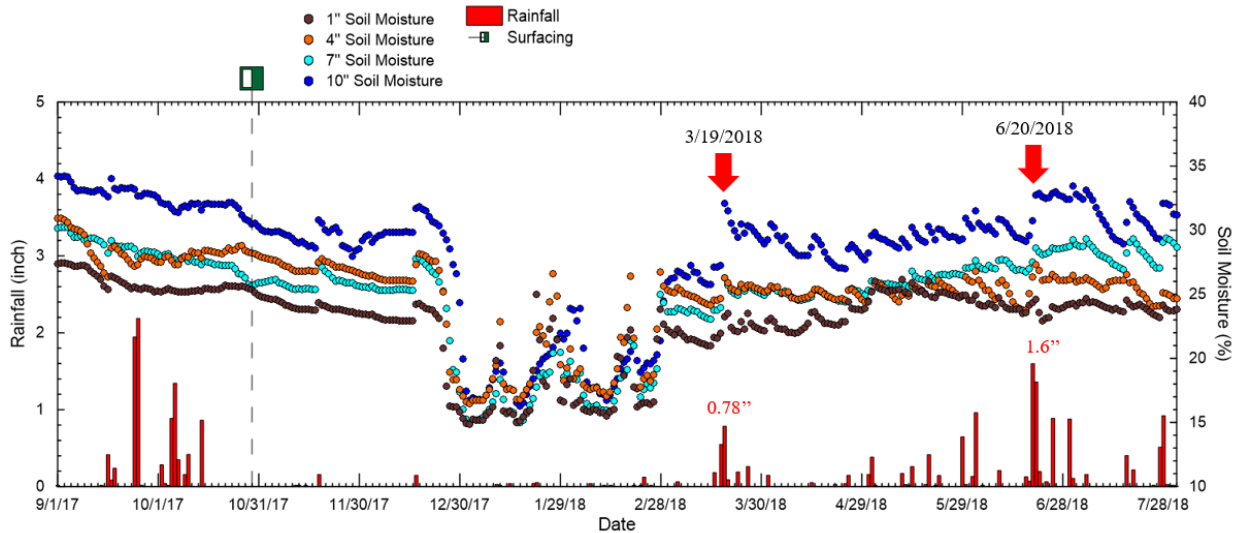
Figure 55. Effects of Rainfall on Soil Moisture at Hickman (timber ties)

Figure 55 shows rainfall and soil moisture from September 2017 to July 2018 at the Hickman long-term monitoring site. This site had timber ties. The vertical line in Figure 55 shows when machine tamping was performed on October 28, 2017.

In some time periods in Figure 55 the soil moisture did not increase continuously with depth. In November 2017, for example, the soil moisture at 4 inches was greater than that at 7 inches. This is likely due to fouling at intermediate depths below the ballast surface.

Figure 55 clearly shows increases in soil moisture after rainfall followed by gradual drying out until the next rainfall. The periods of heavy rainfall around March 19, 2018, and June 20, 2018, were followed by significant increases in soil moisture, particularly at the lower depths.

Figure 55 also shows the rain in October 2017 did not cause an increase in soil moisture. Before surfacing on October 28, 2017, the ballast was saturated and was not draining. The surfacing caused the ballast to start draining and respond to rainfall in a more natural way.
