Fouled Ballast Waiver Operations and Results

1. REPORT DATE January 2022		2. REPORT TYPE Technical Report		3. DATES COVERED June 12, 2017–January 31, 2019	
4. TITLE AND SUBTITLE Fouled Ballast Waiver Operations and Results			5a. CONTRACT NUMBER 693JJ6-18-D-000005		
			5b. GRANT NUMBER		
			5c. PROGRAM ELEMENT NUMBER

11. SPONSOR/MONITOR'S REPORT NUMBER(S) DOT/FRA/ORD-22/01	
12. DISTRIBUTION/AVAILABILITY STATEMENT This document is available to the public through the FRA website .

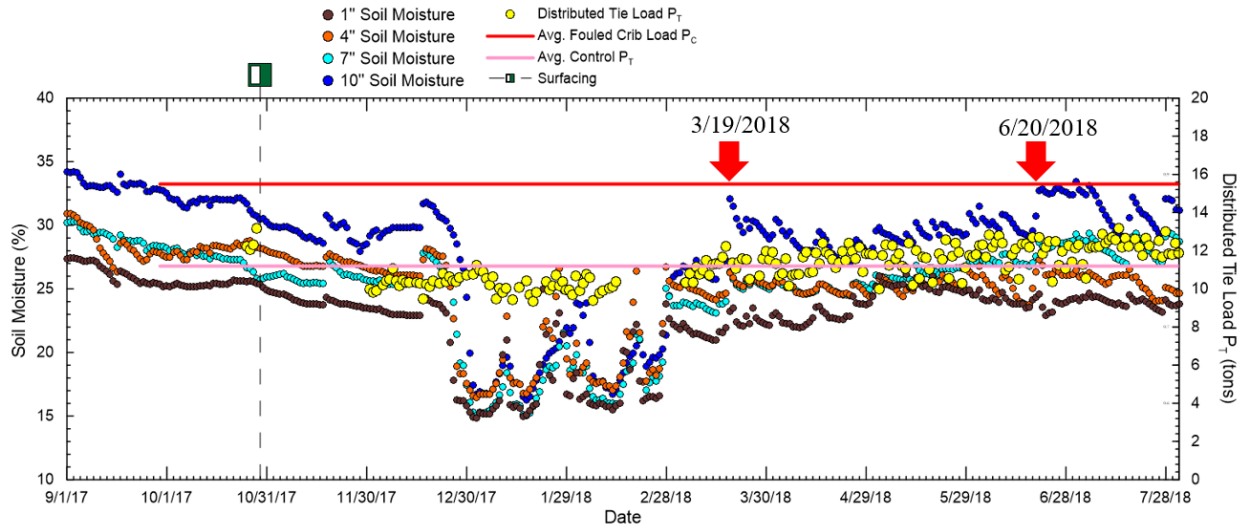
Figure 56. Effects of Soil Moisture on Distributed Tie Loads at Hickman (timber ties)

Figure 56 shows changes in soil moisture and distributed tie load, P_T , at the Hickman long-term monitoring site for the same time period as that shown in Figure 55. The solid pink line in Figure 56 is the average distributed tie load for the control site at Hickman, which also has timber ties. It indicates the support expected at a timber tie site with clean ballast. The red line is the average wheel load (measured in the crib) for the fouled site at Hickman. It indicates the distributed tie load for an unsupported tie at this site.

Figure 56 shows no sudden changes in distributed tie load when the moisture content increased on March 19, 2018, and June 20, 2018. Thus, the distributed tie load results show rainfall and soil moisture did not affect track stiffness at the Hickman timber tie site.

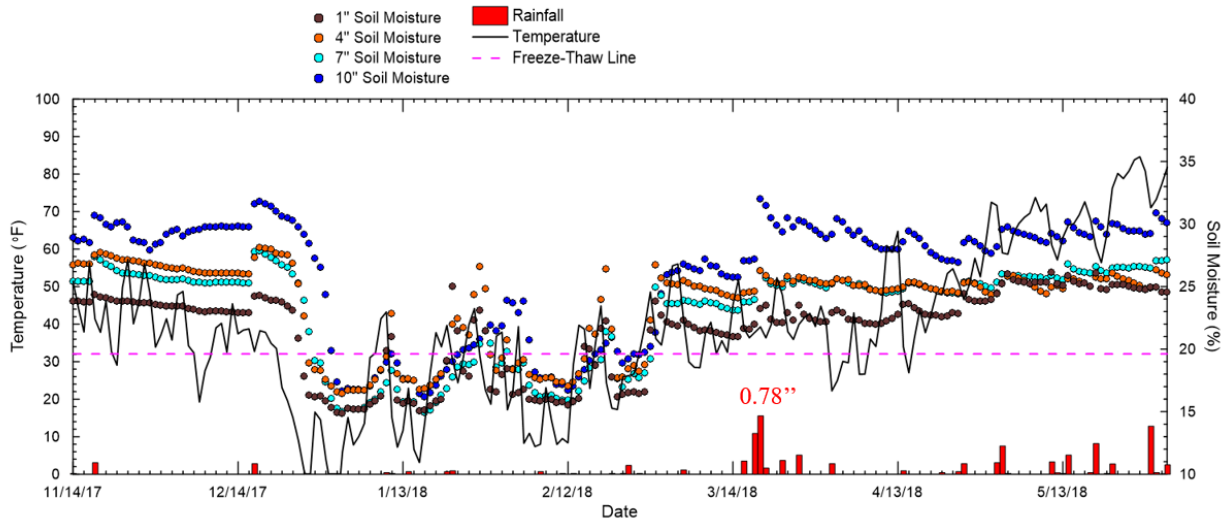
Figure 57. Effect of Ambient Temperature on Moisture Content at Hickman (timber ties)

Figure 57 shows temperature and moisture content for the time period between November 2017 and June 2018 at the Hickman long-term monitoring site. This site had timber ties. The dashed pink line is the freeze-thaw boundary at 32 °F.

Figure 57 shows soil moisture measured by the sensors drops during periods when the ambient temperature is below freezing for long enough for the ballast to freeze. This is due to the reduction in output from the sensors when the water in the fouling material goes from the liquid to solid state.

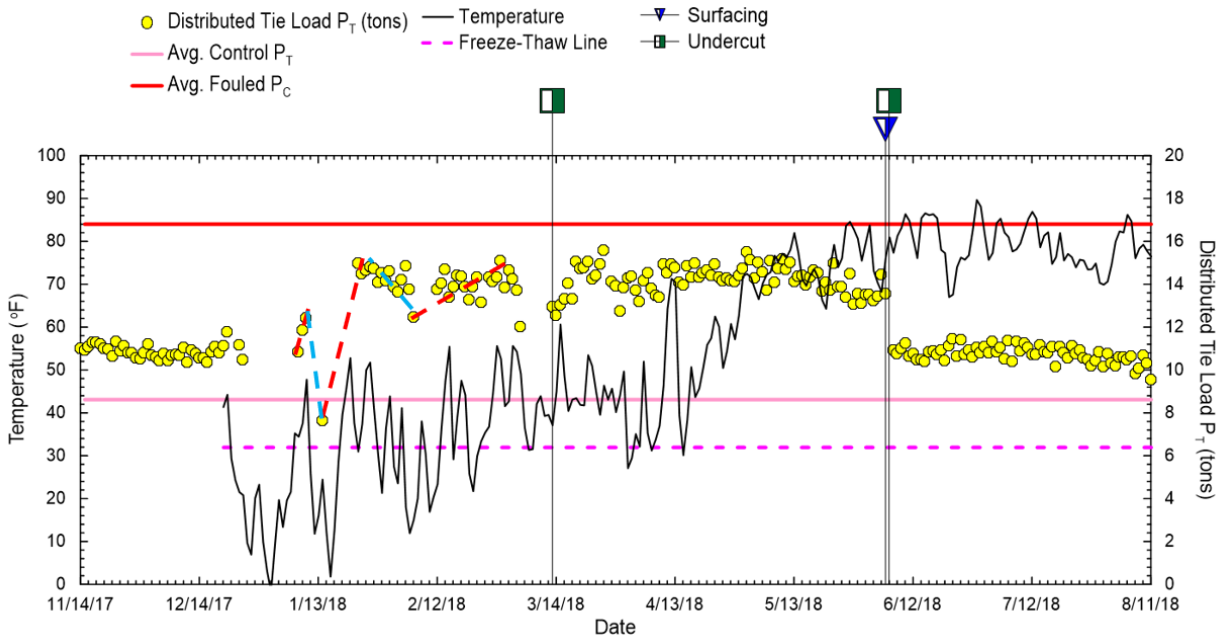
Figure 58. Effect of Ambient Temperature on Distributed Tie Loads at Waldron (concrete ties)

Figure 58 shows temperature and distributed tie load, P_T , for the time period between November 2017 and August 2018 at the Waldron long-term monitoring site. This site had concrete ties. The dashed pink line is the freeze-thaw boundary at 32 °F. Changes to distributed tie loads during freezing in January and February 2018 are indicated by blue dashed lines while the changes during thawing are indicated by the red dashed lines.

The solid pink line in Figure 58 is the average distributed tie load for the control site at Roca, which also has concrete ties. It indicates the support expected at a concrete tie site with clean ballast. The red line is the average wheel load (measured in the crib) at Waldron. It indicates the distributed tie load for an unsupported tie at this site.

Figure 58 shows the ambient temperature was low for several days around January 13, 2018. This could be expected to cause the ballast to freeze. At this time there was a reduction in distributed tie load. A similar effect can be seen when the temperature dropped for several days before February 12, 2018. Together, these observations illustrate the increase in track stiffness when fouled ballast freezes.

Figure 58 shows the ambient temperature was above freezing for several days after January 13, 2018. This could be expected to thaw the ballast. At this time there was an increase in distributed tie load. A similar effect can be seen when the ballast thawed after February 12, 2018. Together, these observations illustrate the reduction in track stiffness when fouled ballast thaws.

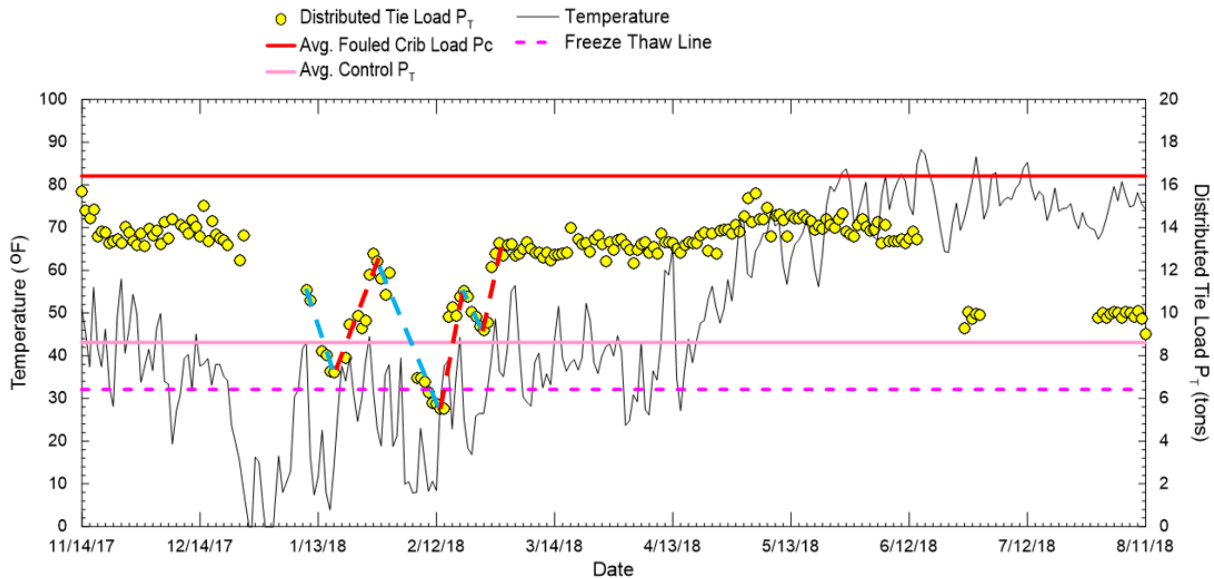
Figure 59. Effect of Ambient Temperature on Distributed Tie Loads at Roca (concrete ties)

Figure 59 shows the temperature and distributed tie load, P_T , for the time period between September 2017 and April 2018 at the Roca long-term monitoring site. This site had concrete ties, as did the site at Waldron, but the degree of ballast fouling was less than at Waldron.

Changes during thawing periods are indicated by red dashed lines in Figure 59, while changes during freezing periods are indicated by the blue dashed lines. Comparing Figure 59 with Figure 58 it can be seen that the effects of freezing and thawing on distributed tie load tend to be smaller when the ballast is less fouled. This is attributed to the fact that the plasticity index of the fouling material at Waldron was lower than that at Roca (see Table 9). The higher plasticity index at Roca allowed the fouling material to absorb more moisture than at Waldron. The expectation of the higher moisture content can result in higher stiffness on freezing and higher compressibility on thawing.

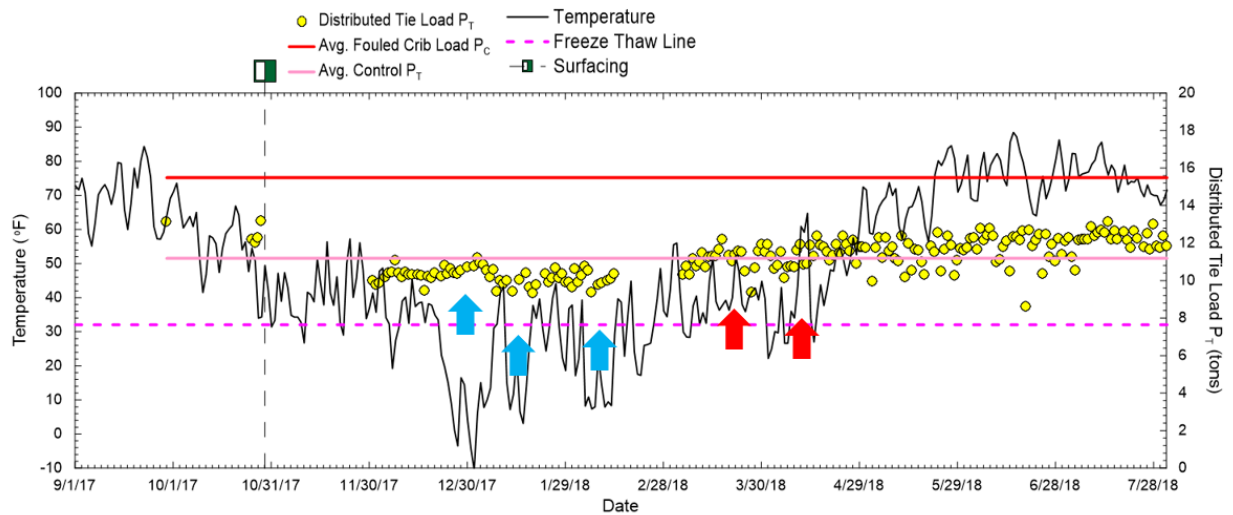
Figure 60. Effect of Ambient Temperature on Distributed Tie Loads at Hickman (timber ties)

Figure 60 shows temperature and distributed tie load, P_T , for the time period between November 2017 and August 2018 at the Hickman long-term monitoring site. This site had timber ties.

The three blue arrows in Figure 60 show periods when the ambient temperature was below freezing for several days and researchers expected the ballast to have been frozen. The two red arrows show periods when the ambient temperature was above freezing for several days and the expectation of the ballast is that it thawed.

Freezing and thawing do not appear to have a significant effect on distributed tie load at the Hickman site on timber ties. Thus, these temperature cycles do not appear to affect track stiffness at this site.

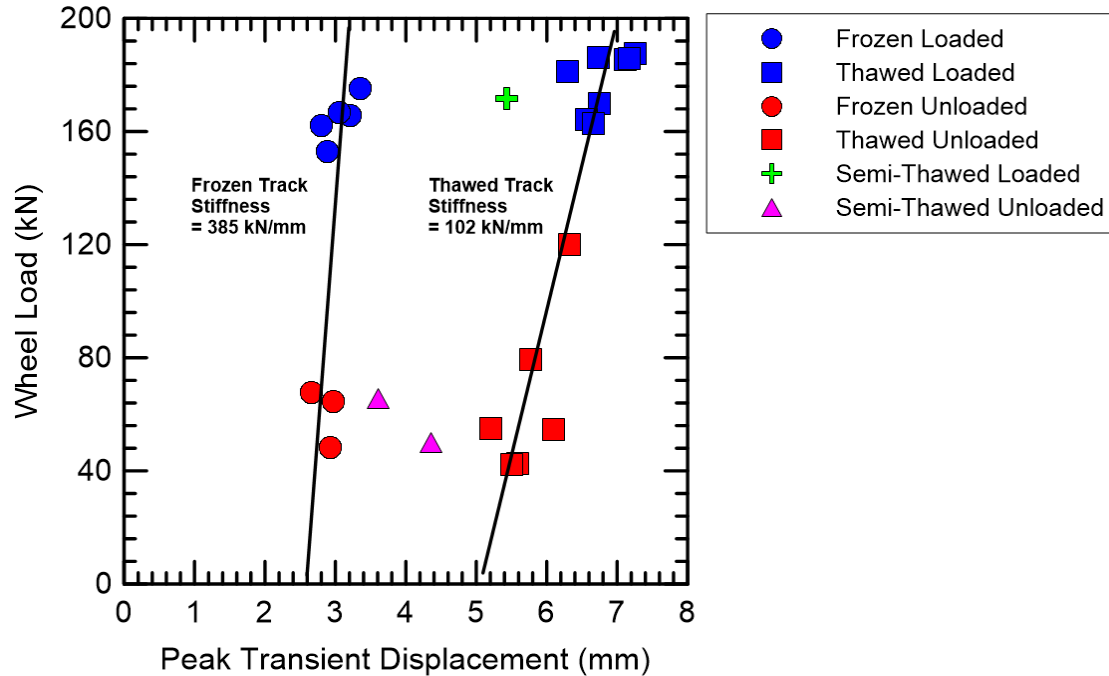
Figure 61. Effect of Temperature on Track Stiffness at Parkville (concrete ties)

Figure 61 shows wheel loads plotted against transient rail displacements at the Parkville long-term monitoring site. This site had concrete ties and a similar degree of ballast fouling as at Waldron. Results are shown separately for loaded freight cars (blue symbols) and lightly or unloaded freight cars (red symbols) at different periods in the freeze-thaw cycle. The frozen period was from December 20, 2017, to January 4, 2018, when the ambient temperature was continuously below freezing. The thaw period was from February 26, 2018, to April 10, 2018, when the ambient temperature was continuously above freezing.

Figure 61 shows the calculated track stiffness is four times greater for the frozen period (385 kN/mm) than the thawed period (102 kN/mm), indicating the expected higher track stiffness when frozen.

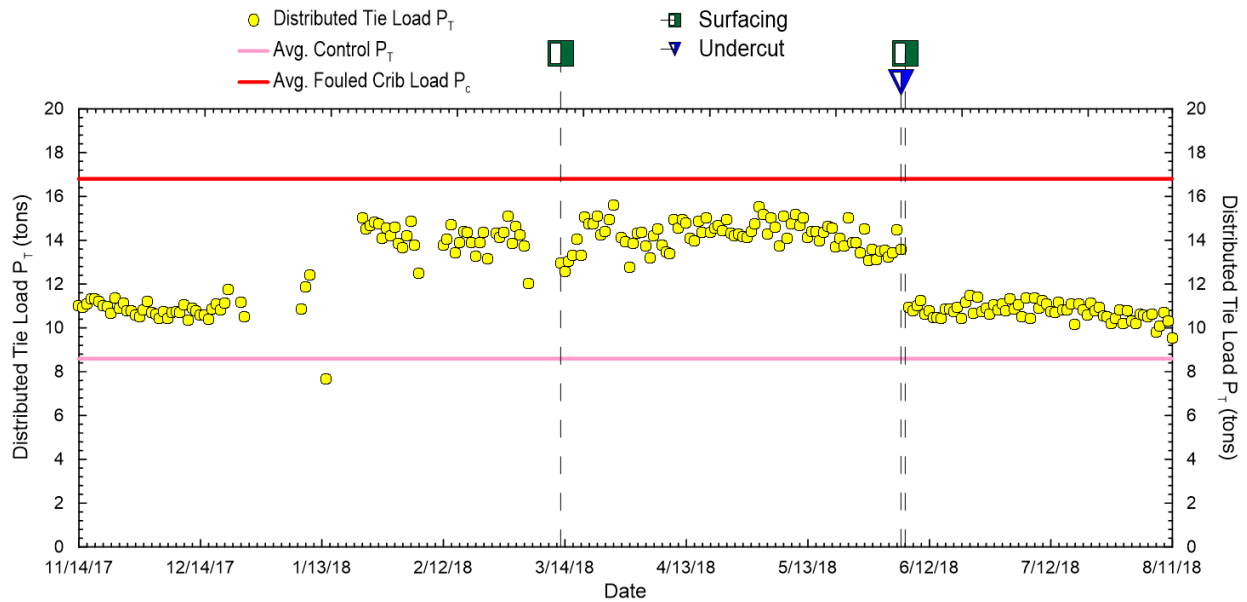
Figure 62. Effects of Remediation on Distributed Tie Load at Waldron (concrete ties)

[Figure 62](#) shows the changes in distributed tie load, P_T , during the period between November 2017 and August 2018 at the Waldron long-term monitoring site. This site had concrete ties. The vertical lines and arrows in [Figure 62](#) show when surfacing and undercutting were performed.

Figure 62 shows surfacing on March 13, 2018, had little effect on distributed tie load. This remediation did not improve concrete tie support with fouled ballast. Section 5.3.4 discussed the lower value of distributed tie load for the data point just before surfacing was due to the fouled material freezing.

The undercutting and surfacing on June 5, 2018, reduced distributed tie load. This remediation improved the ballast support to the concrete tie. The improved support was close to that provided by clean ballast under the concrete ties at the Roca control site.

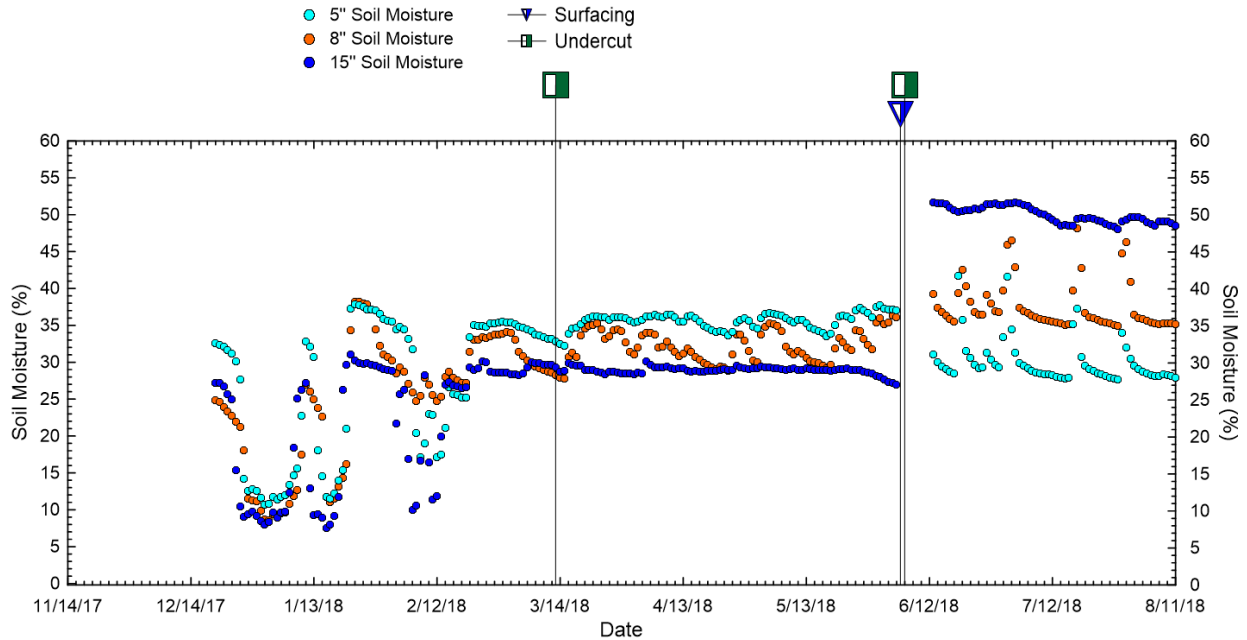
Figure 63. Effects of Remediation on Soil Moisture at Waldron (concrete ties)

Figure 63 shows the changes in soil moisture at the Waldron long-term monitoring site for the same time period shown in Figure 62. Soil moisture is shown at various depths below the surface of the ballast. The variation in moisture content in the winter of 2017/18 is due to freezing and thawing as explained in Section 5.3.4.

Figure 63 shows the surfacing on March 13, 2018, produced little change in soil moisture at all depths. This is expected since the tamping operation during surfacing disturbs the ballast but does not replace it.

The undercutting and surfacing on June 5, 2018, and June 6, 2018, had some effect on soil moisture. Prior to remediation, the soil moisture at 5 inch depth was approximately 35 percent. It changed little after rainfall, which indicates poor drainage. After remediation, it reduced to 30 percent and continued to reduce with the improved drainage provided by the clean ballast.

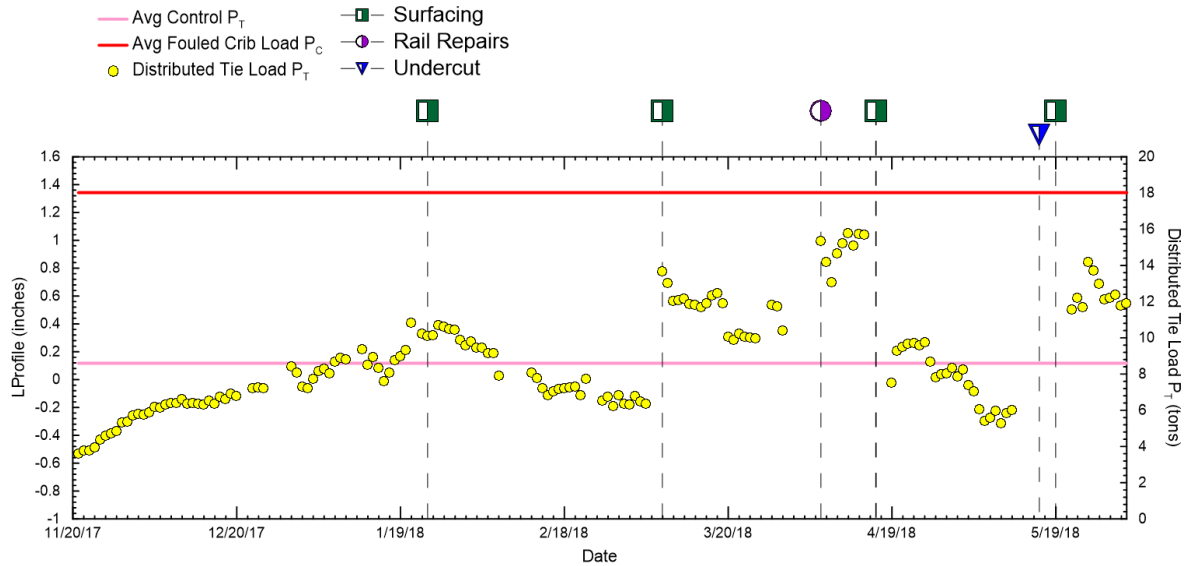
Figure 64. Effects of Remediation on Distributed Tie Load at Parkville (concrete ties)

Figure 64 shows the changes in distributed tie load, P_T , during the period between November 2017 and June 2018 at the Parkville long-term monitoring site. This site had concrete ties. The vertical lines in Figure 64 show when surfacing, undercutting and rail repair was performed.

Figure 64 shows that the performance of surfacing occurred on three separate occasions. On January 24, 2018, it had no effect on distributed tie load. On March 8, 2018, it increased distributed tie load, which indicates a reduction in tie support. On April 16, 2018, it reduced distributed tie load, which indicates an improvement in tie support.

The count of peak accelerations greater than 10 g increased after surfacing on March 8, 2018. This coincides with the increase in distributed tie load shown in Figure 64. It is likely due to the tie having weak support after the surfacing operation.
