U.S. Department
of Transportation
Federal Railroad
Administration

Locomotive Crash Energy Management Vehicle-to-Vehicle Tests 1 & 2: Analyses and Test Results

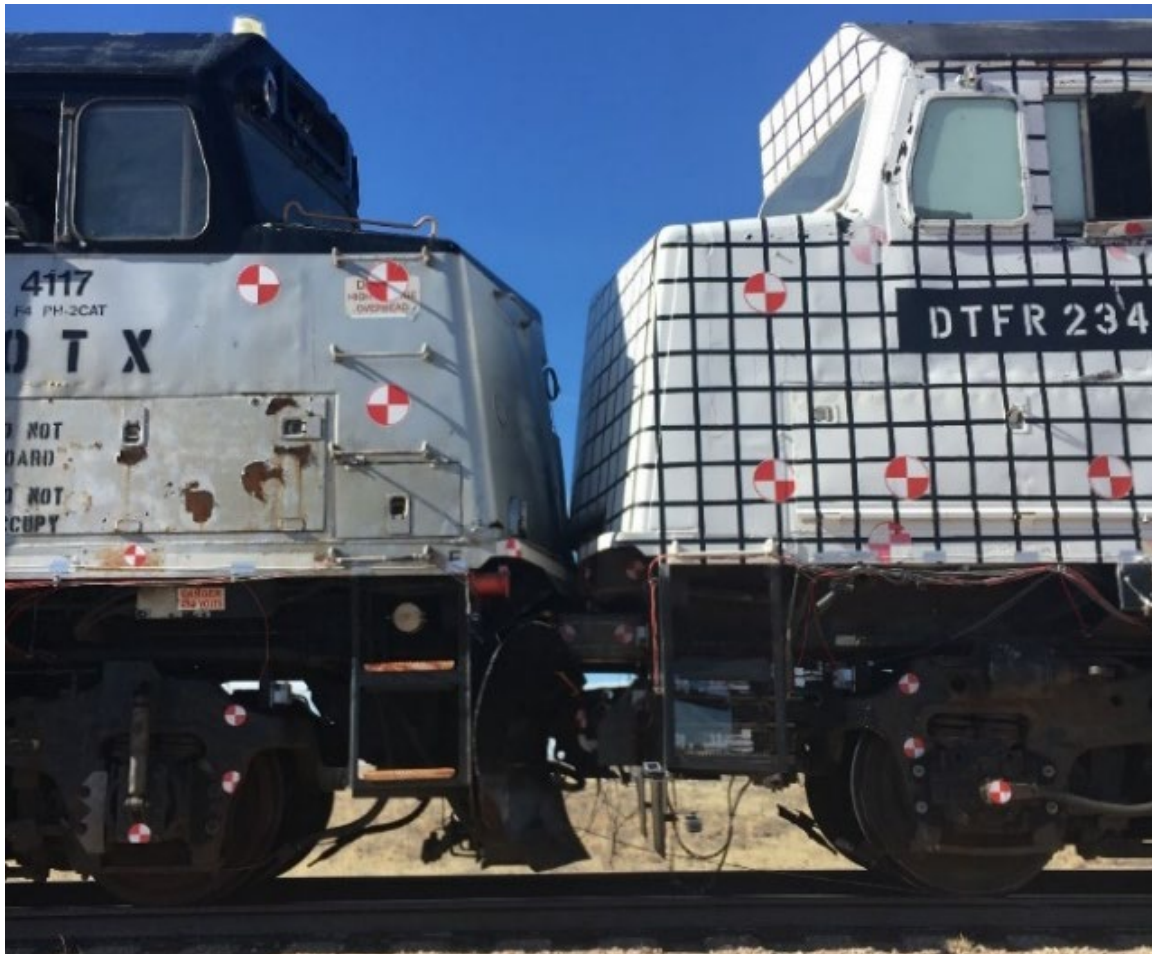
On the day of the test, the weather conditions were clear with low winds. The research team decided both couplers would be left open to increase the chance of coupling, and the couplers were aligned within 1 inch vertically. The conventional locomotive's air brakes were applied, and the hand brake was secured before the impact. The target impact speed was 21 mph, and the actual impact speed was 19.3 mph. [Figure 14](#) shows the vehicles after the test. The vehicles were kept in-line. There was no derailment of the vehicles and no sign of override.

Figure 14. Post-test photo of the locomotives

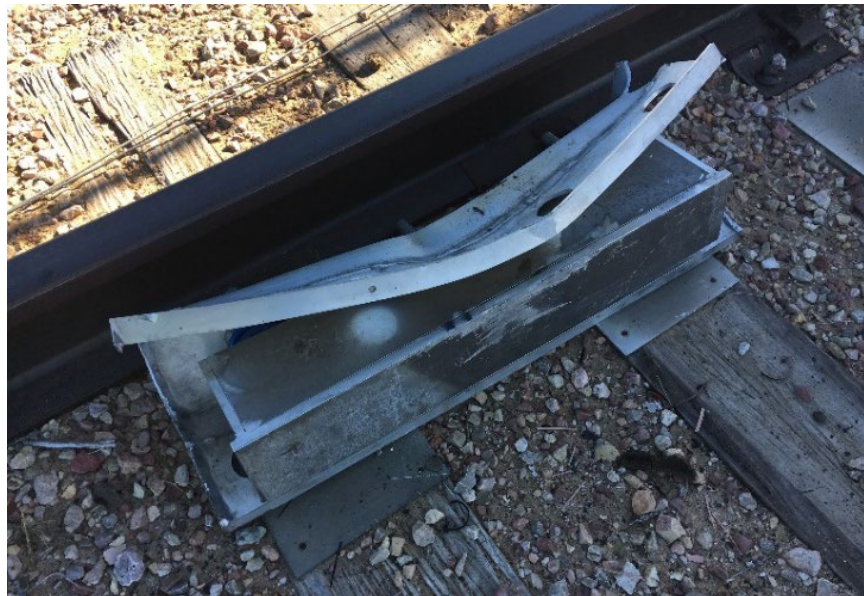
During the test, the couplers engaged at impact but did not lock together. The PBC triggered properly and moved back into the draft pocket. As the PBC moved back, the coupler carrier broke away, as designed. The intact coupler carrier before the test is shown in [Figure 15](#). [Figure 16](#) shows the failed coupler carrier where it fell after the PBC head moved back through it and disengaged it.

Figure 16. Post-test photograph showing the coupler carrier lying on the track

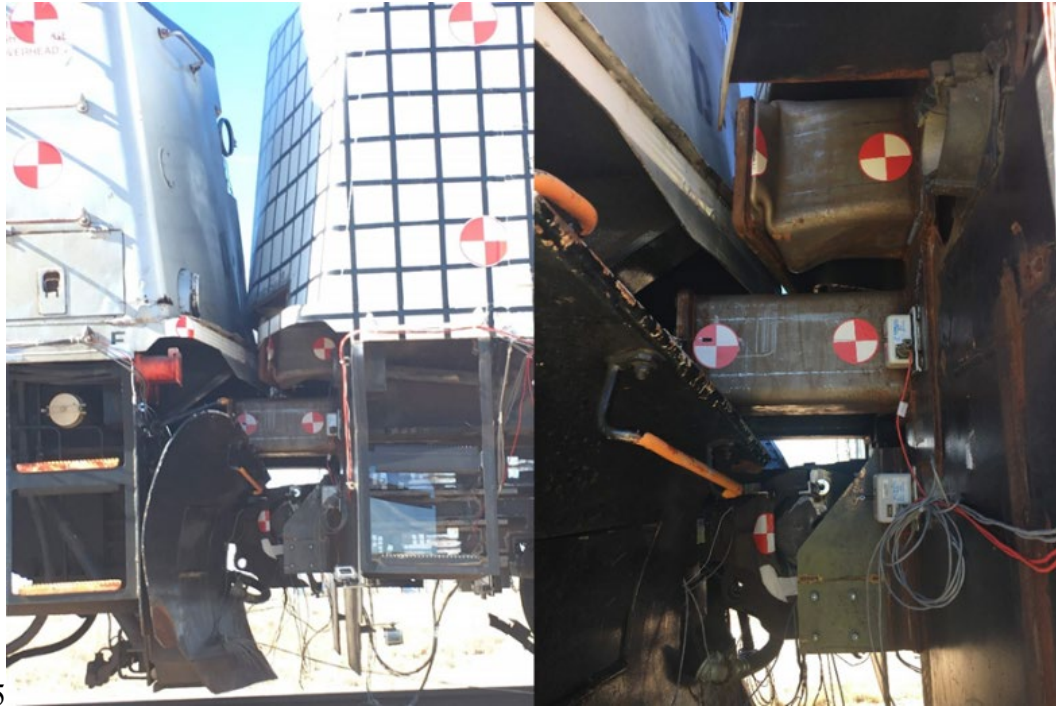
As the PBC was pushed back, the top DAC tubes impacted the front of the conventional locomotive and began to crush. [Figure 22](#) shows the two locomotives engaged after the impact. The photo on the right shows that only the upper DAC tubes crushed; the lower DAC tubes did not deform, as expected.

Figure 22. Post-test photo of CEM system; close-up on the right

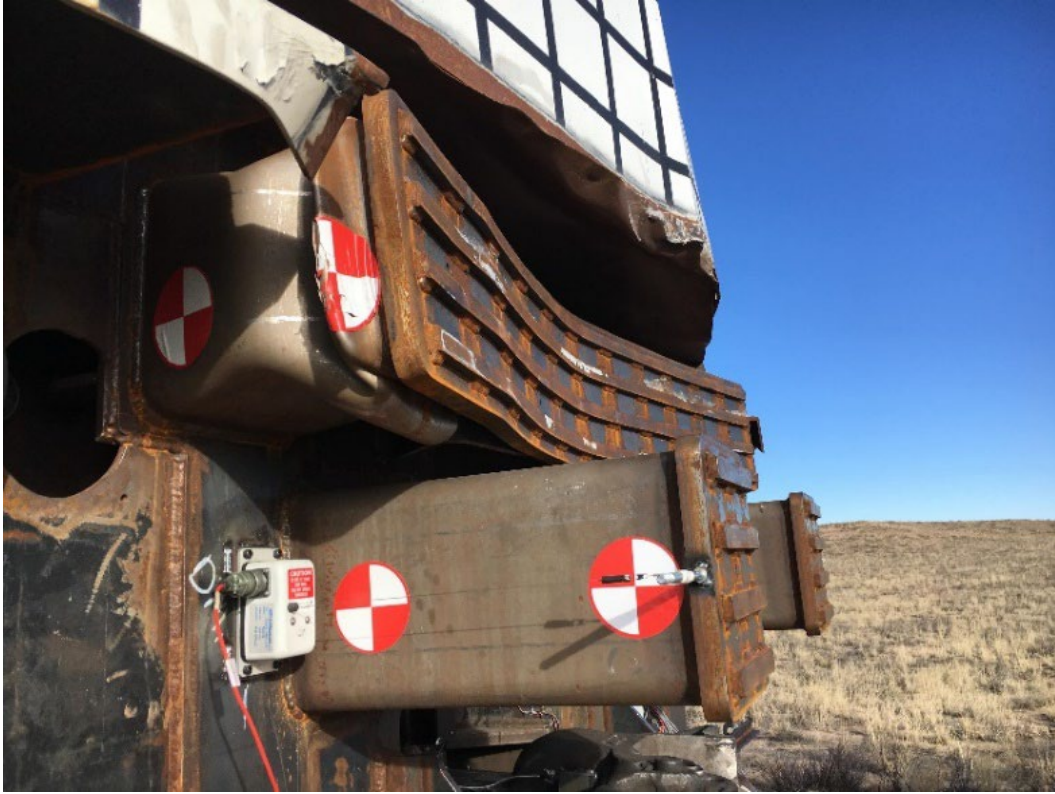
For comparison, [Figure 23](#) shows the undeformed DAC before the test, and [Figure 24](#) shows the deformed DAC after the test and after the vehicles had been separated. [Figure 25](#) shows side views of both the right and left upper DAC tubes. The crush was greater on the right side than on the left — due to an approximately 2” lateral offset between the locomotives at the moment of impact.

Figure 24. Post-test photograph of DAC showing that only the upper DAC tubes deformed

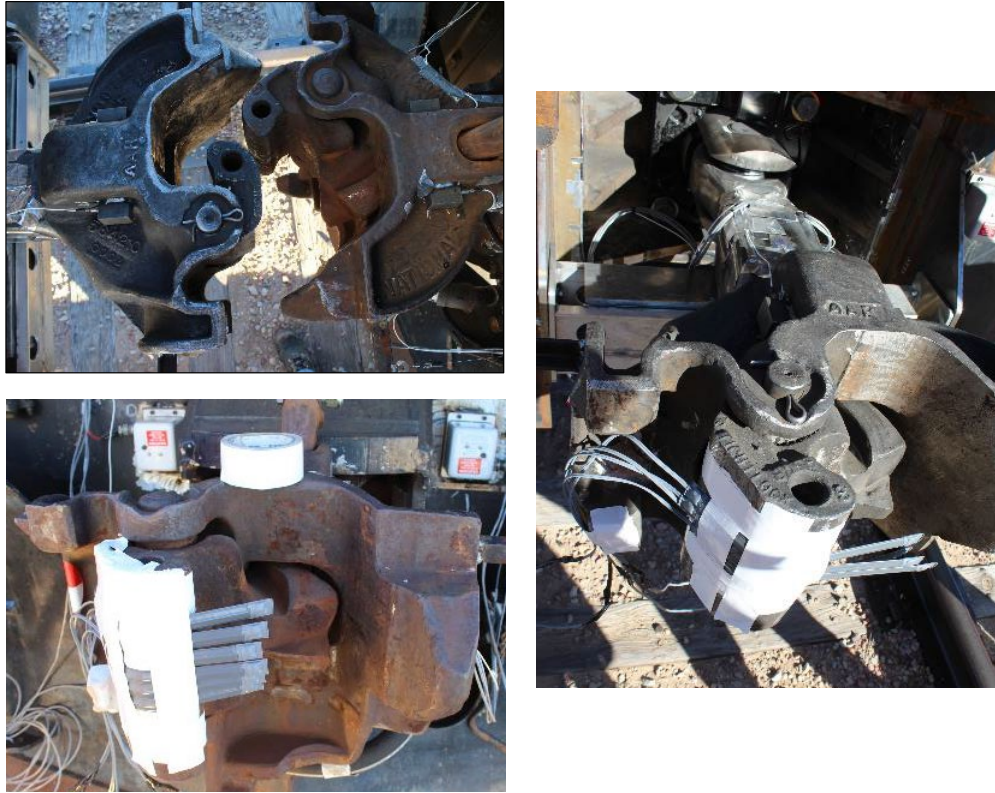
couplers at impact and the positioning and thickness of the impact sensor bundle. Figure 36 shows a pre-test photograph of the couplers (left) and a photograph of the conventional locomotive coupler with the impact sensors taped to the front surface of the knuckle, just prior to running the test (right). Note also that one of the two couplers shown at left appears to have been closed.

Figure 36. Top Left — a pre-test photograph of the couplers from above; bottom left — impact sensors affixed to the front surface of the stationary conventional locomotive; right — impact sensors affixed to the front surface of the CEM locomotive coupler

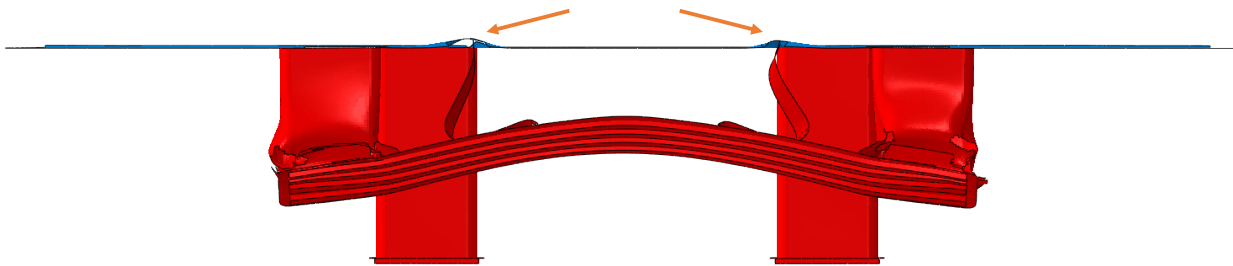
After removing the DAC assembly and inspecting the DAC support structures, one further area of damage was revealed where the angled, upper DAC support plate on the left side of the CEM locomotive was welded to the front plate, as is illustrated on the left in [Figure 50](#). The front plate did not have a doubling plate at this location, as it did behind the DAC tubes. There was clear evidence of damage at the top of the welded connection between the angled support plate and the end plate, as shown at right in [Figure 50](#).

The damage in this area was consistent with pre-test model predictions which indicated high levels of plastic strain in this region prior to folding of the angle support plates, as shown in [Figure 51](#).

Figure 51. Detail of deformed CEM locomotive at the end of the simulation of V2VT1 showing plastic deformation at the top of the welded connection of the angled support plate to the end plate, as indicated

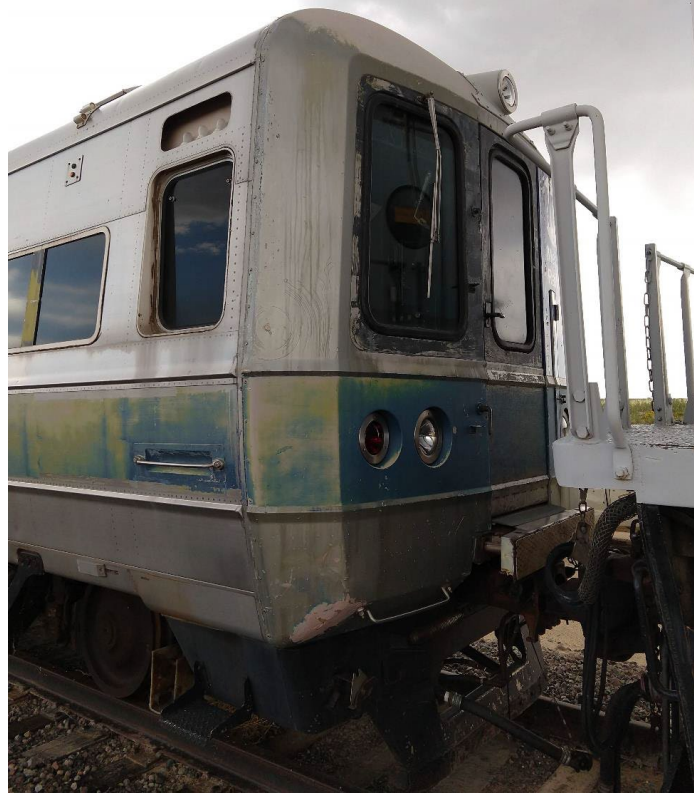
- This cab car has a buffer beam extending forward below the doorway at the end of the car, as pictured in [Figure 54](#). The beam is open at the back and is connected to the end beam behind it, with two cylindrical spring/damper components. The FE model developed for the coupling tests (see [Section 8.6](#)) did not include this component, as it was missing. It needed to be modeled and integrated into the cab car model.
- This cab car had not been remediated to remove asbestos. It therefore had interior components, including a composite floor covering.

Figure 54. Buffer beam at forward end of M1 cab car selected for VTVT2

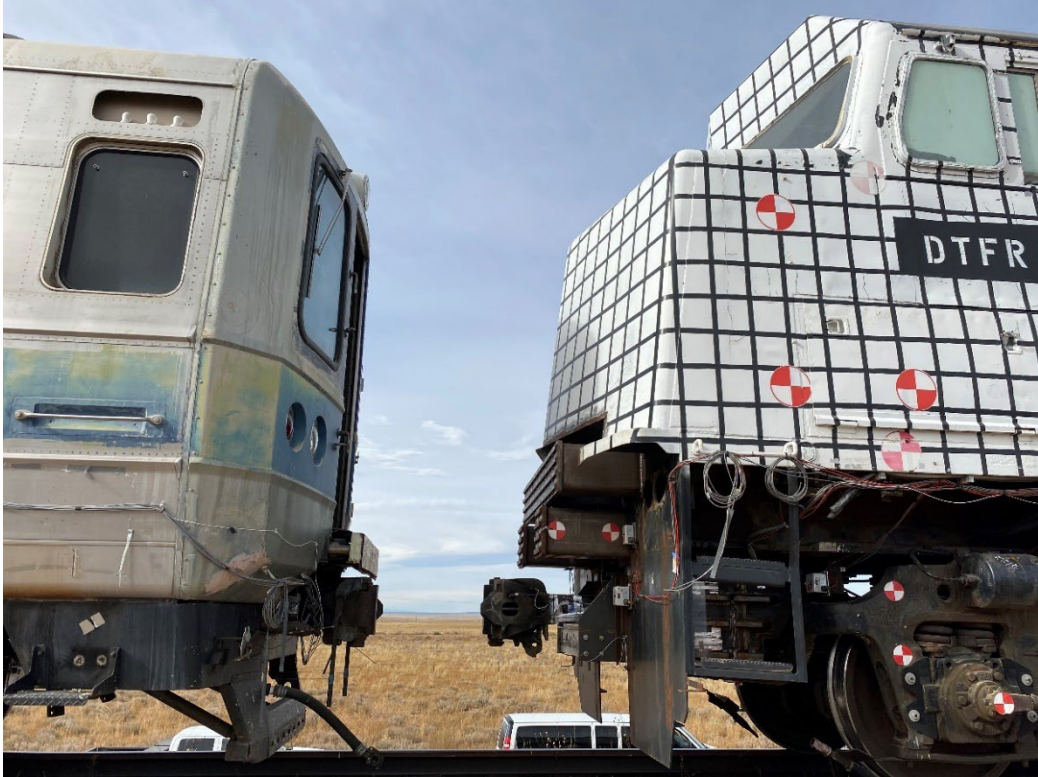
Figure 63. Pre-test photo of the impact interface

On the day of the test, the weather conditions were clear with low winds. Both couplers were left closed, and the couplers were aligned within 1” vertically. [Figure 63](#) is a pre-test photo of the impact interface. The target impact speed was 33 mph, and the actual impact speed was 32.8 mph. [Figure 64](#) shows the impact interface after the test. The vehicles were kept in-line. There was no derailment of the vehicles and no override.

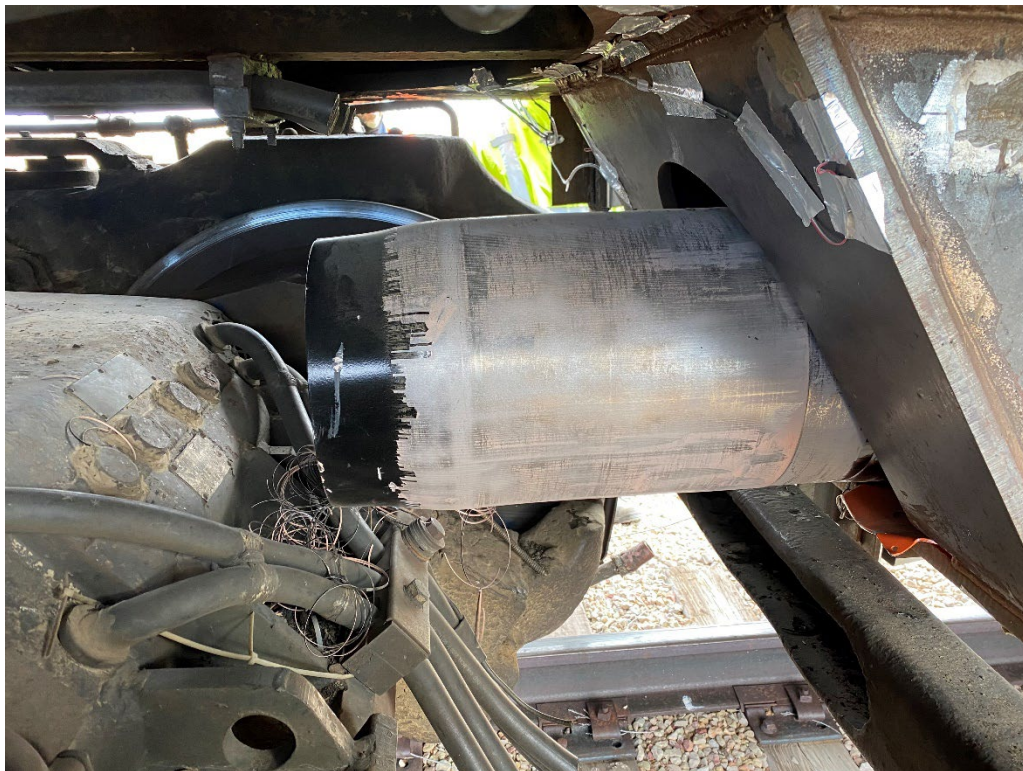
At this point in the collision, the top DAC tubes impacted the end frame of the M1, causing the M1 collision posts to deform inward, as seen in [Figure 66](#) and from inside the M1 in [Figure 68](#). The PBC head continued to move back and the deformation tube was expanded along its entire stroke of 21", as shown in [Figure 69](#). This was confirmed by evidence of contact between the limit stop mounted on the sliding lug and the rear of the PBC head, as shown in [Figure 70](#). This contact was designed to occur at the full stroke of the PBC.

Figure 69. The PBC deformation tube was expanded along its entire stroke of 21”

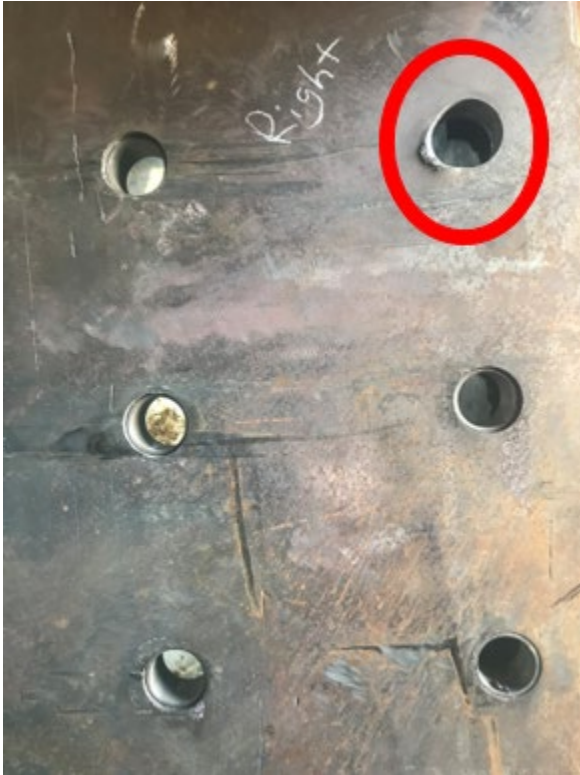
All shear bolts broke, but one (#5) did not break as cleanly as the others, as shown in [Figure 75](#). This caused some damage to its draft pocket bolt hole, as shown in [Figure 76](#). No damage was imparted to the corresponding bolt hole in the sliding lug.

Figure 76. Draft pocket deformed bolt hole

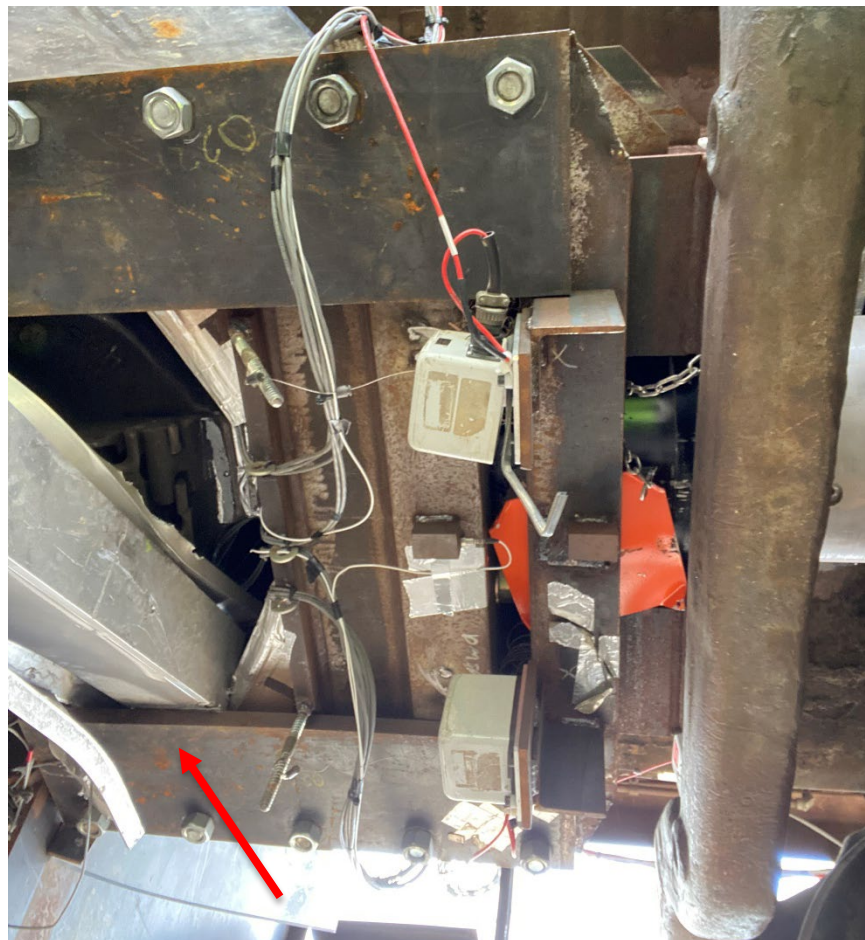
As the PBC head moved back, the coupler carrier broke away, as designed. To prevent the frangible coupler carrier from interfering with instrumentation wiring, both sides were tethered to the draft pocket side plates. However, the tethers might not have been long enough, and one side of the damaged coupler carrier became caught between the sliding lug and a sliding lug support plate, as shown in [Figure 67](#), causing damage to the sliding lug support plates.

As mentioned previously, one of the sliding lug support plates was deformed as a result of the coupler carrier getting caught between the sliding lug and the support plate, as shown in [Figure 77](#).

Figure 77. One of the two sliding lug support plates was deformed
