U.S. Department  
of Transportation  
**Federal Railroad  
Administration**

RR 23-13 | August 2023

## INVESTIGATION OF RADIOGRAPHY TECHNOLOGY FOR BOLSTER AND SIDE FRAME INSPECTIONS

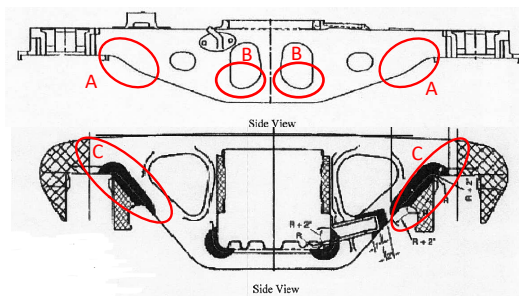
**Figure 3: Bolster and Side Frame Radiography Locations**

Figure 3 shows two locations, A and B, on the bolsters designated for radiography and one location, C, on the side frames. For the remainder of this report, the labels in Figure 3 will be used to describe the location of the radiographs. These locations were chosen based on previous analysis.

Radiography at Location B was conducted using a single-wall exposure and single-wall view. Location A used a double-wall exposure and double-wall view. Location C used a double-wall exposure and a single-wall view. The exposure time for Location A was approximately 21
