Federal Railroad Administration, Office of Railroad Safety

Accident Investigation Summary Report HQ-2023-1824

Norfolk Southern Railway Company (NS) Derailment

Anniston, Alabama

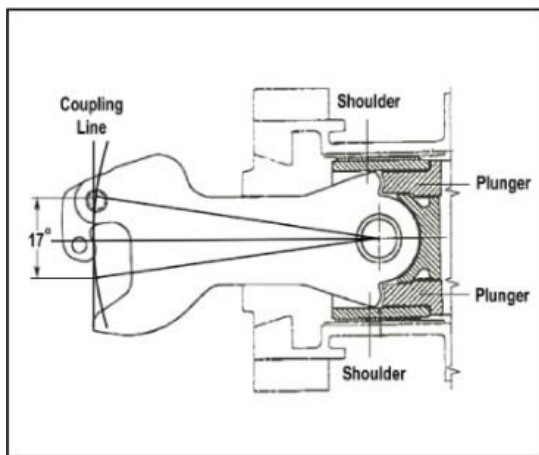
Figure 1: Alignment Control

The revenue freight locomotives in train 245A109, RMEX 6 and RMEX 8, were not equipped with alignment control couplers, which limit lateral coupler movement under buff forces. Alignment control draft systems limit the lateral force transferred to the track under high longitudinal buff forces and reduce the risk of derailment. Locomotives without alignment control tend to “jackknife” when placed behind locomotives that generate high dynamic brake (DB) forces, particularly when exposed to significant trailing tonnage and subject to high buff forces.

Alignment control draft systems use a mechanical means to control lateral movement of the coupler. This normally consists of specific couplers that use wings to compress wedges that push against the draft gear in the direction of swing. Non-alignment systems do not cushion nor control lateral forces. The non-alignment control systems, mostly used in switching service, are designed to allow additional travel motion of the coupler shaft in the draft pocket. This additional travel is used to navigate tight track curvatures of industry tracks during switching operations.

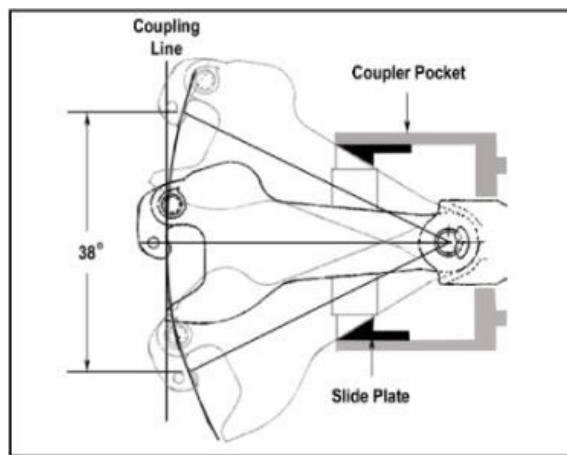
Figure 2: Non-alignment Control

Coupler stop blocks, either metal or rubber, are used to reduce the amount of side-to-side movement of the coupler shaft on non-alignment control couplers, but do not reduce lateral forces. The rear draft pocket, of the RMEX 6, showed evidence that the right rear coupler stop block had recently been dislodged. The rear draft pocket of RMEX 8 showed evidence that the left rear coupler stop block had been recently dislodged. The metal mounting brackets displayed signs of a fresh break, evidenced by shiny metal.

FRA conducted a simulation using Train Energy and Dynamics Simulator (TEDS) which identified the train had experienced excessive buff forces around MP 707 (14 miles prior to the POD) exceeding 300 KIPS.⁶ These forces likely caused the coupler stop blocks to break away. The missing stop blocks were not recovered.

In response to this accident FRA recommended, and NS adopted, an improvement to the NS form ME-925 to better identify non-alignment control couplers during an inspection.
