CSX Transportation

Safety Culture Assessment Report

January 13, 2025

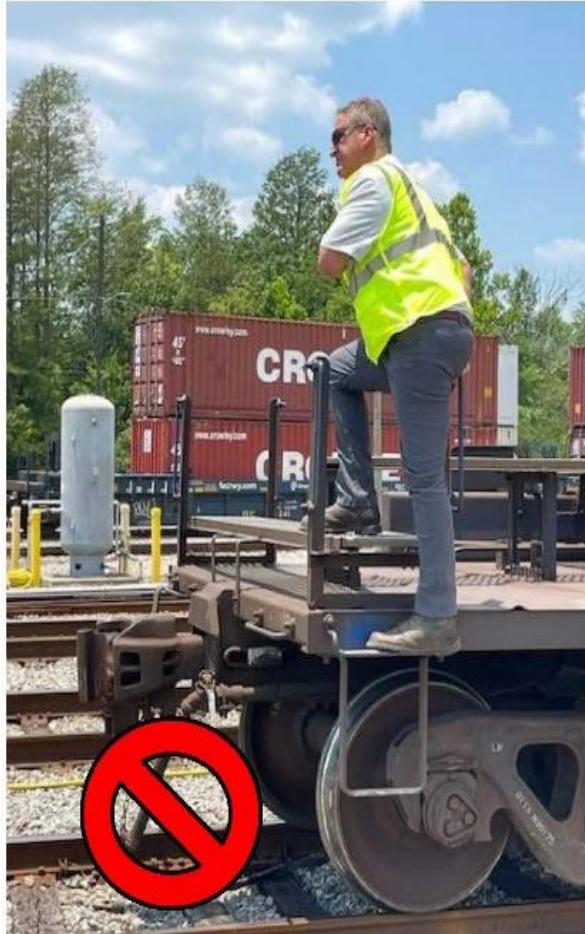
Riding Intermodal Equipment

Riding intermodal equipment as shown in the manner [below] is considered to be **non-compliant** as it does not allow the employee to be prepared for unexpected movements and slack action at all times as required by **2102.1(3)**. Additionally, riding in this manner is considered to be **non-compliant** with the requirements of **2102.2(e)(b)** – as it constitutes riding the end of a car being shoved.
