U.S. Department
of Transportation
**Federal Railroad
Administration**

Evaluation of Damaged Tank Car Structural Integrity

1. Report No. DOT/FRA/ORD-88/02		2. Government Accession No.		3. Recipient's Catalog No.	
4. Title and Subtitle Evaluation of Damaged Tank Car Structural Integrity			5. Report Date January 1988

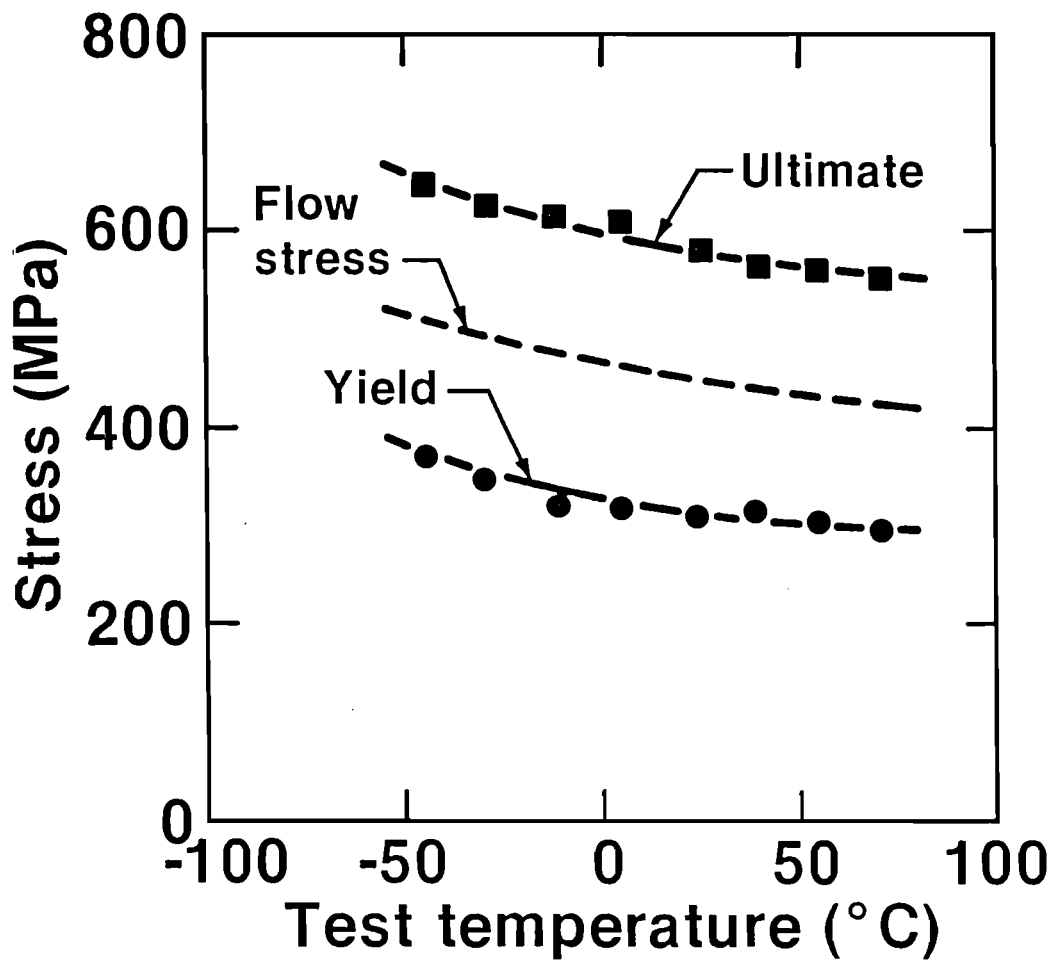
The tensile test results for the as-received material are shown in Figure 4. The flow stress curve shown in this figure is obtained by averaging the measured yield and ultimate stresses. The effect of prior strain on the yield stress, ultimate stress, and uniform elongation is shown in Figure 5. Both the yield and ultimate stresses increased with increased prior strain, although the increase for the latter was less pronounced. The uniform elongation decreased with increased prior strain.

Figure 4. Uniaxial tensile stress vs. test temperature for A515 steel.

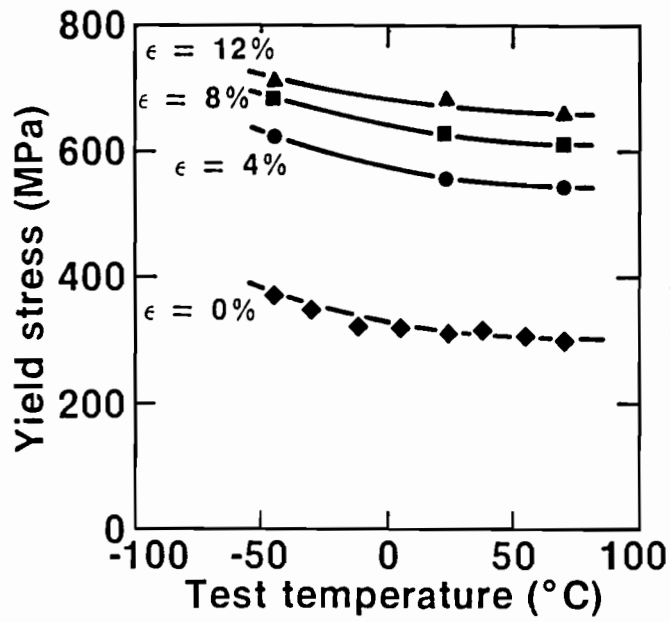
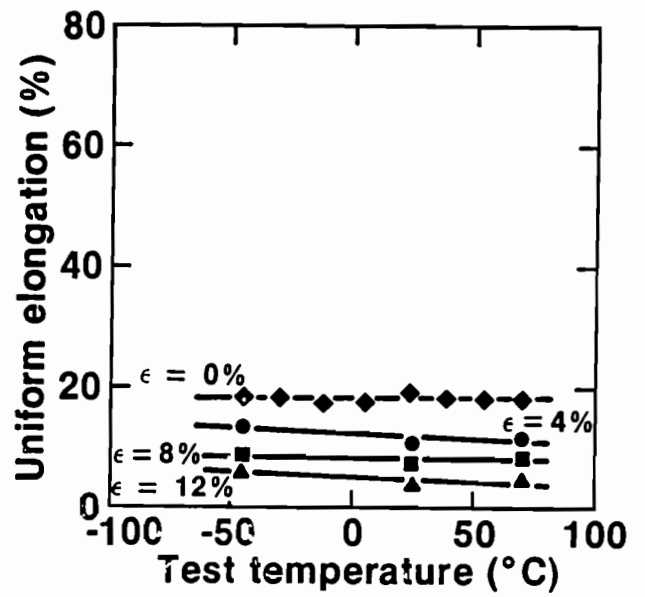
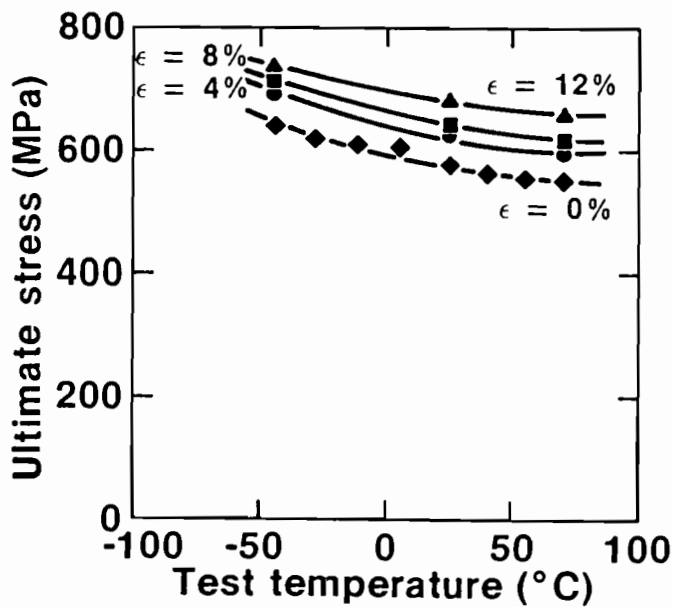
Figure 5. Effect of prior strain on uniaxial tensile properties of A515 steel: (a) yield stress, (b) ultimate tensile strength, and (c) uniform elongation.

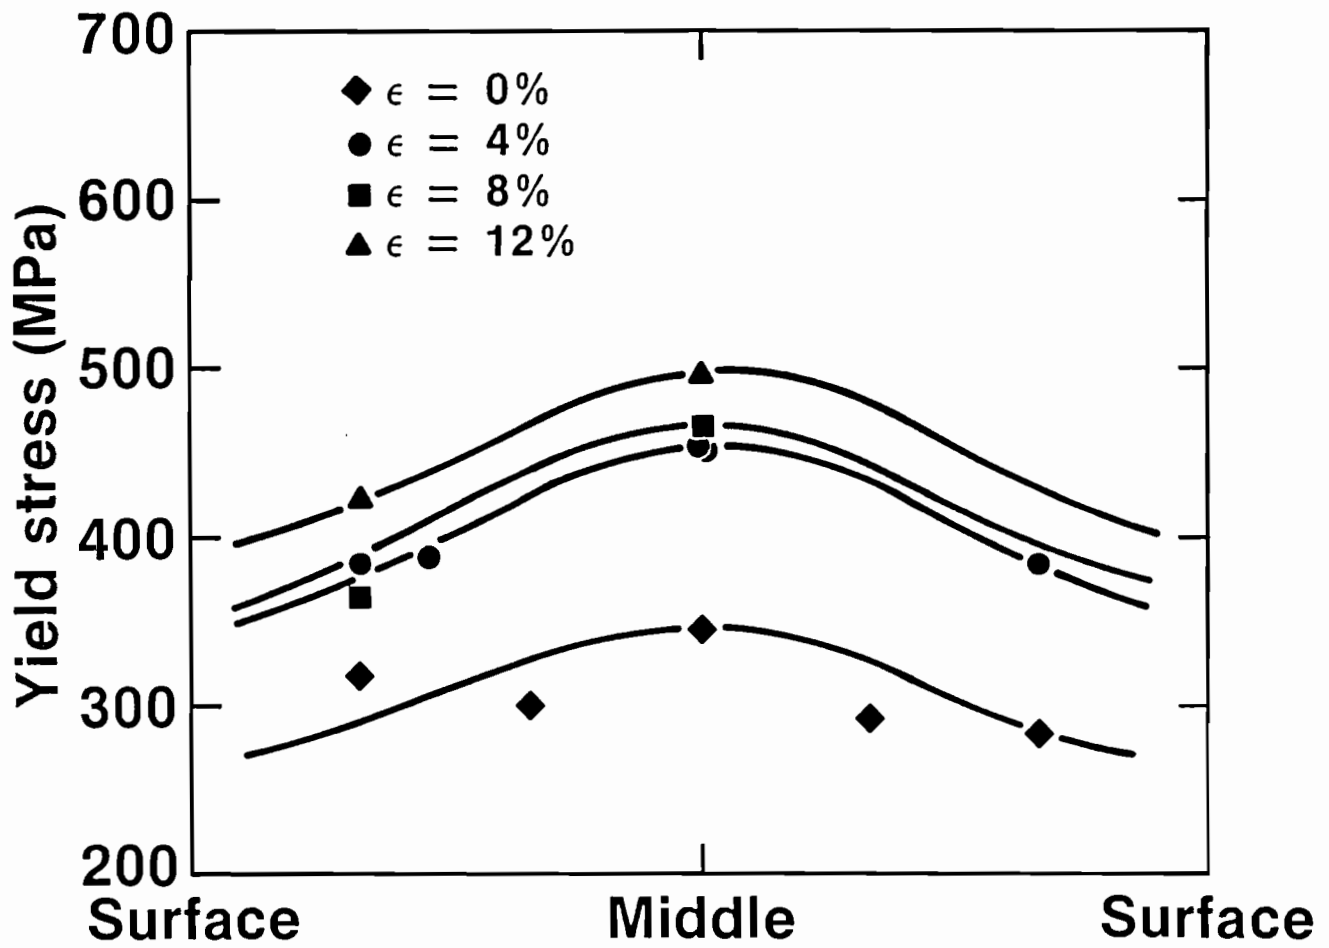
Figure 8. Comparison of through-thickness yield stress (shear punch data) at various prior strain levels.

from shear punch tests at room temperature as a function of thickness position. This figure shows that the variation through the thickness is significant. Since tensile sample gage sections corresponded to the centerline of the plate, agreement between the two test techniques is best here, as shown by Figure 9. It should be noted also that the through-thickness variation was largely retained in the strained specimens, with a significant peak in yield stress at the centerline, see Figure 8. The peaks in ultimate tensile stress were less pronounced, and there were no corresponding valleys in the reduction in area (RA) or strain hardening exponent (n).

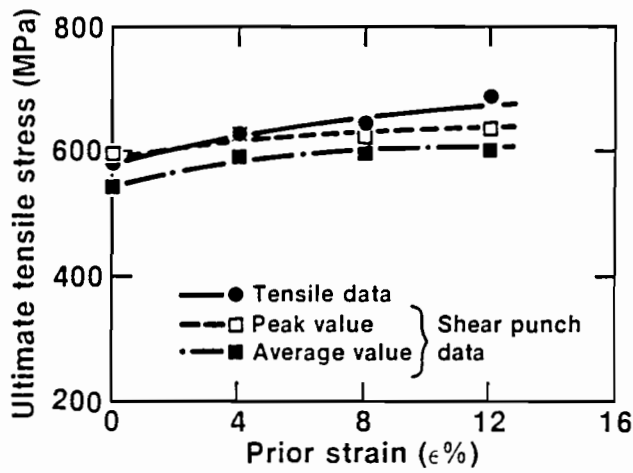
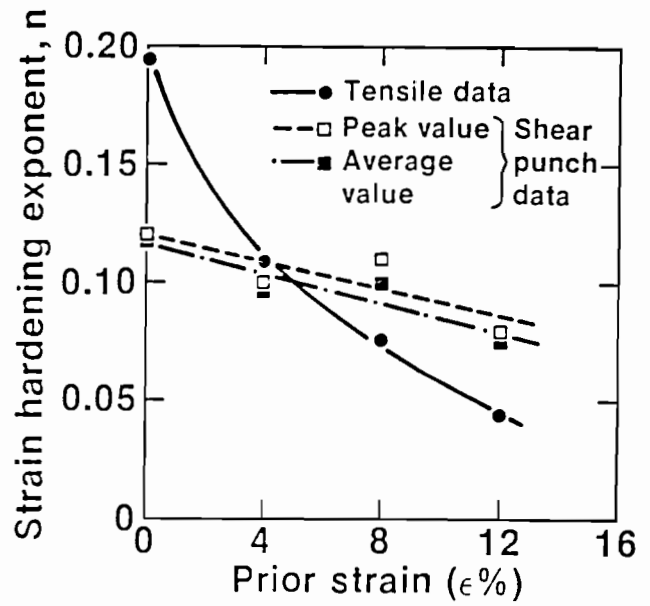
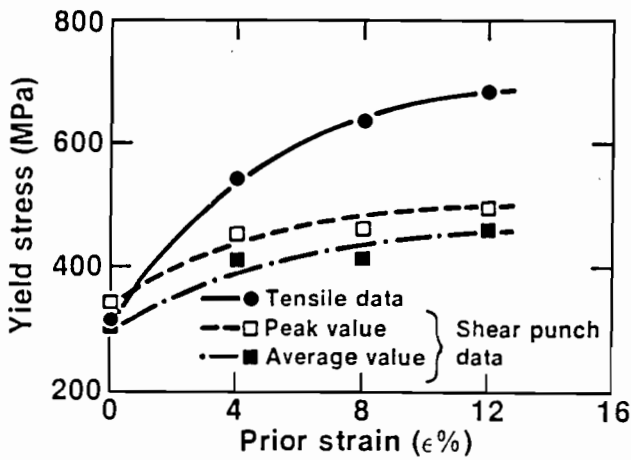
Figure 9 provides plots of shear punch data for strained material; both through-thickness average and peak values are shown. The peak values were obtained from tests performed at the middle of the plate. As shown in Figure 9(a), the values of ultimate stress determined in shear punch and tensile tests on strained material are in good agreement. However, a discrepancy developed between the two techniques for yield stress measurements on specimens with increasing prior strain [Figure 9(b)]. Because n is determined from a ratio of yield to ultimate stress,⁴ this discrepancy was propagated to estimates of n as well, and this is shown in Figure 9(c). The discrepancy in yield stress may arise largely from the difficulty in determining the yield load in shear punch tests from the point of deviation from linearity in the load-displacement curve. As the material becomes harder with prior strain, this point becomes more difficult to discern. It might be more applicable to use an offset similar to the 0.2% offset used to estimate the yield strength for standard tensile specimens. The ultimate stress, on the other hand, is determined from the maximum point on the load-displacement curve. Here the uncertainty in picking the point is much reduced, and there is little discrepancy between shear punch and tensile data.

Figure 9. Comparison of uniaxial and shear punch data at various prior strain levels.

Test results in Figures 9 and 10 show the effect of prior strain (due to an accident condition) on tensile properties. The results in Figure 9 suggest that the changes in tensile properties are becoming saturated after about 12% prior strain. These data provide guidance for predicting the changes in tensile properties of material in a damaged railroad tank car.

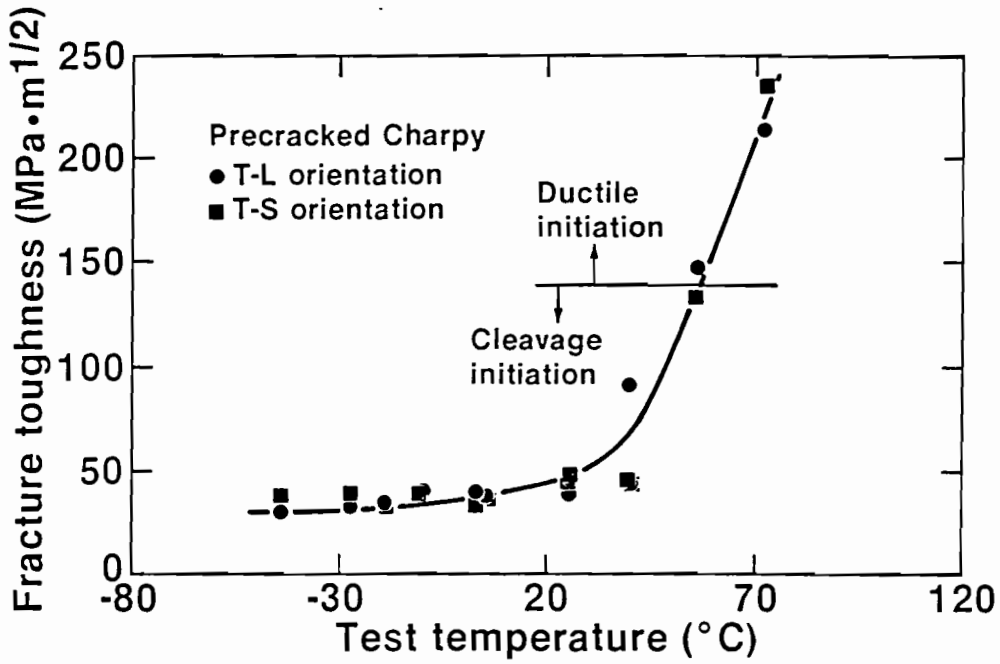
The measured dynamic fracture toughness (K_{I_d}) values for as-received material as a function of test temperature are shown in Figure 11 and the plane strain fracture toughness (K_{I_C}) data in Figure 12. In the dynamic fracture toughness tests at and below room temperature, brittle cleavage fracture was observed after no significant amount of crack extension. This is compared with the static fracture toughness results which show substantial dimple rupture at and below room temperature. It is expected

Figure 11. Dynamic fracture toughness (K_{I_d}), vs. test temperature for A515 steel unstrained specimens.

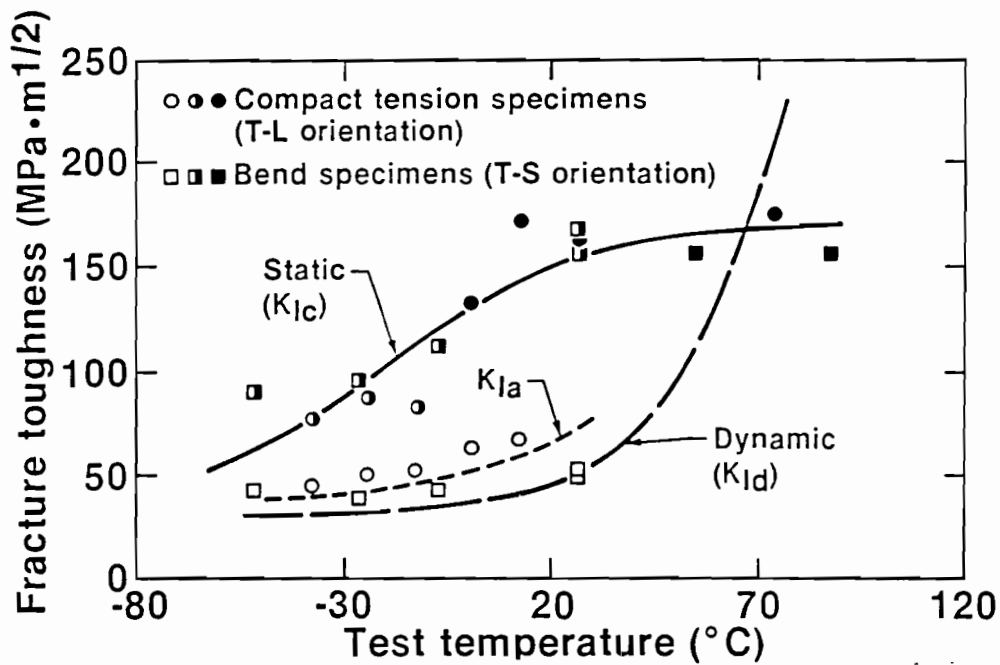
Figure 12. Fracture toughness values (K_{Ic} , K_{Ia} , K_{I_d}) vs. test temperature for as-received A515 steel specimens.

that the accident condition will be represented by the dynamic results. The stress intensity factor for crack arrest, K_{Ia} , was calculated from the arrest load and measured crack size after cleavage arrest using the correlations given in Sections A3.5.3 and A4.5.3 of ASTM Standard E 399-83 for bend and compact specimens, respectively. In Figure 12, the solid symbols represent ductile initiation fracture, the half-filled symbols indicate cleavage initiation fracture, and the open symbols are for crack arrest data.

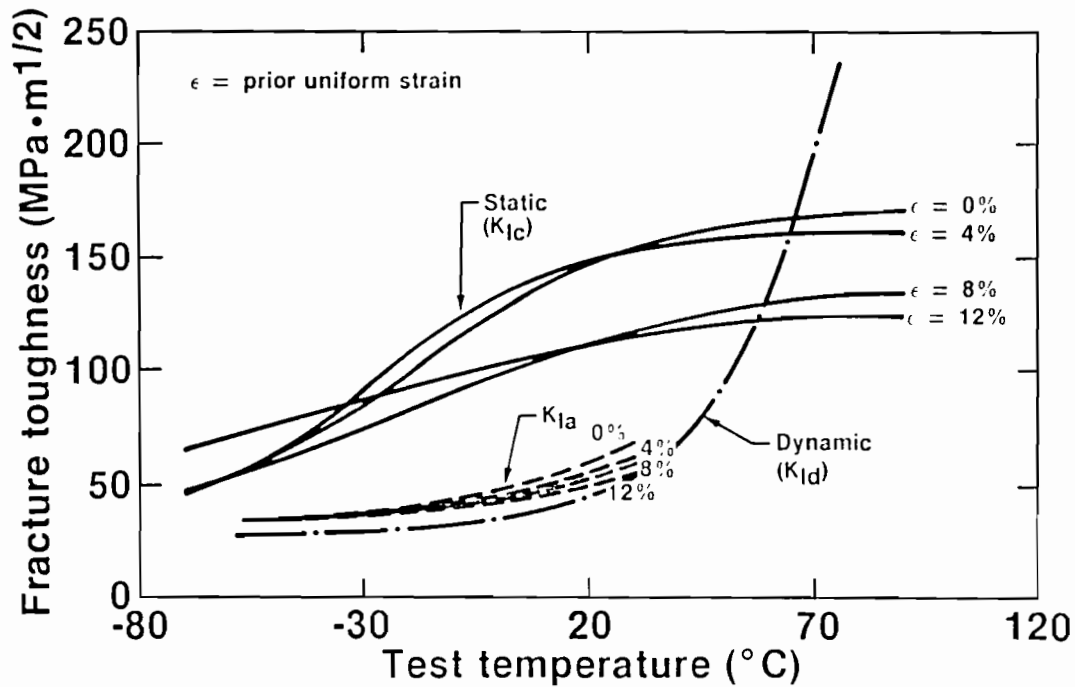
The effects of prior strain level on the K_{Ic} and K_{Ia} values are shown in Figure 13. Moreover, the effect of prior strain on the tearing modulus (T) at 75°C was determined, and this is shown in Table 2. The effect of prior strain was to decrease the upper shelf fracture toughness value (K_{Jc}) by about 25%, and it dropped the tearing modulus to about one third of its value for the as-received material. Hence, for this material, the tearing modulus is apparently a more sensitive parameter than K_{Jc} in indicating changes in fracture behavior due to prior strain. It is also worth noting (Figure 13) that although prior strain did not affect K_{Ia} at lower shelf temperatures, K_{Ia} decreased with increasing prior strain in the transition temperature region.

Figure 13. Effect of prior strain on fracture toughness.

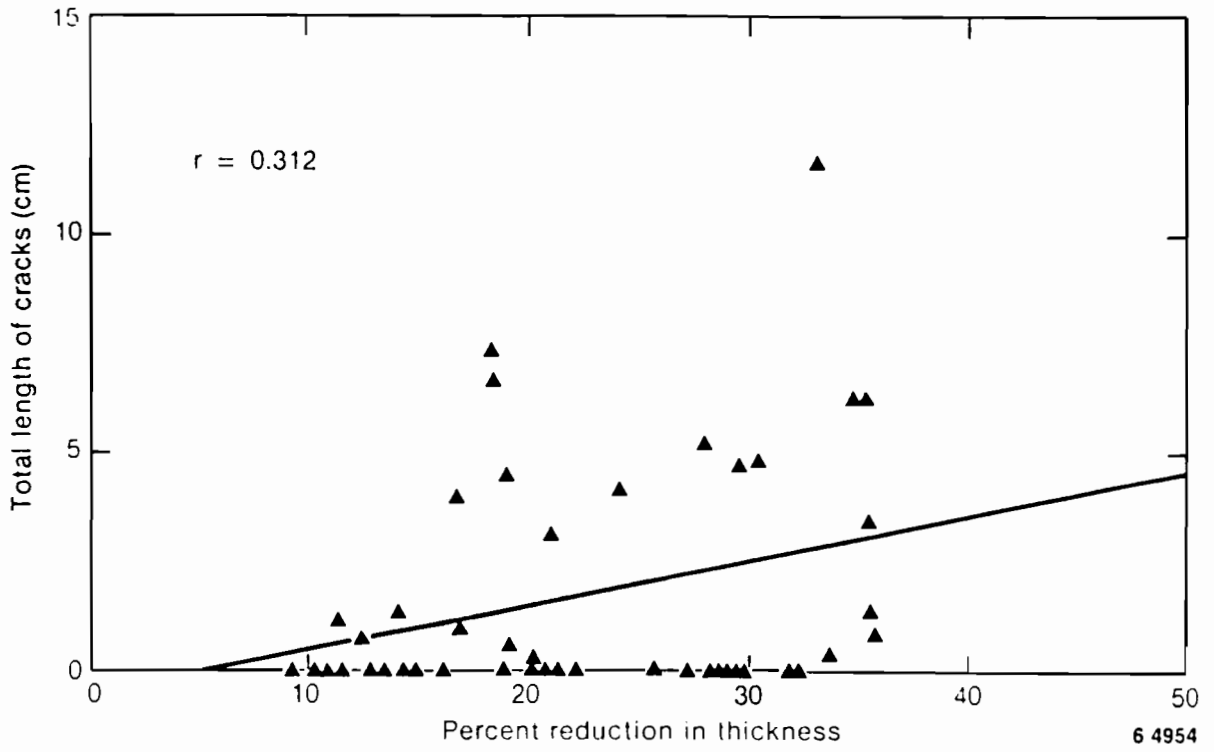
Figure 14. Scatter plot of total length of cracks vs. reduction in thickness.

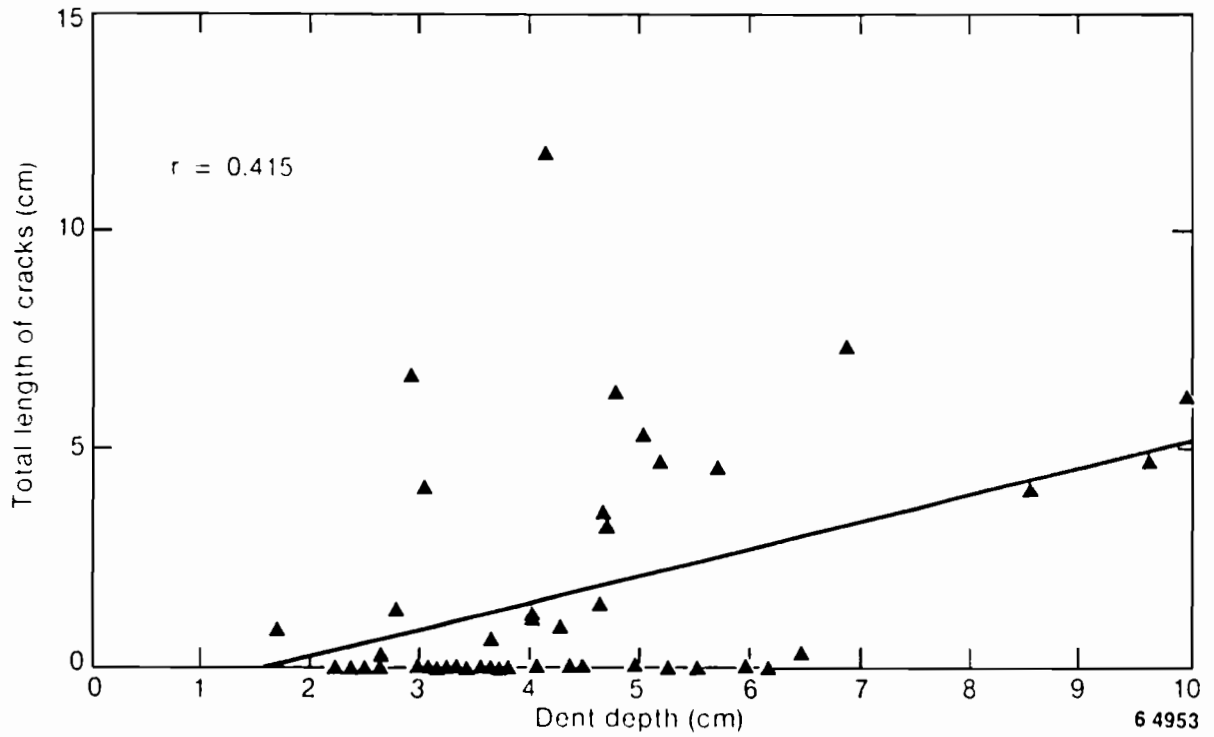
Figure 15. Scatter plot of total length of cracks vs. dent depth.

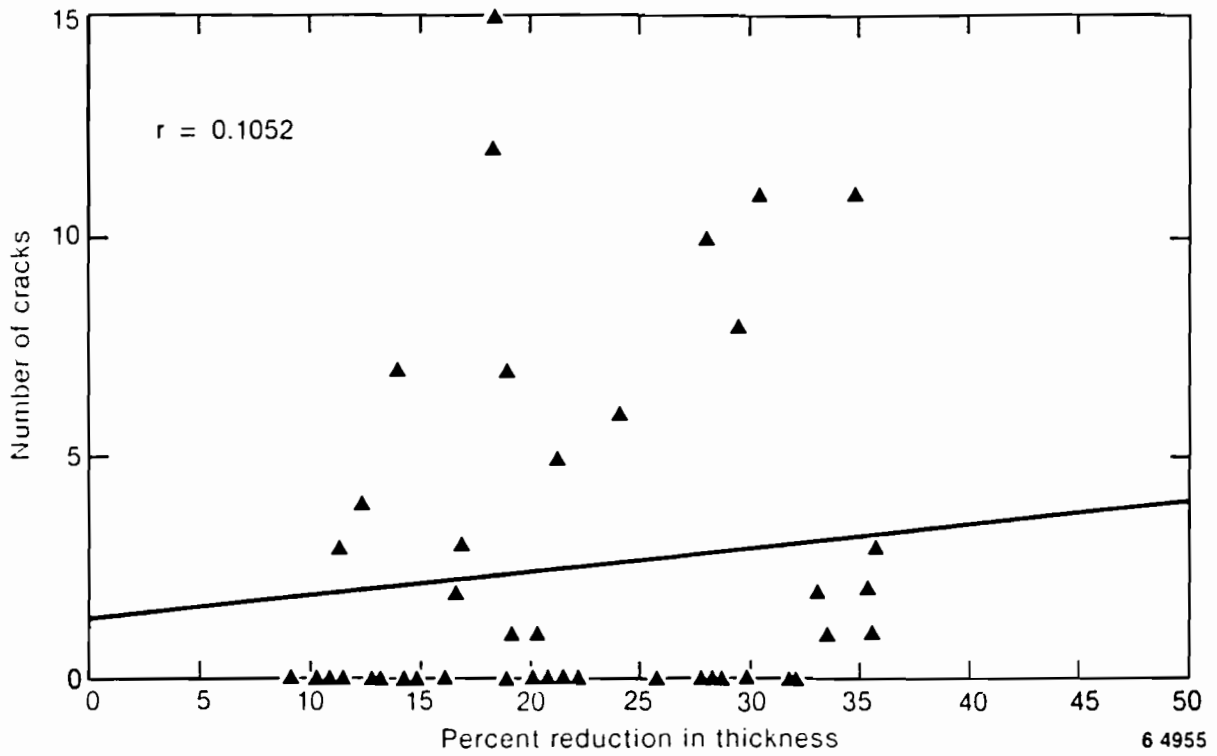
Figure 16. Scatter plot of number of cracks vs. reduction in thickness.

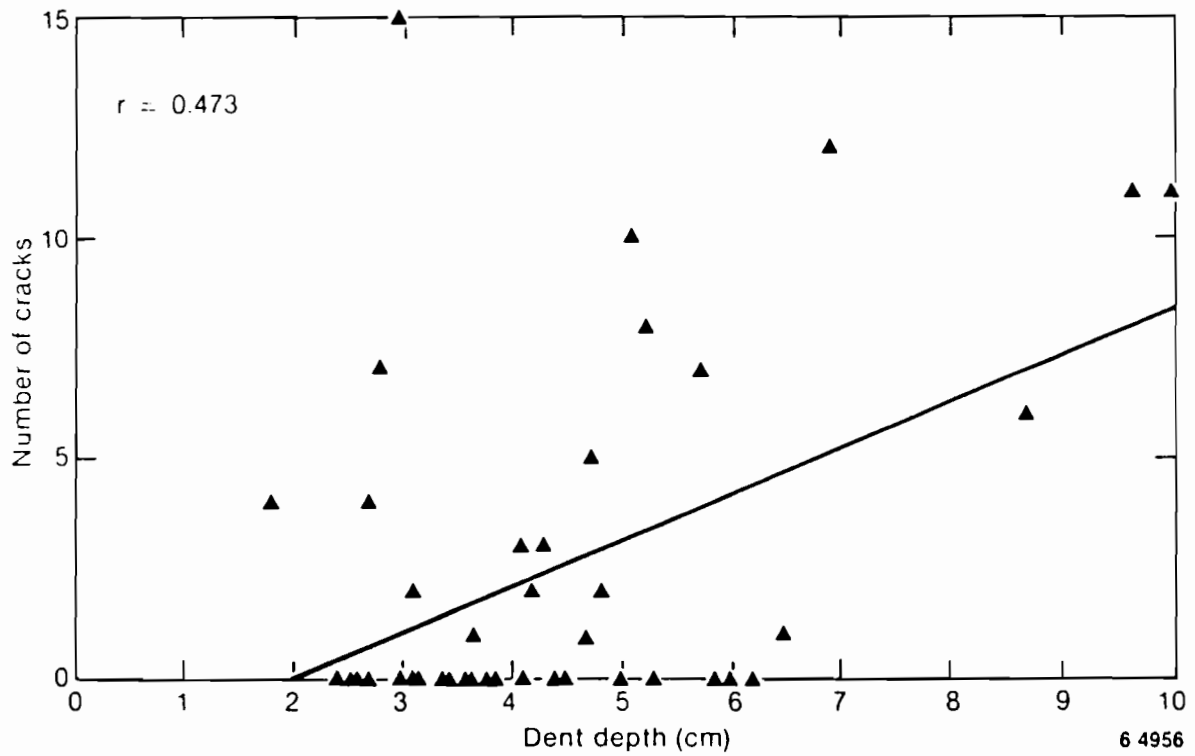
Figure 17. Scatter plot of number of cracks vs. dent depth.

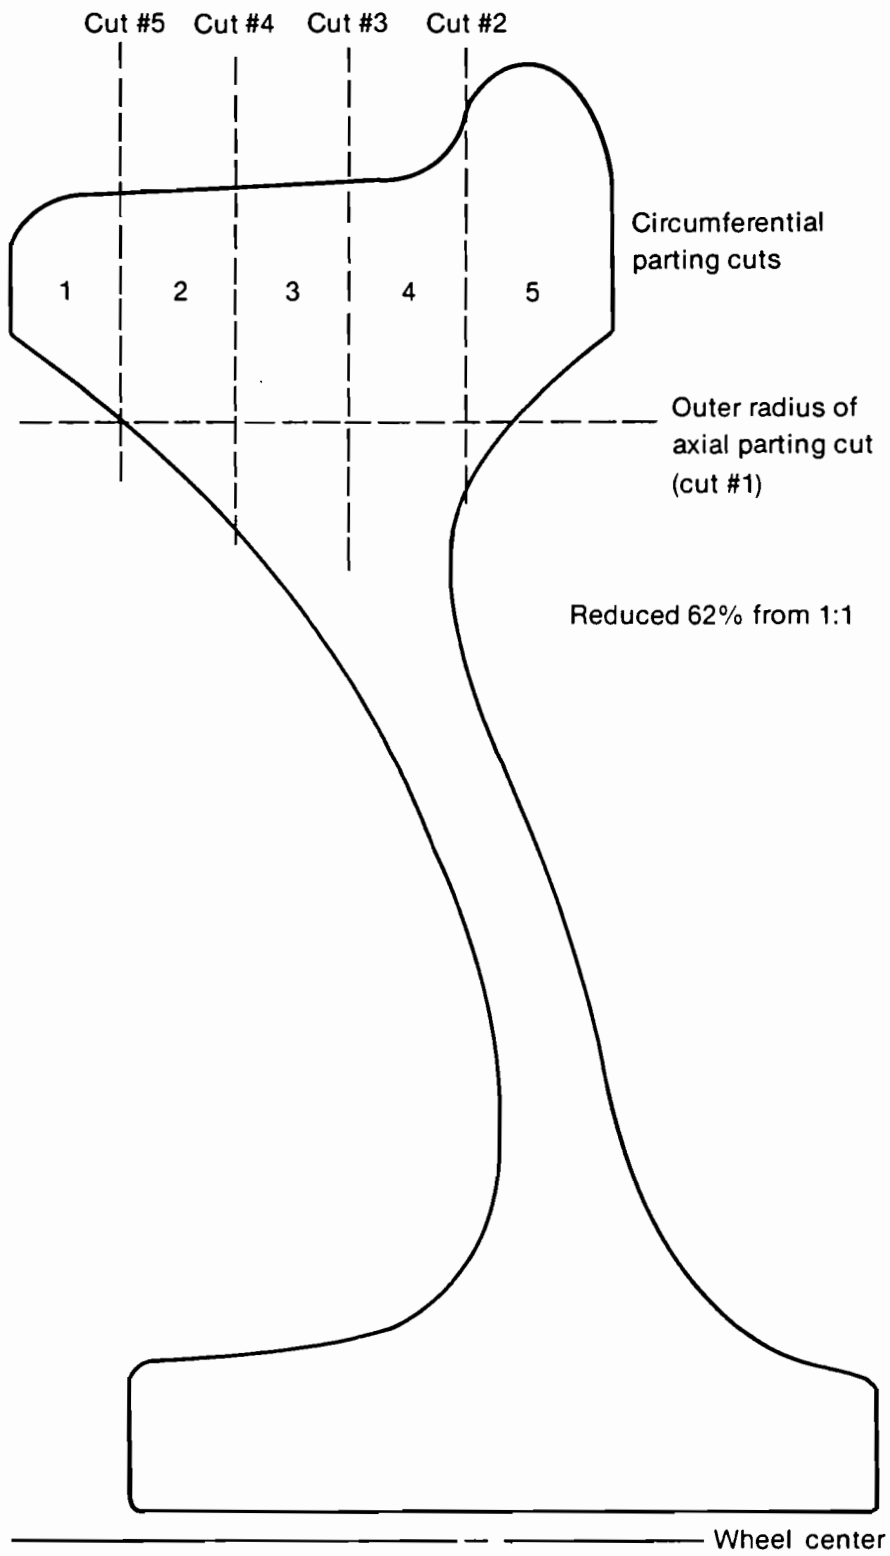
Figure 34. Railroad wheel slicing plan.

Figure 34 shows a sketch of the cross section of the wheel geometry that was sectioned. The moire gratings (300 1/mm) were put on the 0 degree and 90 degree portions of the ring corresponding to section 2 of the wheel. Figures 35, 36, and 37 show the moire patterns after the cutting occurred on the wheel. Figure 35 shows the hoop and radial patterns for the 0 degree cut. Figure 36 shows the hoop and radial displacement patterns for the 90 degree cut. Figure 37 shows the shear displacement fields for both the 0 and 90 degree cuts. In all figures each fringe is a line of constant in-plane displacement; the displacement increment between fringes is

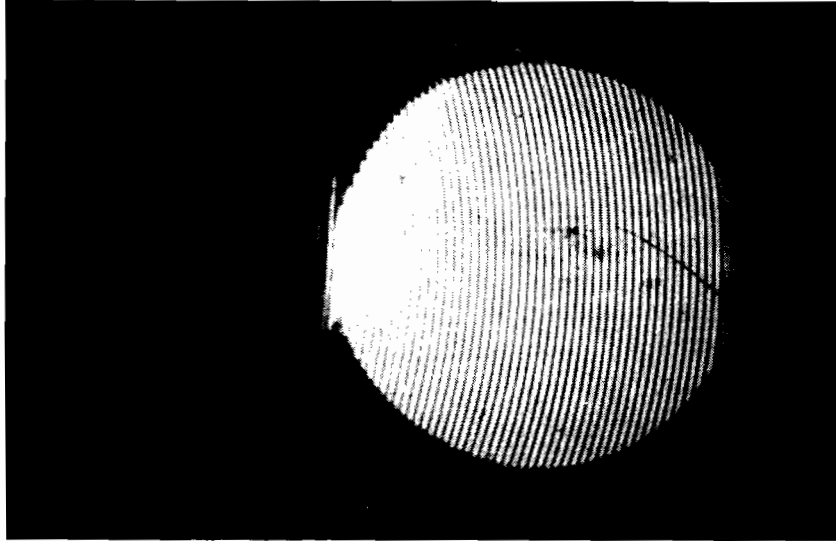
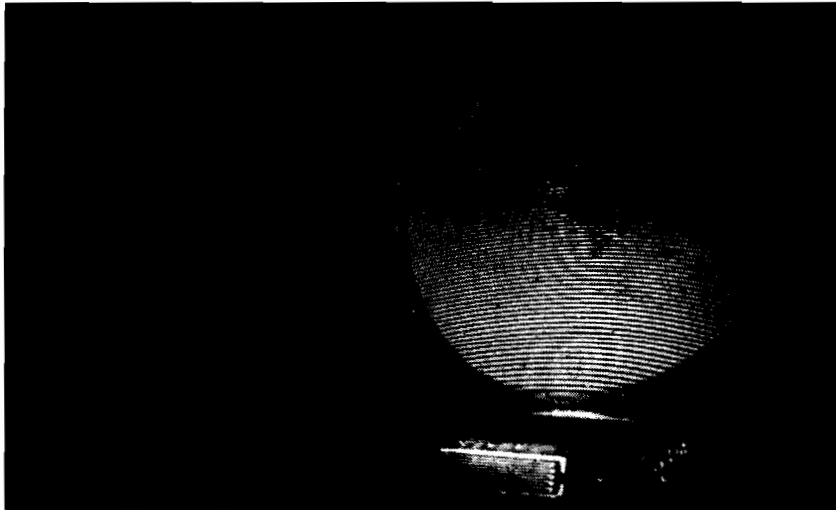
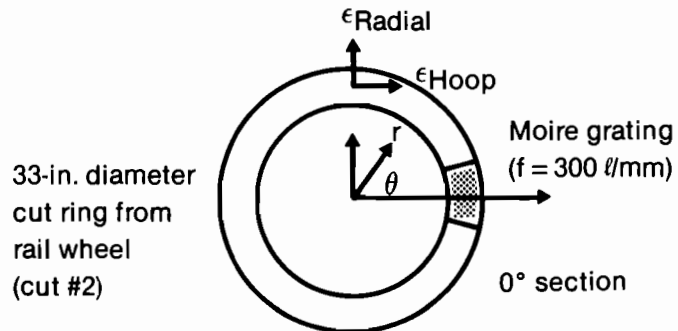
Figure 35. Elastic residual displacement field, 0° section.

Hoop in-plane displacement field field ($f = 300 \text{ } \mu\text{m}$) Mag = 10.4/7.0

Radial in-plane residual displacement field ($f = 300 \text{ } \mu\text{m}$)
M = 4.5/3.5

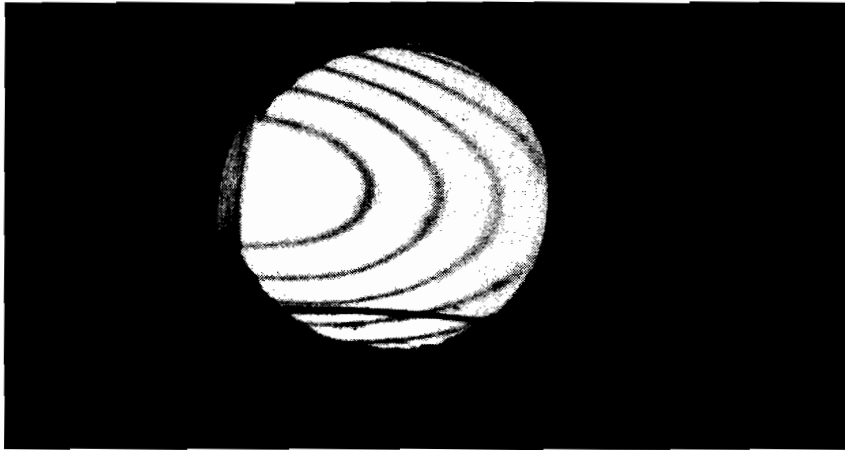
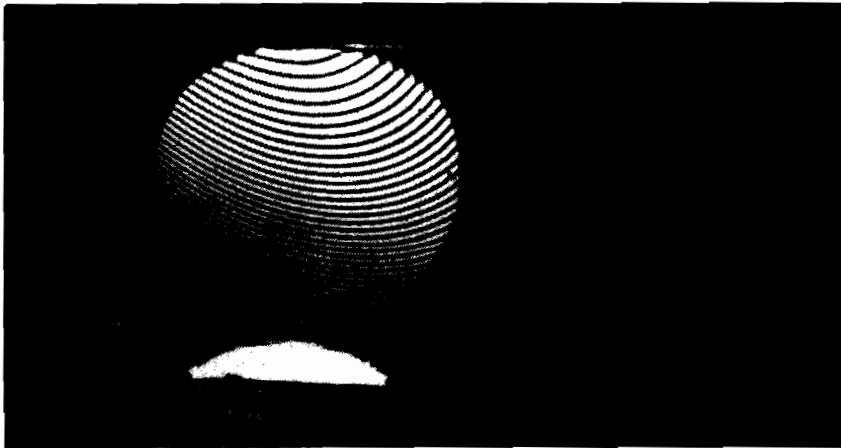
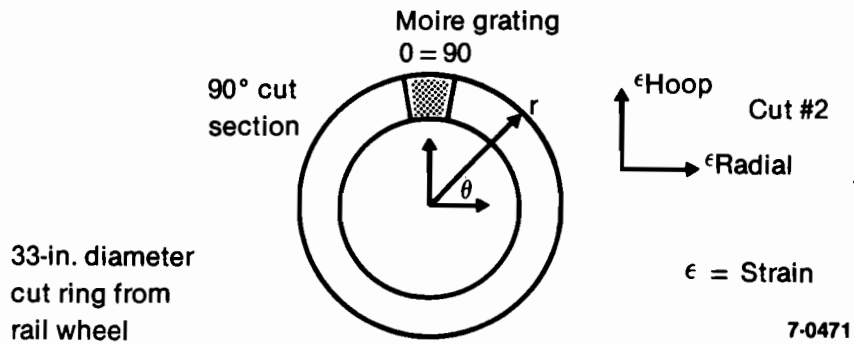
Figure 36. Elastic residual displacement field, 90° section.

Hoop in-plane residual displacement field ($f = 300 \text{ } \mu\text{m}$) Mag = 7/6.3

Radial in-plane residual displacement field ($f = 300 \text{ } \mu\text{m}$)
Mag = 7.5/6.3

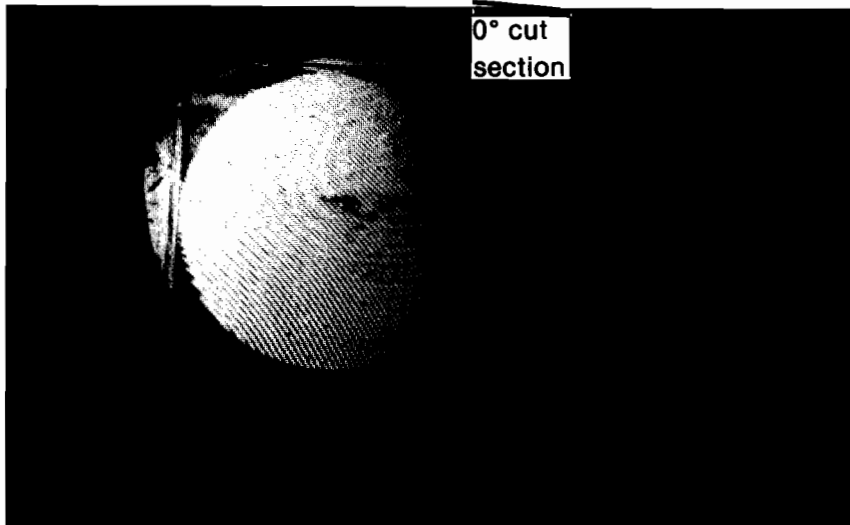
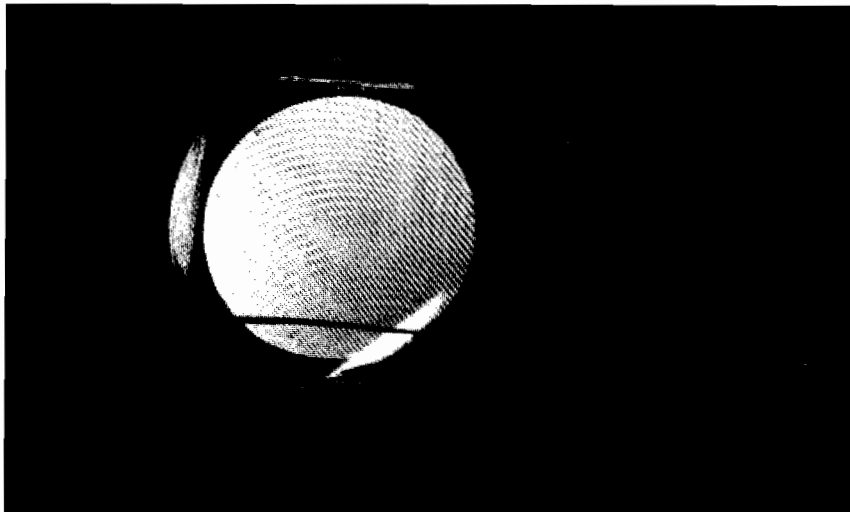
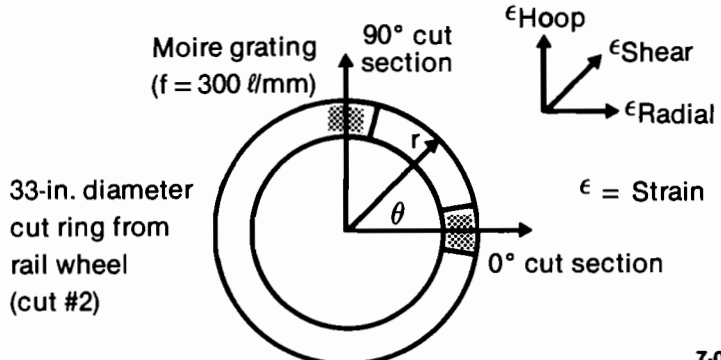
Figure 37. Elastic residual displacement field, shear displacement.

Shear (r-θ) in-plane displacement field (f = 300 μ m) Mag = 7.4/17.0

90° cut section in-plane shear (r-θ) displacement field (f = 300 μ m) Mag = 6.5/6.3
