**F R A
TASK ORDER #30A
WORK EFFORT 2
SHORT TERM TEST**

FINAL REPORT
Acquisition and Analysis
of
Wayside Acoustical Noise & Infrared Heat Signatures
associated with
Roller Bearing Defect Progression

SERVO CORPORATION OF AMERICA
111 New South Road
Hicksville, New York 11802

June 1989

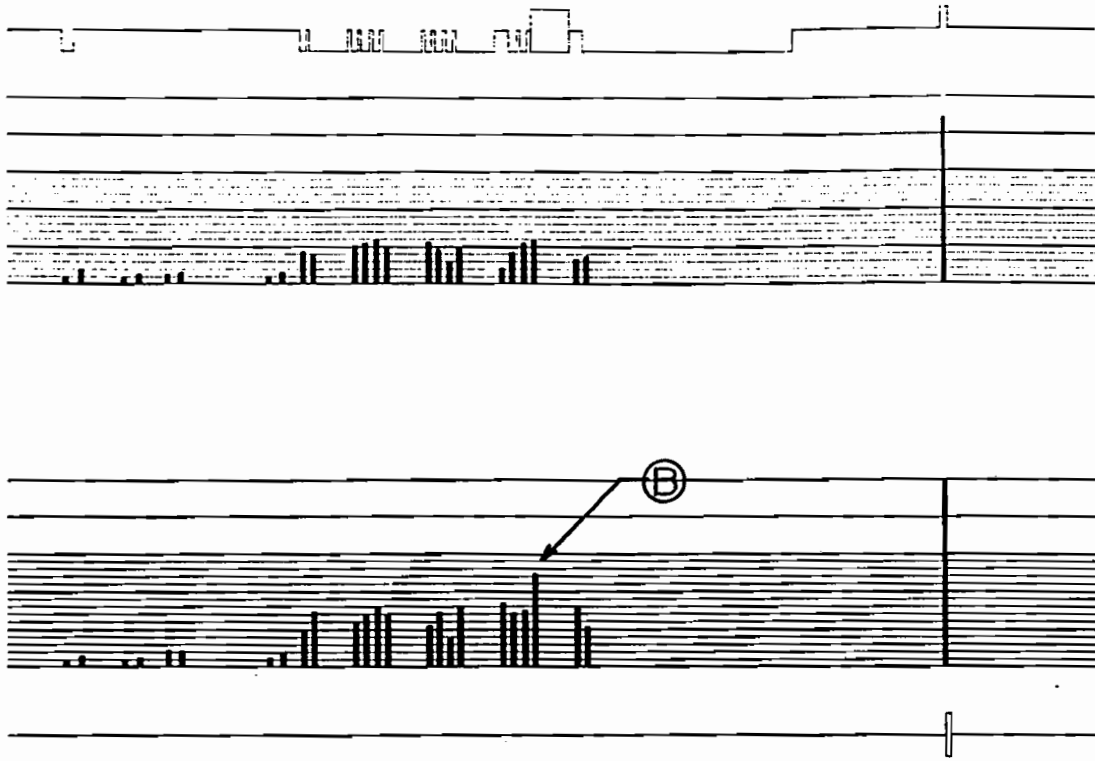
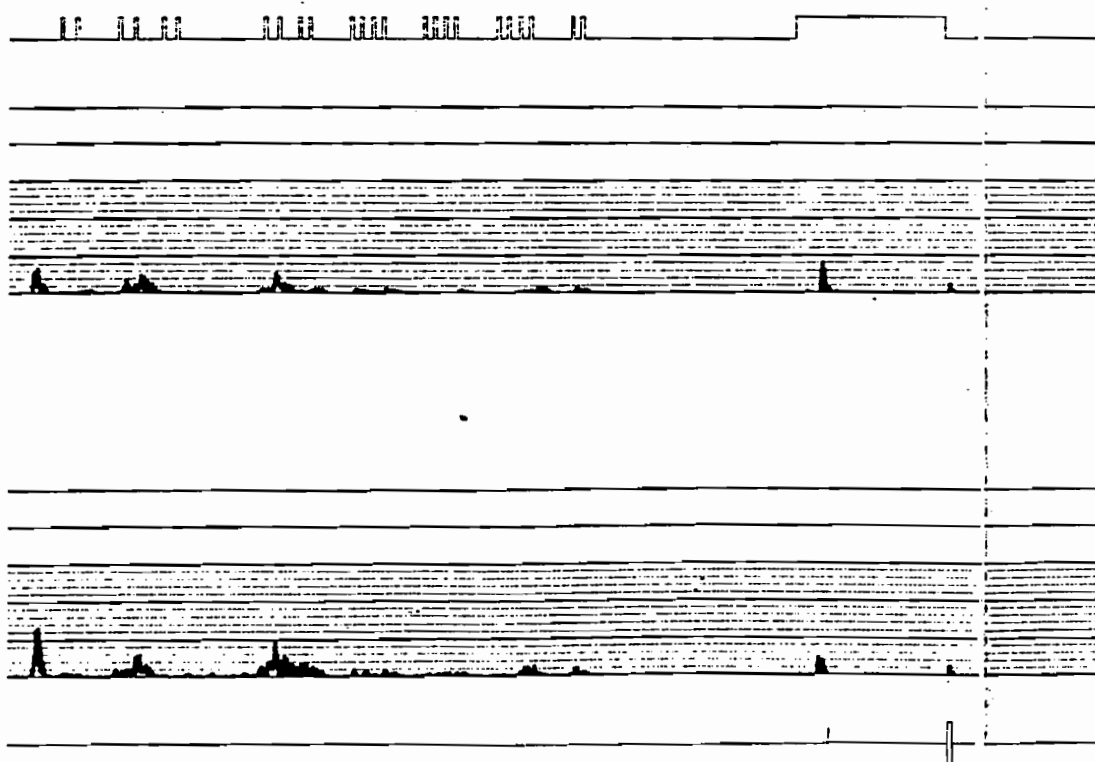
CHART 1

BN ACOUSTIC DETECTOR
 MILEPOST 1310.8
 DATE 03/10/89 TIME 08:32
 TRAIN 3 DIRECT EAST SPEED 58MPH #AXLES 24
 AXLE-COUNT-FROM-HEAD
 ALARM TYPE HEAT RL# 2 AXLE# 22
 HOT BEARING 12.0MM

BN ACOUSTIC DETECTOR
 MILEPOST 1310.8
 DATE 03/10/89 TIME 08:32
 TRAIN 3 DIRECT EAST SPEED 58MPH #AXLES 24
 AXLE COUNT FROM HEAD
 ALARM TYPE HEAT RL# 2 AXLE# 22
 HOT BEARING 12.0MM

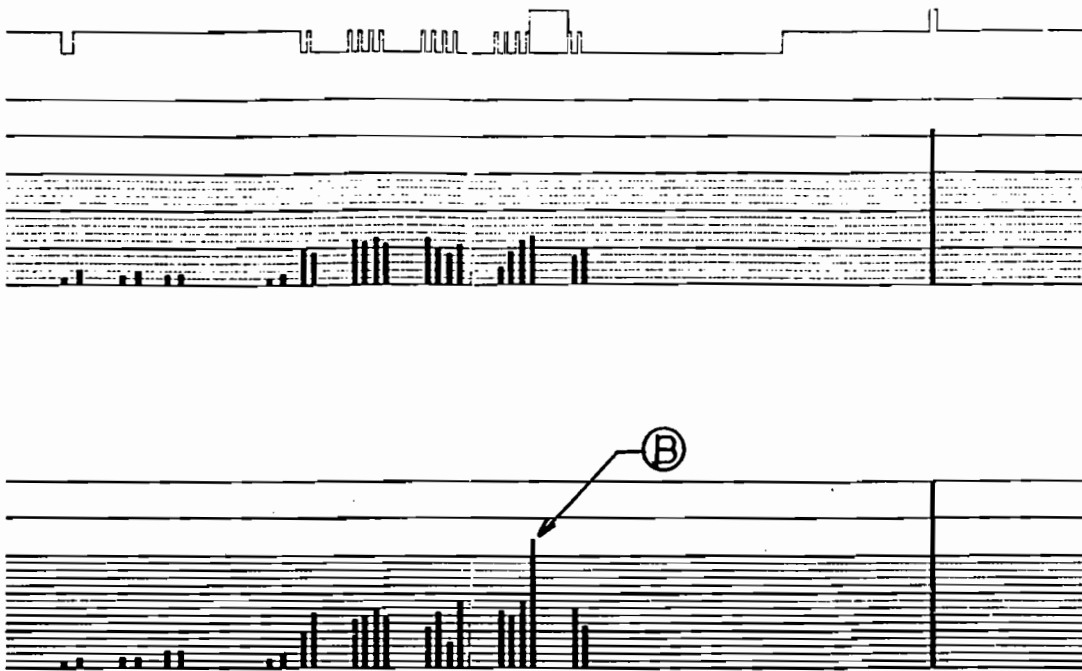
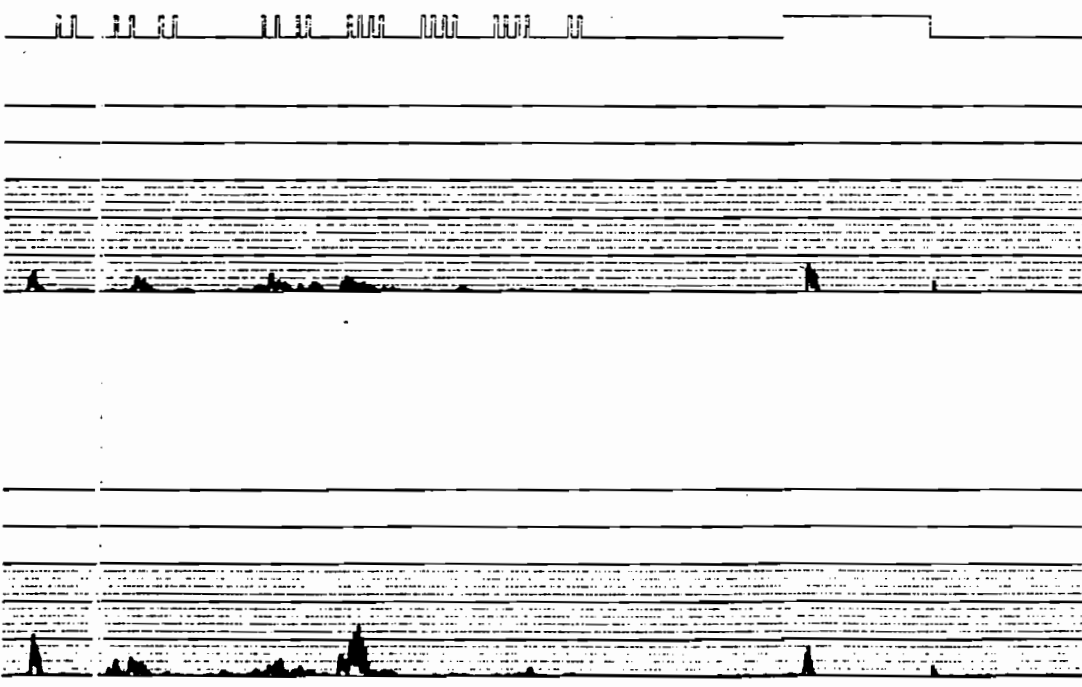
CHART 3

BN ACOUSTIC DETECTOR
 MILEPOST 1310.8
 DATE 03/10/89
 TIME 11:40

TRAIN	DIRECT	SPEED	MAXLES	TEMP
7	EAST	59MPH	24	83F

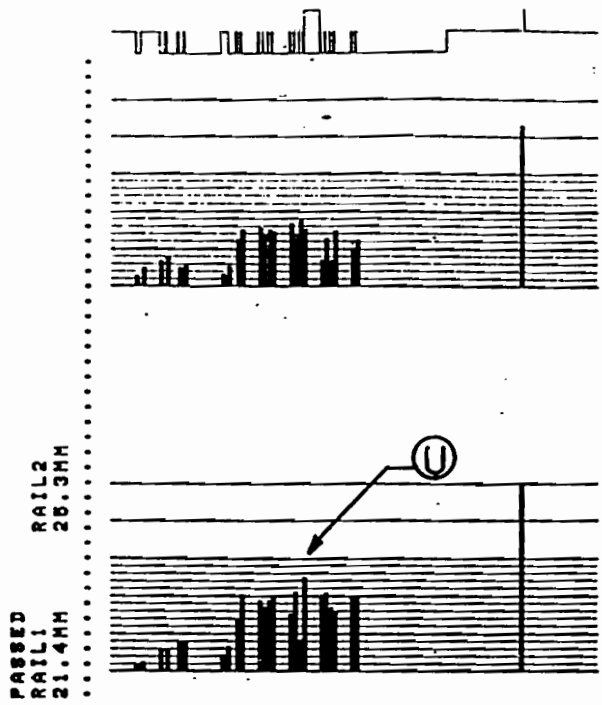
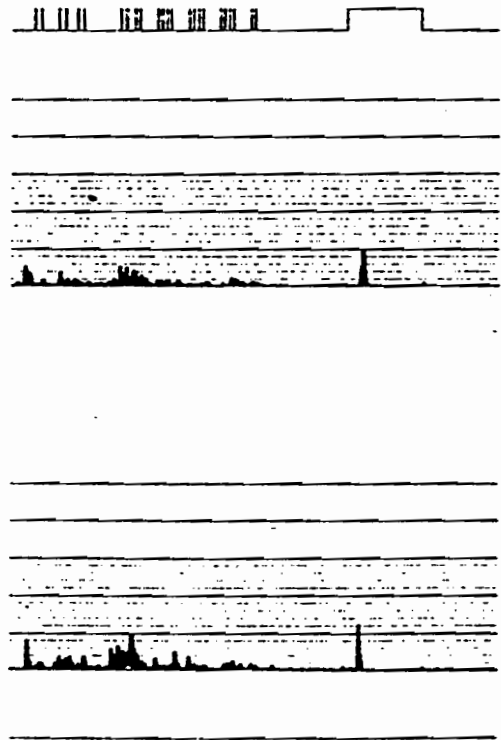
BN ACOUSTIC DETECTOR
MILEPOST 1310.8
DATE 03/28/89
TIME 14:22

TRAIN DIRECT SPEED MAXLES TEMP
29 EAST 68MPH 24 70F

AXLE COUNT FROM HEAD
ALARM TYPE HEAT RLM AXLEM
HOT BEARING 12.1MM 2 18

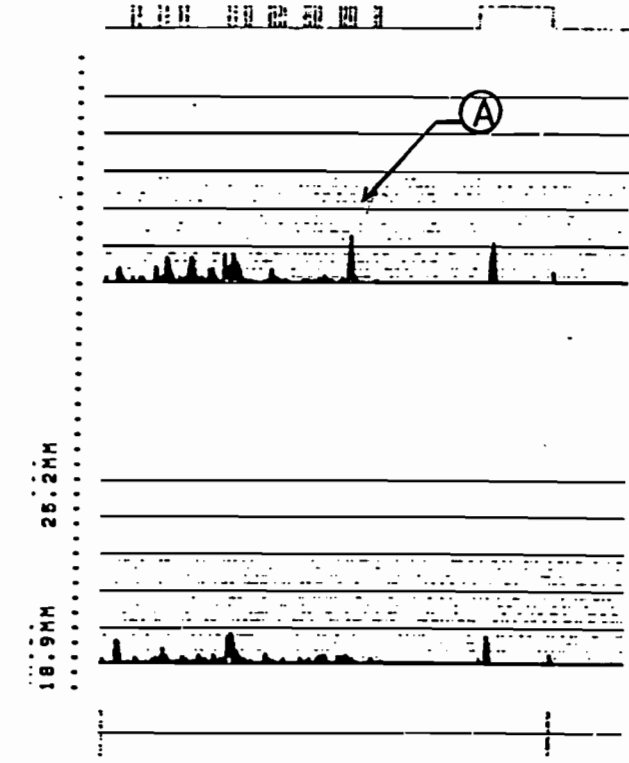
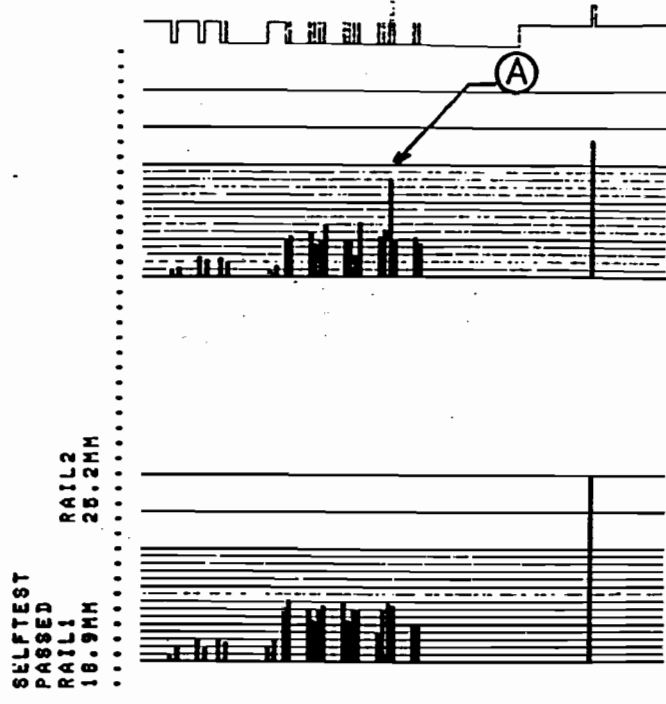
BN ACOUSTIC DETECTOR
 MILEPOST 1310.8
 DATE 05/08/89 TIME 17:36
 TRAIN 9 DIRECT WEST SPEED 61MPH #AXLES 24 TEMP 90F
 AXLE COUNT FROM HEAD
 ALARM TYPE HEAT R/LW AXLEW
 HOT BEARING 12.9MM 1 21

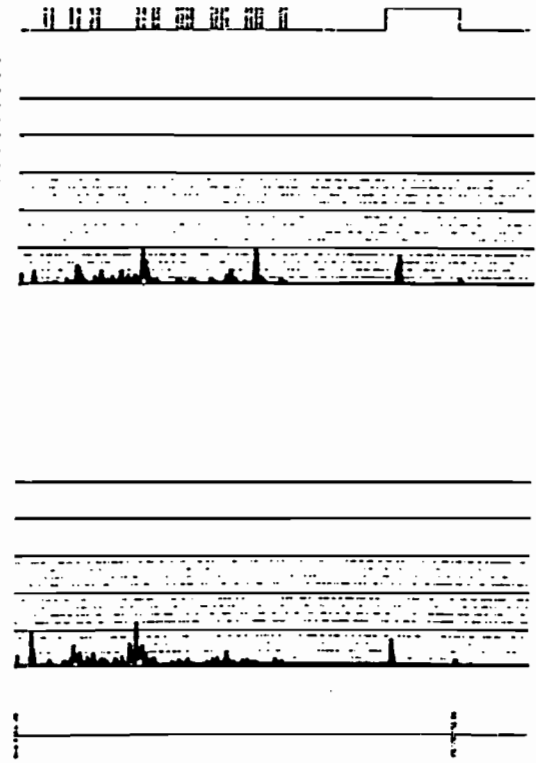
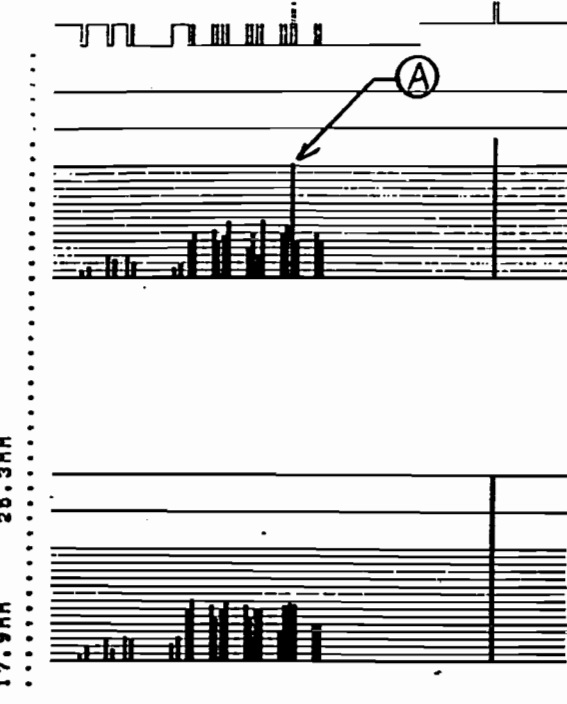
CHART 17

BN ACOUSTIC DETECTOR
 MILEPOST 1310.8
 DATE 05/08/89 TIME 17:49
 TRAIN 10 DIRECT WEST SPEED 60MPH #AXLES 24 TEMP 89F
 AXLE COUNT FROM HEAD
 ALARM TYPE HEAT R/LW AXLEW
 HOT BEARING 14.9MM 1 21

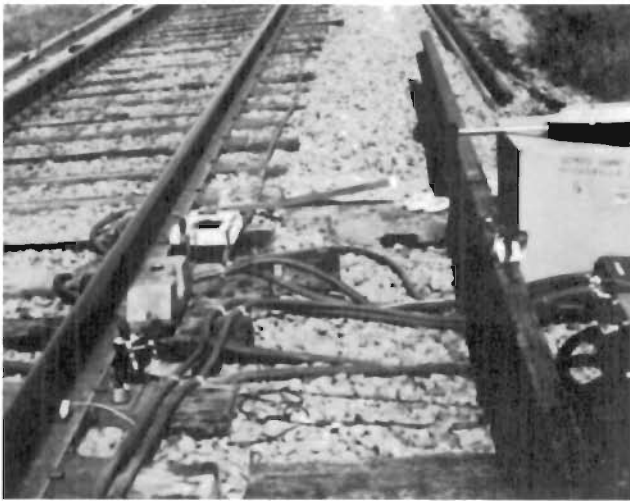
NORTH PLATTE SUBDIVISION
June 1987

A few weeks later, in July, a pilot prototype system was installed to process and record acoustical signals for both the north and south rails in real time. Defects were located by trainside and axle count. The first automatic acoustical detection of a defective bearing occurred on 14 July 1987. The defective bearing was on a loaded eastbound 109-car unit coal train moving at 40mph. The wheel set was removed at the Bailey Yard. Subsequent dis-assembly and inspection revealed a deep Brinell in the cup raceway.
