NBSIR 84-2858

REPORT NO. 11
OBSERVATIONS OF THE APRIL 8, 1979
RAILROAD ACCIDENT AT CRESTVIEW,
FLORIDA

April 1984

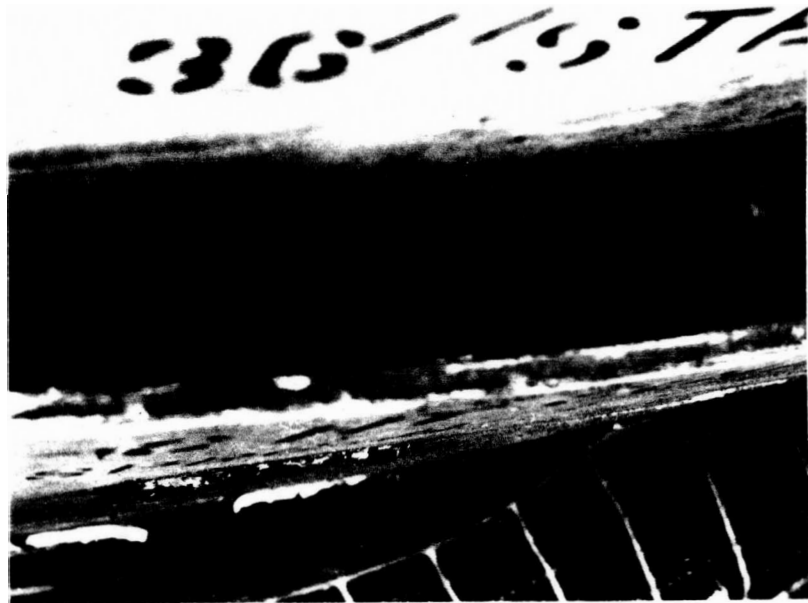
Sill, Coupler, Wheel, other parts (in that order) Head shield support pad (see 2-2) and head shield (2-3 and 2-4). Head shield was hit from one side with a gentle crushing force. Damage is shown in photos.

Photo 2-2: View of the area between the B head-plate and head-shield of tank-car GATX 93444.

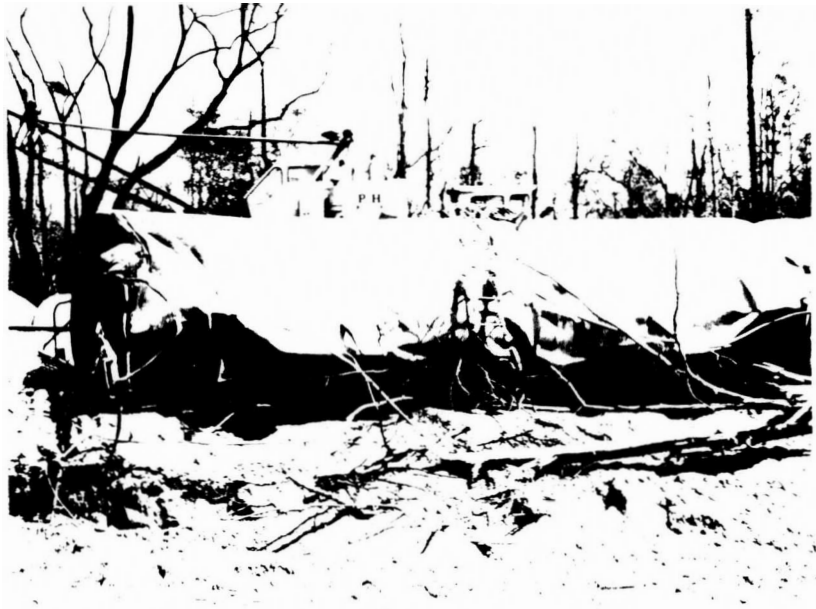
Photo C1-17: A-end of tank-car GATX 92097.

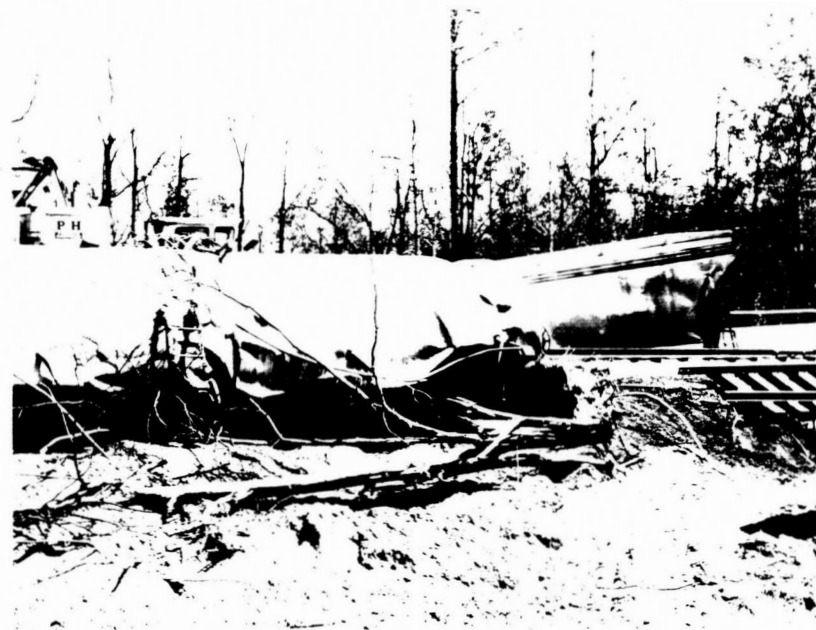
Photo C1-18: B-end of tank-car GATX 92097.

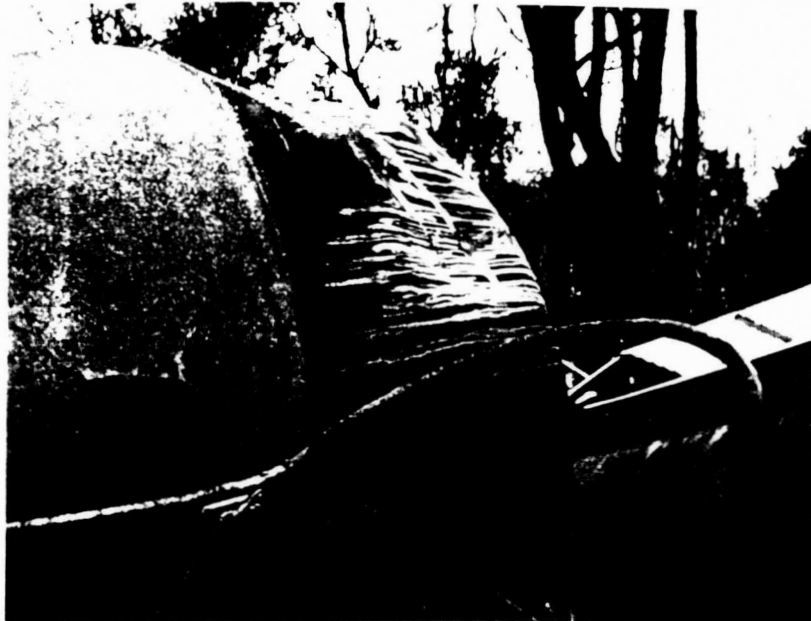
Photo C2-6: Close-up view of the A-head of tank-car GATX 44019.

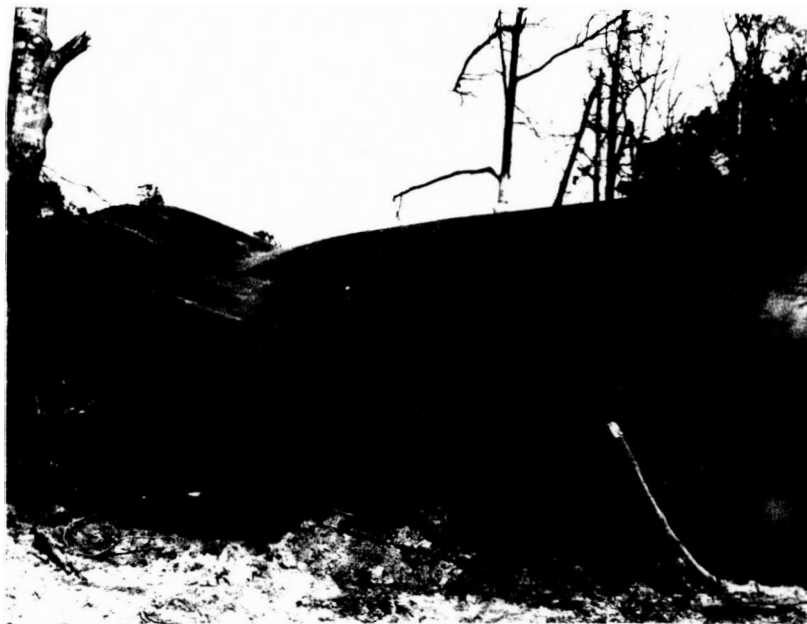
Photo 2-20: Crushed area of tank-car NATX 23367.

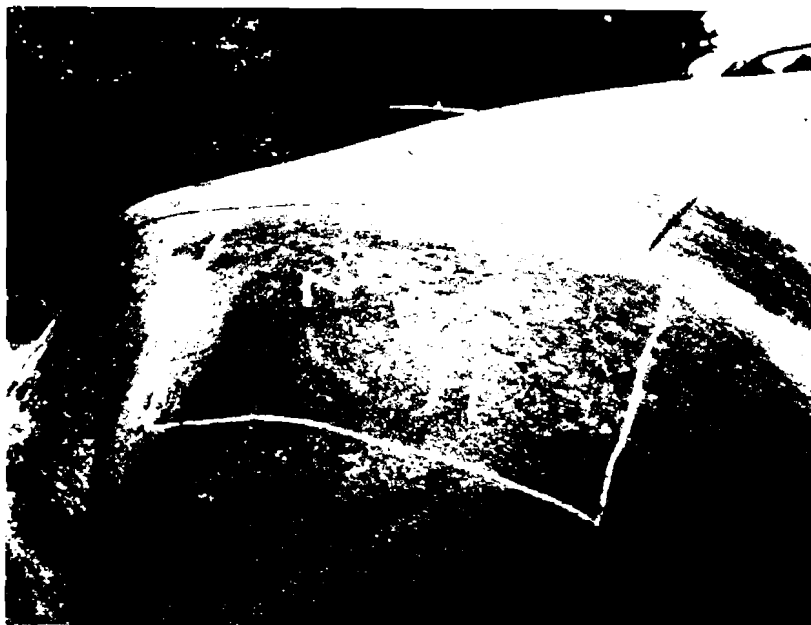
NBS 13 is located in two shell courses (one contains 63" rupture); NBS 13A is located in the severely dented head plate, but it is in a relatively undeformed part of this head plate.

Photo C5-9: Close-up of sample NBS 13A marked on the B-head-plate of tank-car ACFX 81395.

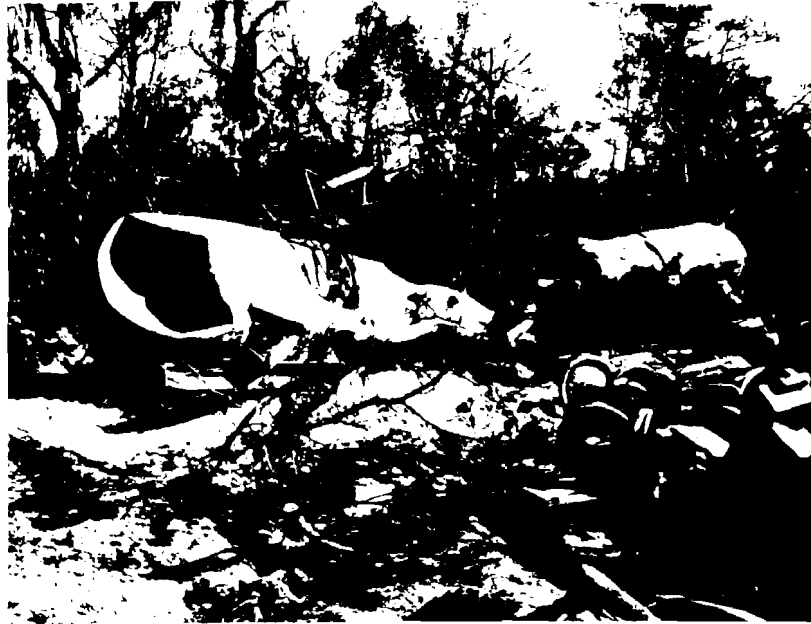
photo C3-12: A-end of tank-car ACFX 82959 (left) and tank-car IMCX 2827 (right).

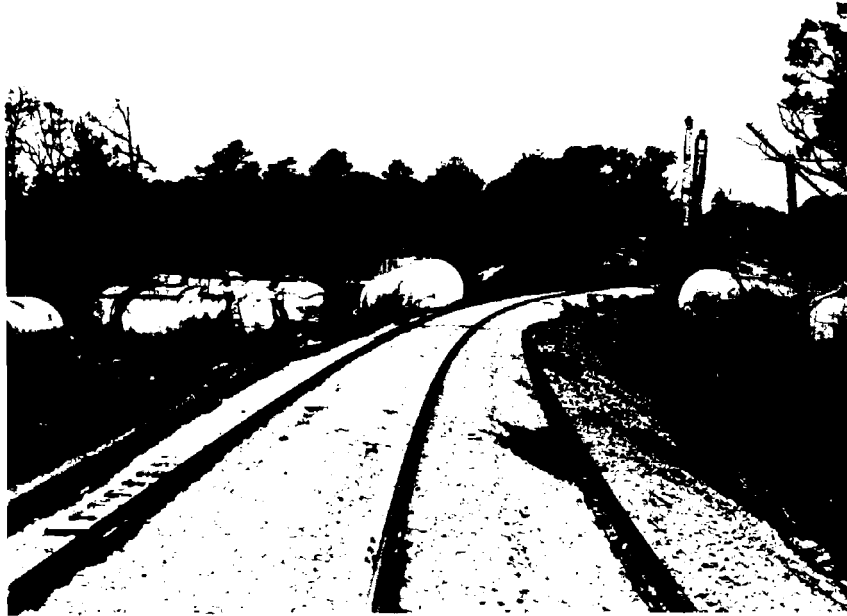
Photo 1-34: Same as 1-33 But in a section of woods a bit closer to the track and West of photo 1-33.
