REPORT NO. RR930-PM-79-23
AUGUST 1979

EXAMINATION OF CRACKS IN WABCO AND KNORR DISC BRAKES

PROJECT MEMORANDUM

U.S. DEPARTMENT OF TRANSPORTATION
RESEARCH AND SPECIAL PROGRAMS ADMINISTRATION
TRANSPORTATION SYSTEMS CENTER
Cambridge MA 02142

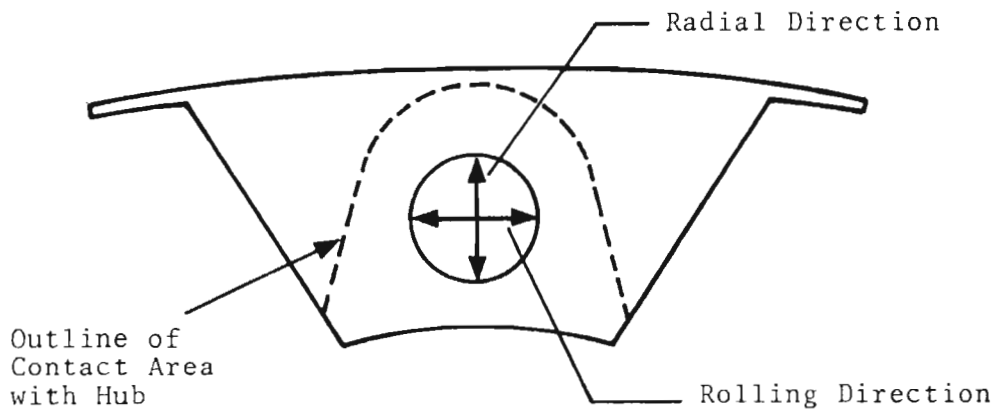
Measurements were taken of the tang holes in two directions, the rolling and radial directions (Figures 11 and 12), and at the outside and inside surfaces. The acceptable diameter, as stated by Wabco, is between 0.745 and 0.805 inch. All measurements were within these limits (Table 1). The holes appear to have elongated in the radial direction. No major differences were detected between the outside and inside surface measurements.

FIGURE 12. DIAGRAM OF WABCO DISC BRAKE TANG

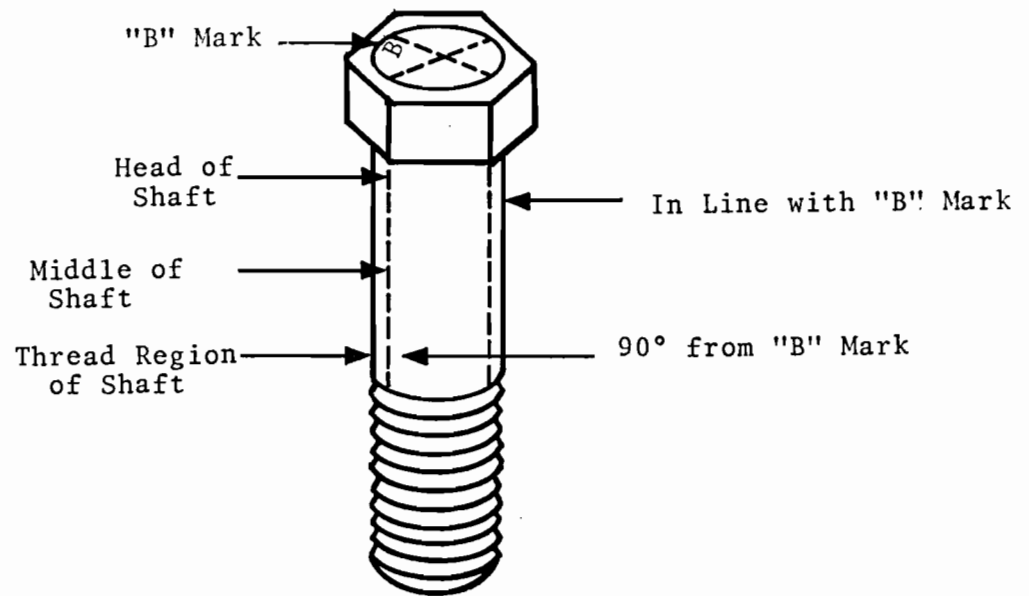
The bolts, not having a standard orientation with respect to the tang, were measured with respect to a "B" marking on the bolt head (Figure 13). Measurements were made along lines down the shaft of the bolt in line with the "B" and at 90° from the "B". The bolt/shafts were measured at three locations along the lines: next to the bolt head, next to the threads, and halfway between. The acceptable range for bolt diameter is 0.74 to 0.75 inch. The average (over eight bolts) of each measurement is presented in Table 2. All averages were within the acceptance range. However, two of the bolts had measurements that exceeded the maximum by .002 inch, while one bolt was below the minimum by .011 inch.

FIGURE 13. DIAGRAM OF CONNECTING BOLT

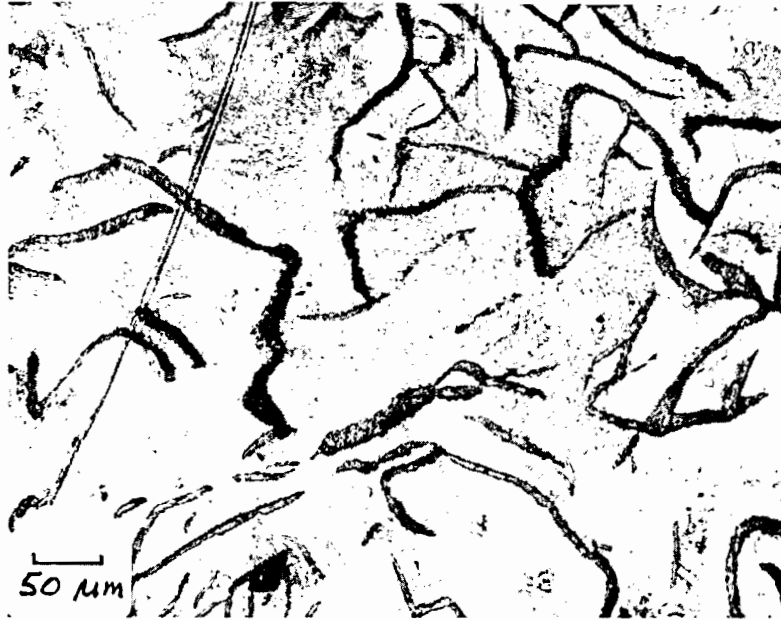
The microstructures of the Knorr and Wabco disc brakes (Figures 14 and 15) were typical for gray cast iron: a matrix of gray cast pearlite with graphite flakes randomly distributed throughout the structure. The grain size, microhardness, flake density, and Rockwell "B" hardness versus the location on the disc are given in Table 4.

FIGURE 15. MICROSTRUCTURE OF KNORR DISC BRAKE. THE SAMPLE WAS TAKEN NEAR THE OUTER RADIAL EDGE. MAGNIFICATION 200X

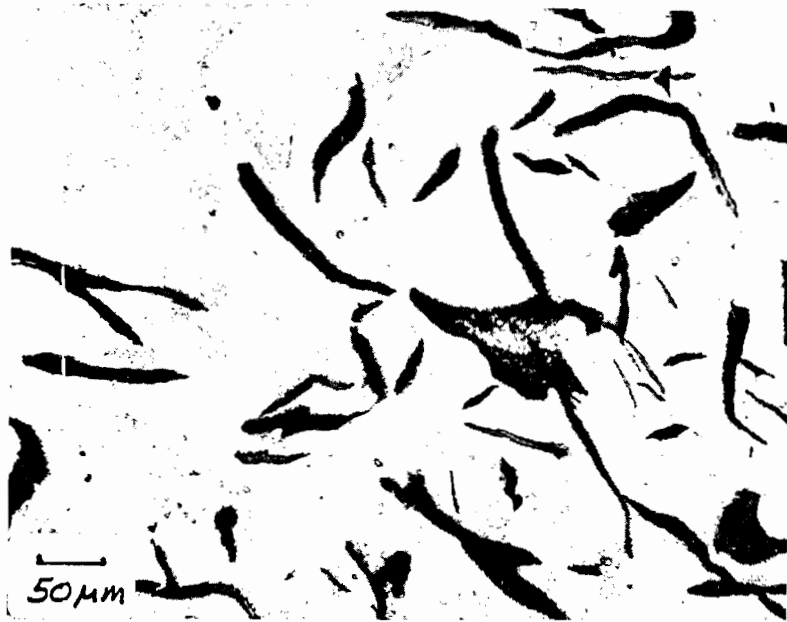
The microstructure of the tangs consisted of pearlite colonies with randomly distributed and oriented graphite flakes (Figure 16). This is typical of a gray cast iron. The microstructure of the tangs was very similar to that of the disc region of the brake (Figures 16 through 18). The graphite flake density for the tangs was $2.8 \times 10^4 / \text{cm}^2$, while in the disc it was 2.3×10^4 flakes/cm². The average colony size in the tangs was 40 μm while in the disc it was 35 μm . These differences could account for the differences in microhardness between the disc and tangs.

FIGURE 17. MICROSTRUCTURE OF WABCO DISC BRAKE TANG.
NOTICE THE SIMILARITY TO THE MICROSTRUCTURE OF THE
DISC FIG. 18. MAGNIFICATION 200X
