CONCRETE AND WOOD TIE PERFORMANCE THROUGH 425 MGT

TRANSPORTATION TEST CENTER
PUEBLO, COLORADO 81001

1. Report No. FRA/TTC-81/06		2. Government Accession No.		3. Recipient's Catalog No. PR82 200379	
4. Title and Subtitle Concrete and Wood Tie Performance, 425 MGT				5. Report Date October, 1981

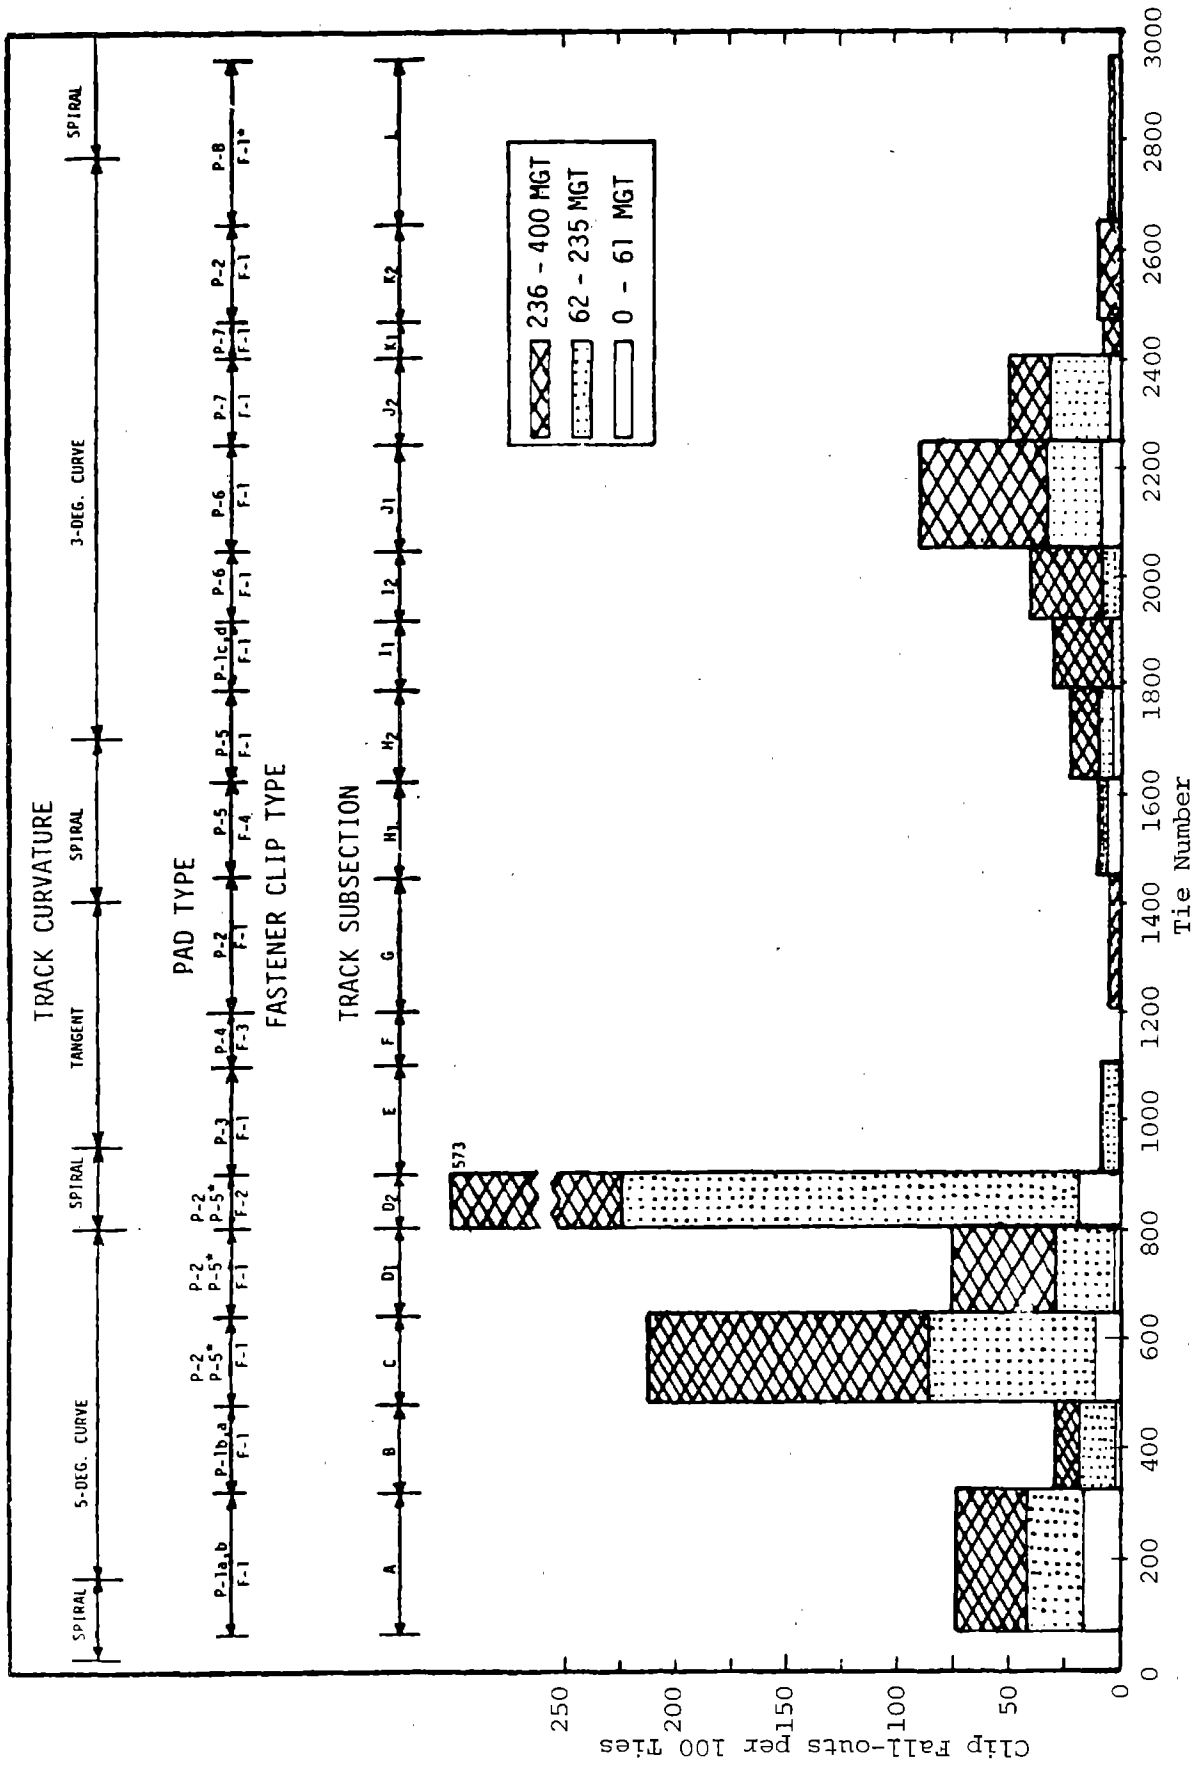
FIGURE 5-2. FASTENER CLIP FALL-OUTS IN CONCRETE TIE SECTION 17, 0-400 MGT.

The history of clip fall-outs through 425 MGT is summarized in figure 5-2. It can be seen that by far most fall-outs occurred in subsection D₂ where no external insulator was used. This installation with its internal insulator was not approved by the manufacturer. Other subsections where high fall-out rates occurred were:

One issue, which arose when the fall-out problem became evident, concerned the possible effect of pad hardness on the fall-out rate. In subsections C, D₁ and D₂ the soft Type P-2 pad was replaced with a medium hard Type P-5 pad at 235 MGT. It can be seen in Figure 5-2 that fall-outs continued at a slightly higher rate after the pad replacement. The highest fall-out rate in the 3° curve occurred with a hard type P-6 pad.

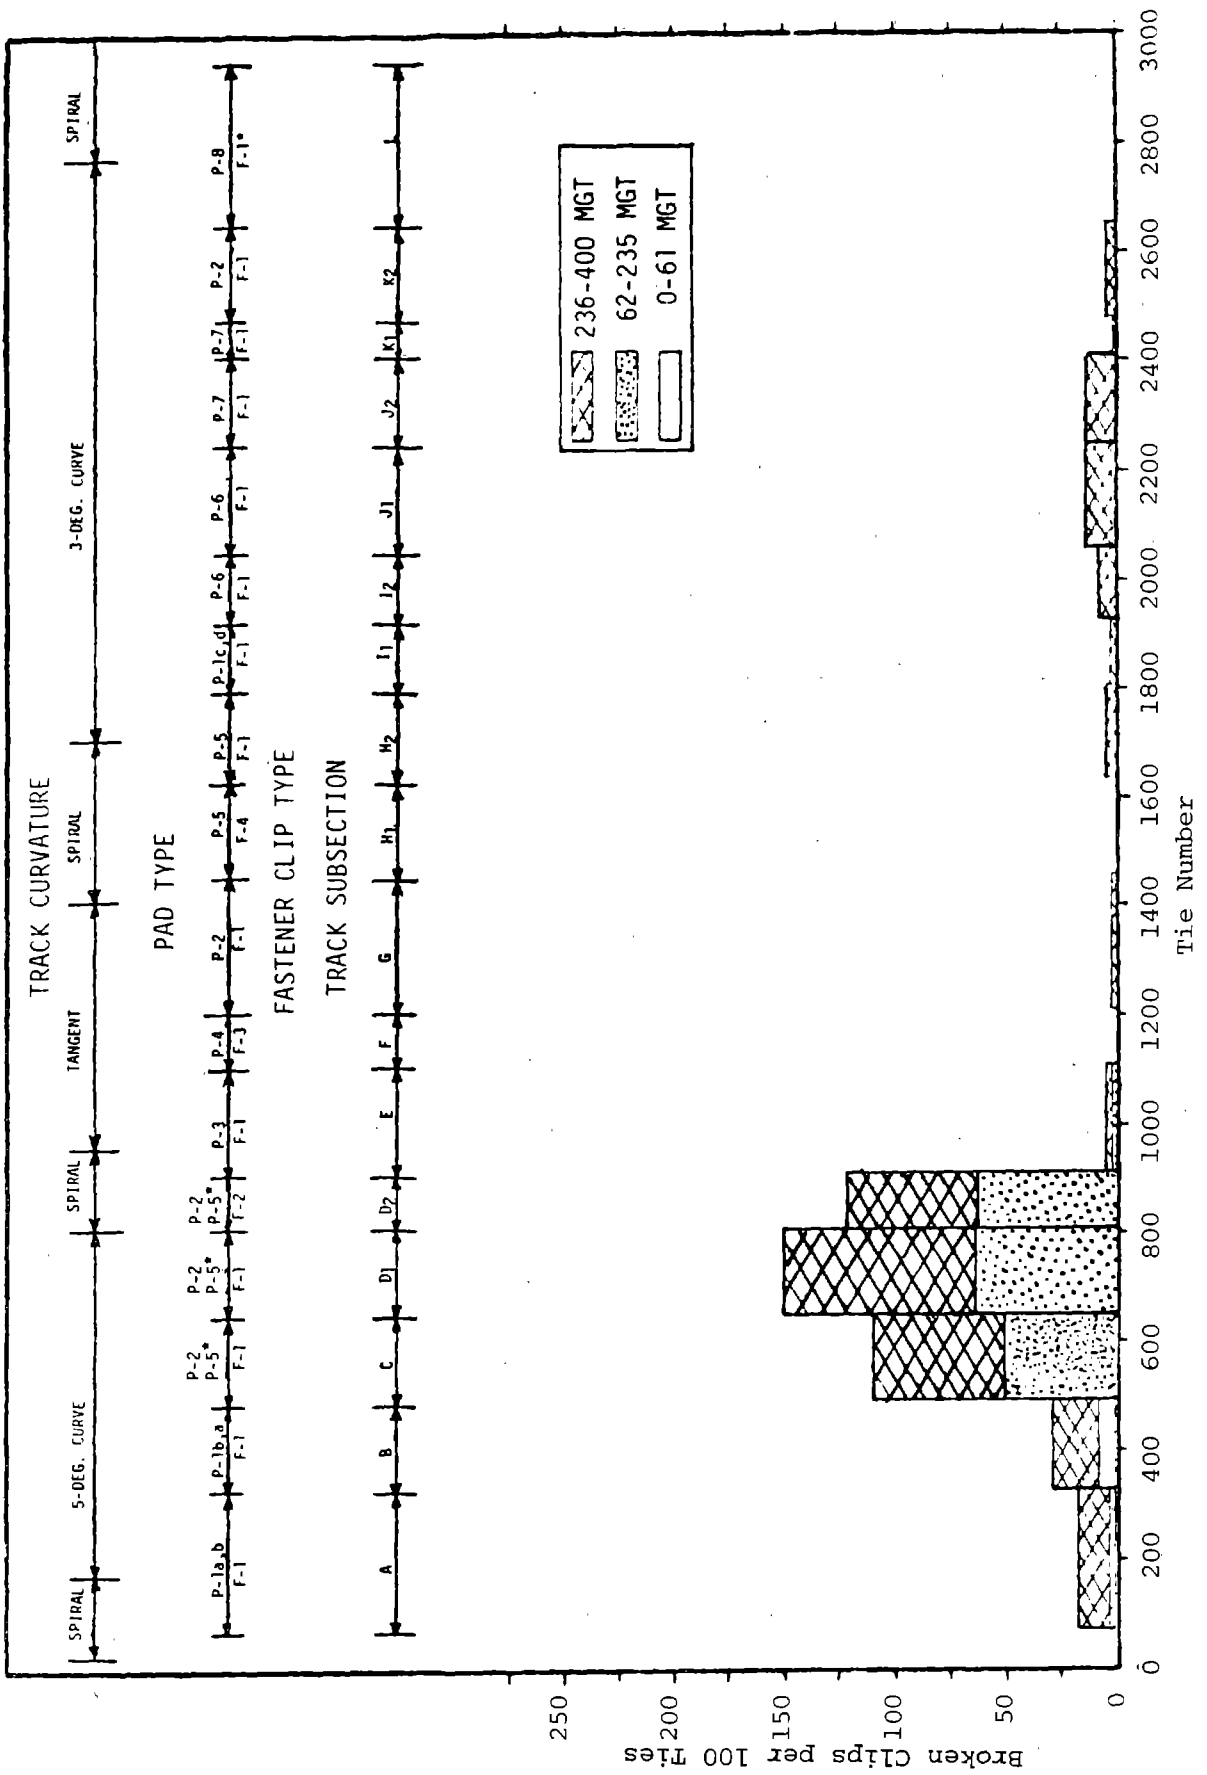
FIGURE 5-3. REPLACEMENTS OF BROKEN FASTENER CLIPS IN CONCRETE TIE SECTION 17.

A summary of clip fractures in Section 17 over the first 425 MGT is shown in Figure 5-3. The highest rates occurred in subsections C, D₁ and D₂. These fractures were approximately equally distributed over the period before 235 MGT (soft Type P-2 pads) and after 235 MGT (medium hard Type P-5 pads). Apparently, the hardness of the pads had little, if any, effect on the rates of either fall-outs or fractures.

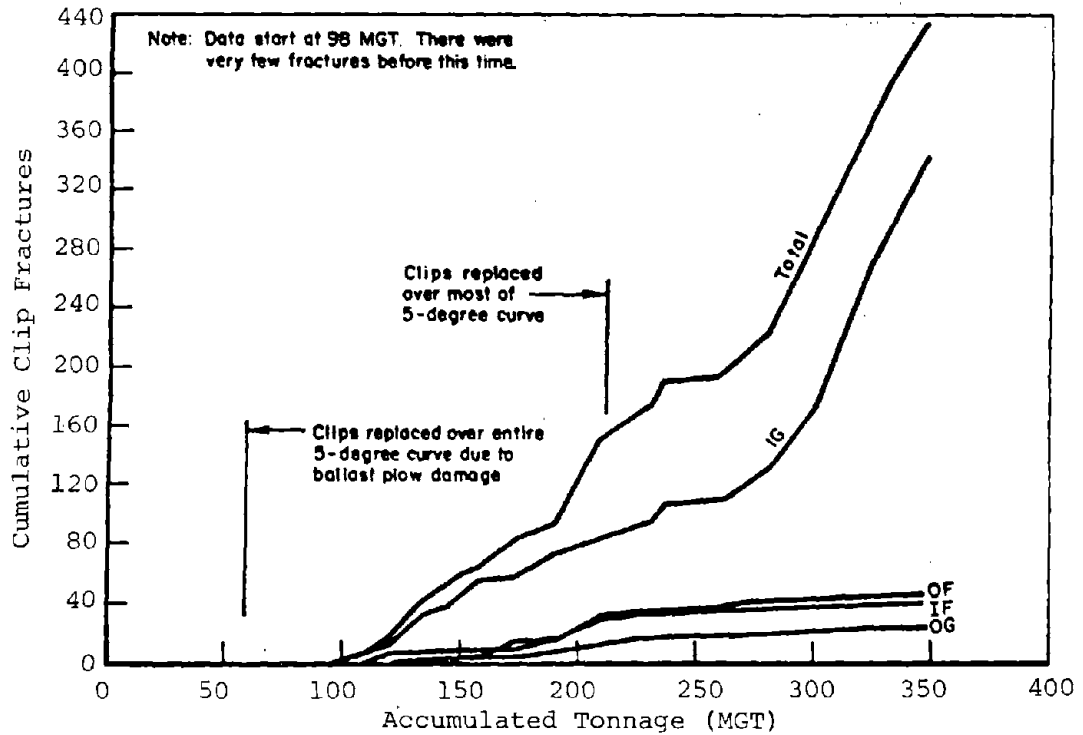
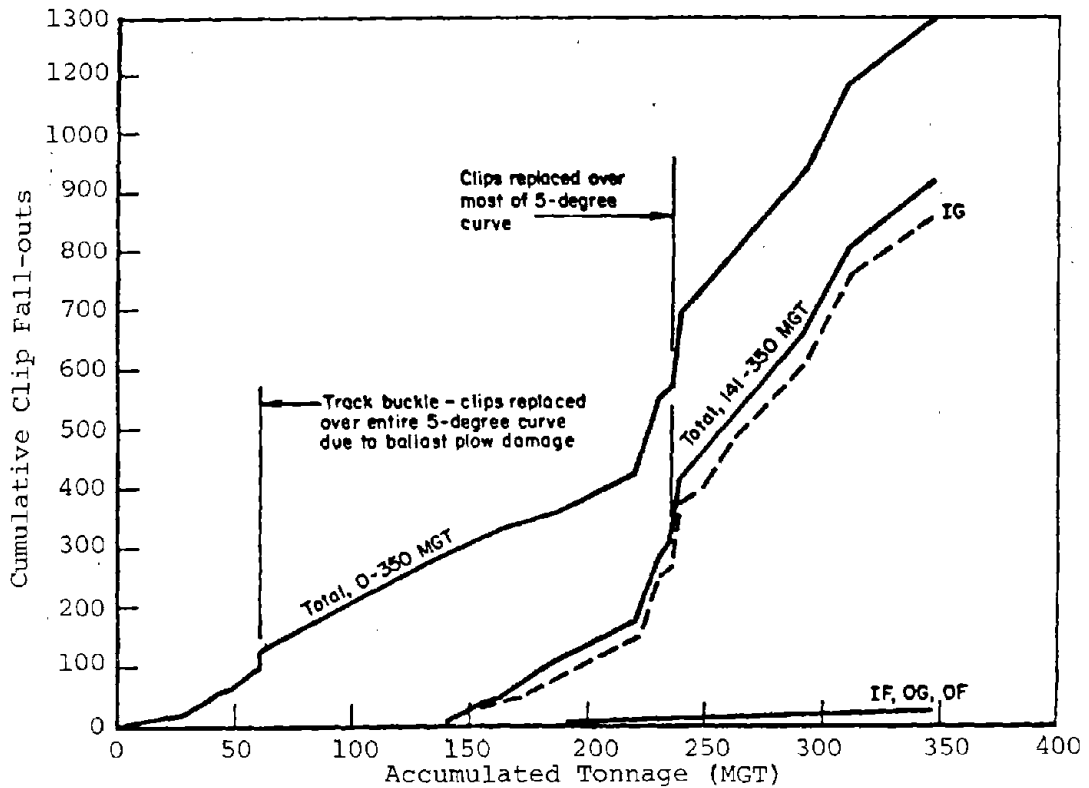
FIGURE 5-4. CLIP FALL-OUTS AND FRACTURES BY LOCATION ON TIE.

Rates of fall-out and fracture are plotted vs MGT, over the period of 0 to 350 MGT, in Figure 5-4. For a restricted period (141-350 MGT) the rates are presented by location on the tie. It can be seen from the figure that:

- Most clip fall-outs and fractures occurred at the inside gage (IG) location on the tie. Over all of this period of time (until a train derailment at 358 MGT) the counterclockwise travel of the train up the grade in the 5° curve resulted in a reduction of speed to about 31-32 mi/h, vs a balance speed of 34 mi/h with 4" superelevation. In addition, the draft force of the train on this grade is thought to have created a significant component of lateral load on the inside rail, directed radially inward.
- The clip fracture problem began at about 100 MGT, or about 40 MGT after the replacement of the original clips with clips from a batch made in England. (The replacement was necessitated by damage from a ballast regulator rather than by the sun kink at 61 MGT.)

Cumulative fastener fractures vs MGT for period 0-350 MGT (Subsection D₂ fractures not included).

Cumulative fastener fall-outs vs MGT for period 0-350 MGT (Subsection D₂ fall-outs not included).

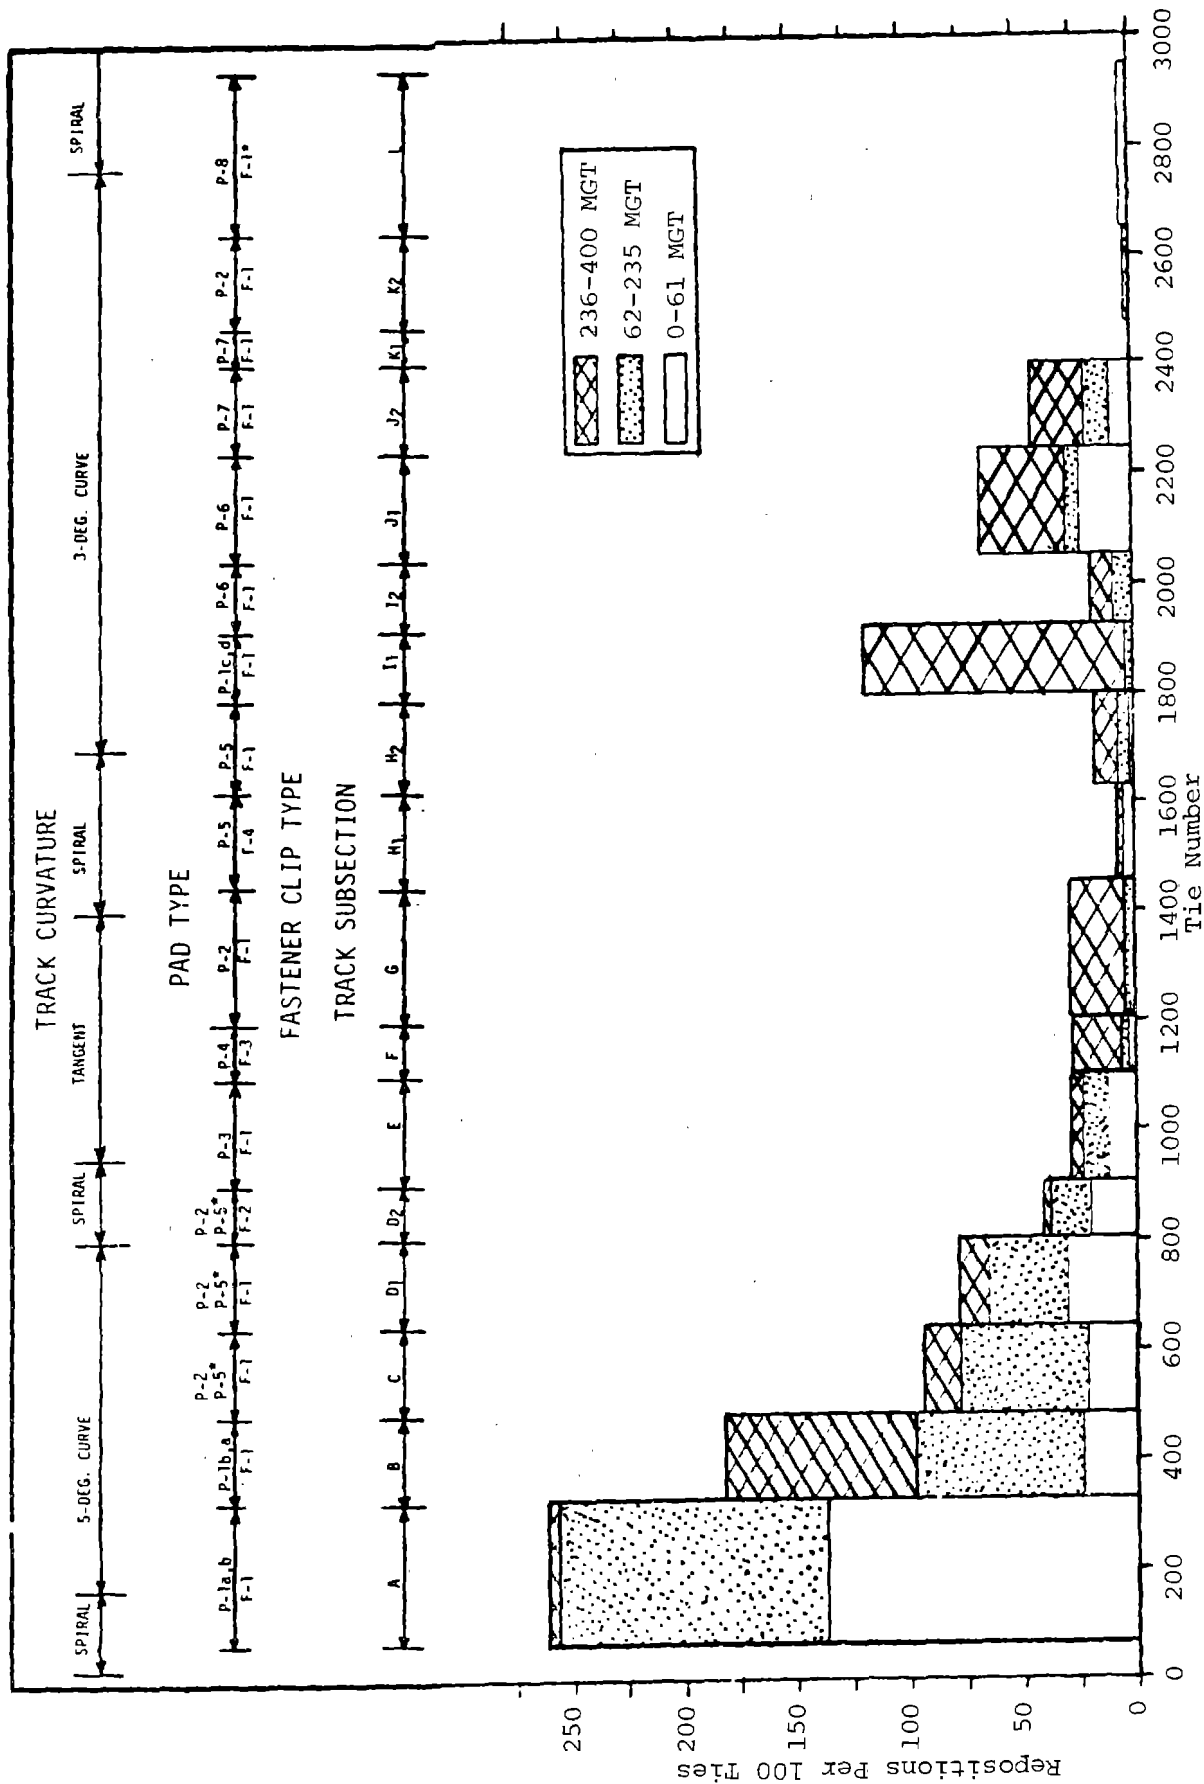
FIGURE 5-5. TIE REPOSITIONS IN CONCRETE TIE SECTION 17.

A primary function of the fastener system is to provide sufficient longitudinal restraint between the rail and the tie to inhibit tie skewing and bunching. A lower longitudinal restraint is indicated in Figure 5-5 by the frequency with which tie repositioning was required in the 5° curve with 2% grade and in the 3° curve. The restraint was lowest in subsections A and B, which were located near the bottom of the 2% grade in the 5° curve. The frequency of repositioning to correct tie skewing led to the installation of rail anchors in subsections A and B shortly before the rebuild at 235 MGT and in the 3° curve at 235 MGT. Anchors were installed on every tie in subsection A and on every other tie (normal wood tie practice) in subsections B and in the 3° curve. It can be seen in Figure 5-5 that subsection B continued to require repositioning after the 235 MGT rebuild.

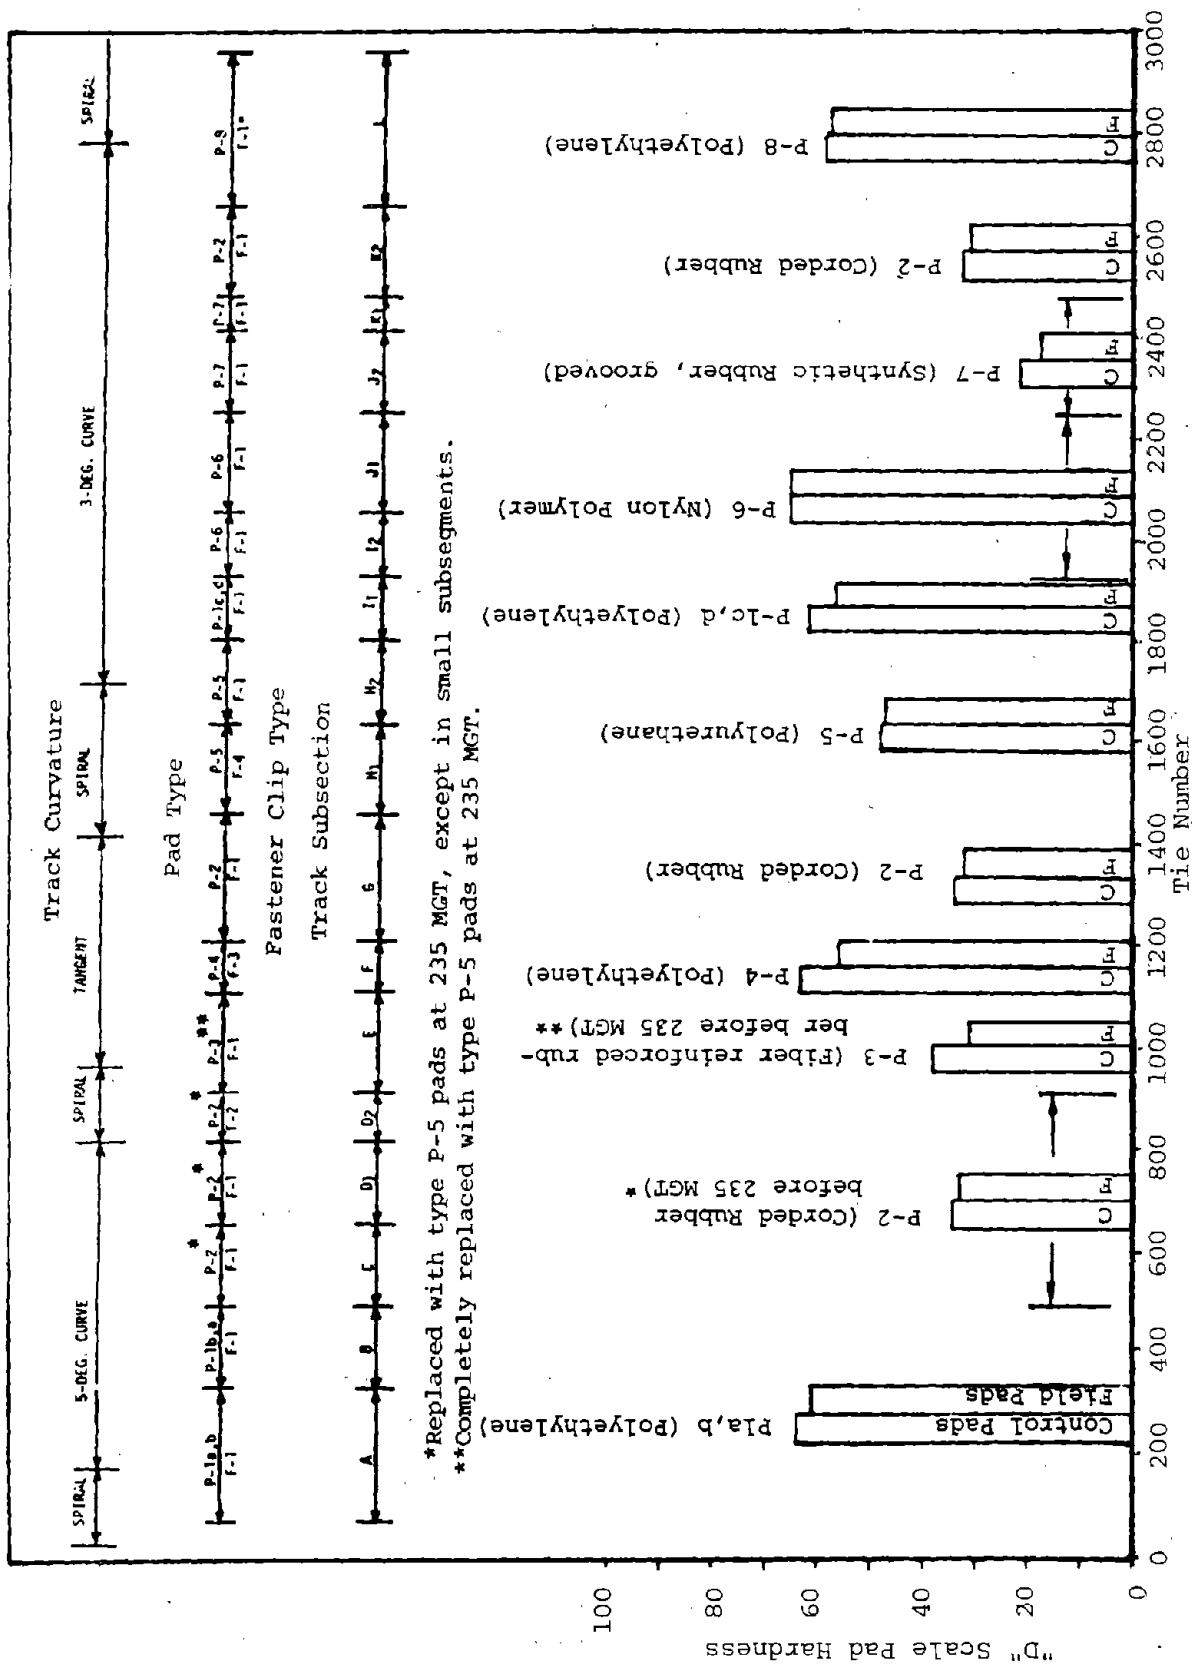
FIGURE 5-6. HARDNESS OF PADS IN CONCRETE TIE SECTION 17.

A total of 8 types of pads were installed in the various subsections of concrete tie Section 17 for the first 425 MGT. Pad materials and average hardness measurements are shown in Figure 5-6. "D" scale durometer measurements (a scale normally used for hard rubber) were taken on field pads and on control pads stored off-track. It can be seen that the field pads generally lost hardness relative to the control pads. The pads can be classed generally by their initial hardness as:

- "Hard" - Types P-1, P-4, P-6, P-8
- "Medium Hard" - Type P-5
- "Soft" - Types P-2, P-3, P-7.

*Replaced with type P-5 pads at 235 MGT, except in small subsections.
 **Completely replaced with type P-5 pads at 235 MGT.

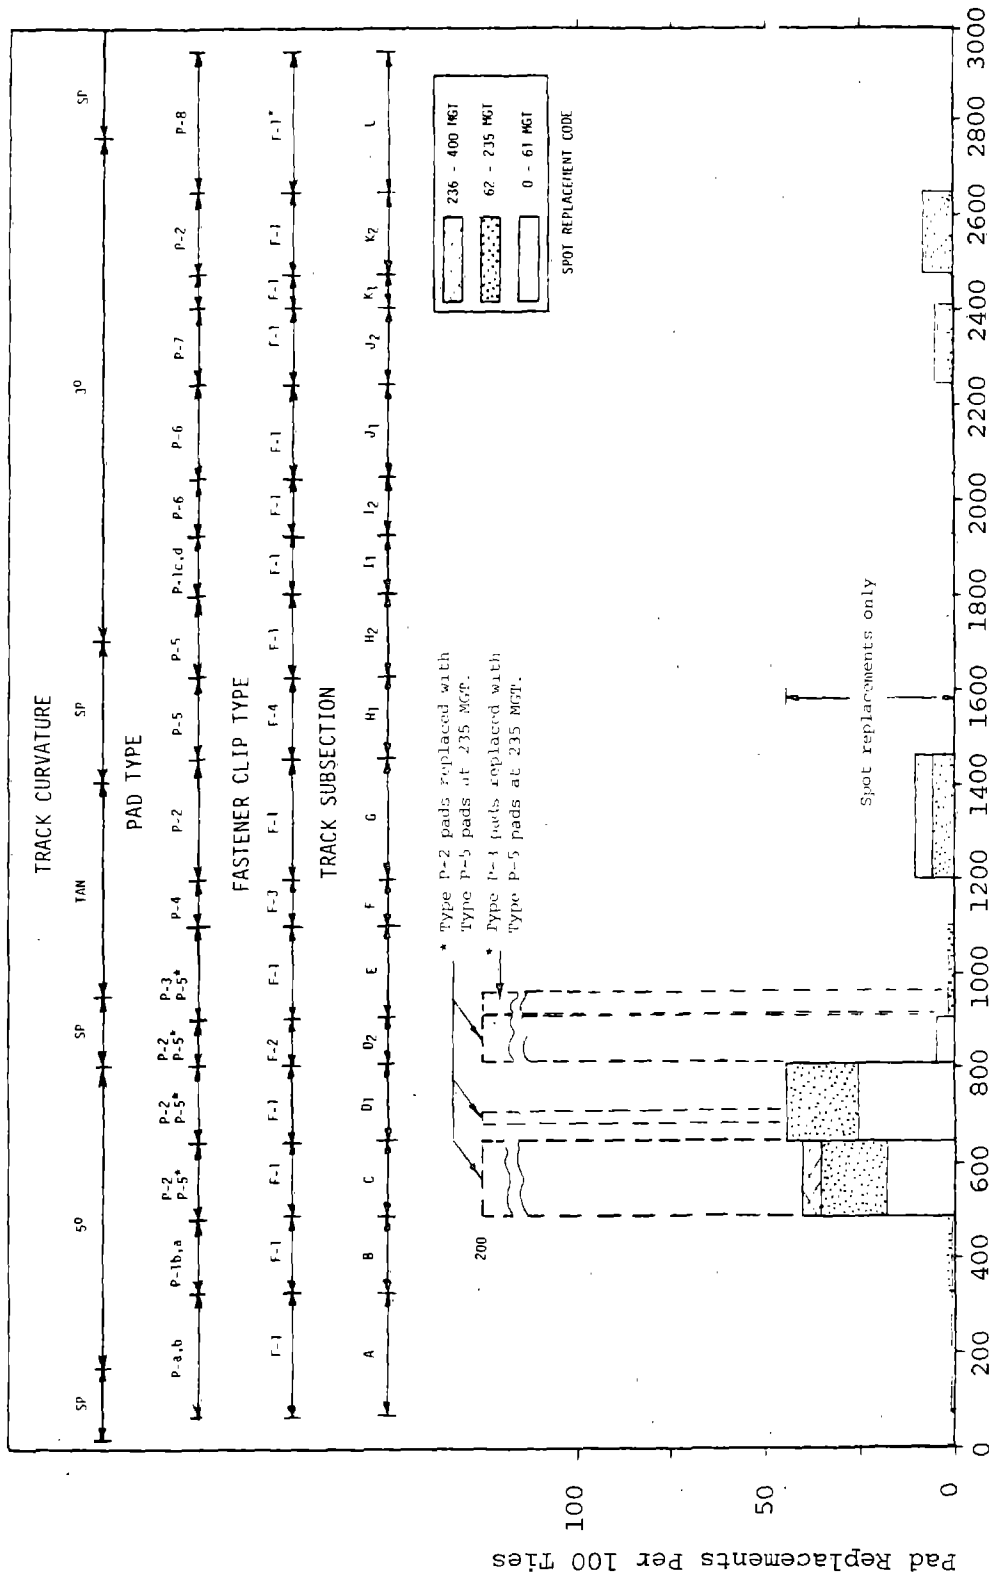
FIGURE 5-7. REPLACEMENTS OF TIE PADS IN CONCRETE TIE SECTION 17.

A summary of total pad replacements in each subsection over 425 MGT is presented in Figure 5-7. This figure verifies the previously discussed inspection, showing significant replacements only in soft pad regions. Typical wear conditions found on three types of pads at 235 MGT are illustrated in Figure 5-8.

Subsection	Tie Numbers	Original Pad Type	Percent Defects	Action
A, B	0070-0488	P-1a, P-1b (Polyethylene)	1.9 (16/838)	Defective pads Replaced
C	0489-0654	P-2 (Corded Rubber)	32 (24 pads form a sample of 76 over C-D ₂)	Complete Replacement with Type T-5 Pads
D ₁ (1)	0655-0679			Old Nondefective Type P-2 pads reinstalled
D ₁ (2)	0680-0704			Complete Replacement with Type T-5 pads
D ₁ (3)	0705-0729			Old Nondefective Type P-2 pads reinstalled
D ₂	0730-0808			Complete Replacement with Type T-5 pads
E (Spiral portion)	0910-0956	P-3 (Fiber Reinforced Rubber)	18 (17/94)	Complete Replacement with Type P-5 pads
G	1207-1458	P-2 (Corded Rubber)	3.2 (16/504)	Defective Pads Replaced in-kind
H ₁ , H ₂	1459-1804	P-5 (Polyurethane)	0.3 (12/692)	Defective Pads Replaced in-kind
I ₁	1805-1927	P-1c, P-1d (Polyethylene)	0.4 (1/246)	Defective Pad Replaced in-kind
I ₂ , J ₁	1928-2257	P-6 (Nylon-Polymer)	2.3 (15/660)	Defective Pads Replaced in-kind

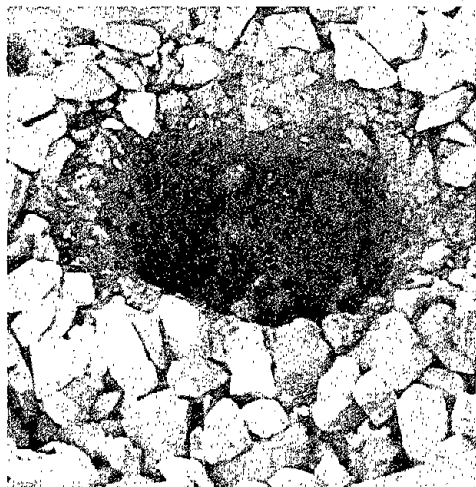
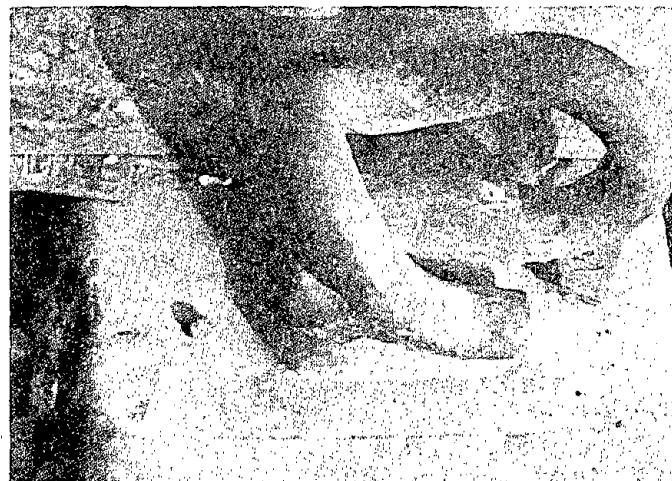
(c) Insulator Broken,
Clip Displaced

(d) Rail Seat
Bending Crack
