**Federal Railroad
Administration**

Performance of Degraded Roller Bearings

6. AUTHOR(S) Kevin Kesler and Chris Tinto		Revised: 12/28/90	
7. PERFORMING ORGANIZATION NAME(S) AND ADDRESS(ES) ENSCO, Inc. Applied Technology and Engineering Division 5400 Port Royal Road Springfield, VA 22151		8. PERFORMING ORGANIZATION REPORT NUMBER DOT-FR-89-08

9. SPONSORING/MONITORING AGENCY NAME(S) AND ADDRESS(ES) Federal Railroad Administration Department of Transportation 400 Seventh St., S.W. Washington, DC 20590		10. SPONSORING/MONITORING AGENCY REPORT NUMBER FRA/ORD-90/12

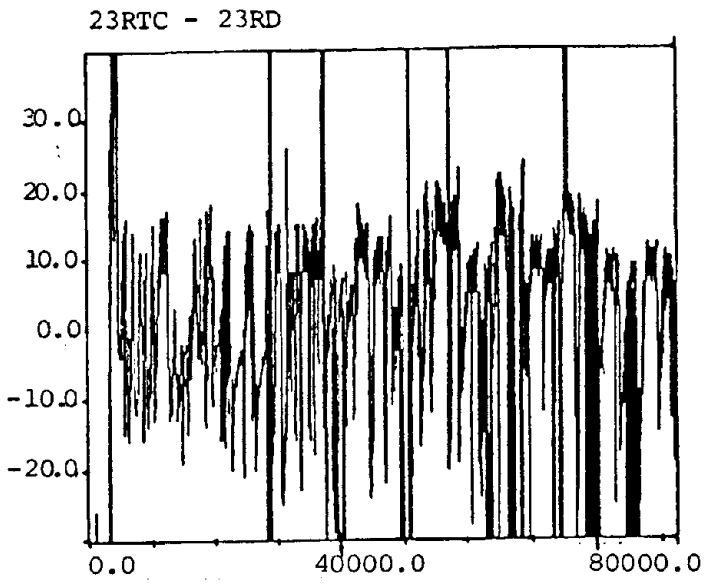
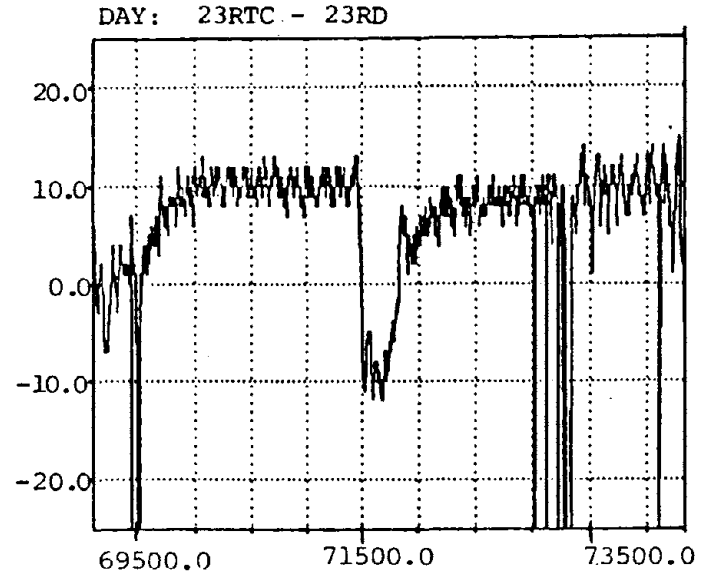
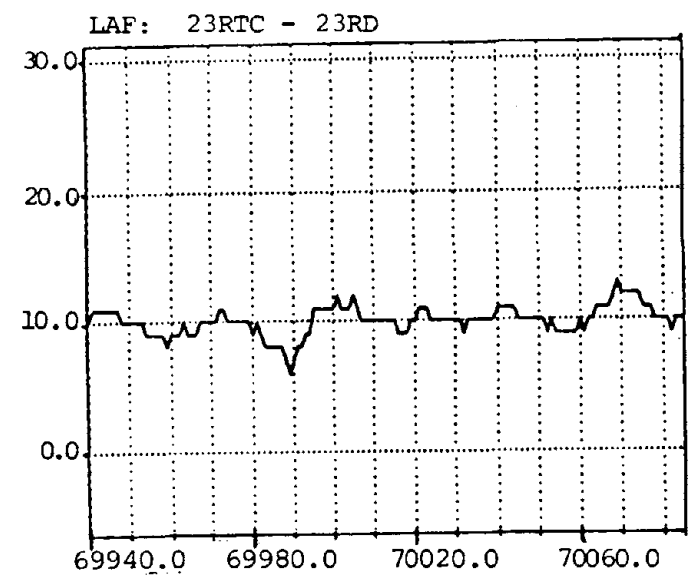
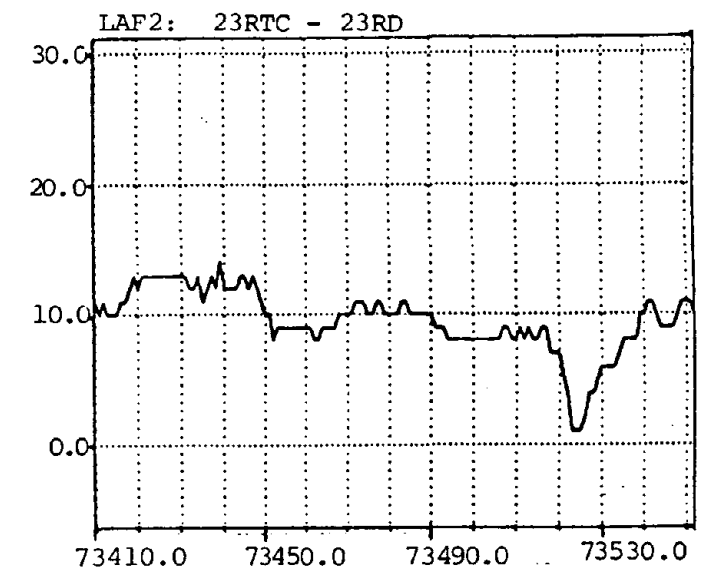
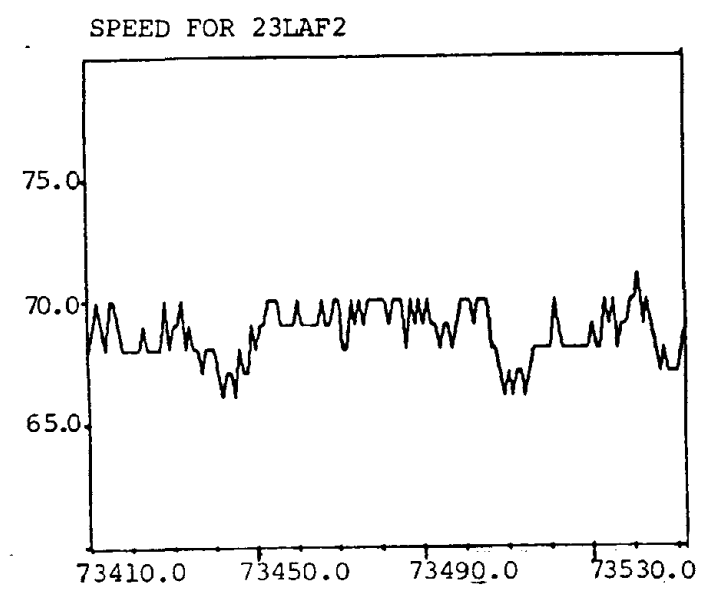
FIGURE 4-6. OUTBOARD VS. TOP OF CUP BEARING TEMPERATURE

From the data that is available, the top of cup temperatures ran about 10° F warmer than the side of cup temperatures during normal operations, (See example Figure 4-6) showing the temperature difference between the top of cup and side of cup for normal conditions on car 2, axle 3, right side. Thermal plots are presented for the entire test, one day and one lap. Speed and location reference (ALD) data are also presented for the single lap in the figure. This data is significant because wayside overheated bearing detectors must measure temperature at points along the bottom and side of the bearing housing whereas the heat in a overheating bearing is primarily generated in the load zone at the top of the cup. Figure 4-11 (page 27) shows both top of cup and side of cup temperatures in an overheating condition, where the temperature difference is approximately 120° F.

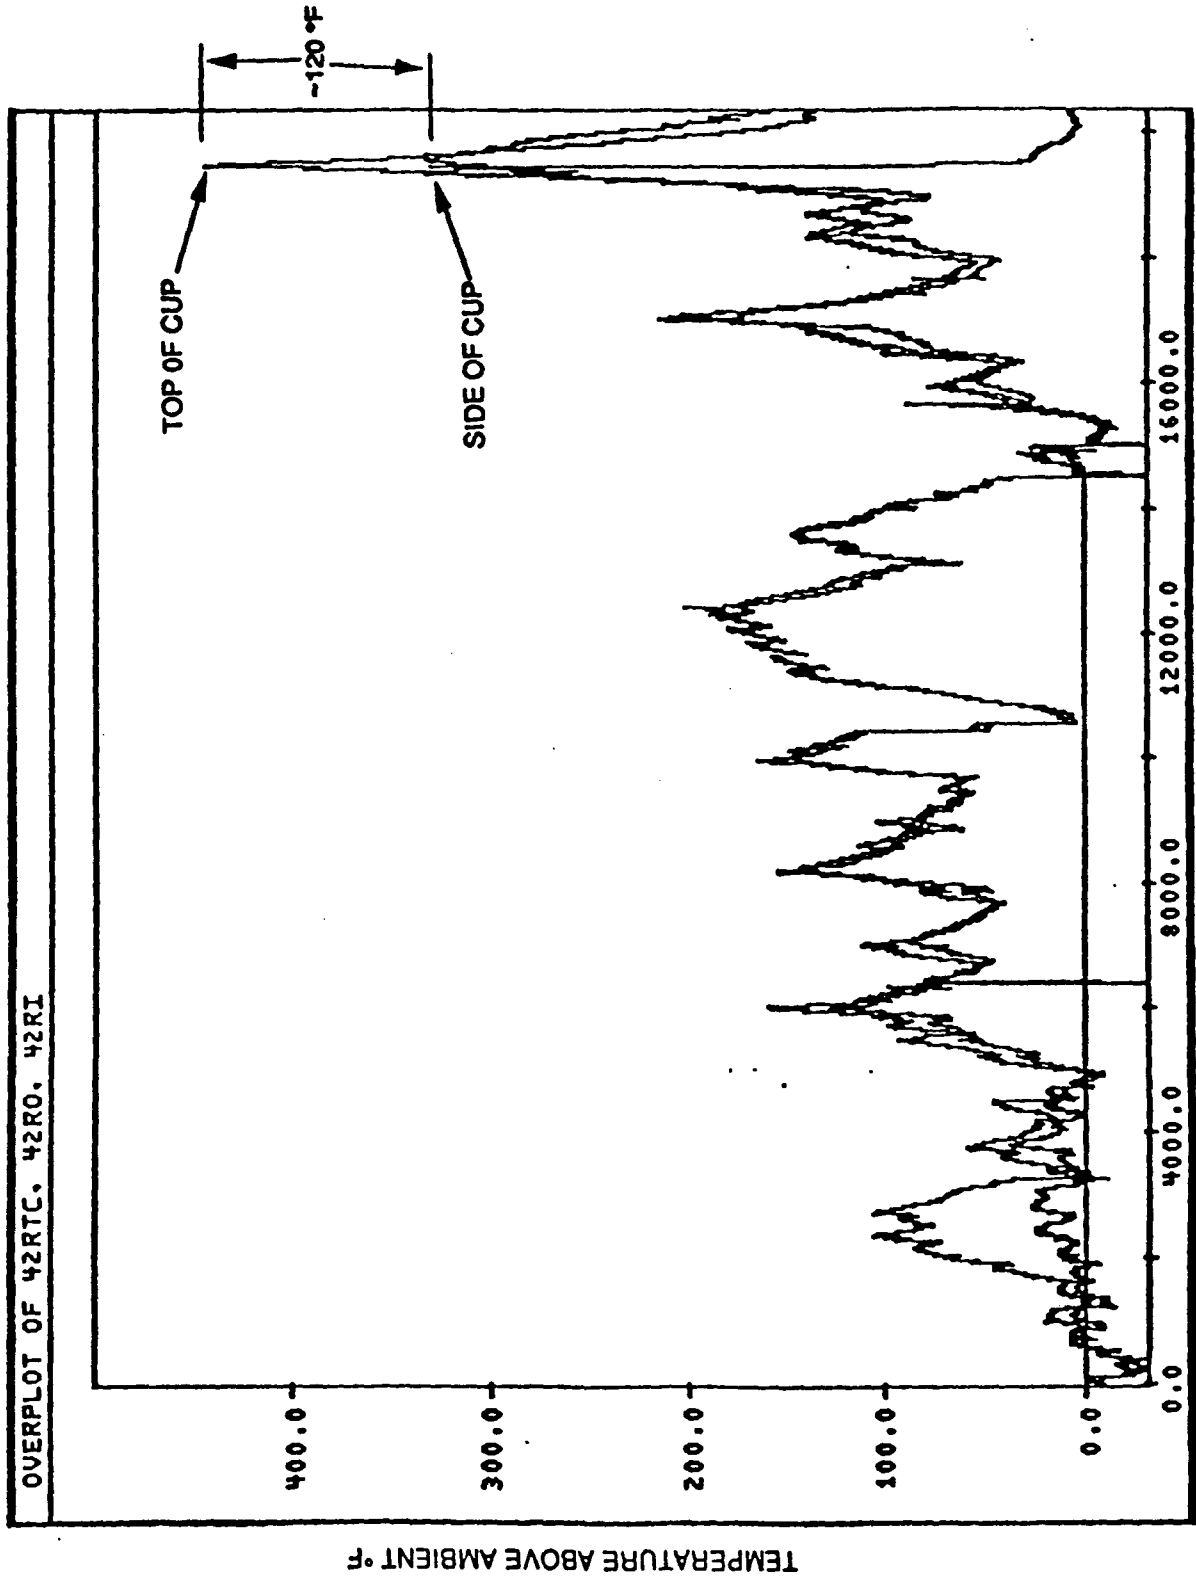
FIGURE 4-11

Plots of the temperature above ambient for bearing 42R are shown over the entire test in Figures 4-10 and 4-11 for the top of cup and outboard race respectively. On March 7th the consist ran for approximately forty minutes at 30 mph followed by 10 minutes of 40 mph running. The top of cup temperature reached just over 100°F above ambient on two successive laps. A total of 40 miles of testing was run.

OVER PLOT OF TOP OF CUP AND SIDE OF CUP DURING OVERHEATING

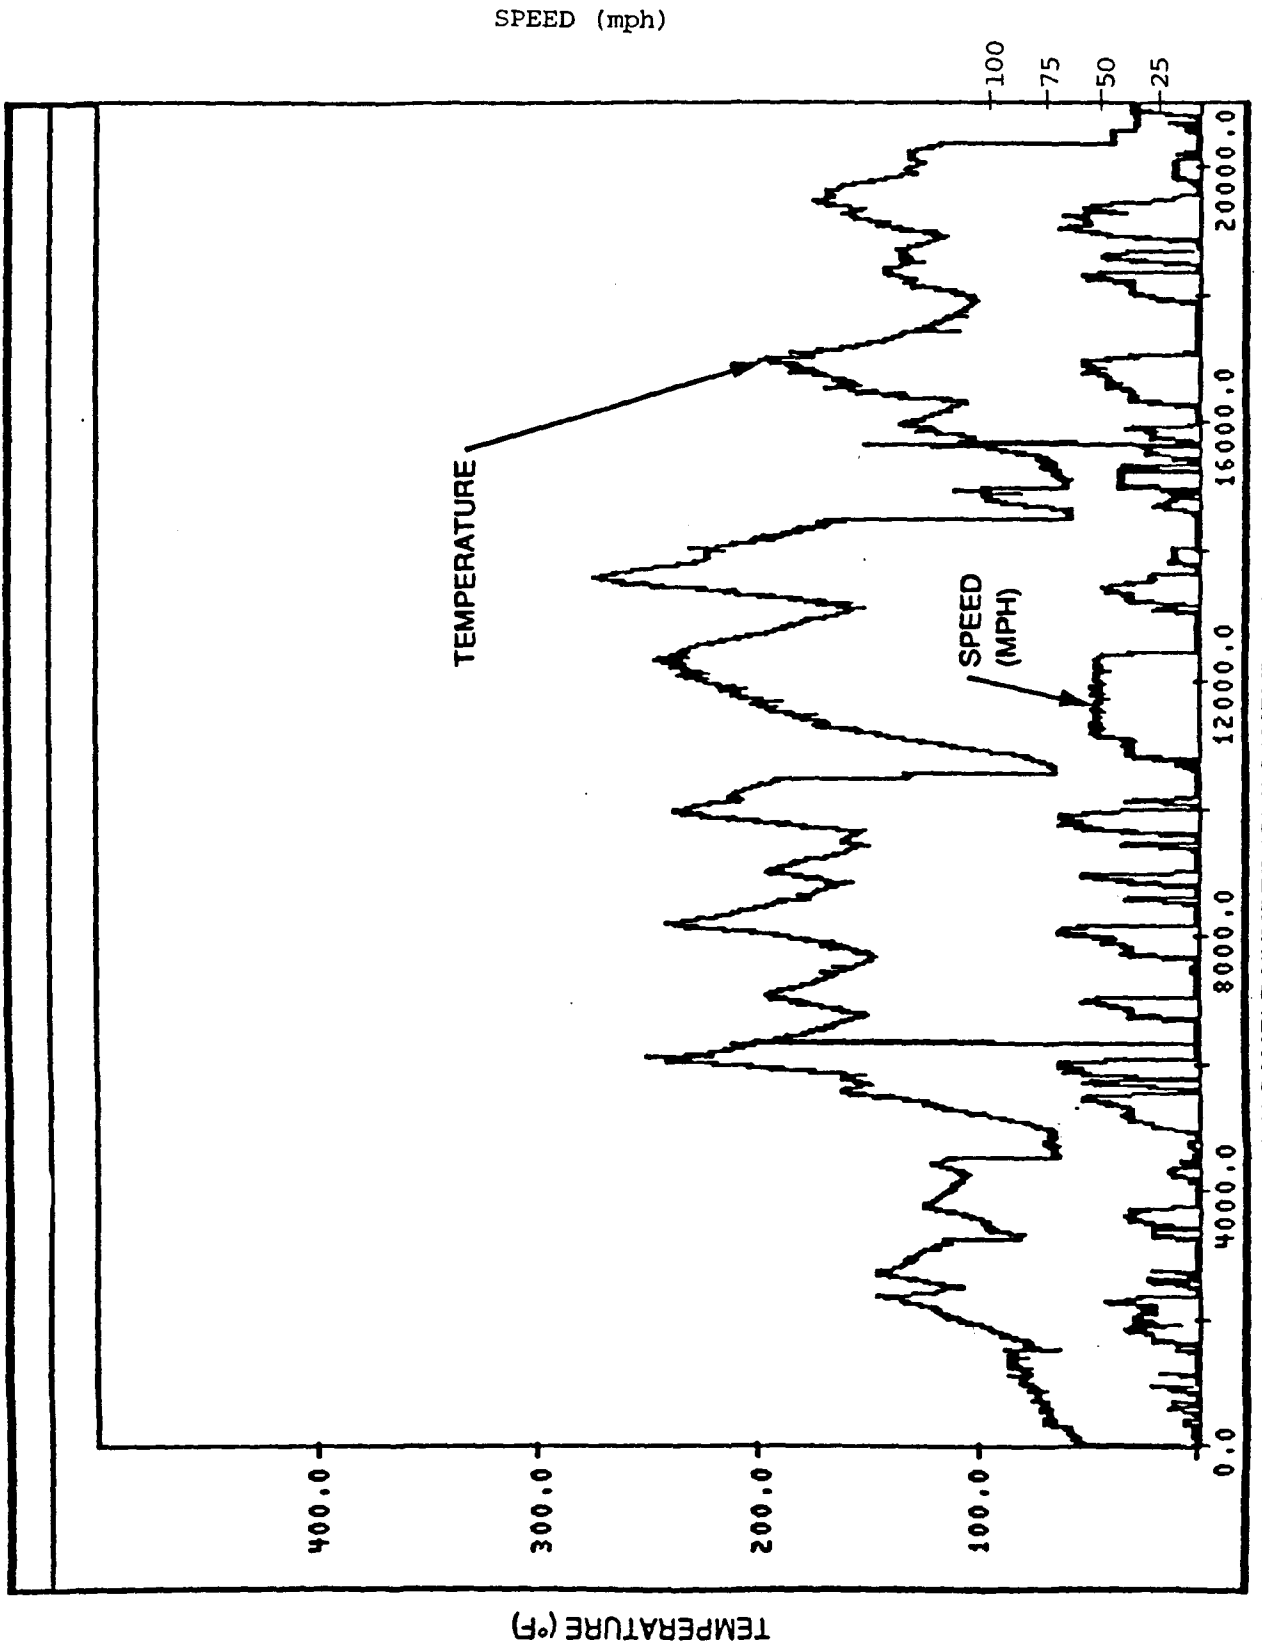
FIGURE 4-21

day the bearing reached nearly 280° F briefly during 50 mph operation. (See Figures 4-21, 4-22 and 4-23 for plots of the speed and temperature data for this bearing). The wheelset containing this bearing was removed from the test consist on March 15 to allow sustained high-speed running so that higher mileage could be accumulated on the other test bearings. The wheelset was held for future additional testing.

BEARING 41R OUTBOARD RACE TEMPERATURE VS TIME

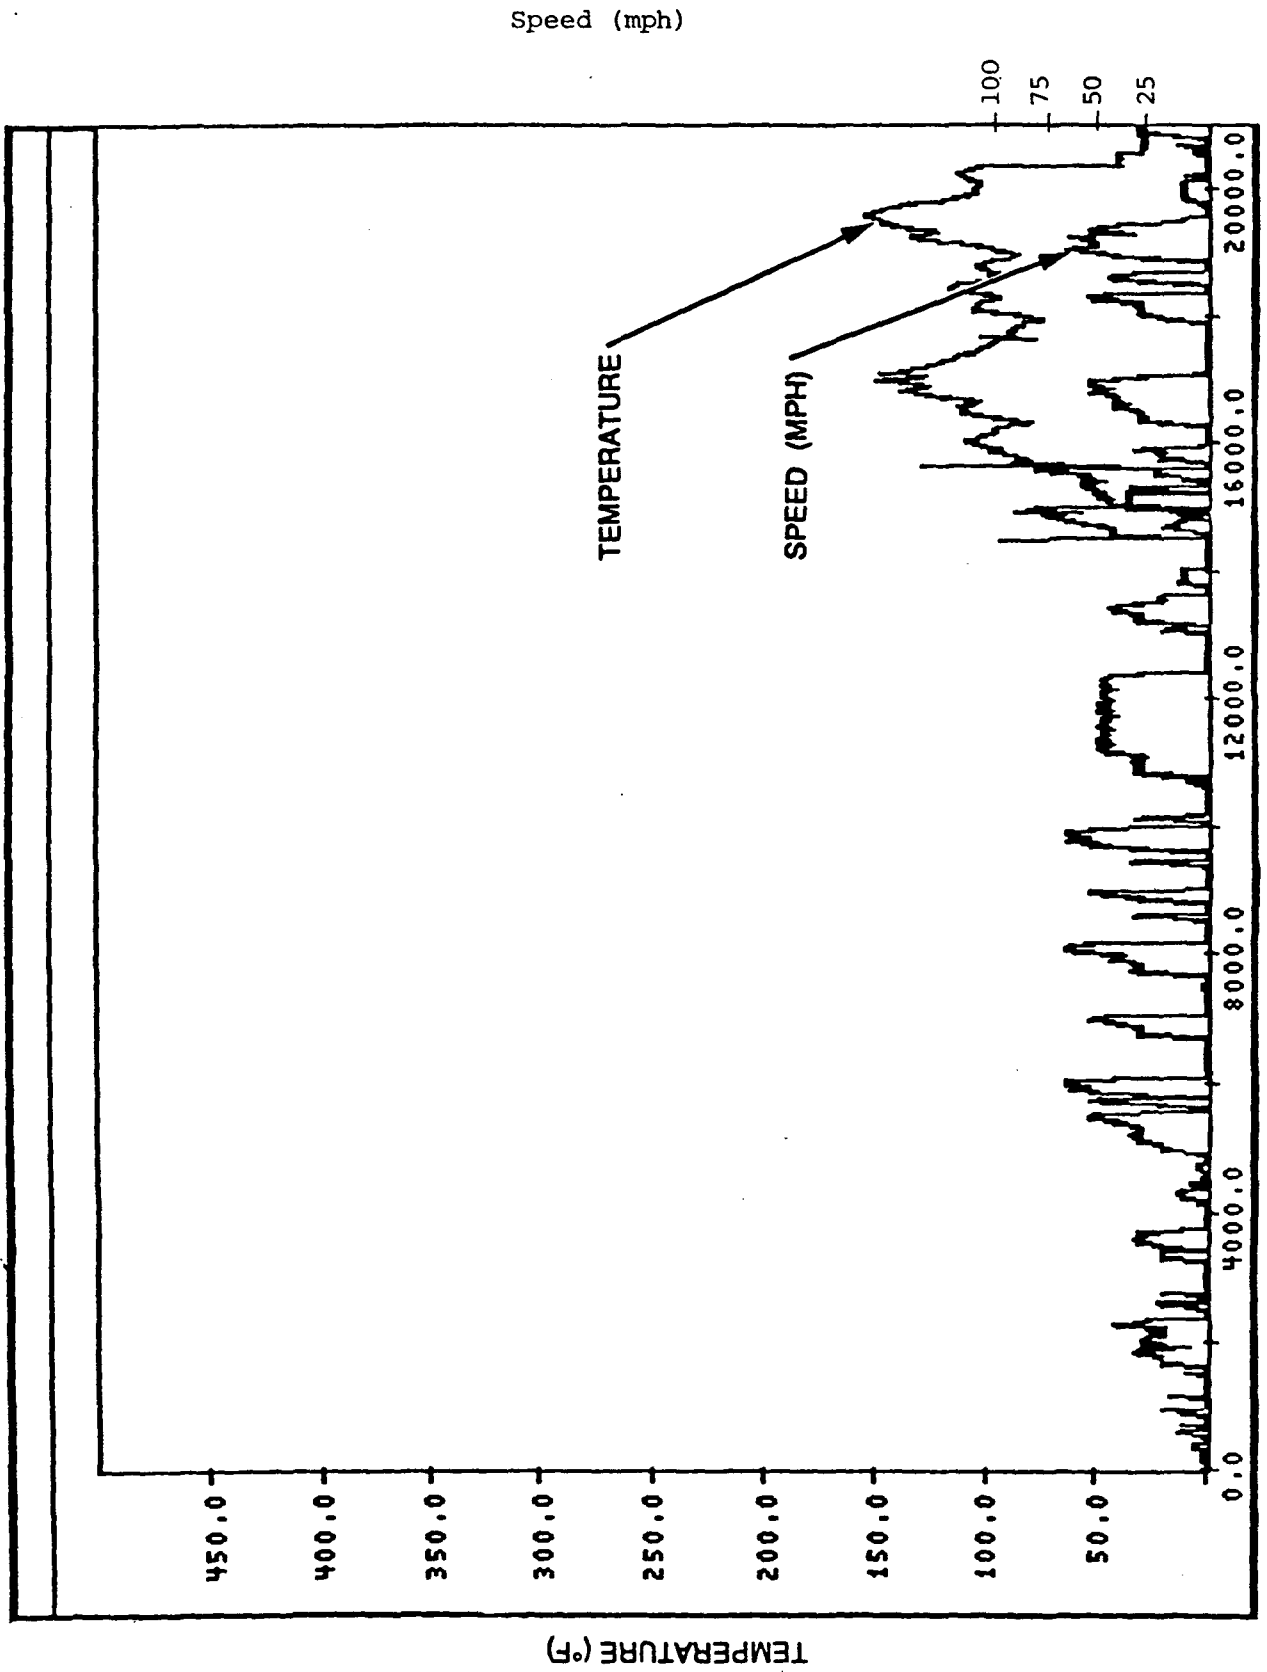
FIGURE 4-22

BEARING 41R INBOARD RACE TEMPERATURE VS TIME

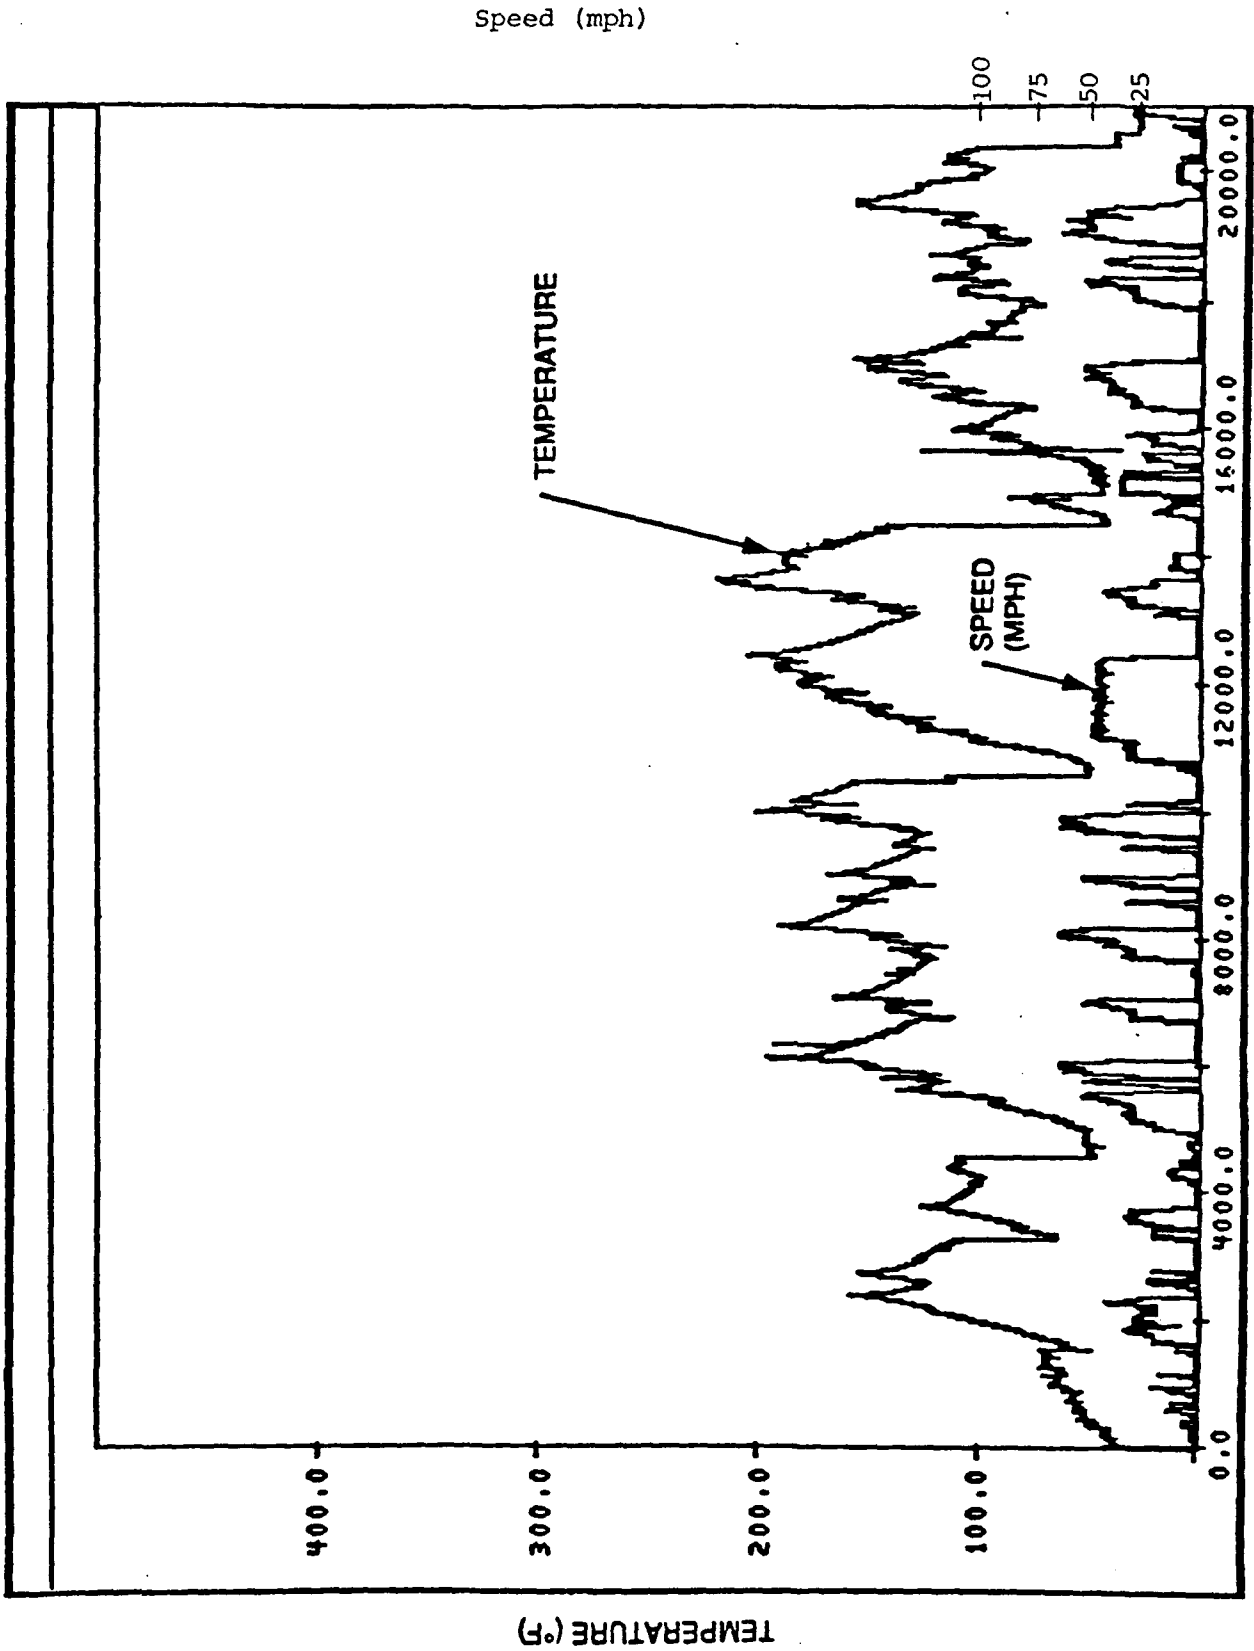
FIGURE 4-23

BEARING 41R TOP OF CUP TEMPERATURE VS TIME
