REPORT NO. UMTA-IN-06-0009-83-3

COLD WEATHER TRANSIT TECHNOLOGY PROGRAM

VOLUME 3 - INVESTIGATION OF THE HIGH INCIDENCE OF RAIL PULL APARTS ON CONTINUOUS WELDED RAIL

May 1983

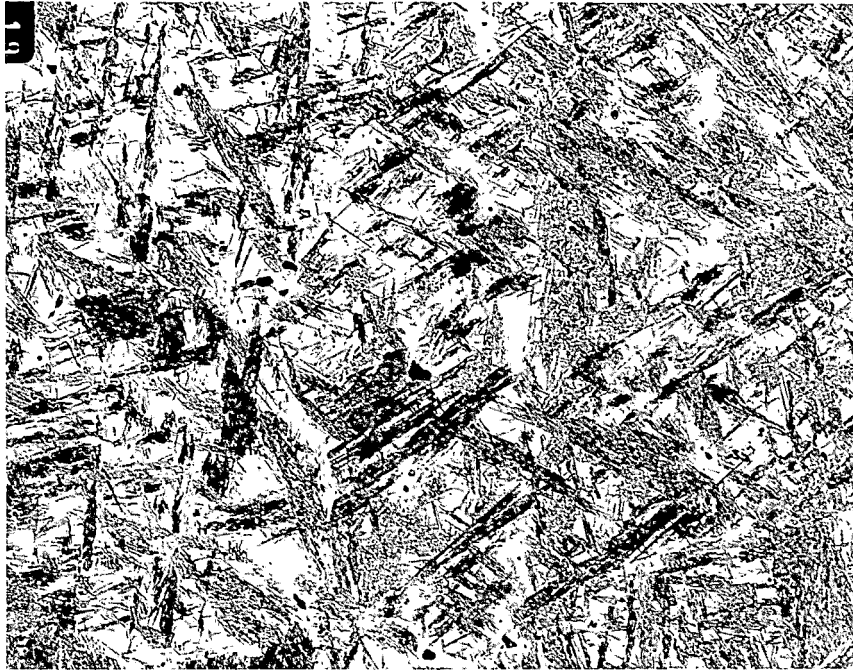
Figure 4.3.2-11 Photomicrograph - specimen #C-6 showing a hard (RC 43) weld containing banite and martensite. Nital Etch. (100x)
