# Tank Car Damage Assessment Procedure Study

William P. Wright

DOT/FRA/ORD-84/04

May 1984  
Final Report

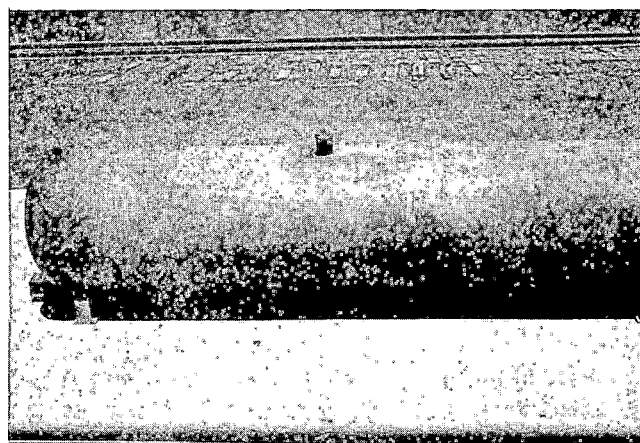
Figure 24: The 1/5 Scale Tank Car Model

A side view of the 1/5 scale model tank car and an end view are presented in Figures 24 and 25, respectively. The latter view shows the dent in the end which was photographed. The dented

ends of the model and the bulged section of the three plates were inspected by the magnetic particle (direct contact, coil, and electric magnet contour probe) and ultrasonic methods. The 10 MHz transducer was used to inspect the thin 1/5 scale tank (approximately 3 mm thick) and the 2.25 MHz transducer for the thicker sample plates (approximately 15 mm thick) for better resolution.

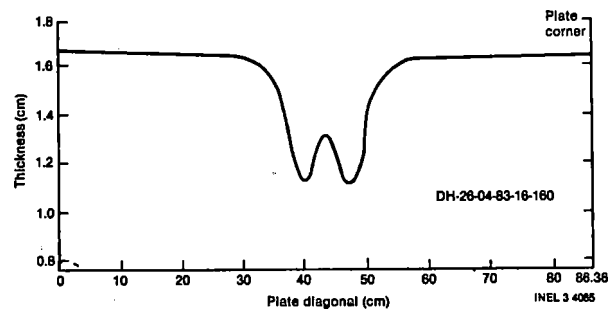
Figure 32: Typical Example of Thickness Versus Position for Flat Plate Specimens

The thicknesses of the specimens were measured using an ultrasonic thickness gauge. Figure 31 presents an example of the plots showing the depth and radius of curvature of the dents and Figure 32 presents a typical plot of thickness as a function of position across the dent. It was found that easily visually observed fractures and tears were located in the areas of greatest

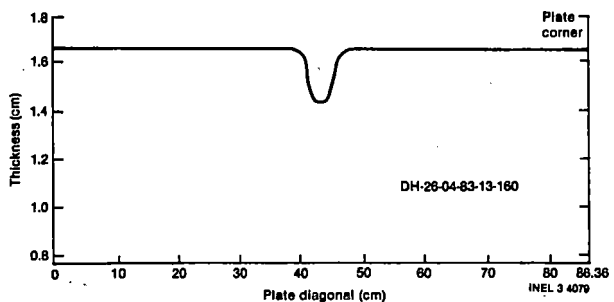
Figure 34: Thickness Plot Without Sufficient Deformation to Cause Severe Thinning

thinning. Section thinning as much as 32% was observed. Figure 33 presents an example of typical areas of severe thinning which consist of two lobes on the thickness plot the plate specimen. Figure 34 presents a case where the thinning level was not severe. Those areas of greatest thinning constitute the points where the residual strength are in question.

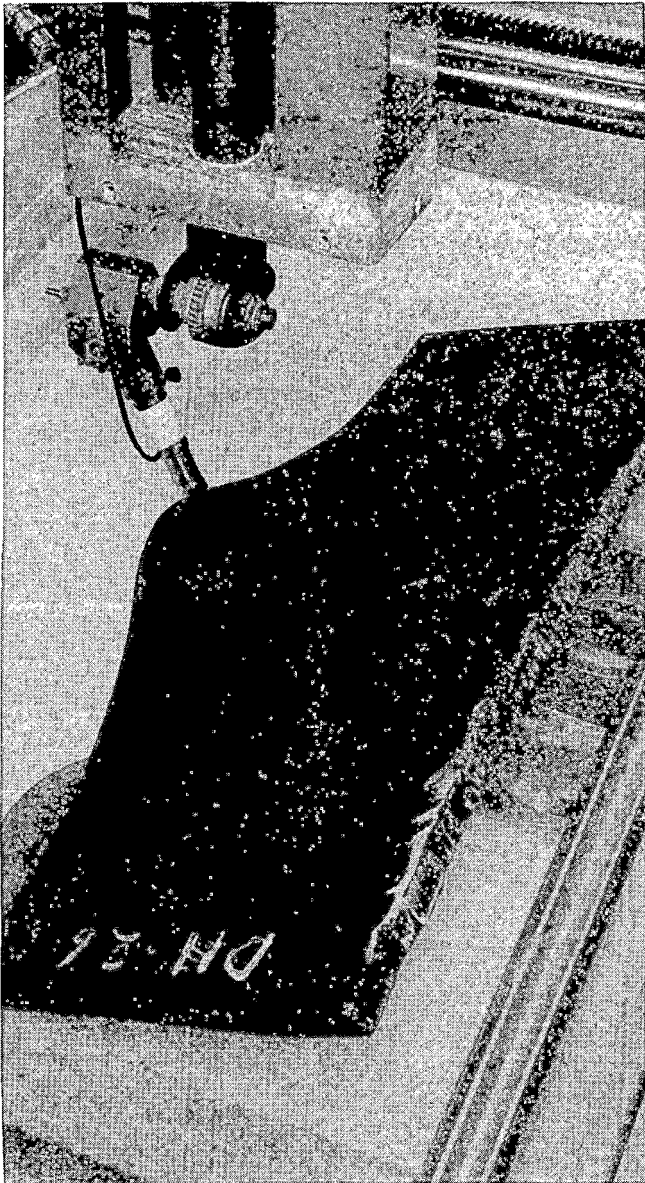
Figure 39: Ultrasonic Examination of Flat Plate Specimen

The plates were examined using a computer-controlled ultrasonic imaging system for immersed ultrasonic testing. A photograph of the system used is presented in Figure 39. The areas in which it was assumed that information on distressed metal were {1} areas near known cracks, {2} areas in otherwise "sound" metal, {3} areas having relatively stronger echo signals at high frequencies than at low frequencies, and {4} areas having the same orientation as known cracks (which indicate stress directions). These properties were postulated for areas which contain severely disturbed metallurgy and therefore metal which may be on the verge of outright rupture.

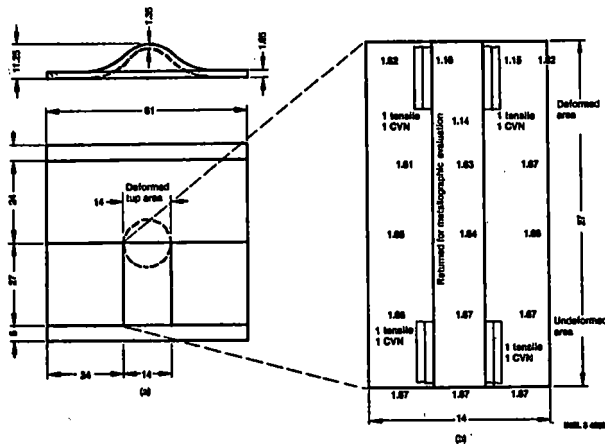
Figure 41: Thickness Measurements {mm} and Locations of Test Specimens Removed From Plate DH-26-04-83-160; a. General Schematic, b. Section Removed From Plate

Two plates were analyzed for estimating the fracture toughness of the undeformed and the deformed material. Figures 41 and 42 presents schematics of the two plates showing the thickness measurements and the location of test specimens. Time and material limitations prevented the development of valid Plane Strain Fracture Toughness  $\{K_{IC}\}$  measurements. Thus estimates were made using  $K_{IC}$  the True Stress-True Strain curve developed from tensile specimens and these are listed in Table 6. These tests were conducted at 294  $\{K_{70}\}$   $\{F\}$ .

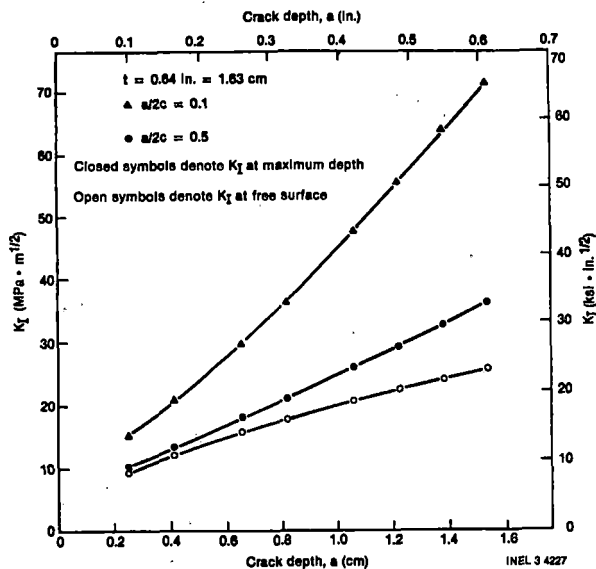
Figure 43: Applied Stress Intensity Factor and Crack Depth for Undamaged Tank Car

For undamaged tank cars, the estimate of  $K_{IC} = 110$  MPa \* m<sup>1/2</sup> {100 ksi \* in.<sup>1/2</sup>} in Table 6 for material at 274 °K {70 °F} was used to calculate the critical crack depth (i.e., that which would cause failure) if the 16.3 mm {0.64 in.} thick wall was exposed to a stress of 161 MPa {23.3 ksi}. The results of these calculations are shown in Figure 43 for two aspect ratios,  $a/2c = 0.1$  and  $a/2c = 0.5$ , where  $2c$  is crack length and "a" is the crack depth. The peak  $K_I$  values occur at maximum depth for  $a/2c = 0.1$  and at the free surface for  $a/2c = 0.5$ . Experimental evidence suggests that when  $K_I$  {at the free surface} =  $K_{IC}$ , crack initiation will frequently not occur due to the plane stress {as opposed to plain strain} condition at the free surface. Under plane stress conditions  $K_{critical}$  is greater than  $K_{IC}$ ; therefore, crack initiation occurs somewhere else around the perimeter of the crack. The curves represented by the solid triangles and the open circles in Figure 43 bound the conditions for failure. For analytical purposes, a conservative estimate was made that the failure conditions are governed by the plot for  $a/2c = 0.1$  in Figure 43. The calculated conditions for failure are given in Table 7.

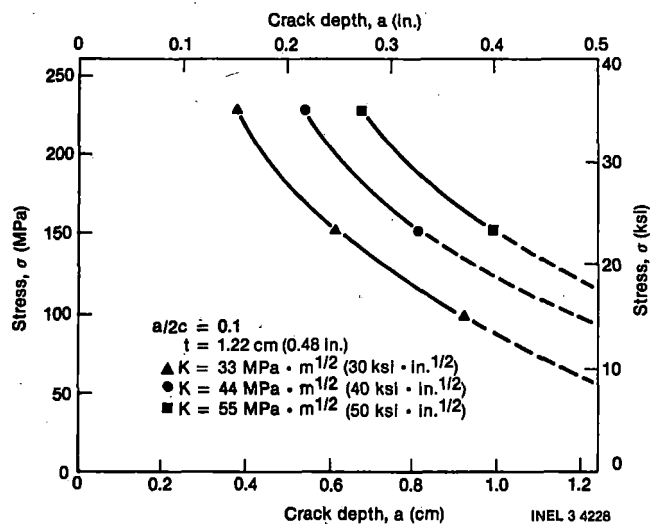
Figure 44: Applied Stress and Crack Depth With  $a/2c = 0.1$

For the damaged tank car, where the wall thickness has been reduced 25%, Table 6 shows the estimated value of  $K_{IC} = m^{1/2} \{40 \text{ ksi} * \text{in.}^{1/2}\}$ . Figure 44 shows a  $K_{IC}$  plot of critical stress versus crack depth for three values of  $K_{IC}$ . An example of how these plots may be used is as follows: {1} NDE revealed an estimated average crack length of 1.27 cm {0.5 in.} {disregarding the small defects} and a maximum crack length of 44.5 mm {1.75 in.} {not penetrating the wall thickness}. These measurements were obtained from plates 16 and 22 where 349.3 mm {13.75 in.} and 279 mm {11.0 in.} die diameters were used, respectively, with a 140 mm {5.5 in.} top, and {2}  $K_{IC} = 44 \text{ MPa} * m^{1/2} \{40 \text{ ksi} * \text{in.}^{1/2}\}$ . {3} Figure 44 shows for  $a/2c = 0.1$ , if  $a = 0.44 \text{ cm} \{0.175 \text{ in.}\}$ , then the critical stress is approximately 102 MPa {40 ksi}.

in conjunction with the data in Figure 44 to estimate the accuracy needed for measurements of  $K_{IC}$  and NDE measurements of crack depth. No discussion of weldments has been attempted in the study thus far, but these are potentially the most vulnerable areas from the viewpoint of a failure.

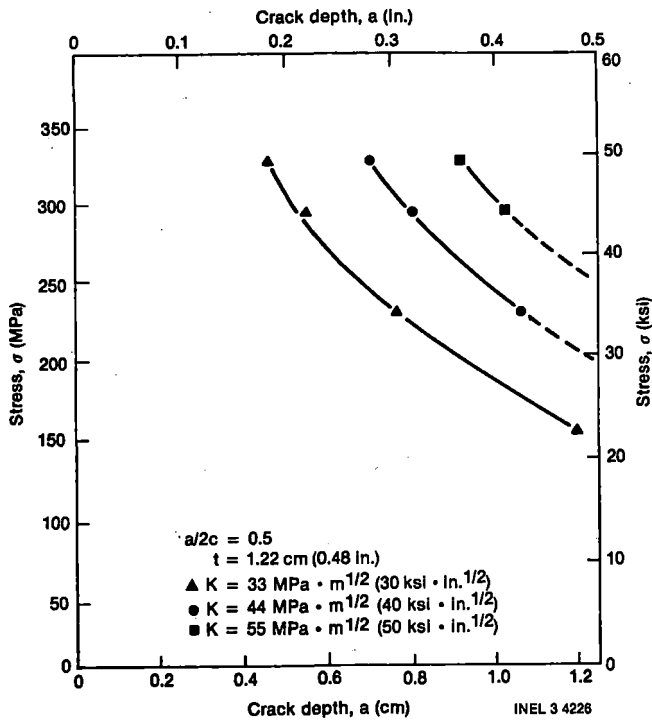
Figure 45: Applied Stress and Crack Depth With  $a/2c = 0.5$

A similar set of curves for  $a/2c = 0.5$ , presented in Figure 45, are used to make a comparison of the critical stresses shown in Table 7. For  $K_{IC} = 44 \text{ MPa} * m^{1/2} \{40 \text{ ksi} * \text{in.}^{1/2}\}$ : {1} If  $2c = 12.7 \text{ mm} \{0.5 \text{ in.}\}$  and  $a = 6.4 \text{ mm} \{0.25 \text{ in.}\}$ , then the critical stress is equal to 372 MPa {54 ksi} which appears to be less than the extrapolated value in Figure 44 for  $a/2c = 0.1$  for the same crack length. {2} If  $2c = 23.4 \text{ mm} \{0.92 \text{ in.}\}$  and  $a = 11.7 \text{ mm} \{0.46 \text{ in.}\}$ , then the critical stress is equal to 223 MPa {32.3 ksi}. For  $K_{IC} = 33 \text{ MPa} * m^{1/2} \{30 \text{ ksi} * \text{in.}^{1/2}\}$ : {1} If  $2c = 23.4 \text{ mm} \{0.92 \text{ in.}\}$  and  $a = 11.7 \text{ mm} \{0.46 \text{ in.}\}$ , then the critical stress is equal to 60.5 MPa {23.8 ksi}.
