**Federal Railroad
Administration**

Task Force Report Rail Failure Evaluation

May 1984

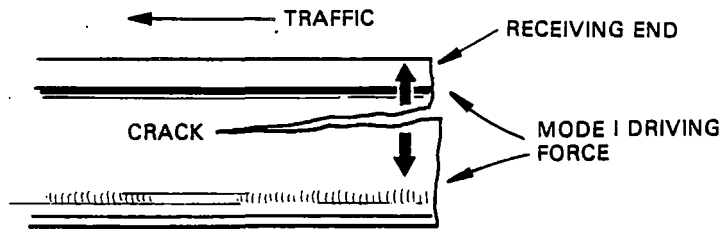
FIGURE 6. COMMON MODE I LOADING OF RAIL WEB

The fracture features observed in the first 8 feet of the subject rail are of the type commonly associated with Mode I (opening) crack propagation. Common Mode I behavior would require a driving force acting to separate the rail head from the base, as indicated schematically in Figure 6. Such loading might be possible via reactions between the rail end and the joint bars which secured the plug rail to the subject rail. On the other hand, wheel loads might be able to drive a web crack independent of the joint-bar reactions in either of the two ways suggested in Figure 7. Details of the interaction between driving force and crack propagation can only be obtained from further tests.

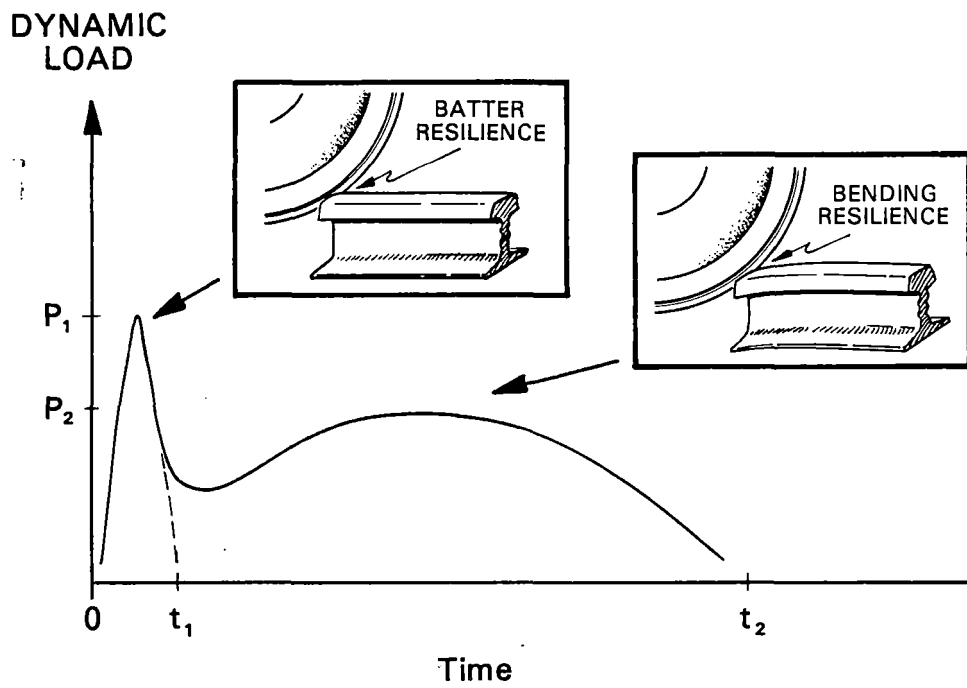
FIGURE 8. DIVISION OF DYNAMIC LOAD INTO SHORT AND DELAYED PEAKS

The vertical dynamic load resulting from the passage of the lead axle was assumed to consist of a short-time peak (P_1) and a delayed peak (P_2), as shown in Figure 8. The short-time peak is associated with battering of the rail-end corner by the upsprung mass of the lead-axle wheelset. The delayed peak is associated with rail bending (a more resilient deformation mode than corner batter). Consequently, P_1 is larger than P_2 , and the difference between the short and delayed peaks increases as the train speed increases. Also, the duration (t_2) of the delayed peak is about four to ten times the duration (t_1) of the short peak. To estimate the total load at either peak, one must add the static wheel load (which depends on vehicle weight) to the dynamic load.

The total load is estimated to be approximately twice the static wheel load when the train speed is 10 mph, and the short peak can be as much as ten times the static wheel load for a 70 mph train speed. Data obtained on normal service loads as a part of the

FRA/TSC track research program shows that loads of two to three times the static wheel load occur frequently, and in rare instances wheel flats may cause loads up to six times the static wheel load in high-speed (70 mph) service. Table 3 summarizes the results of the load calculations for a locomotive axle. Peak vertical impulsive load, including the static wheel load, is shown as a function of train speed and height mismatch. Table 4 shows estimated impulse loads and duration times for both the initial and delayed peaks for a fixed height mismatch.

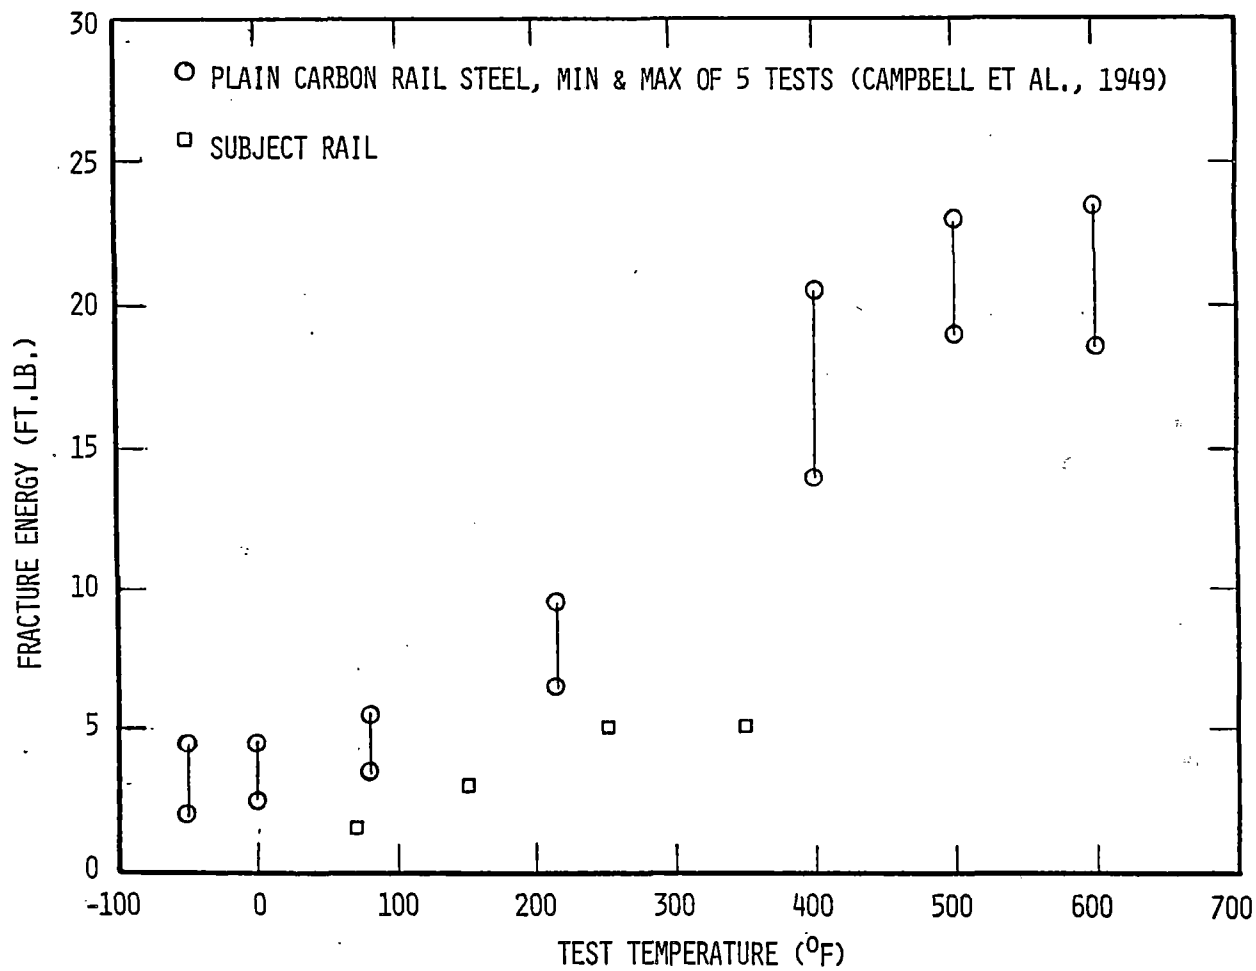
FIGURE B-8 COMPARISON OF CHARPY V-NOTCH TEST RESULTS

Charpy fracture energy is an approximate comparative indicator of fracture toughness for similar metals, e.g., the subject rail and other steels with similar carbon content. Figure B-8, comparing the UP data with independent results for plain carbon rail steel, suggests that the subject rail has less fracture toughness than plain carbon rail. An empirical formula for conversion of fracture energy to fracture toughness (Besuner, 1976) has been applied to the charpy data, with the result that the fracture toughness of the subject rail is estimated to be about 44 percent of the fracture toughness for plain carbon steel at 70°F.

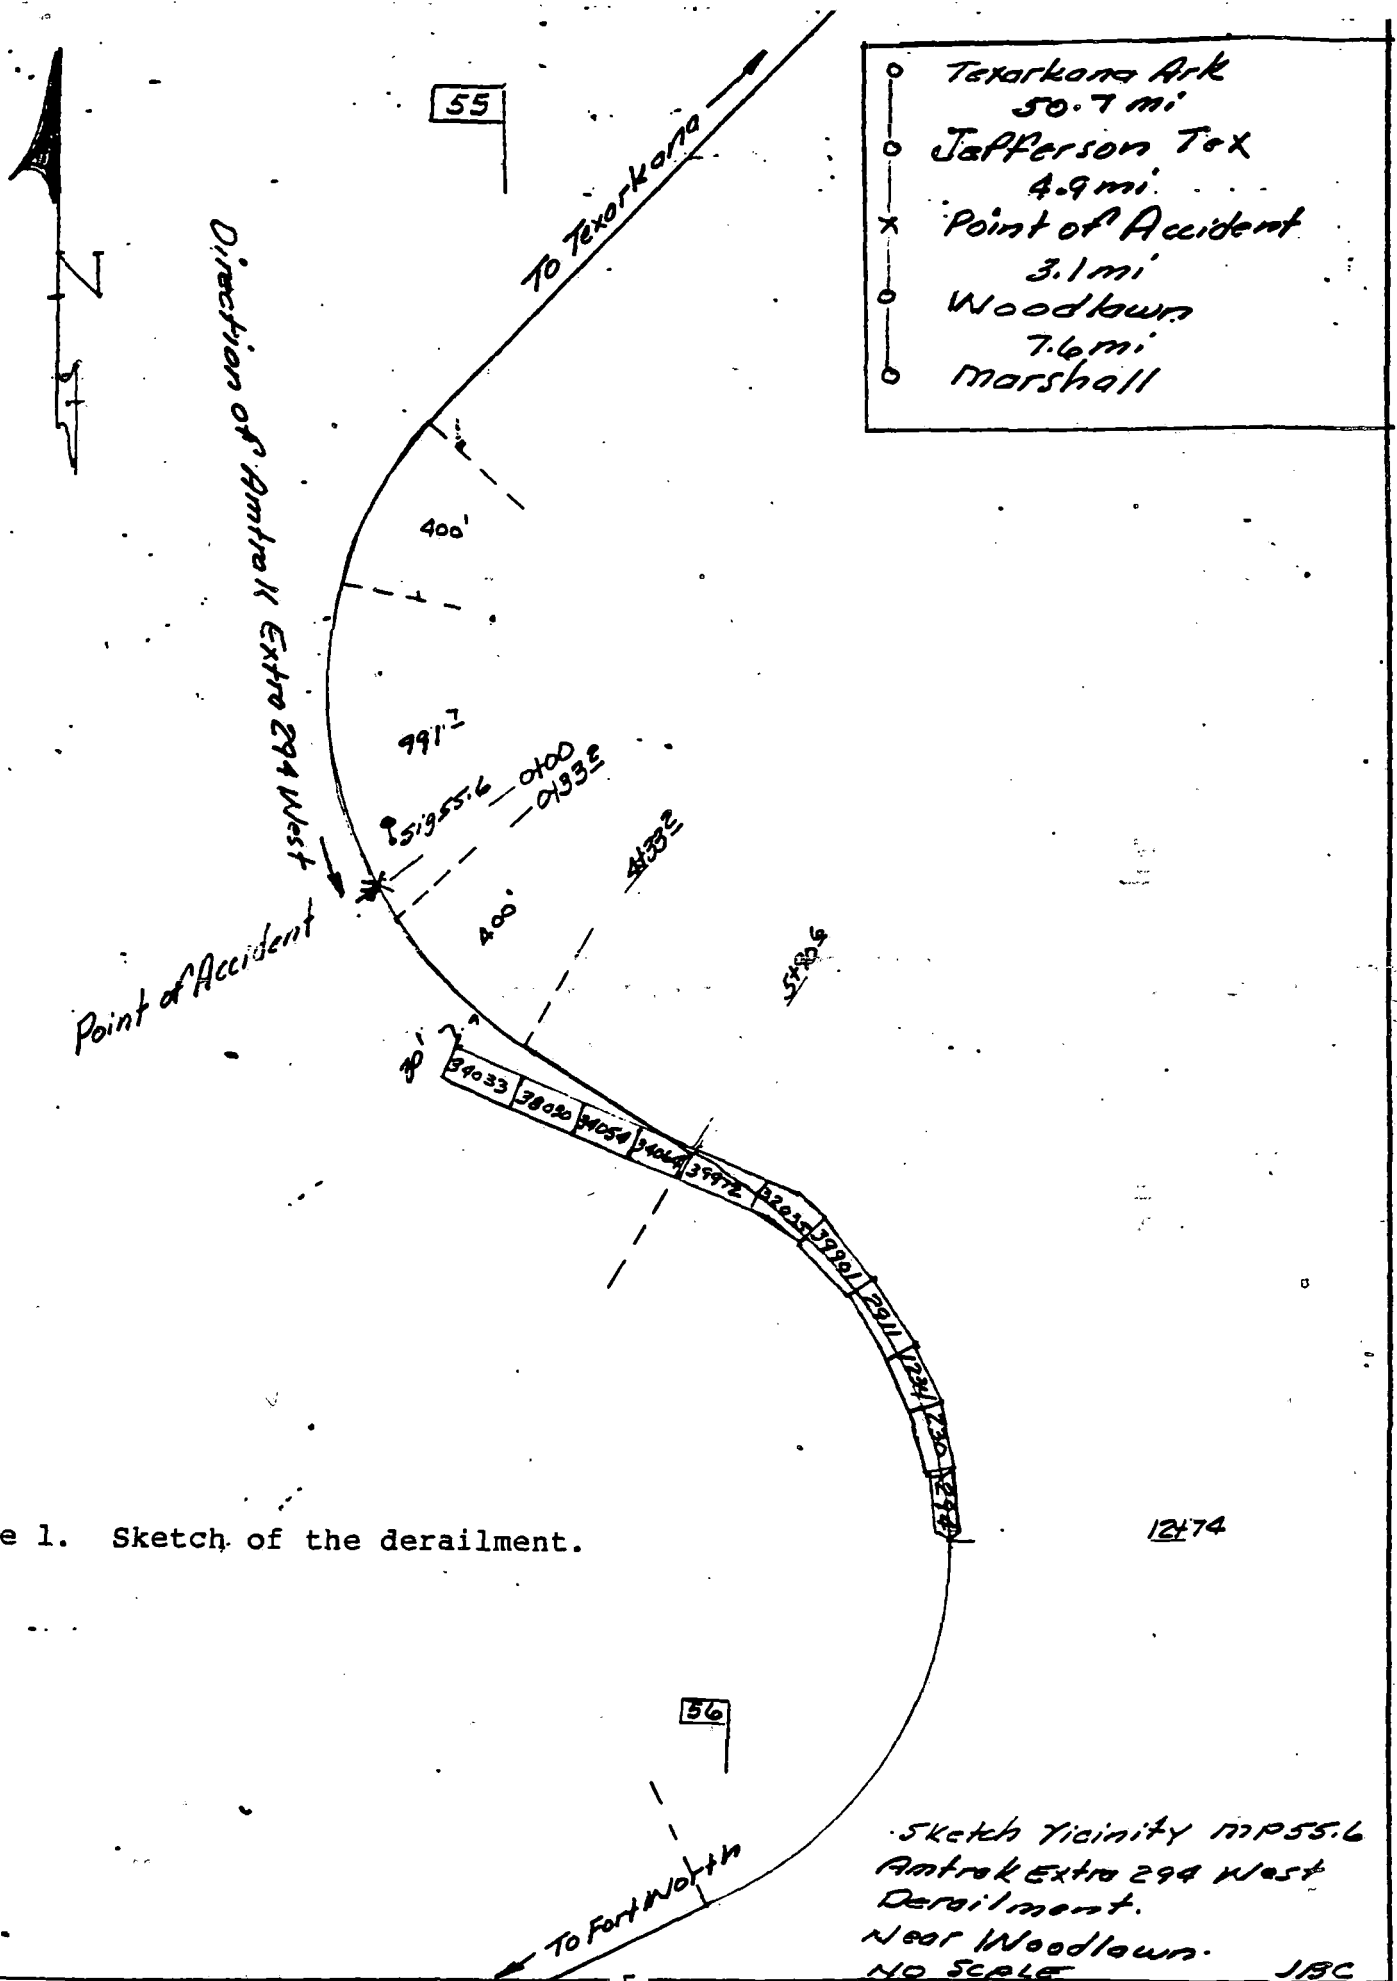
Figure 1. Sketch of the derailment.

At about 10:10 a.m., as Passenger Extra Amtrak 294 West was traveling at about 72 mph over the repaired track at milepost 55.6, the eight rear cars became derailed. The CWR adjoining the western end of the replacement rail shattered into small pieces under the train during the derailing action. When the leading locomotive stopped 1,274 feet west of the point of derailment, the two locomotives and the first car remained on the track, and the next four derailed cars remained essentially upright. The sixth car was derailed and was leaning approximately 40 degrees to the north. The seventh, eighth, and ninth cars were derailed and rested on their north sides, after they had slid on their sides along the ground north of the track. (See figure 1.)
