Equipment testing and analysis: glazing impact test

An evaluation of two plastic and glass window systems subjected to projectile impacts

DOT/FRA/ORD-87

March, 1988
Final Report

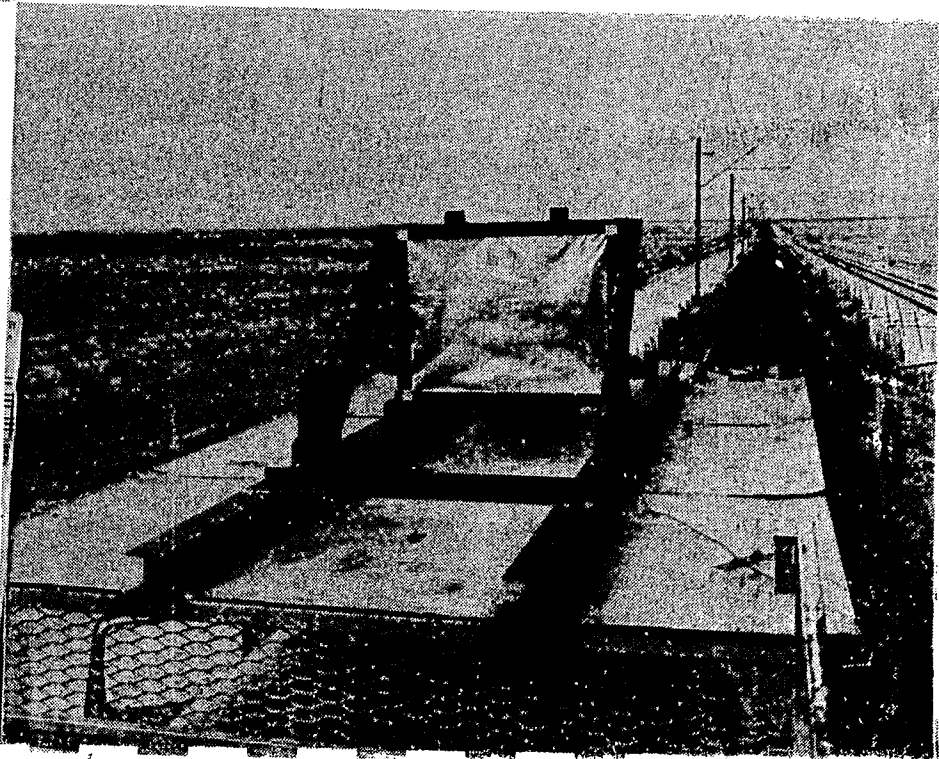
As the photographs show, the Acriveu SA glazing specimens received only localized abrasion or marring at the point of impact with the cinder blocks. No other damage was noted. The inner safety glazing from each test appeared untouched, and the aluminum witness plates were intact with no penetrations or dents visible. The Acriveu SA and Safety glazing system passed the Type II Large Object Impact test.

Figure A-4. Front view of Acriveu SA & Safety glazing system after the first 12 fps cinder block impact run.

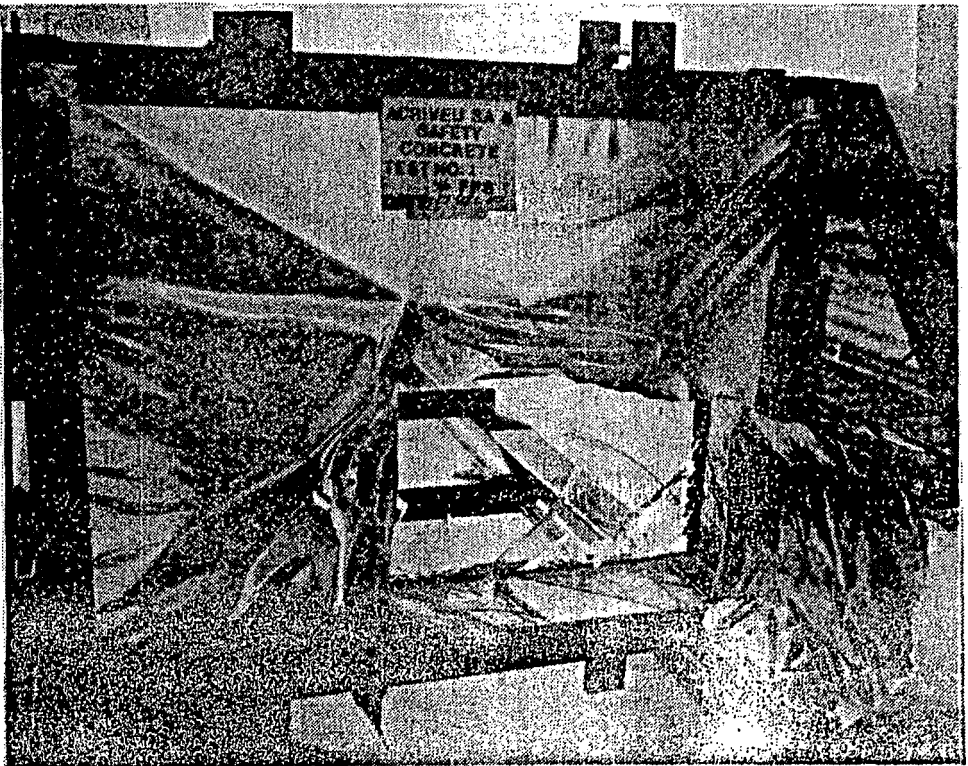
Results from the Type I Large Objects Impact test series (44 fps) on the Acriveu SA and Safety glazing system are presented in Figure A-12 through A-15. These photographs show complete failure in both tests, with each cinder block breaking and passing through the glazing system and witness plates. The plastic Acriveu SA material appears to have a brittle quality.

Figure A-12. Front view of Acriveu SA & Safety glazing system after the first 44 fps cinder block impact run.

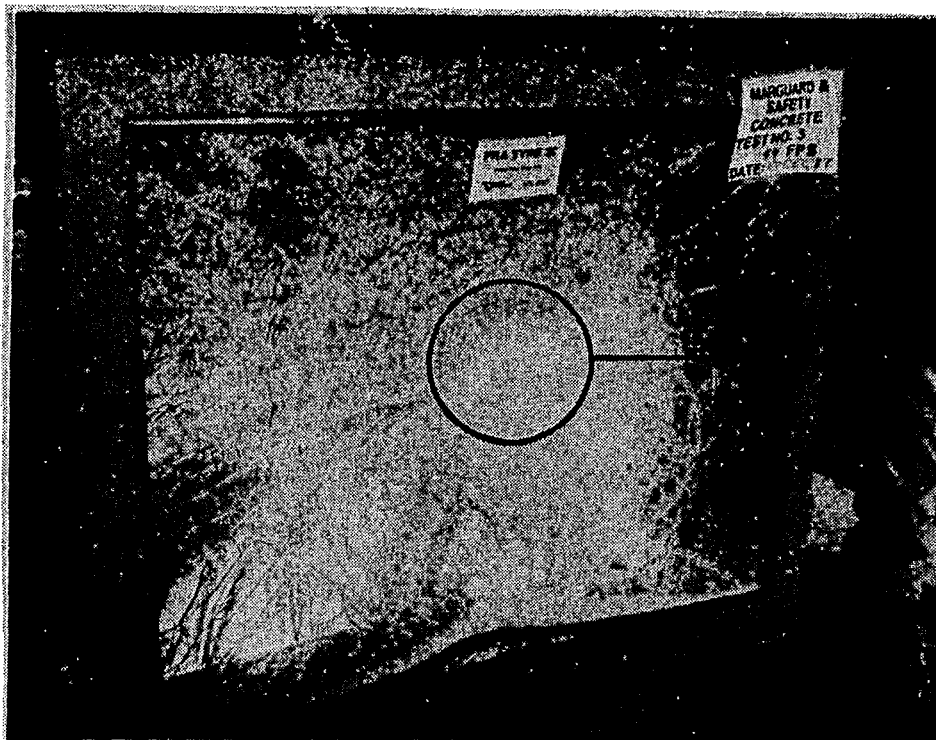
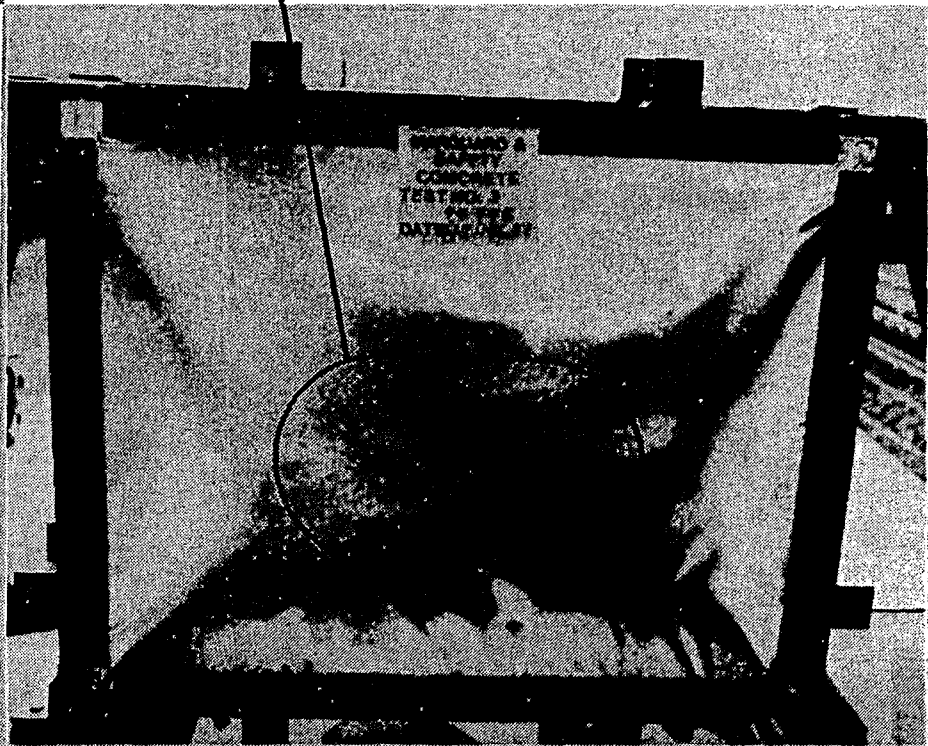
Results from the Type I Large Object Impact test series (44 fps) on Margard and Safety are presented in Figures A-16 through A-19. These photographs show that the cinder block deflected off the Margard material and did not break or crack it, while the rear mounted safety glass was totally cracked and crazed. In the first test, Figures A-16 and A-17, the Margard was somewhat pushed in and came out of the bottom of the mounting frame. The safety glass held together well, but 4 or 5 small punctures were noted in the witness plate, along with many small dents or dimples. In the second test, the Margard remained flat after the impact and stayed in the frame. The safety glass held together well and only 2 small penetrations were seen in the witness plate, along with several small dents. The plastic Margard material appears to have a pliant quality. However, the Margard and Safety glazing system failed the Type I Large Object Impact tests.

- Test Type: Type I Large Object Impact
(Test #1)
- Recorded Velocity: 31.1 mph (45.6 fps)
- Cinder Block Weight: 24 lbs

5 small penetrations, several dents.

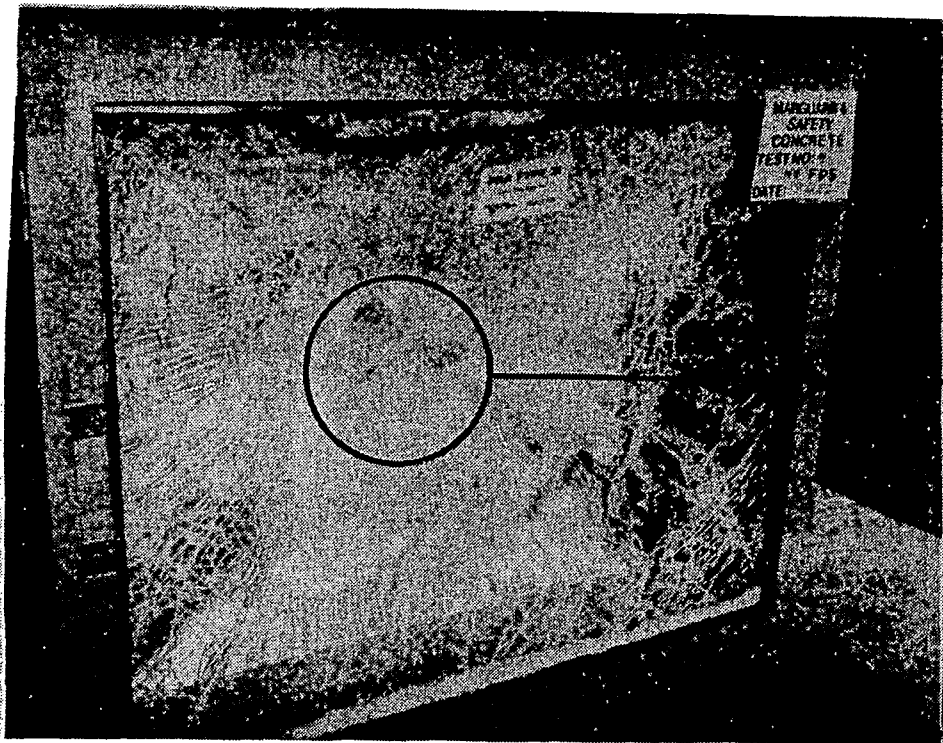
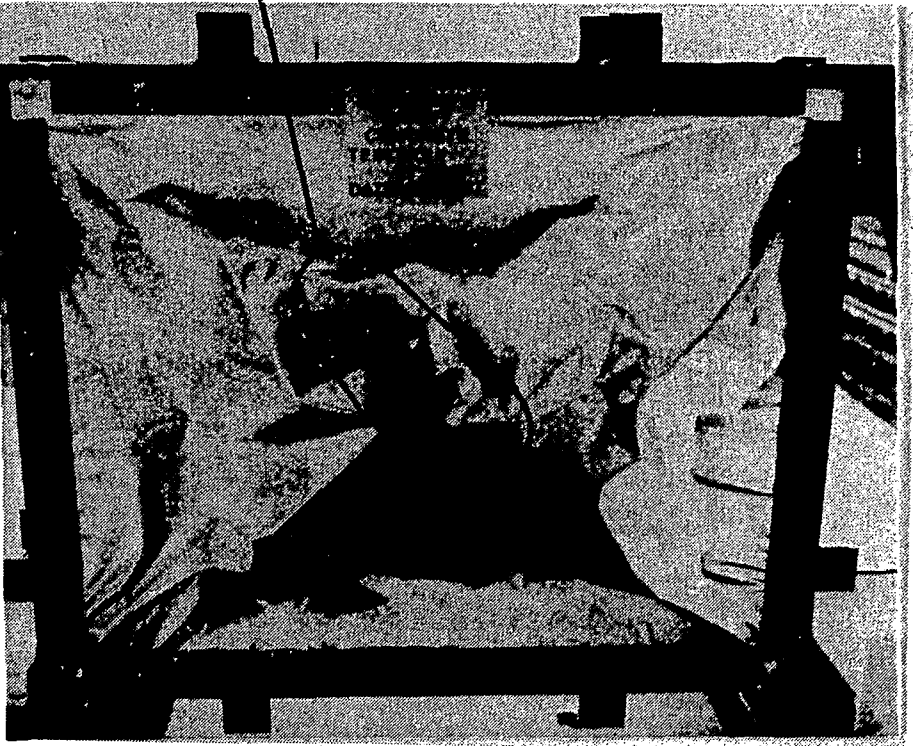
- Test Type: Type I Large Object Impact
(Test #2)
- Recorded Velocity: 31.7 mph (46.5 fps)
- Cinder Block Weight: 24 lbs

2 small penetrations, several dents

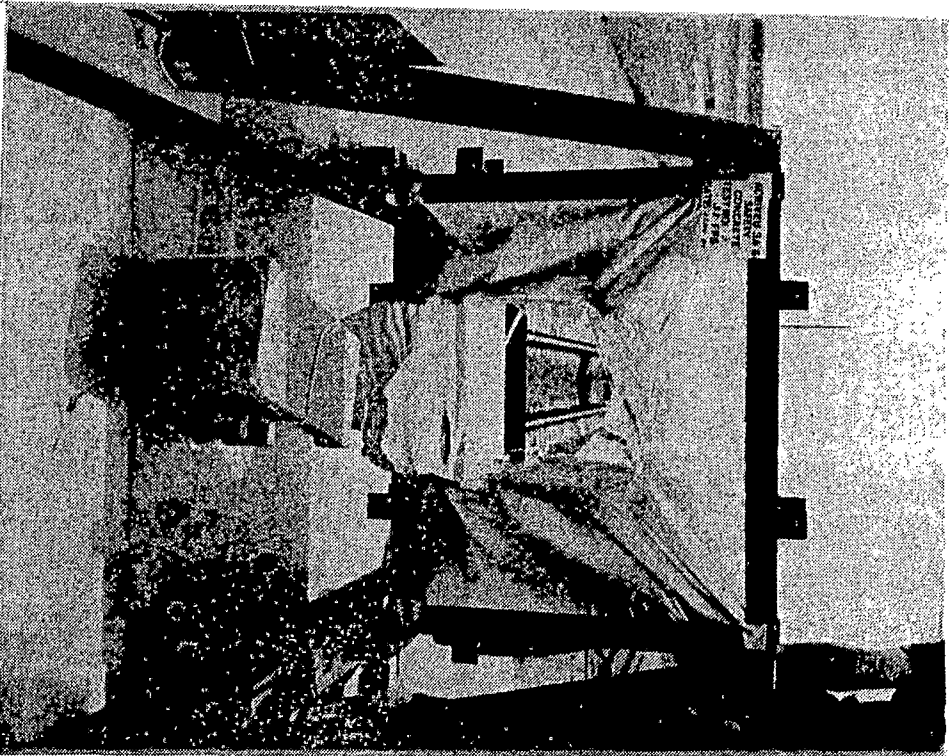
One additional Large Object (cinder block) Impact test was conducted on the Acriveu SA and Safety glazing system. This test was conducted in an attempt to find the threshold velocity at which this glazing system will fail and was not a part of the Appendix A test requirements. The impact speed was reduced from 44 fps (30 mph) in the Type I test to 37 fps (25 mph). Photographs from this test are presented in Figures A-20 and A-21. As can be seen from these pictures, the cinder block broke through the glazing specimens and the witness plate. The block appeared to break through the glazing with more difficulty than at 44 fps. It was estimated that the Acriveu SA and Safety glazing system would have survived a 29 fps (20 mph) impact.

- Test Type: Impact-to-Fail (one test only)
- Recorded Velocity: 25.1 mph (36.8 fps)
- Cinder Block Weight: 24 lbs

Figure A-20. Front view of Acriveu SA & Safety glazing system after the "impact-to-fail" cinder block impact run.

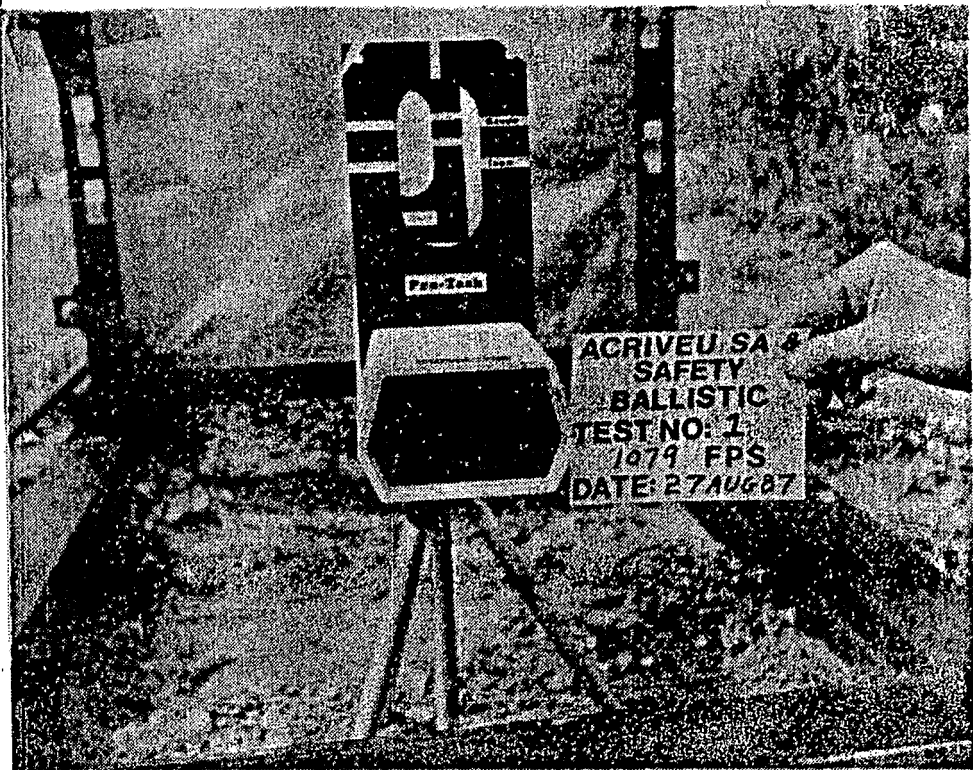
The two photographs taken after the first ballistic impact (Figures A-29 and A-30) clearly show the impact area at the center of the glazing specimen, and the localized, dimpled pattern on the witness plate. The bullet passed through the plastic material and impinged onto the safety glass. Some fragments of the safety glass (approximately 6) passed through the witness plate, while others only created bumps or a dimpled effect. The cracks or crazing which are evident in the glazing material occurred primarily in the safety glass. The Acriveu SA and Safety glazing system failed the first of three ballistic impact tests.

Figure A-29. Front view of the Acriveu SA & Safety glazing system after the first bullet impact.

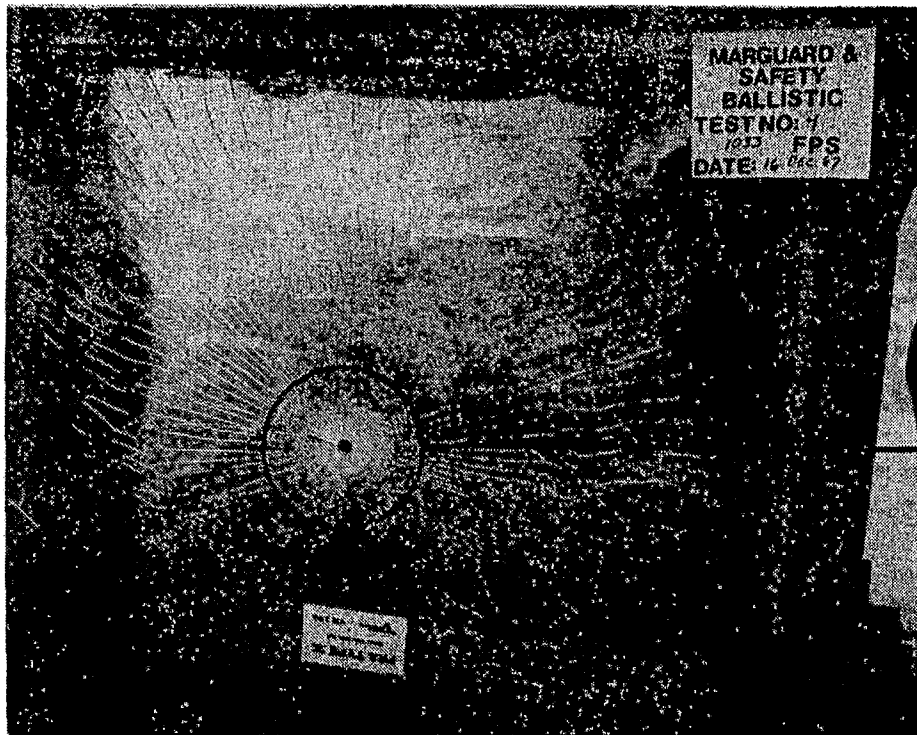
Results from the Types I and II Ballistic Impact test series are presented in Figures A-35 through A-40. In all three tests, the bullet penetrated the plastic Margard material and impinged on the Safety glass. The cracked or crazing pattern in the Safety glass was similar in the three tests, and small penetrations were seen in each of the witness plates (between 3 and 6 were counted in each test). Several dents were also visible in each witness plate as can be seen in the photographs.

Figure A-35. Front view of a Margard & Safety glazing system after the first ballistic impact test.

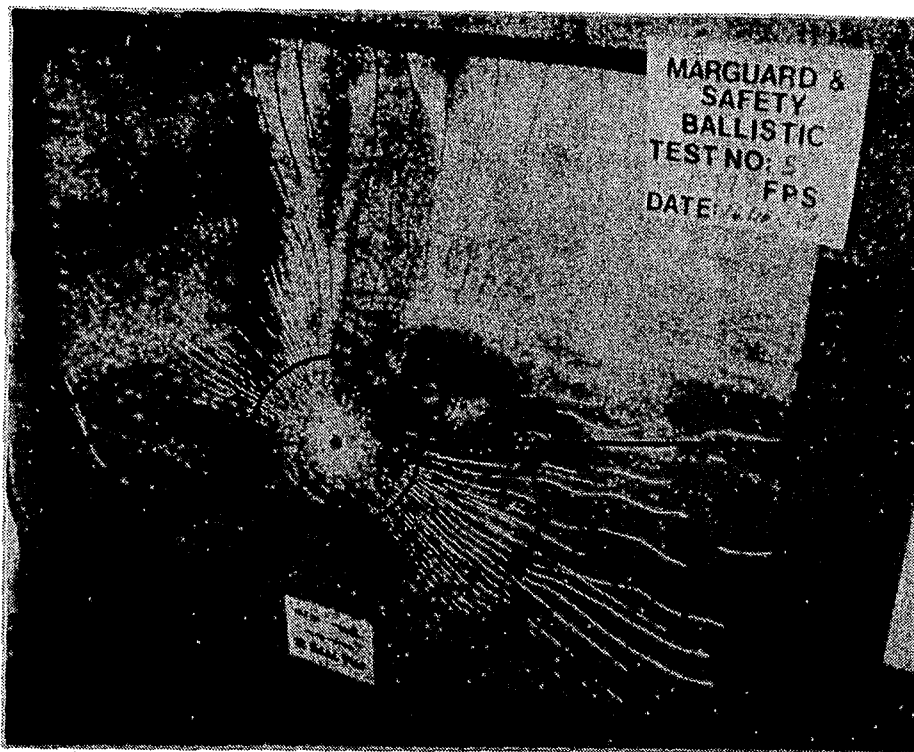
- Test Type: Types I & II Ballistic Impact (Test #2)
- Indicated Velocity: 1037 fps
- Muzzle to target Distance: 78.5 feet

Few small penetrations,
several dents.

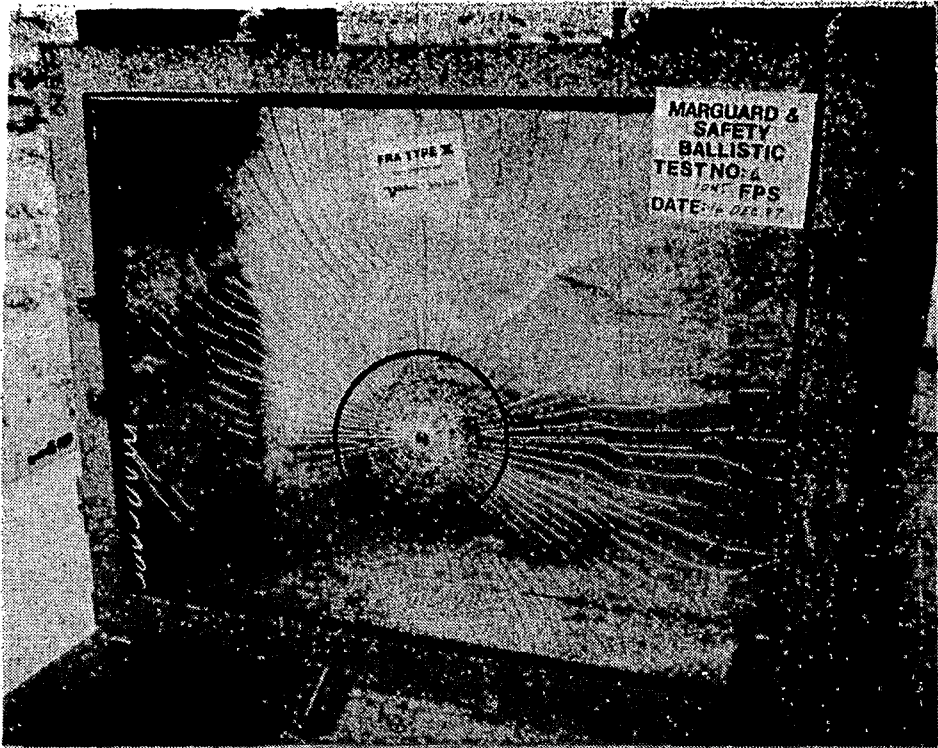
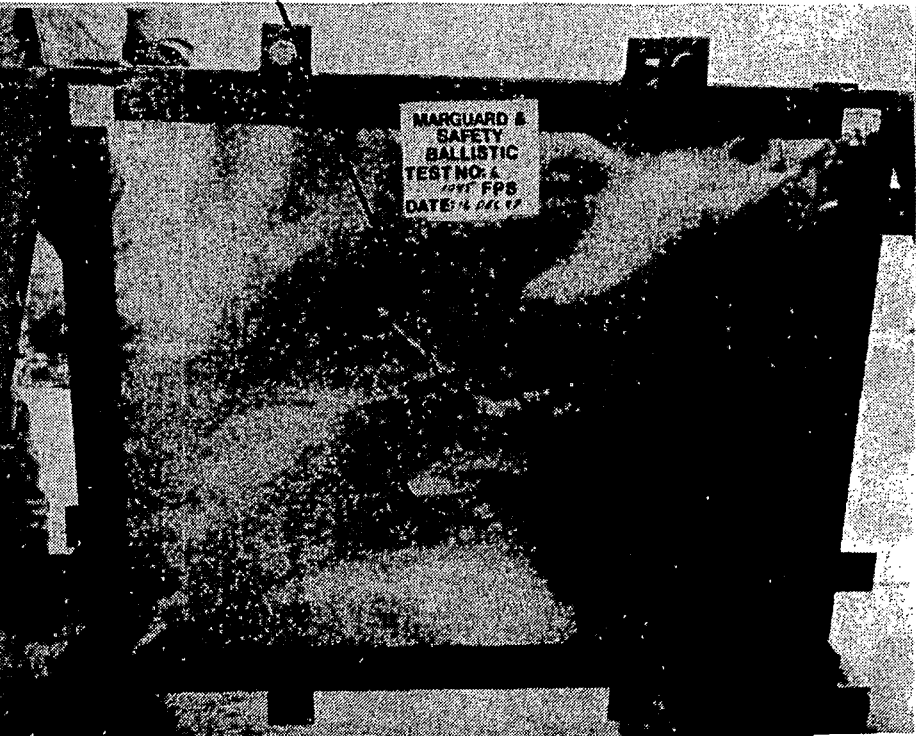
- Test Type: Types I & II Ballistic Impact (Test #3)
- Indicated Velocity: 1045 fps
- Muzzle to Target Distance: 78.5 feet

Two small penetrations,
several dents.

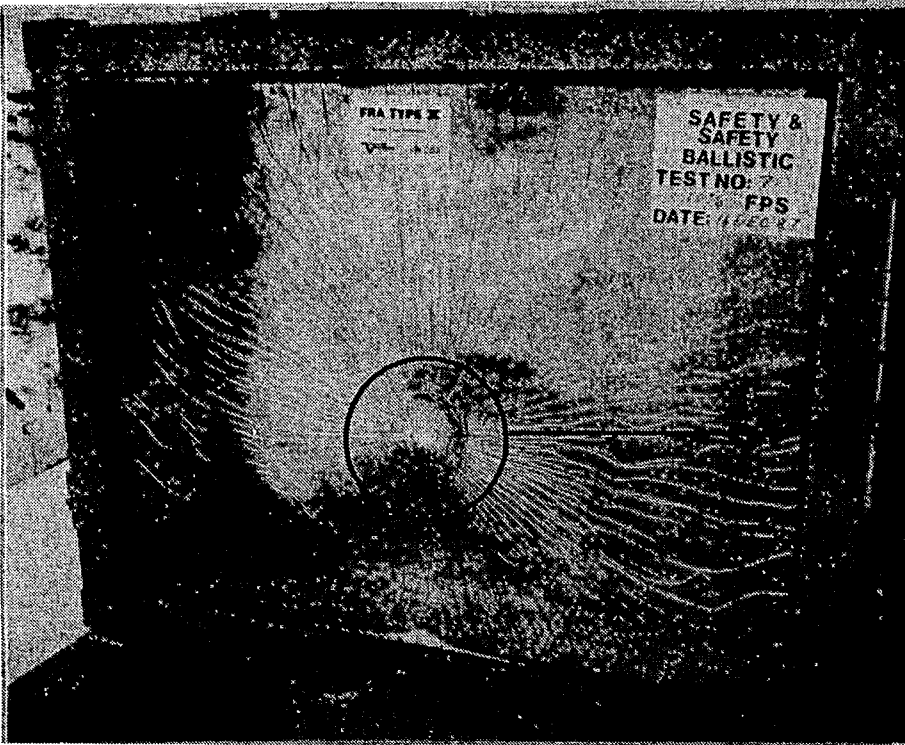
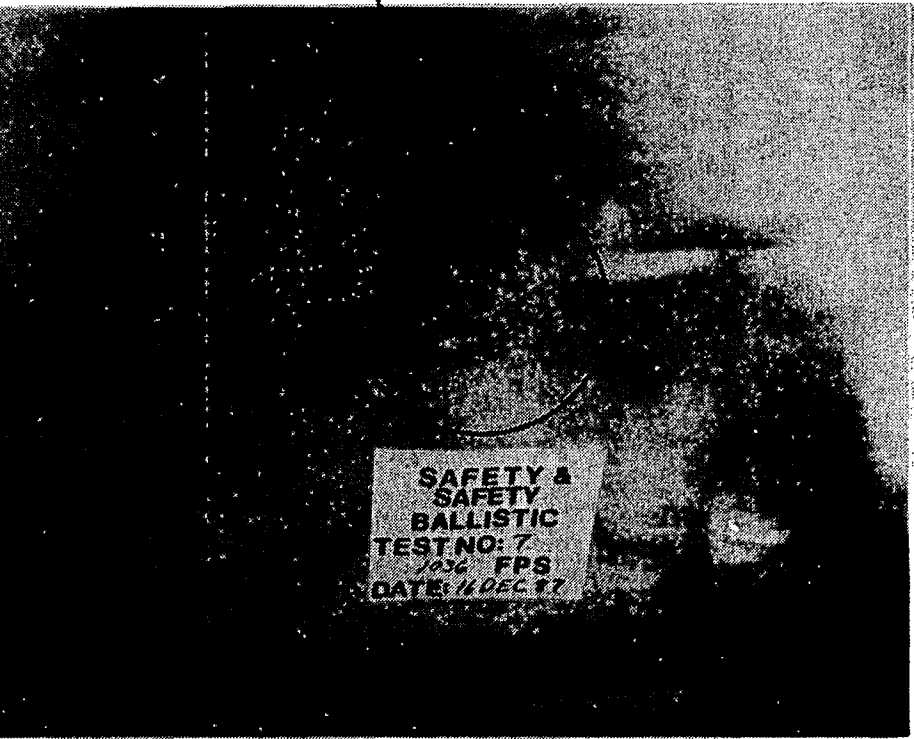
- Test Type: Types I & II Ballistic impact (single test)
- Indicated Velocity: 1036 fps
- Muzzle to Target distance: 78.5 feet

Cluster of dents, no penetrations.

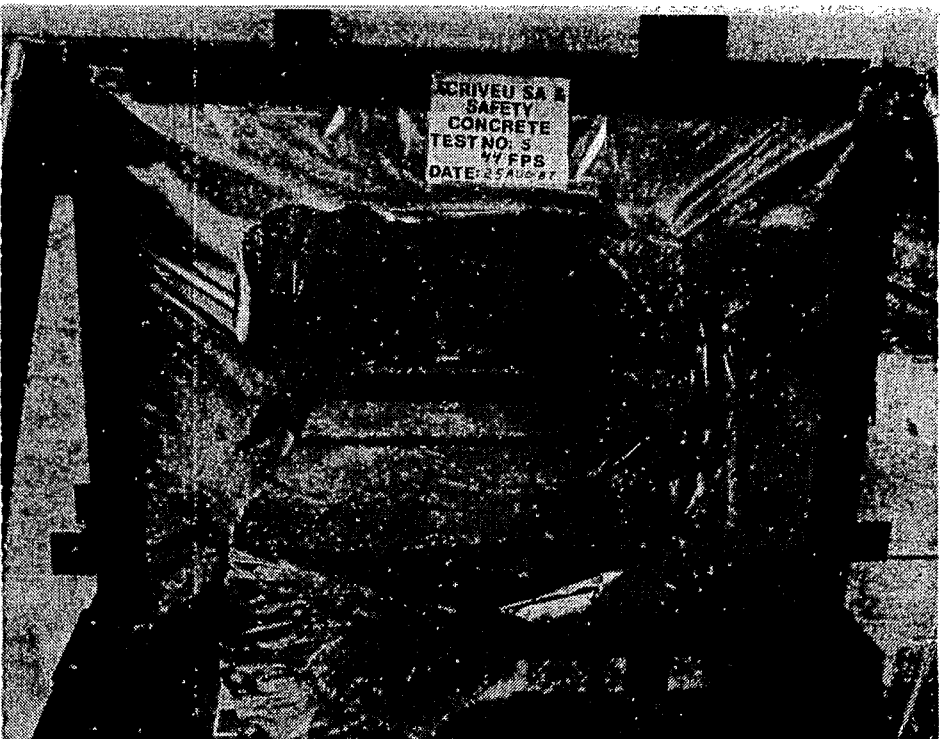
A full "Appendix A" test series of Acriveu SA/Safety and Margard/Safety glazing systems was conducted initially with the Safety glazing installed backwards. This was done mistakenly, without the knowledge that the safety glass is designed to face an impact from one designated side only. The manufacturer of the safety glass claims that installing the glazing backwards will cause it to spall and splinter much more easily when subjected to an impact. This in fact, seems to be the case.

Figure C-1. Front view of an Acriveu SA & Safety glazing system, Safety Glass installed backwards, after the first 44 fps cinder block impact run.

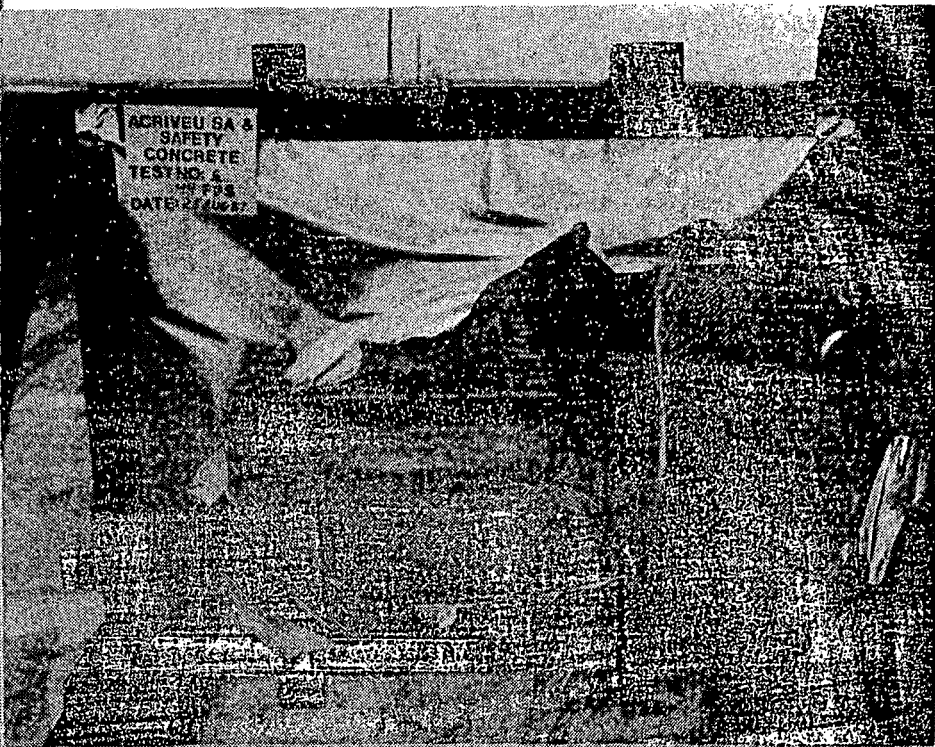
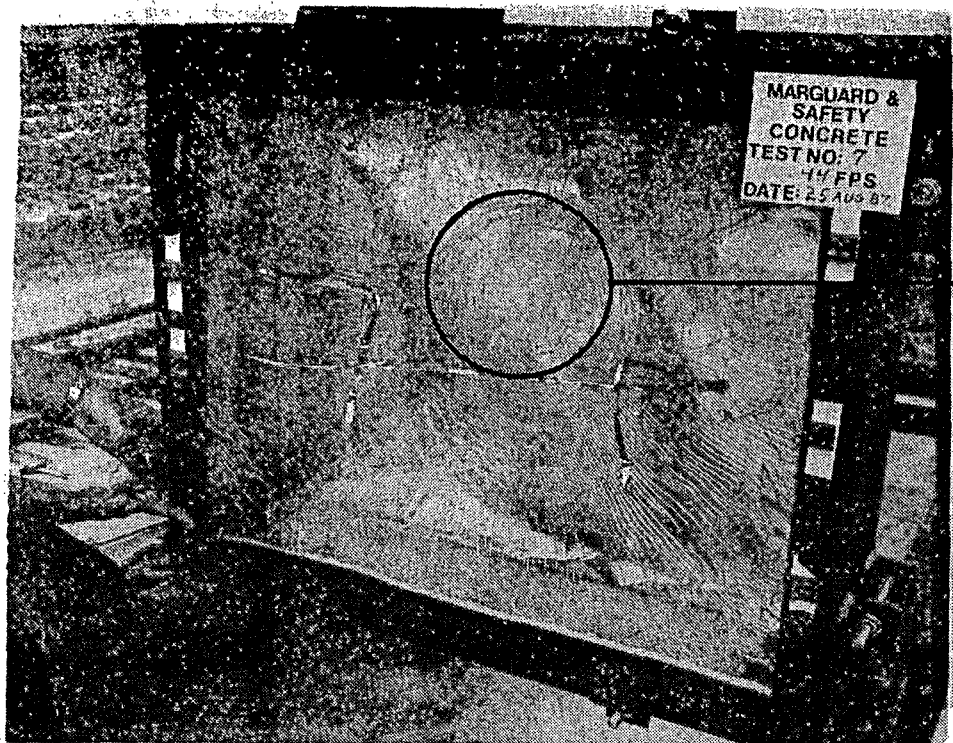
Figure C-3. Front view of an Acriveu SA & Safety glazing system, Safety Glass installed backwards, after the second 44 fps cinder block impact run.

- Test Type: Type I Large Object Impact (Test #1)
- Recorded Velocity: 30.8 mph (45.2 fps)
- Cinder Block Weight: 24.2 lbs

Areas of dents and penetrations.

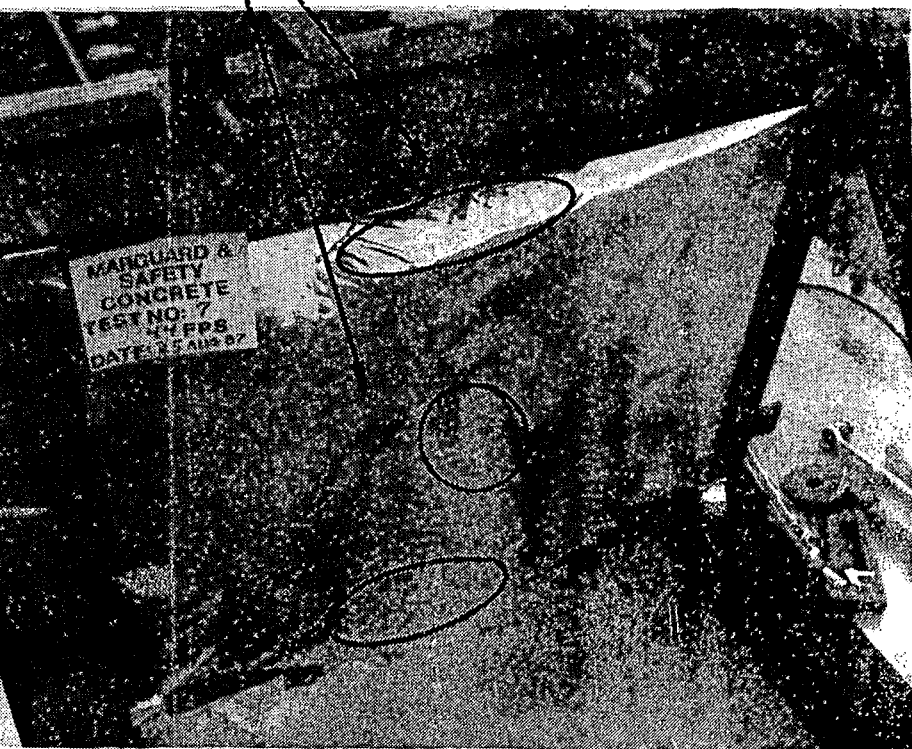
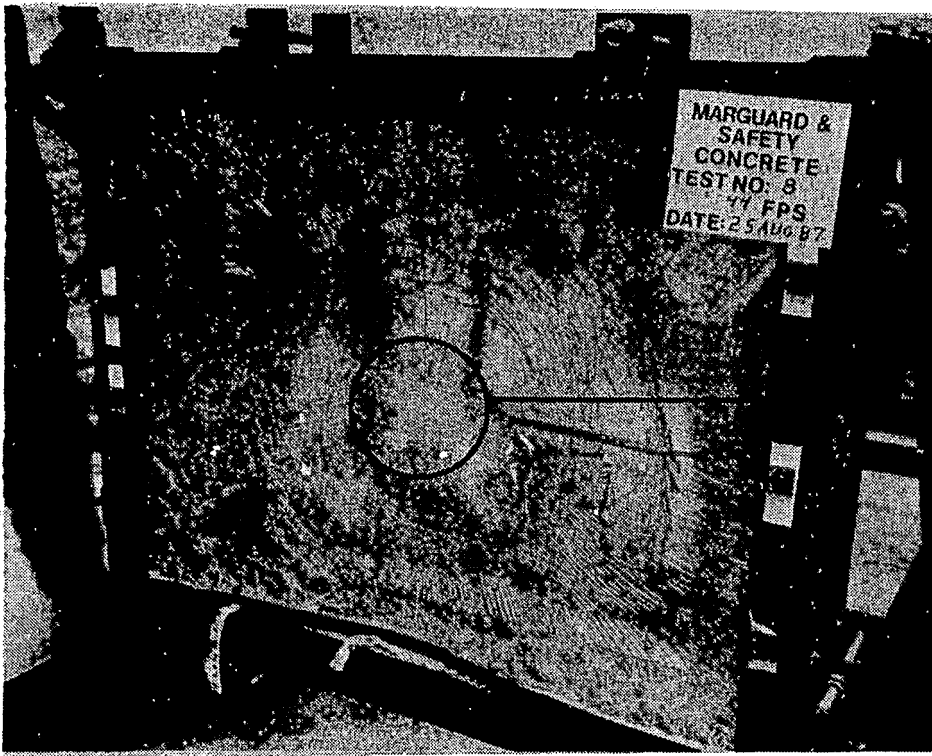
- Test Type: Type I Large Object Impact (Test #2)
- Recorded Velocity: 30.8 mph (45.2 fps)
- Cinder Block Weight: 24.5 lbs

Areas of dents and penetrations.

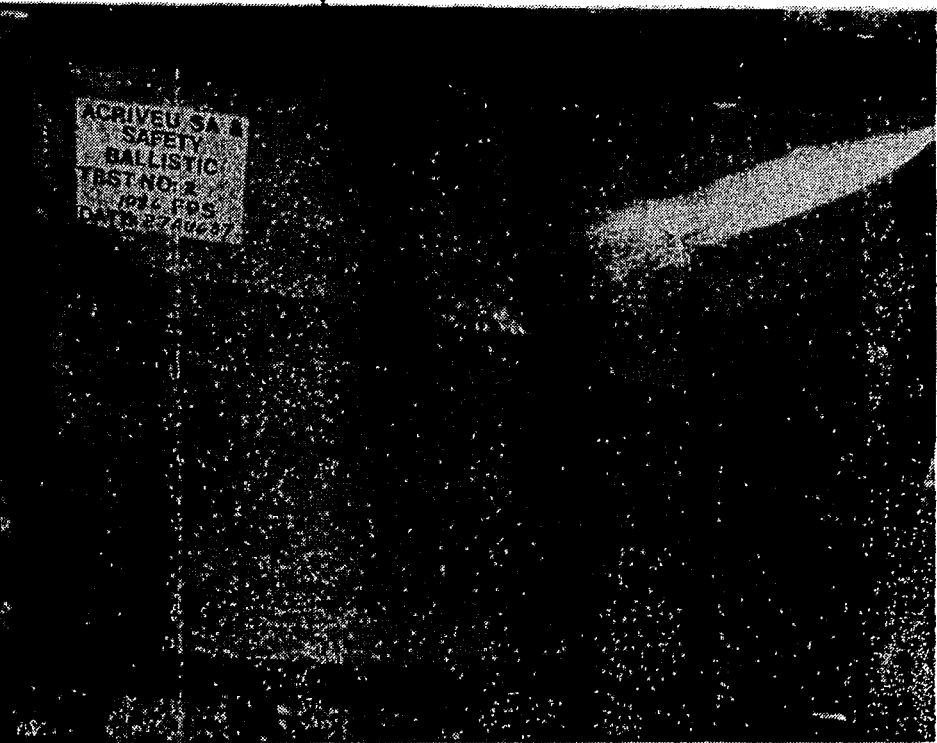
ACRIVEU SA & SAFETY - REVERSED

Point of Impact

Cluster of small penetrations and dents.

- Test Type: Types I & II Ballistic Impact (Test #3)
- Indicated Velocity: 1077 fps
- Muzzle to Target Distance: 63 feet

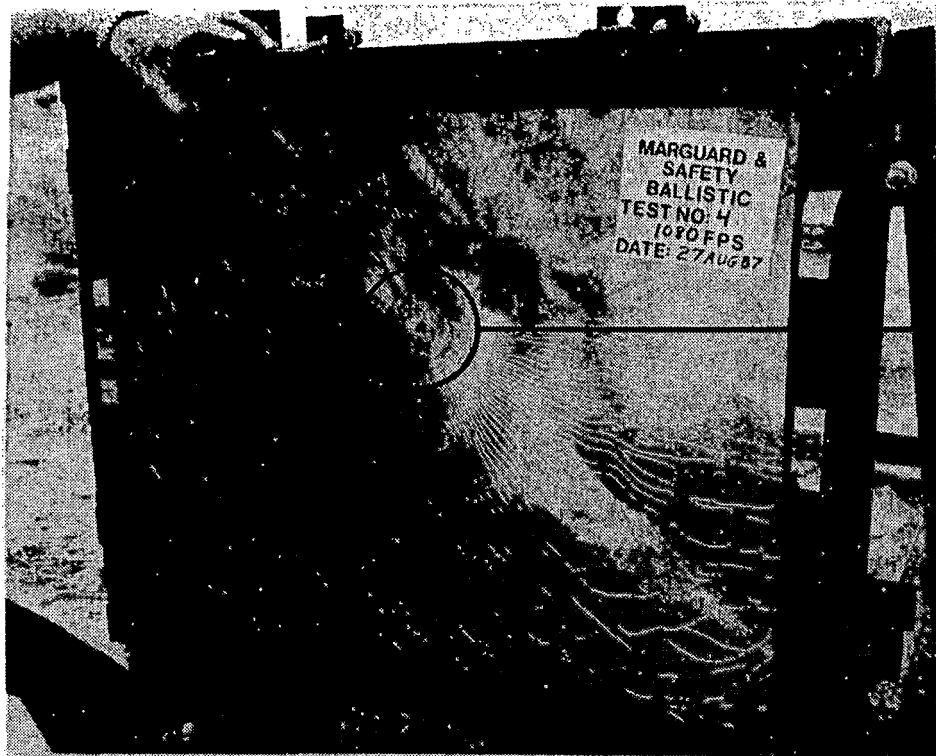
MARGARD & SAFETY - REVERSED

Point of Impact

Cluster of small penetrations and dents.

- Test Type: Types I & II Ballistic Impact (Test #1)
- Indicated Velocity: 1080 fps
- Muzzle to Target Distance: 63 feet
