**FAST/HAL RAIL PERFORMANCE  
EXPERIMENT AND OVERVIEW**

**AAR REPORT R-796  
FRA/ORD-91/24**

***Facility for Accelerated Service Testing  
Heavy Axle Load Program***

**November 1991**

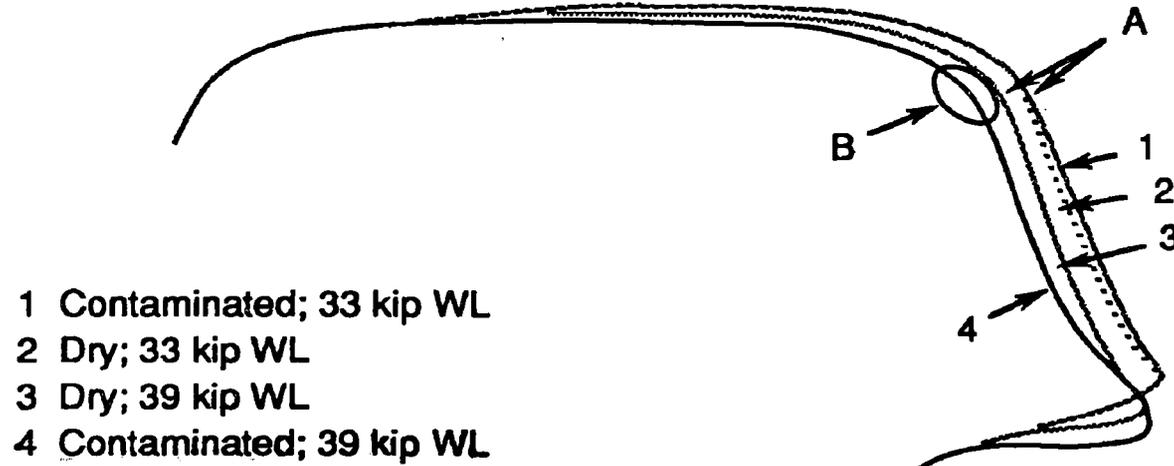
**Figure 10. Profile Configurations in Section 25 SiCrV HH Rail at Various Times During the HTL and HAL Tests**

Curving model analyses have been undertaken using the rail profiles shown in Figure 10 for the 33 kip and 39 kip wheel load contaminated conditions and the wheel profiles given by Bob Florom. The intent has been to determine if wheel and rail profile differences could have contributed to the GF changes which have been attributed to wheel load only. The results are tabulated below for a 5-degree curve with the following coefficients of friction: high rail ball, 0.35; low rail ball, 0.30; high rail gage face, 0.25.

The results suggest that the rounding of the gage face/running surface transition with an ensuing decrease in the angle at flange contact should have reduced the wear rate and train resistance substantially. The opposite actually happened. Thus, although curving model analysis shows that wheel and rail profile differences could have contributed to the differences in GFs observed, the observed behavior in the contaminated phase is not in agreement with the analysis predictions.

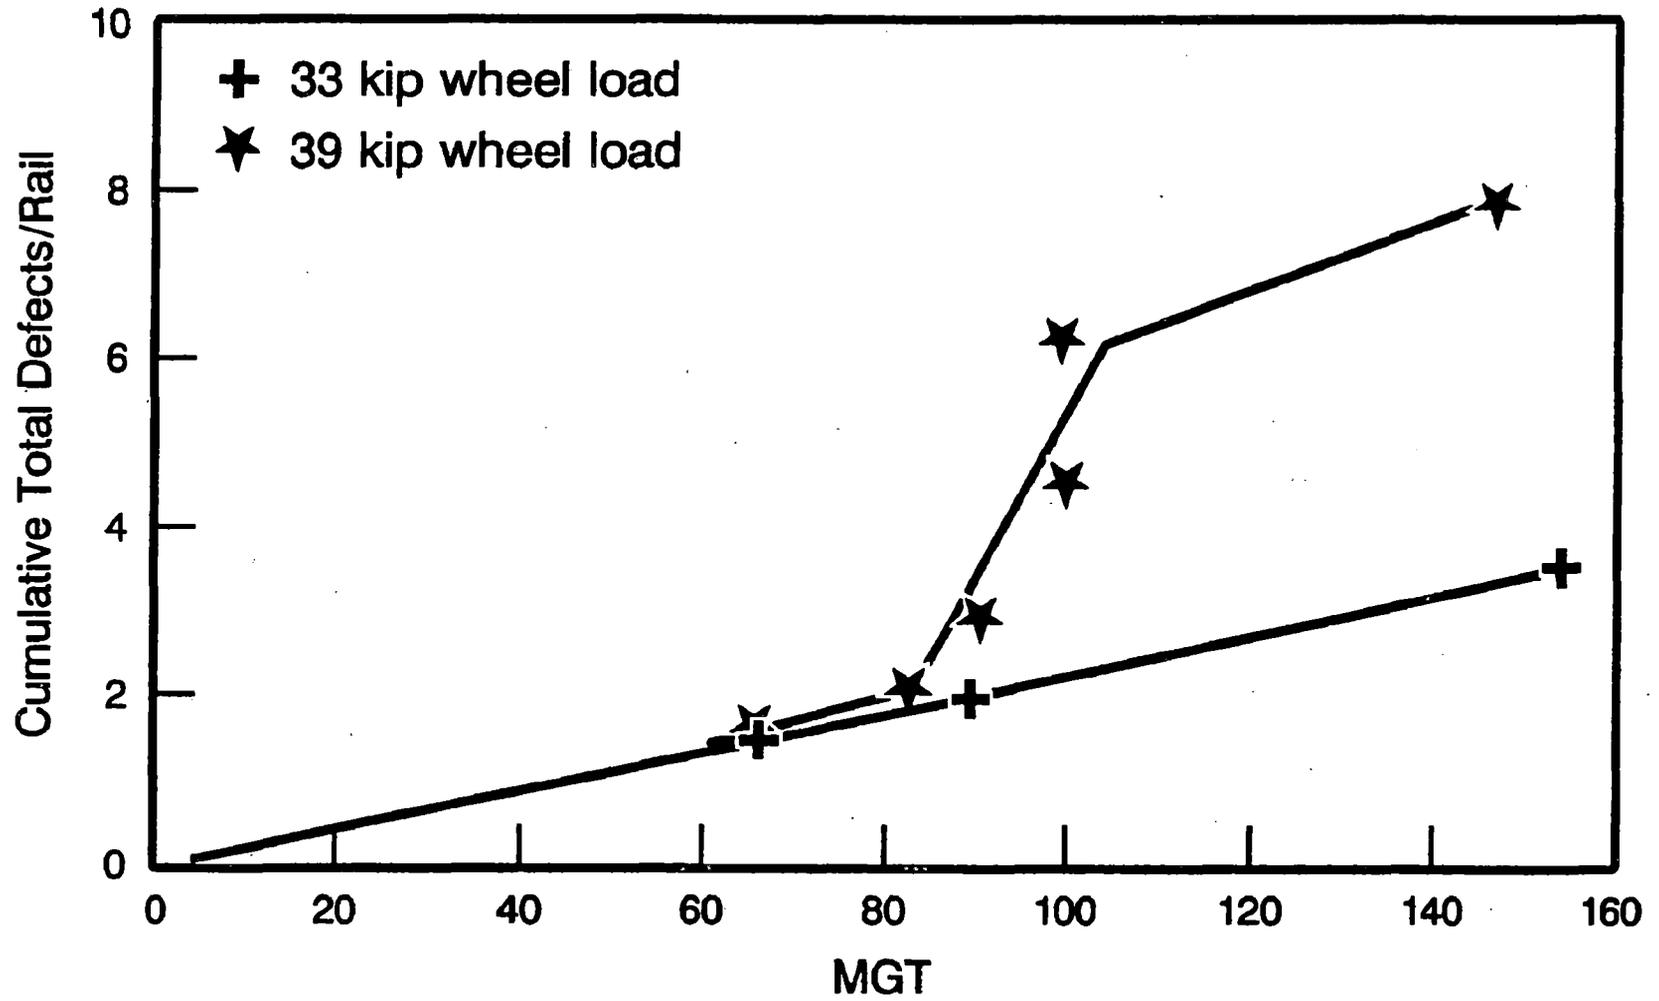
Figure 11. Fatigue Defect Accumulation Behavior as a Function of Service Exposure/NSC 169 Old Unused

In the metallurgical characteristics evaluation test, some rails were carried through from the previous HTL (33 kip wheel load) test; these are referred to as survivor rails. Other rails from the same tests as rails previously in the HTL tests were introduced new into test at the beginning of the HAL test; these are referred to as old unused rails. Figures 11 and 12 illustrate how the 39 kip wheel loads have influenced the total defect occurrence behavior (defects/rail installed) by way of comparison with rails of the same type exposed to 33 kip wheel loads only. The NSC 269 old unused rail initially exhibited a defect occurrence rate similar to that observed in the HTL tests. But at 80 MGT the rate increased apparently only to slow down again after 100 MGT to a rate similar to that for the 33 kip wheel loading. Overall though, the defect occurrence rate was slightly more than twice as large under the 39 kip wheel loads. The Bethlehem 289 old unused rail behaved quite differently. From 60 MGT to 120 MGT, the rate was about the same as the overall rate under the 33 kip wheel loads. But above 120 MGT the rate seems to have dropped to zero (no additional defects were reported between 120 and 150 MGT). Thus for this rail type the overall defect occurrence rate has decreased by about 50 percent with increased wheel load.

It is not really likely that the defect occurrence of any steel would decrease with increased wheel load. Perhaps the differences are due to rail-to-rail variations (most probably in metallurgical cleanliness).

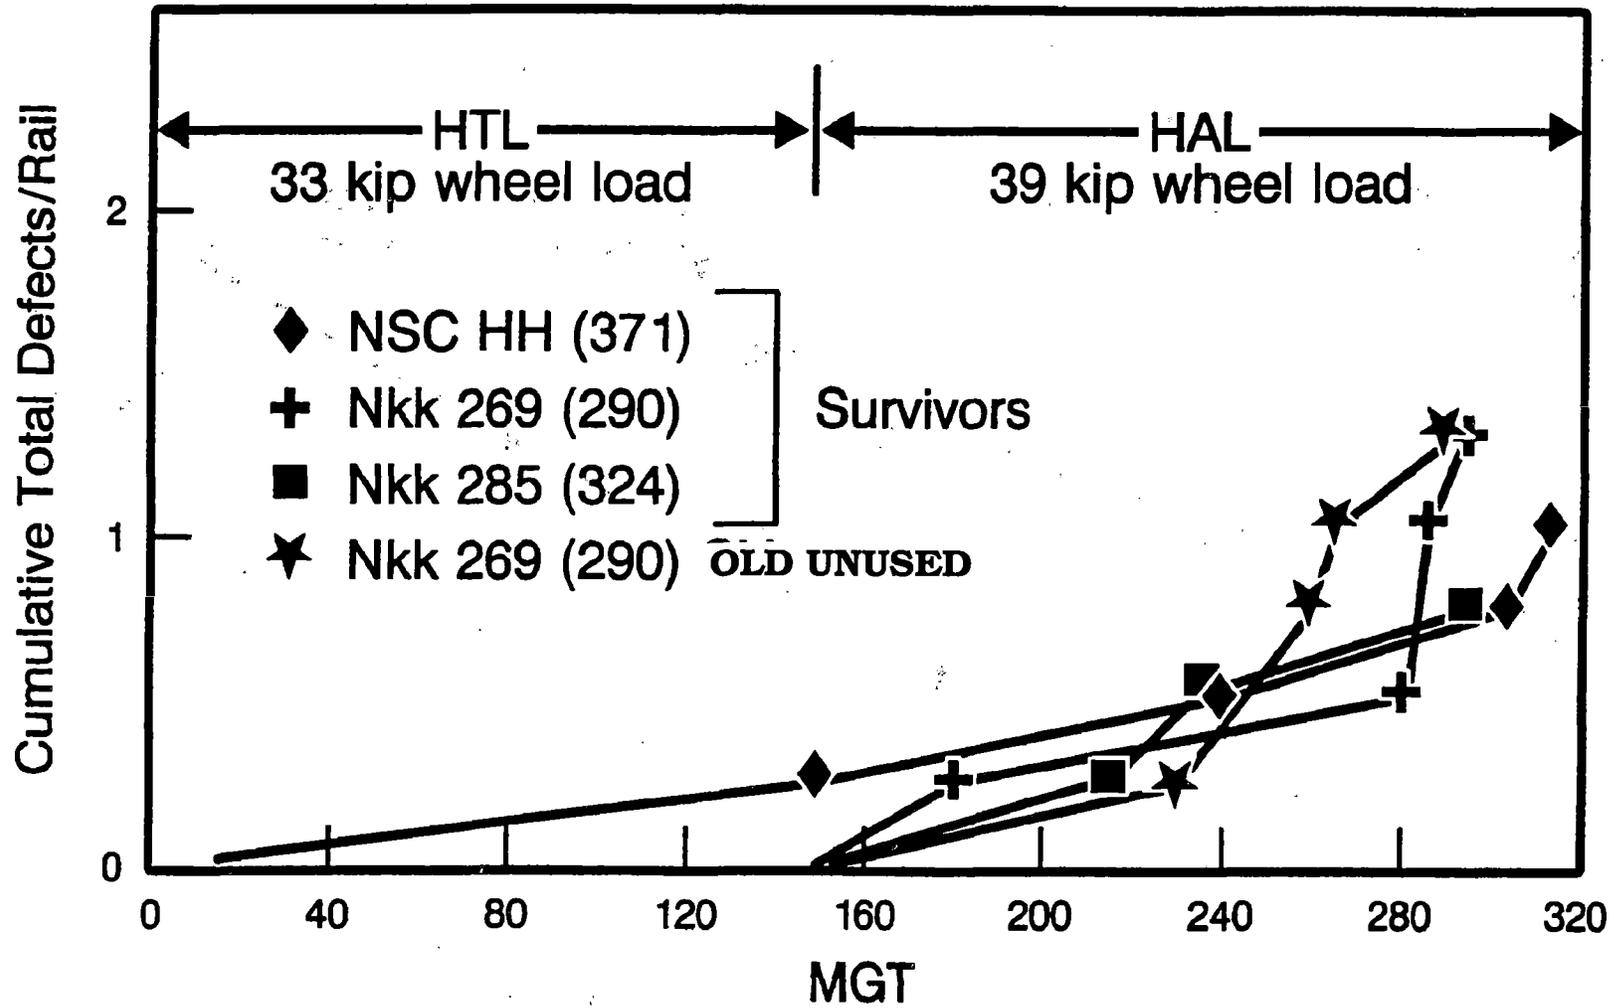
Figure 13. Survivor Rail Fatigue Defect Accumulation Behavior as a Function of Service Exposure

The defect occurrence behavior of the survivor rails is less subject to rail-to-rail variability effects because the same rails have been retained in test through both wheel load periods. Figure 13 portrays the defect occurrence behavior for three survivor rails; one old unused data set has been included for comparison. The NKK 269 and 285 rails produced no defects in the period of the 33 kip wheel load tests, but did begin to produce defects with the introduction of the 39 kip wheel loads. The rate was low at the start (150-240 MGT) but increased at 240-280 MGT. The 269 old unused and survivor rail behaved much the same on average suggesting that little conditioning due to 33 kip operation of the rail occurred. The NSC HH rails were considerably harder than the NKK rail shown, but nevertheless did produce one defect (in four rails) under the 33 kip wheel loads. The increase in defect occurrence rate was only slight through the 39 kip wheel load from 150 MGT to 290 MGT but a higher rate may have begun to appear at 300 MGT.

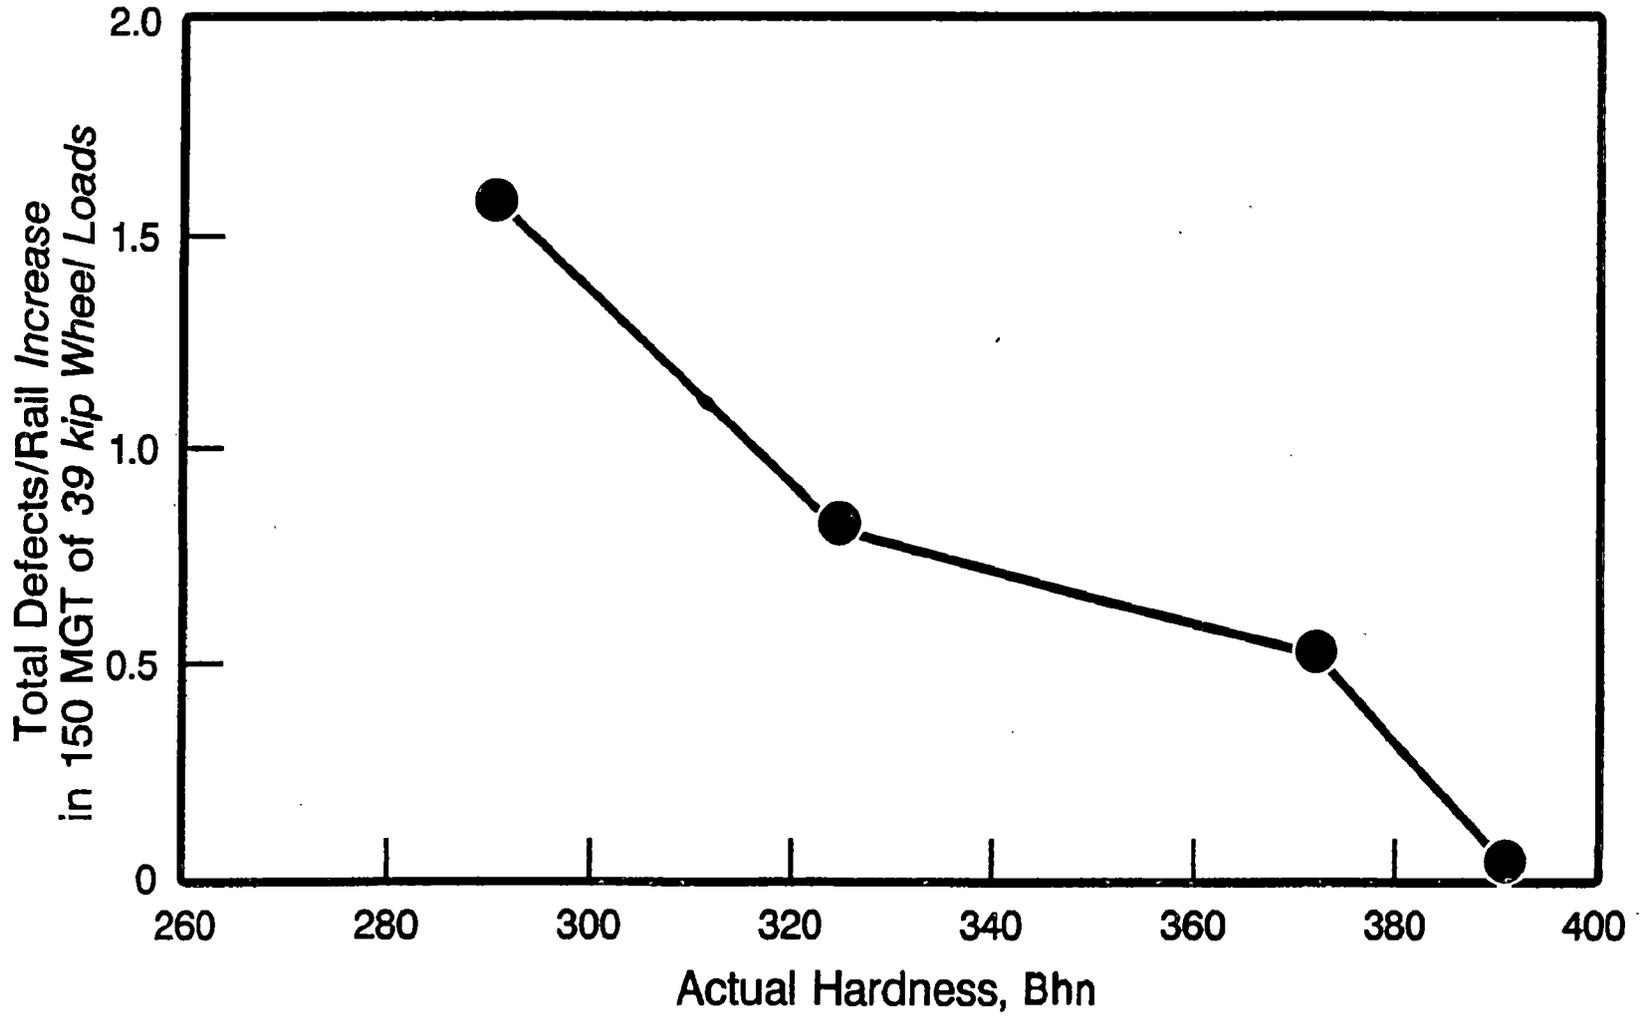
Figure 14. Additional Fatigue Defect/Rail Increment Due to 39 Kip Wheel Loads (in 150 MGT)

The effect of increased wheel load on defect occurrence behavior seems to depend upon hardness of the rail as shown in Figure 14. In the 150 MGT period under 39 kip wheel loads, a 390 Bhn rail would not be expected to exhibit an increase in defect occurrence rate. Were one to go beyond 150 MGT, it is likely that even the 390 Bhn rail would exhibit an increase in defect occurrence rate. Ideally Figure 14 should have been composed as relative defect occurrence rate for the 39 kip vs. 33 kip wheel loads as a function of hardness, but that was not possible because no defects formed in the NKK rails in 150 MGT under the 33 kip wheel loads.

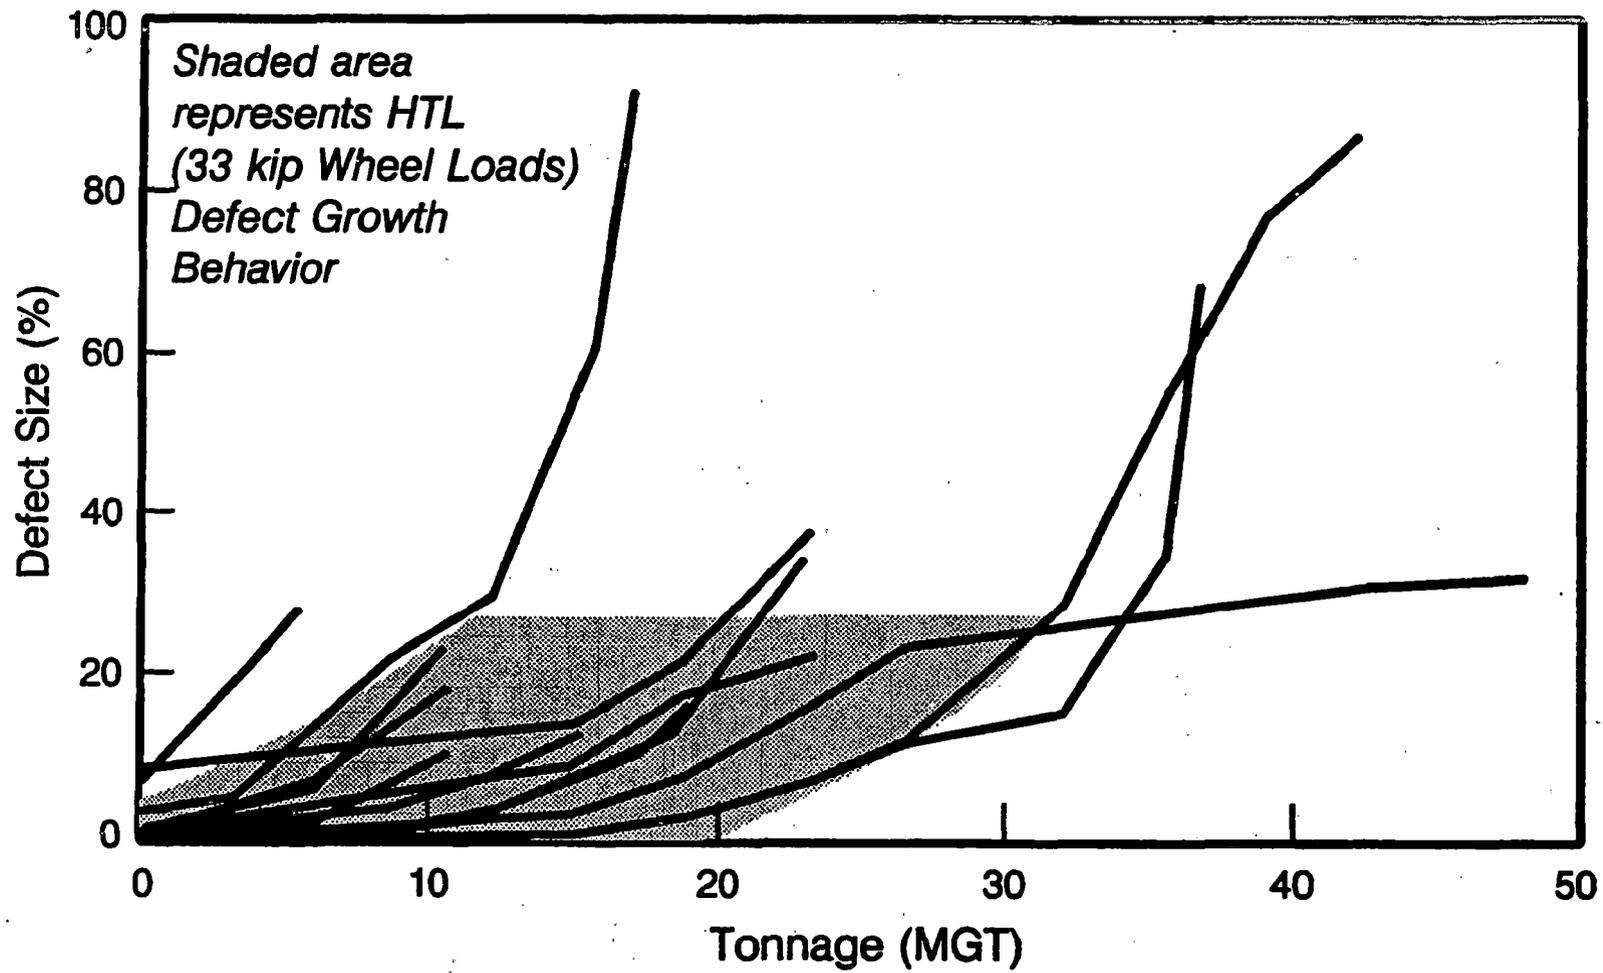
Figure 15. Trnsverse Defect Growth Behavior

The final parameter of concern in the metallurgical characteristic tests is crack growth rate. The crack growth curves for a typical cross section of rails that developed DF's under the 39 kip wheel loads as shown in Figure 15 with the results from 33 kip wheel loads tests superimposed as the shaded area. Generally, the growth behavior under the 39 kip wheel loads seems about the same as that observed under the 33 kip wheel loads.

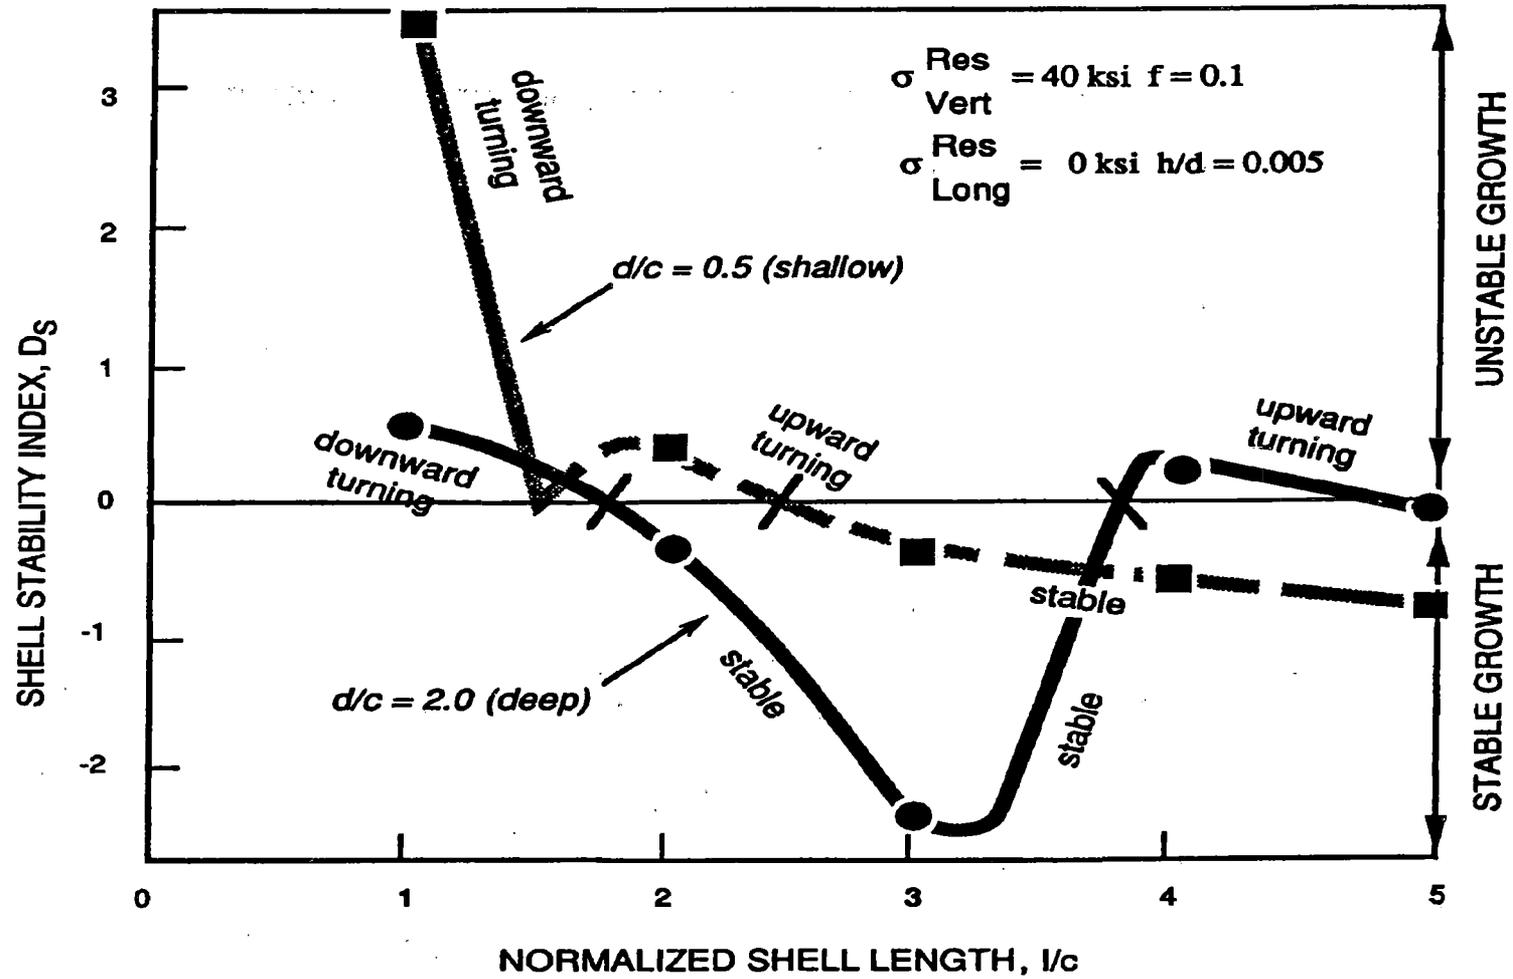
Figure 18. The Effect of Shell Depth on Shell Turning Parameter as a Function of Shell Length

However, answers to the original questions can be provided. Bi-planar shells were again observed to be associated with the asymmetric profile. Figure 16 shows the appearance of the bi-planar shell with its origin under the relieved (by grinding) portion of the ball. All of the shell/DF's that formed in the B rail were located unusually close to the surface (about 0.2" deep) and exhibited only very short shell growth before turning to DF's. The origin of the shell appeared to be at an oxide inclusion as shown in Figure 17. The prompt turning of the shell to a DF after only a brief period of longitudinal growth is consistent with an analytical model of shell growth. It predicts that the closer the shell initiates to the surface the shorter will be the shell growth before turning occurs and the greater will be the turning tendency. This is demonstrated in Figure 18.

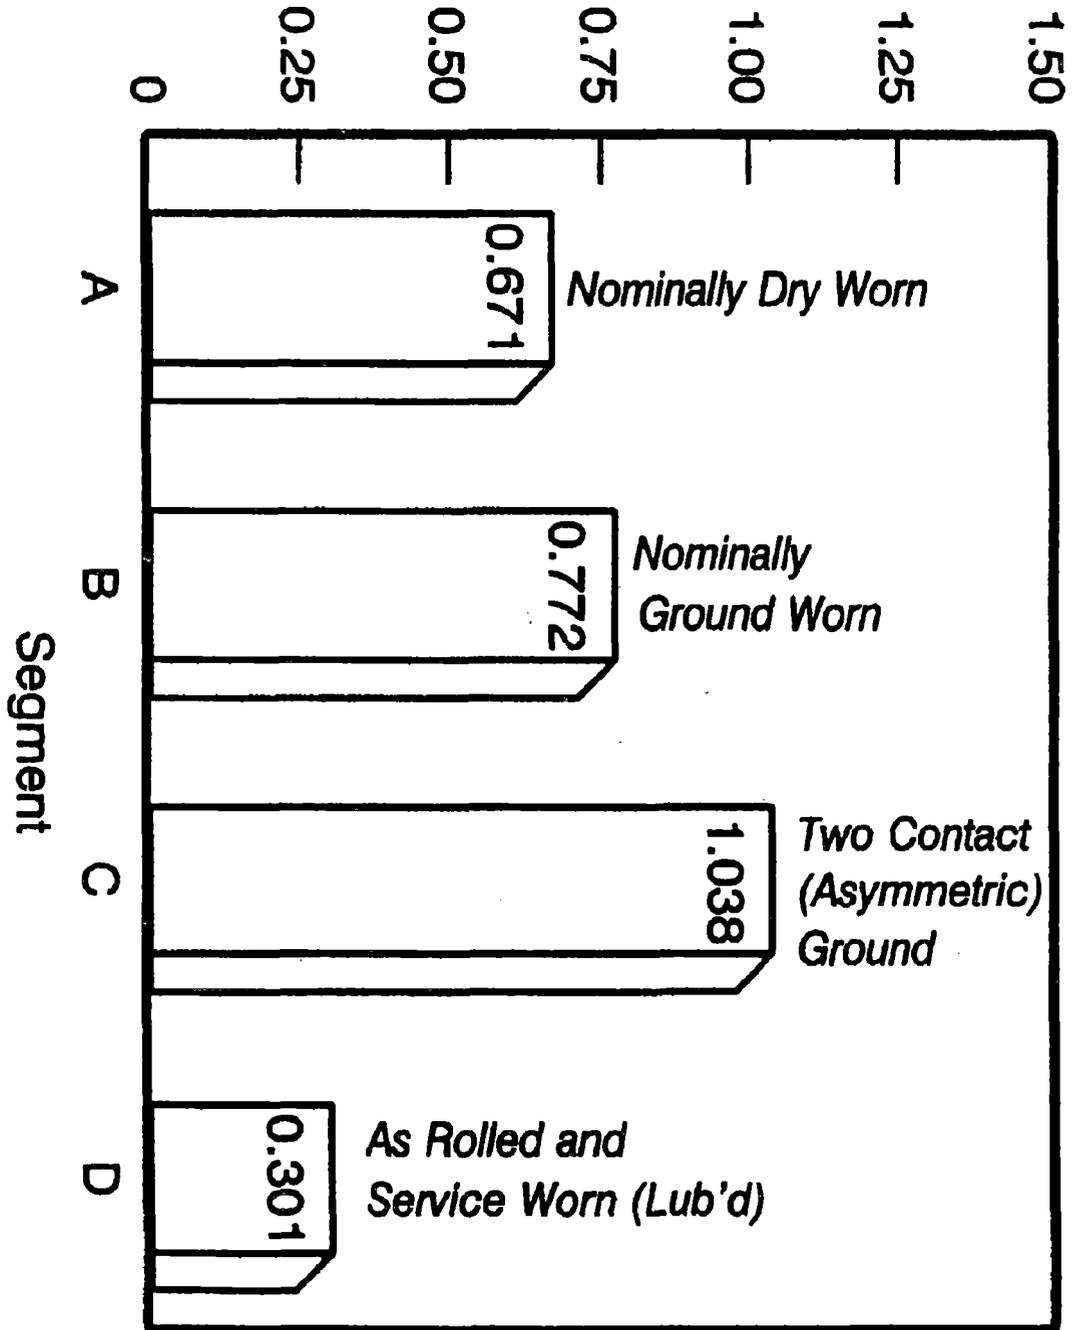
Figure 19. Comparison of Lubricated Gage Face Wear Rates in the Pilot Grinding Test Zone

The asymmetric profile has again been associated with a higher lubricated GF, as illustrated in Figure 19. The lowest overall GF occurred with the as-rolled 133 RE rail profile. The wear rates of the dry-worn and ground-worn rails (segments A and B respectively) seem unusually high considering the intended conformality (and single point) of contact. Figure 20 shows why. The rails in the first two segments were supposed to have been ground to create (segment B) and maintain (segments A and B) a worn profile. But the profile actually ground initially on these rails was asymmetric. Figure 21A shows that in the period in which an asymmetric profile existed on the rails in segments A and B the gage face wear rate was quite high (0.0009" to 0.0012"/MGT). After the profile was corrected to what it was supposed to be (near 50 MGT), the wear rate diminished to about 0.0001"/MGT in these two segments. Figure 21B illustrates the consistently high gage face wear rate of the asymmetric profile (segment C) and the low wear rate of the as-initially-rolled profile (segment D). There is a brief period of about 20 MGT shown in the figure at the beginning where the configuration of the as-initially-rolled profile was undergoing change before any gage face wear occurred at the 5/8-inch gage point. Even though the lubricated GF of the asymmetrically ground is apparently higher, the rate is still about only 1/3 that expected for the dry condition.

Overall Average  
Lubricated Gage Face Wear Rate  
0.001 Inches/MGT

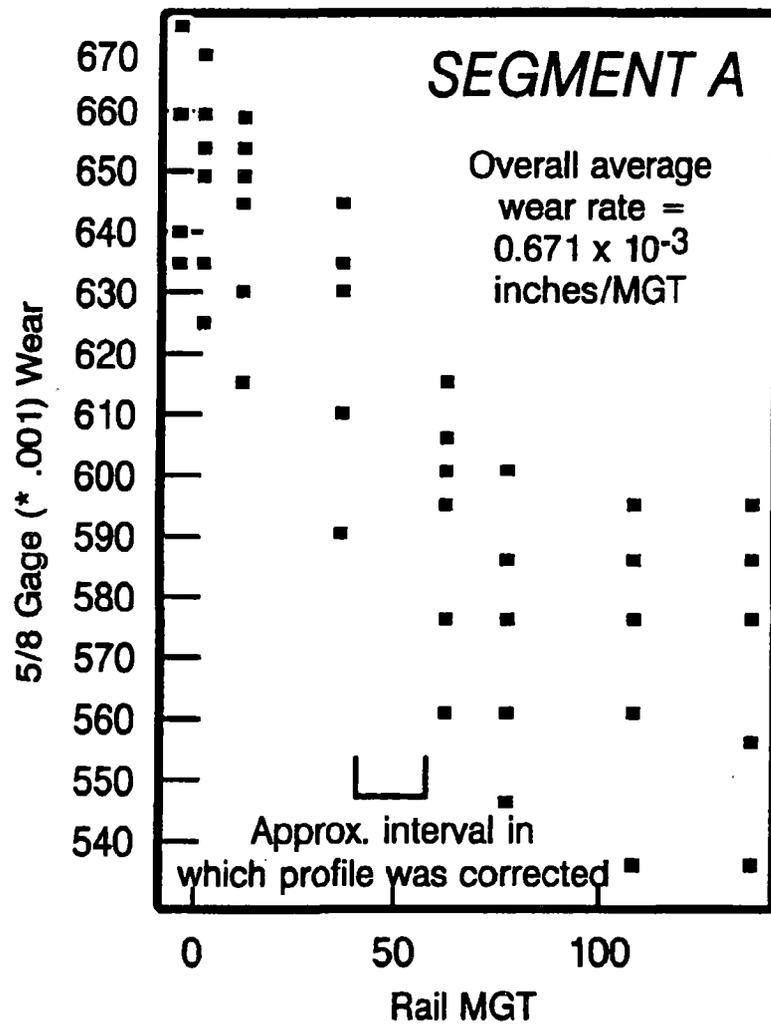
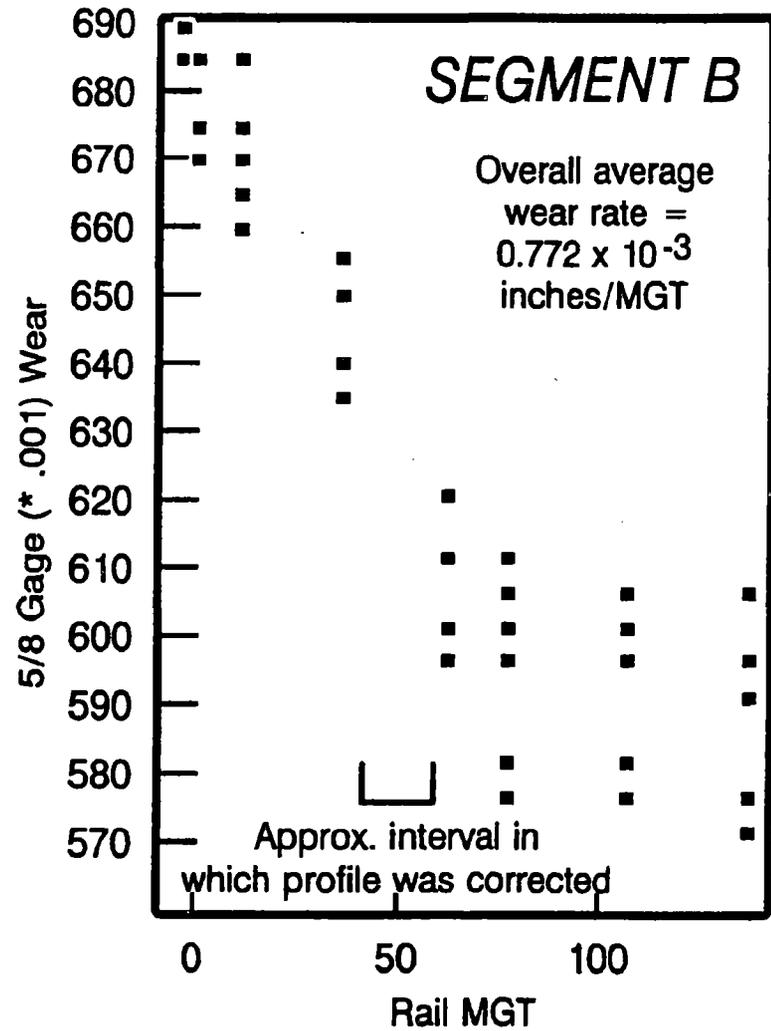
Figure 21a. Wear in the Pilot Grinding Test Zone

One final observation is relevant. It was intended to grind segments A and B to the worn profile removing about 2 mm/100 MGT. Head height loss measurements suggested that the removal rate was much closer to 1 mm/100 MGT.

Thus, the results of the pilot grinding test were a mixed bag. The occurrence of bi-planar shells and the existence of a higher GFs were confirmed in the asymmetric profile test segment. But the unbalanced mix of B and C rails may have confounded the defect occurrence rate results (along with the small size of the experiment). Grinding a worn profile with the available 4 stone/rail grinder turned out to be a greater challenge than expected. Reliable removal of the specified amount of metal requires much better precision of measurement that was at first practiced.

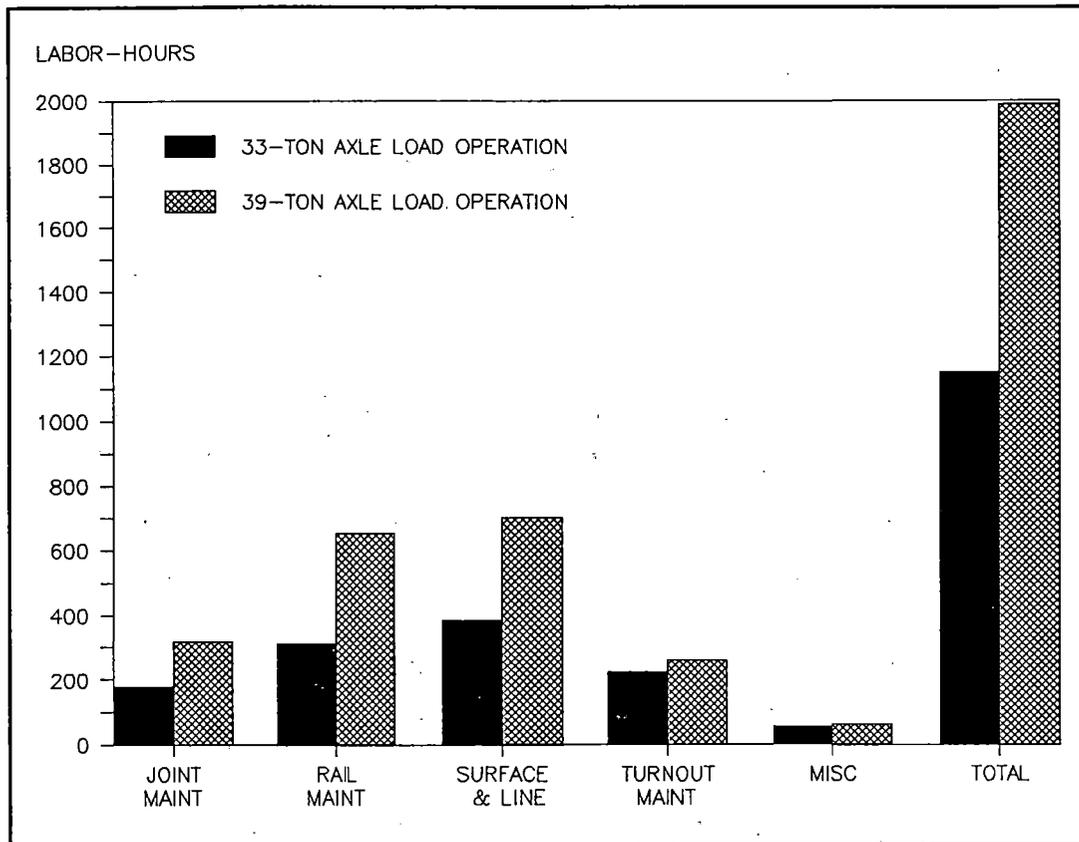
**Figure 15. Breakdown of Track Maintenance Effort**

Figure 15 indicates the cumulative labor hours of effort for the following basic track maintenance categories: joint maintenance, rail maintenance, surface and lining operations, turnout maintenance, and miscellaneous. A total effort in labor hours is also shown. These values represent the total number of standardized labor hours for each maintenance category required to keep the track in the same general condition for the initial 85 MGT of each test train period.

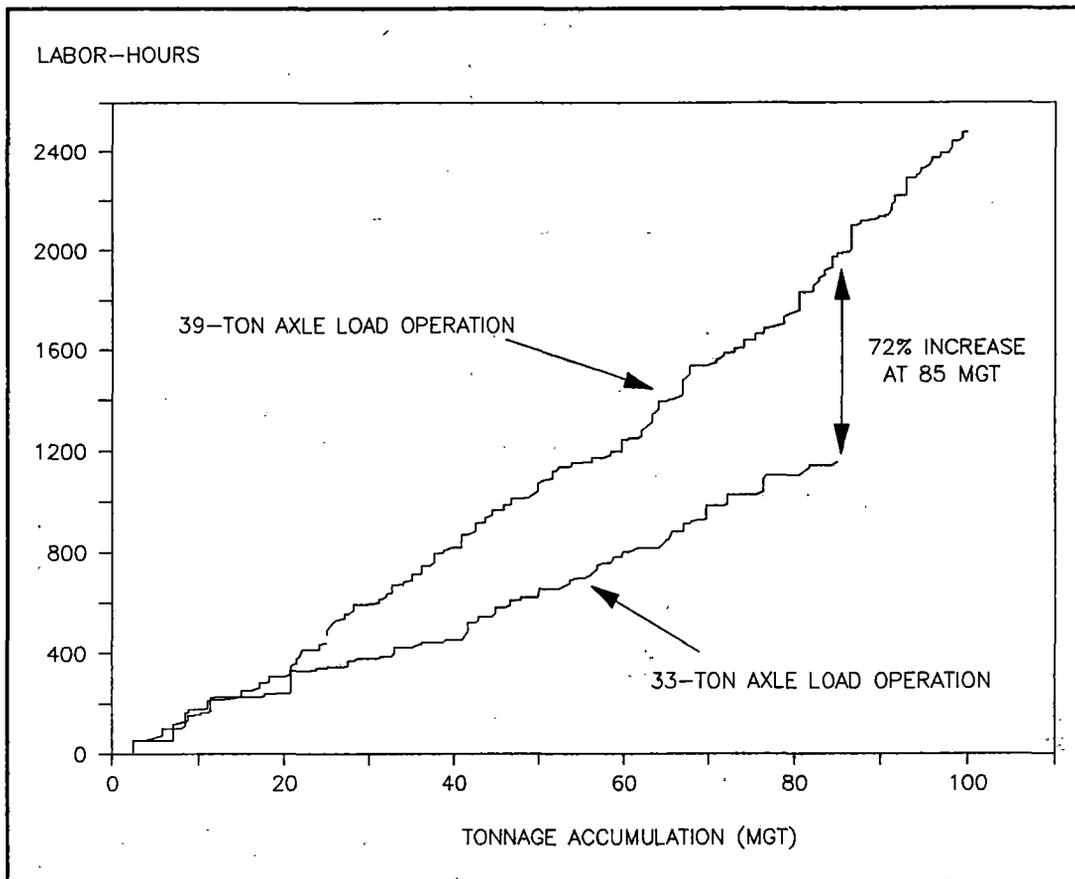
**Figure 16. Track Maintenance Effort as a Function of Tonnage**

Figure 16 shows the cumulative labor hour maintenance data by MGT for each test train period. For reference, the total labor hours for the 3-ton axle load test are shown beyond the 85 MGT base comparison period. Data beyond the initial 85 MGT baseline is shown for the 39-ton axle load test period. Labor hour maintenance totals continued at about the same rate per MGT as tonnage was accumulated to 100 MGT.

The difference in cumulative labor hours after 85 MGT between 33- and 39-ton axle load test periods indicates a 72 percent increase due to the heavier axle load. Caution must be used in interpreting this data, as a significant error band in the total figures does exist. These labor hours represent spot maintenance demand, and as such is often dependent on the discretion of the field track supervisor. The data does not represent long-term replacement demand, such as out of face tie renewal, ballast work, or other capital investment related activities. The spot maintenance efforts represent comparison of activities needed to keep similar track at the same general geometry level during two periods of axle loads.
