Seismic Damage Assessment of Rail Structures in Japan after the January 1995 Kobe Earthquake

**Parsons Brinckerhoff Quade & Douglas, Inc.
San Francisco, California**

April 1995

**U.S. Department of Transportation
Federal Railroad Administration
Office of Research and Development
Washington, DC 20590**

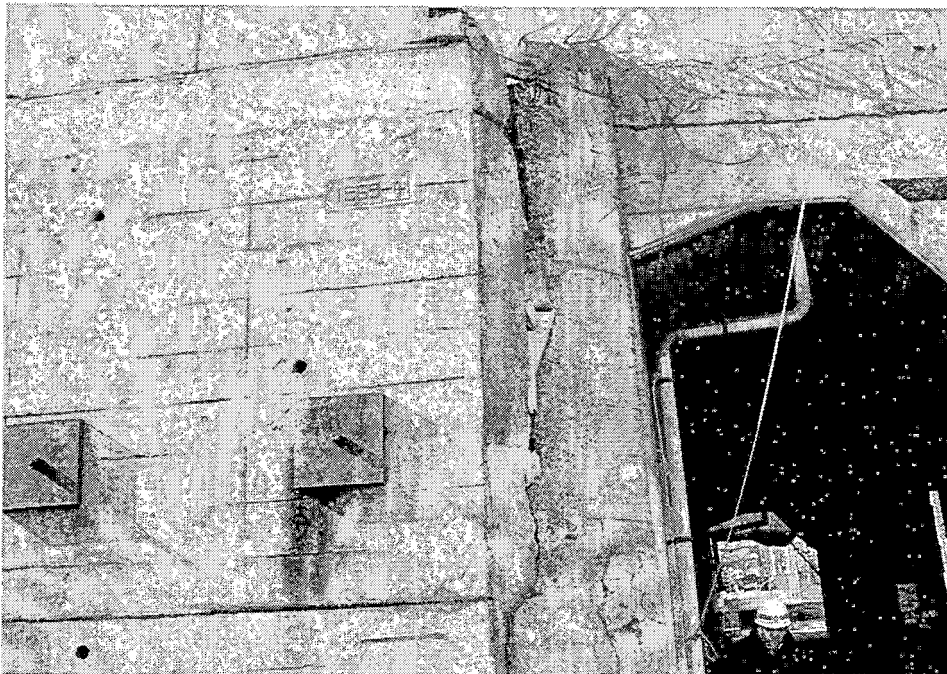
JRT-2. The failed retaining wall opened at this abutment.

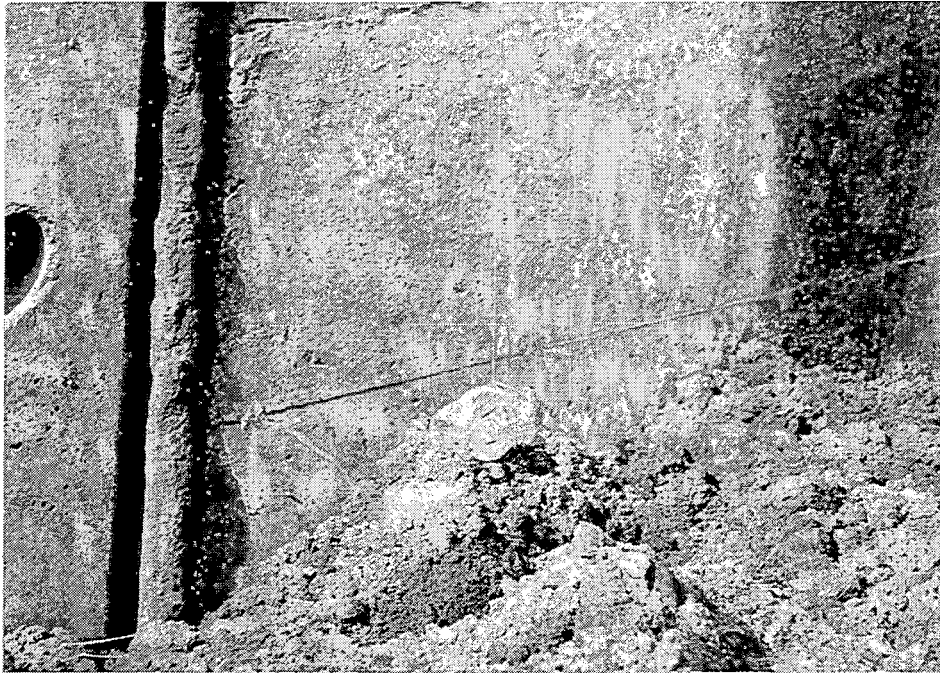
At the west end of the aerial section is a retained embankment. The reinforced concrete walls are leaning outwards over 300 mm, based on an observed plumb bob. The reinforced concrete is still intact and the contractor is coring holes through the walls and embankment and installing 35 mm through bolts with 300 mm square plate bearings. The through bolts are placed about 2 meters apart. It is unknown if the displaced retaining walls endangered the adjacent track enough to warrant interruption of service.

JRT-3. This concrete plumb bob indicates a 400mm lean in the retaining wall.

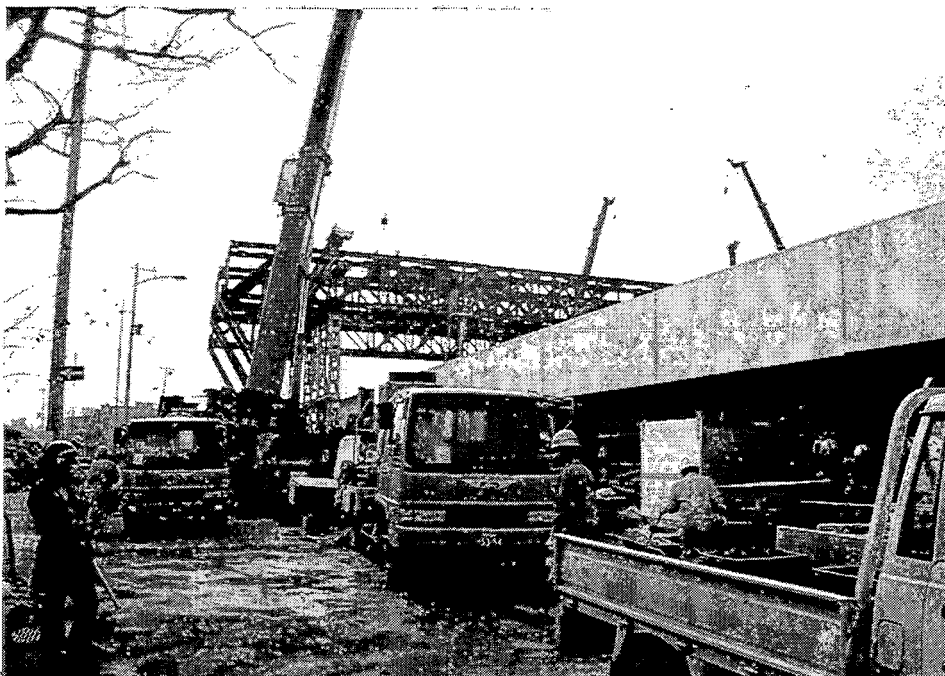
A couple of hundred meters of the structure is very short with 4 to 5 meter headroom beneath the pier caps. This shorter section at the west end of the viaduct seems to have been much more seriously damaged than the slightly fallen section eastwards. The observed damage was typically located at the top of columns with spalling, cracked concrete and buckled column main reinforcing bars. We were unable to observe much of the damage simply because the contractor had completed significant amount of work among the needs for demolition, jacking, temporary supports and reconstruction. This is a truly commendable feat given that we visited the site only 6 weeks after the January 17, 1995 Earthquake. Many columns were removed from the temporarily supported structure with their main bars cut 800 to 900 mm below the pier cap. New reinforcing bars were being mechanically spliced to these dowels and new square column ties added to the 1 meter square columns. Finally a 9 mm plate steel jacket was installed around the connection. In some cases the steel plate jacket extended full height.

JRT-15. The viaduct here is very short and susceptible to shear forces. The collapsed sections are consistent with high shear force demand.

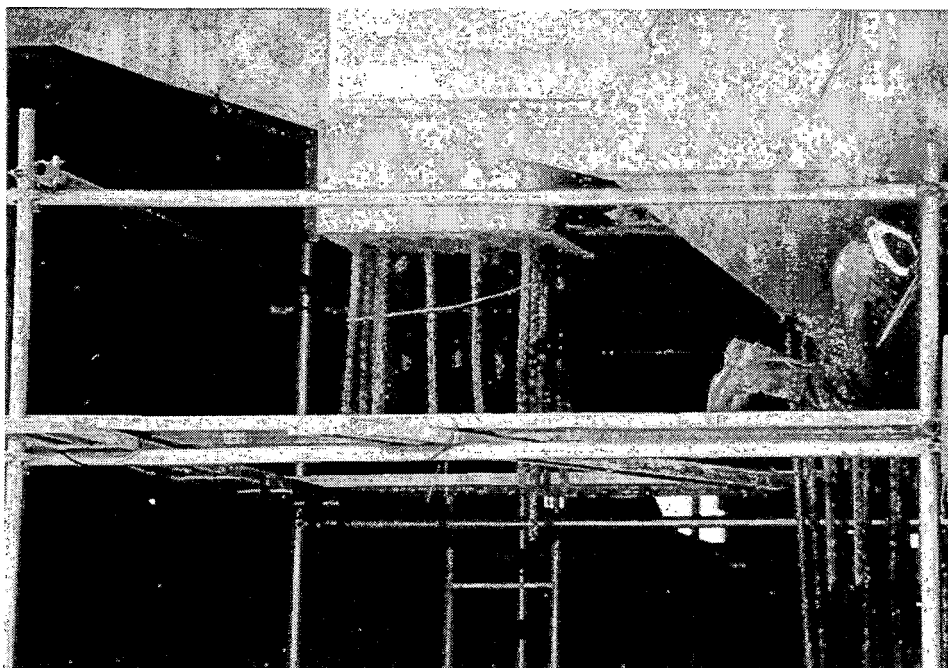
JRT-16. In some areas the columns were cut at the top with 500mm left of the main reinforcing.

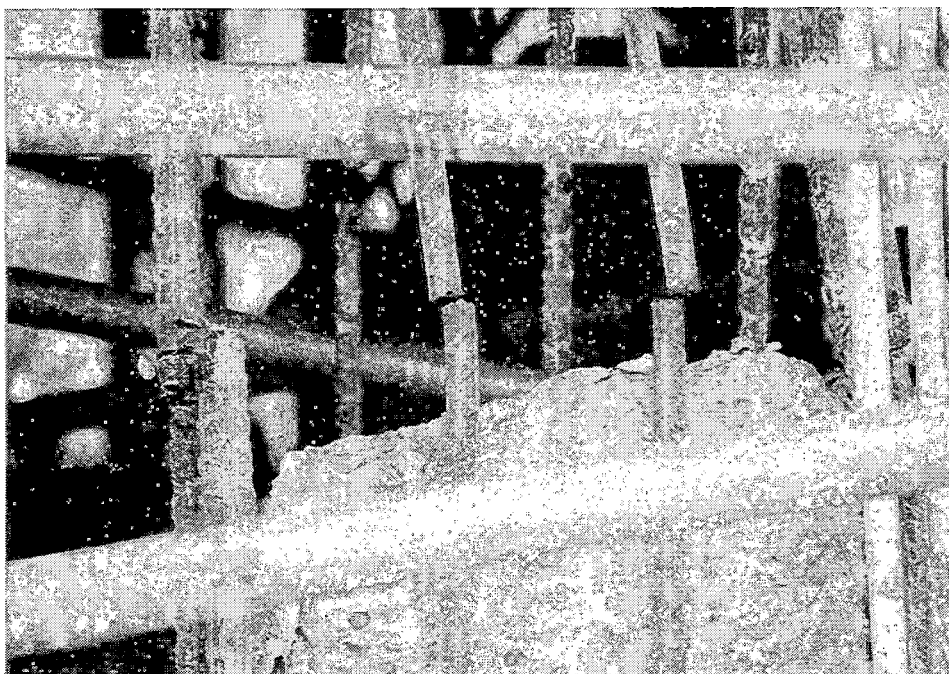
JRT-26. The center two column bars (transverse) appear ruptured while the left side (longitudinal) bars appear to have been flame cut.

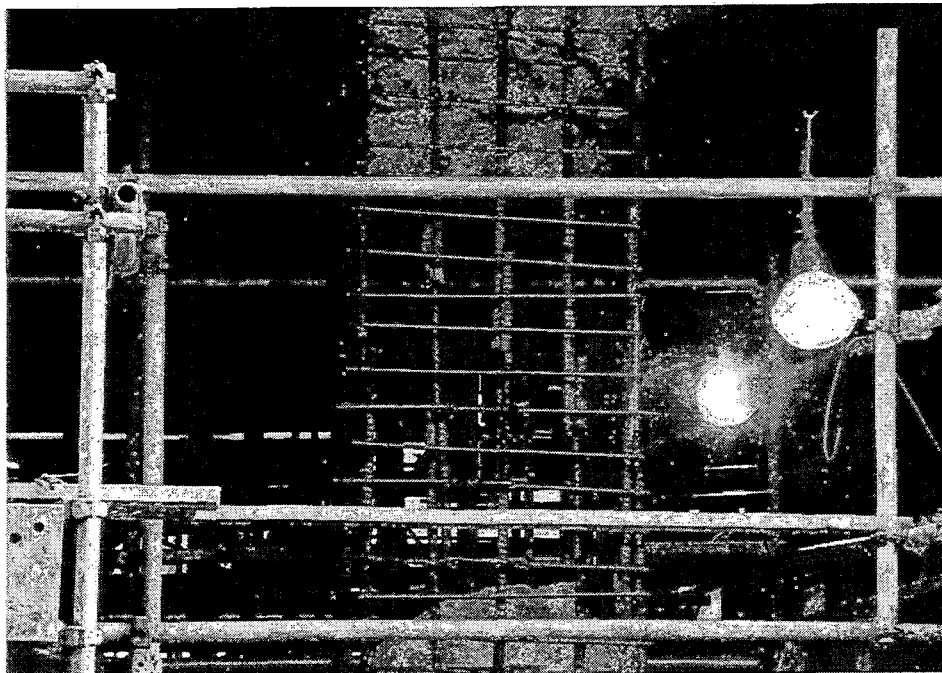
JRT-28. Typical column repair. Note the tie spacing, splices and lack of cross ties.

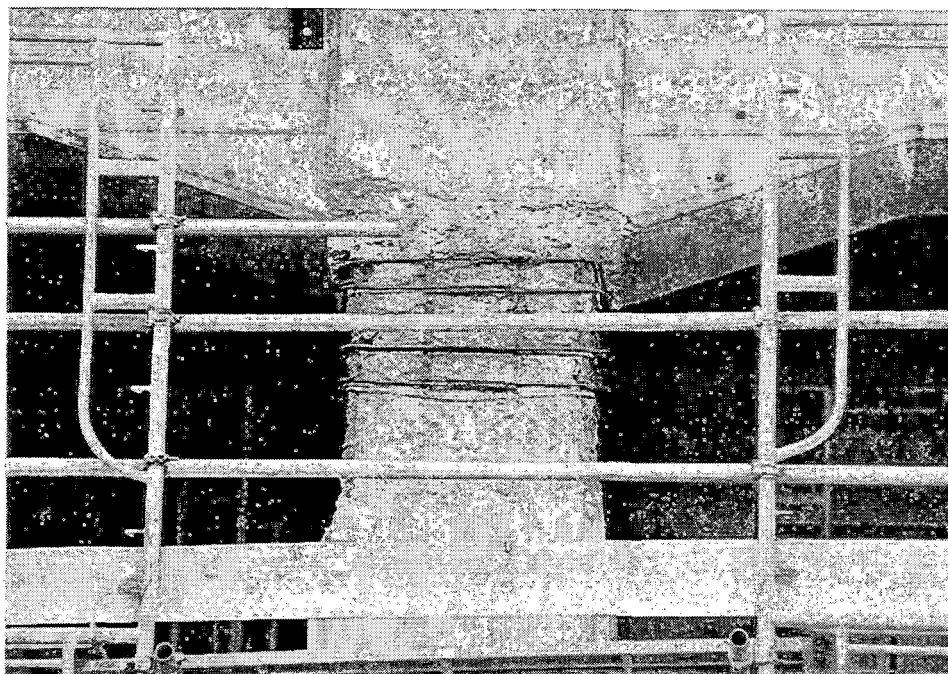
JRT-31. A plastic hinge started to form at the top of this column. Additional ties and a vertical stirrup are being added.

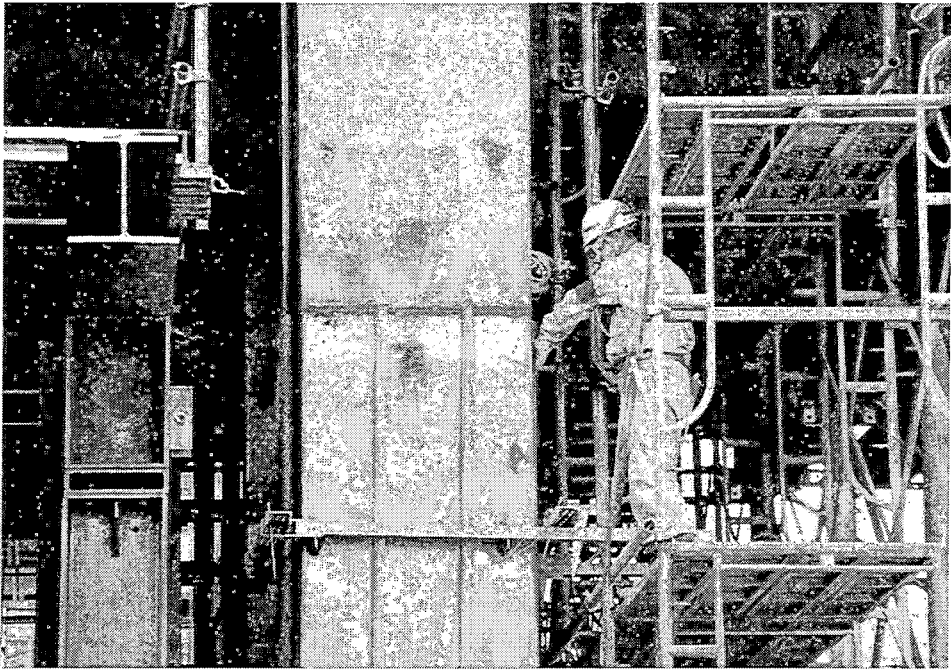
JRT-33. Welder is preparing to seal steel plate jacket.

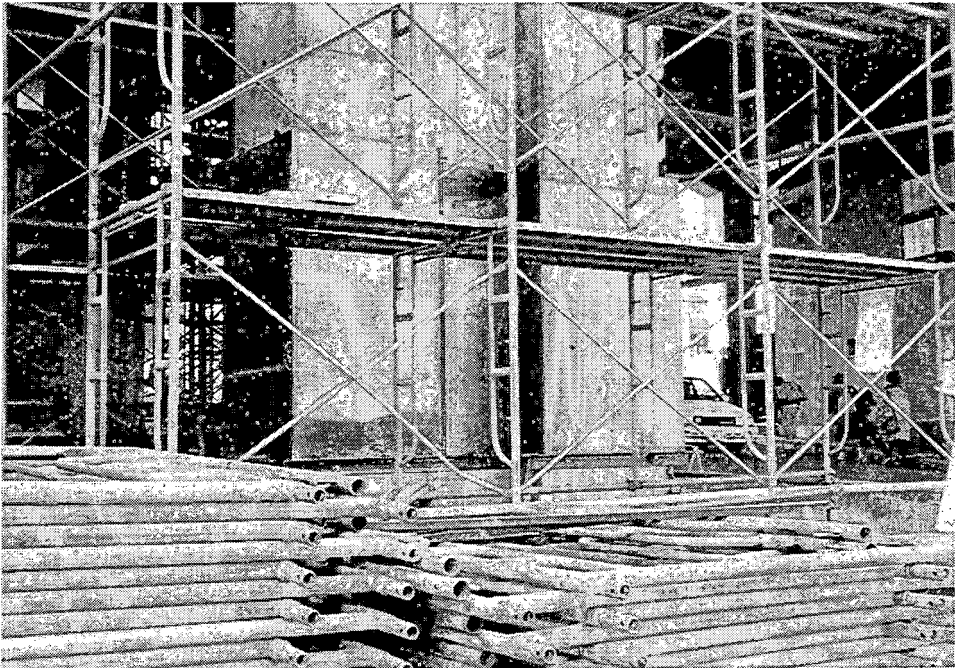
JRT-34. Unusual shaped steel plate jacket on this pier wall.

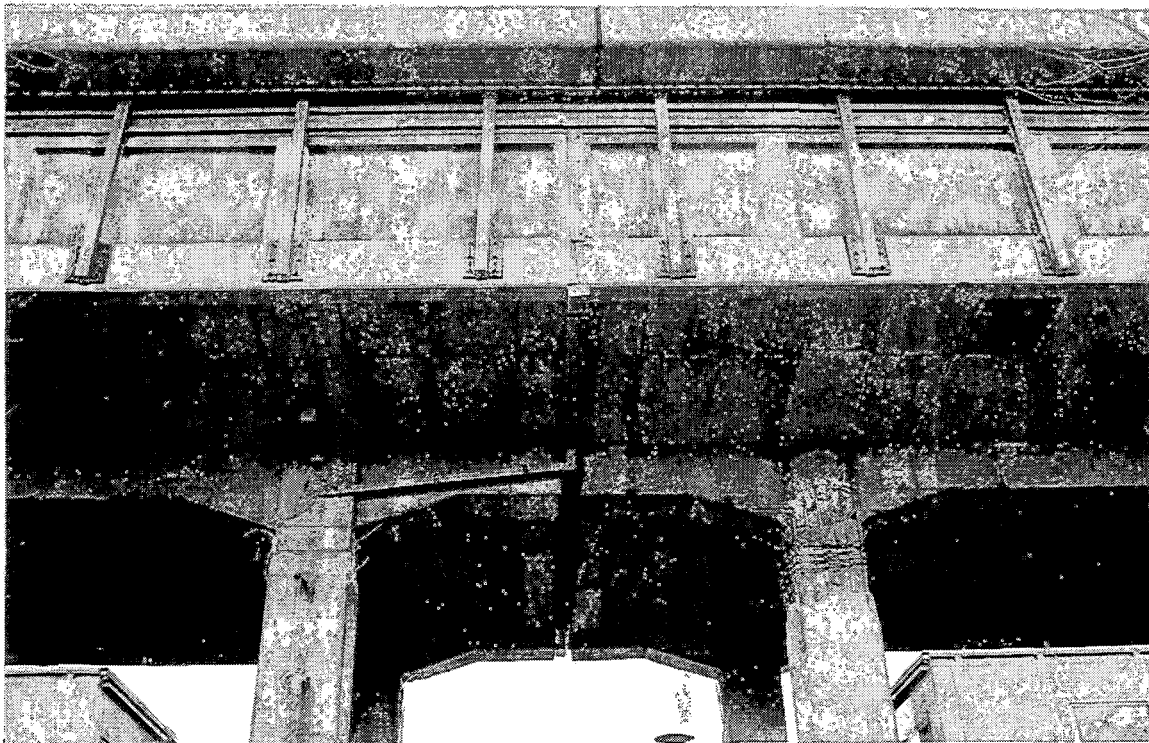
JRS-24. An expansion joint that is typical at mid span.

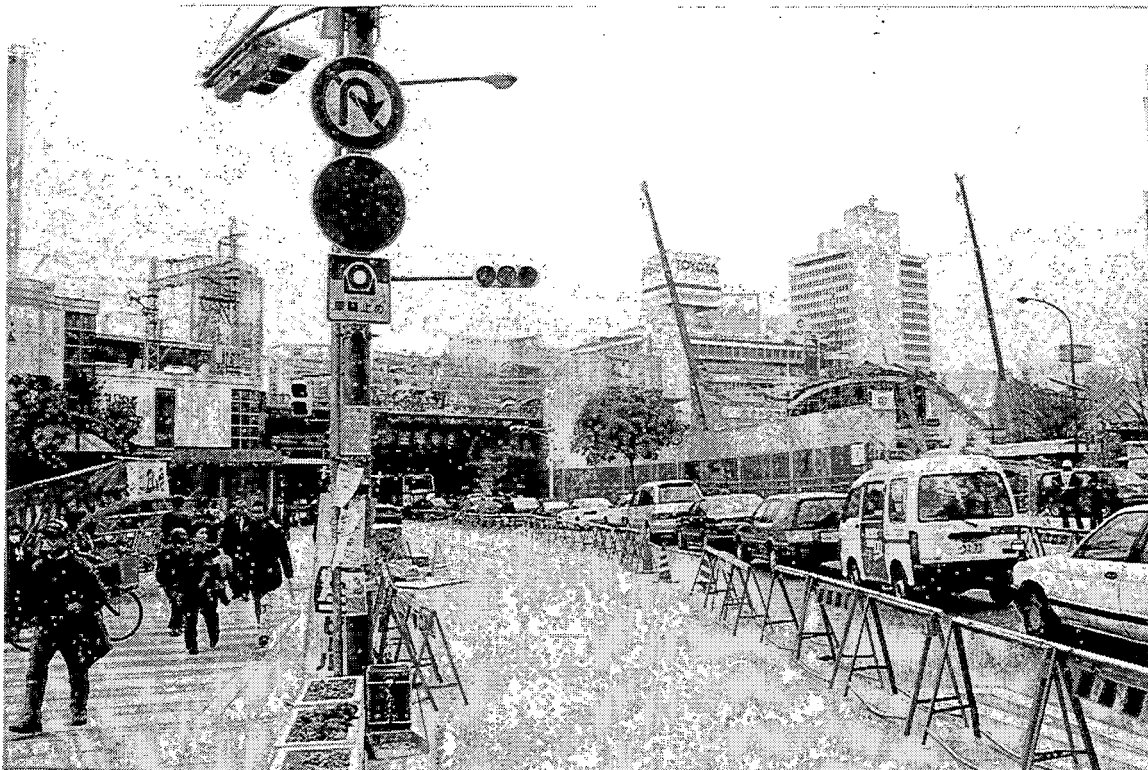
SS-4. This area of Kobe was very heavily damaged. The JR Sannomiya Station is elevated crossing the street. The Kobe Municipal Subway Station is closed for repair behind the barriers to the far left. The Hanshin Subway was damaged below the street just beyond the bridge. The Port Island Peplemover is down this street about 1km.

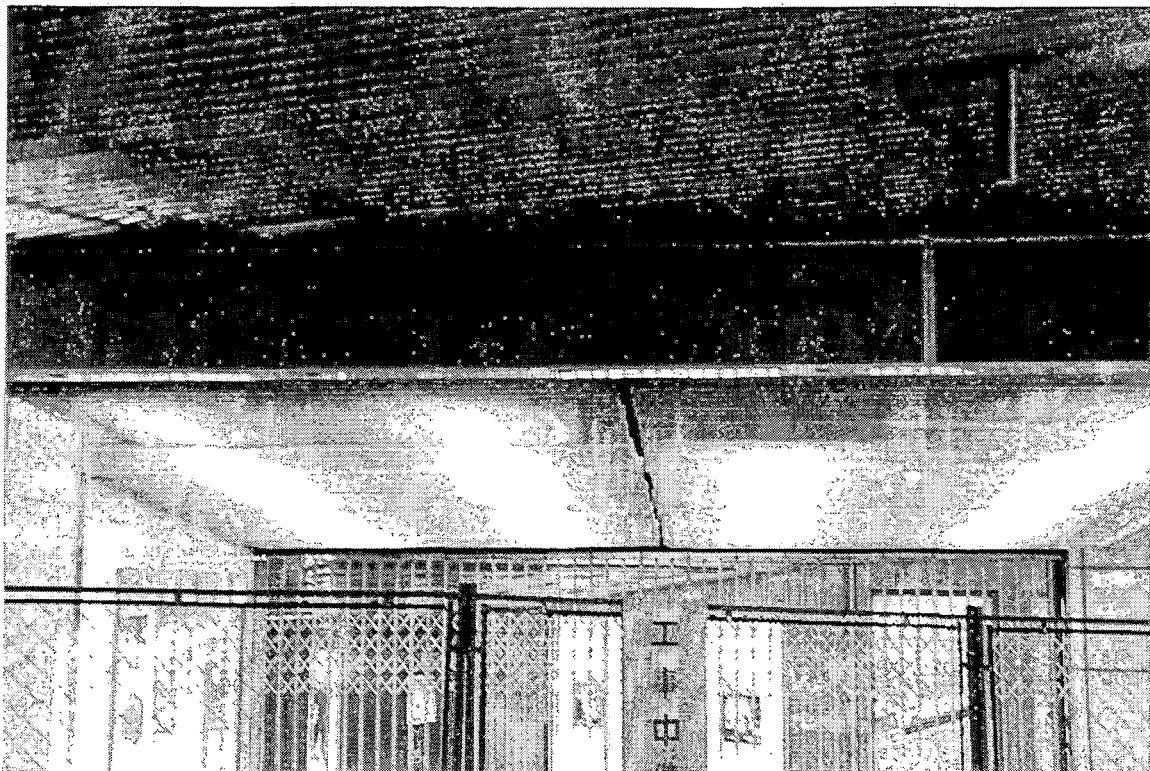
SS-6. This access to Kobe Municipal Subway Sannomiya Station is closed.

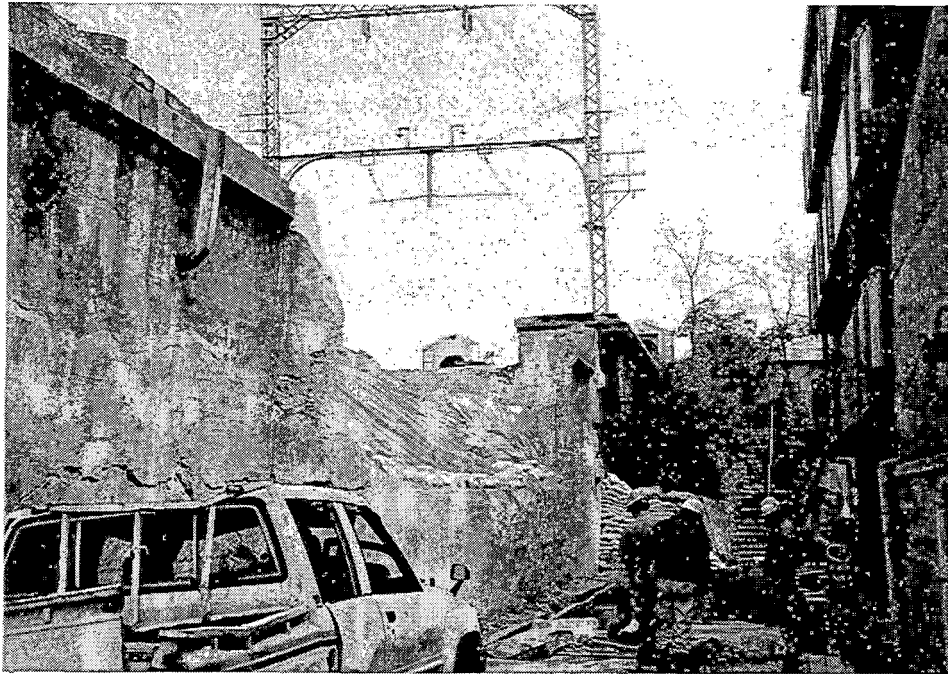
HER-5. Another section of failed gravity retaining wall; there is another failed section above the sandbags in the background. Note the horizontal crack above the parked vehicle.

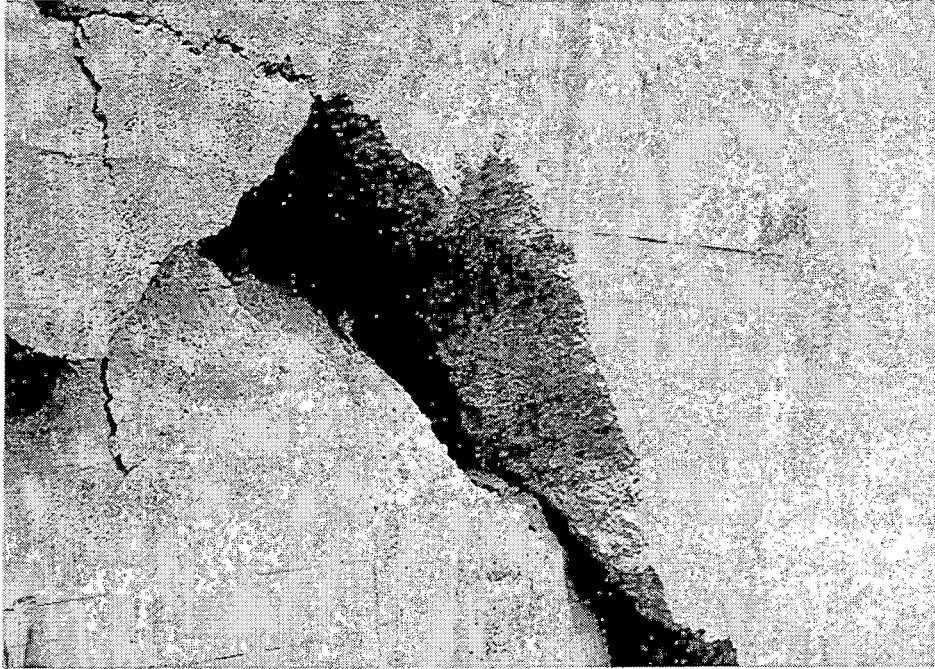
HER-9. The crack in the retaining wall shows that the wall is unreinforced concrete.

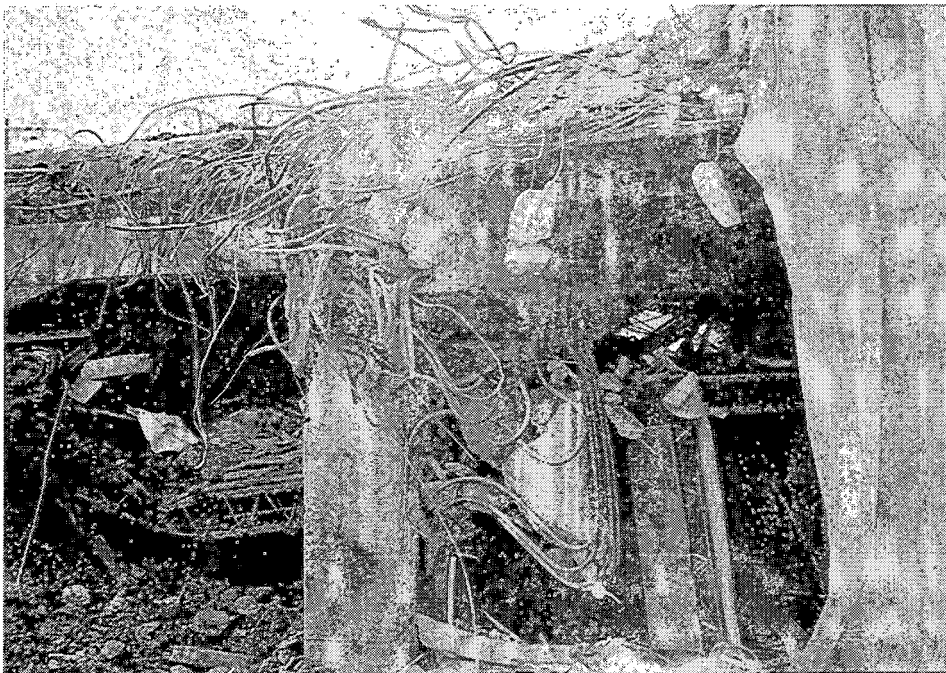
HER-10. Beginning of the failed viaduct; the steel members were used for residential and commercial buildings constructed under the viaduct.

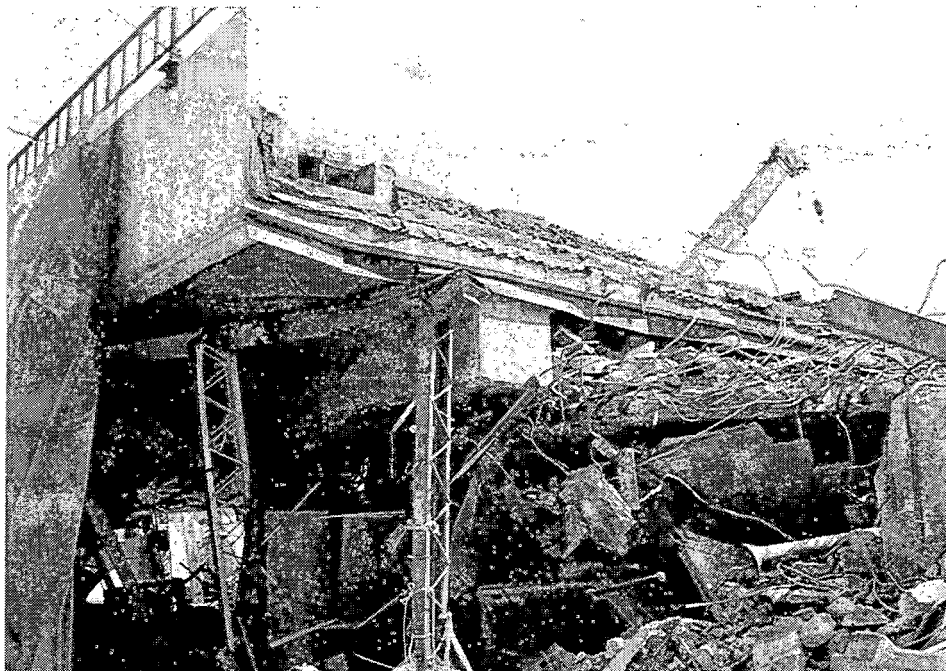
HER-11. The viaduct collapsed to the left of the expansion joint but was destroyed to the right. The joints were located at midspan. The ballasted rail provided no restraint.

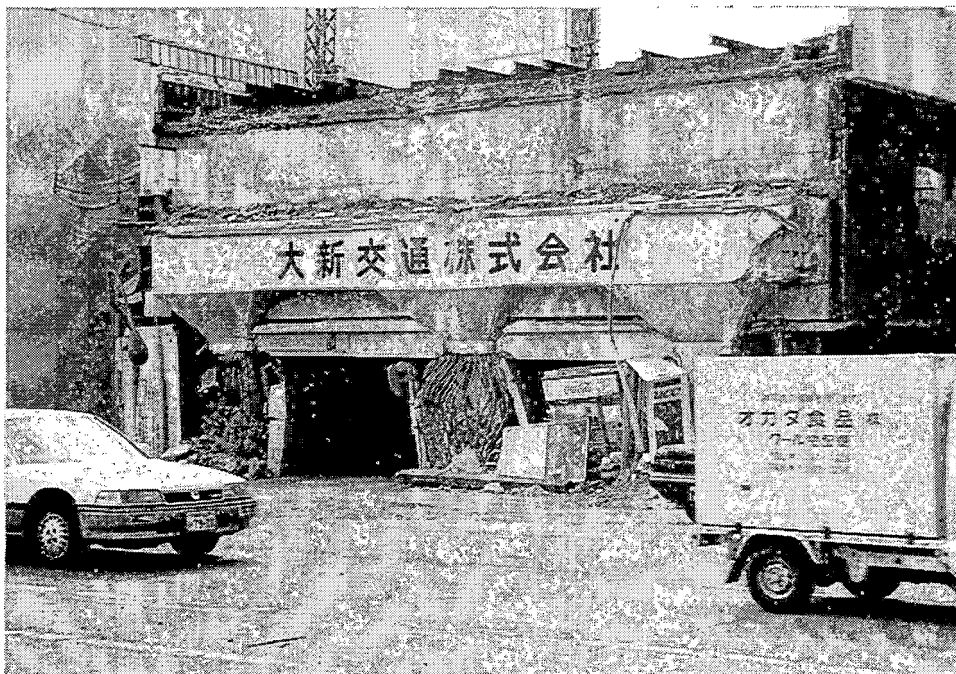
HER-12. This pier supported a steel plate girder span across the four lane street. The plate girder dropped to the street and was removed. The rails are still on the ballast on top.

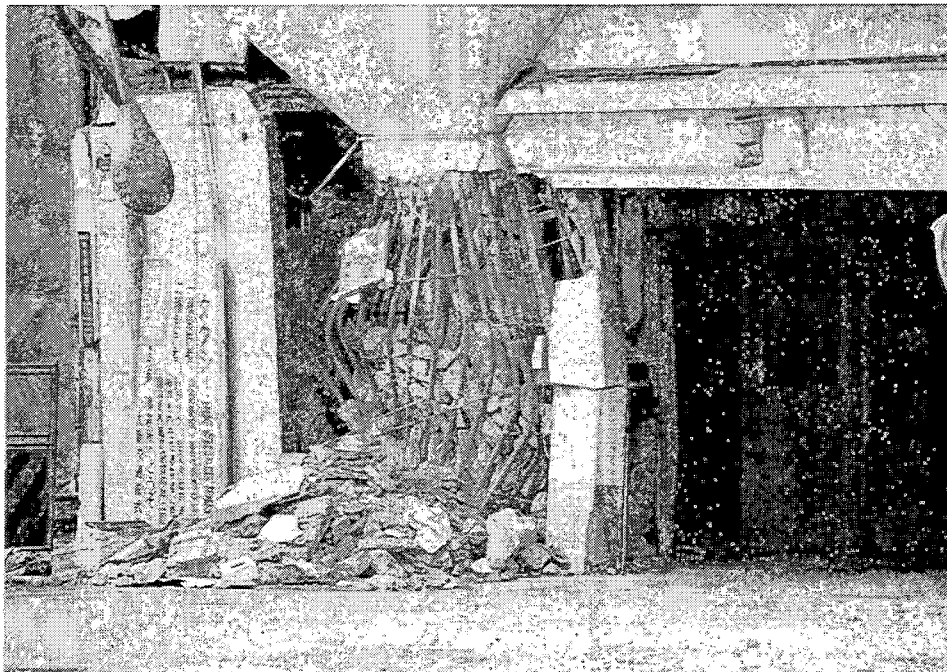
HER-14. Close up of the left column of the pier. The structure has not settled much with respect to the door inside the garage. The glass in the door appears intact. This column shows a few ties were present.

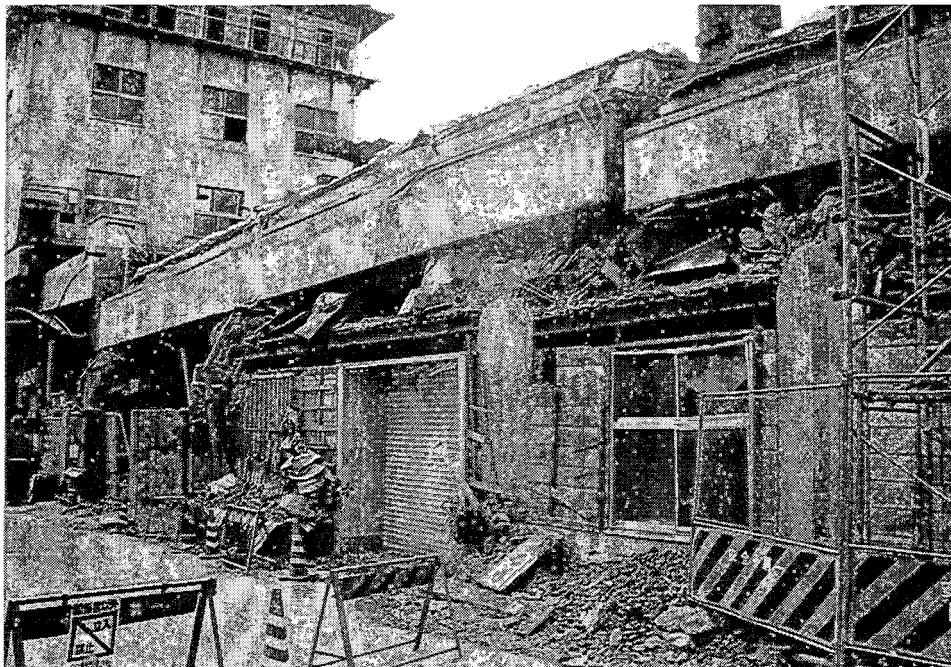
HER-16. This section is completely destroyed above the steel beams. The steel beams were installed for secondary uses of this facility. The beams seem to have concentrated the damage at the tops of the columns. This section was some sort of siding ending at the building.

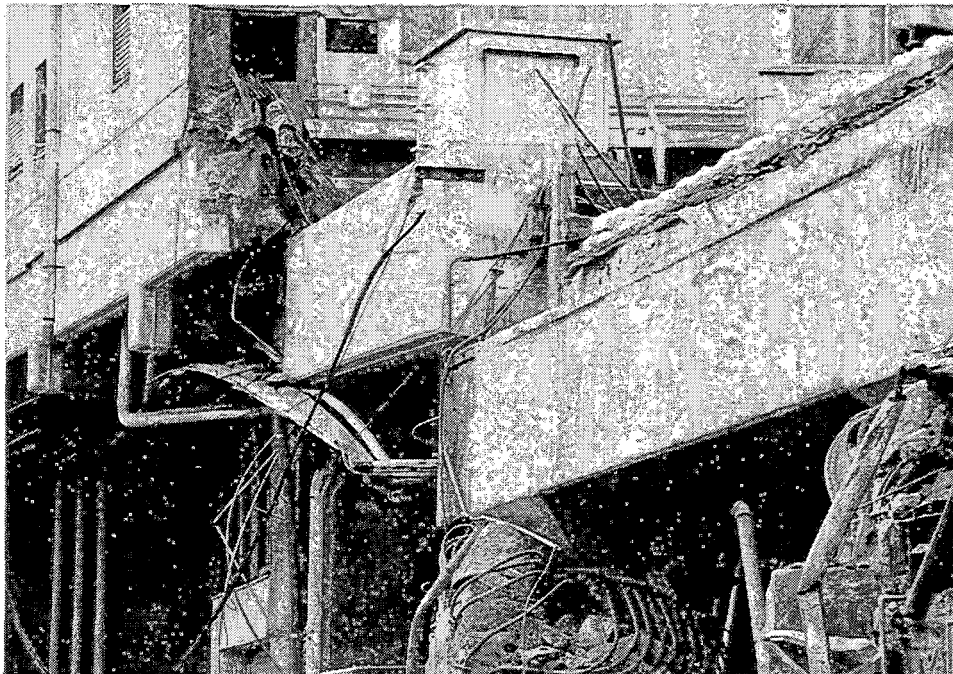
HER-18. The progressive collapse here is unusual.

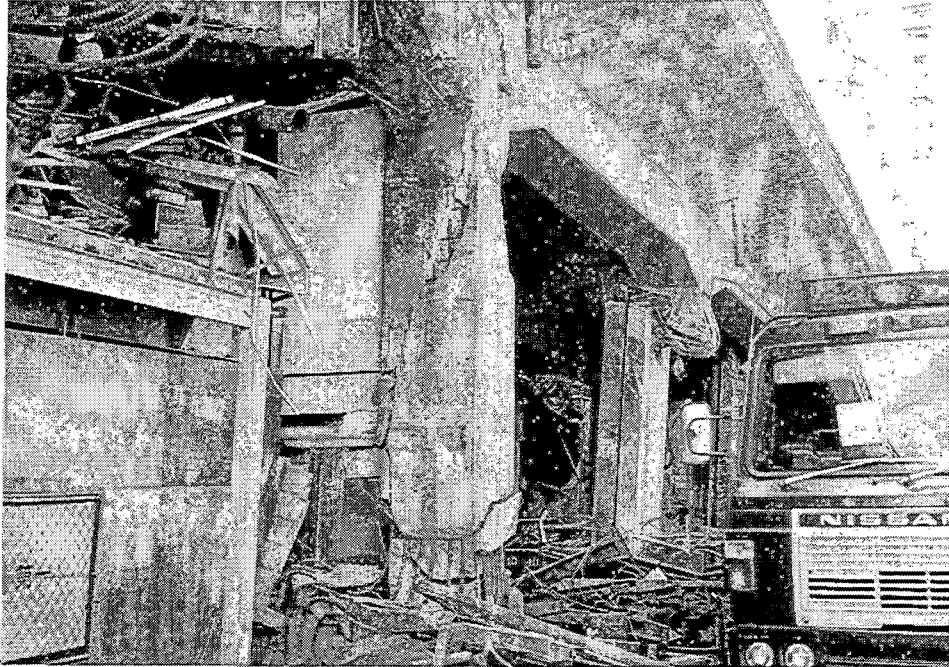
HER-19. This shear crack in the column is inclined much more than 45 degrees. Without the secondary frame system, damage extends to the footing.

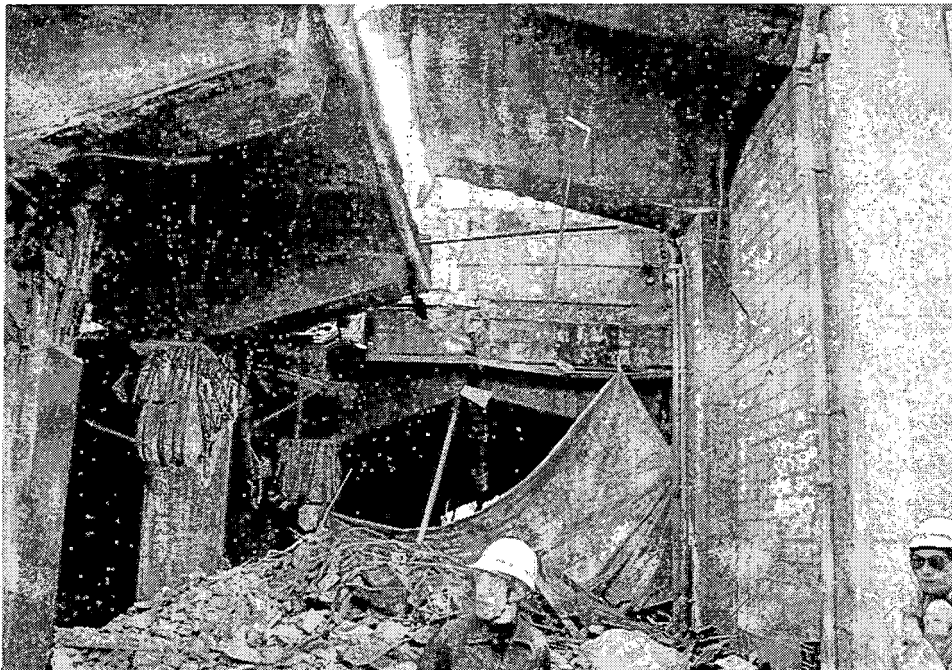
HER-20. The masonry infill wall on the right seems to have helped by increasing shear capacity. Note the expansion joint at mid span and the adjoining parallel structure in the background.

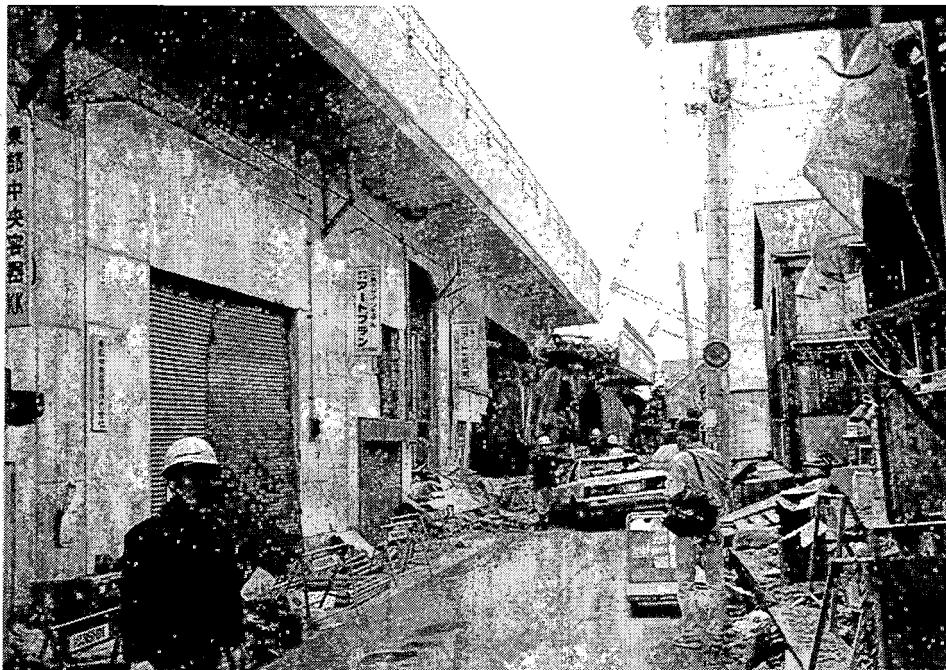
HER-21. The secondary framing and shear walls have had a very positive impact on this frame. The rubble and debris starting up the street prohibited our access and observation for the next three or four blocks.

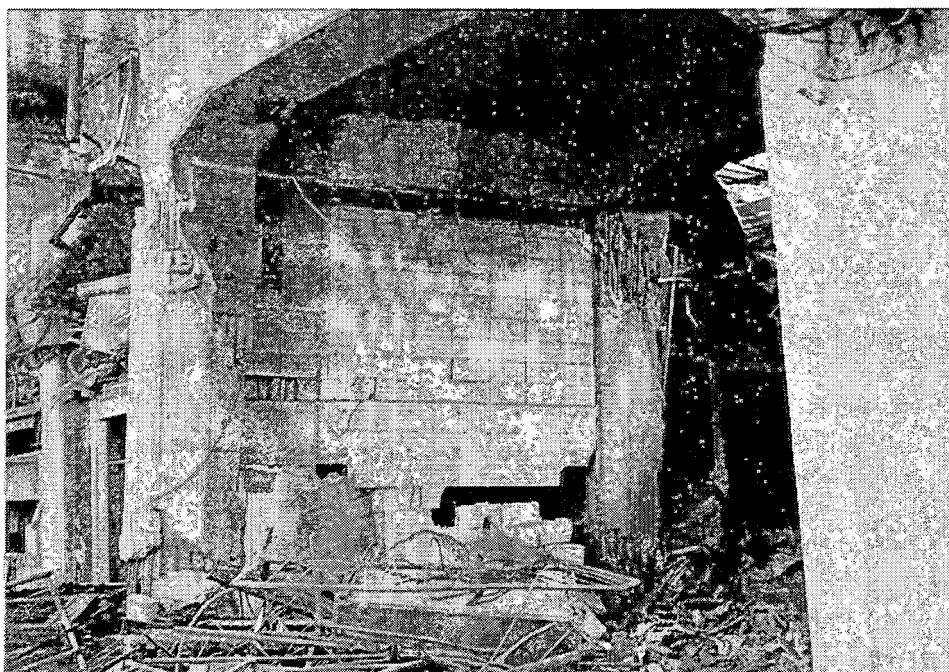
HER-22. This unreinforced infill wall did not have adequate shear capacity. Note the shear cracks in both columns at greater than 45 degree angles and the flexure damage at the base of the columns.

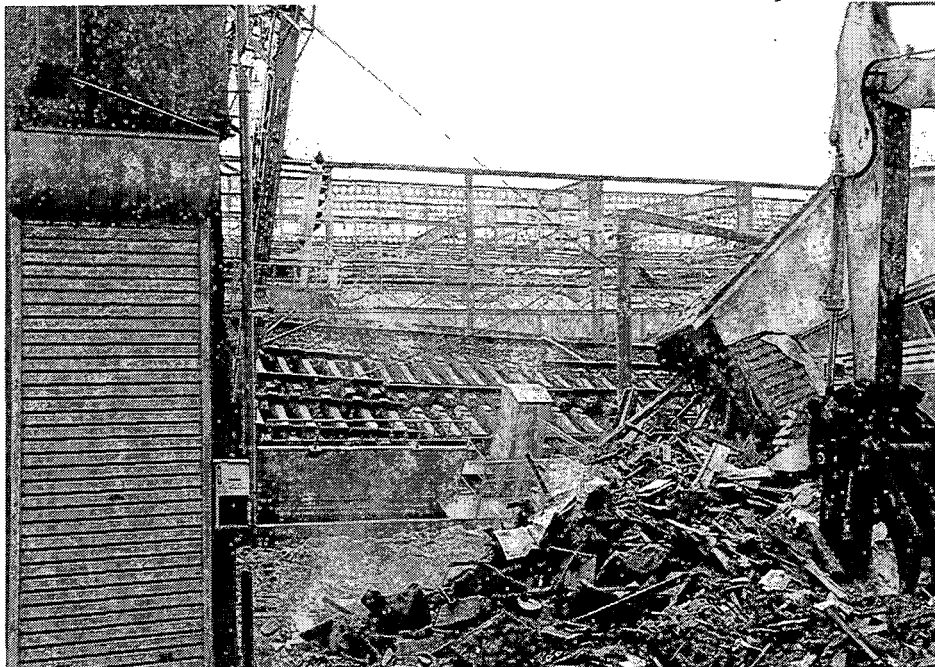
HER-24. The viaduct fell in the foreground. The train parking area in the background collapsed derailing 58 cars.

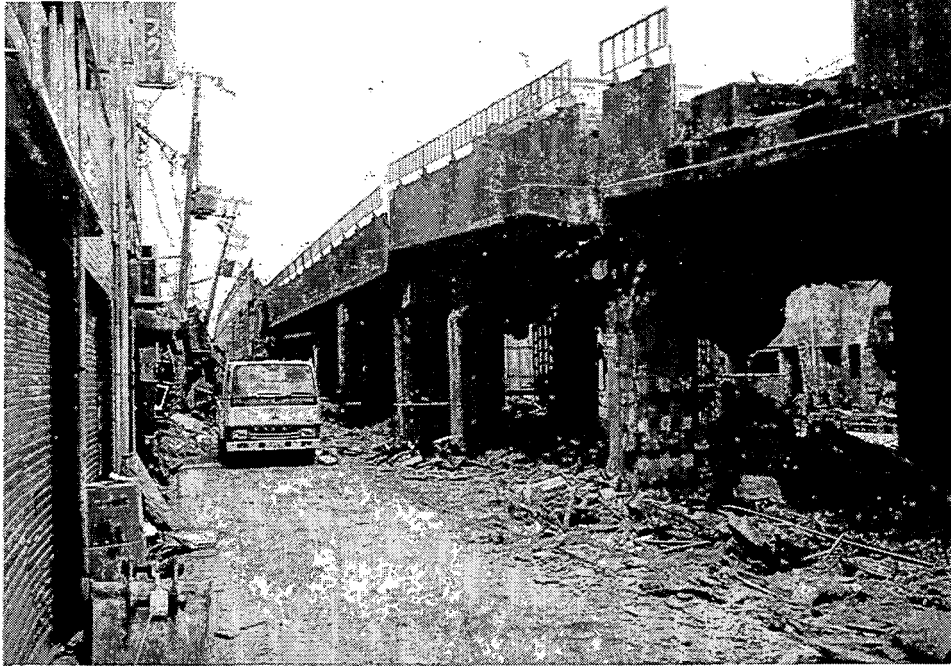
HER-25. Broken columns and disjointed superstructure will require demolition.

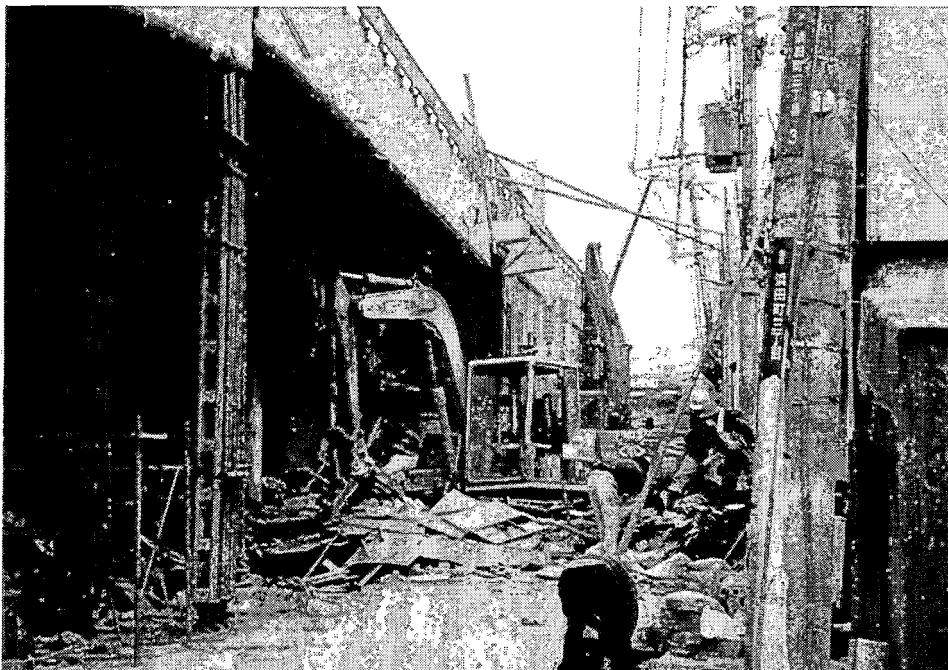
HER-27. More damage and debris is adjacent to the viaduct.

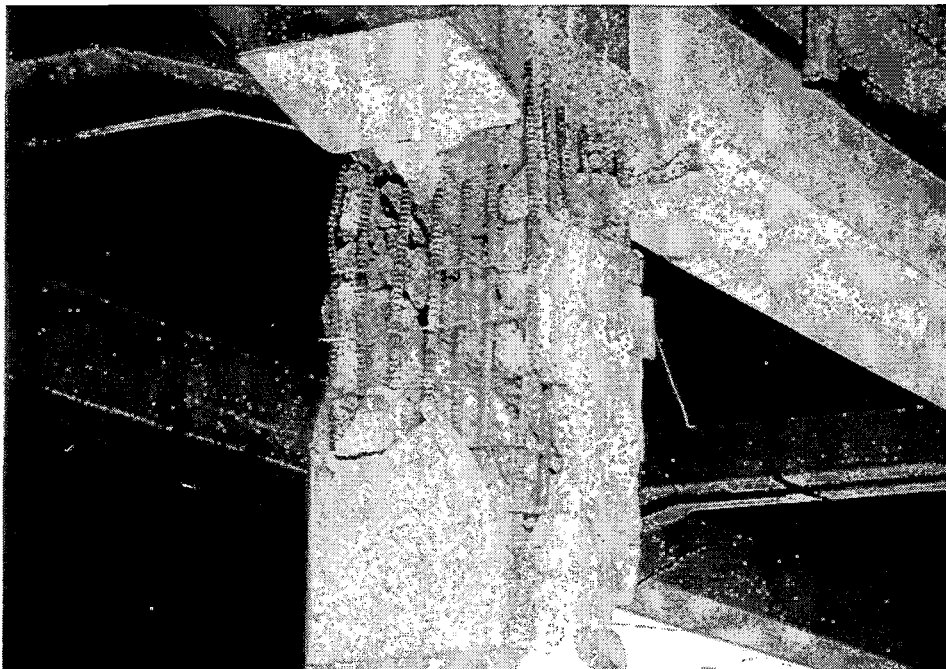
HER-32. Damage to a column west of Shinzaike Station; major transverse shear cracking and longitudinal spalling are evident.

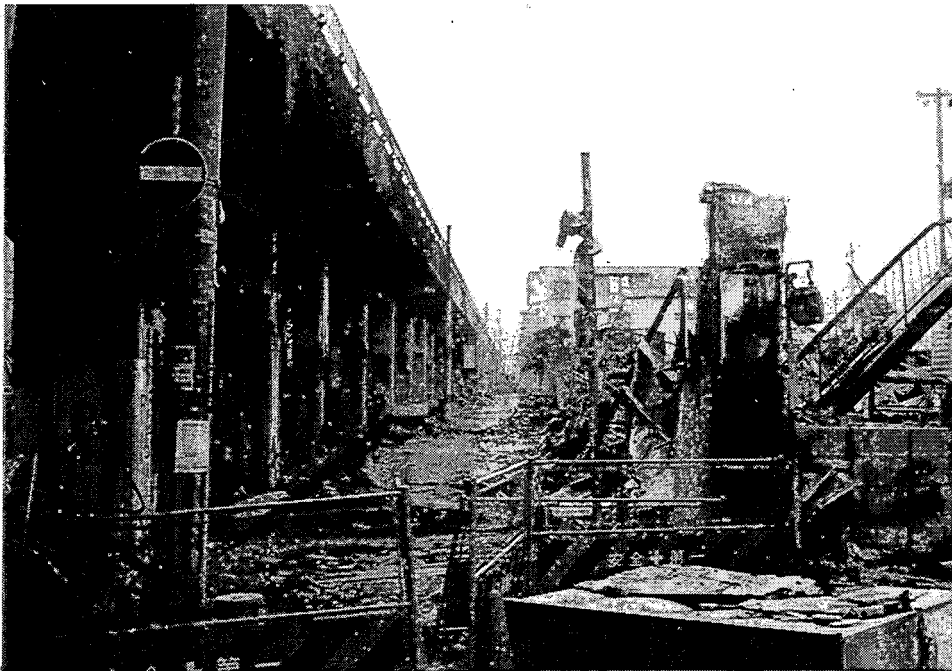
HER-34. West of the station the damaged viaduct continues for at least another kilometer. The structure was blackened by fires that consumed many blocks. There isn't as much damage here. The structure is a little taller.

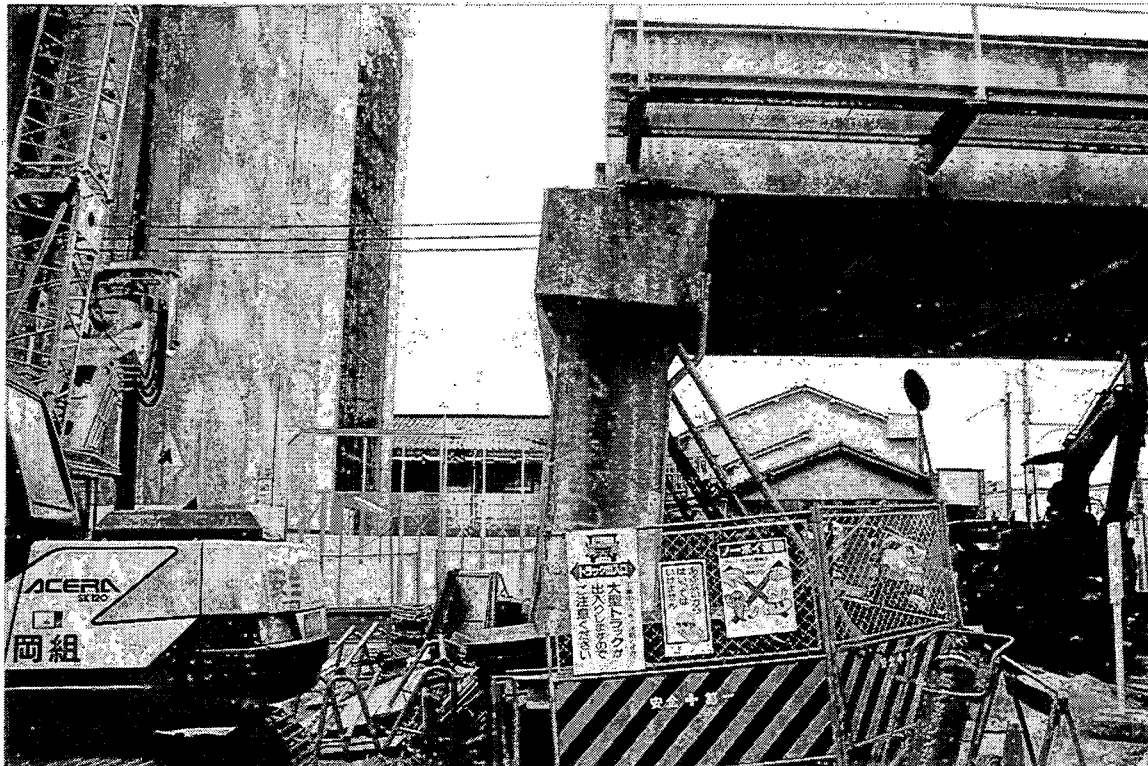
HC-9. The pier wall supporting this steel through girder is leaning significantly only at this end indicating the bearings slipped. The adjoining concrete structure was removed entirely.

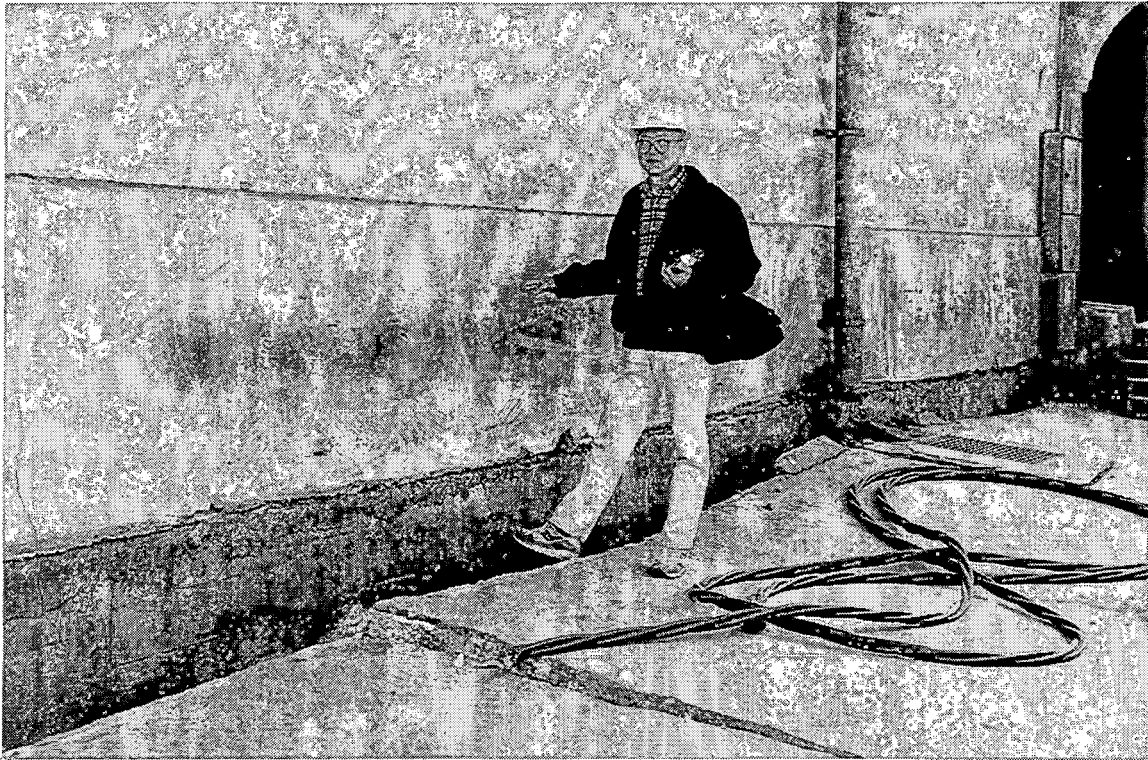
PI-7. This loading dock adjacent to the people mover displaced over 300 mm horizontally and over 400 mm vertically from the side of the warehouse.
