Seismic Damage Assessment of Rail Structures in Japan after the January 1995 Kobe Earthquake

**Parsons Brinckerhoff Quade & Douglas, Inc.
San Francisco, California**

April 1995

**U.S. Department of Transportation
Federal Railroad Administration
Office of Research and Development
Washington, DC 20590**

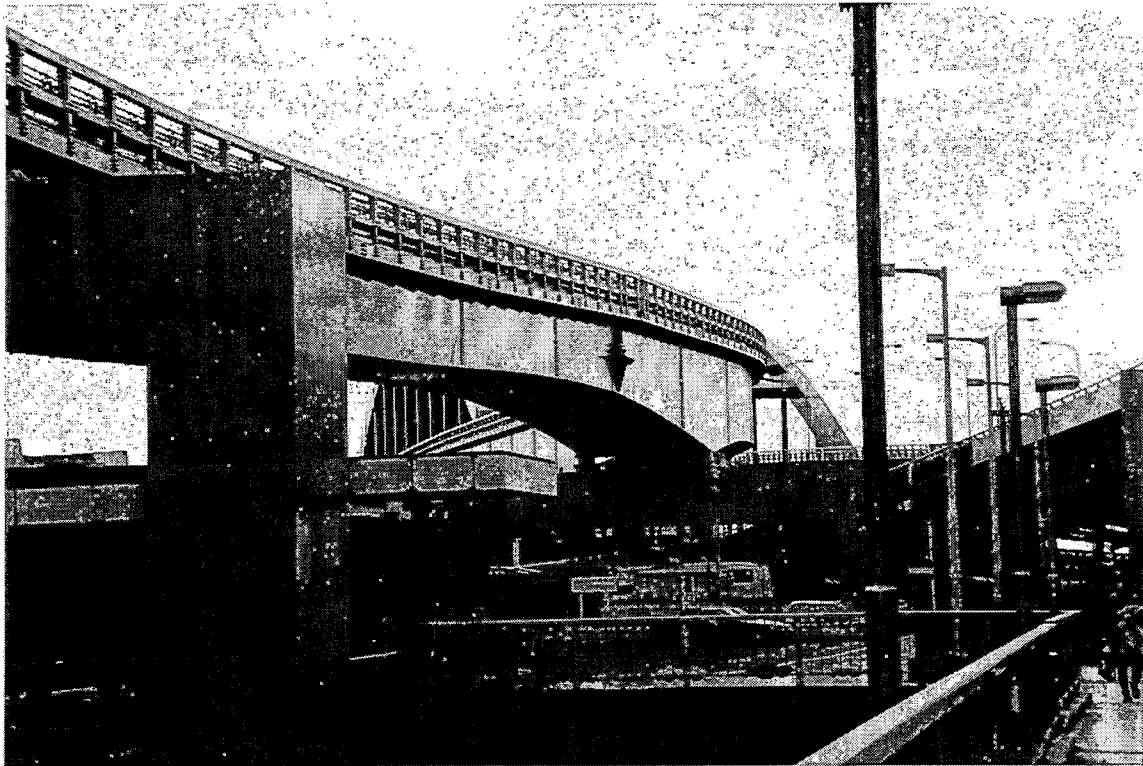
PI-11. The steel box girder span approaching the arch span was undamaged.

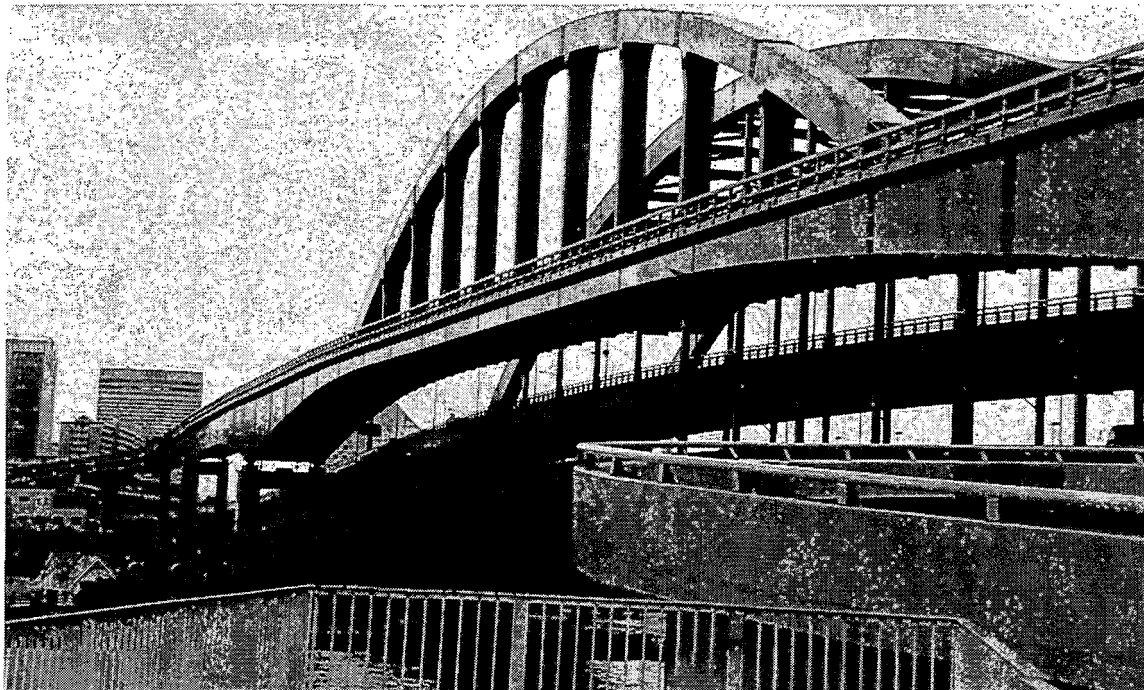
PI-13. The single arch bridge in the foreground carried the people mover south to Port Island. It appeared undamaged. The highway bridge at the bottom right was severely damaged in the next span. The double deck arch in the background supports highway traffic.

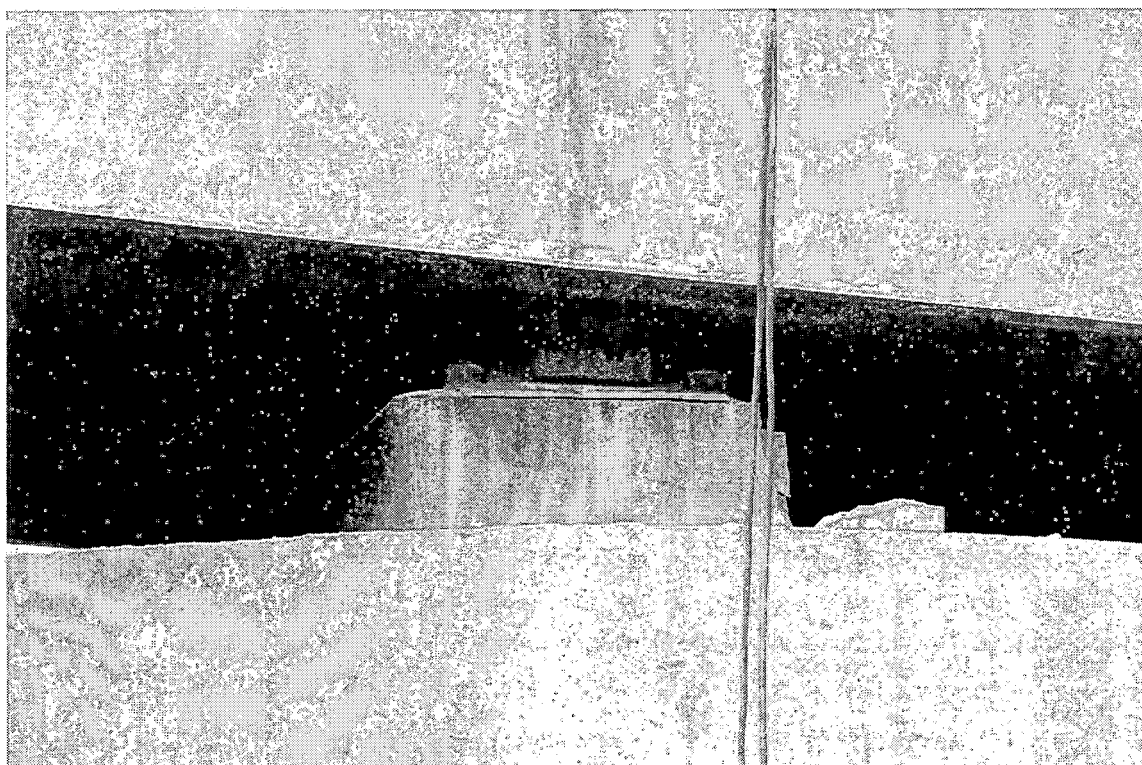
PI-18. A close-up of the the isolation bearing

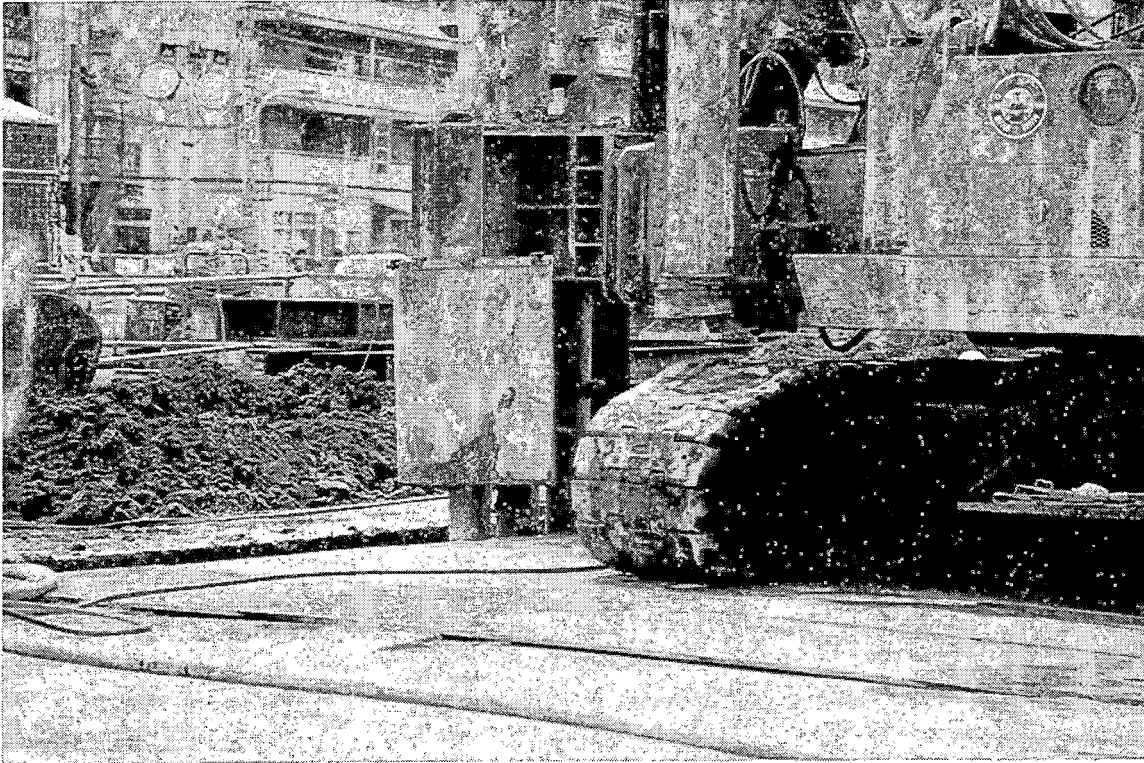
KMS-5. The contractor is constructing a soil cement wall with soldier piles to support the excavation of the station.

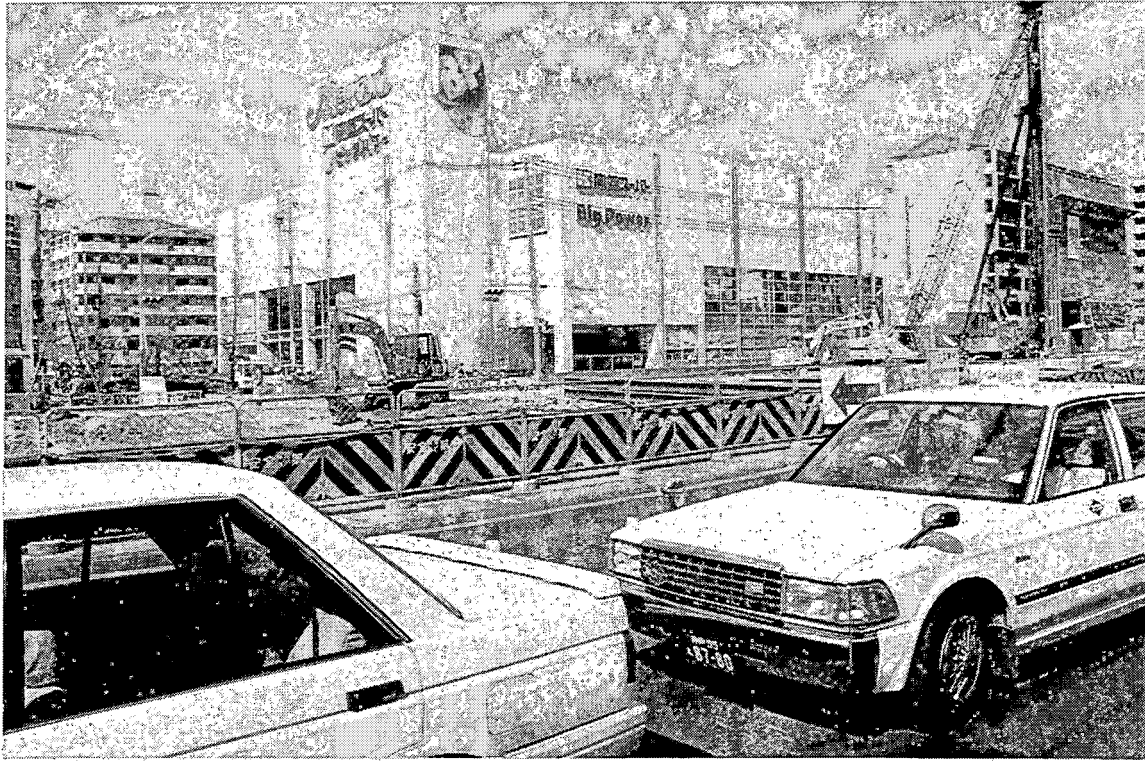
KMS-7. The buildings in the neighborhood of the failed station suffered minimal damage.
