**Federal Railroad
Administration**

Locomotive Fuel Vapor Reclamation System Field Evaluation and Cost-Benefit Analysis

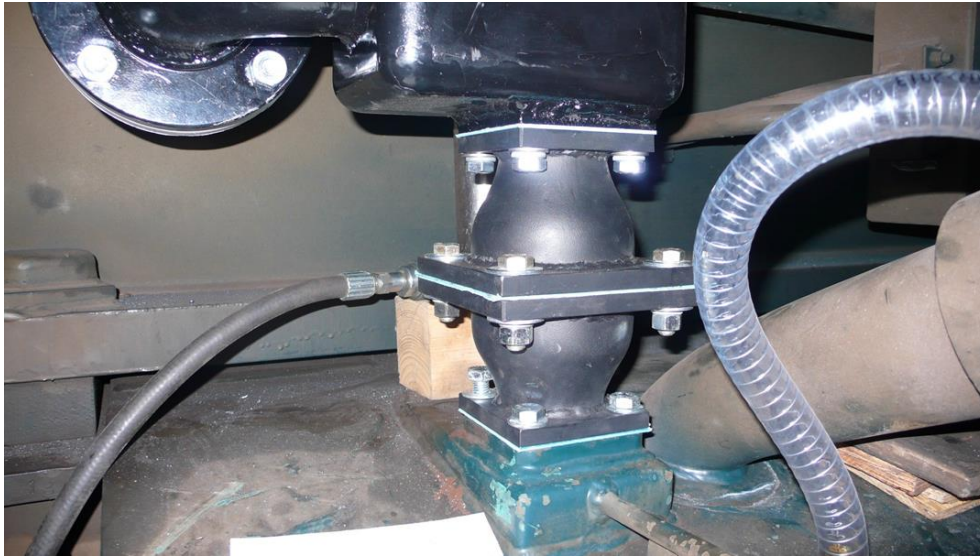
Figure 2. Modified vent pipe with float valve fitting

The original vent pipe was disconnected from a small vent box that permitted venting out the vapor-air mixture to the ambient. An “L” shaped pipe was connected to the top of the float valve assembly as shown in Figure 2. The float valve was intended to prevent flooding of the DVRU vapor suction pump and the condenser by the excess fuel in the event of accidental overfill of the tank by the BNSF maintenance staff during routine railroad refueling operations.

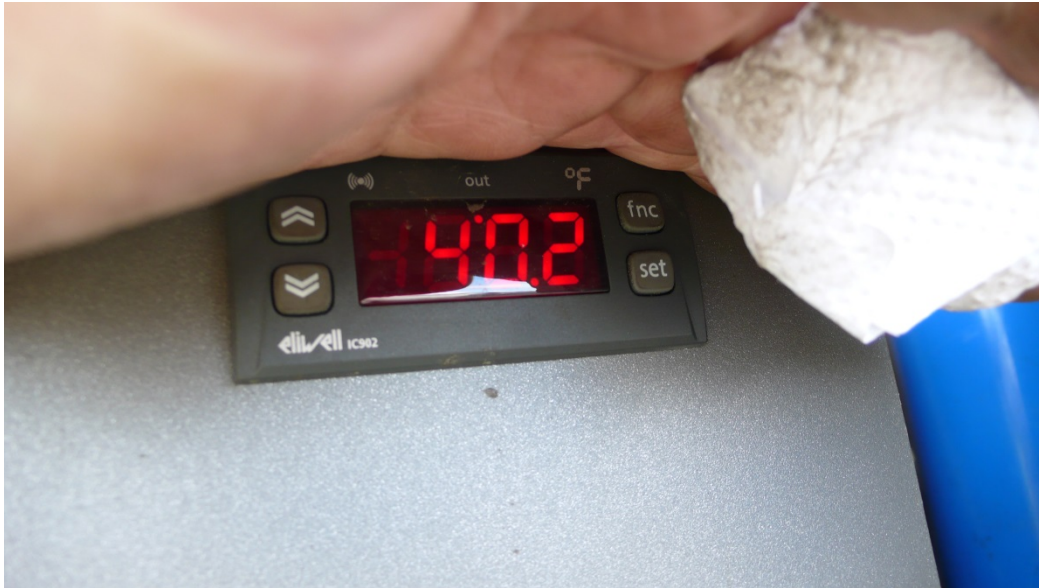
Figure 22. Chiller display showing status of circulating coolant temperature

The DVRU switches, both for the inverter and the monitoring equipment were found still ‘ON’ as shown in Figure 21, and the chiller unit was still functioning normally at its preset temperature of 40 °F as shown in Figure 22.

Because of the very little time available, it was not possible for the QNA engineers to repair, replace and test all components of the DVRU at Mandan to make it fully functional and to install an additional water-proof cover to effectively protect the electronics control box against future pressurized water ingress. To retrieve the residual recorded data from the Data Taker, QNA personnel brought the unit back to QNA. Further, the team switched off the inverter to shut down the fan and the chiller unit until the whole DVRU system could be checked and powered 'ON' at a BNSF Maintenance Depot.
