## Appendix A.1: Equipment Interactions

## Appendix A.2.1: Additional Detail on Structural Damage to Passenger Locomotive and Cars

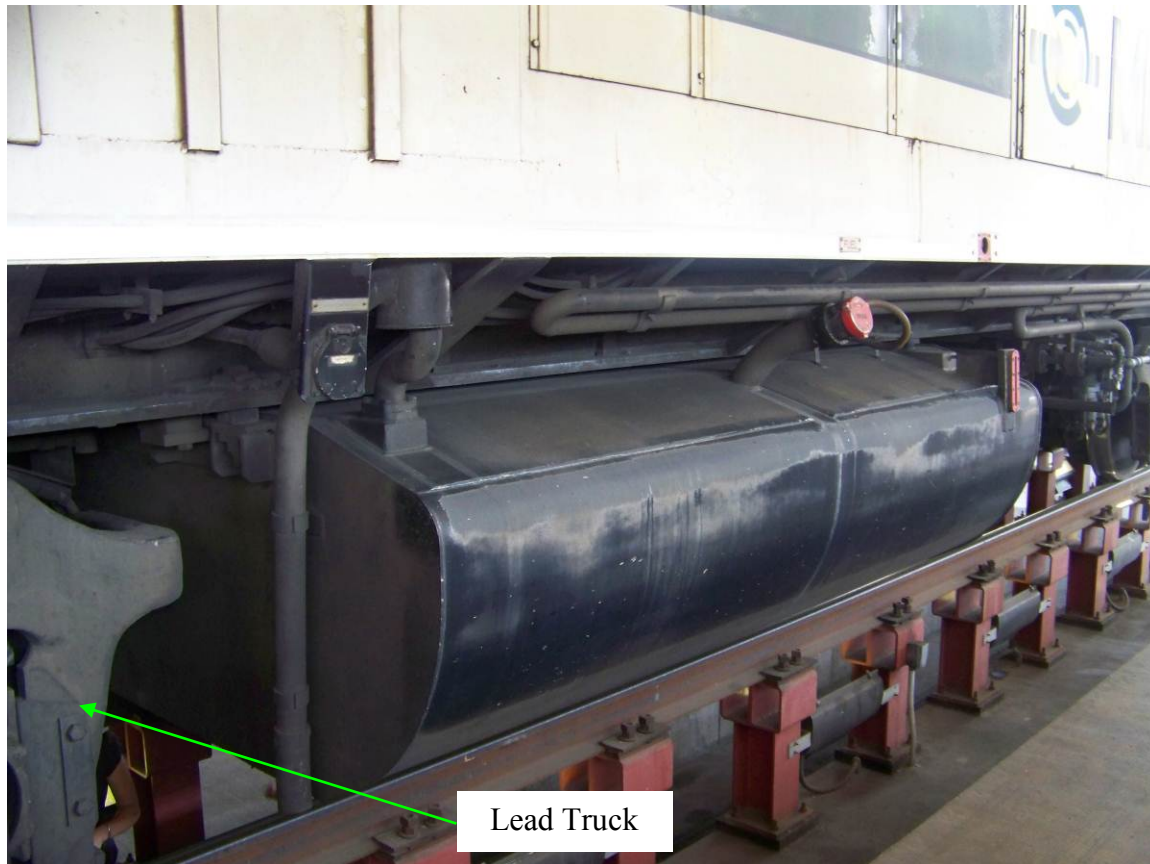
**Figure A.3-1. Exemplar Passenger Locomotive Fuel Tank**

An exemplar fuel tank, on an undamaged locomotive of the type involved in the accident, is shown in Figure A.3-1. The lead end of this fuel tank is located inboard of the lead truck, which is indicated in the figure.

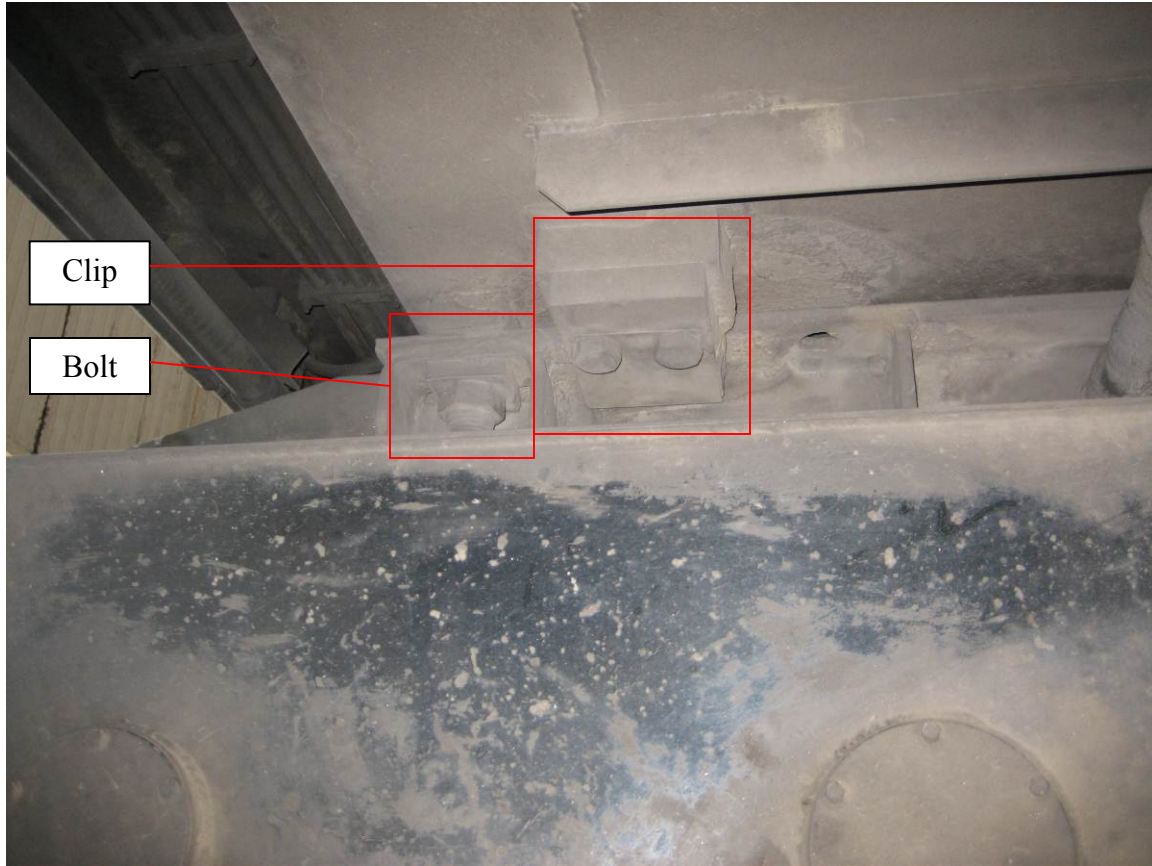
**Figure A.3-2. Fuel Tank Attachment to Underframe**

The fuel tank on this type of locomotive is suspended from the underframe of the locomotive, attached to the locomotive by bolts and clips, as shown in Figure A.3-2. This arrangement is found at the four corners of the fuel tank. The particular location shown in Figure A.3-2 is at the rear of the fuel tank, on the locomotive's left-hand side.

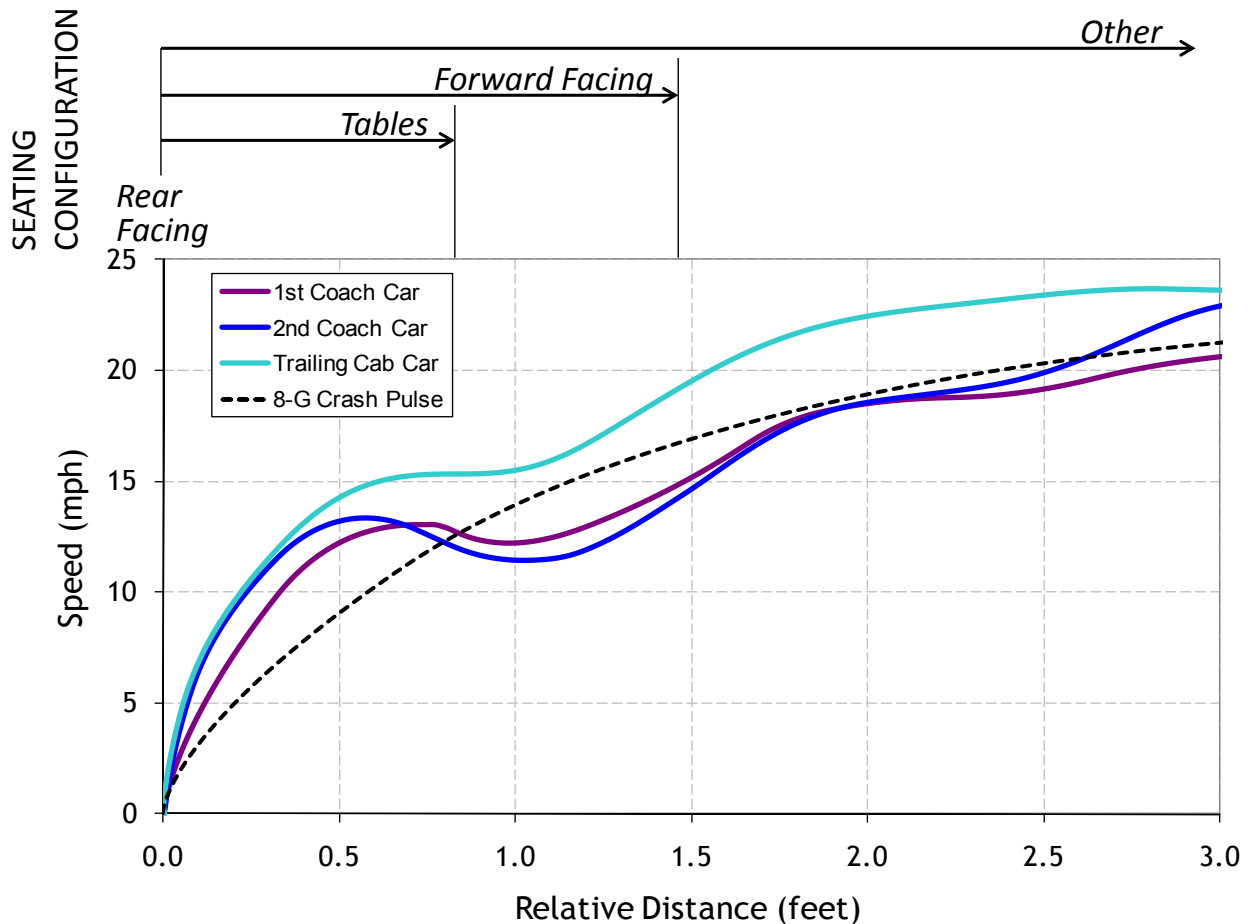
**Figure A.4-5. Secondary Impact Velocities for Each Occupied Vehicle**

Figure A.4-5 shows the SIVs for the passenger train. The horizontal axis at the bottom of the plot represents the distance travelled for an occupant in free flight with respect to the carbody (which varies with seating configuration as shown at the top of the plot). The vertical axis represents the velocity of an occupant in free flight, also with respect to the carbody. The first 0.3 seconds of the gross motions in Figure A.4-4 are used to plot the relevant SIV data for this accident. For comparison, the SIV plot associated with the 8-g crash pulse (used for passenger seat crashworthiness testing) is also plotted in the graph.
