**Federal Railroad
Administration**

In-Track Demonstration of Laser-Treated Rail to Reduce Friction and Wear

1. AGENCY USE ONLY (Leave blank)		2. REPORT DATE May 2007	3. REPORT TYPE AND DATES COVERED	
4. TITLE AND SUBTITLE In-Track Demonstration of Laser-Treated Rail to Reduce Friction and Wear			5. FUNDING NUMBERS DTFR 53-00-C-00012 Task Order 226

9. SPONSORING/MONITORING AGENCY NAME(S) AND ADDRESS(ES) U.S. Department of Transportation Federal Railroad Administration Office of Research and Development, MS 20 1120 Vermont Avenue, NW Washington, DC 20590			10. SPONSORING/MONITORING AGENCY REPORT NUMBER DOT/FRA/ORD-07/17

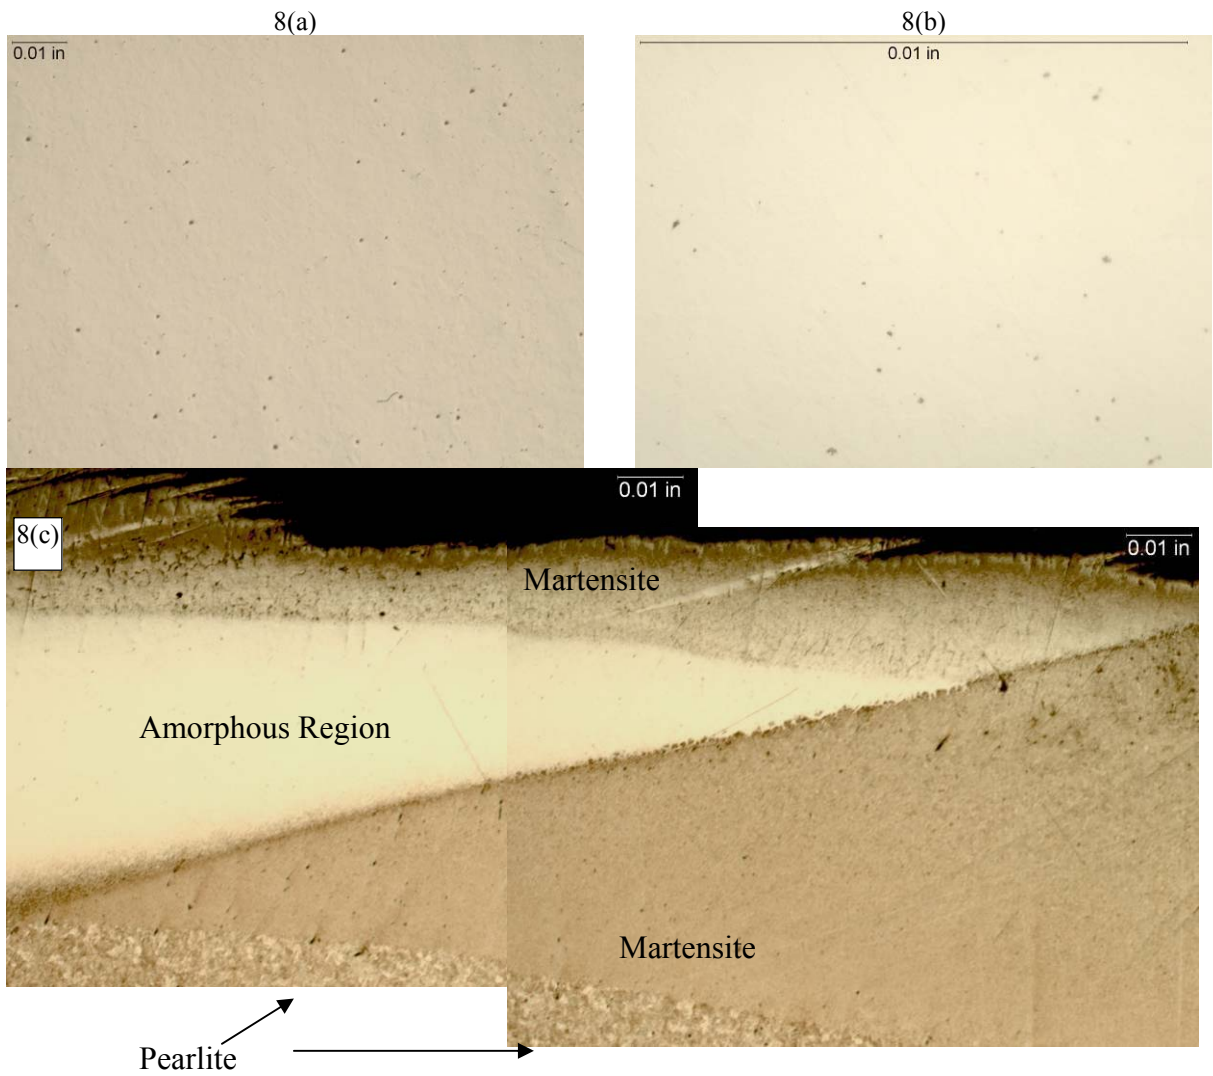
The microstructures of the laser-glazed samples were observed under various magnifications on both the polished and etched samples. The etching reagent used was NITAL 2 percent for ~3 seconds at room temperature. The polished surface for the non-service tested (gage and field) microstructures contained a limited number of inclusions (probably sulphurs) visible at low and high magnification (Figures A-8(a) and 8(b) respectively). Figure A-8(c) shows the etched microstructure where various regions can be identified as in agreement with a previous report conducted on laser-glazed rails [Ref.1]. These regions contain martensite, amorphous areas (presumably the white zones in Figure A-8(c)), and, in the lower part of the sample, the unaffected (non-glazed) region showing the fully pearlitic structure.

**Figures A-8(a) and 8(b). Microstructure of the Laser-Glazed Region After Polishing.
Figure A-8(c). Micrograph of the Various Regions Observed at the Glazed Regions**

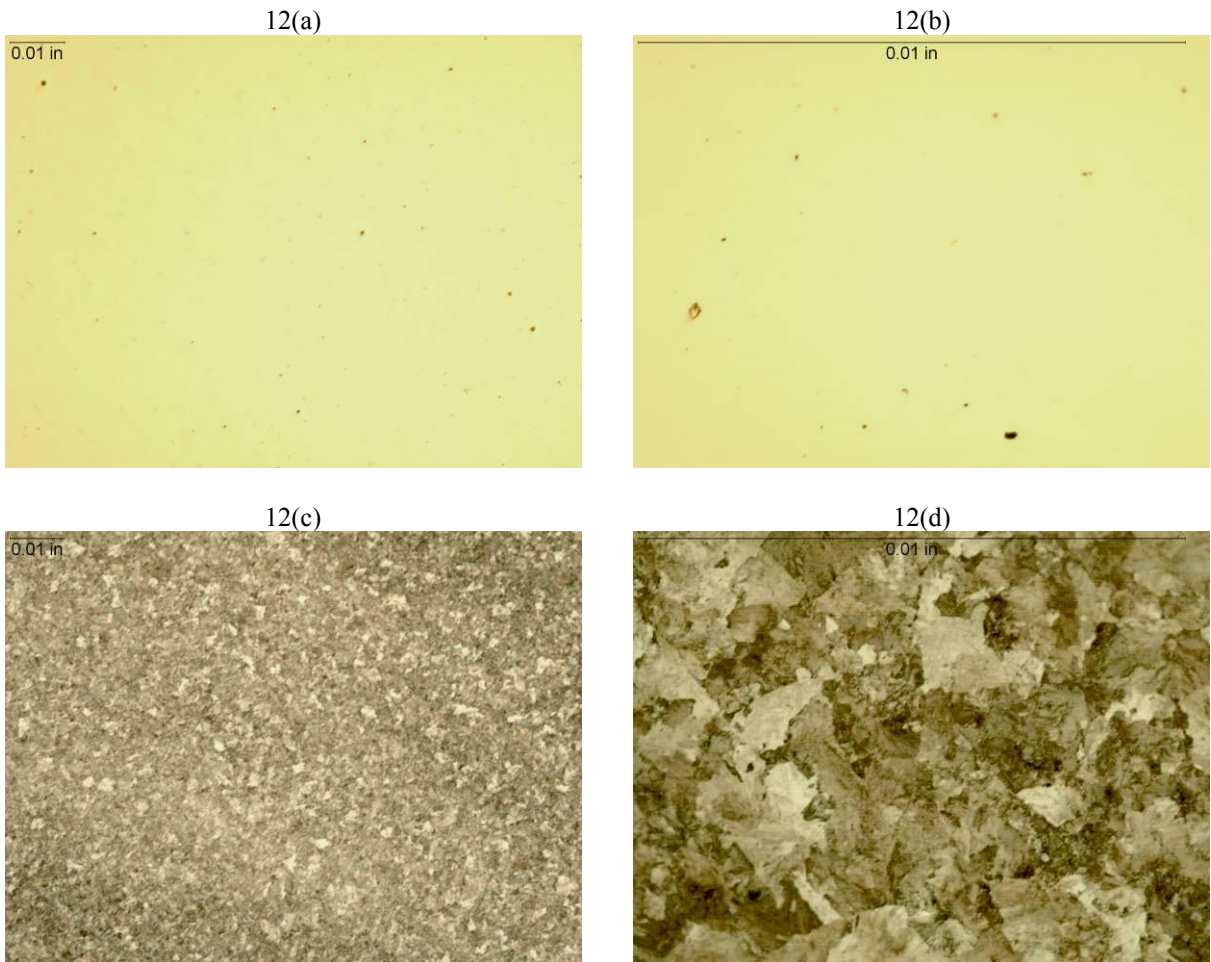
Figure A-12 shows the microstructures of the rail's field sections. For the field regions, only a set of pictures for the non-service tested and the service-tested rails is presented since the microstructure in either case shows no significant differences under various magnifications up to 500x. After polishing, the microstructure shows a low amount of inclusions, probably sulphurs; on the other hand, the etched microstructure is fully pearlitic as expected.

**Figures A-12(a) and 12(b). Microstructure for the Laser-Glazed Rail Showing as Polished Surface.
Figures A-12(c) and 12(d). Etched Microstructure.
Figures A-12(a) and 12(c). 50x Magnification.
Figures A-12(b) and 12(d). 500x Magnification**

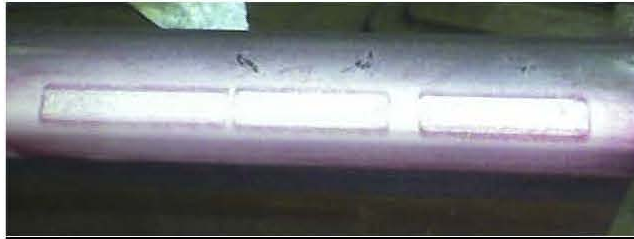
As shown in Photograph 3. Dye Penetrant testing was used on preliminary test glazing passes to check for cracks. There were no cracks observed.

Photograph 3: Dye Penetrant Testing Single Tracks

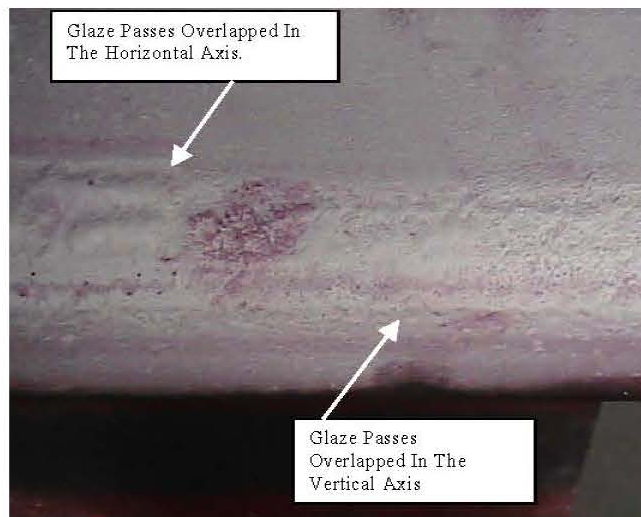
Photograph 4: Dye Penetrant Testing Of Overlapping Sections

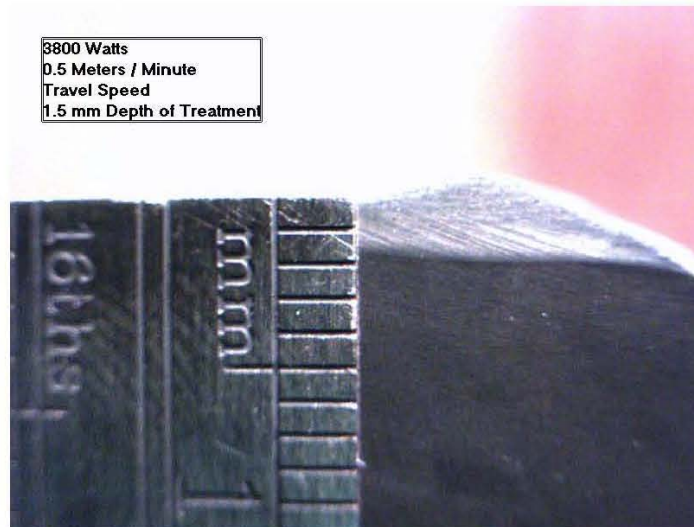
Photograph 5: Cross Section of Glazed Section Required 1-1/2 mm Treatment Depth.

- As shown in photographs 5 & 6, the preliminary test specimen rail was checked by cross sectioning, etching and measuring, to ensure the parameters used for glazing the 40’ rail section would produce the required treatment depth minimum of 1-1/2 mm deep.

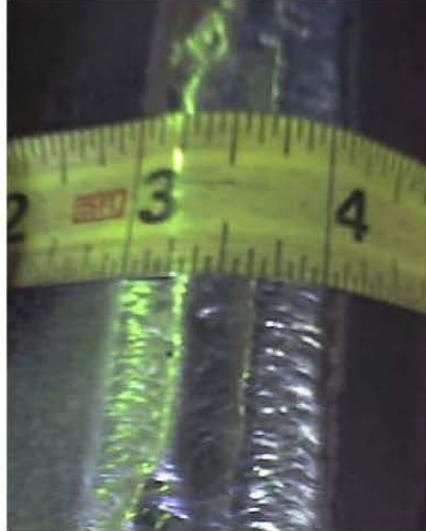
Photograph 7 shows the width of the laser glaze at 1" wide when using the parameters of 3800 Watts, .5 Meters/minute travel speed and 94mm focal length. This requires two overlapping tracks.

Photograph 7: 1" Glaze Width

As shown in photograph 7, the glazed section was measured to ensure the glazed region was “approximately 1 inch” wide.

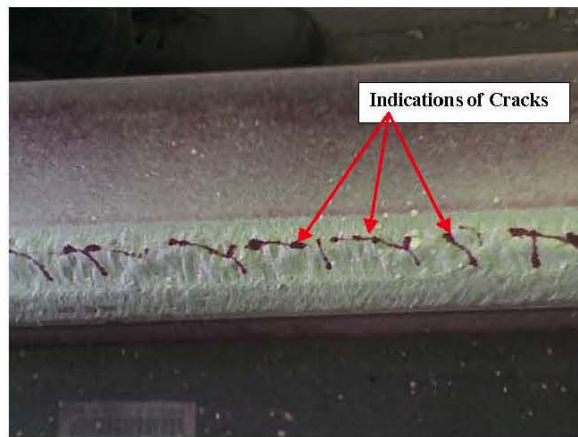
- The entire glazed section of rail was checked for cracks by using the Dye Penetrant method of inspection. Cracks were found along the entire length of the rail in the pass one area of the glaze. Photograph 11 shows the type of cracking that was found along most of the length of the rail section. Although the center of the rail section appeared to have some slight indications of cracking, the indications were less than (as can be seen in Photograph 12) the indications observed on the rest of the rail. It should be noted that the center section of the rail is where the rails had been previously welded together and ground smooth. The rest of the rail had mill scale on it. It was cleaned with a power wire brush prior to the laser glazing process.

Photograph 11: Dye Penetrant Inspection of 40’ rail section.

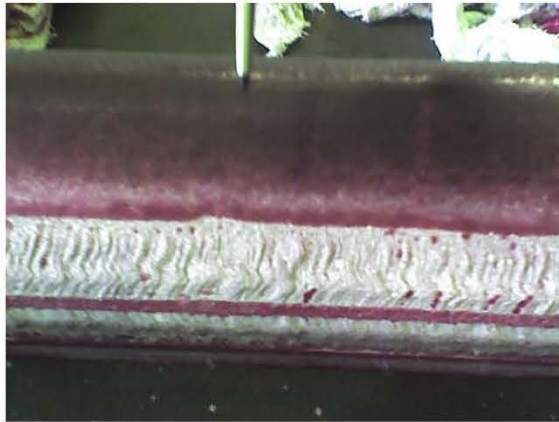
Photograph 12: Dye Penetrant Inspection Showing Center Section of Rail With Clean Ground Surface.
